THE ANCIENT ROOF OF GLASGOW CATHEDRAL: ITS CONDITION AND RESTORATION. BY W. T. OLDRIEVE, F.R.I.B.A., F.S.A. Scot.

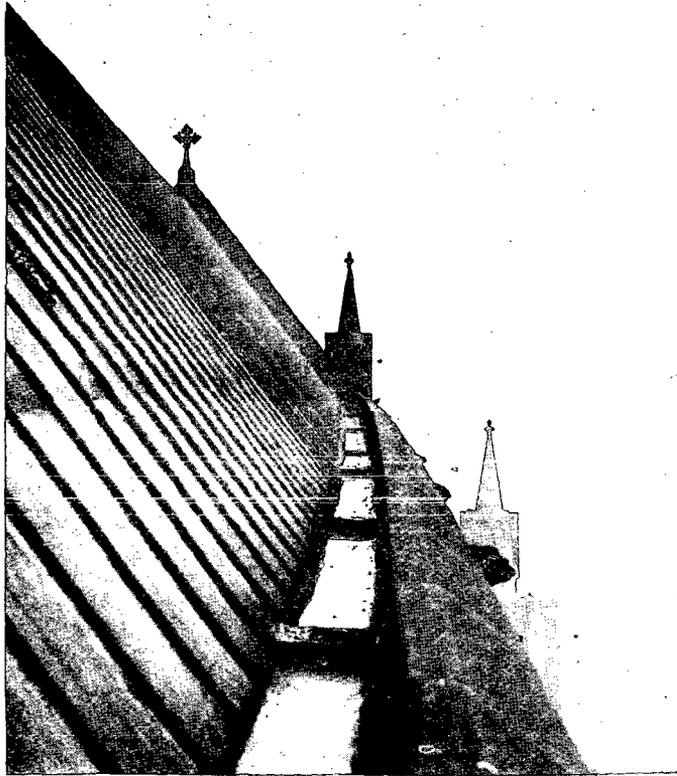
Measurements with the plumb line were taken at intervals, and it was found in 1909 that the maximum thrust was over the central north pillar of the nave, where, from the top of the capital of the main pillar to the wall-head, the wall-face was falling outward to the extent of $13\frac{5}{8}$ inches. In the choir the maximum thrust was on the south side near the second detached pillar from the east end, where the face of the wall was leaning outward at the top to the extent of $13\frac{1}{4}$ inches.

The views shown indicate better than any description which I can give what was discovered as regards the general state of the roof. Standing at one end of the gutter on either side of the nave or choir, and glancing along the parapet, what should be seen as a straight line is a very considerable curve (see fig. 1): indeed, to any one unaccustomed to ancient buildings the first impression is truly alarming, and suggests instability and danger which really do not exist if the process of the outward thrust is arrested.

Fig. 1. North Gutter of Roof over Nave, looking west, showing "bulge" of wall caused by thrust of old roof timbers.

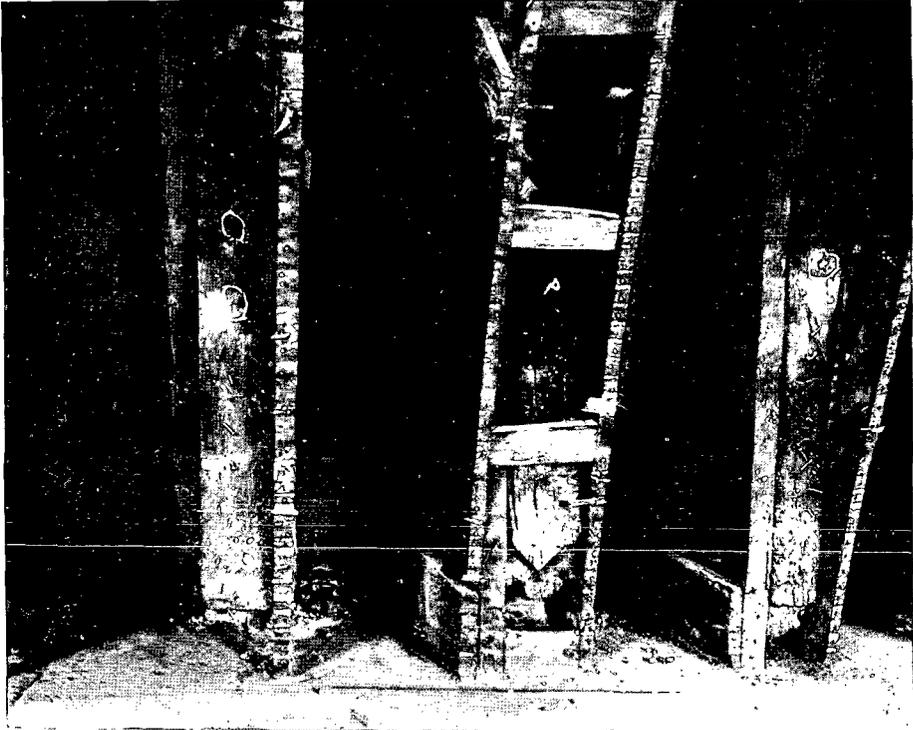
and had no bearing whatever upon the wall-head, as shown in figs. 2 and 3.

Fig. 3. Condition of old Rafters of Choir Roof, as seen from the inside, when stripped of plaster and lathing.

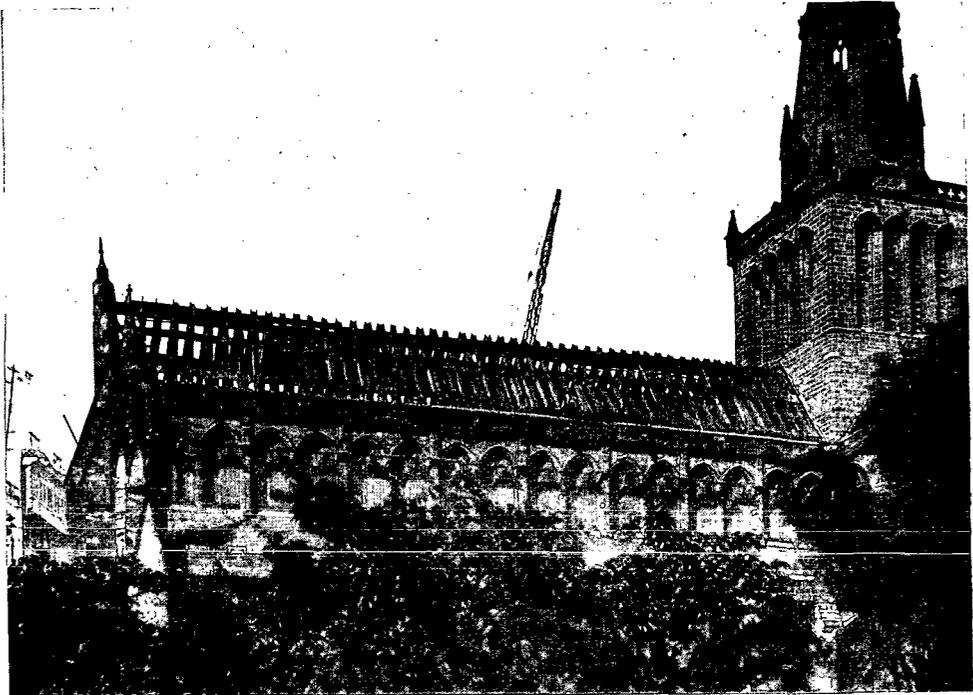
One great defect of the trussed-rafter type of construction, open or ceiled, was the absence of any longitudinal tie other than the wall-plate. A view, shown by fig. 5, of the old trussed-rafters of the nave, as exposed at Glasgow after removing the outside boarding, shows how the rafters have gradually moved over (about 12 inches at the apex) under pressure from the prevailing west wind. There can be little doubt, that but for the boarding and the resistance of the

tower, the roof would have collapsed for want of a longitudinal tie along the ridge.

Fig. 5. Old Roof over Nave, showing the rafters leaning over to eastward.

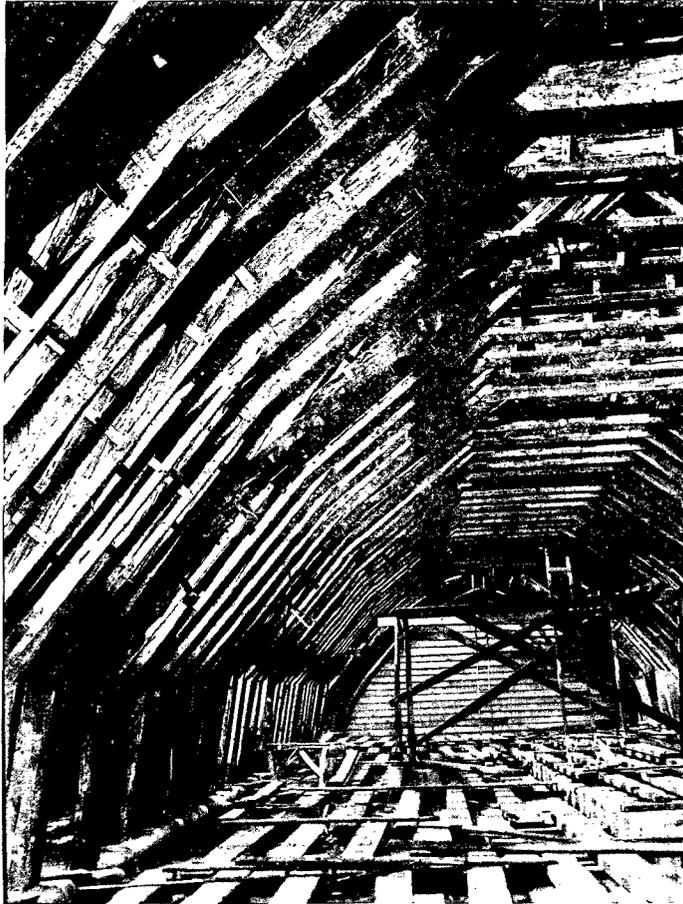
Fig. 7. Old Timbers of Nave Roof, as seen when stripped of plaster and lathing.

It was found on exposing the ancient timbers of the roof over the nave, as shown by fig. 7, that, unlike the choir roof, there was no

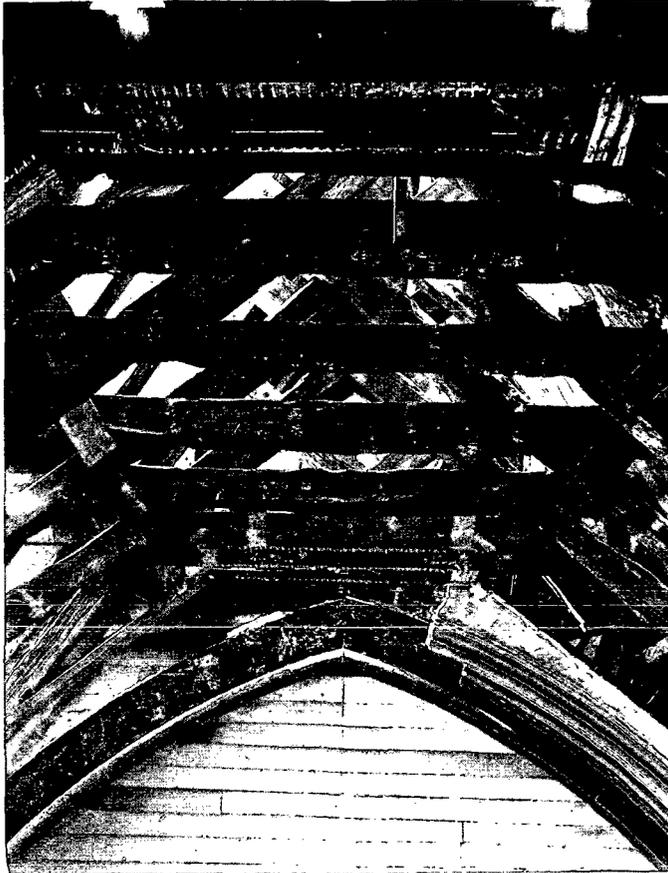
evidence whatever of there ever having been internal boarding. The timbers themselves were, as shown by fig. 8, of the same trussed-rafter type, but without the trefoil suggestion, while the length of the nave was divided into bays by massive bowtell-moulded lower edges to the

Fig. 8. View of the old Timbers at apex of Nave Roof.

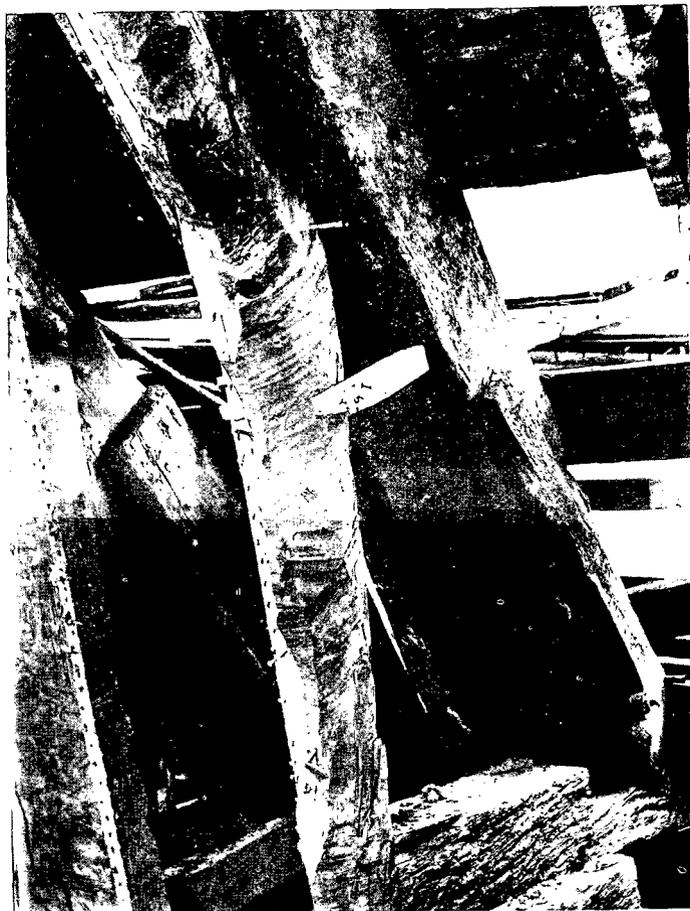
principal rafters over the main wall-shafts, as seen by fig. 9. Evidently there had been tie-beams at these points.

Fig. 9. One of the principal Rafters of Nave Roof, showing remains of bowtell moulding.

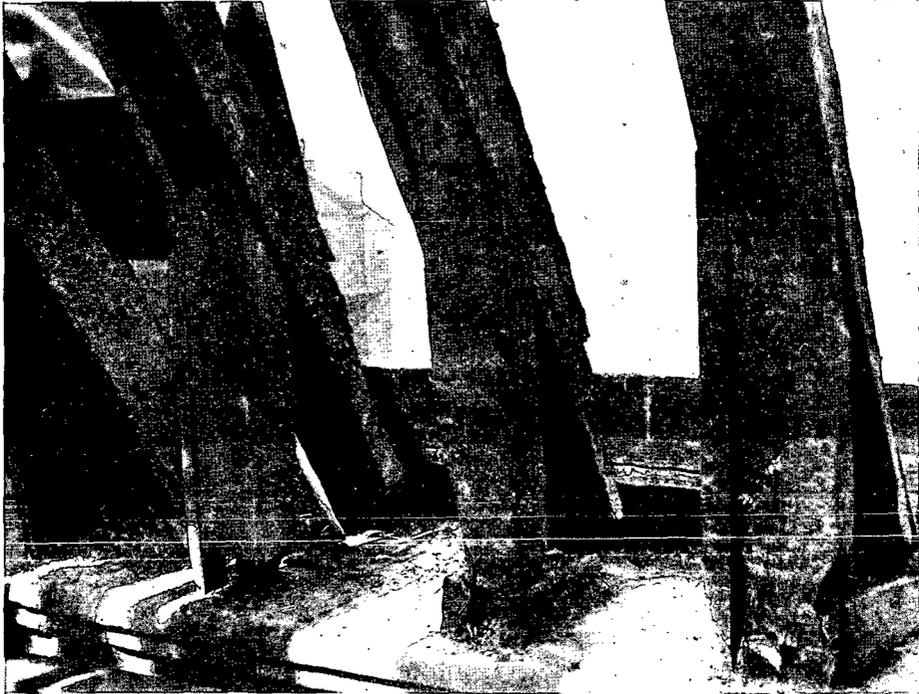
The condition of the old rafters is indicated by fig. 10; and while separate members of the old trusses have been re-used wherever the old oak was found sound enough for this to be possible, only one comparatively complete truss could be used in the nave roof, and only one complete trussed-rafter of the roof of the triforia.

Fig. 10. Condition of old Rafters of Nave Roof at the wall-head.

respect of those parts where the construction was known to be defective, by hidden supplementary steel. This was achieved, firstly, by relieving the main walls of outward thrust, and, secondly, by providing longitudinal rigidity. So far as the choir is concerned these objects have been attained by setting steel trusses at intervals of about

12 feet between the rafters, sufficiently strong to resist the entire strain of dead load plus stress of wind and weather, and by means of steel joists as purlins to transmit the weight of the whole of the oak trussed-rafters to the steel trusses, so that there can be nothing but vertical pressure upon the walls. In the second place, longitudinal rigidity has been attained by means of these steel purlins riveted to the steel ribs and built into the walls of the tower and the east gable, also by

continuous double steel wall-plates upon the wall-head. The steel reinforcement has in the nave also been adopted in such a way as to relieve the timbers of excessive strain both laterally and longitudinally: the tie-beams have steel fitch-plates 12 inches \times $\frac{1}{2}$ inch secured by adequate angle plates and bolts to steel angles 6 \times 6 inches, and resting on double steel wall-plates 3 inches \times 1 inch, such wall-plates forming, as in the choir, continuous longitudinal straps anchored at the ends to the tower and to the west gable. Other two similar steel bands 3 inches \times $\frac{1}{2}$ inch form a sufficient ridge tie to resist any possible strain longitudinally at the apex of the roof. Architecturally I should have preferred to omit the

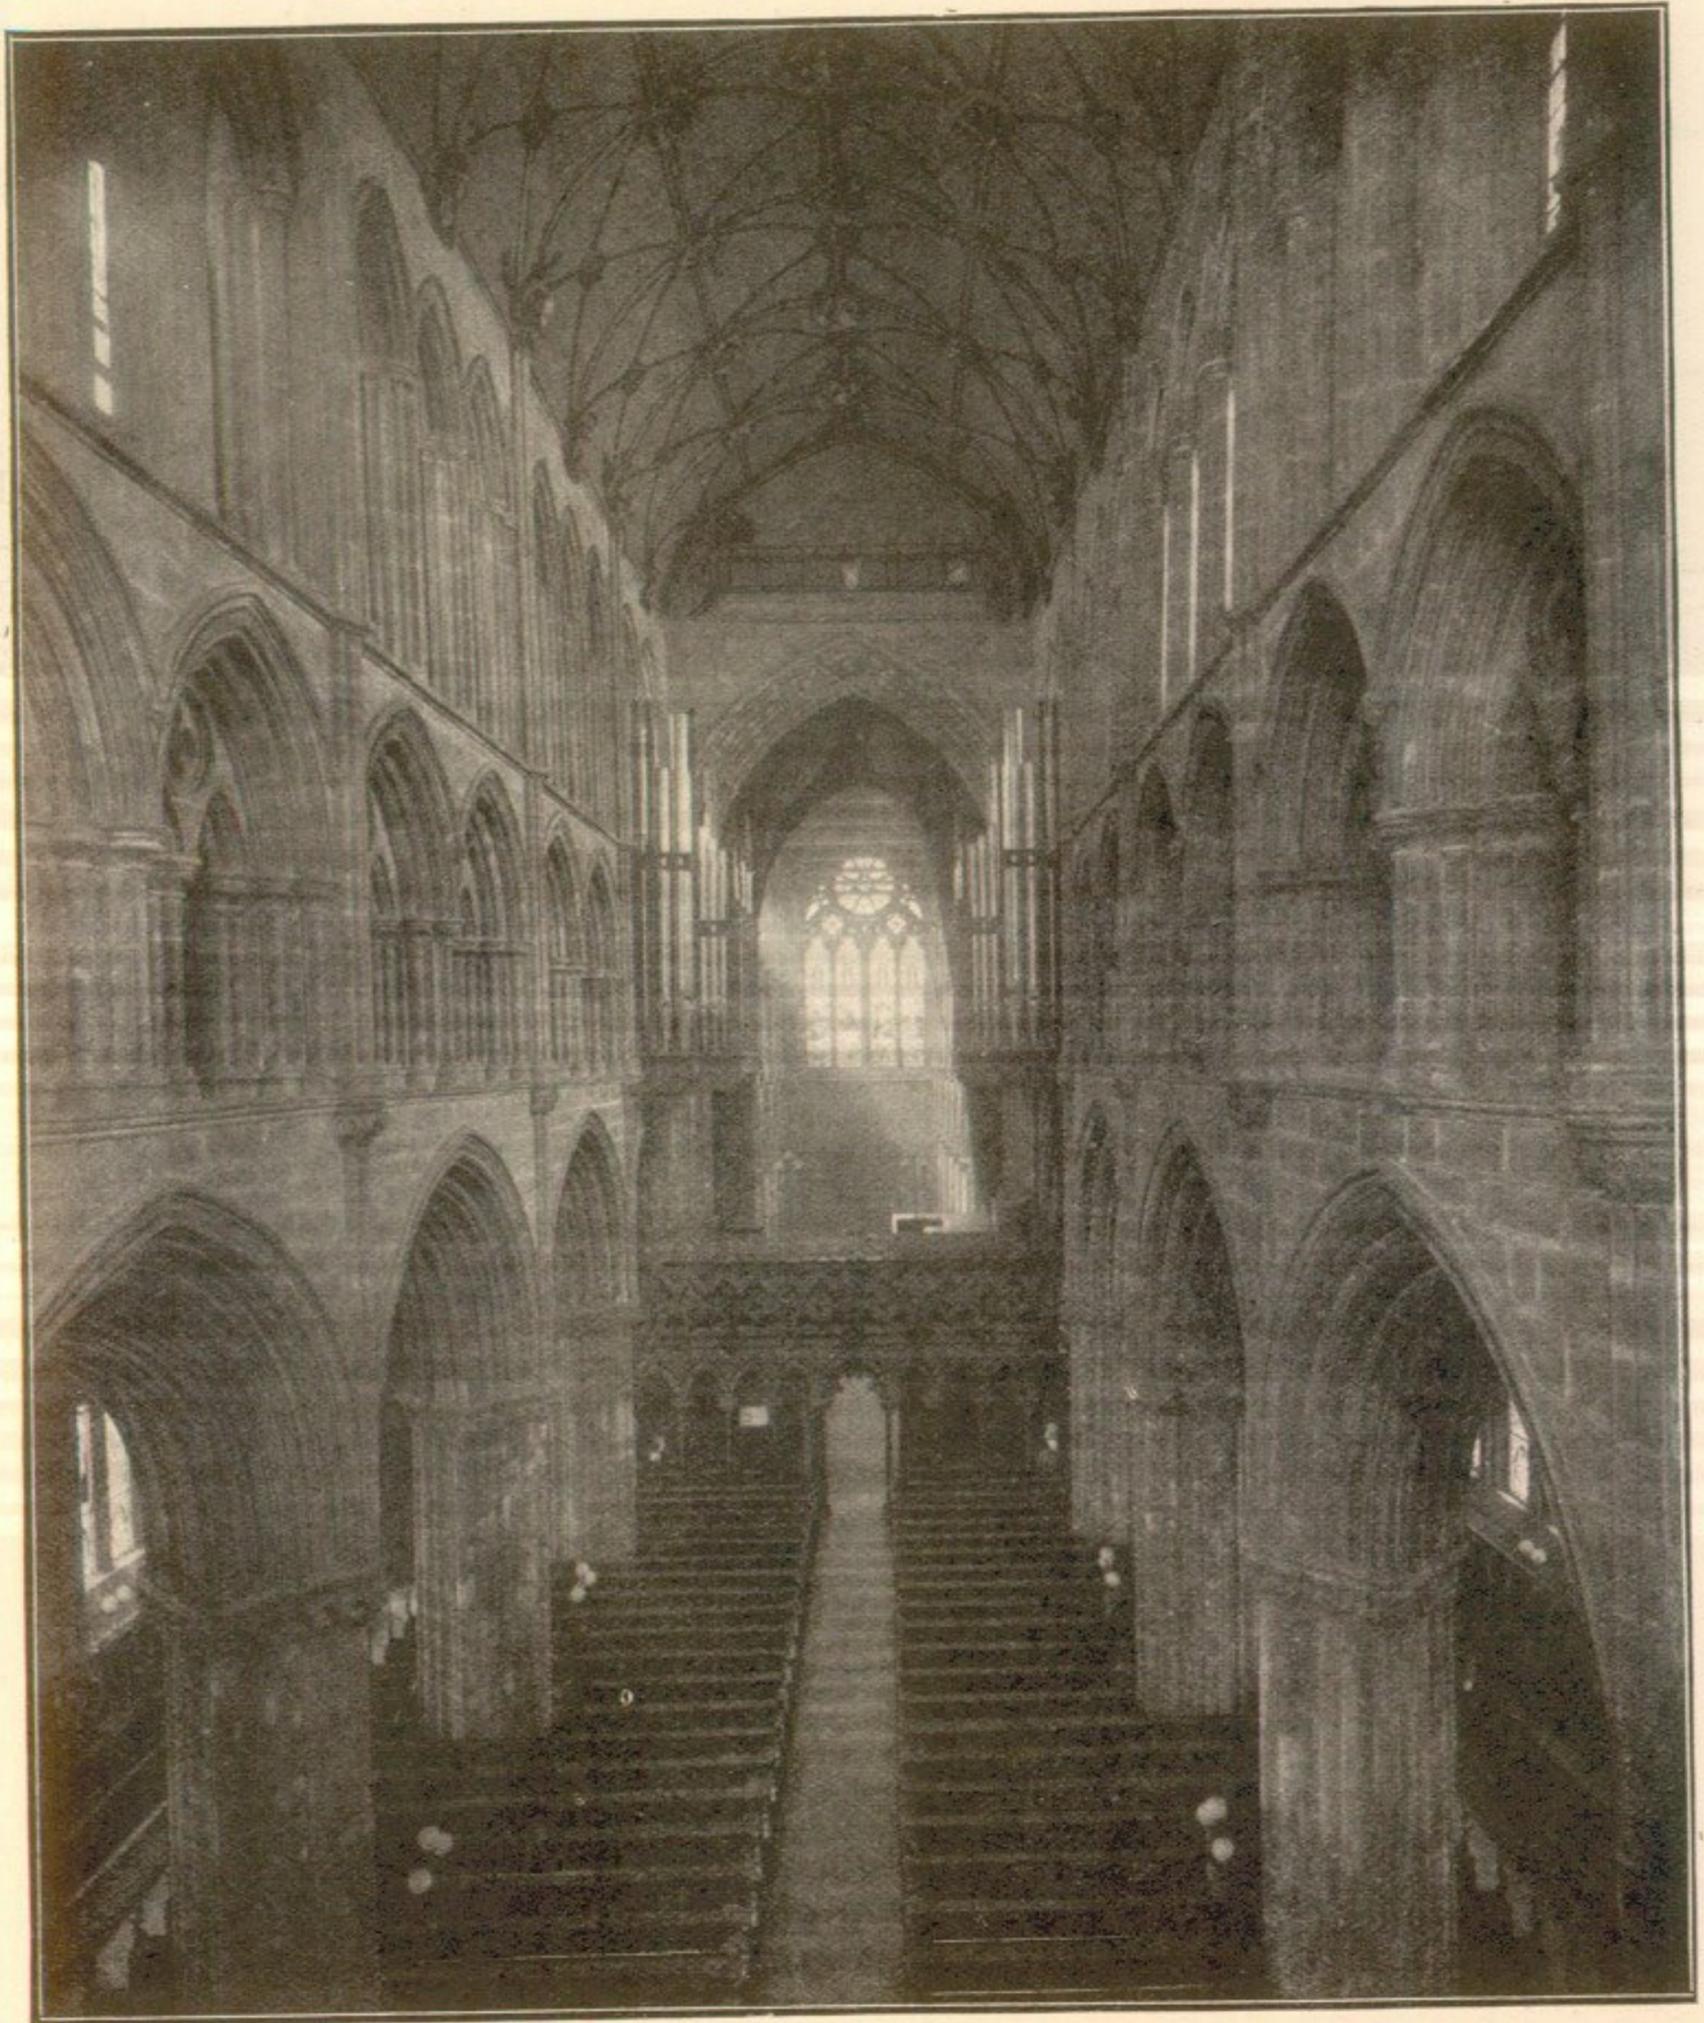
Fig. 11. Interior of Choir, looking west, and showing the oak roof restored.

The appearance of the interior of the Cathedral after the completion of the new roofs is shown by fig. 11 of the choir, and by fig. 12 of the nave.

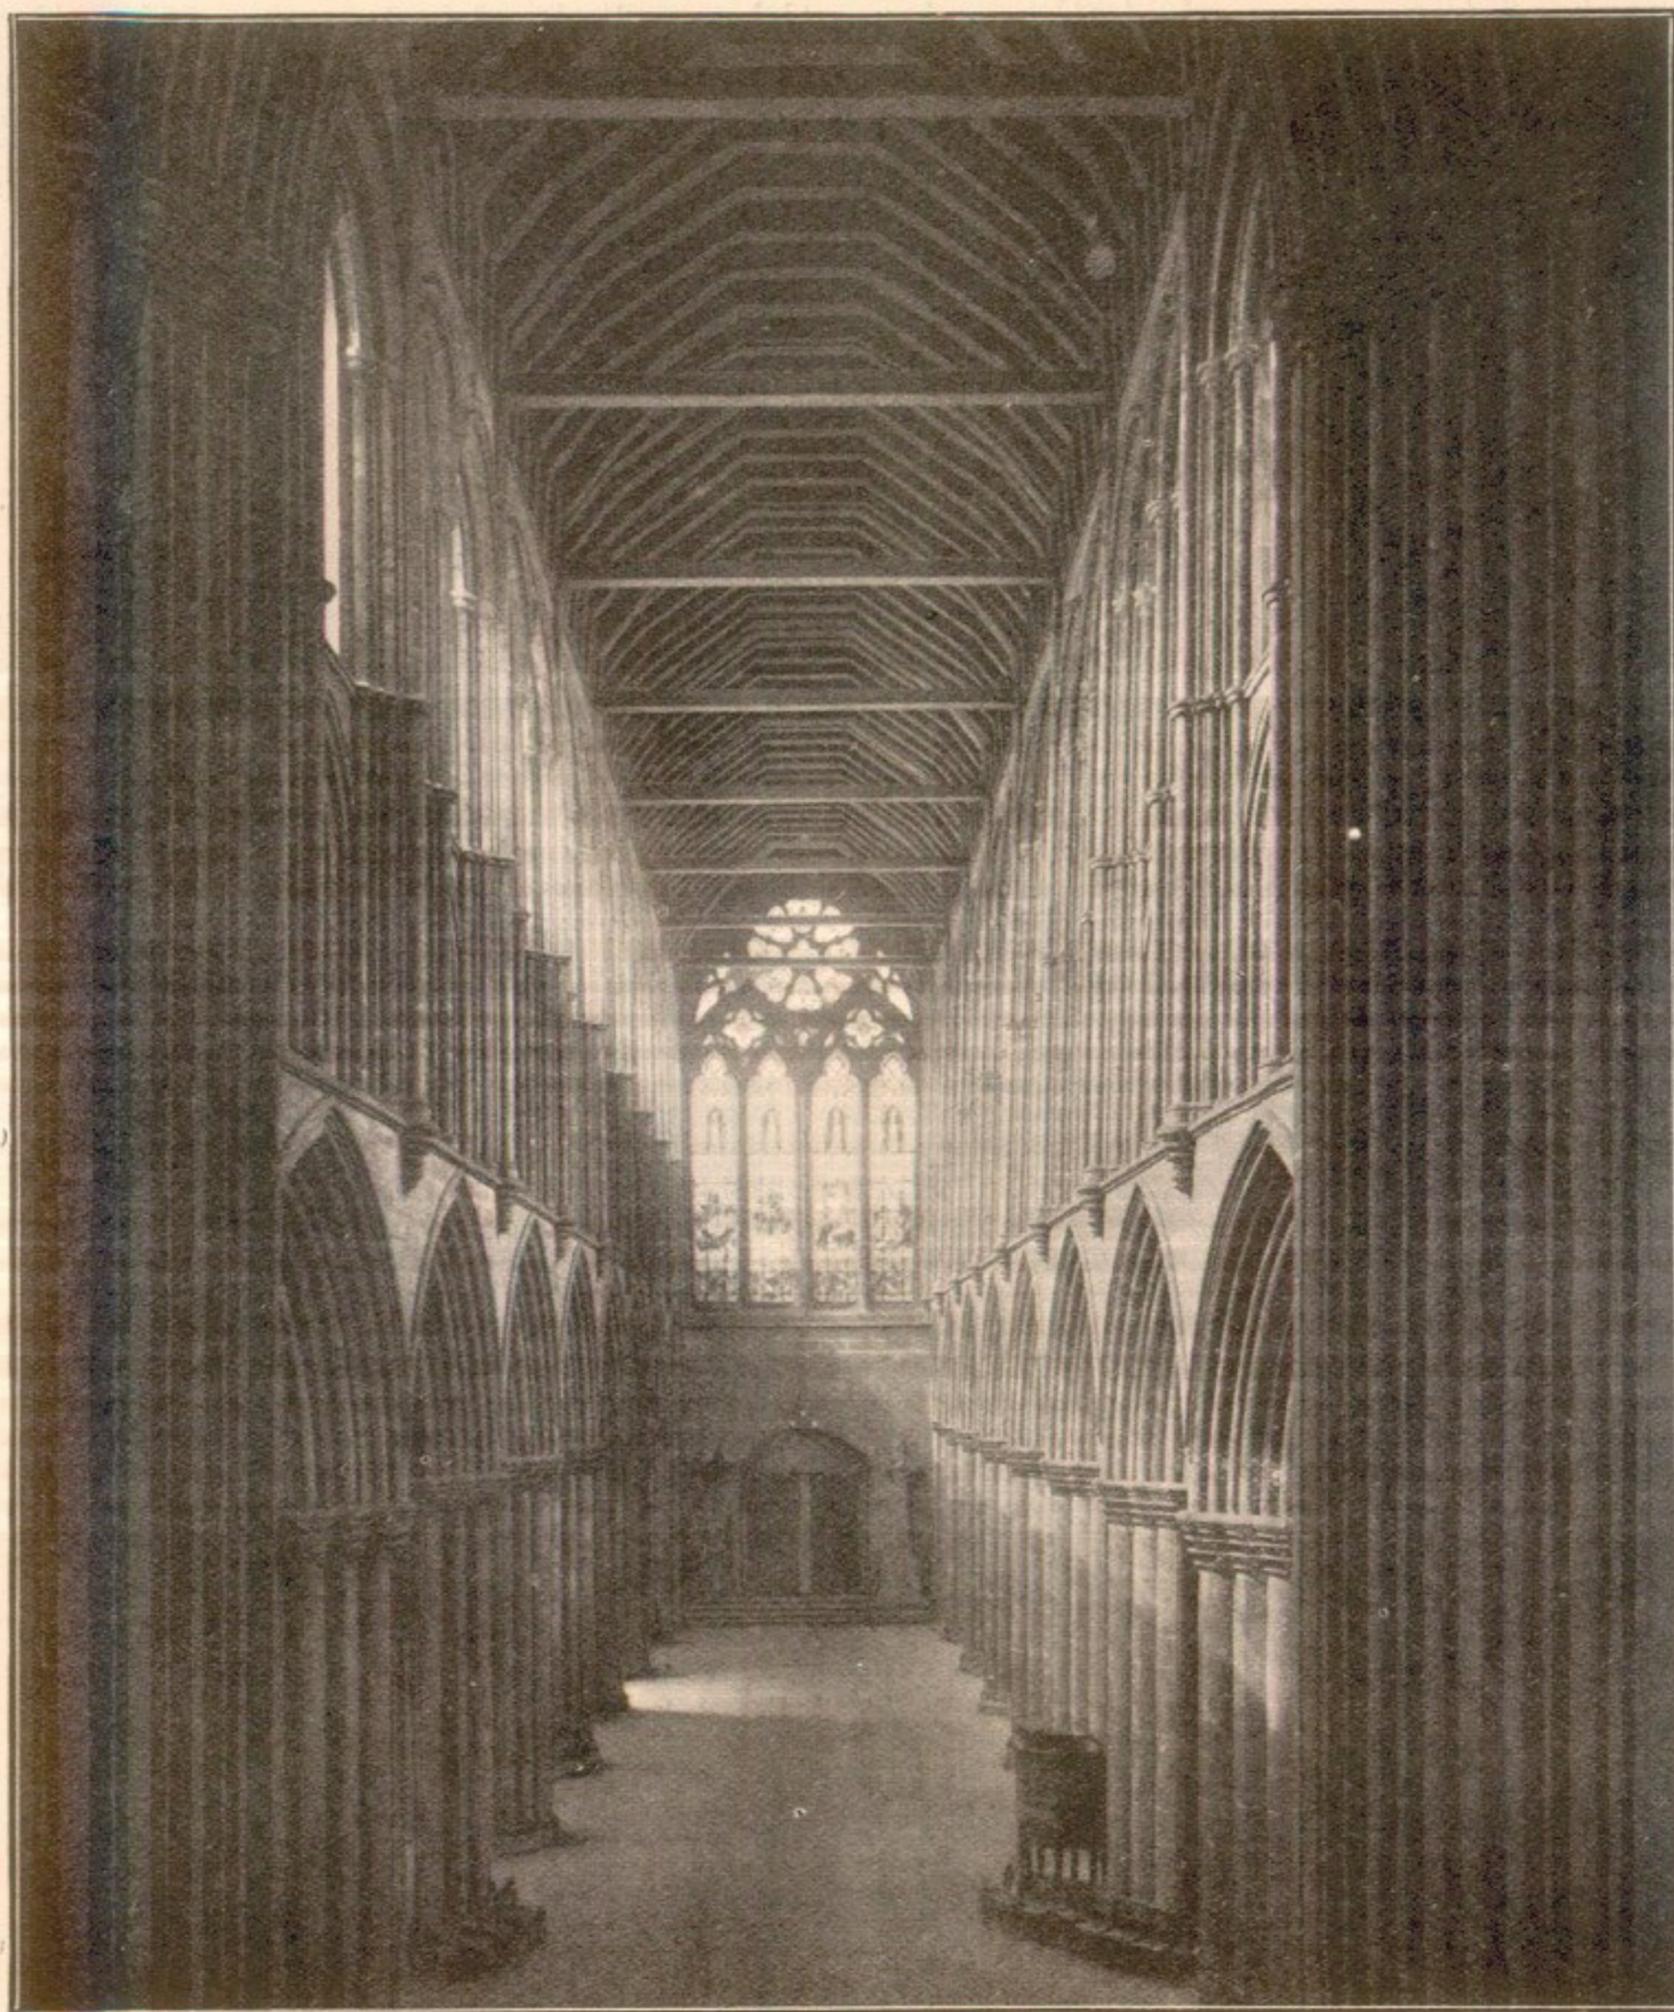
Fig. 12. Interior of Nave, looking west, and showing the "open-timbered" oak roof restored.
