## 9 DUNASBROC

### 9.1 *Physical description and location*

### 9.2 *Erosion*

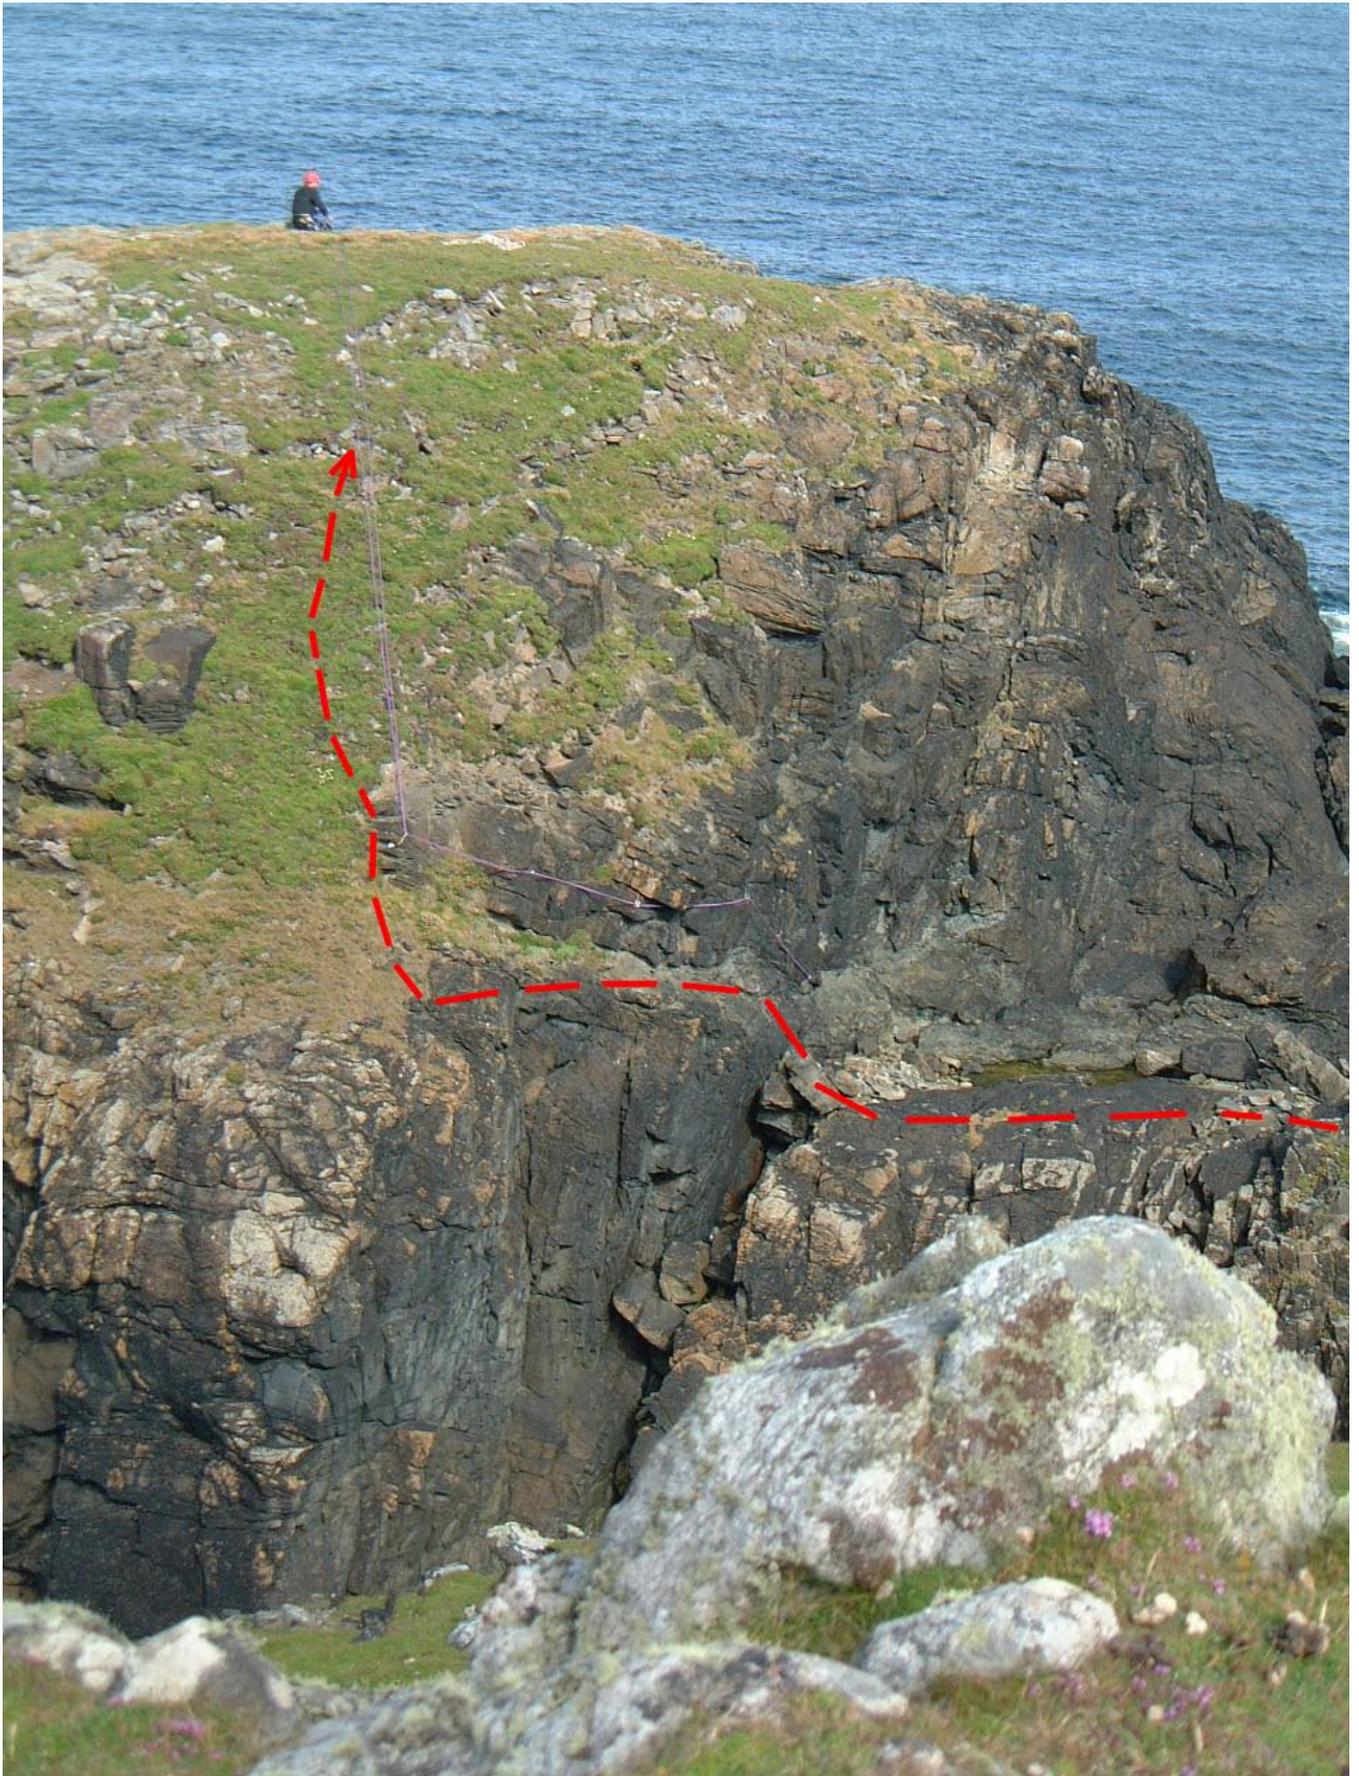
*Illus 24 Dunasbroc access from the west*

Safe access to Dunasbroc (*illus 24*) was relatively straightforward compared with other sites in the project. It was possible to walk down the grassy landward slope to the rock ramp situated at the foot of the stack. This ramp is approximately 5m above sea level, and so is accessible even at high tide.

A difficult and exposed ledge then wound clockwise from the base of the stack following a natural line of weakness in the rock created by quartz-rich veins. This path included a 0.4m wide ledge, which had to be traversed for 3–4m before gaining an easier angled ridge which could be followed back anti-clockwise to gain the summit platform area.

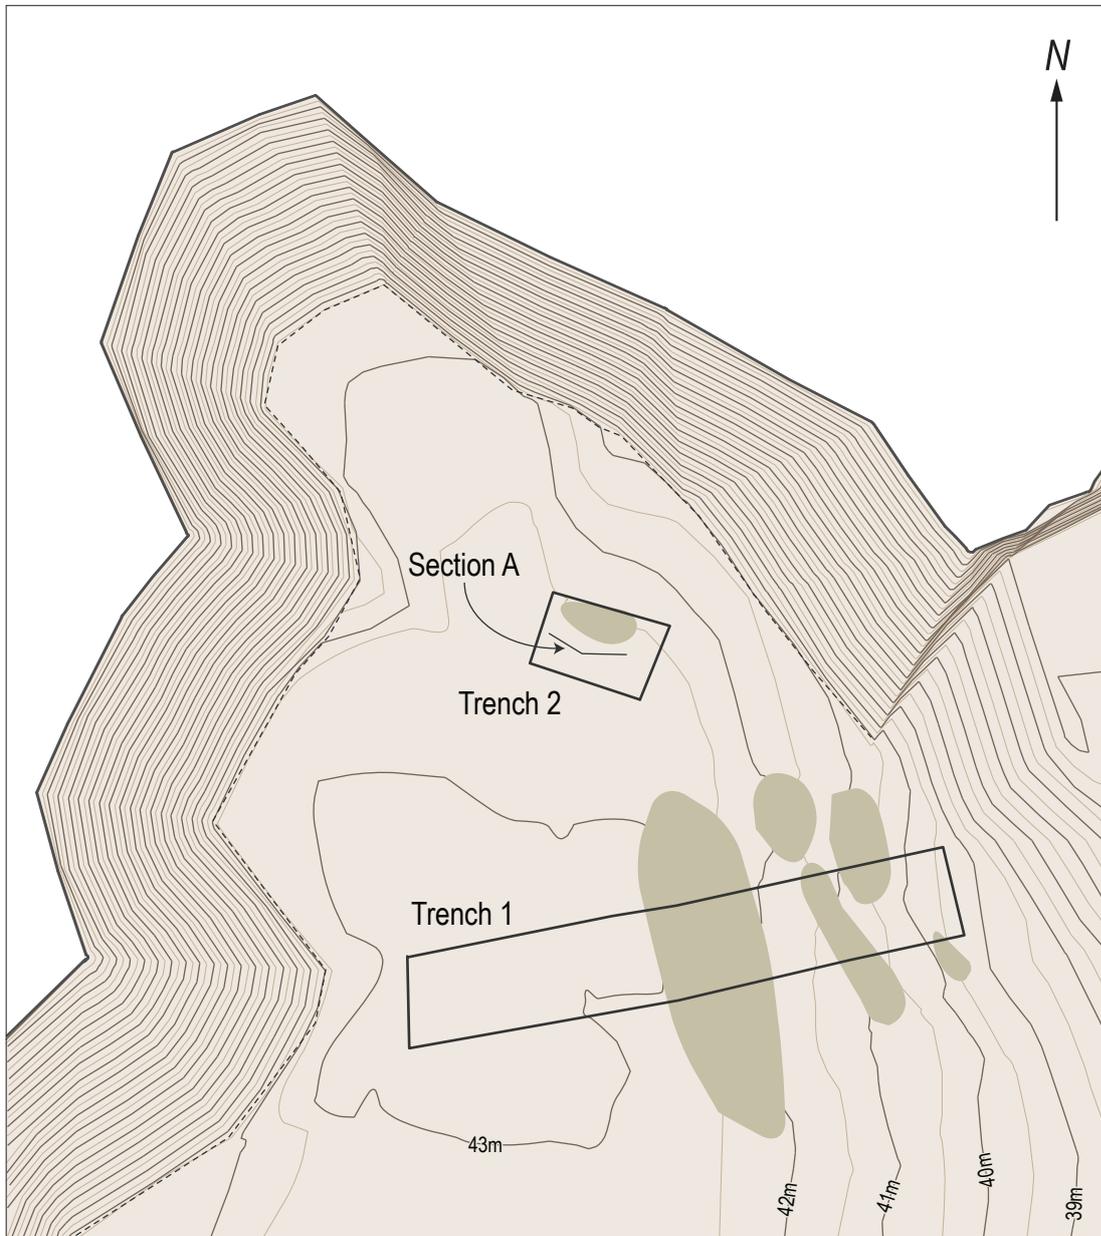
*Illus 26 Map of trenches on top of Dunasbroc*

Each eroding scar has been identified by a letter, beginning from the north. Their locations are marked on illus 26.

This was the flat area on the top of the stack (*illus 26*). Measuring roughly 15 × 6m, the platform was formed of bedrock except on its eastern edge, where vegetation and soils, the latter probably anthropogenic, were noted (see *Part III, Section 18*).

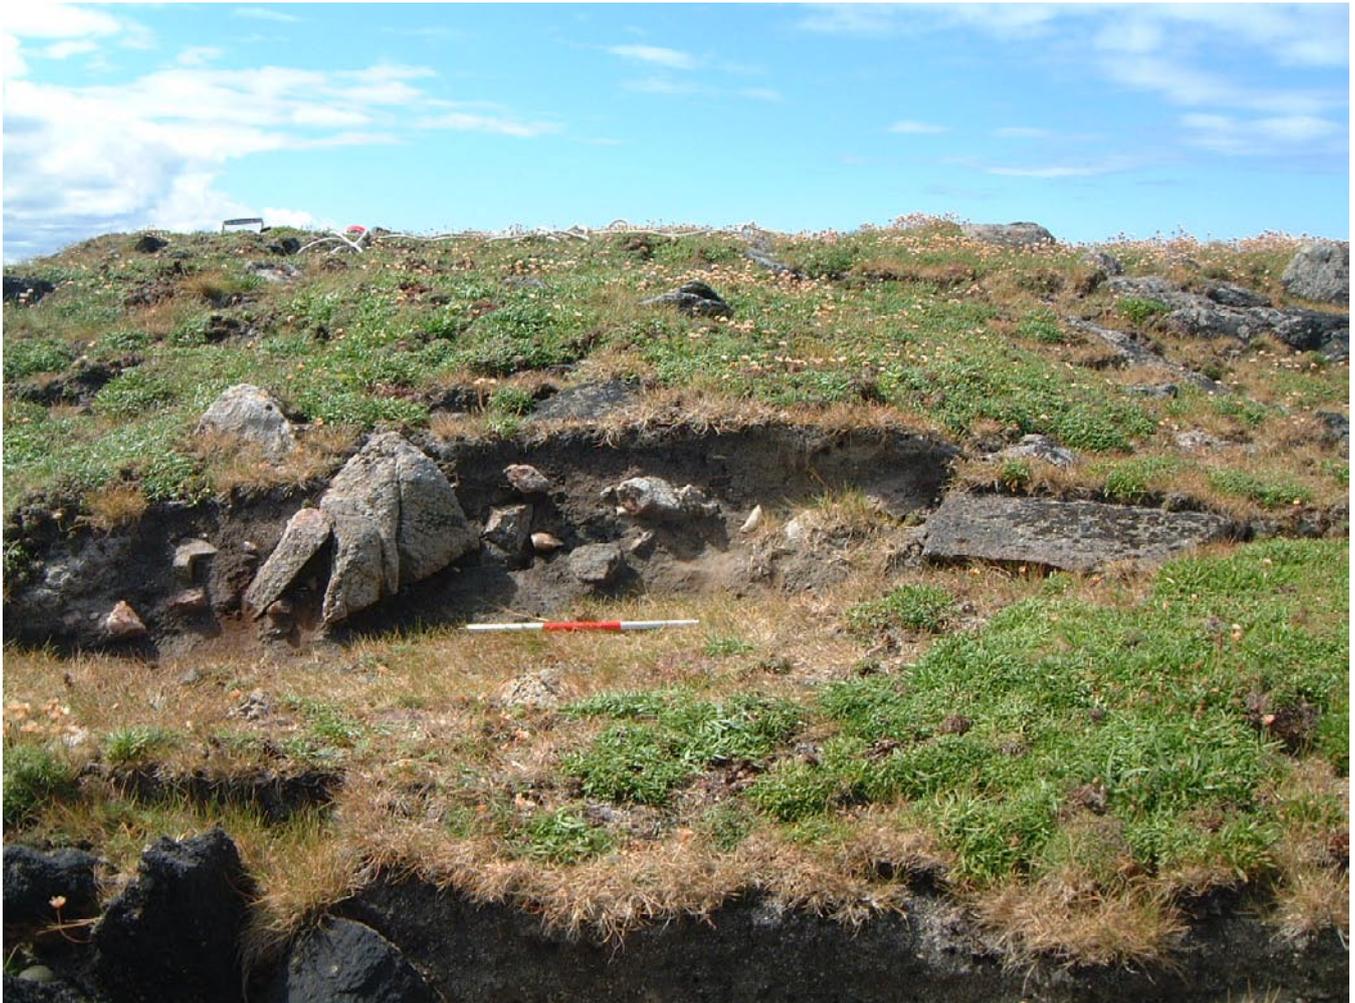
*Illus 27 Erosion scar A, Dunasbroc from the east. Scale 0.3 m long.*

A small, 0.3 × 1m, east-facing section yielded ceramic sherds, unworked quartz chips and pebbles,

small flecks of charcoal and two rough 300mm-long slabs of gneiss (illus 27). The soil consisted of very compact, almost concreted silty sand, varying from light grey and shell-rich at the top to darker brown organic-rich lower down, without any distinct context change and with charcoal flecks throughout. Sherds of pottery were also found throughout.

Approximately 100mm below the top of the scar, within the lighter coloured sediments and towards the south end, two large decorated body sherds of carinated pottery and one rim sherd were discovered, lying laterally and very close to each other as if smashed in situ (SF8, discussed below).

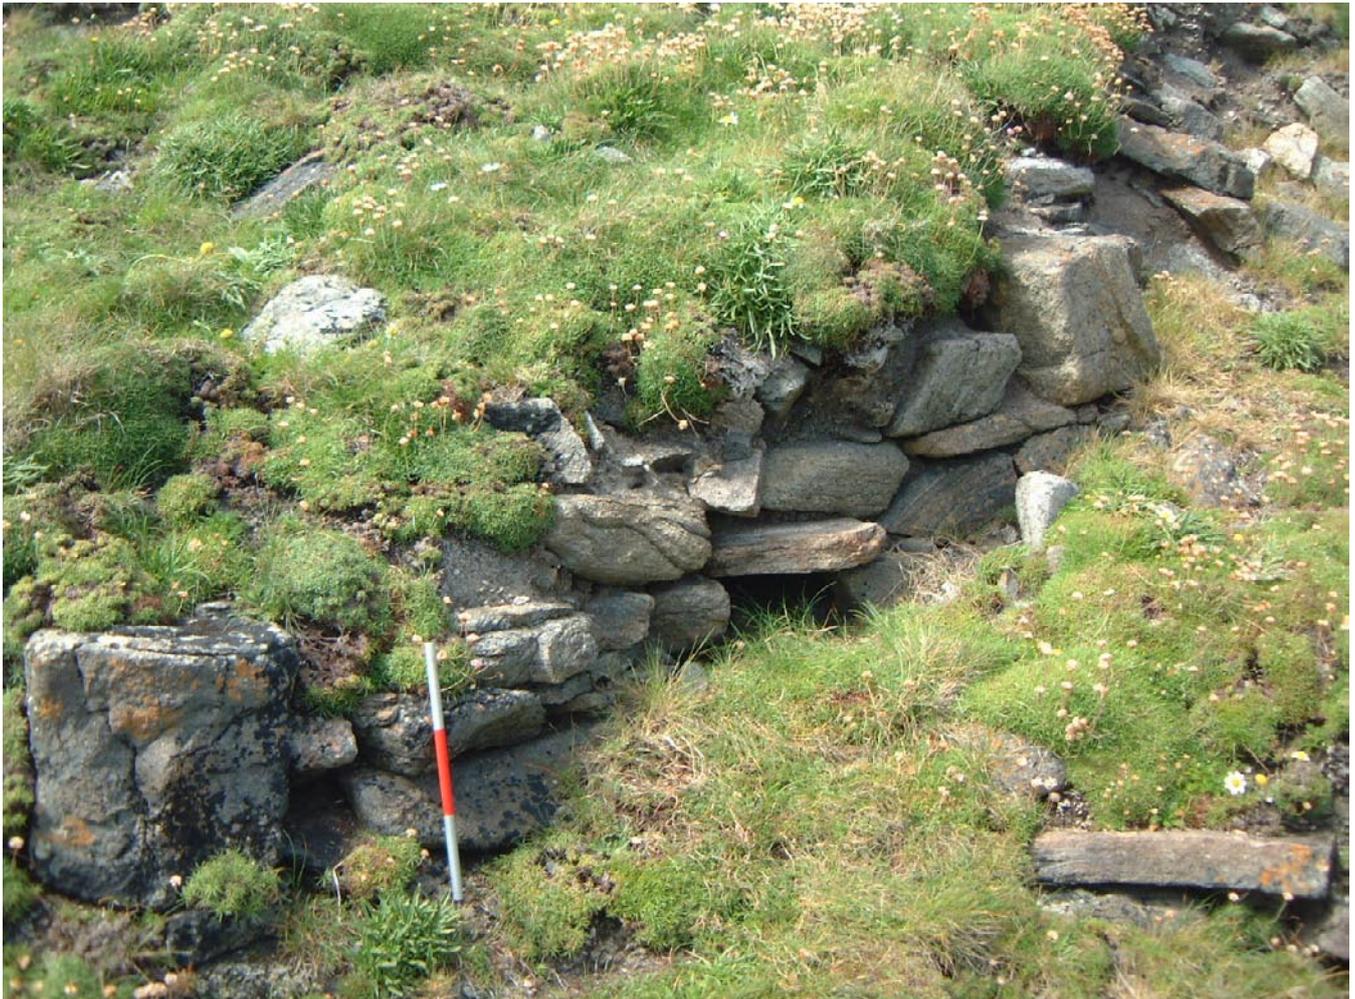
*Illus 28 Walling in erosion scar D, Dunasbroc from the east. Scale 0.3 m long.*

This was the most distinct structural element encountered on the survey. A drystone wall of at

least four courses, and measuring *c* 0.5m long, ran parallel with the contours of the stack for 4m, on the landward face ([illus 28](#)).

The size of the wall stones was in general more substantial than those in the other walls found on the stack, measuring *c* 400 × 200mm on average. Two larger blocks, each *c* 400 × 400mm, lay at either end of this wall, although it is not thought that these were terminals. To the south, the wall disappeared under vegetation and to the north it had probably fallen away, leaving the exposed soil layers in scar C. The soil matrix around the stones was very similar to that of scar C, with a ground stone tool (SF11), and fire-cracked stones found in the upper layers. A dark-brown organic-rich loam, with charcoal flecks throughout, was recorded below those already described.

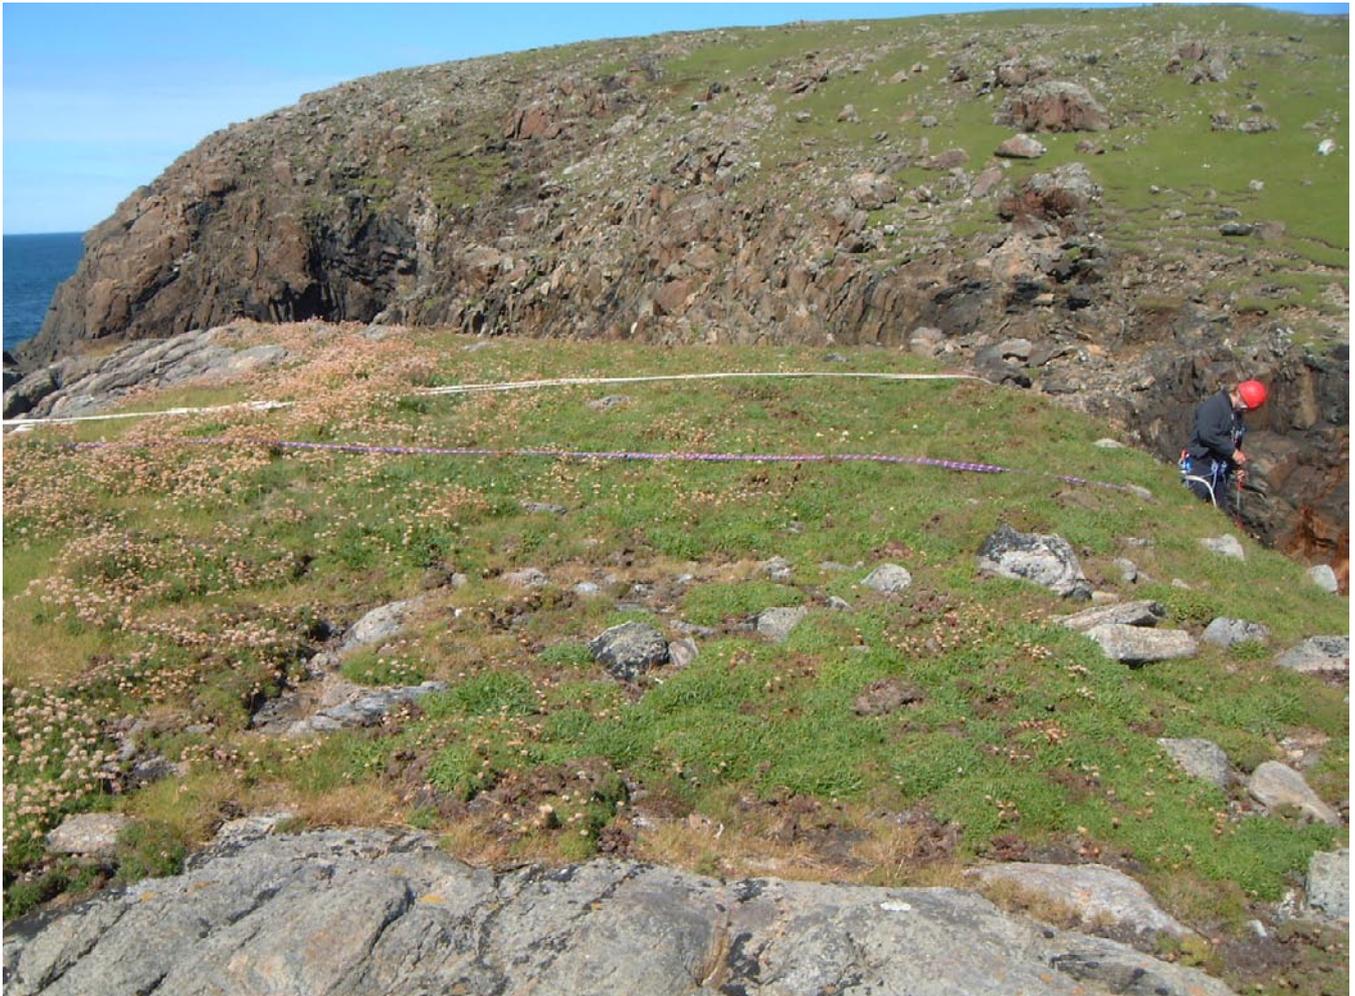
*Illus 29 The level summit of Dunasbroc from the east*

This refers to the c 3m-wide ramp that formed the present access route to the site, just above the traverse. It was not clear whether this ramp would have been present in antiquity, and it may have been an outcome of the slumping and erosion of whatever structures were originally present. Again occupation debris such as animal bone, shell and charcoal flecks could be seen within soils very similar to those uppermost in scar A. Stone tools were also retrieved from the surface here (SF4, *illus 29*).
