II. ACCOUNT OF THE EXCAVATIONS AND DESCRIPTION OF THE PLAN AND INTERIOR STRUCTURES. By J. H. CUNNINGHAM, C.E., F.S.A. Scot.

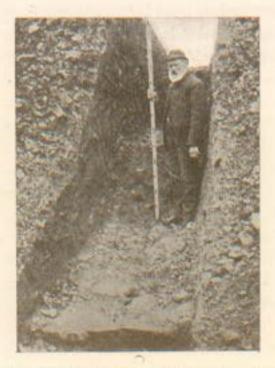
Fig. 11. View of South (west) Section (No. V.) looking north, showing edge of rough stone paving under rampart.

(1) A clearly defined piece of paving on the till beneath the Rampart, 7 to 8 feet in width, made of roughly dressed stones, many of them being 12 to 15 inches in length. This was found in each of the seven sections cut into the Rampart, and distinct traces of it were also observed in the north and east gateways. The paving was invariably found towards the outer edge of the Rampart, and may be seen fully displayed in sections I., II., and VI. It may also be noticed in sections III., IV., V. and VII., but in them the excavation was not continued so far as to uncover the whole of the stone work.

The edge of this paving may be seen in figs. 11 and 12, which are reproduced from photographs taken from the outside of the Inner Rampart, looking into sections V. and VII.

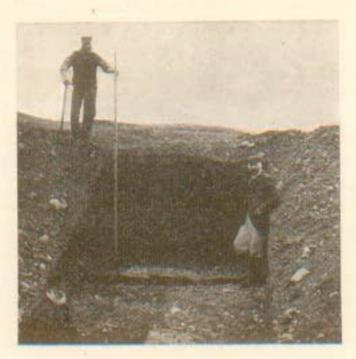
Fig. 12. View of West (north) Section (No. VII.) looking east, showing edge of rough stone paving under ramport.

deeply cut, and appeared to have been deliberately filled in and covered with a layer of gravel about 6 inches thick, laid so as to form a kind of platform, extending to a width of fully 15 feet from the face of the paving. In sections IV. and V. cobble stones, which appeared to have been thrown in to form a drain, were found in the bottom of the ditch. In section VII. the ditch was found to be cut fairly deep, and this may be noticed in the view of that cutting (fig. 12), where the Clerk of Works may be seen standing in the ditch, while one of the workmen holding the levelling rod stands on the top of the Inner Rampart and a visitor stands close beside the edge of the paving.
