PART II.—DESCRIPTION OF THE PLANS. BY MUNGO BUCHANAN,  
CORR. MEM. S.A. SCOT.

# PLAN OF THE ROMAN FORT ON THE ANTONINE VALLUM AT CASTLECRARY, STIRLINGSHIRE. 1902

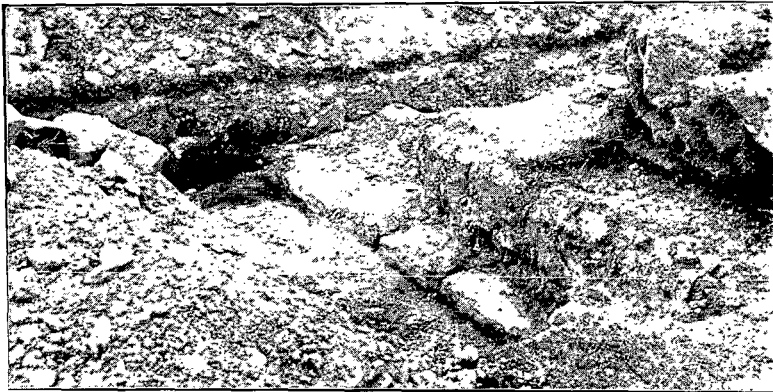
Fig. 6. Inner Stone Kerb ; North Wall.

On this inner surface, fully 6 feet from the back of the wall, is a stone kerb running parallel with it. The stones which form it average 12 inches long by 6 inches deep (fig. 6).

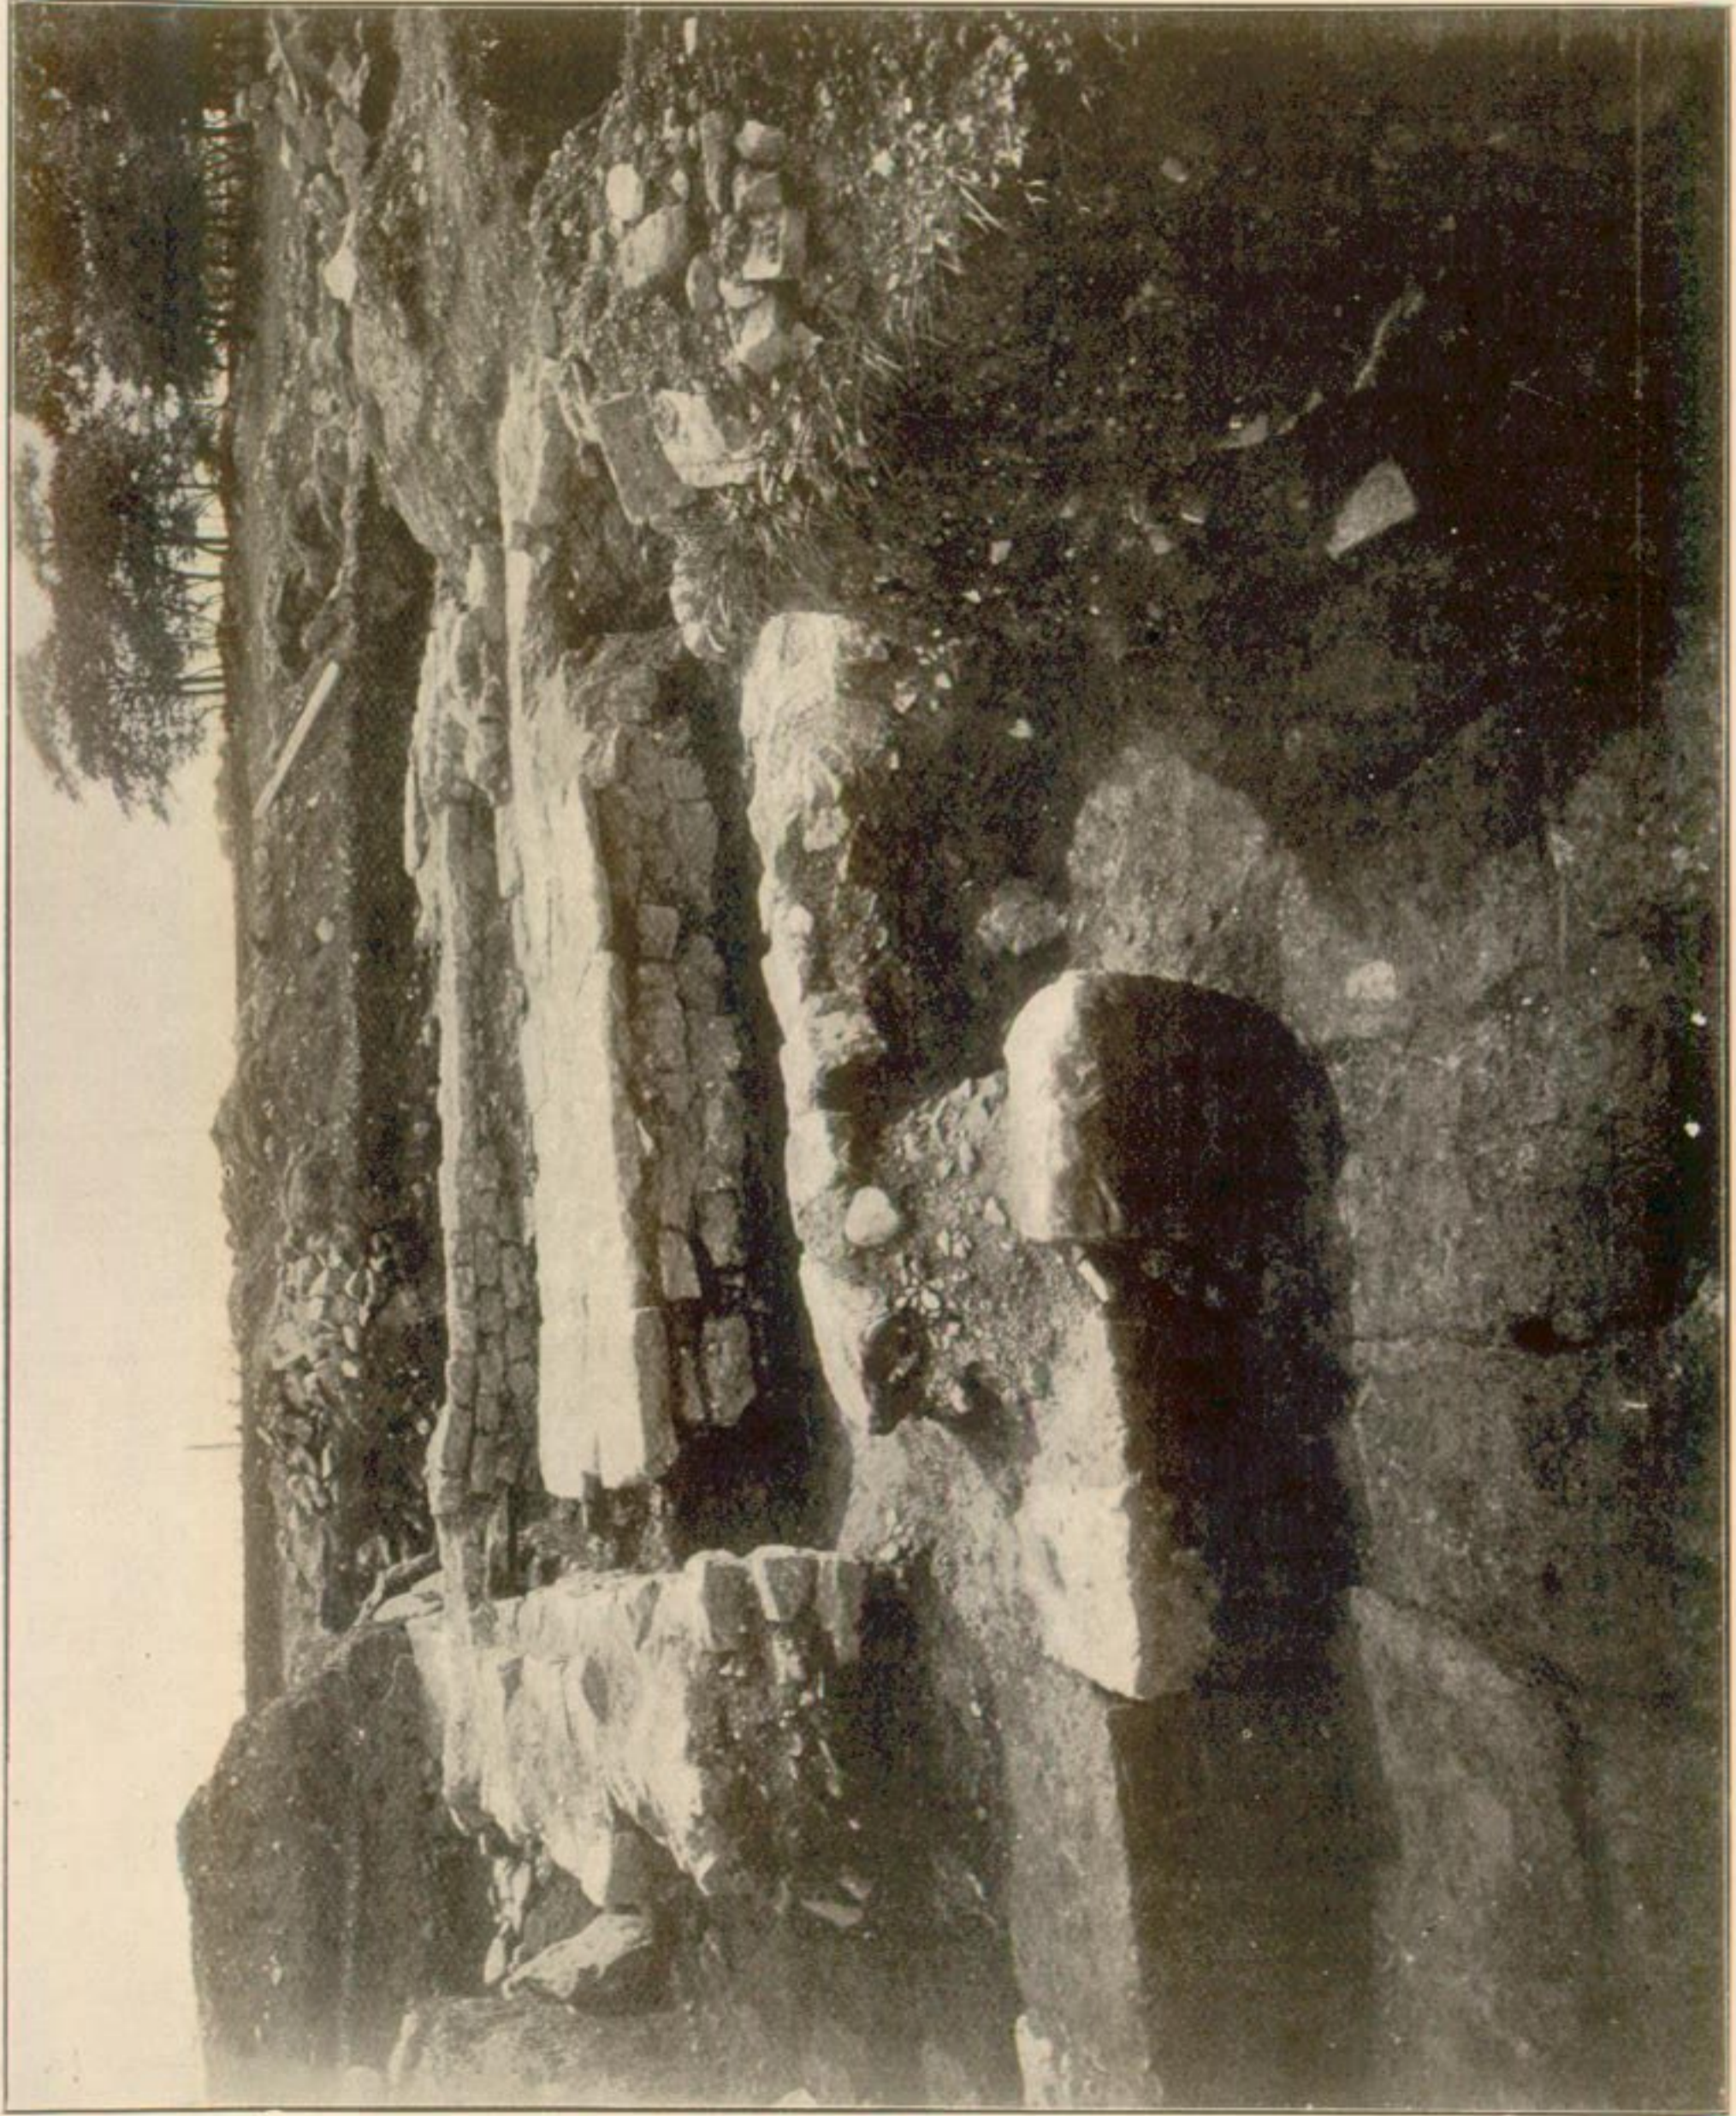
Fig. 7. Latrine, looking south. Foundation of North Wall in foreground.

distinct from what is known of the main structure of the wall, can only now be a matter of conjecture, for the almost entire clearance of the soil from the position allowed no further evidence regarding it, with the exception that the angle of the interior in the corner enclosed by the wall appears to have been a stone paved surface, 2 feet lower than the floor of the adjoining building, the latrine.

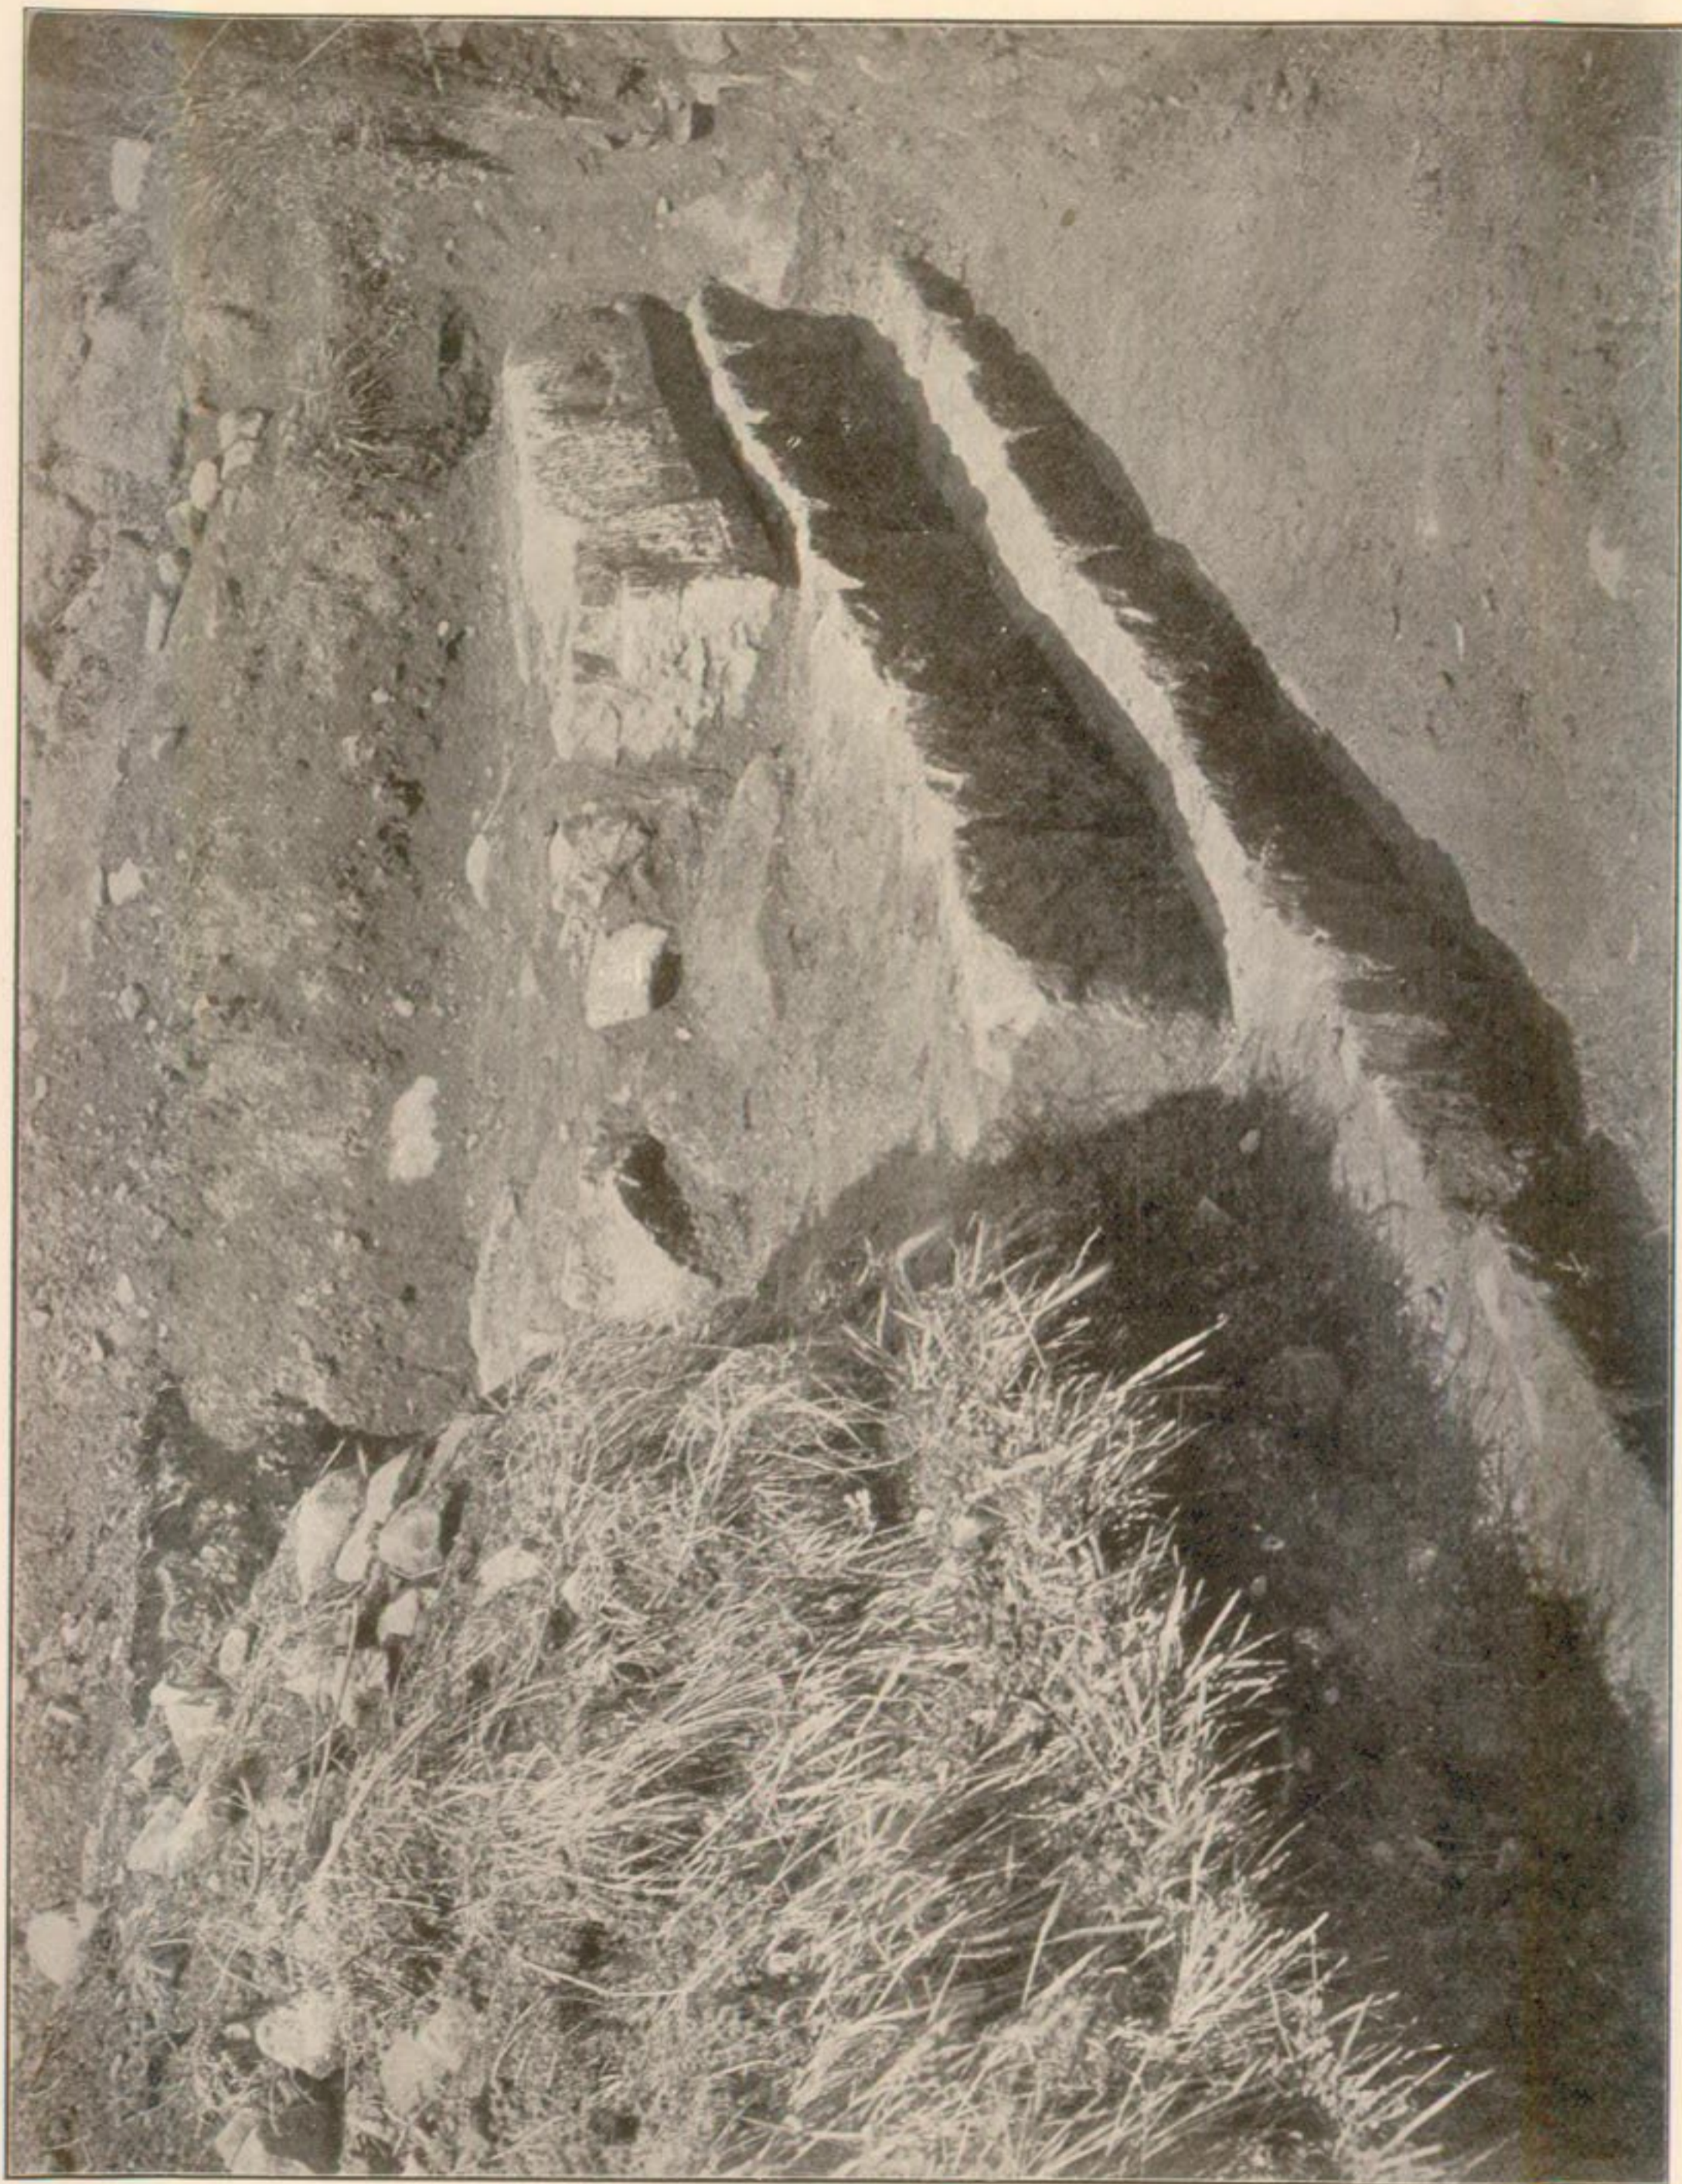
Fig. 9. East Wall, looking north-west.

On the east the wall is now found in the best preservation. A part of it at the north-east corner still exists, which clearly shows all its characteristics—fully described under North Wall. The bottoming, foundation course, and part of an upper course remain *in situ*, and the foundation continues unimpaired as far as the south side of the gate, beyond which it is nearly all removed (fig. 9).

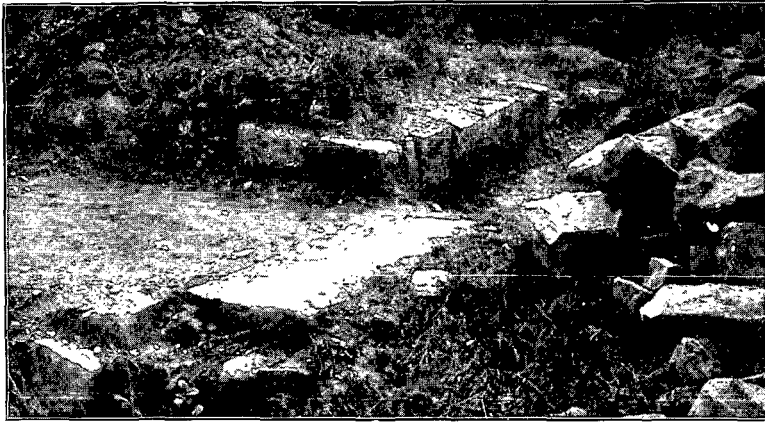
Fig. 14. Stone Sill on north front of Central Building.

The walling of the east building is finely squared and tooled on the face, and one stone still stands which presents a polished surface. The stone sill of the centre doorway bears evidence of having been some time in use (fig. 14).

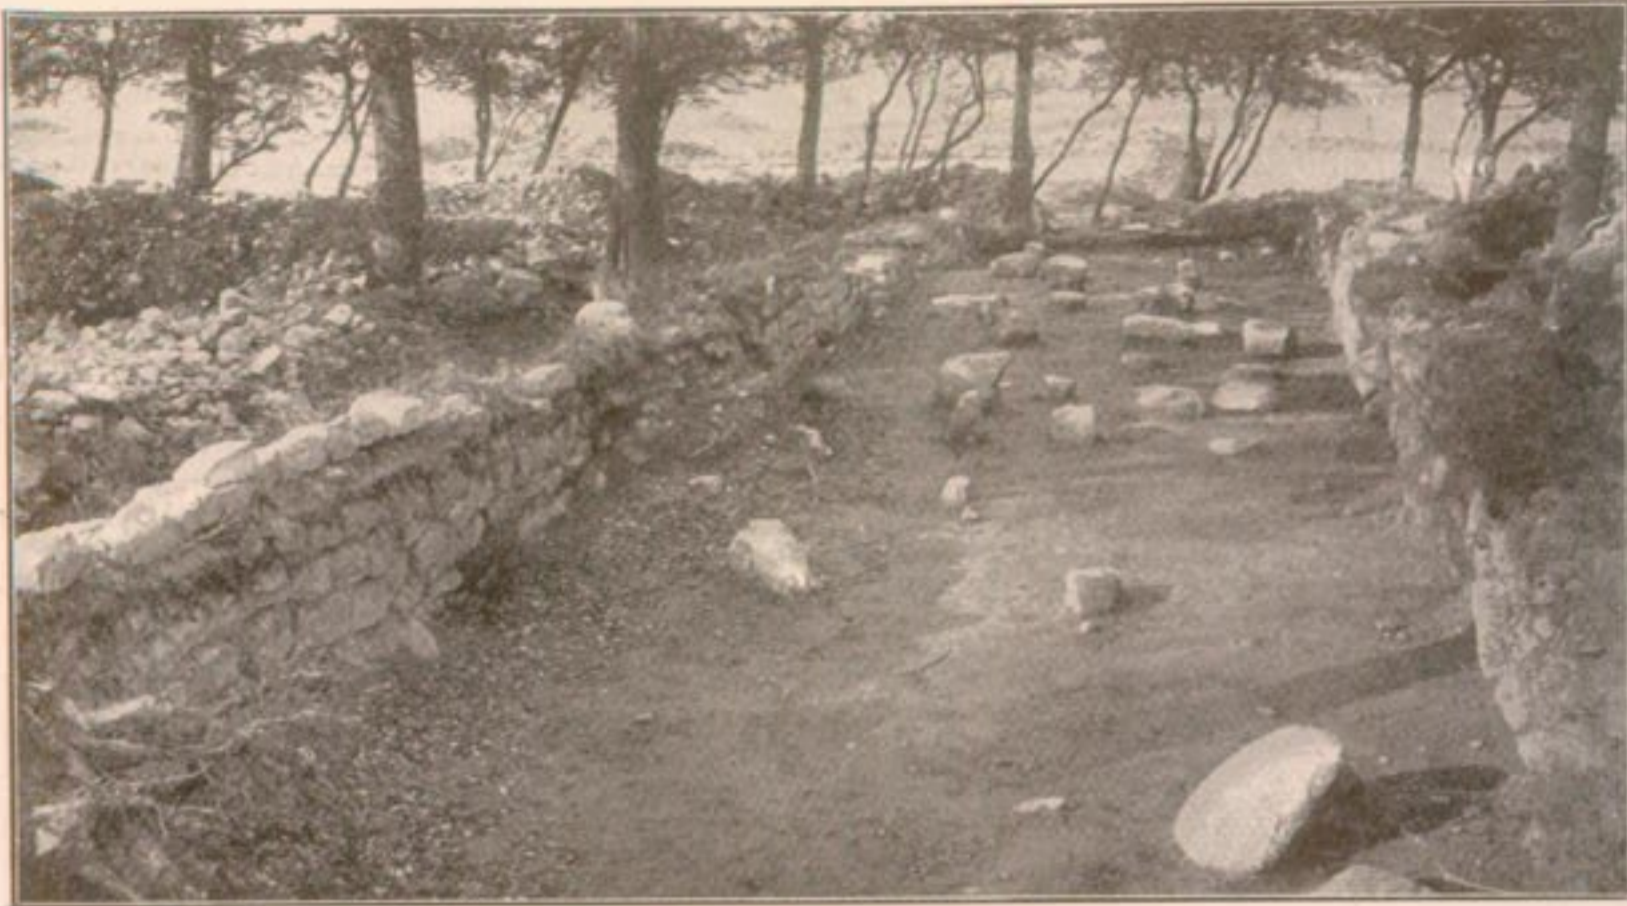
Fig. 16. Buttressed Building, looking north.

On the east of the central block of buildings, separated by a street 21 feet wide, is a strongly buttressed building, all one chamber (figs. 16, 17), 83 feet long and 15 feet wide within the walls. The latter are 3 feet broad, and stand at an average height of 3 feet above the inside floor. Twenty buttresses, each  $2\frac{1}{2}$  feet square, project from the east and west walls, ten on each side, placed opposite one another. (See the ground plan, fig. 13, and Plate I.)

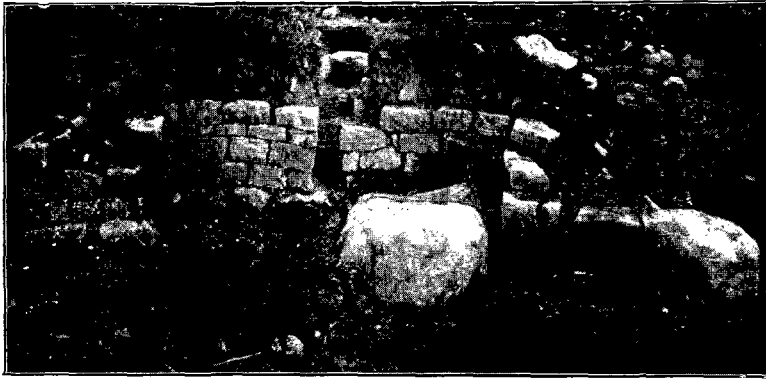
Fig. 18. Outer Face of the East Wall of Buttressed Building, showing buttress built between two large boulders.

boulders, which have been allowed to remain *in situ*. But it appears that the space had proved barely sufficient for it, as the boulders have been slightly chipped to gain the requisite width (fig. 18).

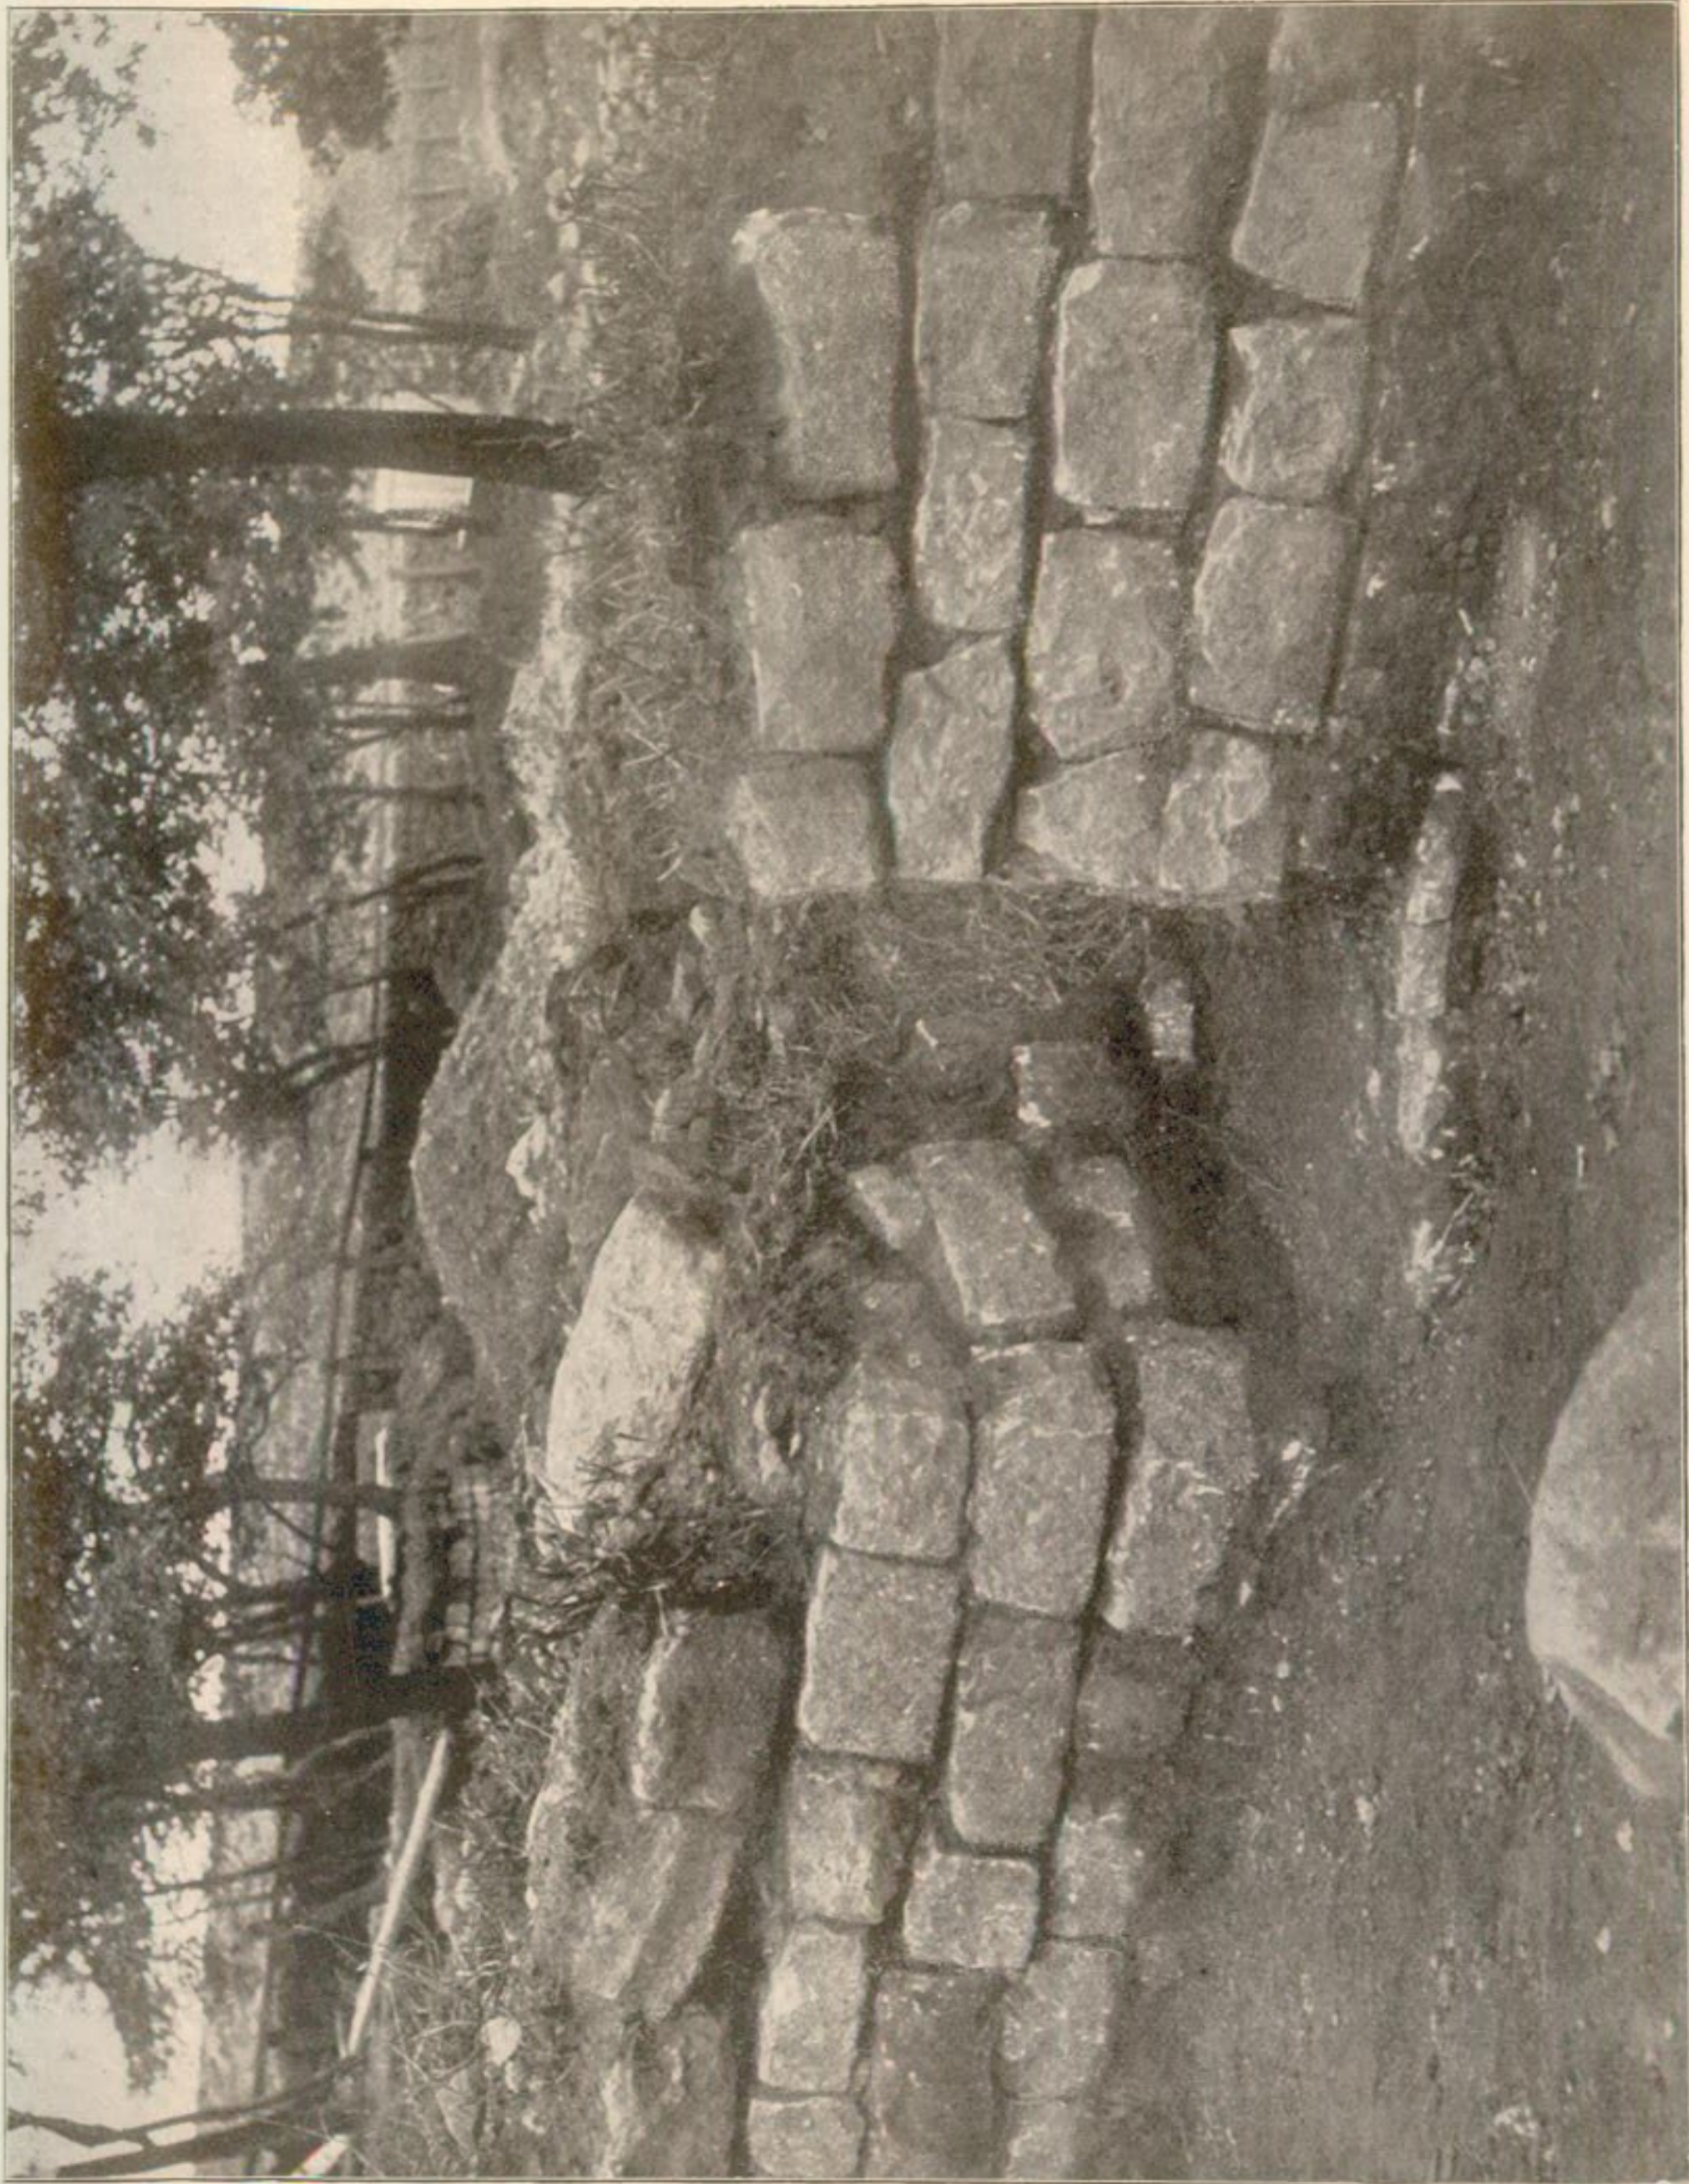
Fig. 19. Interior of Butressed Building, showing opening in wall. West side.

They are open for the entire height of the existing wall, about three feet, and when first exposed appeared purposely closed up with stones, but in a very temporary manner (figs. 19 and 20).

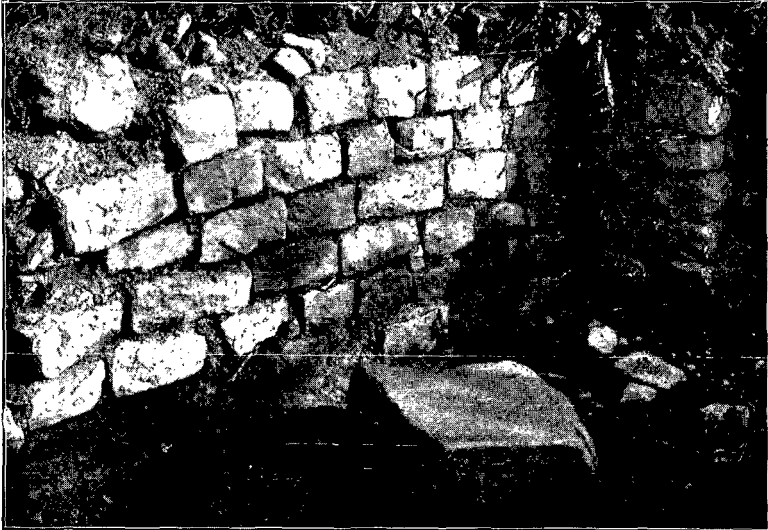
Fig. 21. South-east Corner, interior of Butressed Building, showing Doorway built up.

There is evidence of a subsequent alteration of the south wall of this building, both externally and internally. It appears that a wide doorway originally had existed in this end wall, with buttresses on each side of it, prolongations of the side walls. This door and the entire front have been built up flush with the face of the buttresses, increasing the width of wall to about 5 feet (fig. 21).

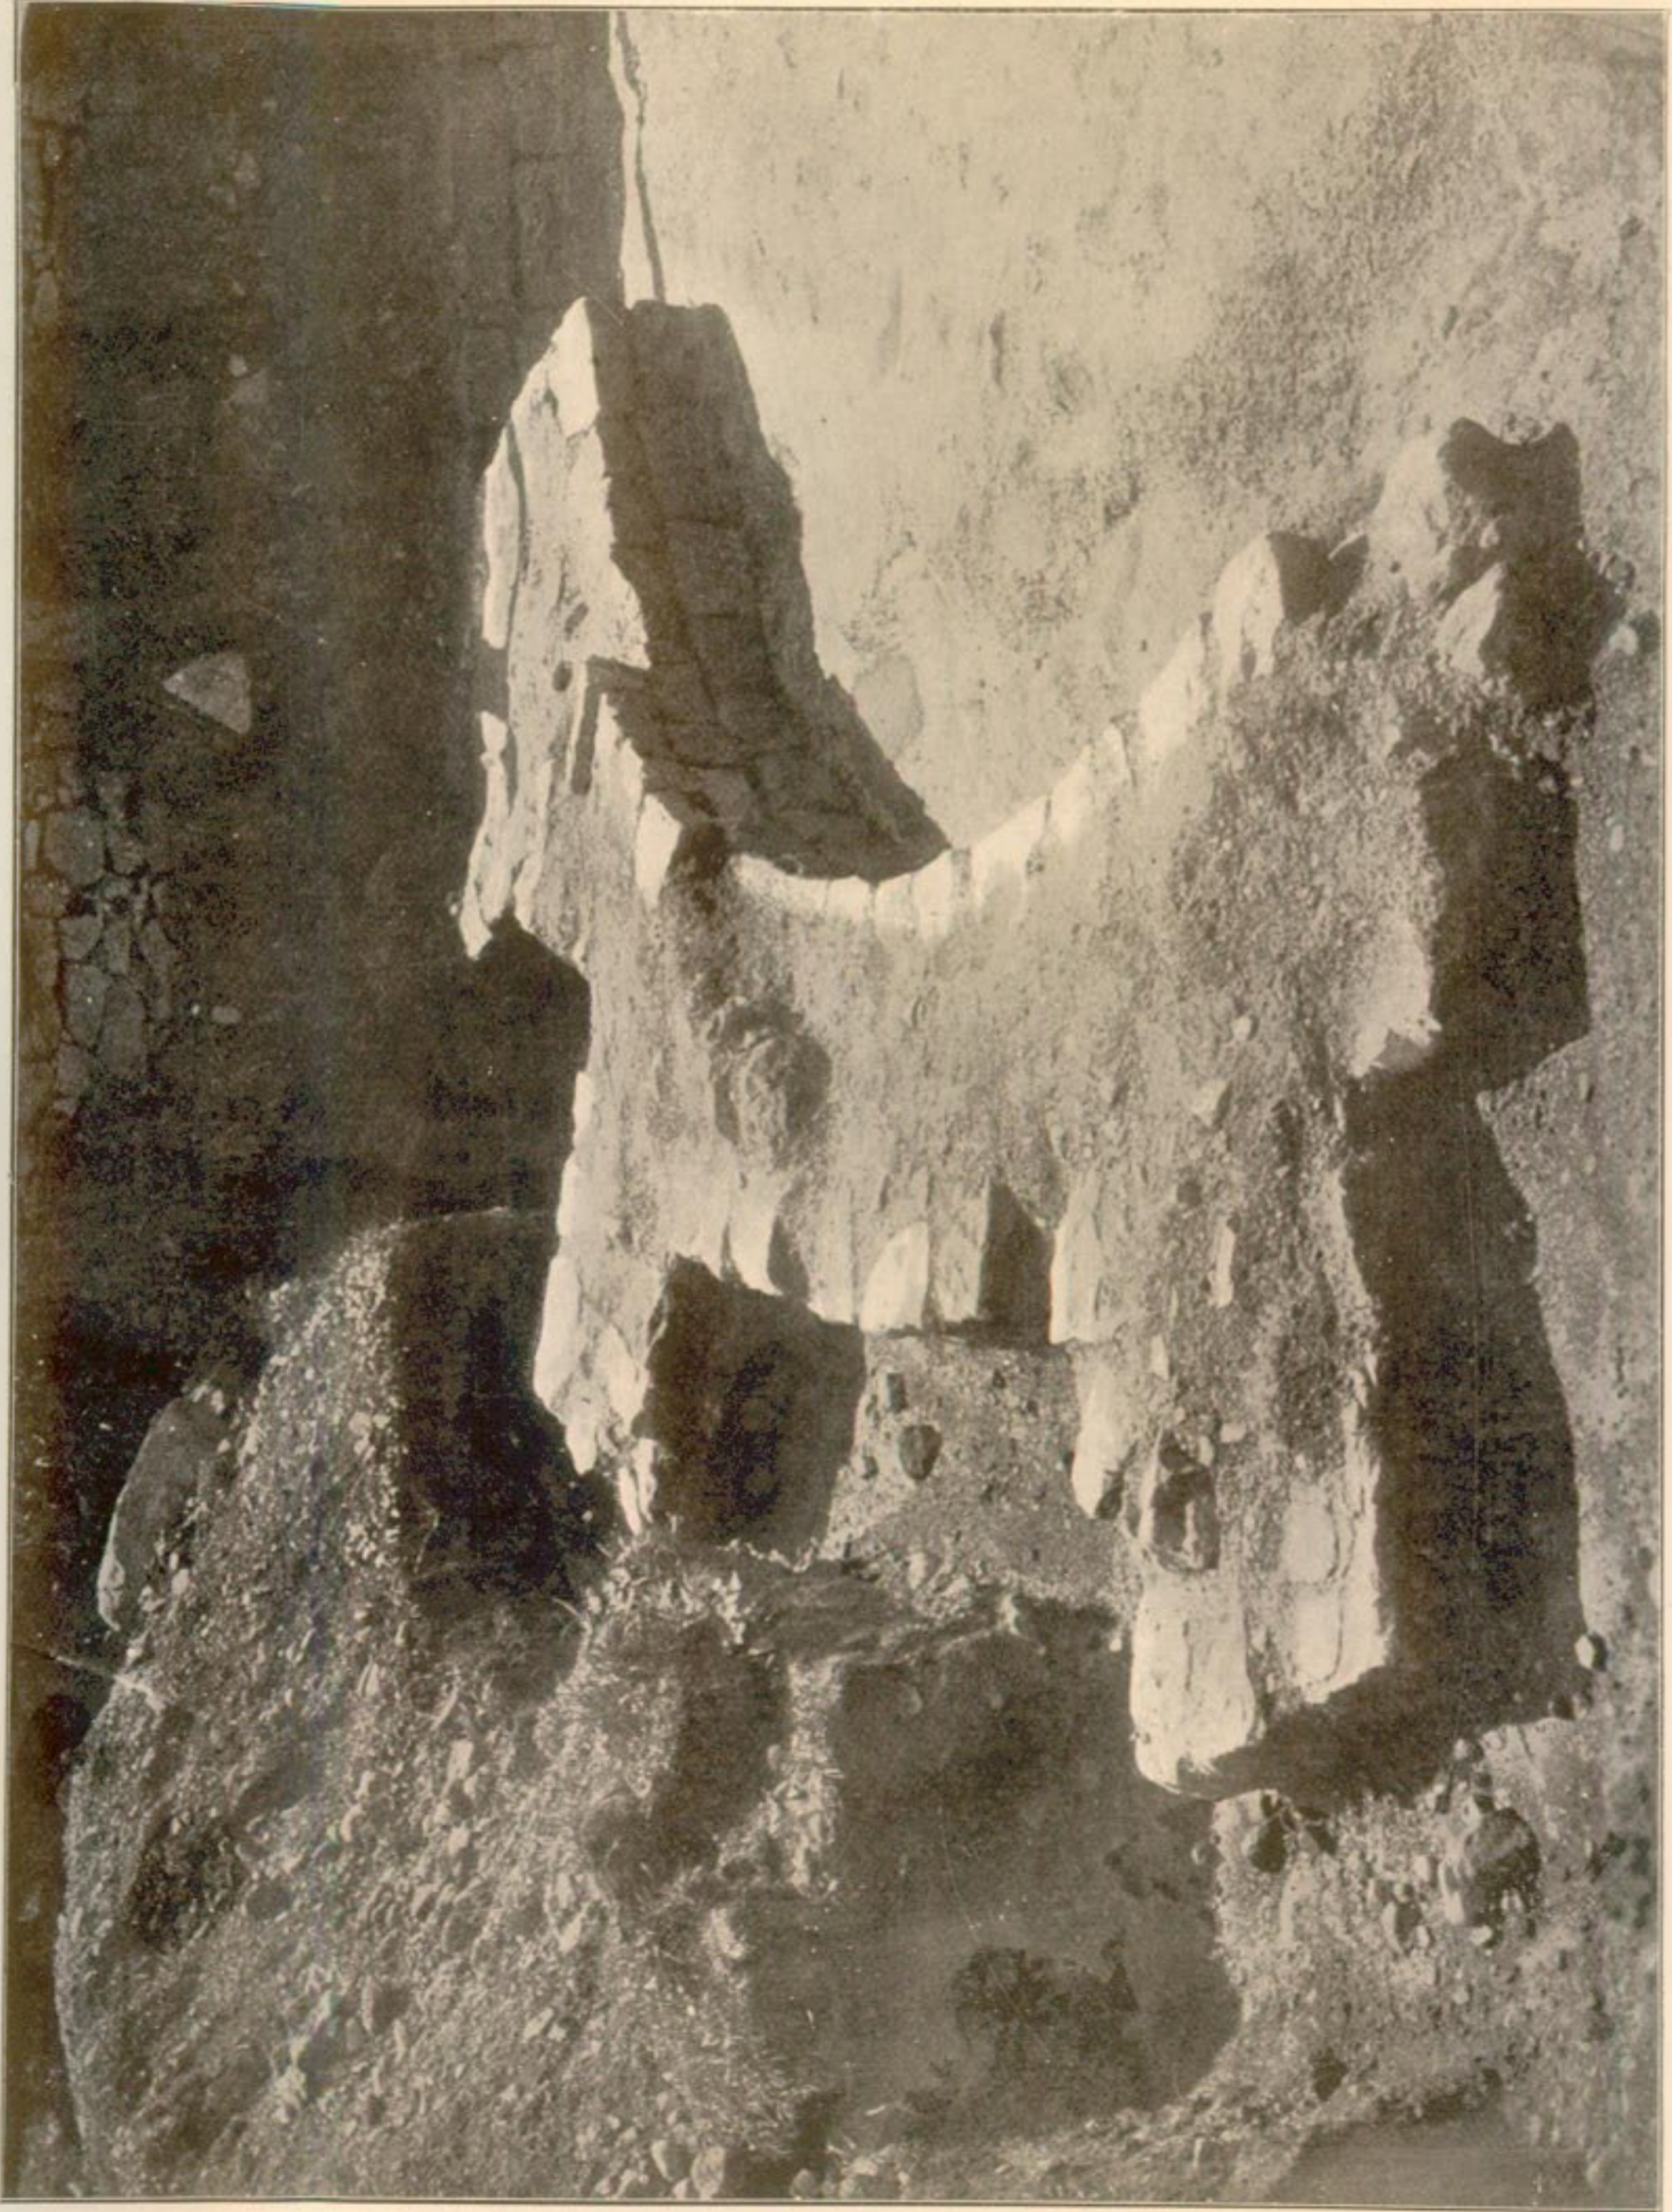
Fig. 22. Apse of Building near south-east corner of Fort.

Situated near the south-east corner of the fort are the remains of the finest piece of building work exposed by our excavations, and these lie close to the present surface (fig. 22).

Its excellence consists in the neatness of the work, its exact geometrical lines, and the regularity of the stone courses. Although the latter are the very lowest, and likely to have been covered up, they have a finished appearance. The common size of stones used is about 9 inches by 6 inches.

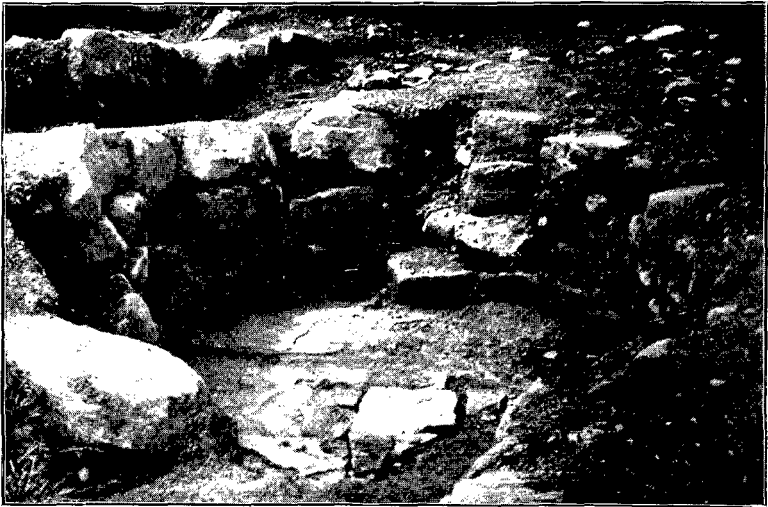
Fig. 23. Oval Building in East Wall, looking west.

Closely adjoining and lower by  $3\frac{1}{2}$  feet is a small oval building, like a furnace (fig. 23). Internally it is 6 feet by 3 feet 9 inches on the flagstone floor. It is not on Roy's plan. The walls stand 2 feet high in four courses, and have a batter of  $4\frac{1}{2}$  inches in that height. A short length of a flue 14 inches wide runs round part of the west end, in the direction of the circular chamber above mentioned. The flagstone paving is bedded on clay, and when exposed showed indications of the effect of fire, and the soil in the flue was highly charged with soot.

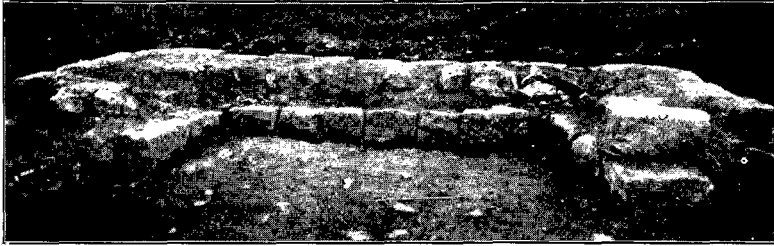
Fig. 24. South-west Corner Tower.

At the south-west corner of the fort—the only one of the south defences that it was possible to examine—are the remains of a 15 feet square building (fig. 24), placed diagonally to the south and west walls of the fort. Two courses of the stonework remain of the unusual width of 4 feet, being the internal part. The outer portion of the structure is all gone, perhaps removed along with the wall of which
