PART II.—DESCRIPTION OF THE PLANS. BY MUNGO BUCHANAN,  
CORR. MEM. S.A. SCOT.

# PLAN OF THE ROMAN FORT ON THE ANTONINE VALLUM AT CASTLECRARY, STIRLINGSHIRE. 1902

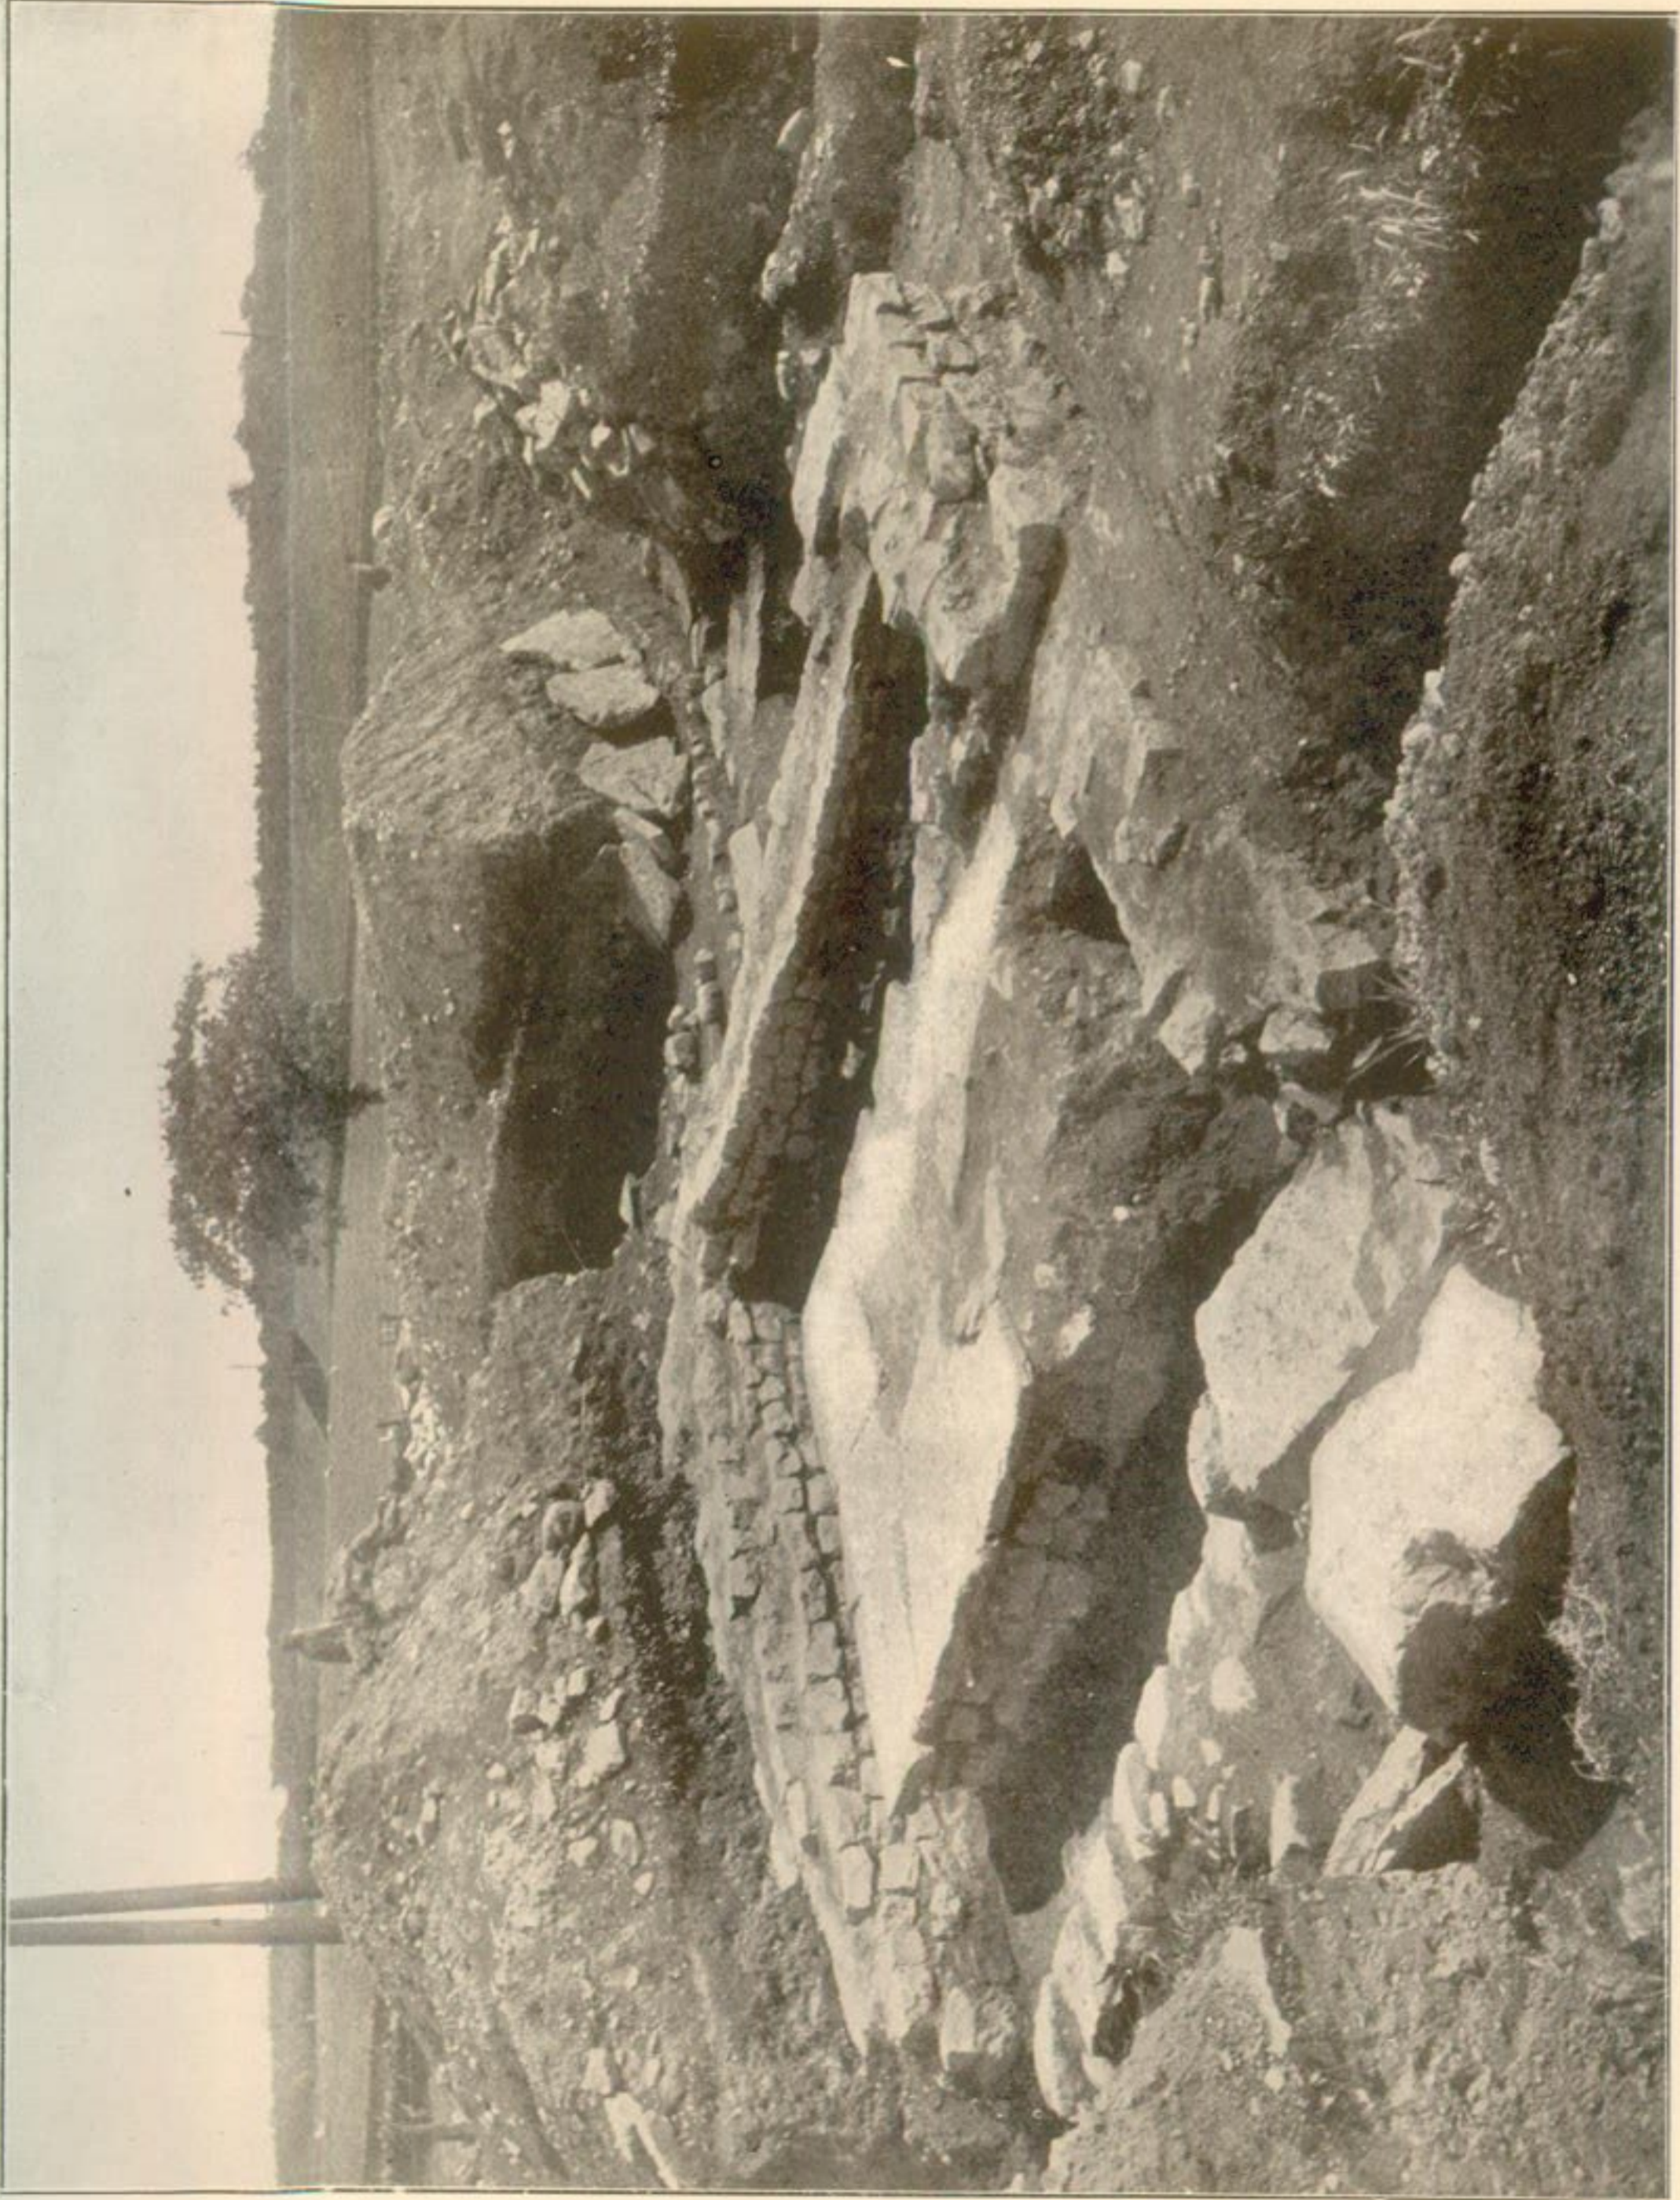
Fig. 25. Latrine, looking south-east.

Situated about 30 feet from the inner face of the east wall, and abutting against the north wall, is the remains of a building 16 feet by 12 feet internally, with walls 2 feet broad (Plate IV.). An entrance door  $2\frac{1}{2}$  feet wide is formed in the centre of its west wall, and the interior is paved with large flagstones. The north and south edges of the paving have each a square-cut recess 2 inches deep by 7 inches long, evidently prepared for receiving standards. An open channel  $1\frac{1}{2}$  feet wide and 2 feet deep runs round three of the sides, and passes underneath the paving on the remaining side, which is that of the entrance. This building (fig. 25) is not truly parallel with the fort wall. In its width it is fully a foot more at the west end than it is at the east end, and the stonework of the walls is very coarse. The level of the door cill is 21 inches above the inner stone margin of the fort wall, and fully 4 feet higher than the wall foundation. Near the west wall of this building begins the expansion of the fort wall from 8 feet to the increased width of 11 feet, which is maintained till its junction with the east wall.

The usual heavy stones of the second course along the inner face of the fort wall are replaced, opposite the space covered by the building, by smaller stones. None are larger than a foot square, and these form the whole northern face of the channel and north wall of the building. In this channel, when exposed, were flagstones placed V-shape, close together at the bottom and wide at top, lying against the sides of the channel. They occurred in nearly the whole length of this channel, but were not found in any other position.

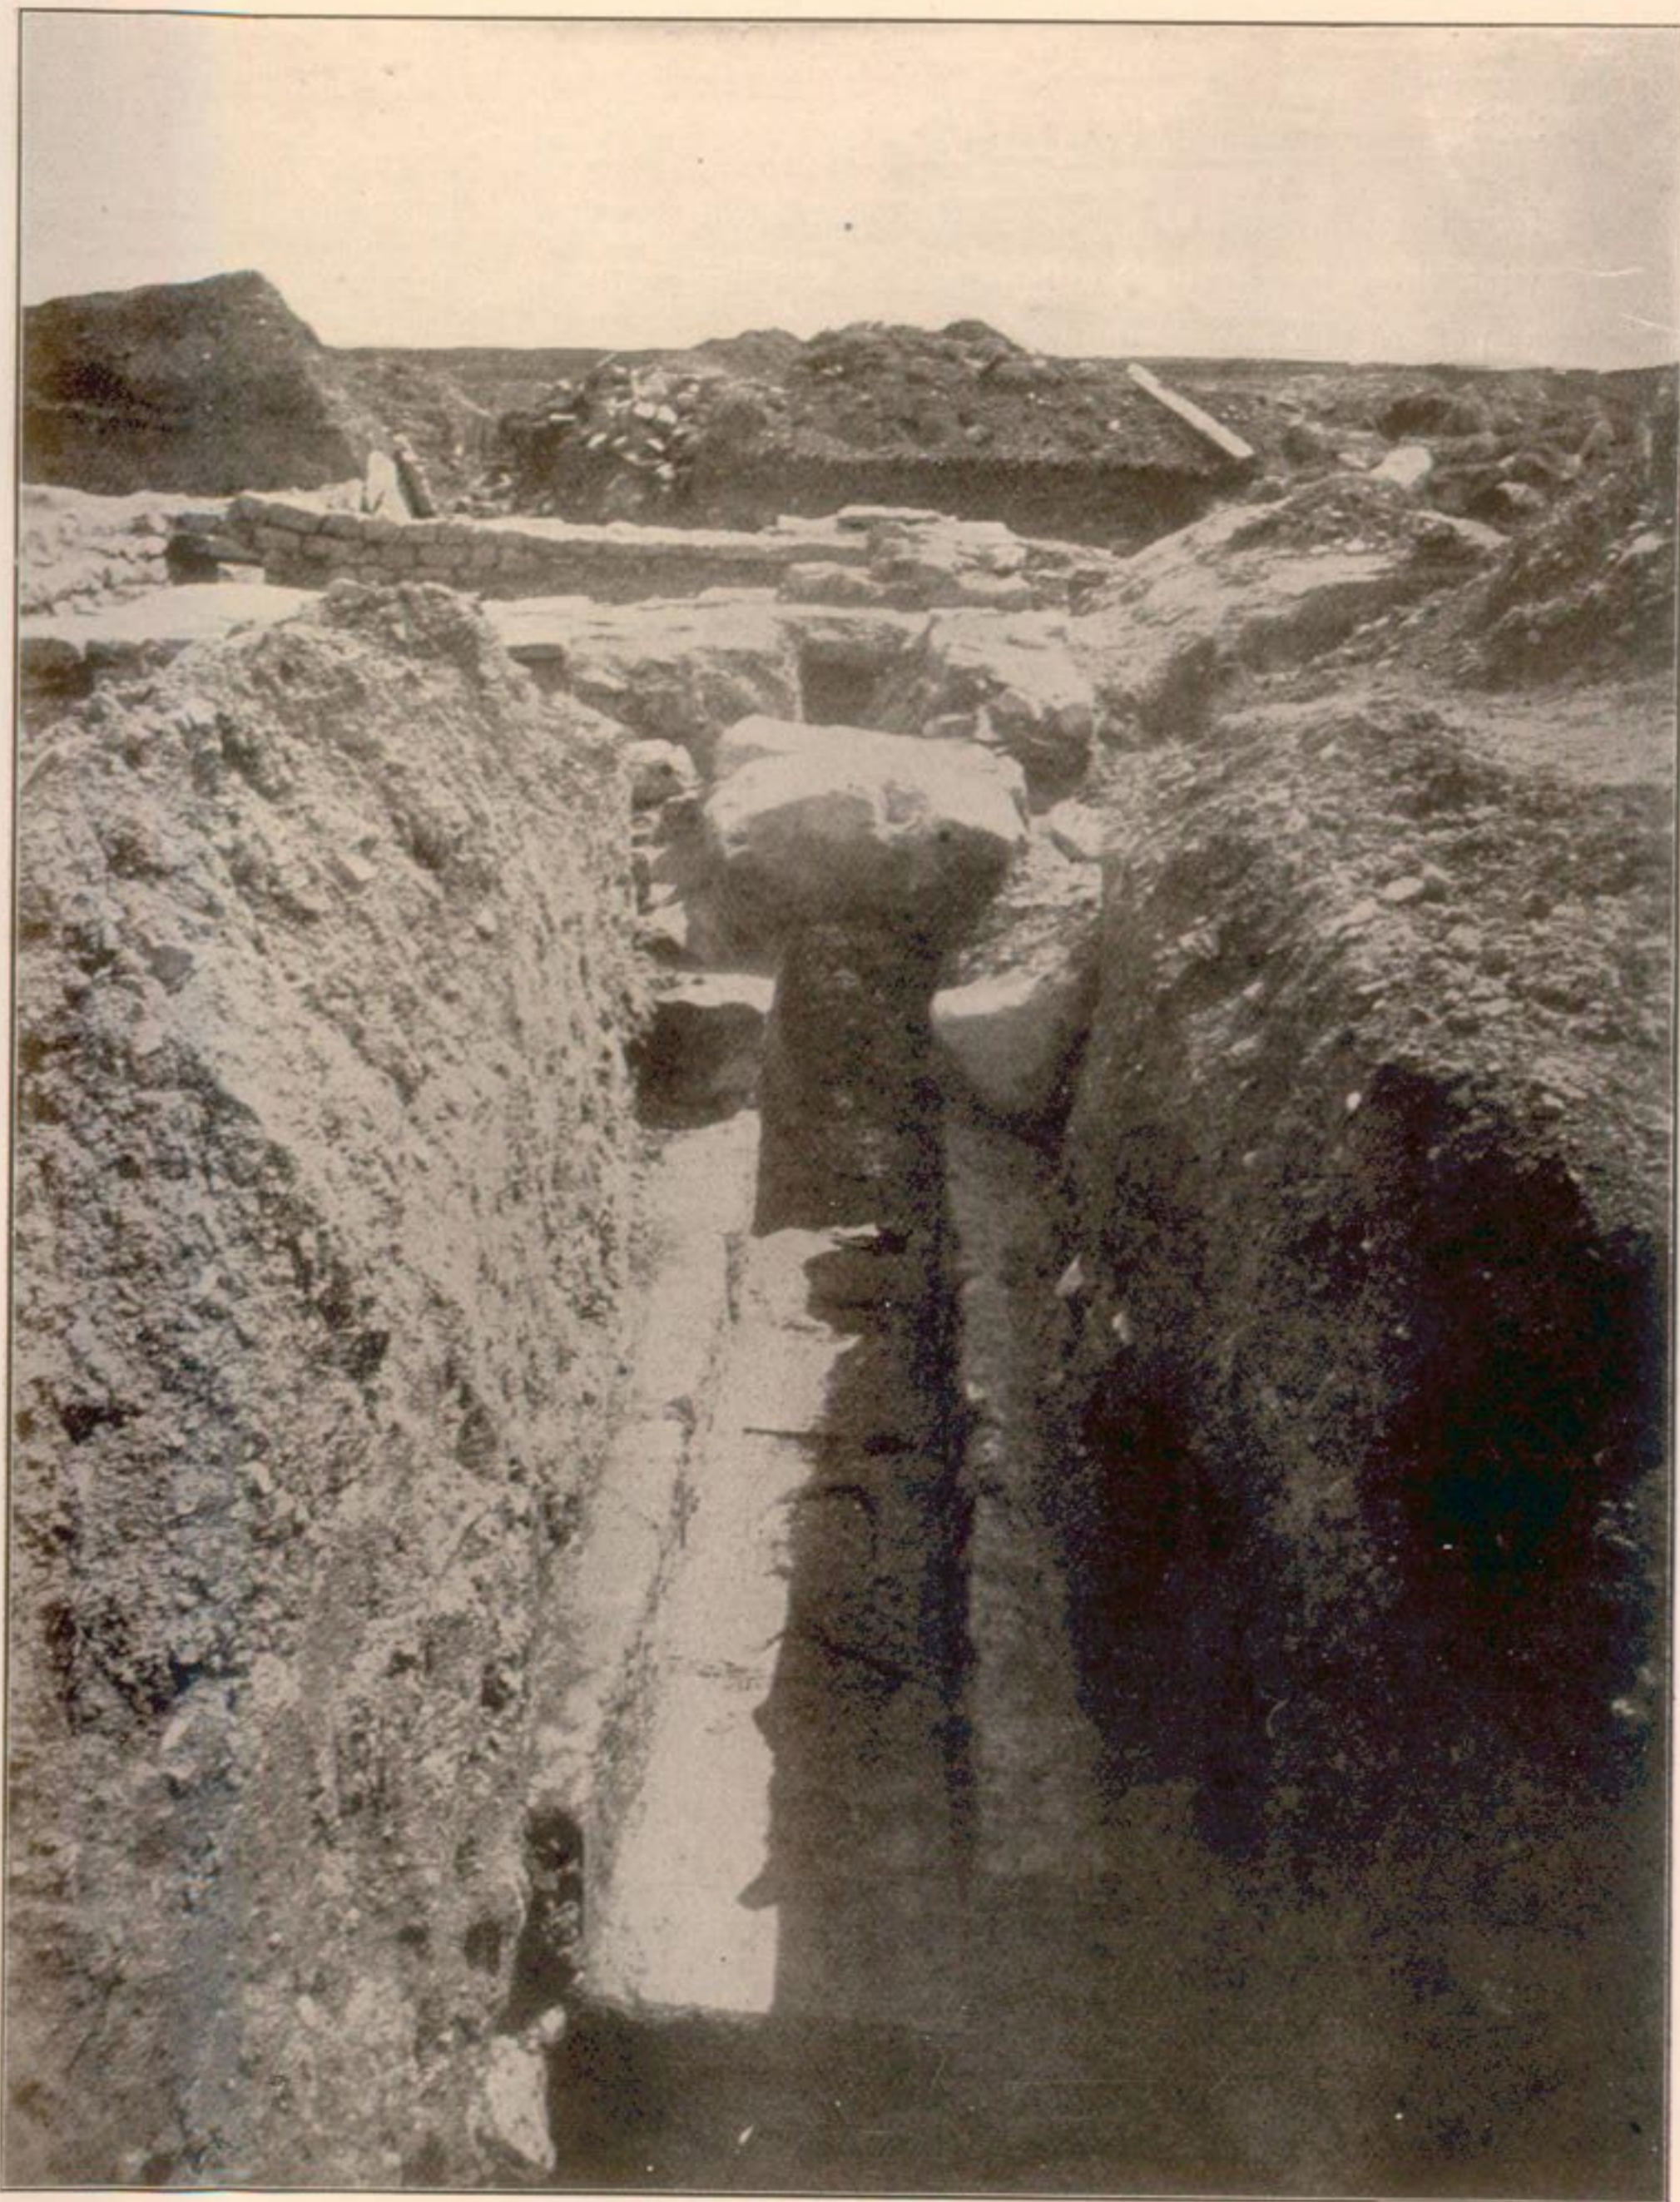
Fig. 26. Conduit through north wall.

The drain leading to the conduit is well constructed of squared stones and covered with large flagstones closely laid, and, as already stated, appears to have been the original drain conducted through the wall. But a part of it seems subsequently to have been disconnected, for at 12 feet south of the building a branch from it has been made to come into the building at the south-east corner, at a higher level by fully a

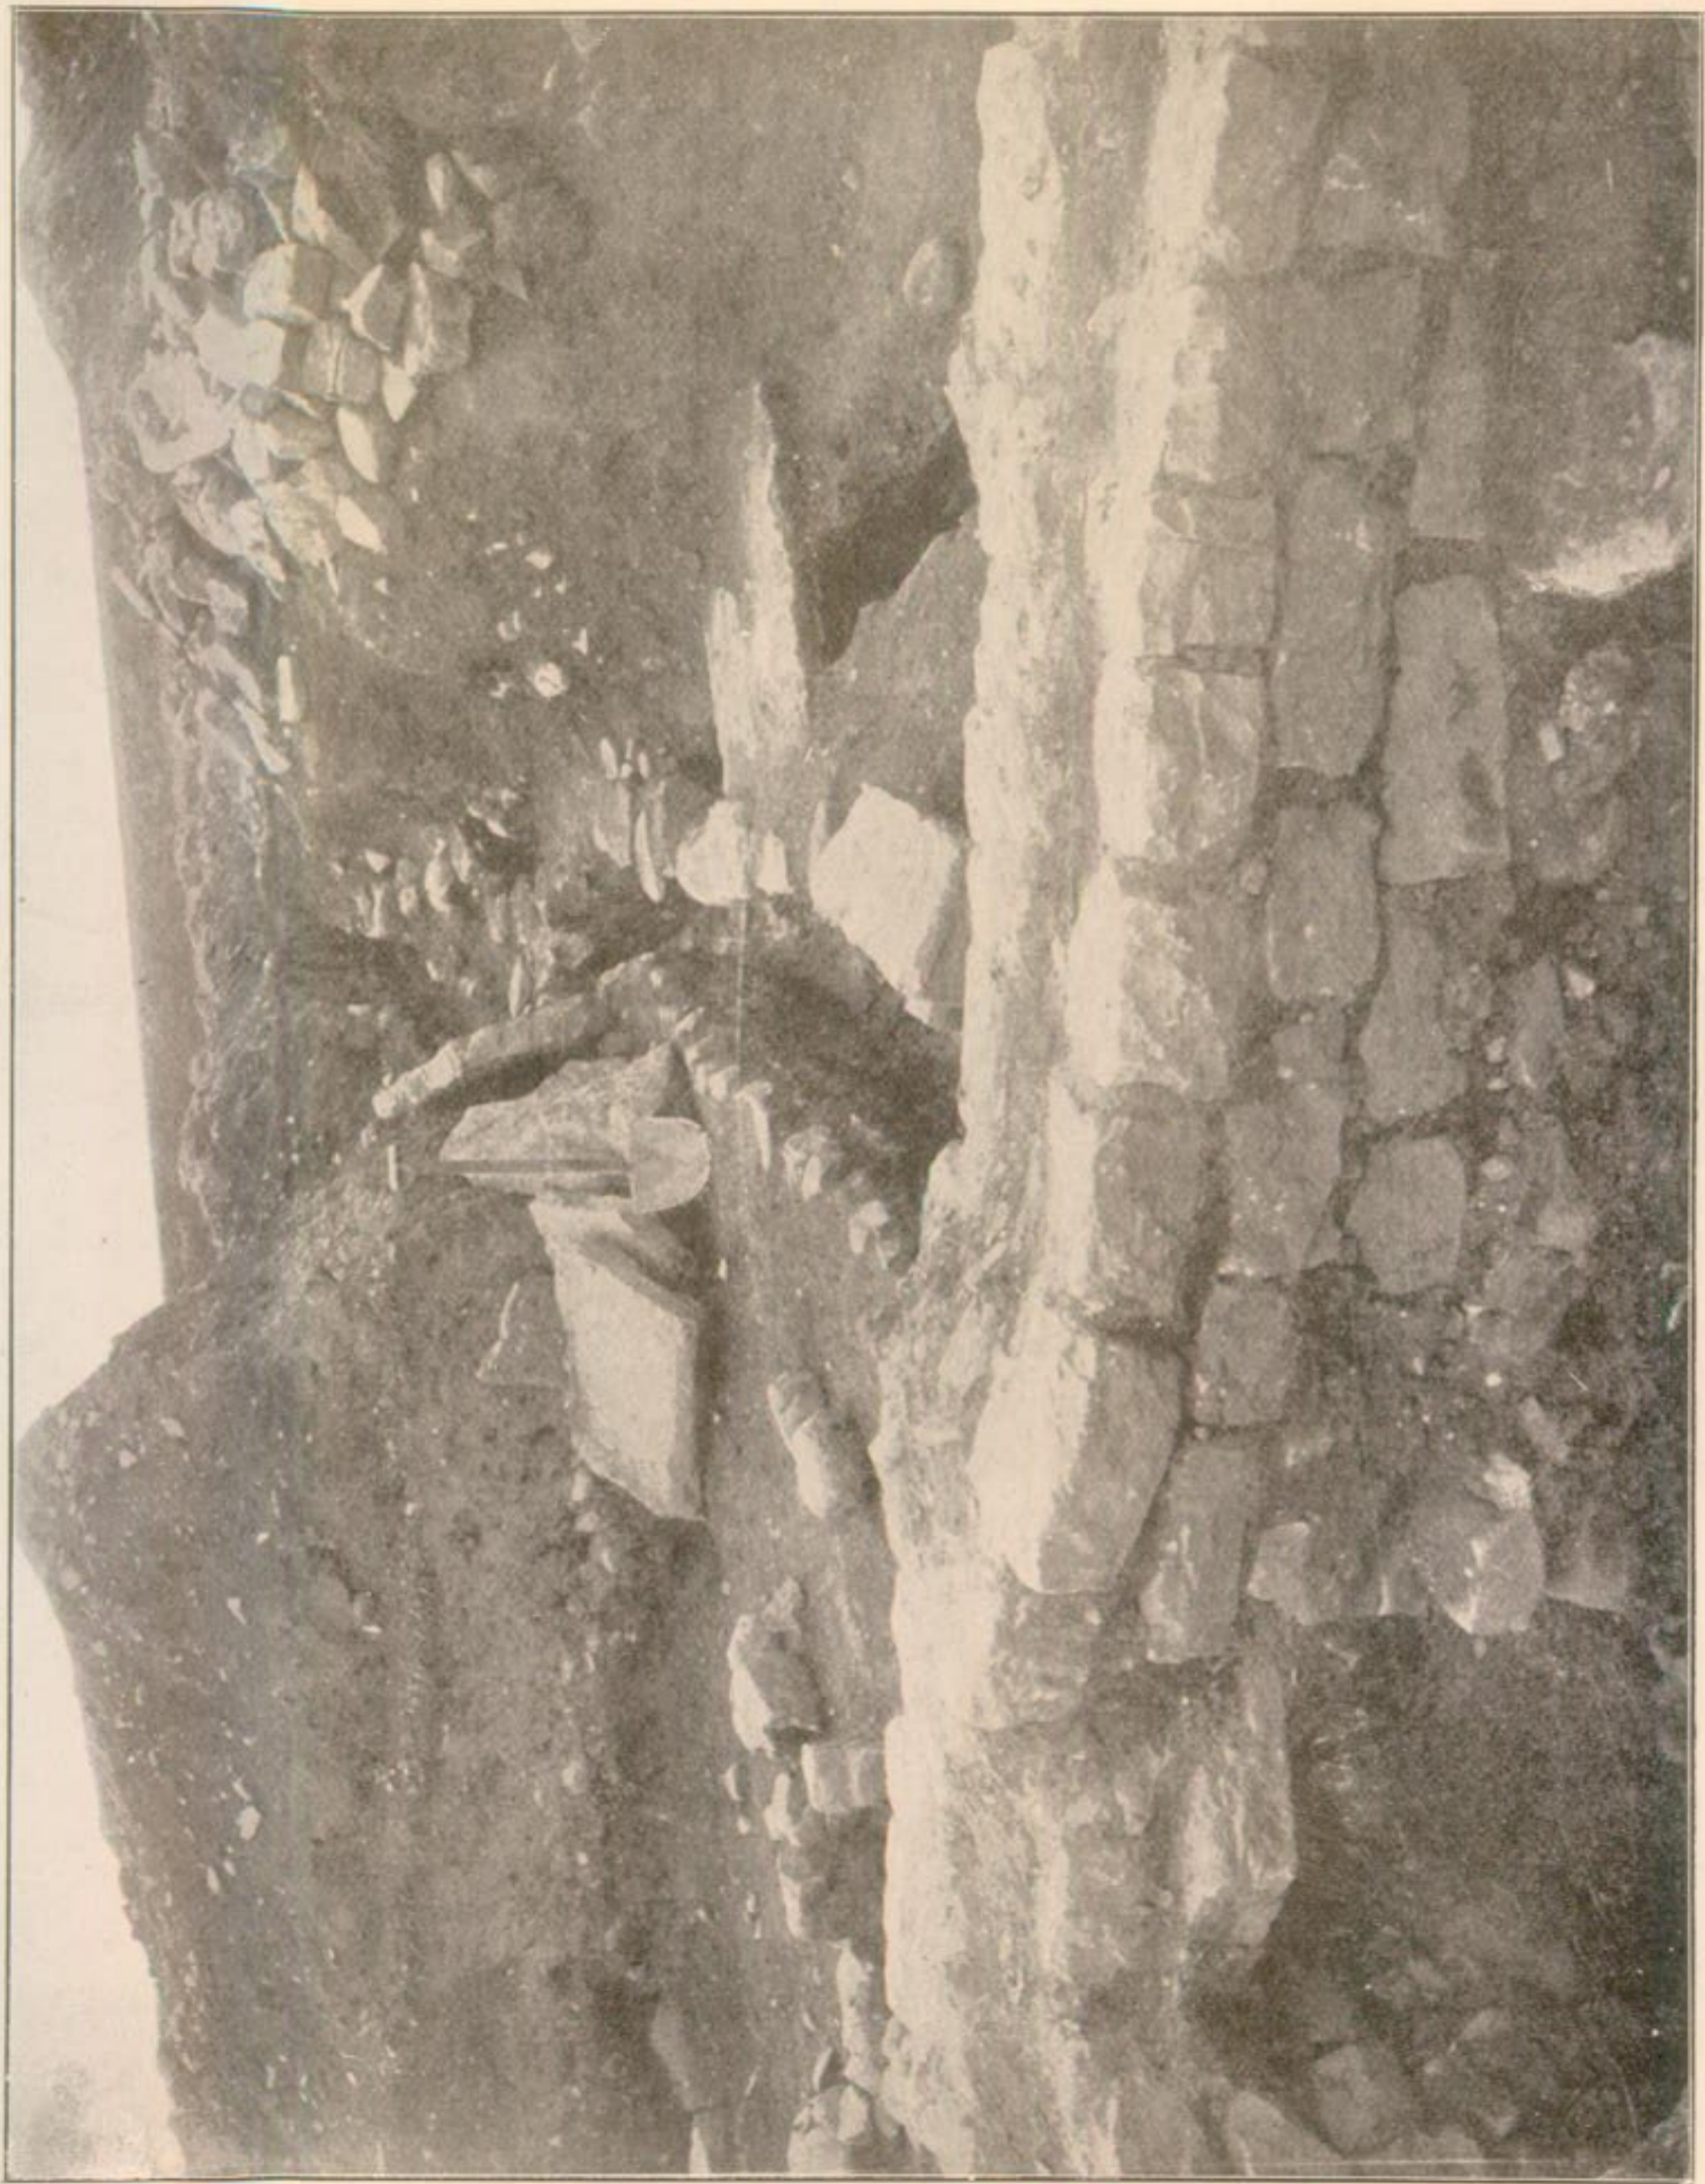
Fig. 27. Latrine, showing entrance of high drain through south wall.

This latter, or high drain, enters the building by a square-built aperture near the east end of the south wall, the opening being 15 inches wide and 21 inches high (fig. 27). Of the internal channels, that on the south falls 6 inches to the westwards. The north has a fall of 9 inches in the same direction.

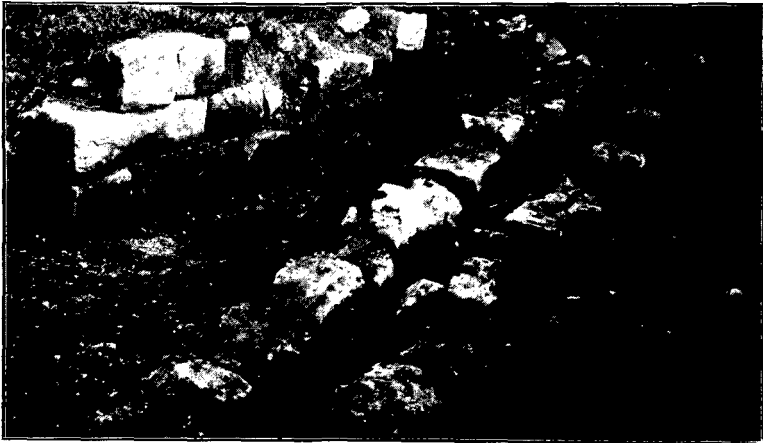
Fig. 28. Drain on west of central buildings.

There is evidence that the main drain outside had been connected with other drains. One of these joined it 20 feet south of the buildings appearing to come from the west. But this is not to be confounded with the large east to west drain running parallel with the fort wall. This latter has its fall westwards and takes a turn at the north gate,
