## Excavations at Craigievar Castle, Aberdeenshire

Moira K Greig\*

### ABSTRACT

*In the summer of 1990 the National Trust for Scotland funded an excavation to increase their knowledge of Craigievar Castle. This excavation revealed the remains of the east wall and part of the south wall of the original barmkin, along with two contemporary stone drains and a few post-holes. The excavation also recovered coins, pottery and glass.*

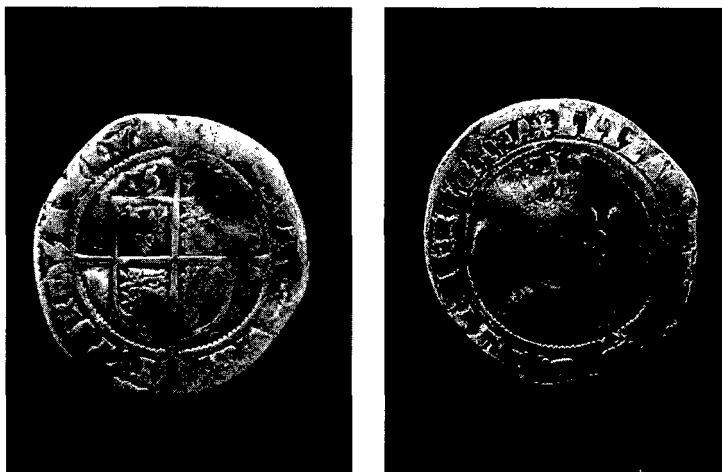
ILLUS 9 Coin of Elizabeth I, dated 1573, found within the south wall of the barmkin

The majority of finds dated from the 17th century to the early 20th century. Any mid- to late-20th-century finds were generally found in the topsoil. Only four artefacts were found in a stratified context, three of these being from the same horizon, layer 112, against the east wall. Both the James VI coins (see the coin report, on fiche) would have been in common use in the 1620s when the construction of the castle was nearing completion. The finding of the well-worn Elizabethan I coin of 1573, within the foundations of the east wall, demonstrates that the wall must have been built a number of years after that date as the coin had obviously been in circulation for some time before being lost (illus 9).
