9. THE ARTEFACT EVIDENCE: NEW STREET GASWORKS

9.1 Introduction

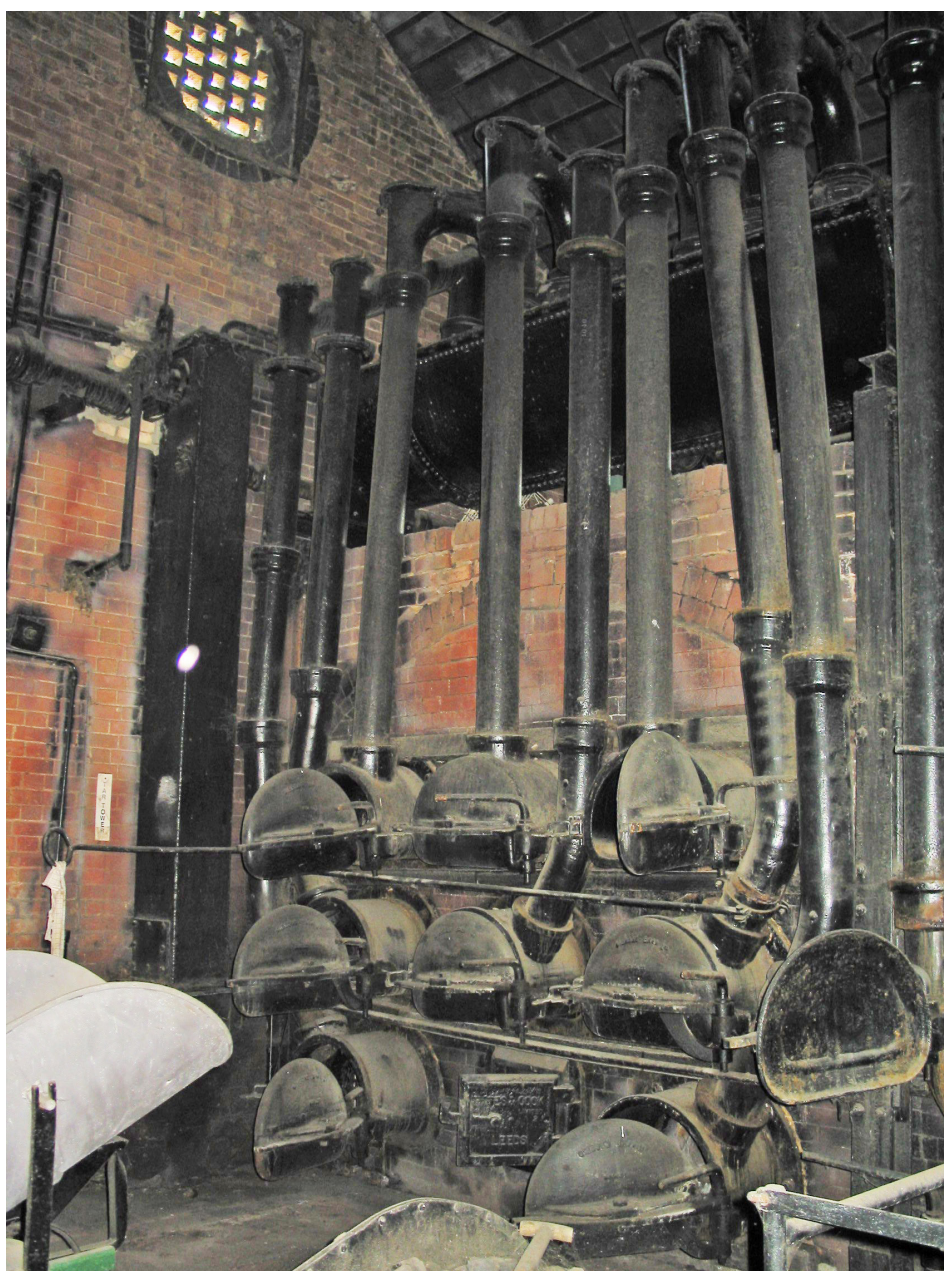
Illus 84 Retort bench with eight retorts, Fakenham Gas Works

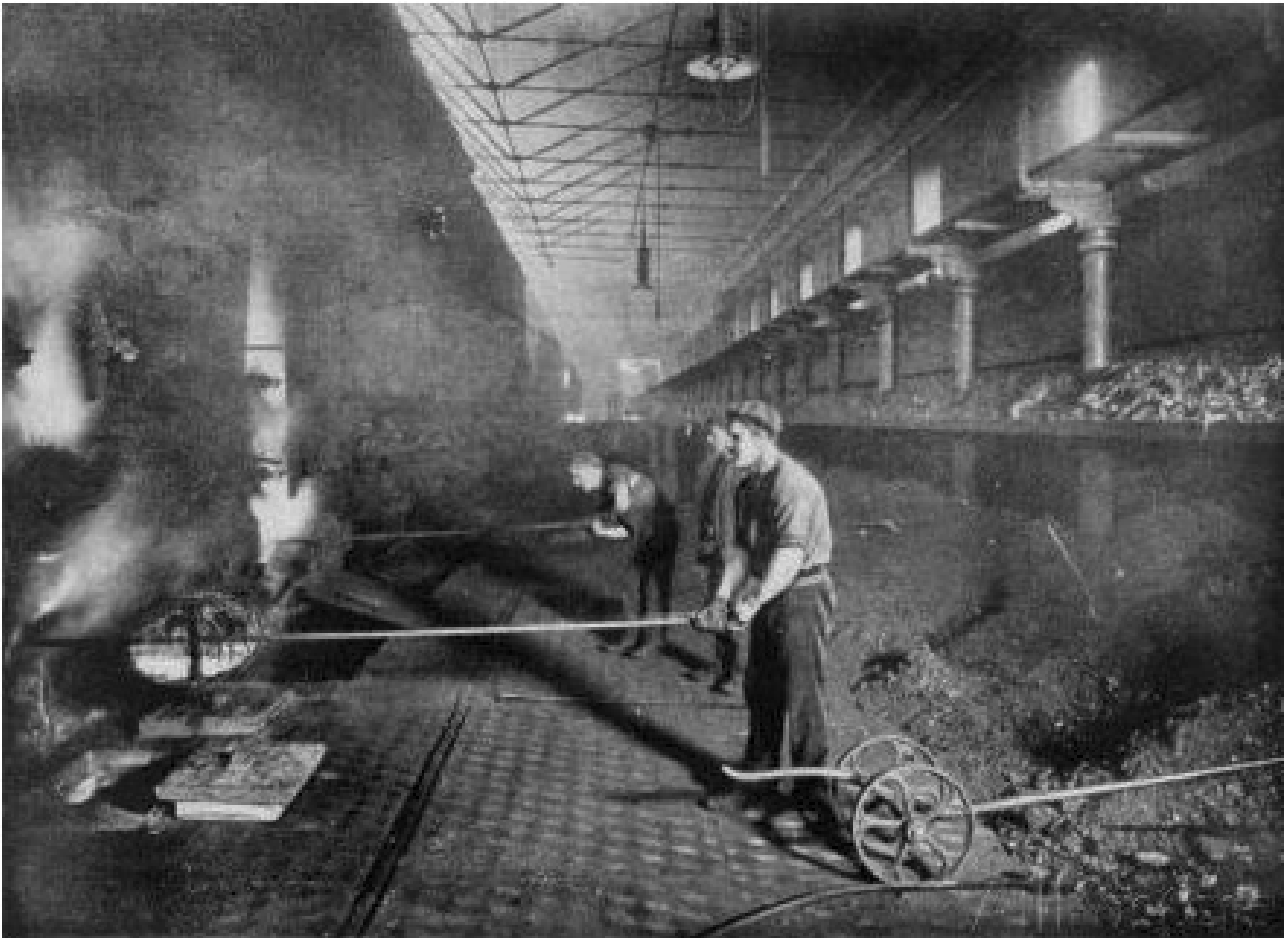
Illus 85 Drawing horizontal retorts, South Metropolitan Gasworks, c late 19th century

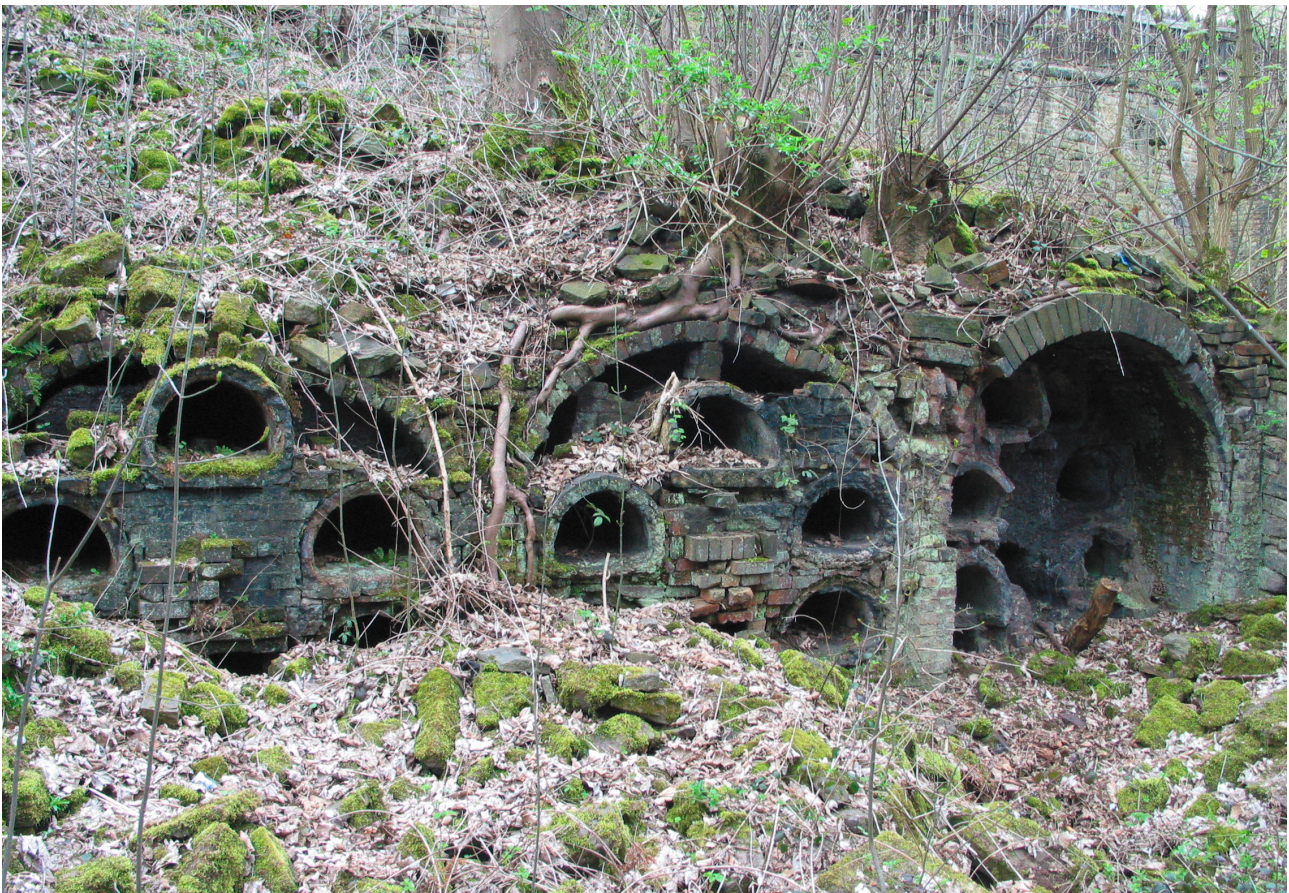
Illus 87 Ceramic retorts at the abandoned gasworks site at Shaw Lodge Mill, Halifax

have been contaminated with waste products. In most cases, they would have been broken up and buried. Illus 87 shows a site at Shaw Lodge Mill, Halifax in West Yorkshire where the retorts have simply been left in situ.

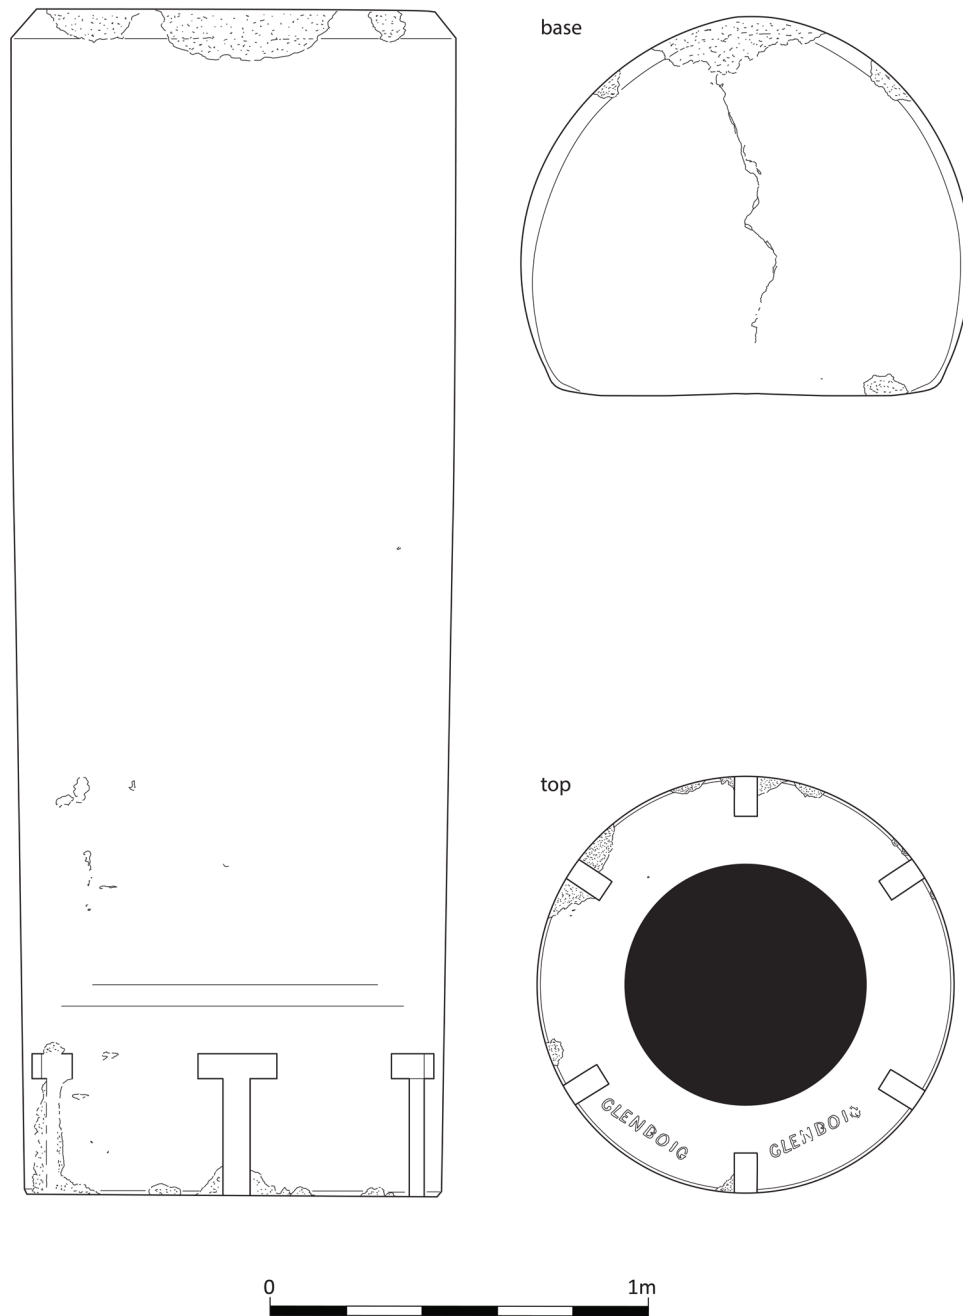
Illus 88 Intact fireclay retort

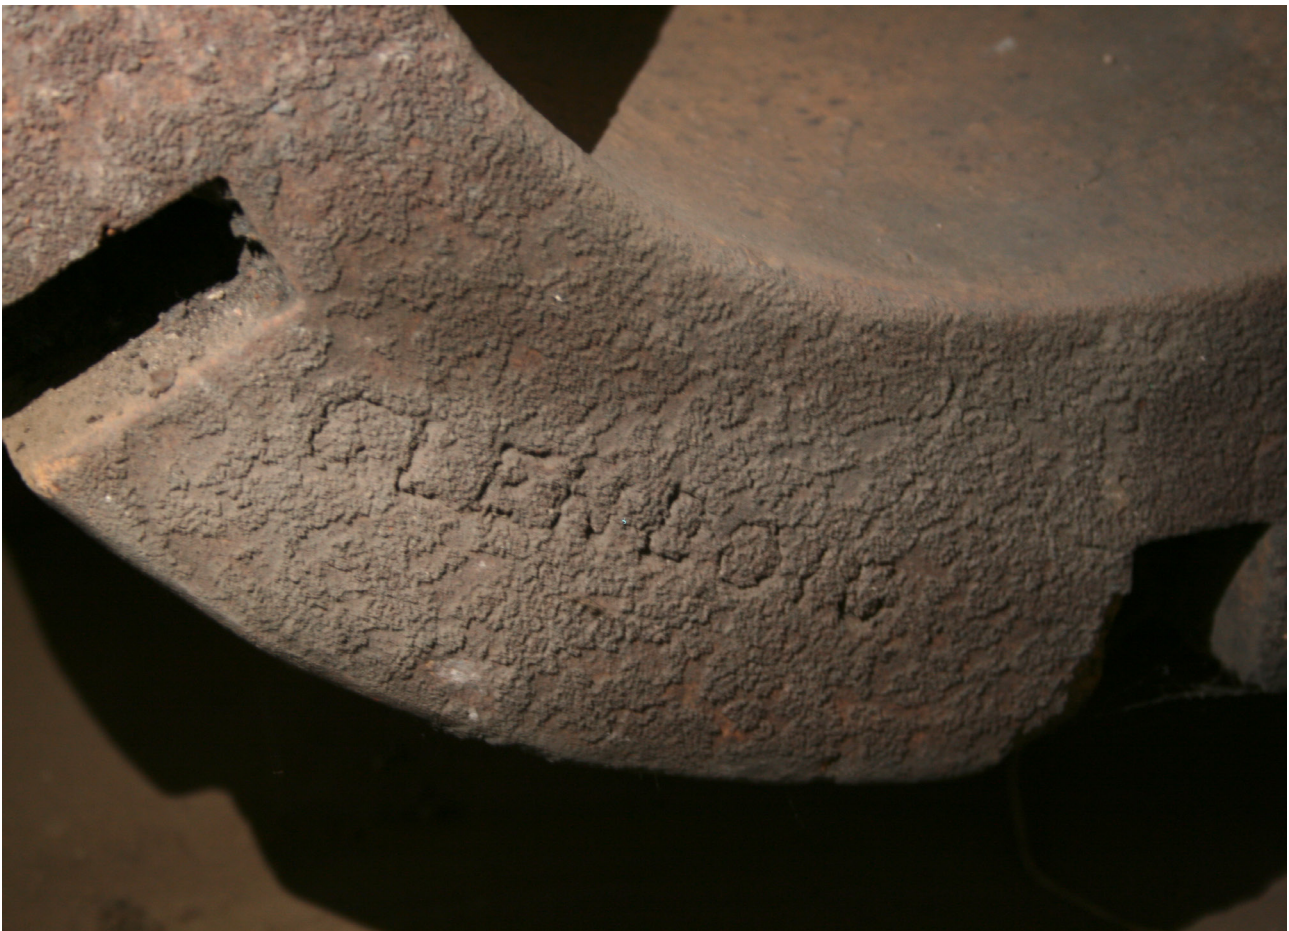
Illus 89 Flange of retort stamped ‘GLENBOIG’

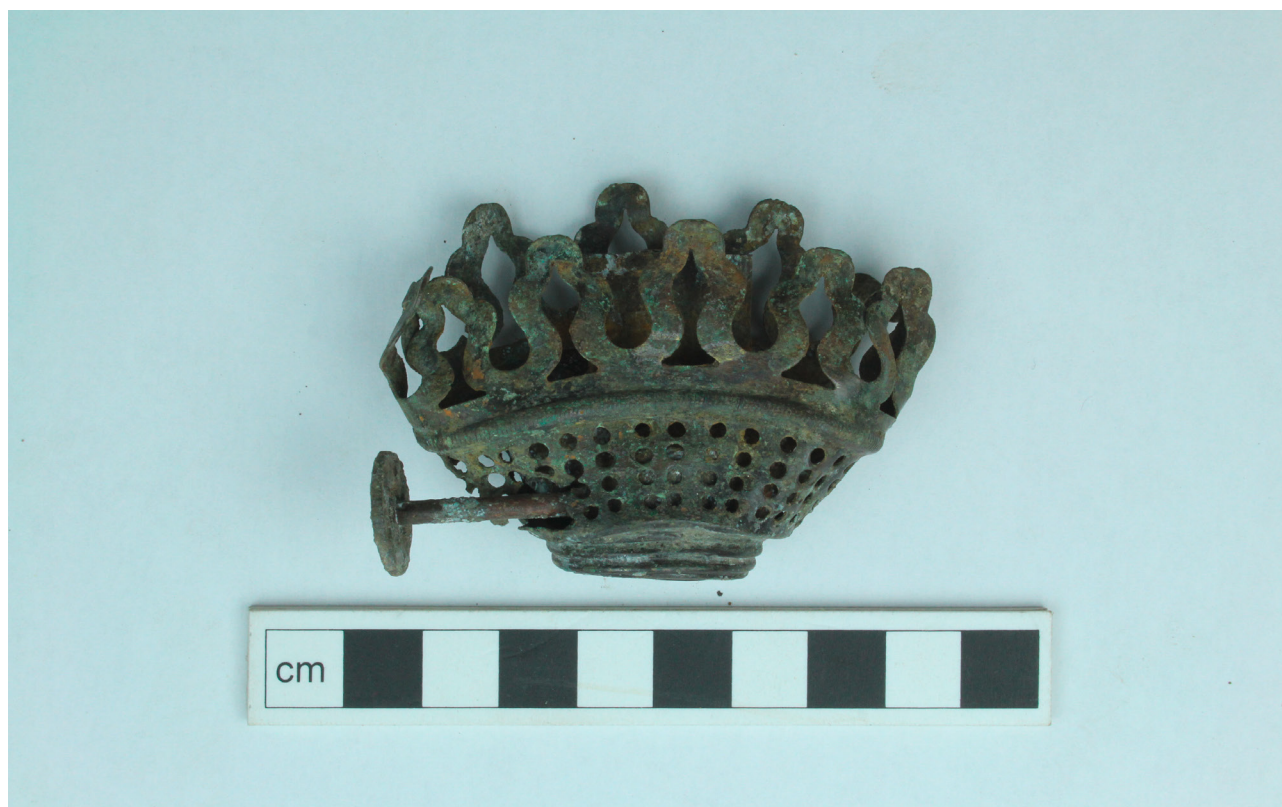
Illus 112 Brass oil lamp fitting, Area FA2, Layer B

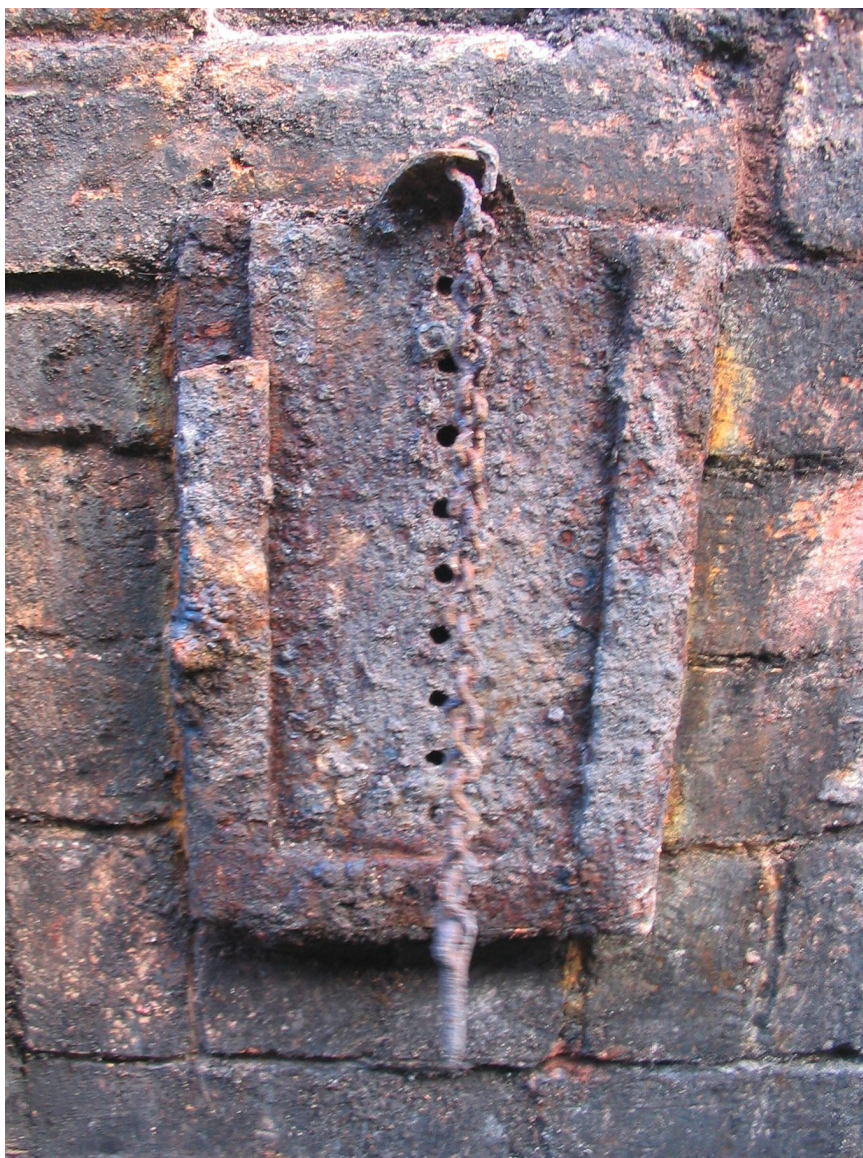
Illus 117 Iron retort inspection box in situ within furnace wall

brickwork structure of the retort furnace, with the tab and chain of the door orientated to the top of the box, showing that it was designed to be pulled upwards to open, to allow inspection of the furnace interior to judge the temperature of the retort (Francis 2010: 12). It may also have been used as a vent to partially increase air intake if needed when left fully opened. The most complete example was found in situ within the brickwork of the Phase 4 furnace in Area 1A, indicating a date of 1875 or later.

► **Retort furnace inspection box.** Iron rectangular box with sliding door/panel. Open face and open rear. Slight inward taper of sides from front to rear. Flanged face with slot for thin sliding door/panel. Door is flat rectangular sheet with tab along one short end, bent upwards for handle/hook/attachment. Hole in tab contains bent S-shaped wire which would have fastened to a chain. Nine circular

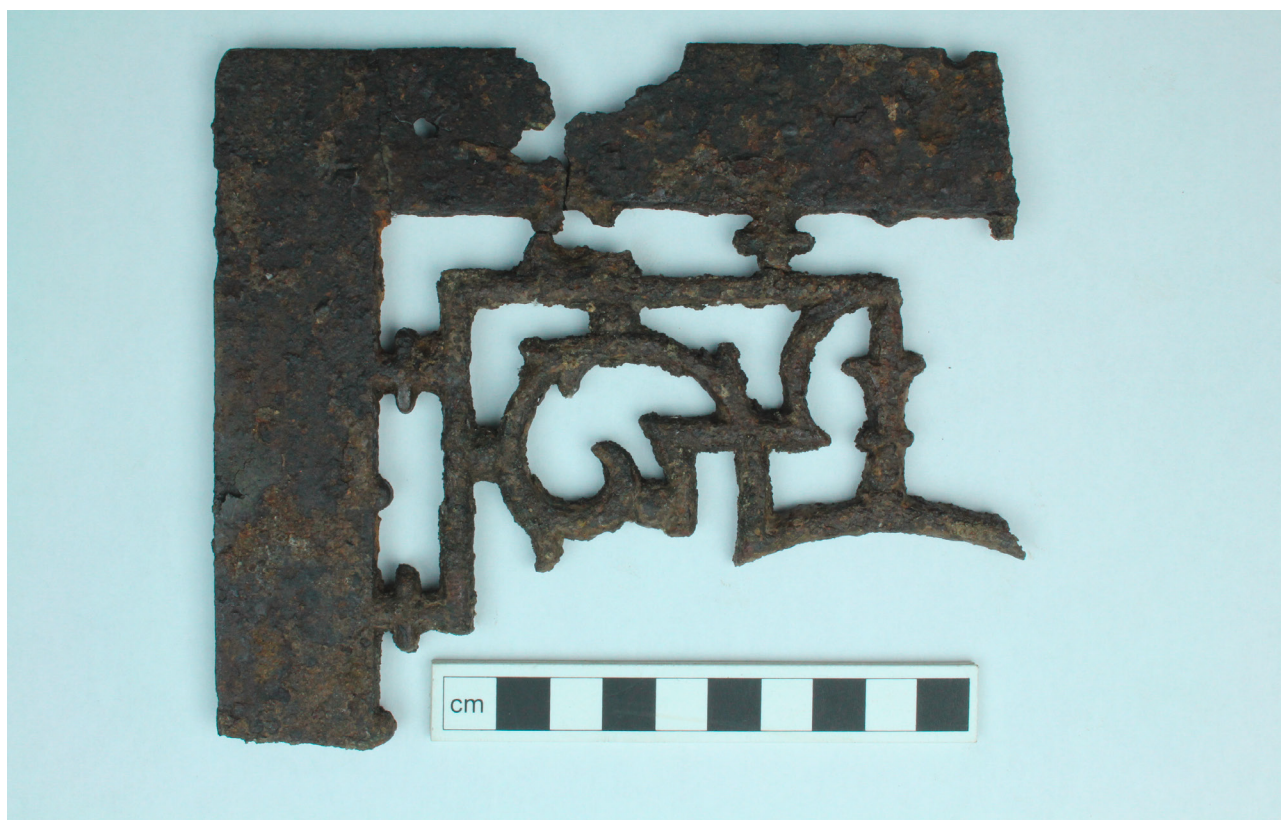
Illus 118 Fretted vent cover, SF21a (K0000)

A further object of note is the corner fragment of a square or rectangular fretted iron vent cover (SF21a; Illus 118). Broken into two fragments, the decorative vent cover was recovered from the demolition fill within Area K. A photograph on display at the Biggar Gasworks Museum shows a similar iron vent cover in situ within a brickwork wall behind a stoker working the retort bank.

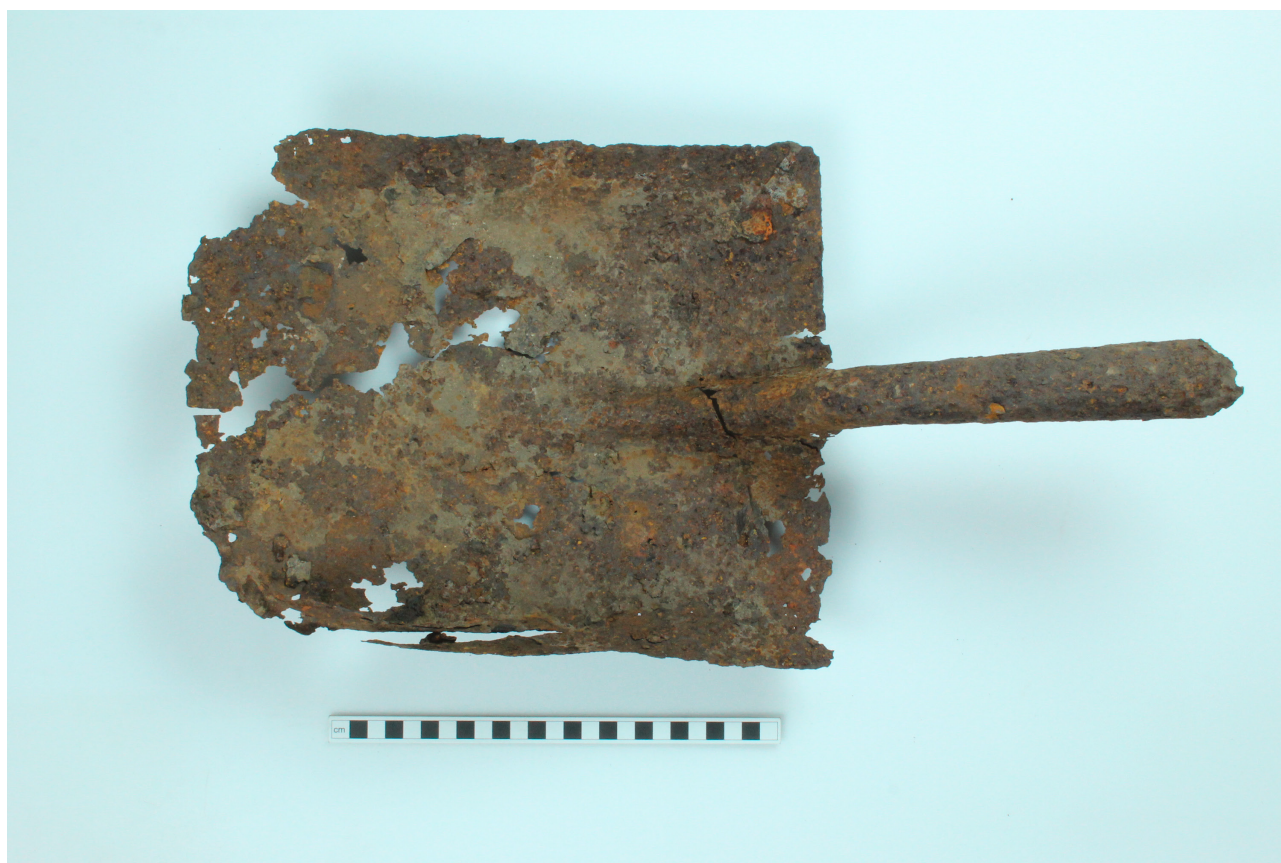
Illus 120 Shovel blade, SF8 (B0001)

The shovel blade (SF8) had an intact socket containing remnants of the wooden handle and a fixing peg still in place (Illus 120). A photograph (Illus 21) taken in the coal shed of the New Street Gasworks around the time of demolition shows the

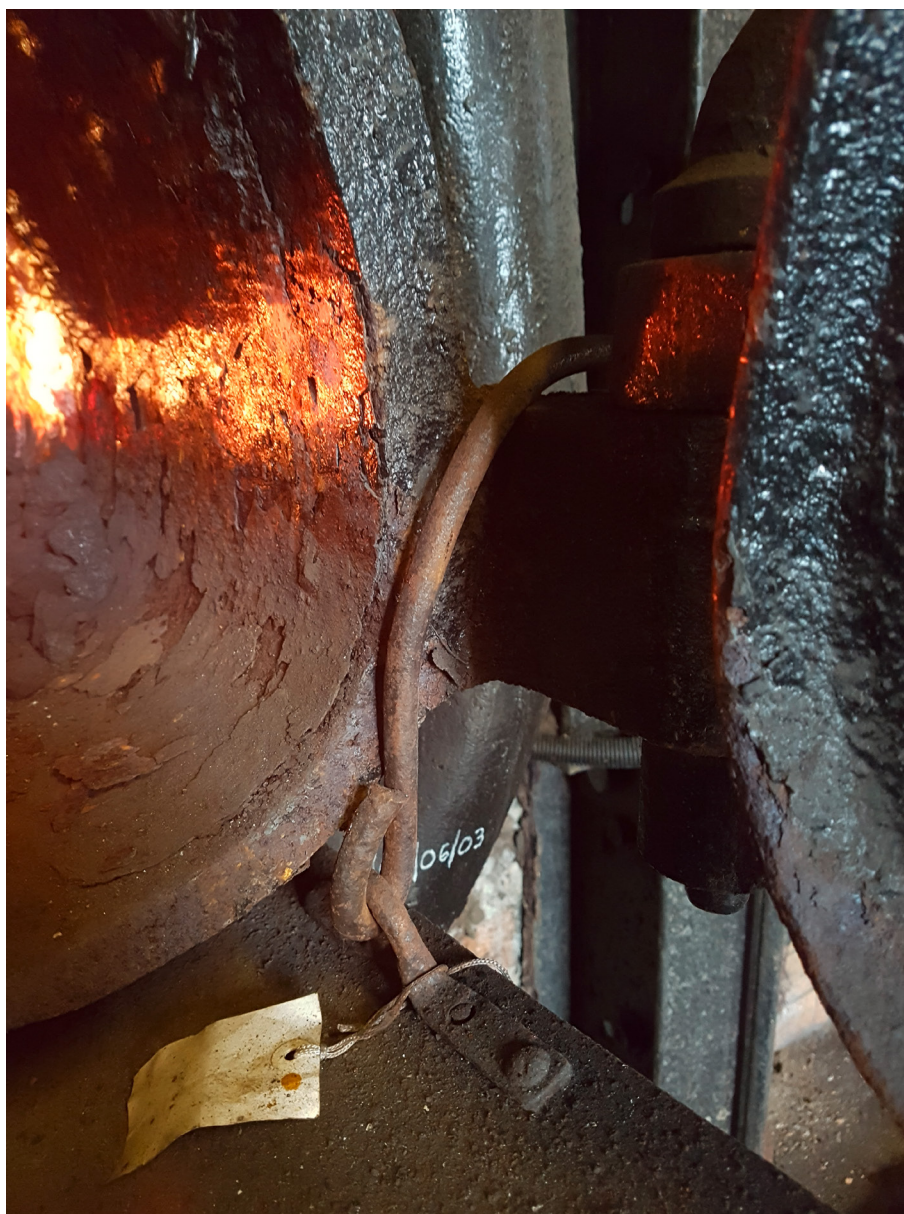
Illus 123 Corrosive vitrified residue build-up in the interior of working retort at Biggar Gasworks Museum

Various industrial residues were encountered during the excavations, particularly in and around Areas C and K, focused on the flues, furnaces and retorts. Small quantities of these residues, totalling 1,025g in weight, were collected as representative samples and have been retained as part of the site archive. Macroscopic examination has allowed these residues to be identified as unintended by-products
