Excavations at Inverlochy Castle, Inverness-shire, 1983–95

John Lewis* & Helen Smith†

ABSTRACT

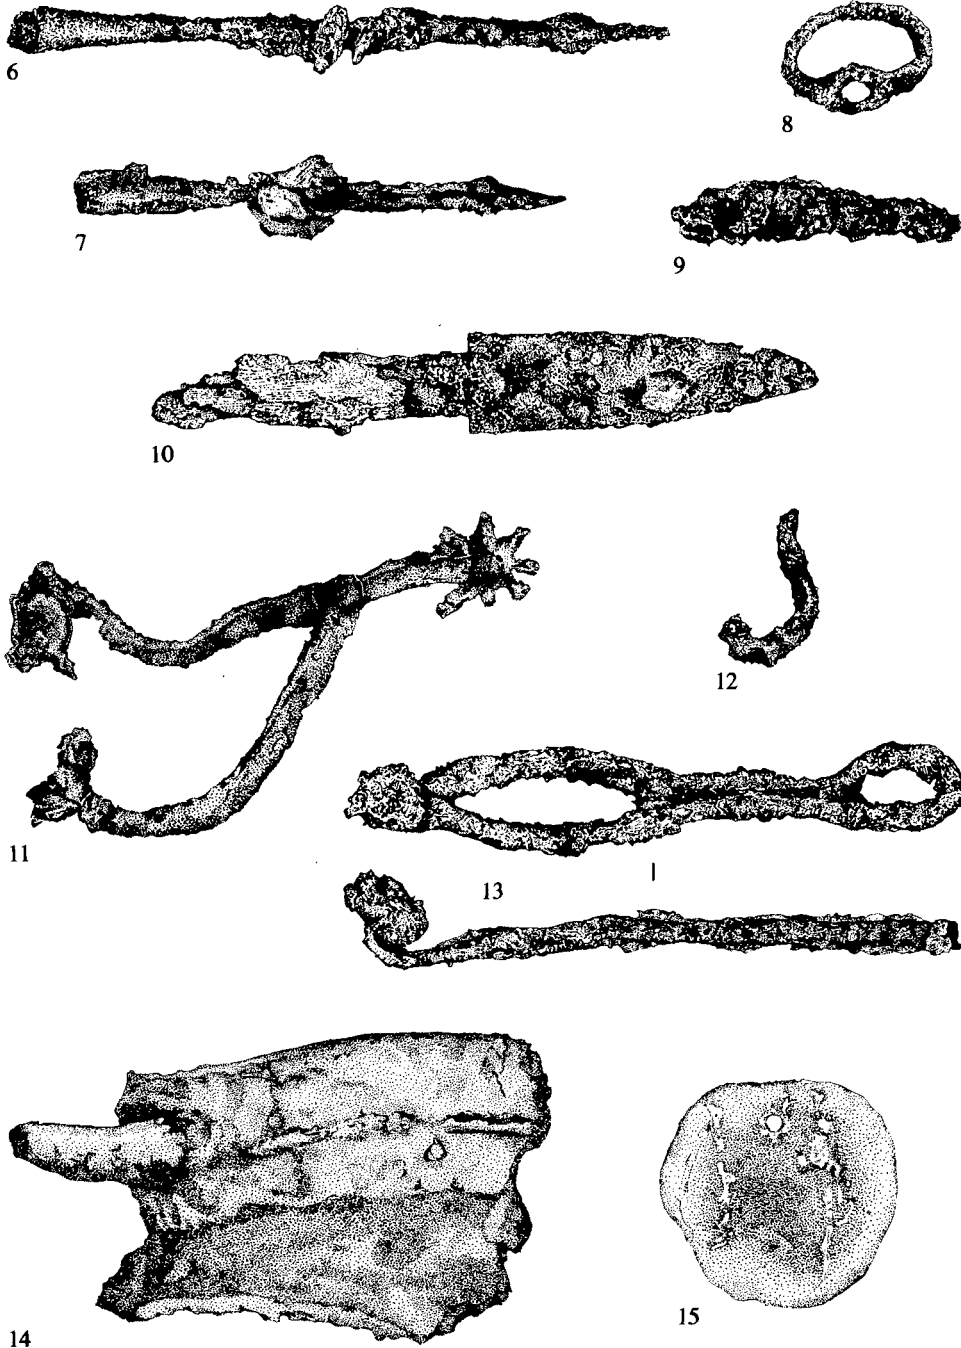
ILLUS 8 Iron and stone objects (scale 1:2)

Two arrowheads were retrieved from the topsoil in Trench 1, but may well have been deposited together much earlier. The only significant difference between them is length, both appearing to be complete. They are of London Museum Type 7 (LMMC 1940) and date from late medieval times when arrows were required to pierce increasingly effective armour as well as the leather or cloth behind it. From the 13th century arrows became thinner and heavier in order to exploit any chink there might be in an opponent's armour. By the 14th century this type of arrow was being used in battle to the exclusion of others; different, barbed types were used for hunting. A Scottish

Neither the knife (below), nor its X-ray, shows any sign of differential corrosion, often associated with steel edging. It has a whittle tang — the most common medieval type — and is likely to pre-date the 15th century when scale tangs became common (Cowgill *et al* 1987, 25).

The terminals of the Inverlochry spur are badly corroded, possibly broken, and with partial fittings still attached: even with the help of X-rays, they are hard to identify. It appears to have two single ring terminals with fittings for straps still in place. Evidently, the leather was attached to the flat plate. The ring that is hooked around the other terminal is possibly the remains of a buckle which held the strap in place. The spikes of the rowel wheel are all broken but the length of the shank cleft allows for a large wheel, up to 45 mm in diameter, similar to the cleft in the Perth example which follows the 14th-century fashion for larger wheels (Ellis 1987, 137). The Inverlochry spur is probably an early 14th-century example.

- 11 **Rowel spur** Length 140 mm, width 92 mm, length of rowel shank 38 mm. Spur with gracefully curving arms. Terminals corroded and difficult to identify but with S-shaped loop attached to left terminal and a small plate, possibly for a buckle, attached to the other arm. Rowel shank quite short with an eight-pointed rowel. No sign of tin plating. Trench 1; topsoil.
- 12 **Hook/nail shaft** Length 40 mm, width 26 mm, thickness 5 mm. Length of square-sectioned iron, bent into hook shape. Possibly a hook or a bent nail shaft. Trench 1; probable post-abandonment deposit.
- 13 **Hasp** Length 162 mm, maximum width 27 mm, thickness 6 mm. Length of iron bar bent into shape; possibly from a door or window. Trench 1; 18th-century or later deposit.

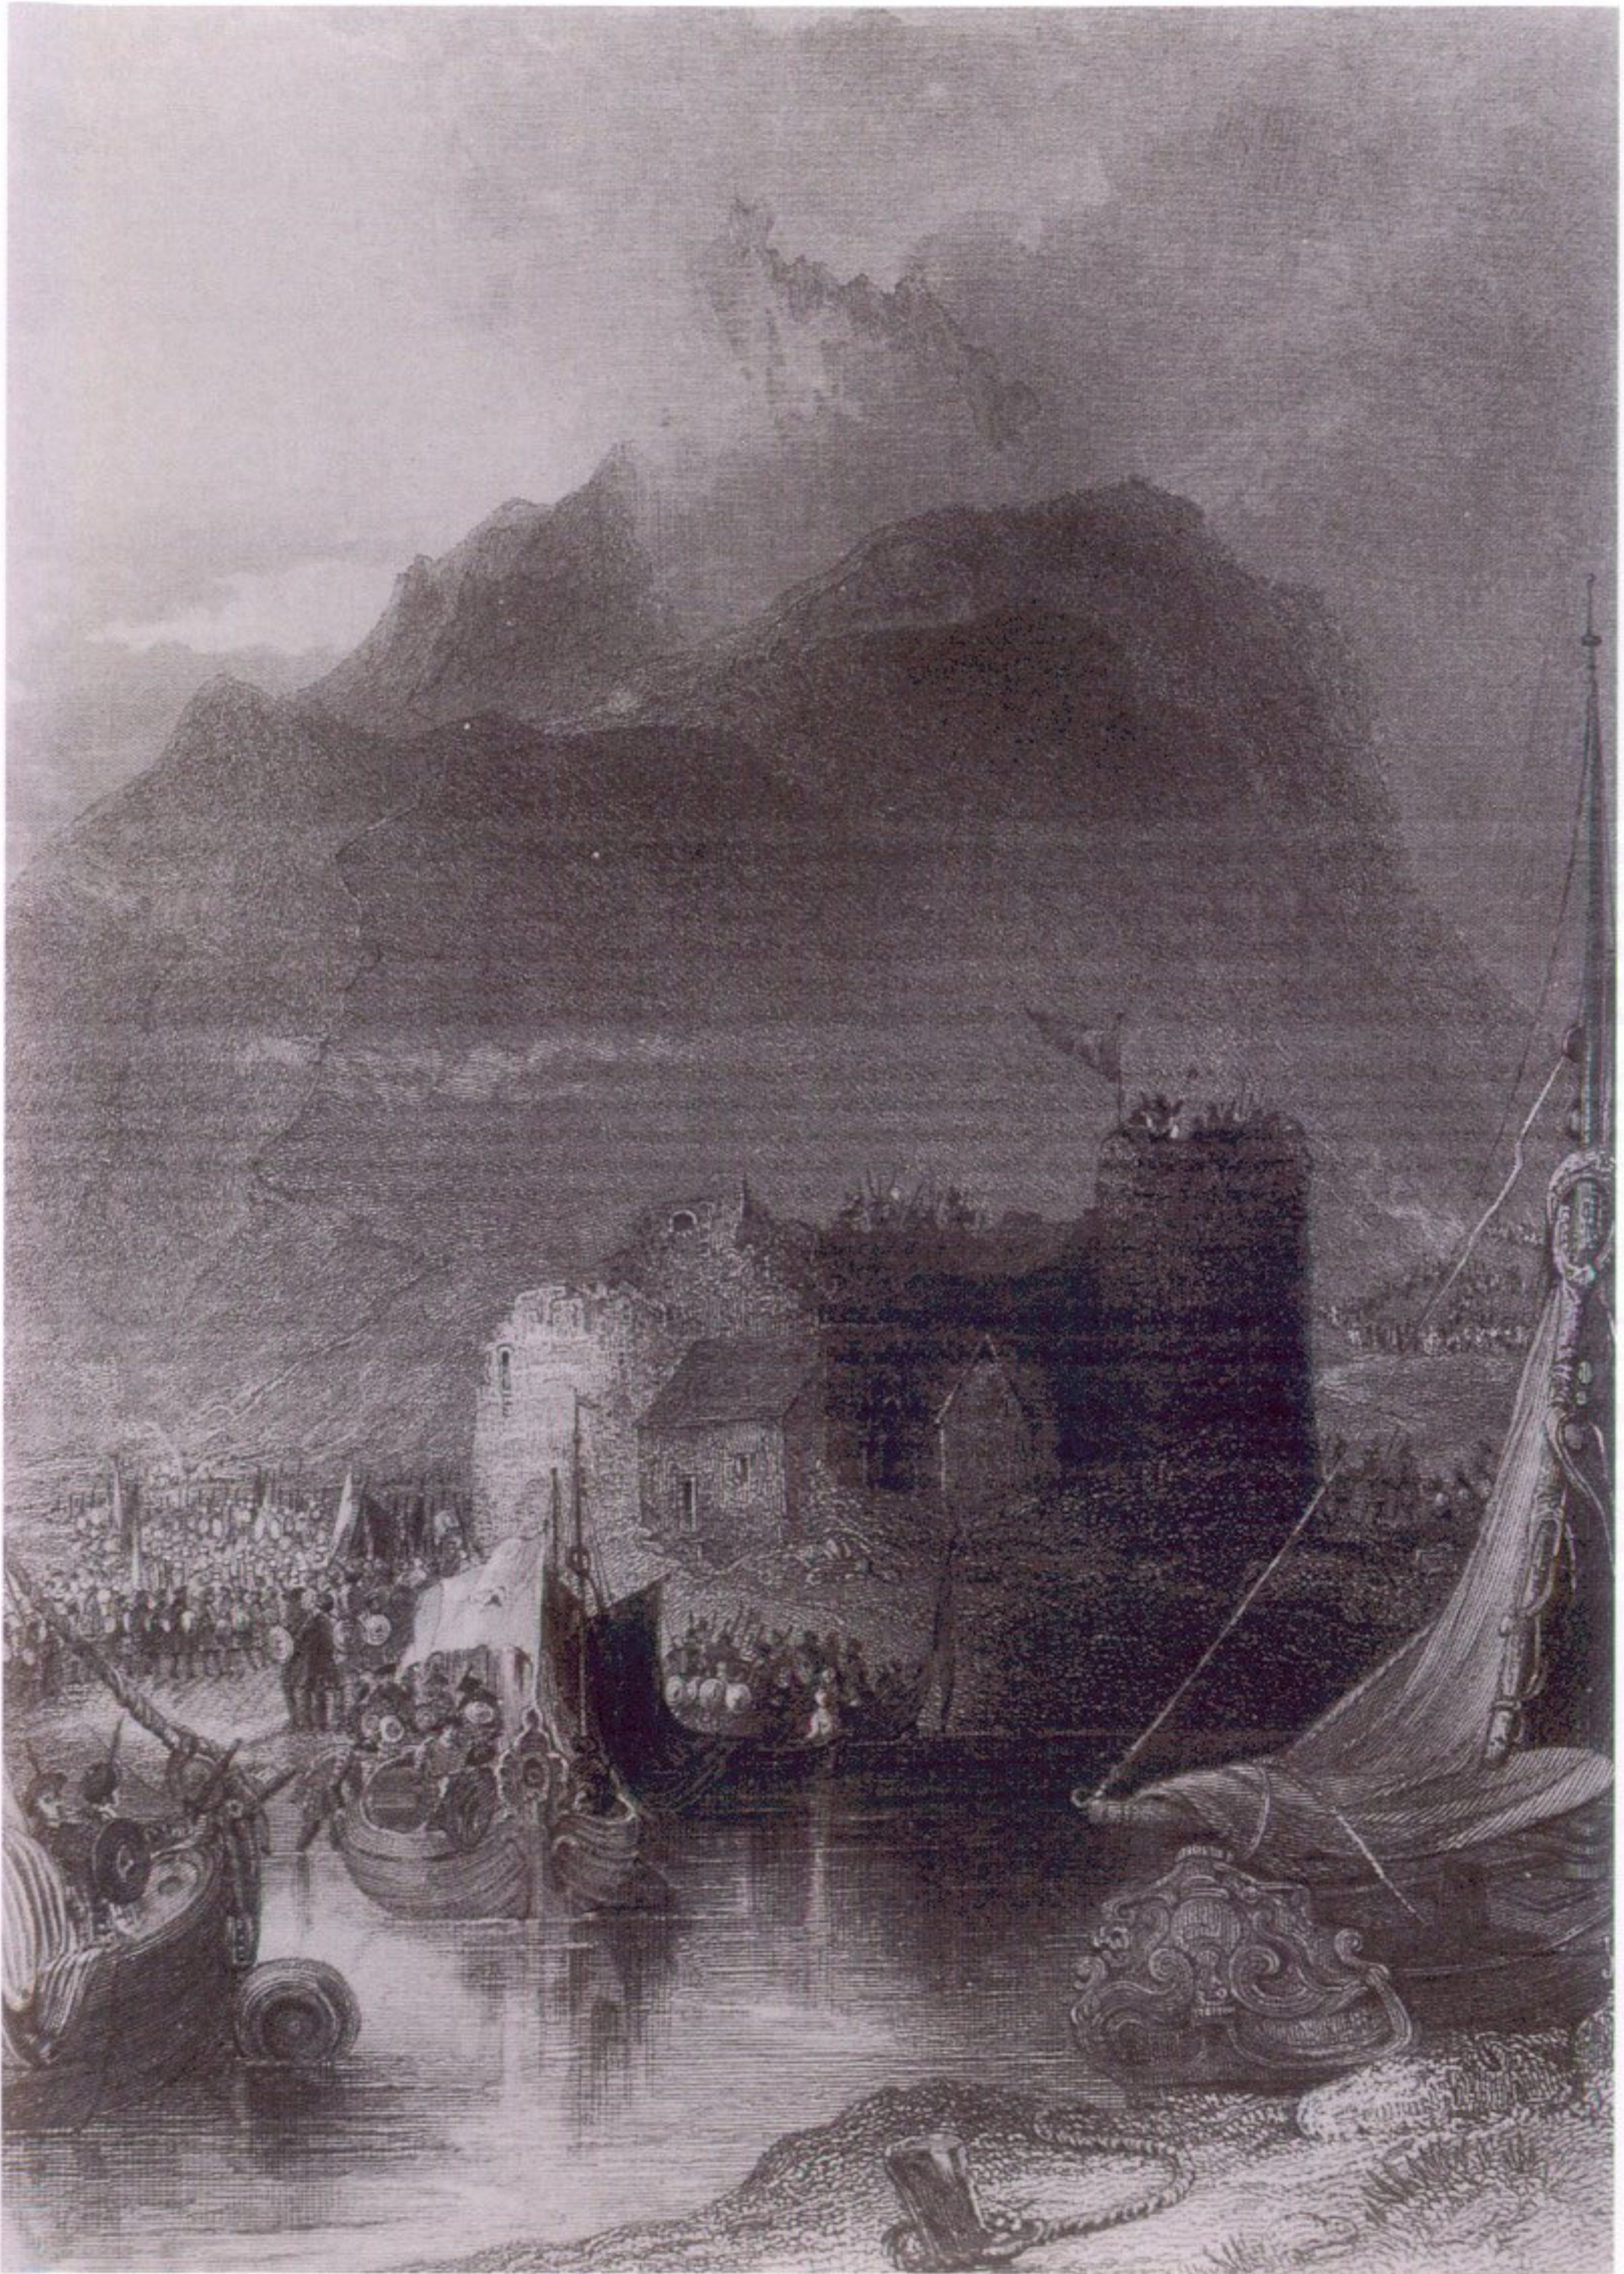
ILLUS 9 The north side of Inverlochy Castle, in a painting of c 1836, showing two lean-to structures against the north curtain wall

The outside face of the north curtain wall bears traces of three structures which once lay against it, two of which are shown in a 19th-century drawing (illus 9). There appear to have been two buildings to the west of the north gate: one indicated by four beam sockets at first-floor level, the other by a roof raggie further west. There had been another structure to the east of the gate. The above-ground evidence for this comprised five beam sockets to support its first floor and a roof raggie which extended over the fish-tail arrow slit in the west side of the north-east tower.

The easternmost of these structures, part of whose floor was probably that uncovered in 1983, was a lean-to building extending as far as (and perhaps sharing a wall with) the medieval structure interpreted as a barbican. The other building, just to the west of the north gate, had been built gable-on to the curtain wall. Whereas the castle is depicted as a partial ruin, both external buildings are roofed, suggesting they were not of any great age when the 1836 picture was drawn. The archaeological evidence supports this: the cobbled floor of the building to the east of the gate had clearly been laid after some of the facing stones of the curtain wall had fallen away.
