## Excavations at Newark Castle, Port Glasgow, 1984 and 1997

### ABSTRACT

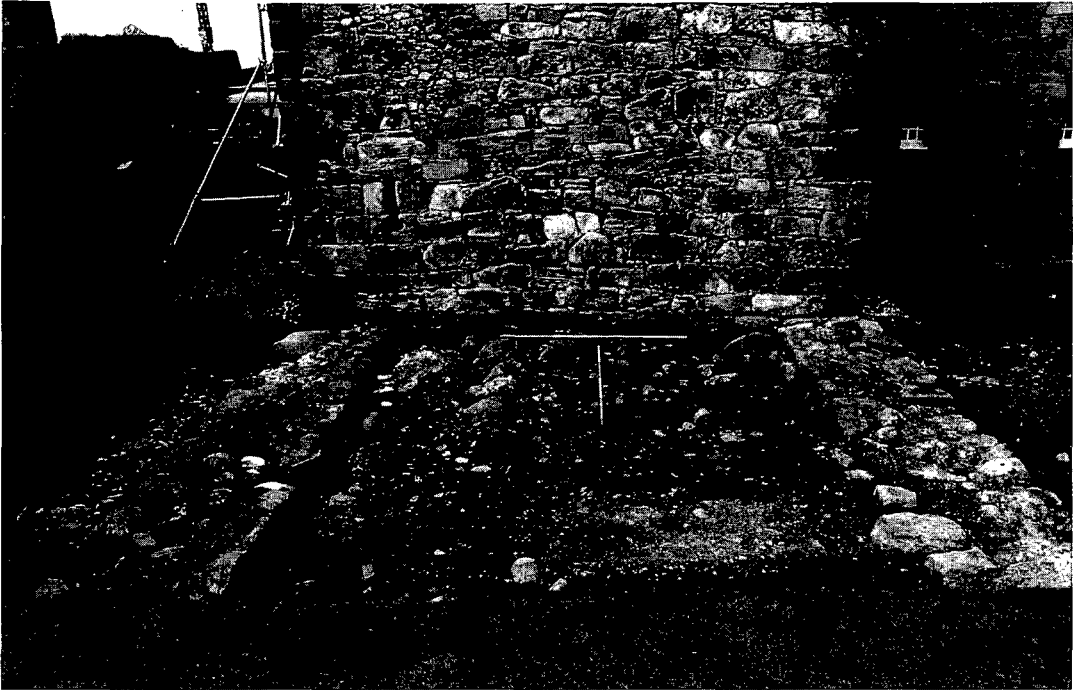
ILLUS 5 Trench A viewed from the south. Note the dumb-bell gunloop in the south wall of the gatchouse, sighted along the outside of the barmkin wall but blocked when wall F09 was built to its immediate west

The remains of three walls were uncovered barely below turf level. Abutting the south-west corner of the gatehouse was wall F09 which survived as one to two courses of mortar-bonded rubble masonry, 1.25 m wide at its base but narrowing slightly on its second course where there was a remnant of a chamfered scarcement. A bedding trench 0.5 m wide, infilled with small rubble, was visible to the west of this wall. Abutting the south-east corner of the gatehouse was the single surviving course of wall F08 which was rubble-built, mortar-bonded and 1.10 m wide. Its rubble-filled bedding trench extended 0.50 m beyond the east face of the wall. It returned westwards some 7.0 m south of the gatehouse, probably to link with wall F09 although the excavation area did not extend far enough to confirm this.

Perhaps the greatest puzzle thrown up by the excavation concerns the relationships between the walls uncovered in Trench A and the gatehouse against which they once stood. Pre-1984 photographs and earlier illustrations, particularly a drawing published in 1852 although perhaps drawn some years previously (Billings 1852, pl 24) (illus 10), show the remnants of the barmkin wall running southwards from the gatehouse along the line of wall F21. Excavation demonstrated that the foundations of that wall abutted those of the gatehouse but, although recent masonry consolidation has obliterated much of the evidence, the walls themselves were probably continuous. Billings' drawing also shows the roof-line of a narrow, single-storey, lean-to building which had stood against the inside face of the barmkin wall. Wall F08 in Trench A (illus 4) appears to have been the east wall of that building whereas wall F09, which was in line with the west wall of the gatehouse, defies easy interpretation. This wall, which clearly did not pre-date the gatehouse, would have blocked the dumb-bell gunloop on its south side, indicating that it was probably built after the barmkin wall was at least part-demolished and perhaps after the castle

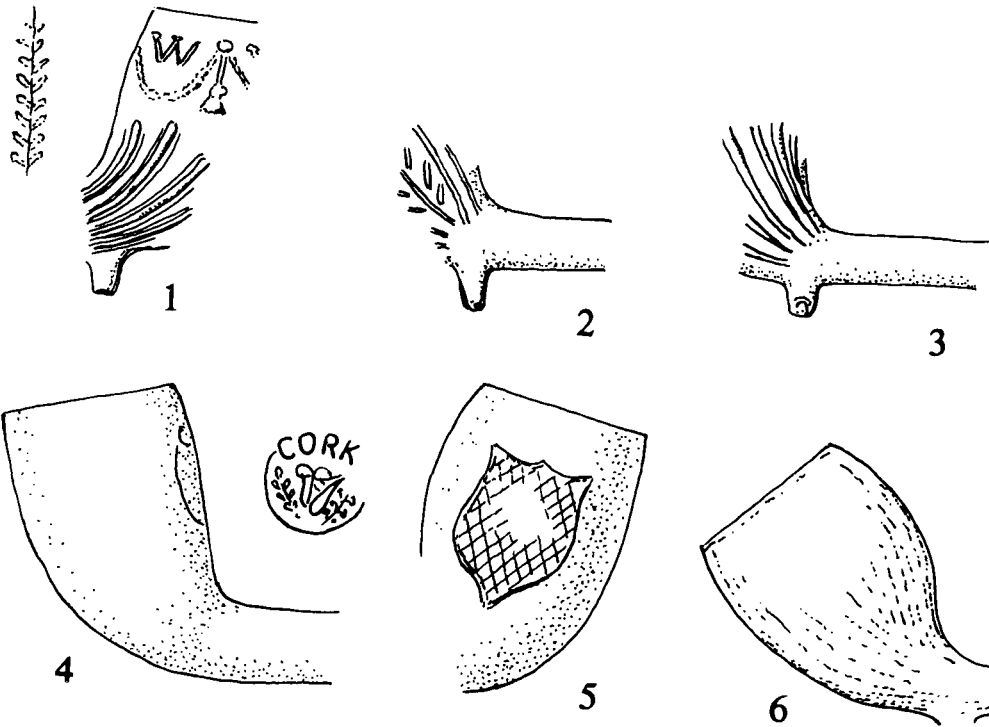
ILLUS 9 Clay pipe fragments (scale 1:1)

Forty-six clay pipe fragments were recovered, all of them post-dating c 1800. There is a distinct difference between early 19th-century forms and later material. The former is typified by thin-walled, spurred bowls, some carrying fluted decorations; examples are nos 1–5. Of these, nos 1 and 2 have fluting combined with foliage. Number 1 is unusual in also having the maker's

initials — W W — above hanging swags. Bowls with this form of decoration and with the maker's name below the rim were common in the English Midlands and Lincolnshire in the late 18th and 19th centuries but were also used by London makers such as Swinyard (Walker & Wells 1979). The Newark example may be an early work from the Glasgow factory of William White which operated between 1806 and 1955.

Most of the pipes post-dating the mid- 19th century are of the thick-walled cutty type. Fragments nos 6 and 8 may be from Glasgow pipes designed to appeal to Irish immigrants. Only stem fragment no 10 has a maker's mark, that of William Christie of Glasgow who was active between 1857 and 1962.

- 1 Rear fragment of thin-walled bowl decorated with flutings and swags and the initials W W in serif lettering. Possibly William White of Glasgow, c 1800–60. (Illus 9.1)
- 2 Lower bowl fragment; thin-walled with foliage between fluting. Early to mid 19th century. (Illus 9.2)
- 3 Lower bowl fragment, thin-walled, with fluting, possible C on the left side of the heel although the poor quality of the moulding makes the marking less certain (it may be a flaw in manufacture rather than a deliberate mark). Early to mid- 19th century. (Illus 9.3)
- 4 Lower bowl fragment with elongated spur. Early to mid- 19th century. (Not illustrated)
- 5 Lower bowl fragment with damaged spur. Early to mid- 19th century. (Not illustrated)
- 6 Thick-walled bowl and stem fragment with a circular stamp with CORK, a harp, leaves and shamrock on the rear; probably a Glasgow product. Post c 1850. (Illus 9.4)

- 7 Thick-walled bowl in pale yellow-white fabric, with a mould-imparted shield on its right side; probably a Glasgow product. Post c 1850. (Illus 9.5)
- 8 Fragment of the rear of a bowl with half a stamp with ..SH [PI]PE in an oval frame, probably denoting 'IRISH PIPE'. Post c 1850. (Not illustrated)
- 9 Stem fragment of a pipe in the form of a tree trunk with lopped branches. Post c 1850. (Not illustrated)
- 10 Stem fragment with ..RIS../.LASGOW in incuse, sans serif lettering, partly obscured by slag; William Christie of Glasgow, active 1857–1962. (Not illustrated)
- 11 Stem fragment marked BURNS CUTTY PIPE on both sides. Post c 1850. (Not illustrated)
- 12 Highly burnished bowl with damaged spur; Dutch, 19th century (cf Duco 1987, 57). (Illus 9.6)

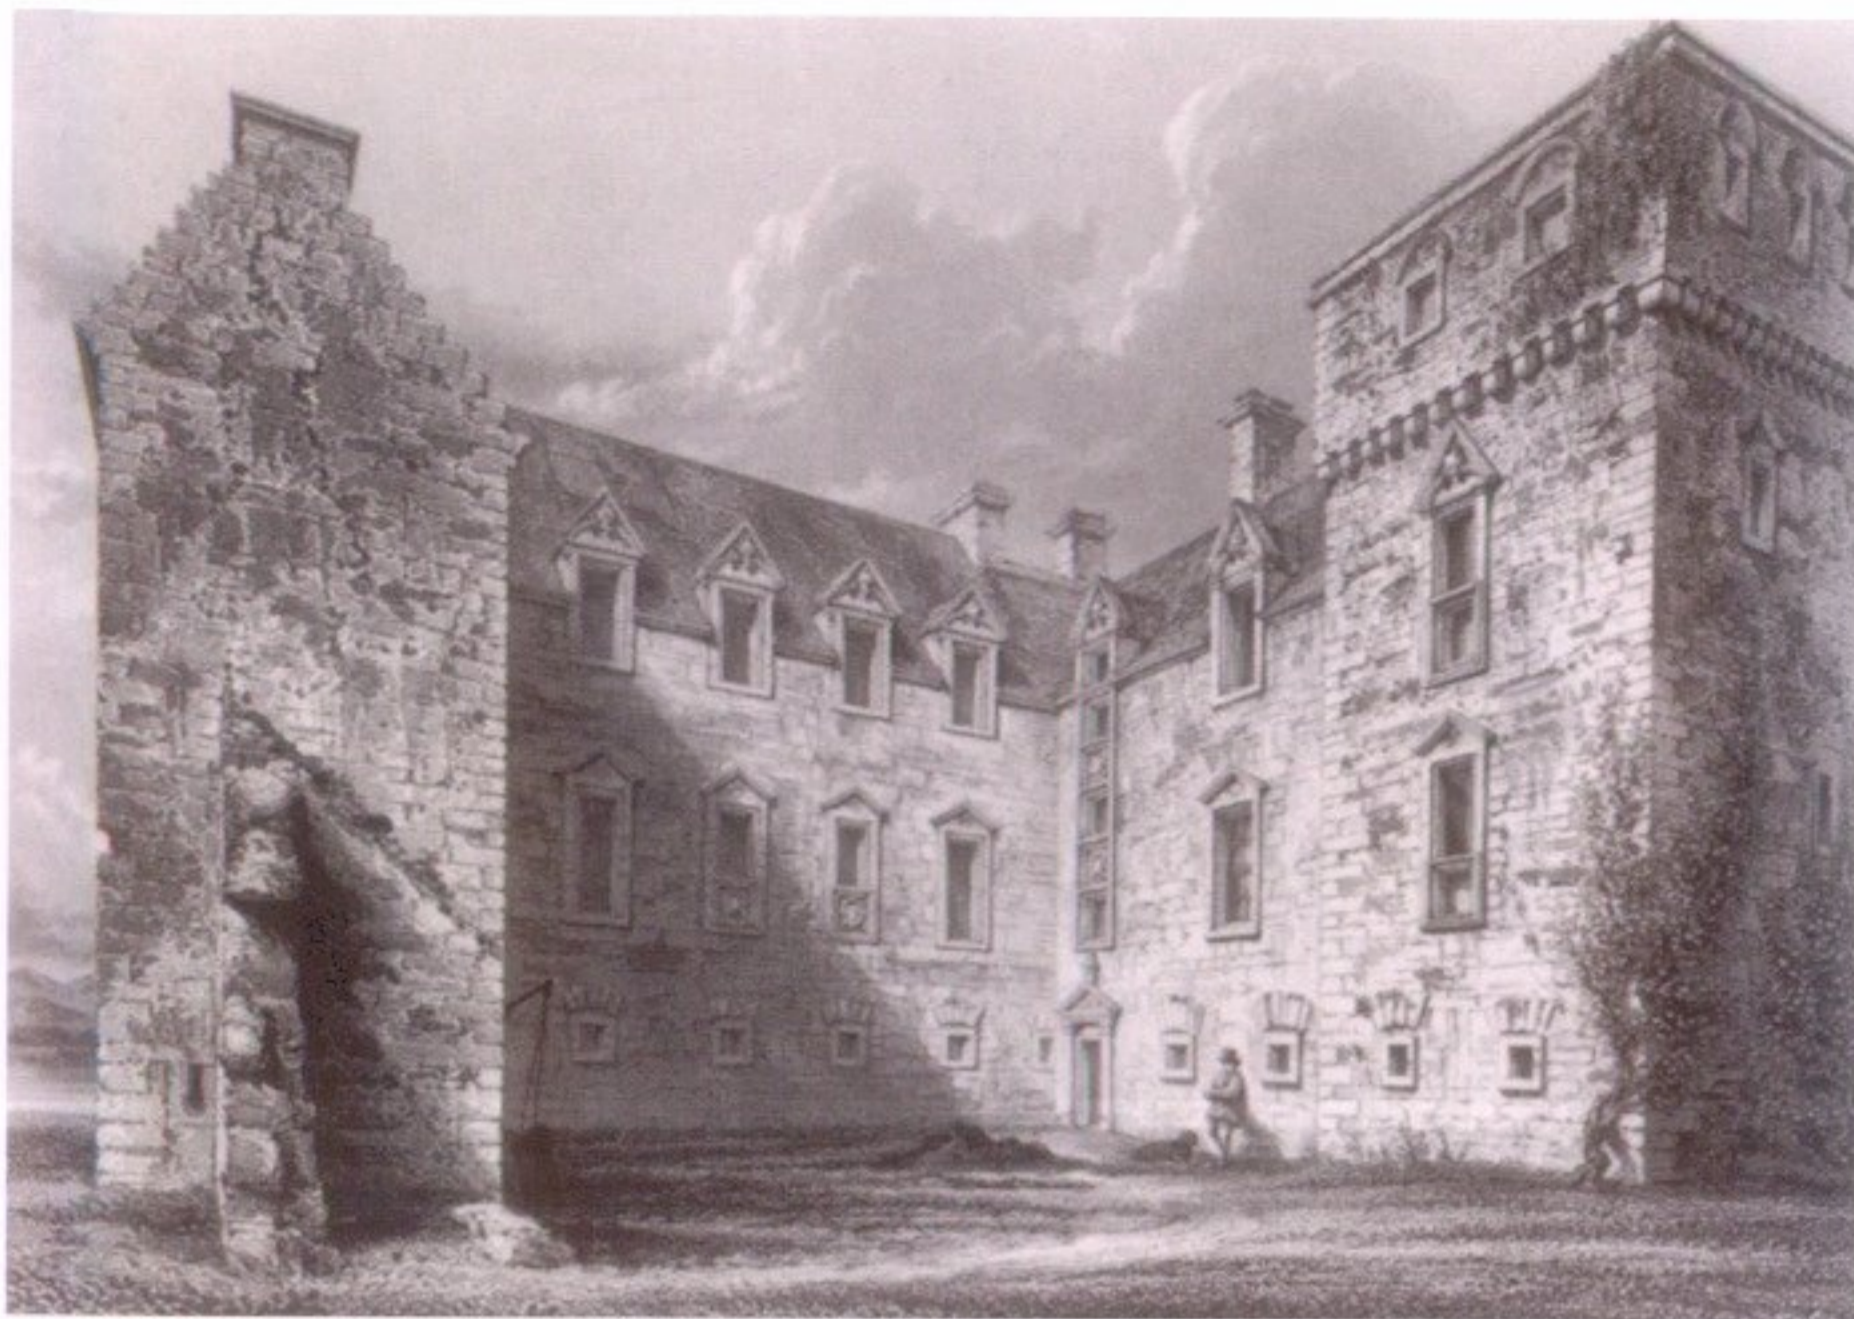
ILLUS 10 Drawing of Newark Castle in the mid 19th century, by Robert Billings (1852, pl 24), showing the remains of the barmkin wall against the south wall of the gatehouse; note the gunloop sighted along the outside face of the barmkin wall

Against the inside face of wall F09, and running parallel with it, were the drystone rubble foundations (F21) of a wall, 1.2 m wide, which may have been at least partly demolished before walls F08 and F09 were built. This wall is thought to have been the west barmkin wall and, although its foundations clearly abutted the gatehouse, the masonry above ground level was probably integral with it (see illus 10).
