Excavations at Craignethan Castle, 1984 and 1995

John Lewis*, Eoin McB Cox† & Helen Smith‡

This report describes excavations carried out within the basement of the ruined north-east tower (1984) and at courtyard level to the immediate east of the tower house (1995) at Craignethan Castle. The former was originally a kitchen but was remodelled at some stage, perhaps to a brewhouse. There was evidence that a range of buildings had been planned for the east side of the inner courtyard but that quite early in the development of the castle (built c 1530) it was abandoned in favour of the impressive tower house. The project was funded by Historic Scotland and its predecessor, Historic Buildings and Monuments.

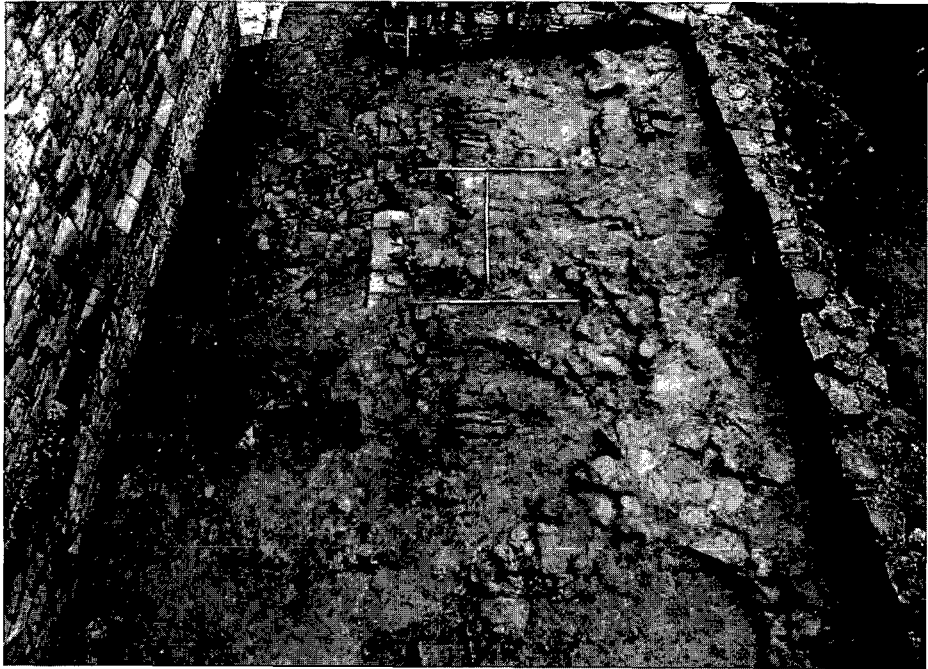
ILLUS 8 View northwards of the east range at courtyard level

The range was some 2 m shorter at this level than it was in its basement because here the walls of the north-east and south-east towers had been thickened, the additional masonry being borne by the vaults of the cellars below. (The curtain wall is also thicker by 1.5 m at courtyard level than at its base, thus imposing additional strain on the foundations of the building.) On the evidence of the latrine chute towards the north end of the east curtain wall, it had probably been the intention to extend the east range above courtyard level, although there is nothing to suggest that this work was ever completed. It is likely that the scheme was abandoned in favour of the tower house which may have incorporated the roles of the putative east and south ranges. Furthermore, if the east range and the tower house had coexisted, the former would have severely restricted the amount of light entering the first-floor hall of the tower.

A level path of crude sandstone flags had been laid against the east side of the tower house, over the roof of the basement passage. At some stage, the sloping ground between the path and the east curtain was also flagged but with smaller, even cruder stones, set in loose, sandy mortar. This surface did not continue around the north and south sides of the tower house, where dolerite setts were in evidence. To the north of the building some of the setts had been fashioned into a V-shaped, open drain; others are of recent origin.
