Ruthven in Badenoch: the excavation of a Highland garrison

ABSTRACT

Excavations in 1983 brought to light physical evidence for the later medieval castle, including the well, and shed new light on the layout of the military barracks which replaced it after the 1715 Jacobite Rising. The project was funded by Historic Scotland.

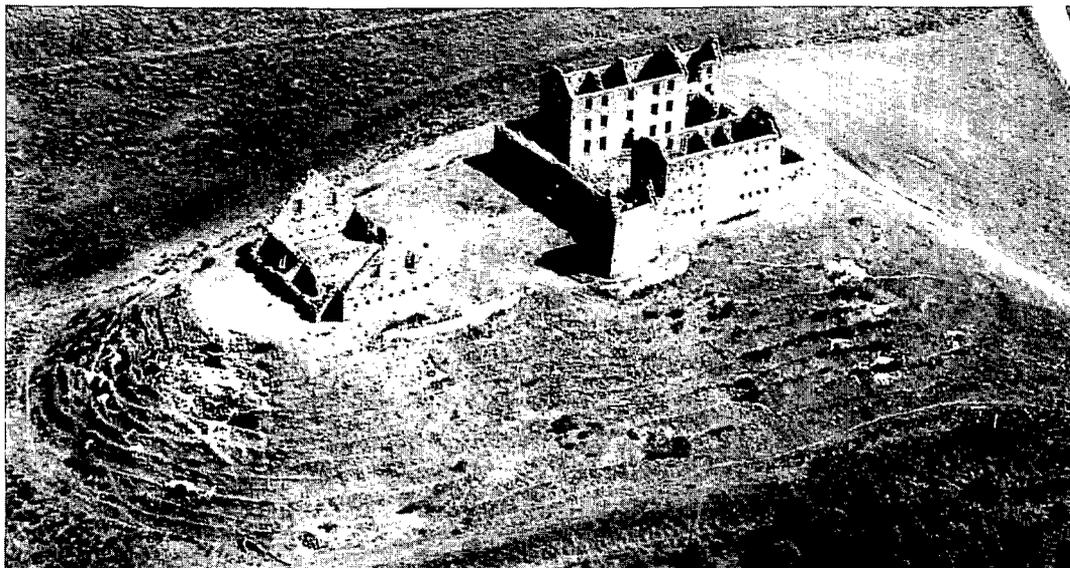
ILLUS 2 Ruthven Barracks from the air (*Royal Commission on the Ancient and Historical Monuments of Scotland*
© Crown copyright)

The post-glacial terrace upon which the ruins stand has been artificially contoured over the years to its present profile; flat topped and with equally displaced slopes commanding a strategic position in Strath Spey (illus 2). The terrace itself is well drained, owing to its sand and gravel composition, while the surrounding alluvial plain of the Spey is very prone to flooding throughout the year giving rise to an impenetrable morass in the environs.

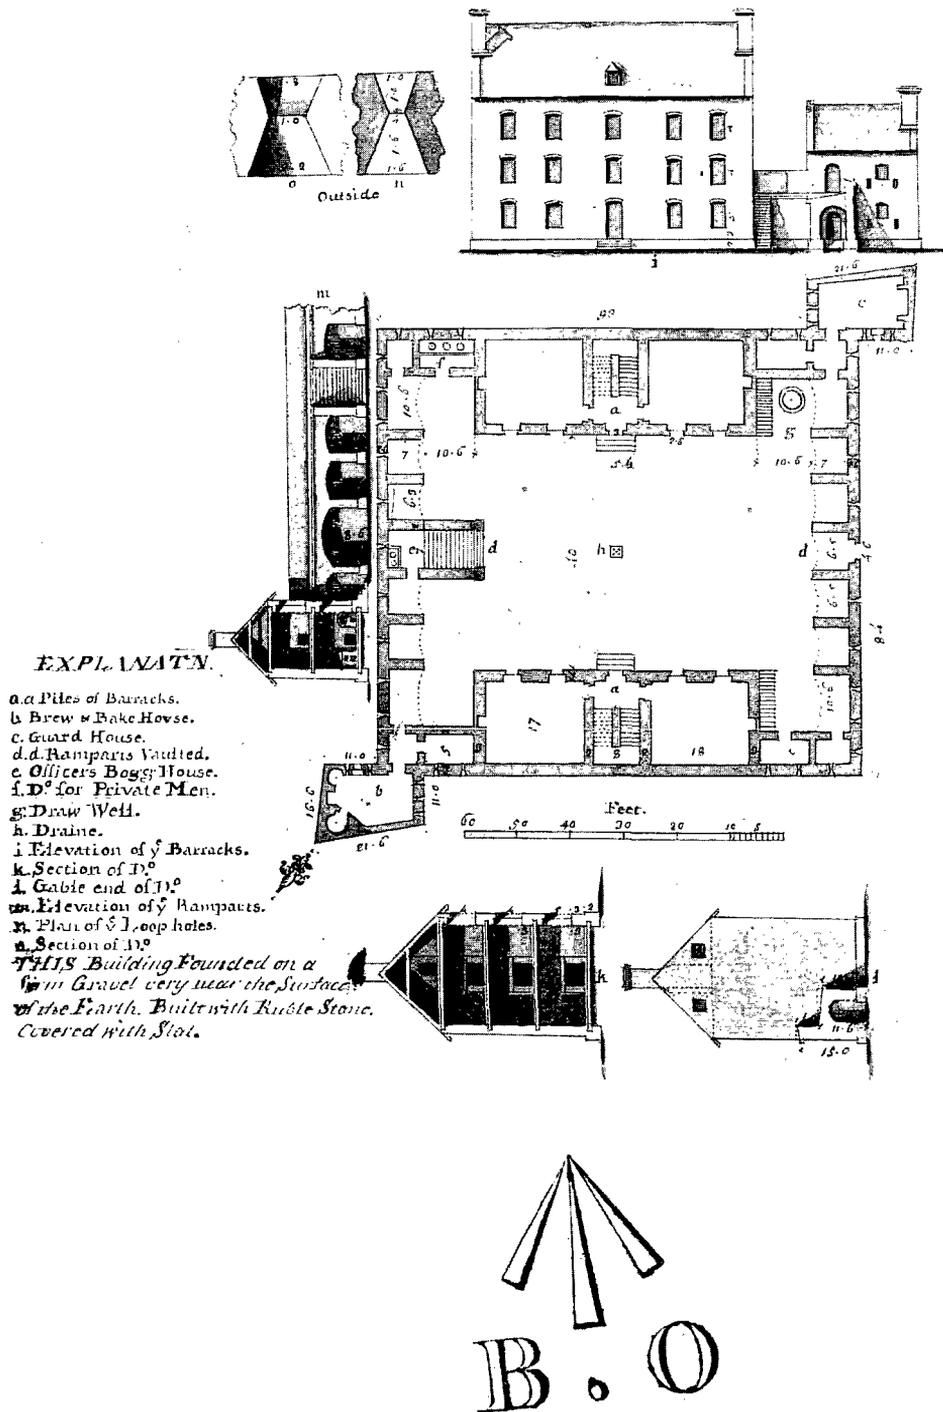
ILLUS 3 Board of Ordnance plan of the proposed barracks, 1719–20. (© Trustees of the National Library of Scotland)

The 1723 edition of the Board of Ordnance plans (illus 3) compares favourably with the extant structure. There are minor discrepancies in the number of gun-loops within the casemates and some differences in the vaults within each corner of the compound. The positioning of the well in the north-west as opposed to the north-east angle is perhaps accounted for by the reuse of an already existing, medieval water supply, of which the barracks’ architect was ignorant. Mackintosh (1897, 371) refers to timbers from an earlier well shaft being discovered during the rebuilding of the well.

According to the Board of Ordnance elevation the parade ground lay 2 ft (960 mm) below the scarcement. No evidence of such a level was found during the excavation, but this could easily be explained by the removal of a formal paved or metalled surface from the parade ground after the destruction of 1746. A tenancy for the rental of Barrack Hill of Ruthven existed before 1796 (R Noble, pers comm) and the subsequent grazing of cattle and sheep, which still continues, may have contributed to the erosion of the mound.

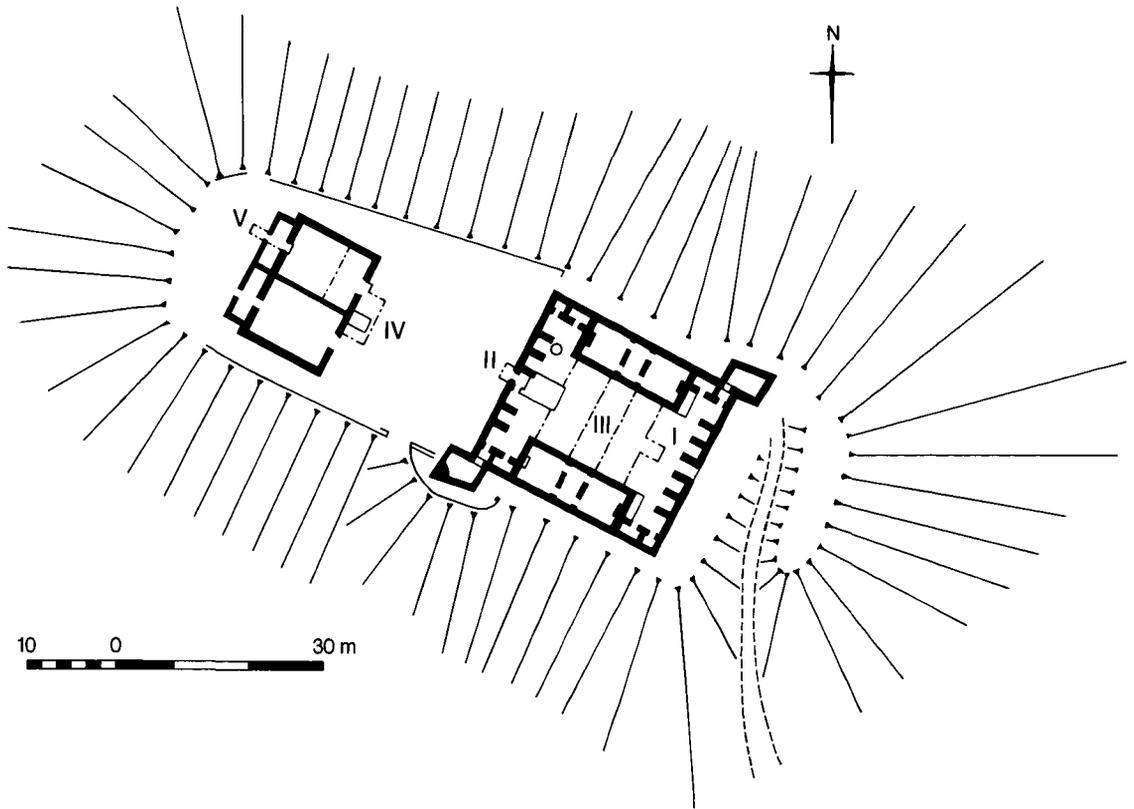
ILLUS 4 Plan of the barracks, showing the areas excavated in 1983

Two trenches excavated within the parade ground revealed the disturbed nature of its surface: it was obvious that the central area had been landscaped since the garrison was abandoned in the 18th century. This was further illustrated by the cobbled drain (56) which terminated at a sump (96) in the centre of the parade ground, for the cover of the sump — a large square schist slab (52) — had been displaced from its rightful position. The cobbled surface (41) in Area II may also have been part of the same drainage system.

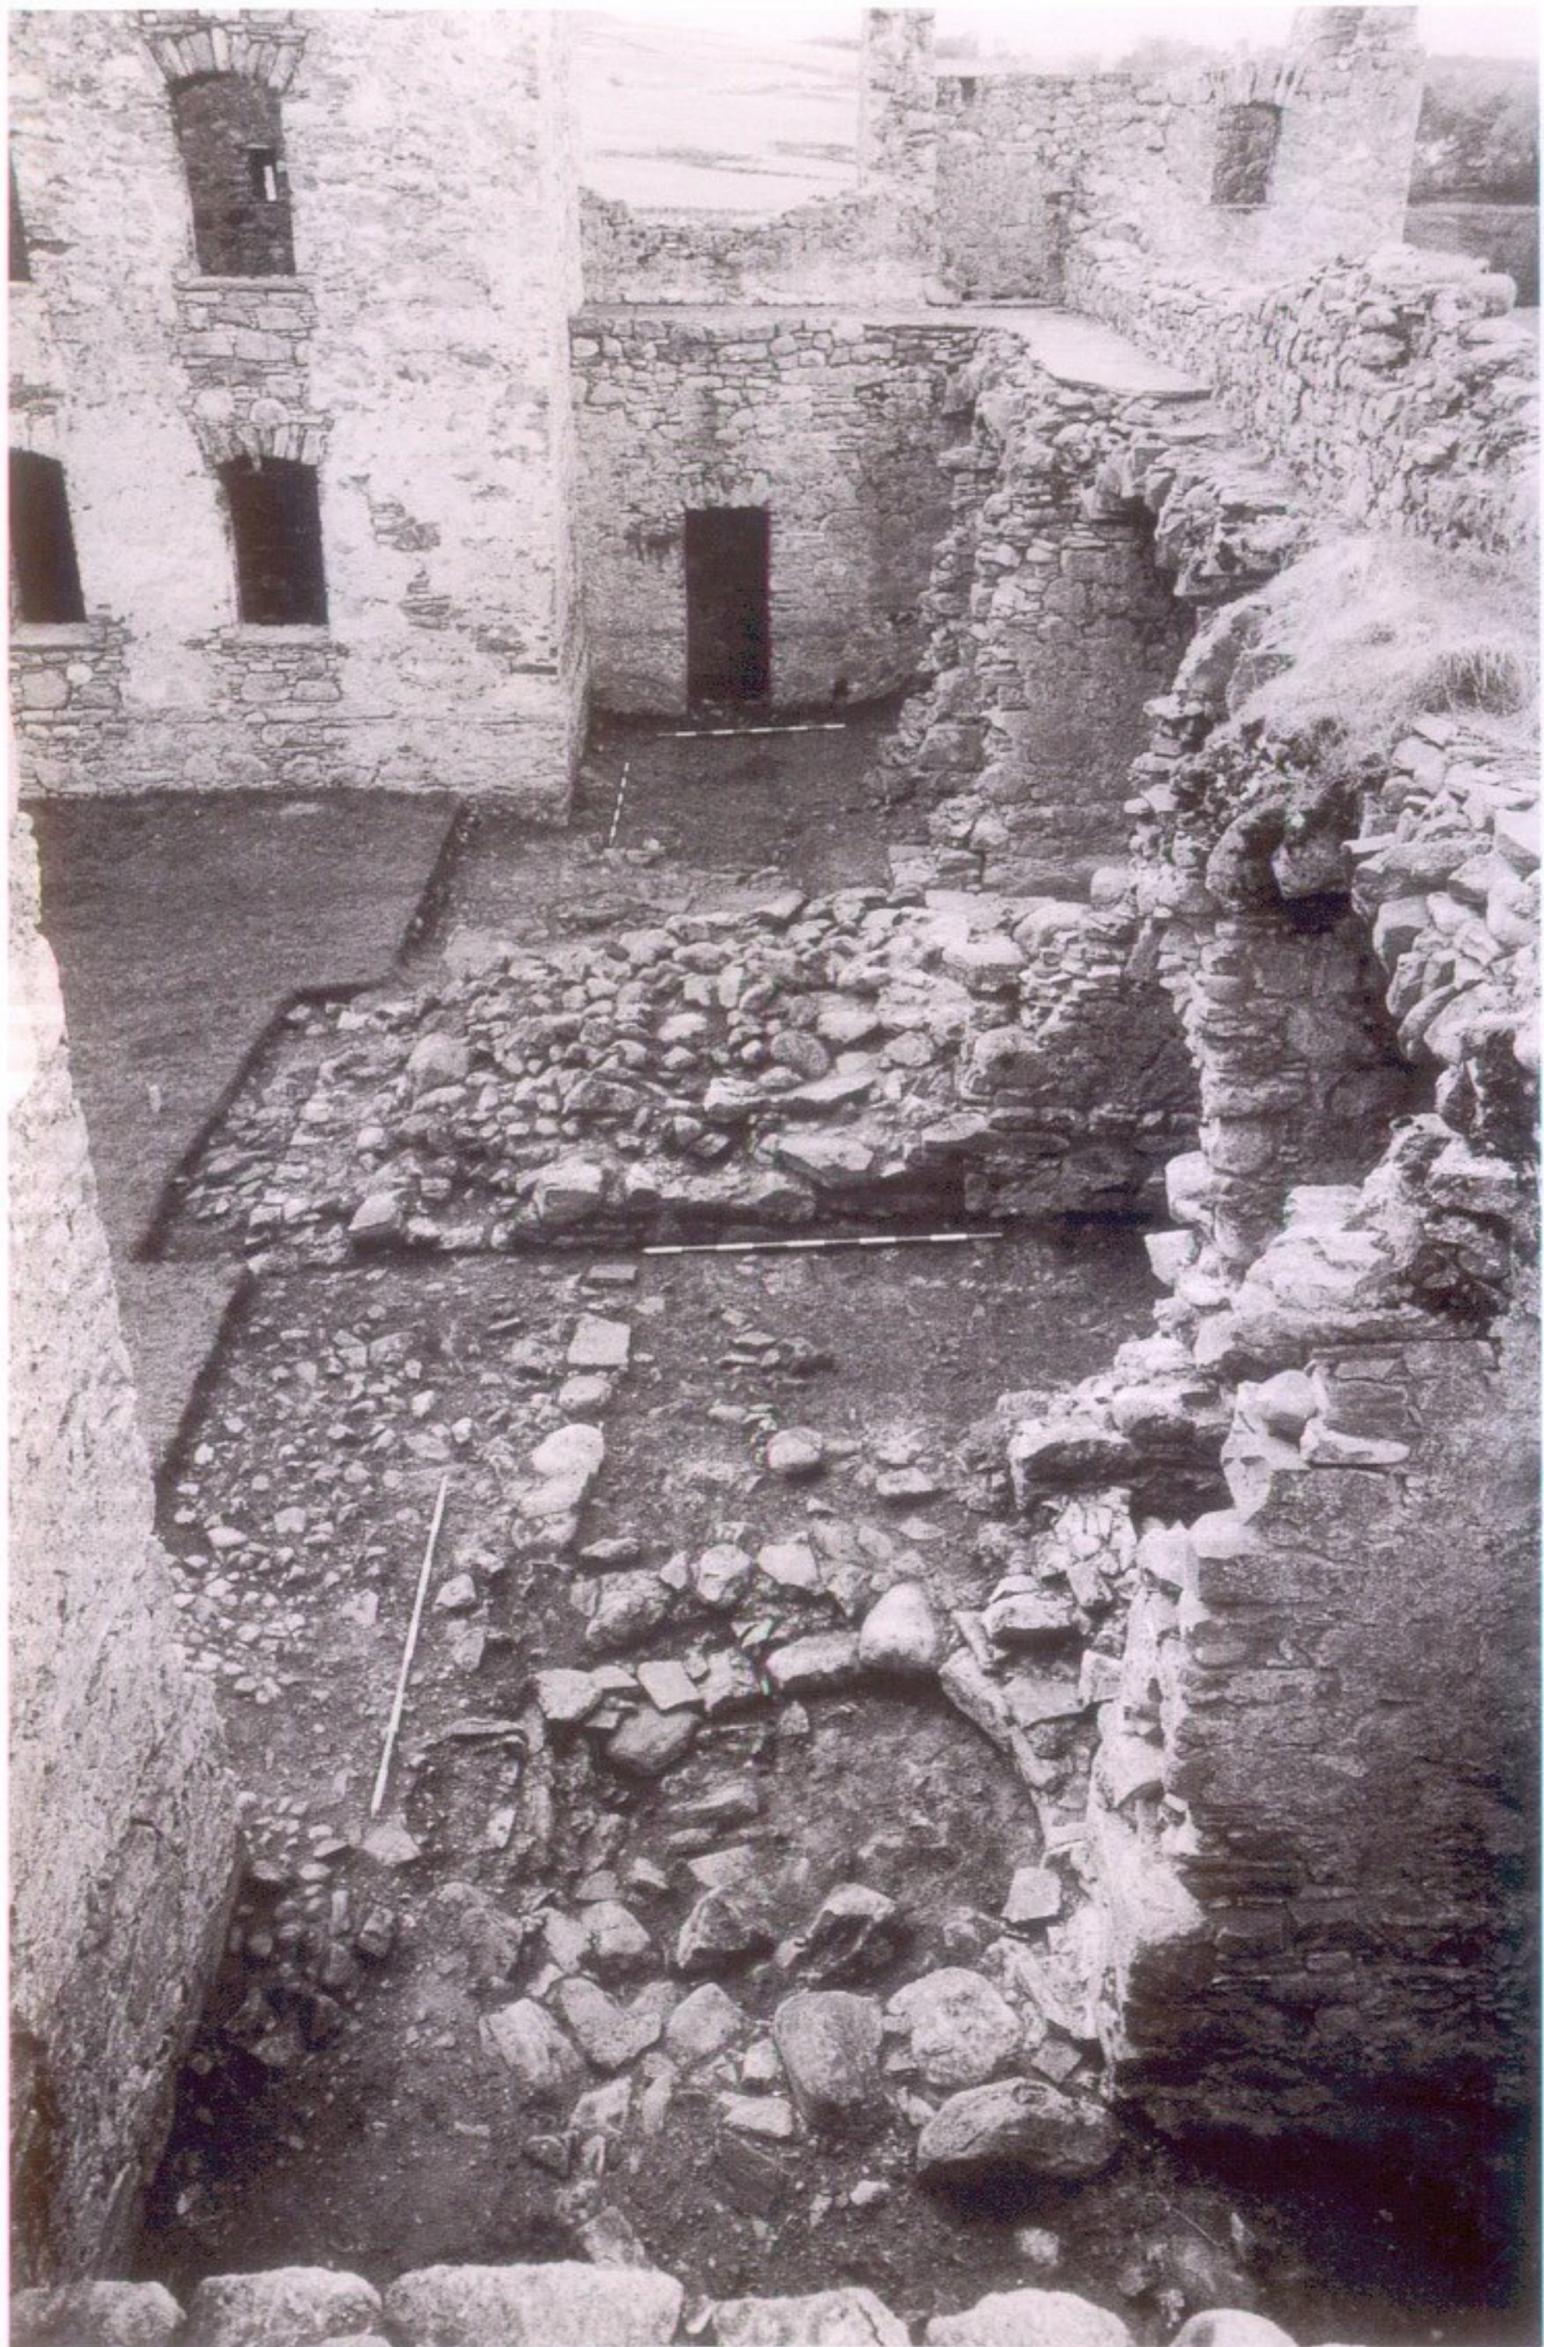
ILLUS 5 The western casemates under excavation (Area II)

The six casemates along the west wall were almost identical to those in the east wall but for the postern gate inserted in 1734 as part of Wade's building programme. No obvious parade ground level remained, except for a patchy cobbled area (33/27) and a crudely flagged surface surrounding the small drain (28) leading

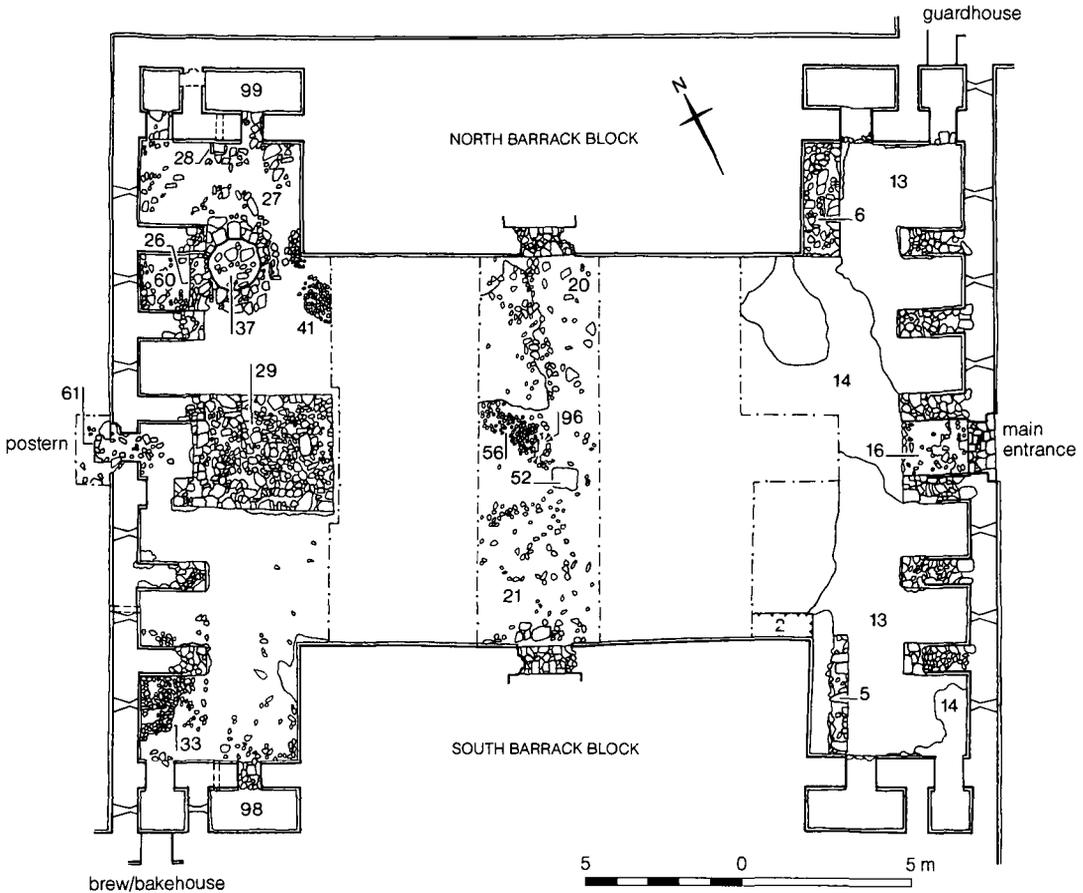
ILLUS 6 Excavation plan of the casemates and parade ground (from left, Areas II, III & I)

In the east half of the parade ground, the area was limited by the enclosure wall on the east angle and vaults on the north and south angles. Once turf and topsoil had been removed little destruction debris was found other than keystones and voussoirs which had fallen from the casemate roofs. They overlay a near-uniform layer of well-sorted yellow sand (Feature 13) into which a patchy gravel aggregate (14) had been pressed. This aggregate appeared to be the surviving remains of a heavily eroded parade ground co-existent with the entrance cobbling (16). The aggregate did not extend into the six casemates which abut the enclosure wall; instead there were thin deposits of disturbed humic sand immediately above the yellow bedding sand.

The casemates in this area and throughout the barracks complex have a scarcement on the internal faces. This course exists at a uniform height and is chamfered along the front elevations of the two barracks blocks and behind forestairs where it does not act as a supporting feature, merely a crude decoration. A wooden step up onto a firing position, which probably rested on this scarcement (illus 7), was suggested by an intermittent mortar level clinging to the internal surfaces of each casemate. This mortar was present at similar heights above the robbed threshold levels in the guardhouse, the adjoining vault entrances, and on the southern vaults. There was also a mortar level against each of the two forestairs (6 & 7). These stairs gave access to the upper level of the enclosure wall, along which would have been a wall-walk, since destroyed. The northern forestair was rendered on its dressed faces to its surviving height of 1.2 m. A loosely

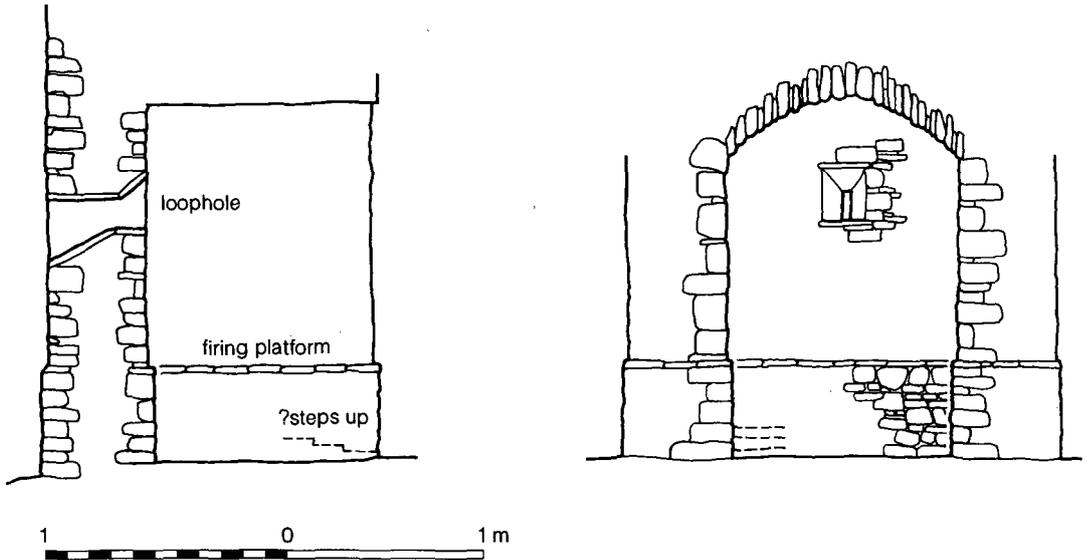
ILLUS 7 Profile and elevation of a casemate

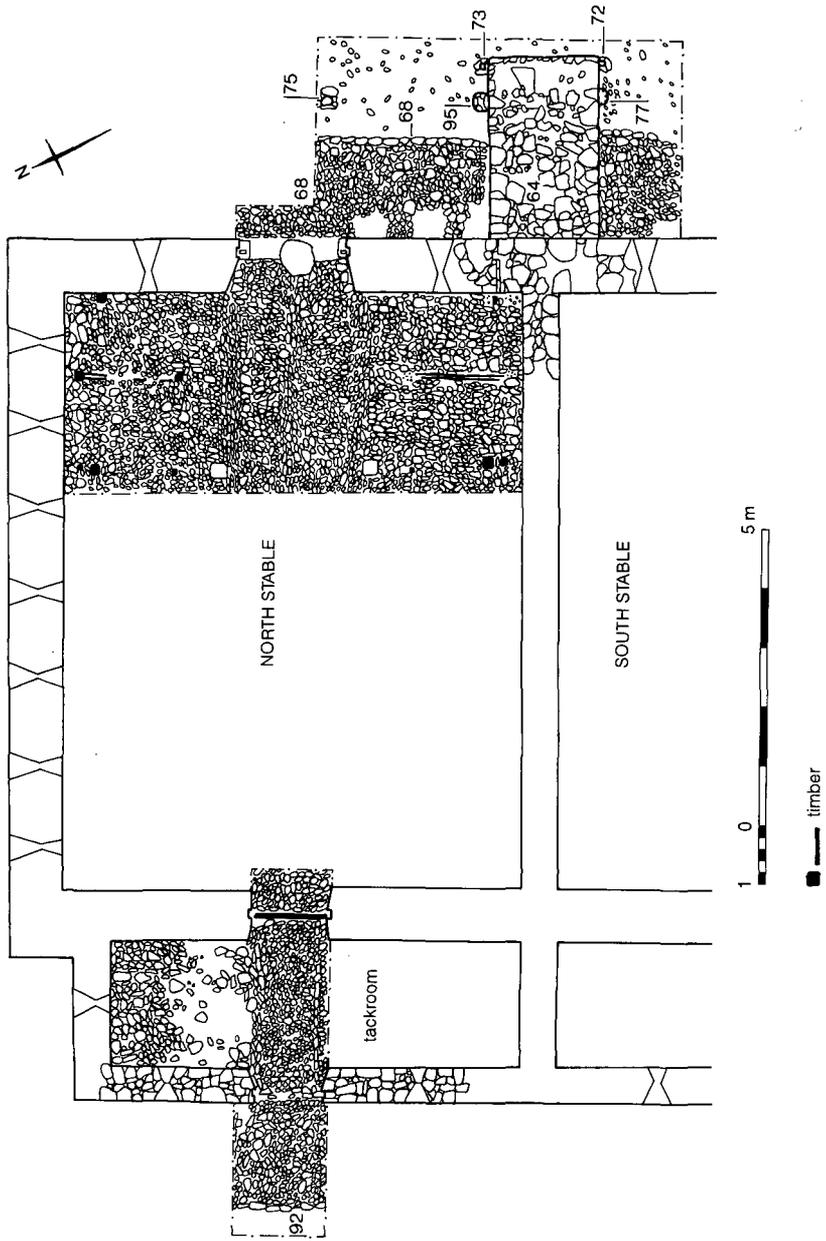
ILLUS 8 Excavation plan of the stables (Areas IV & V)

A substantial area of well-laid cobbles survived beneath a shallow overburden of burnt timber and roofing slates within the stable walls (illus 9). The surface was of tightly laid river-washed 'cassies' bedded in a well-sorted ochre sand. A central ridge with pronounced camber was flanked on either side by parallel drains serving the horse stalls, the drainage gullies apparently sloping westwards. Several burnt timbers (see McCullagh, below), sunk within the densely packed cobbles, reflect the dimensions of the wooden stalls once positioned along each wall. Extrapolating the evidence recovered from this small area, the total number

The cobbled floor of the stable extended westwards as a corridor into the tackroom. The north chamber of the tackroom was flagged with irregularly shaped stones and cobbles partly mortared. As in the stable, the cobbles were overlain by a thin deposit of burnt roof timbers and slates with numerous nails of assorted sizes amongst this destruction material.

A cobbled apron (92) lay outside the west wall of the stable block and echoed the cobble surface (68) east of the building. There were traces of a wooden door frame between the tackroom and stable and the housing for a similar frame could be seen within the faced stonework of the west door.

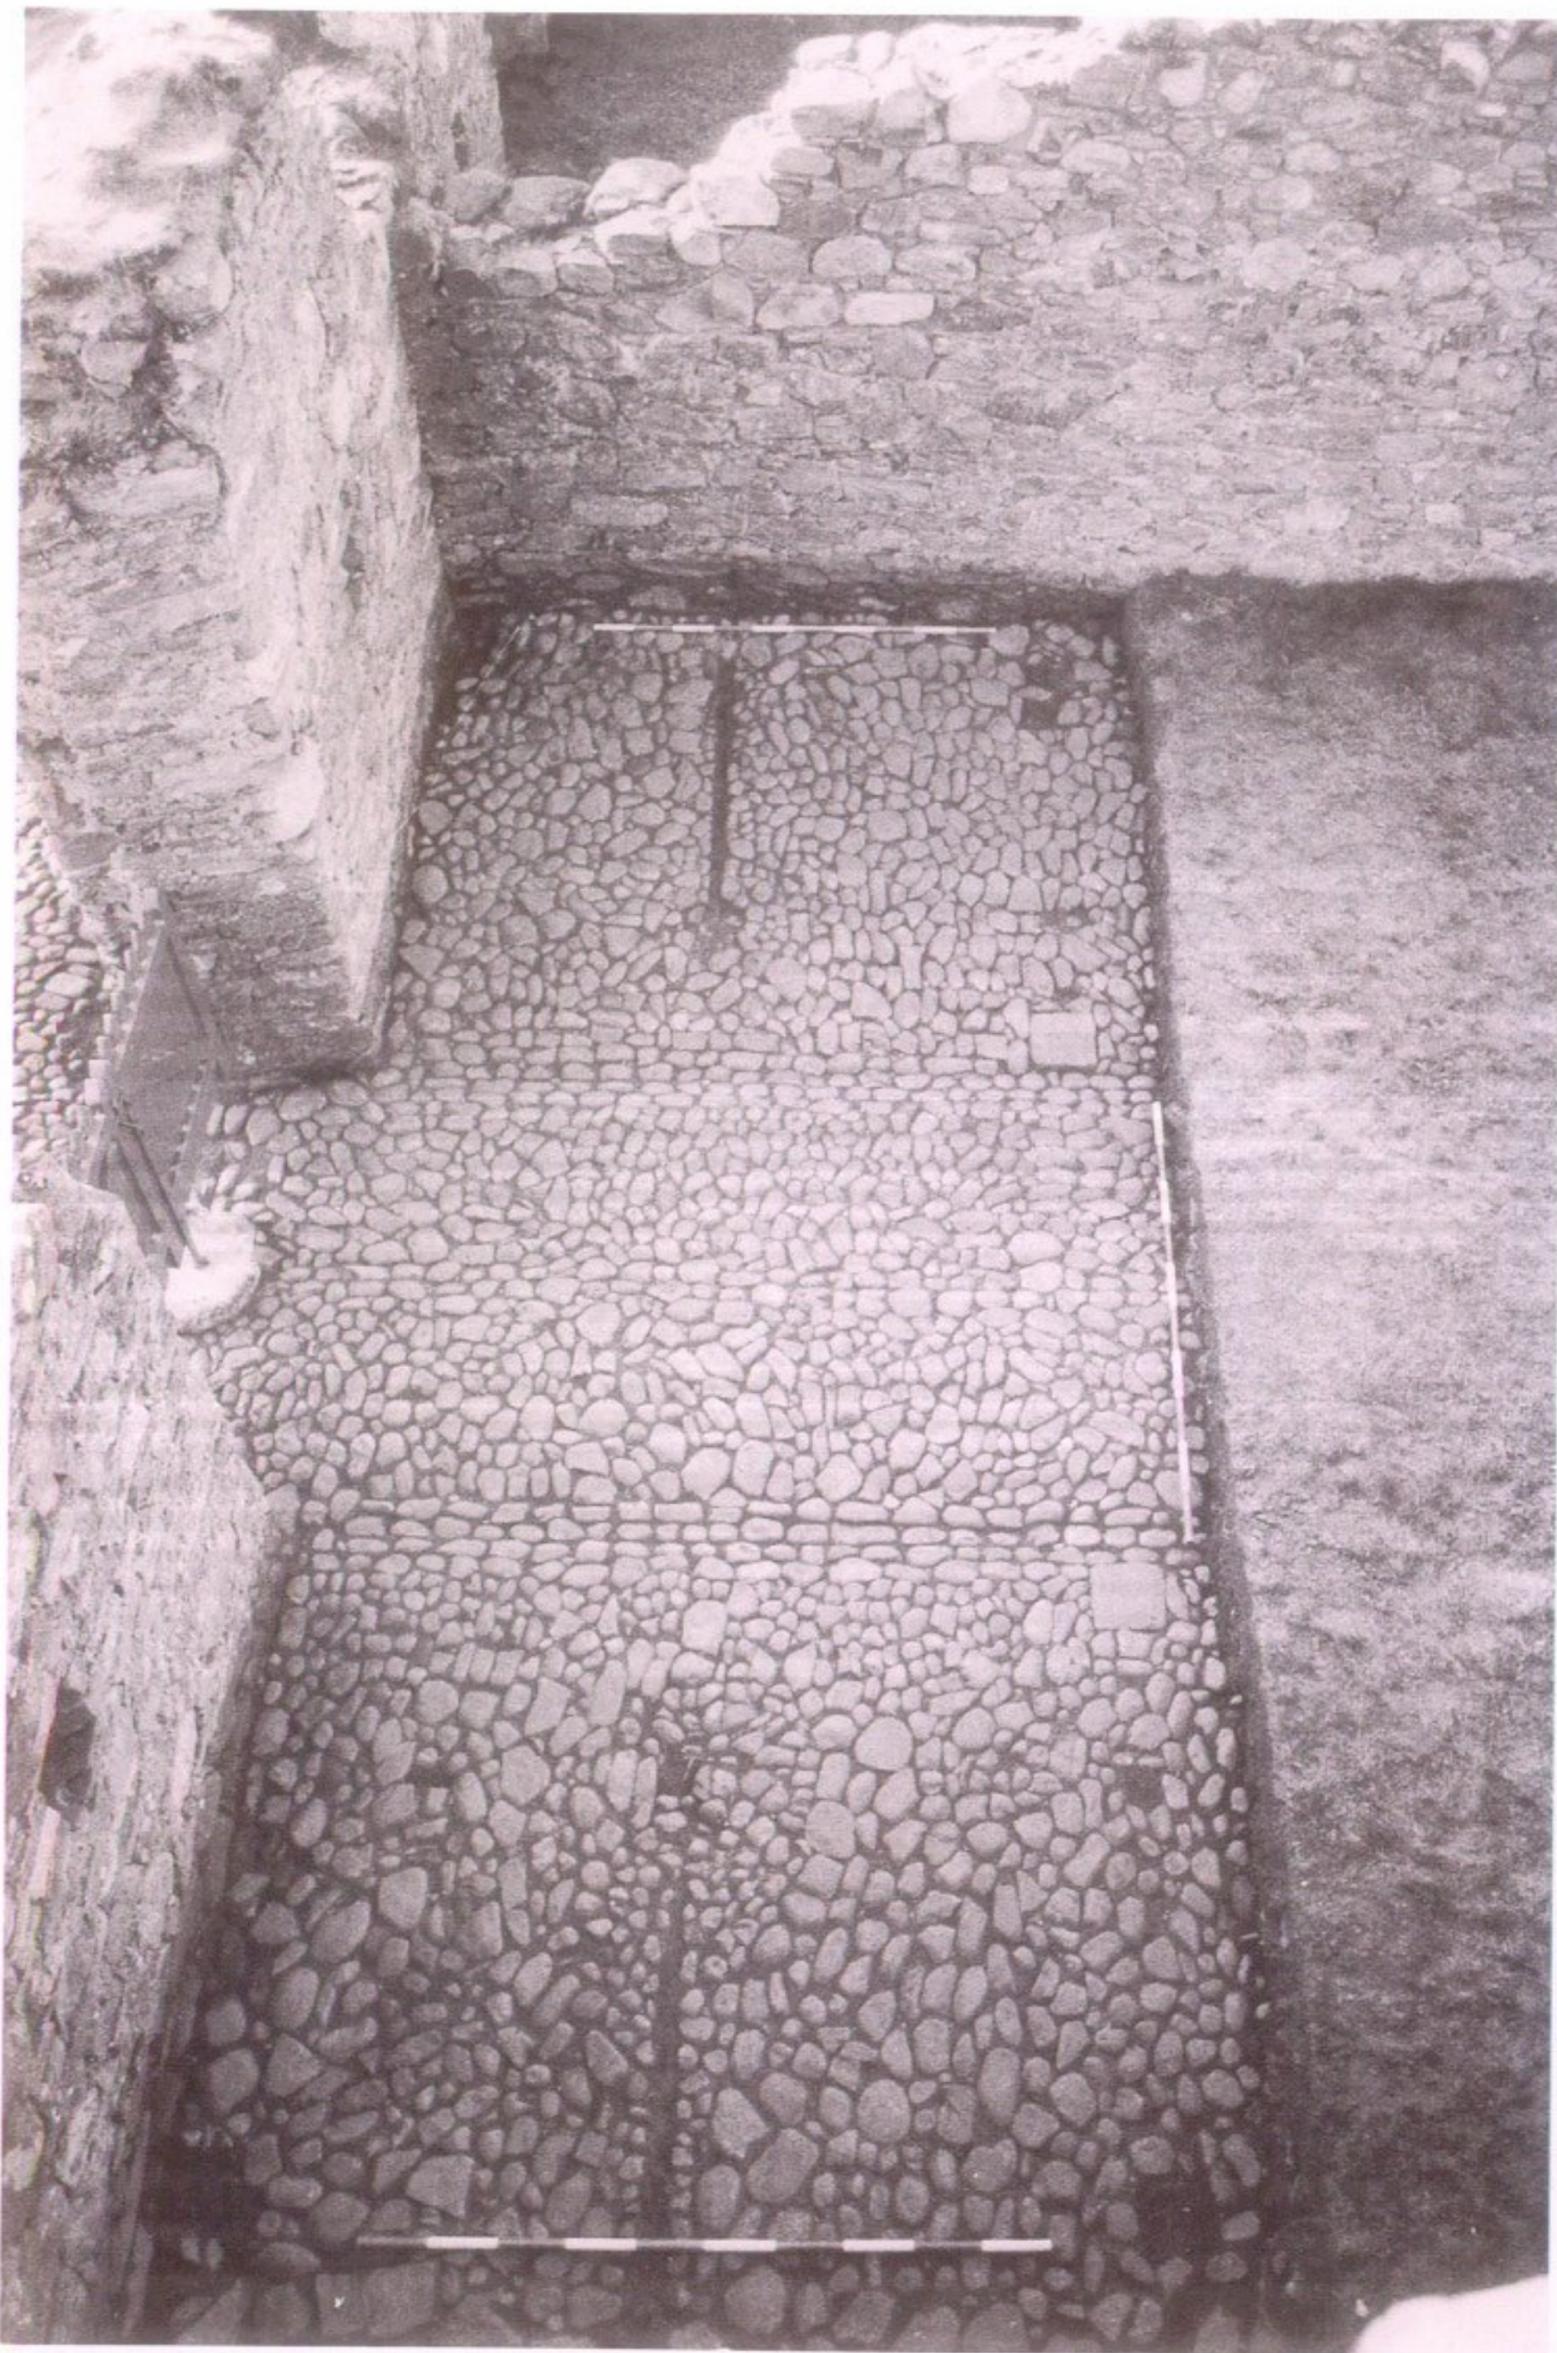
ILLUS 9 The cobbled surface within the northern stable (Area IV)

The cobbling in the stable block and stalls is similar to that found in mains farms and other large houses of the 18th and early 19th centuries. In this respect, Ruthven appears unique for its

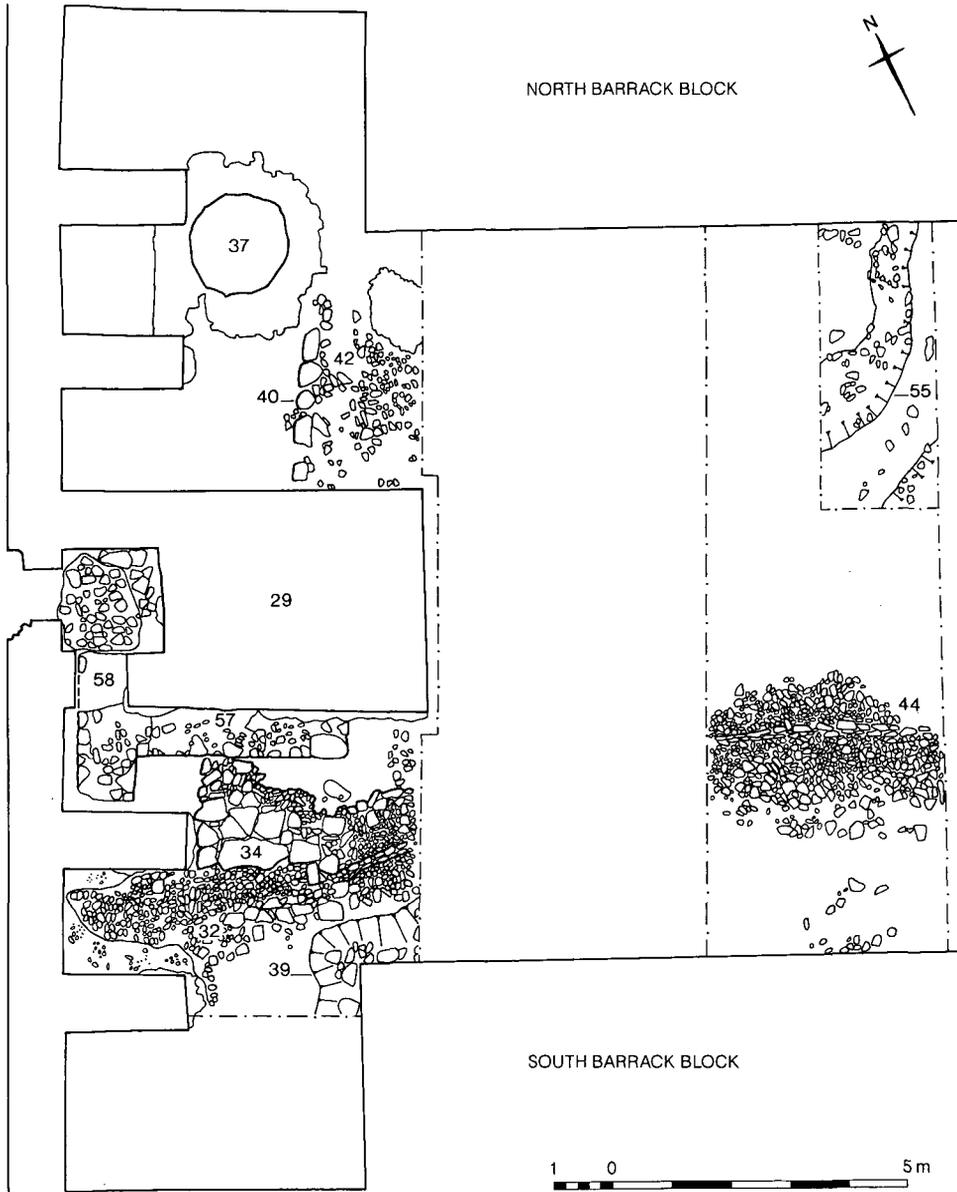
ILLUS 10 Excavation plan of the medieval remains (Areas II & III)

A linear grey mortar-bonded structure (40), with an associated dump of rubble (42), lay below the cobbled drain (41) near to the well and pertained also to an earlier building phase. It is likely that both this feature and the well are elements from the earlier castle, and that the structure was destroyed during the re-sinking of the well by the garrison builders.

Further evidence of medieval occupation was suggested by an extensive spread of mortar and rubble (55), indicative of robbed walls, in Area III. No evidence of pre-barracks structures, however, was found in Area I. A trial trench, some 2 m deep, through modern debris (2) and disturbed sands and gravels revealed no obvious horizon relating to occupation.

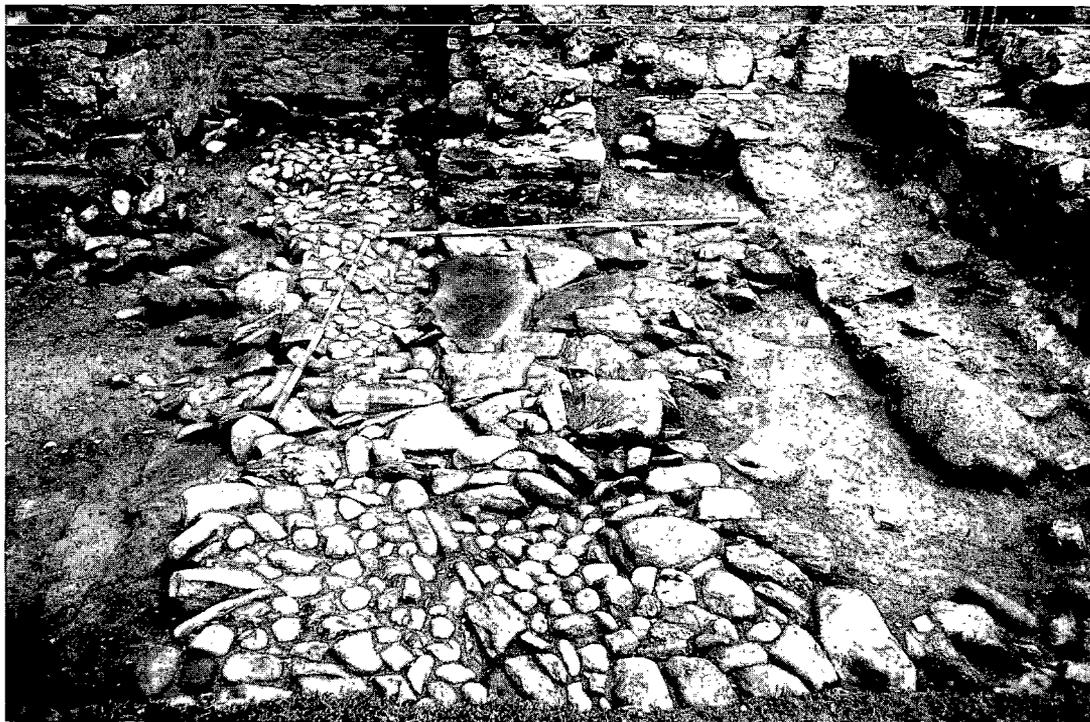
Immediately below the main forestair (29), within the barracks compound, lay two wall remnants (57 & 58) bonded with a pink mortar and dressed on their south and west faces. They had been used as foundations for the forestair and officers' latrine, but quite clearly belonged to a pre-barracks structure, as they had been damaged by foundation trenches of the casemates and postern. The irregularly cobbled and flagged surfaces (32 & 34) would have been external features, contemporary with these earlier walls. A narrow open drain

ILLUS 11 The medieval remains below the main forestair (Area II)

with stones set on their longest axes cut through the cobbles (32) and reappears within the cobbled surface (44) in the adjacent cutting. The drain was cut by a construction trench (39) of the south barracks block, the trench being backfilled with large rounded stones and boulders, many with pink mortar adhering to them.

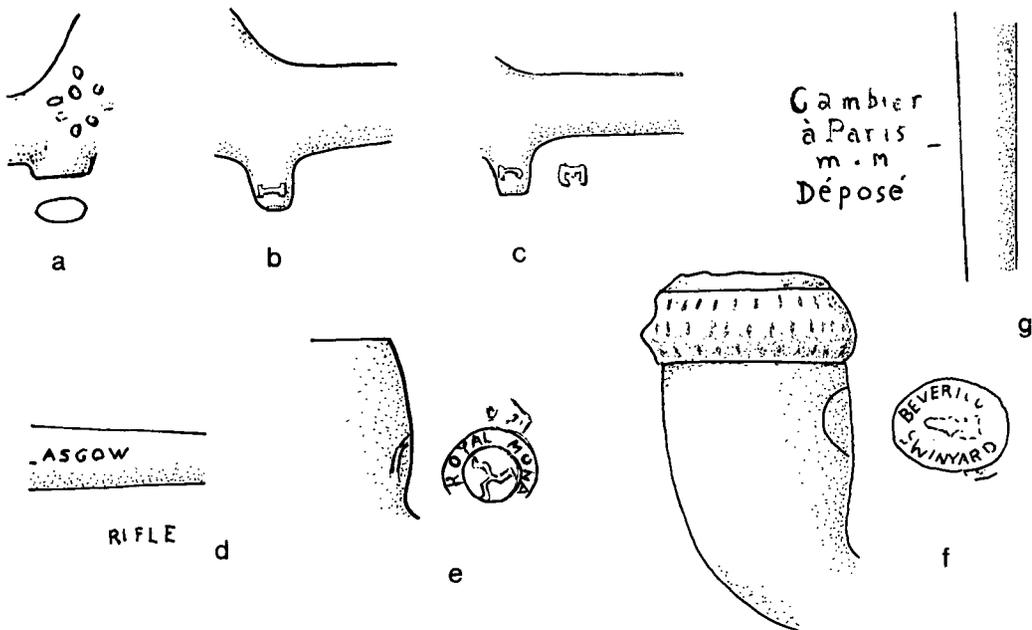
Thirty fragments of clay pipe were recovered from 11 different contexts. All the identified material is of 19th- to 20th-century date, except for one bowl fragment (a) from the pre-barracks drain (32). This is a much abraded unpolished lower bowl fragment with a dot rose on each side. It is a west Netherlands type, c 1650–70 (Duco 1981, 244, nos 36–8), a low-quality export pipe of a type that has a wide distribution throughout Scotland (Davey 1987, 280).

The 19th-century material is derived from a variety of sources. Two fragments (b & c) have maker's initials in relief on the heel, a form or marking which is rarely found after c 1850.

ILLUS 12 Clay pipe fragments

Fragment (c) with the letters J/E is probably from the Aberdeen makers John and James Elrick, active 1830–1910 (Evans 1981, 37), but is likely to date from the early years of their business. Another Scottish pipe is the stem fragment (d) with the incuse stamp (GL)ASGOW/RIFLE CUTTY. Glasgow factories produced a variety of Rifle cutties, post-1870. The short wide bowl (e) has a stamp bearing the Manx emblem surrounded by the legend ROYAL MONA and surmounted by a crown. This may also be a Scottish product, possibly similar to the ‘Isle of Man’ pipe produced by William White of Glasgow in the late 19th century (Gallagher 1987, 152). Another pipe of late 19th- or early 20th-century date is the upright bowl (f) with a metal spark cap which has a hand-impressed oval stamp bearing the names BEVERI[DGE] and SWINYARD. All major Scottish pipemakers produced Swinyard pipes, the designs inspired by the London maker of that name. This particular example is a product of William Beveridge, active in Forres 1869–82 and in Aberdeen 1882–1920 (Evans 1981, 38–9). Beveridge had a closer connection than most with Swinyard, as he possessed and presumably used a number of that maker’s original moulds (Davey 1987, 262).

A stem fragment (g) bears a mark of the Paris company of Gambier, active 1789–1920, although this particular mark was introduced c 1850 (Duco 1986, 106). It is likely to have been part of an elaborate high-quality figural pipe for which that company was famous.
