An Atlantic roundhouse at Durcha, Sutherland

Andrew Dunwell*

ABSTRACT

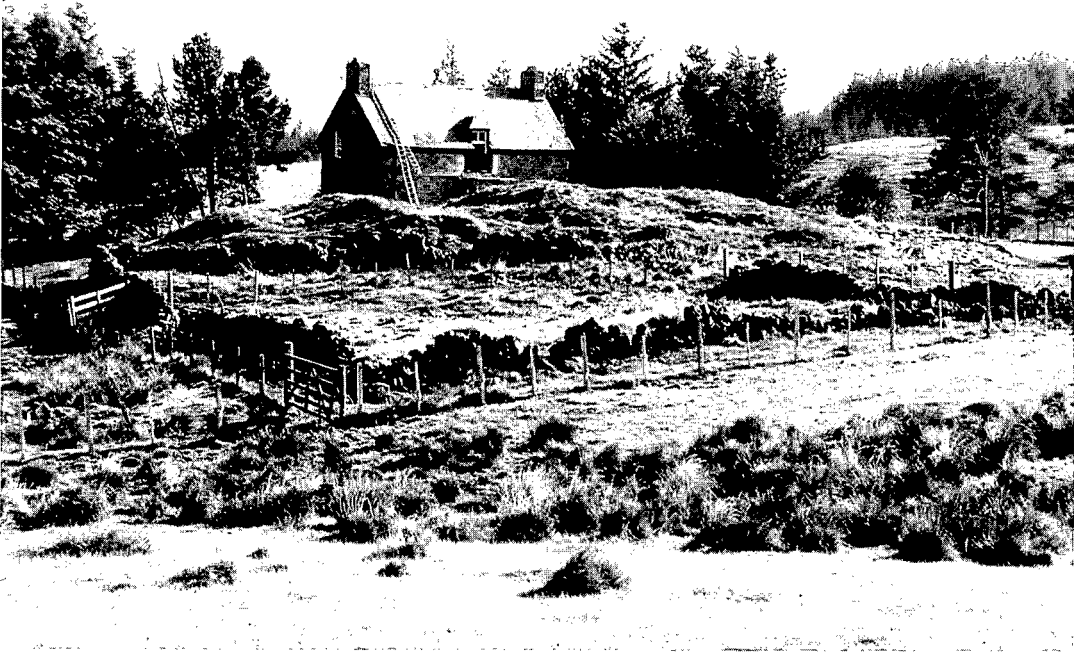
ILLUS 2 View of the site from north-east, showing the house during redevelopment partly obscured behind the grassed mound

Mound (illus 2 & 3)

The mound appears from surface traces to have two main components. A higher, north-western sector, with a relatively level summit and several indentations and scars caused by stone robbing, forms approximately two-thirds of the mound. The south-eastern area is lower and more irregularly mounded and hollowed, although the edge around the south-east corner of the mound forms a smooth arc. With hindsight from the 1996 excavations the basic topography of the mound can be related to the form of the principal structure present. The somewhat ambiguous surface traces previously had led the excavator to speculate on the presence of a galleried

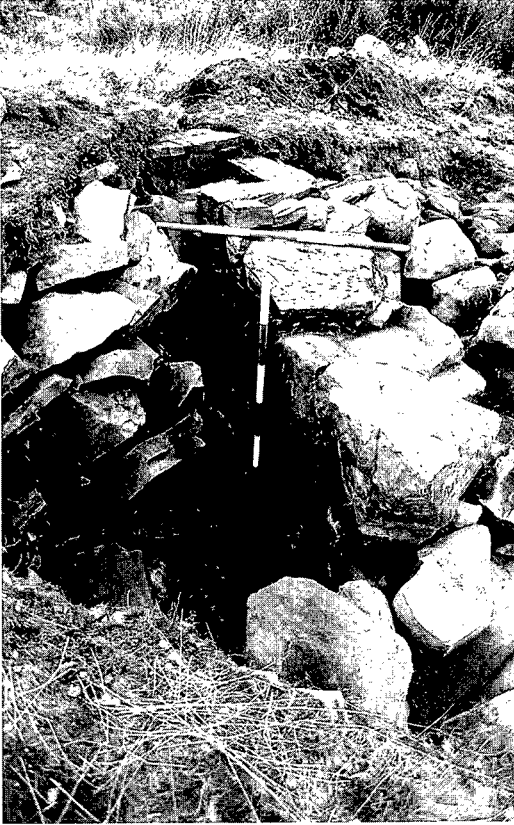
ILLUS 5 (top left) View of the elevation of the inner wall-face from south-east

The inner face of the wall was relatively even, and composed of well-fitted sub-angular stones of varying sizes, including both blocky and tabular examples, with small stones packing any gaps between the larger components (illus 5). Some of the boulders forming the face measured up to 0.75 m from face to rear. It was the irregular rear sides of these larger facing stones which had been exposed in the robbing scar. The inner face was exposed over a sector spanning 3 m, with a depth of up to 1.2 m revealed: its base was not exposed. The variable size of material used in the wall-face parallels the evidence from Crosskirk (Fairhurst 1984, 40).

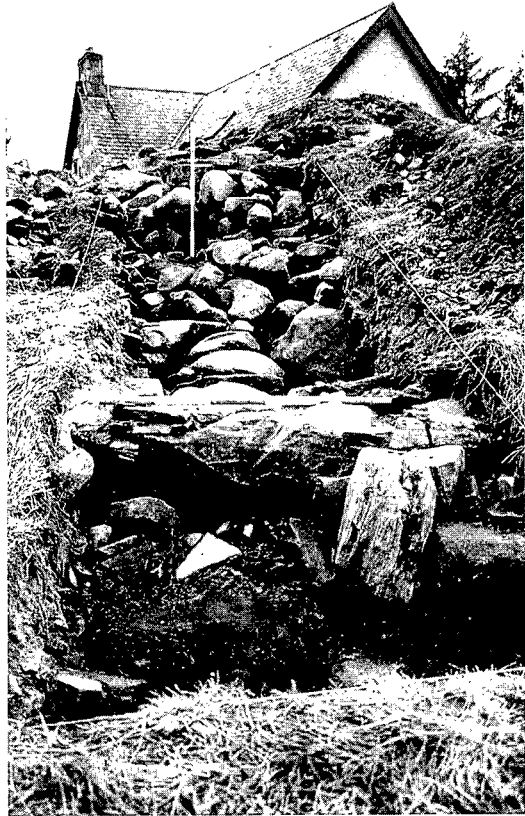
ILLUS 6 (top right) View of the roundhouse wall from north-east, showing house extension as built

The outer wall-face was formed of less regular, sub-rounded boulders, with the gaps between them packed with stacked piles of small angular stones (illus 6). This face was exposed to a height of only 0.4 m, over a sector 1.5 m in length, in the northern arm of the trench. The base of the wall-face was not exposed.

The wall core material comprised a series of largely unconsolidated, but distinct dumps of rounded boulders and cobbles (illus 6). The nature of this material varied between the two arms of the trench, indicating that the core was not formed of a series of concentric deposits. Two roughly coursed lengths of boulder alignment were present within the core, in both cases facing outwards and running roughly concentrically with the line of the wall as a whole. The bases of both were identified, and found to rest on earlier wall core material. These alignments were flimsy and irregular by comparison with the internal and external wall-faces, and represent neither early outer faces subsequently buried within an expanded or buttressed wall nor the lining of intramural chambers. They are interpreted as constructional devices perhaps intended to ensure the stability of the wall and analogous to *murus duplex* style defences. At one point within the core immediately to the rear of the inner face a cluster of slabs forming an even surface had the appearance of paving, but no other evidence was identified to suggest that they formed the floor of an intramural chamber or passage. Alternatively, they may be explained as a temporary working platform used during the construction of the wall, possibly associated with the erection of the inner wall-face.

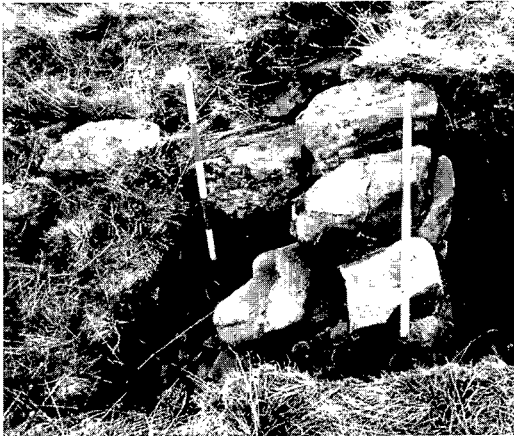
ILLUS 7 (left) View of Trench 3 from west

Trench 3 This was located on the northern side of the mound, at a point where an irregular linear arrangement of boulders was visible running approximately east/west in the face of a robbing scar. This boulder alignment was found to represent the rear of the inner wall-face of the structure (illus 7). The wall-face was identical in construction to that identified in Trench 2, and survived to a level 0.5 m higher than the rubble wall core material backing it, of which only a fragment was exposed. Overlying the wall core and abutting the rear of the inner face was a sub-rounded boulder which formed one end of a further alignment of four boulders visible from surface traces running downslope to the north within a robbing scar. This boulder alignment thus post-dated the robbing of the roundhouse, and is of modern origin. Within the wall circuit the same sequence of deposits as in Trench 2 was identified, comprising a sandy soil overlain by a deposit of angular stones, c 0.5 m deep, tipping away from the wall-face. Finds from this trench were restricted to a range of modern artefacts including glazed pottery, glass and a horseshoe, from the rubble within the wall.

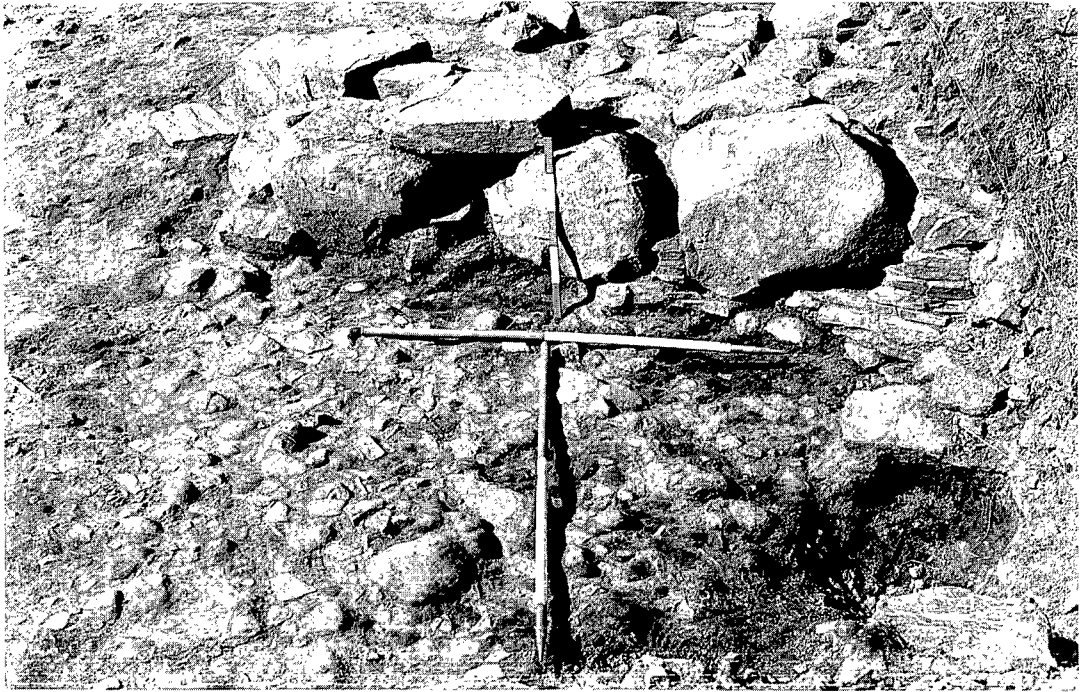
ILLUS 9 Trench 5: view of cobbling and elevation of wall-face

Pre-wall cobbling The roundhouse wall was not the primary construction identified within the trench. A second and evidently earlier area of paving, or compact cobbled surface up to 3 m wide, ran across the trench and beneath the outer face of the roundhouse wall. This cobbled surface was defined to the north by a shallow terrace cut up to 0.2 m deep into the gentle slope to create a level surface beneath the paving; to the south its original extent was not defined owing to truncation by modern activity associated with the standing building. This terrace ran on a slightly different alignment to that proposed for the roundhouse wall and adjacent paved path, both of which sealed it at different points (illus 8 & 11). At the eastern edge of the trench, the northern limit of the cobbled layer was respected by a large sub-angular boulder embedded within the smaller cobble core of the roundhouse wall, 0.9 m north of its outer face (illus 10). This may represent the residual remains of a wall-face associated with the terrace and cobbling, which was subsequently incorporated within the roundhouse wall; alternatively, it could simply be part of the roundhouse wall core.

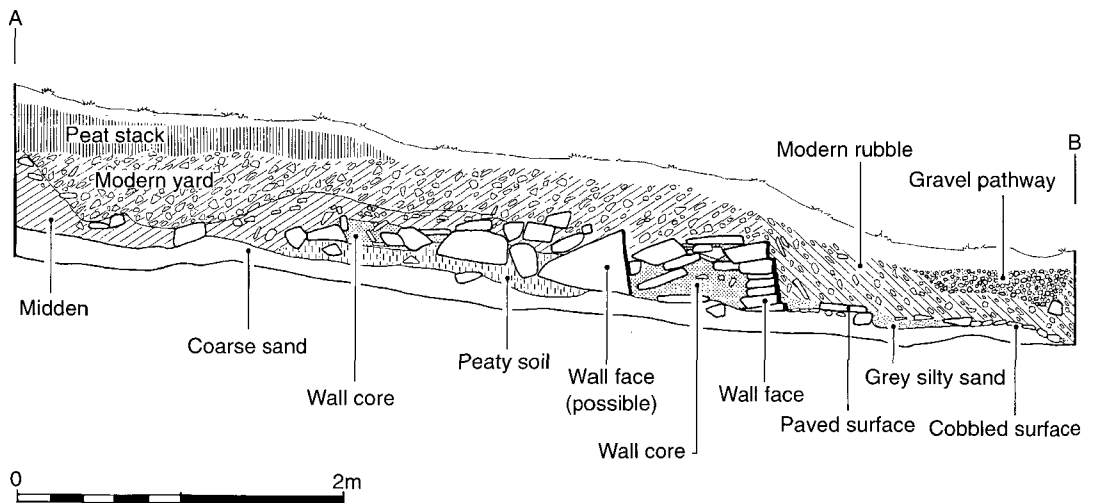
ILLUS 10 Trench 5: section A-B

Sandy layer Sealed beneath the wall core was a layer of coarse, humic sand (illus 10). It was structureless, and had an abrupt boundary to the underlying subsoil, a glacial till. Stratigraphic evidence, and an on-site palaeoenvironmental assessment conducted by Richard Tipping (pers comm), suggest two possible modes of formation: as a buried ground surface or as an accumulation of amorphous organic matter washed down from above. The origin of a layer of peaty soil sealed between this layer and the cobble wall core is unclear.

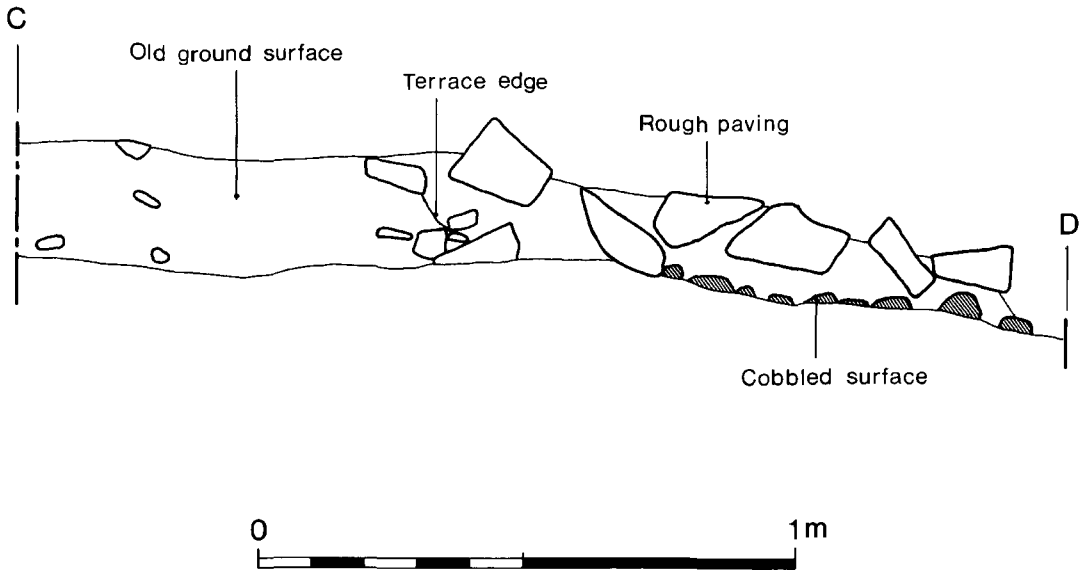
ILLUS 11 Trench 5: section C-D

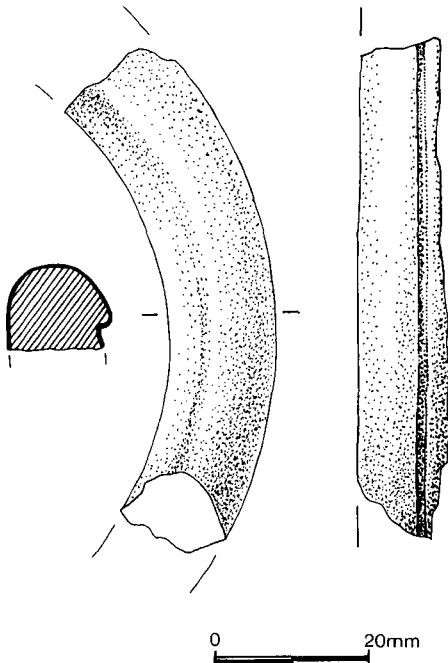
ILLUS 12 Shale bracelet fragment

A fragment of an armlet or bracelet, most probably of finely laminated shale or cannel coal, was found in the midden overlying the wall core in Trench 5. The fragment is 60 mm long. It has been snapped off at both ends, and one face has sheared off. Its preserved surface is smoothed and rounded, and it has cross-sectional maximal dimensions of 14 mm by 12 mm. The fragment has a decorative groove (4 mm by 2 mm) running along the outer face. The extrapolated diameters of the original item are 110 mm (external) and 95 mm (internal). Such artefacts are not diagnostic to period, and are found in Bronze Age to Norse contexts. The majority of these finds, however, occur in later prehistoric contexts. Few decorated examples of such artefacts are known.

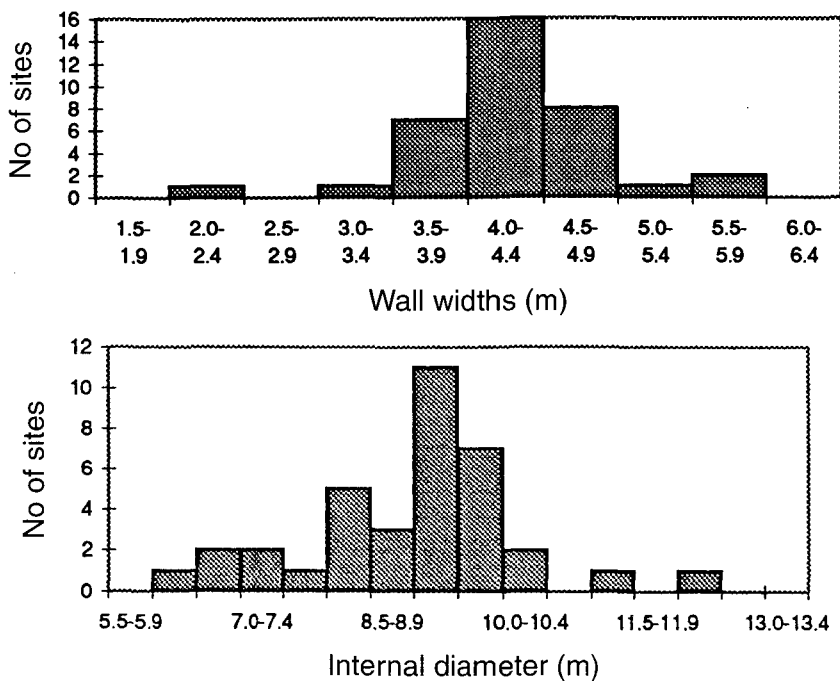
ILLUS 13 Wall widths (above) and internal diameters (below) of selected Atlantic roundhouse sites in Sutherland

the 13 eastern Sutherland structures (9.18 m internal diameter; 4.48 m wall width) considered by Martlew (1983, 257; table 3), using the data from MacKie's (1965; 1971) previous studies of a sample of 120 sites. The analysis presented here is coarse: the quoted dimensions for several sites are based upon only partly visible wall-faces, and the possibility that buttress walls have been measured, thus overestimating original wall width, must be borne in mind.

It is clear that the width of the wall at such sites varies less than the diameter of the internal court. Of the 36 sites studied, 31 have a wall width within the range 3.5–4.9 m and 26 have an internal diameter between 8.0 m and 9.9 m (illus 13). In plotting these two characteristics against each other (illus 14) the clustering of the sites is apparent, and again Durcha falls comfortably within the main cluster. However, there is no apparent trend in this graph to substantiate the claim by the Royal Commission (1911, xx) that 'as might be expected, the thickness of the wall increases with the diameter of the interior'. Assuming the wall width of the Durcha structure to be consistent around its circuit, the walls would form approximately 49.5% of its overall diameter, a figure which also accords well with the mean of 49.38% for other eastern Sutherland Atlantic roundhouses (Martlew 1983, 257, Table 3), and also for Atlantic Scotland more generally.

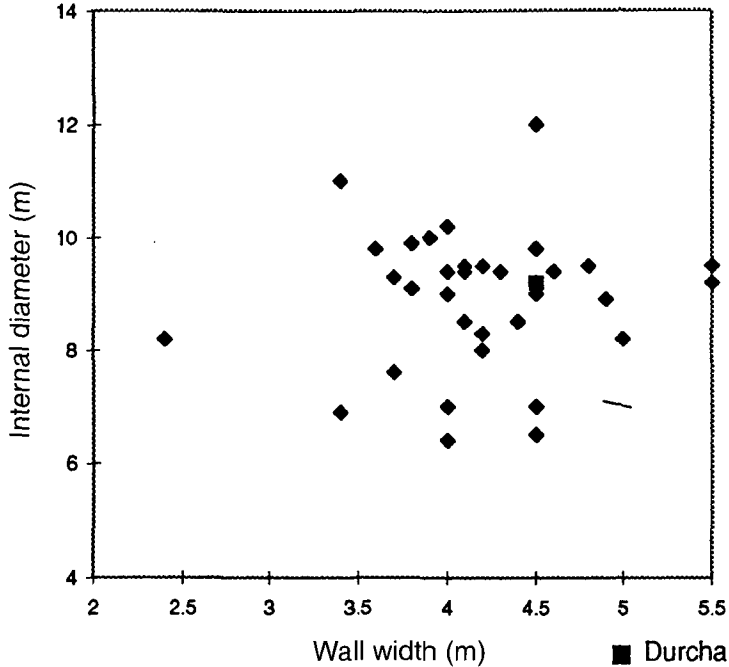
ILLUS 14 Scatter graph of wall widths plotted against internal diameters for selected Atlantic roundhouse sites in Sutherland
