‘Another wall of turf’: geoarchaeological analysis of the Antonine Wall at 72 Grahamsdyke Street, Laurieston, Falkirk

ABSTRACT

EXCAVATION AND SAMPLING AT 72 GRAHAMSDYKE STREET

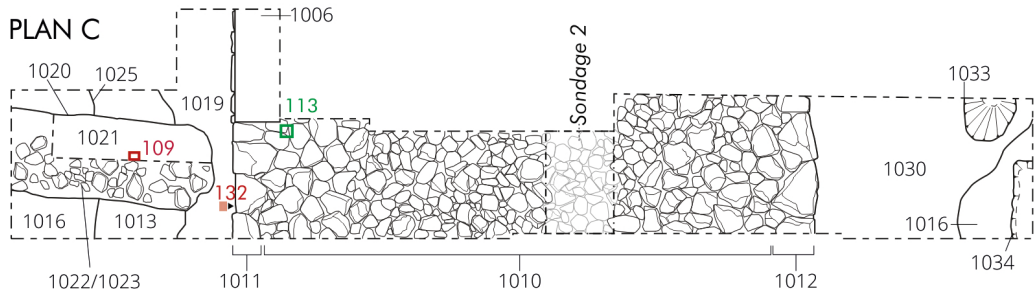
EXCAVATION PHOTOGRAPHS AT PLAN HEIGHTS

ILLUS 2 Trench at three different levels of excavation. Samples identified by three-digit numbers in red, contexts by four-digit numbers in black. (© B Russell, T Romankiewicz, J R Snyder)

colouring of these turf blocks – ranging from light white-grey, to mid grey-brown, to dark red-brown – also enabled the joints between them to be plotted in plan (Illus 2). This revealed their arrangement, which is of particular interest because they were placed diagonally, at around 45 degrees, rather than perpendicular, to the long axis of the rampart (Illus 5; some 10% variation in these angles seems accidental, likely caused by irregularities in turf block dimensions). Each course also seems to have been oriented perpendicular to the one below it, creating a cross lattice pattern with the course below and above. Blocks were placed slightly off-set to the ones beneath them so that as few vertical joints as possible aligned between courses (Illus 5 inset sketch plan). This is the first time that such systematic placing of turf blocks in an oblique arrangement has been noted in a Roman turf structure but not the first time that it has been encountered – as will be discussed below. We have since recorded similar oblique arrangements during our involvement in excavations in 2021 at High Rochester, Northumberland, and have been made aware of comparable evidence from Carlisle (William Hanson pers comm).

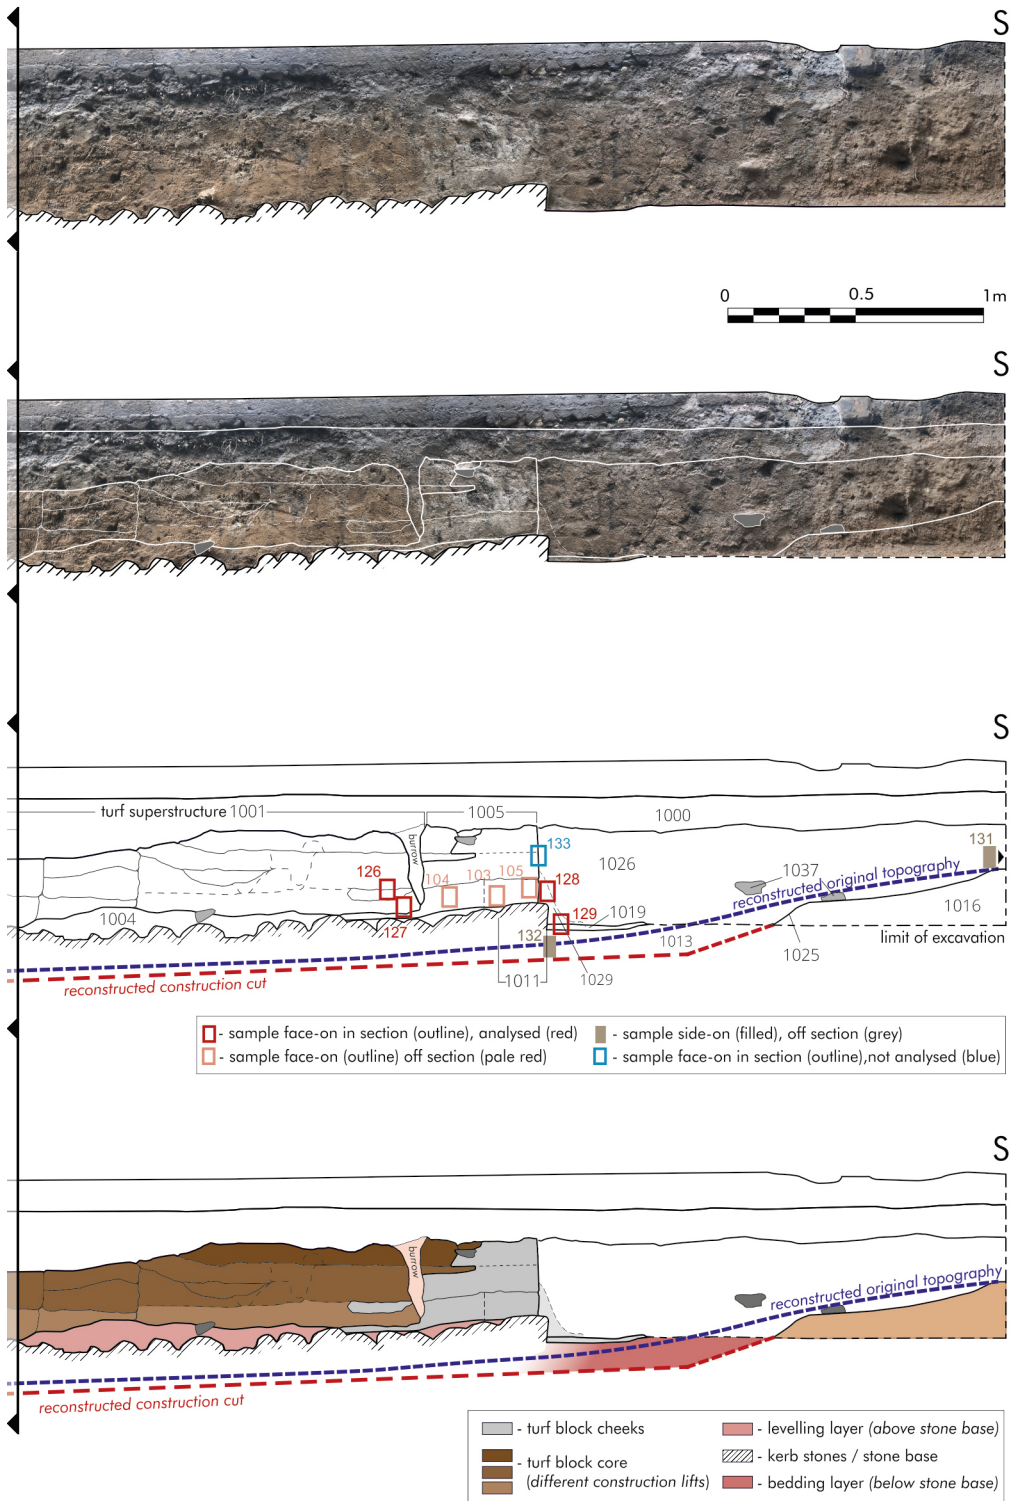
EAST SECTION

ILLUS 3 East section: photogrammetric recording and transcription, line drawing with sample location, and colour-coding of structural elements. Samples are identified by three-digit numbers in red, contexts by four-digit numbers in black. (© B Russell, T Romankiewicz, J R Snyder)

What could instantly be noted about the cheeks, however, is that they were keyed into the diagonally arranged turf blocks behind them, with their rear sides angled to form a saw-tooth join with the core (Illus 5). This meant that the cheeks and turf blocks of the core interdigitated between courses and that these elements were constructed together (Illus 6c). In plan, this was visible by notches cut into the back of the cheek blocks. The sections revealed that this interlinking of cheek and core could be quite substantial in places, with light cheek material stretching 0.20–0.30m into the dark core and vice versa, creating an interleaved pattern in section (Illus 3, S127.C and Illus 7a & c, S104.A, eg Gardner 2021: 82).

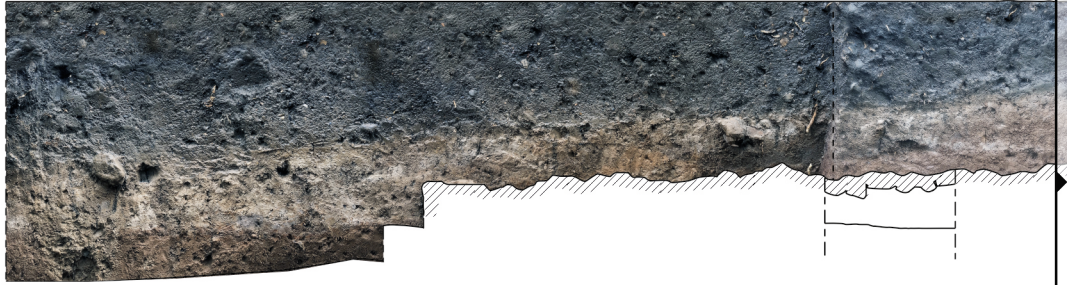
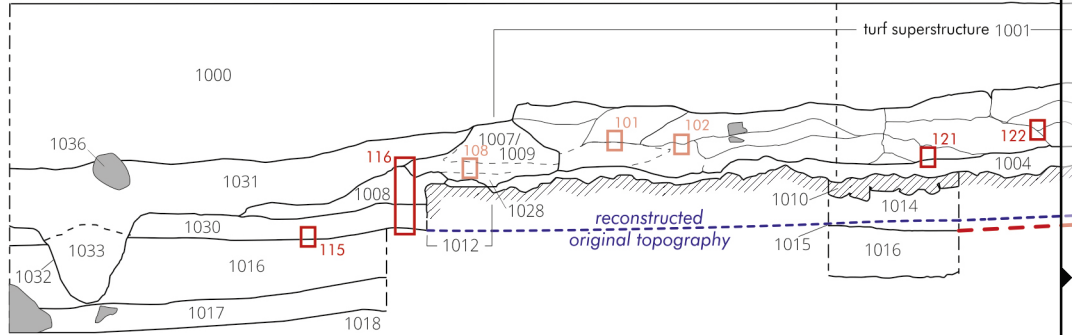
WEST SECTION (reversed)

ILLUS 4 West section: photogrammetric recording and transcription, line drawing with sample location, and colour-coding of structural elements. Samples are identified by three-digit numbers in red, contexts by four-digit numbers in black. (© B Russell, T Romankiewicz, J R Snyder)

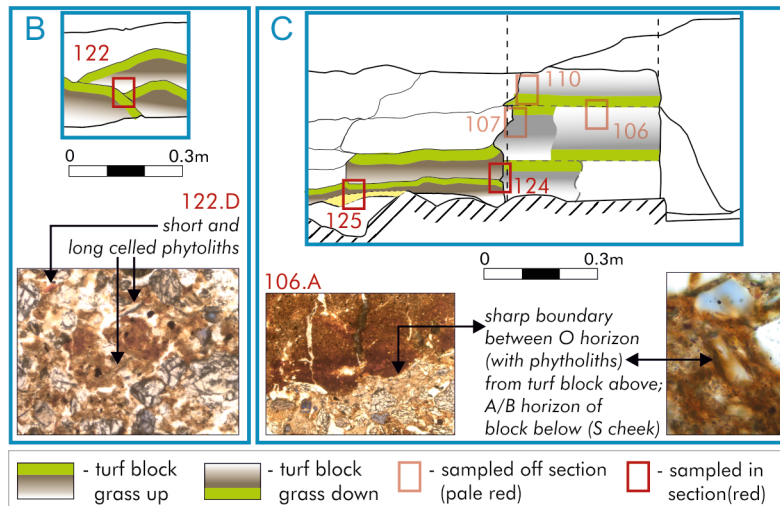
ILLUS 6C West section: details from micromorphological thin sections in area B: 122.D at 100× magnification; in area C: 106.A at 1× and 400× magnification. (© B Russell, T Romankiewicz, T Gardner)

blocky microstructure with less disturbance from soil fauna activity (compare differences between an inverted O horizon of one turf block on top of the A/B horizon of another one below, with a sharp boundary between these, S106, Illus 6c).

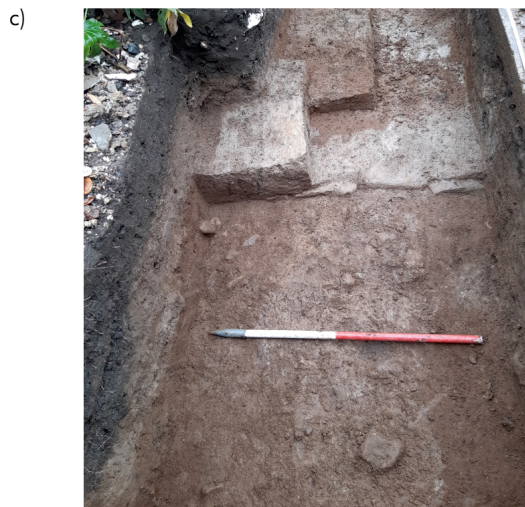
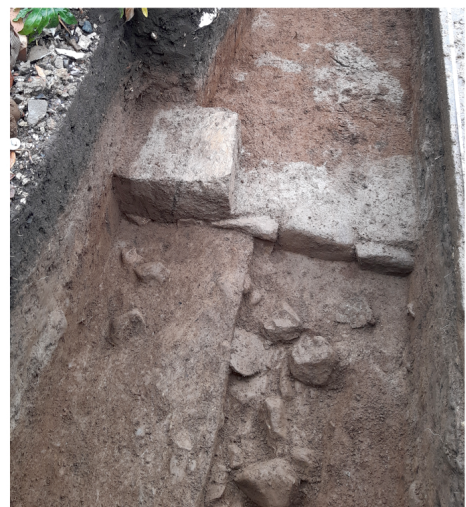
south structure at level of PLAN A looking north

south structure at level of PLAN B looking north

ILLUS 8 (previous page) (a) South and north sections as relating to adjacent parts of east and west sections. Samples are identified by three-digit numbers in red, contexts by four-digit numbers in black; (b) reconstruction in plan of possible location and extent of structure to south, with stone raft C1037, for wall parallel to rampart sitting at higher level in plan than stone raft C1023 for wall perpendicular to rampart; (c) pre- and mid-excavation photographs of south structure. (© B Russell, T Romankiewicz, J R Snyder)

seemingly turning to the west and possibly east, along the face of the Wall, with the stone raft for its footing appearing to sit at a higher level here (Illus 8a: C1037 in south section; Illus 8b). These features most likely represented the wall of a building, with the wall along the rampart needed as support for a low roof structure (Illus 8b & c). Although its foundation slot left a gap of 0.10–0.30m in front of the cheek of the rampart, the wall of the building may have extended beyond this to abut the Wall's south cheek. Turf blocks were visible in the south section of the trench, C1024 and C1027, corresponding to the remains of the superstructure of this small building (Illus 8a). Slides S109 and S131 confirm that the wall built into this gully was also constructed in turf (Gardner 2021: 9, 48–9, table A1.8). The slot itself was filled with turf similar to that used in the core of the Wall's rampart (S109.B), with blocks laid grass-down, likely as a turf footing placed within the foundation slot. This was then overlaid by turf blocks, grass-up (unit S109.A); both turf blocks were from the same source as those used in the cheeks, showing some compaction, applied either during construction or by the load of the wall that these turf blocks represent (see also S131.A; Gardner 2021: 9, 83–5, table A1.21).
