SUPPLEMENTARY MATERIAL

Regime change in 13th-century western Scotland: a reconsideration of the architectural form and early history of the royal castle at Tarbert, Argyll

Mark Thacker¹

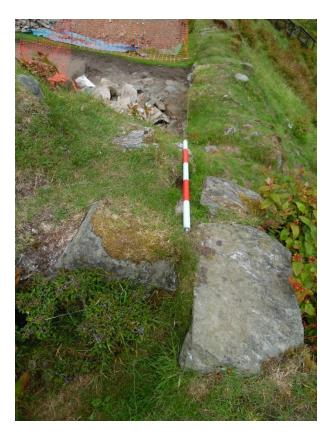
ILLUS S1 Straight Joint 1 from the south-west; highlighting that that the SW face of the cross-wall (and associated core rubble) abuts the internal face of SE curtain wall. Scale 1m/200mm.

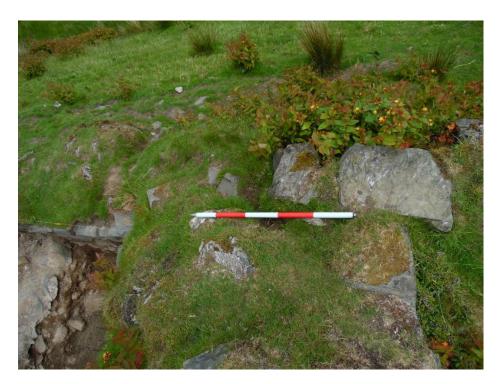
ILLUS S2 Straight Joint 1 from above; highlighting that the cross-wall south-west face and core rubble (bottom of image) abuts the internal face of SE curtain wall (top of image). Scale 1m/200mm.

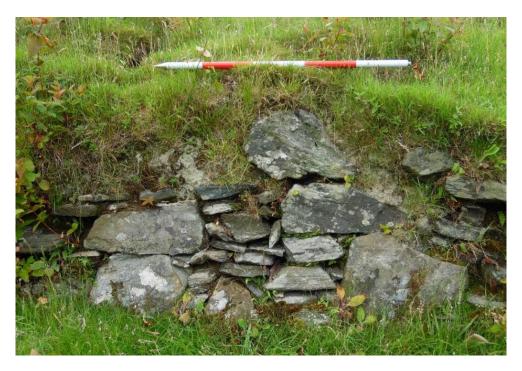
ILLUS S3 External face of SE curtain wall, inner bailey, surviving here to 1.0m above current ground level. Scale 1m/200mm.

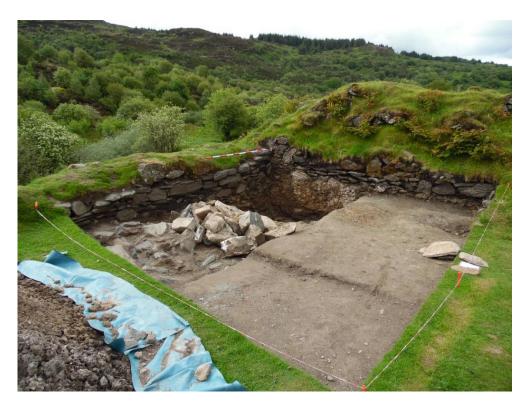
ILLUS S4 Trench 1 of the community excvation, in the south angle of the outer bailey. Scale 2m/200mm.

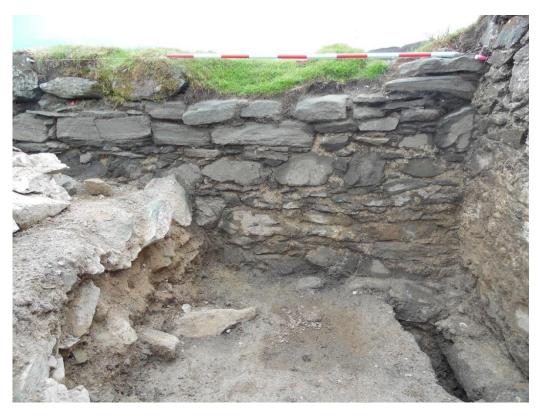
ILLUS S5 Internal Face of SE curtain wall in Trench 1. Note rubble coursing and large slab face blocks. Scale 2m/200mm.

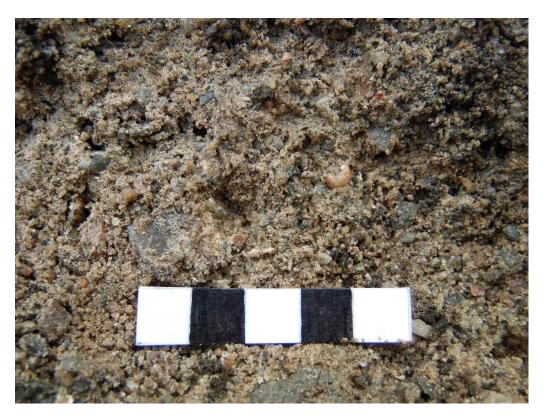
ILLUS S6 Bedding mortar of SE curtain wall. Scale 10mm.

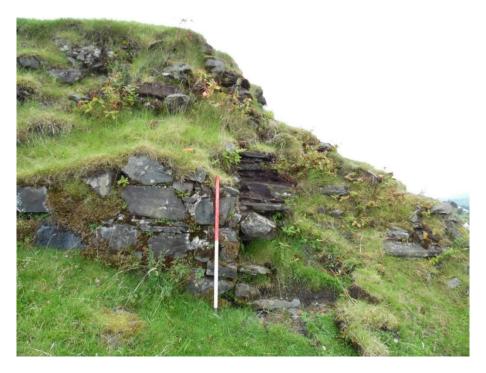
ILLUS S7 Straight Joint 2, from the north-east. This feature aligns with the internal face of the inner bailey north-west curtain wall.

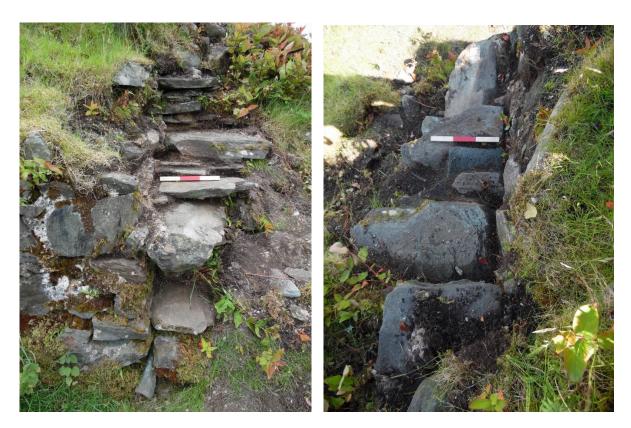
ILLUS S8 & S9 Straight Joint 2 from the north-east (left) and from above (right). The cross-wall clearly abuts the internal face of the inner bailey NW curtain wall, and this has aided its survival. Scales 300/100mm.

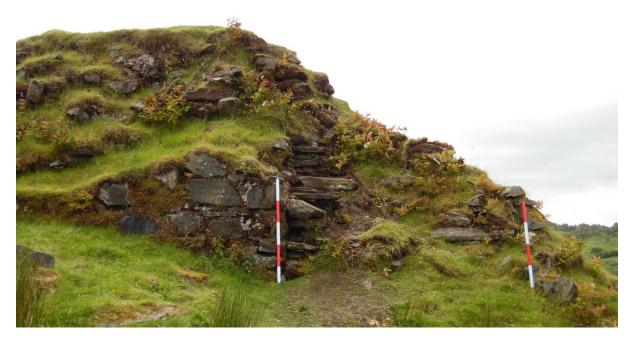
ILLUS S10 Straight Joint 2 from the north-east. The ranging rods delineate the width of the north-west wall of the inner bailey to the SW. Scales 2 x 1m/200mm.

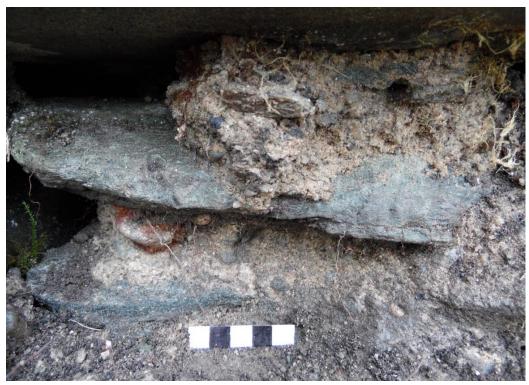
ILLUS S11 Fragmentary and friable remains of bedding mortar in the north-west inner bailey curtain wall at Straight Joint 2. Scale 10mm.

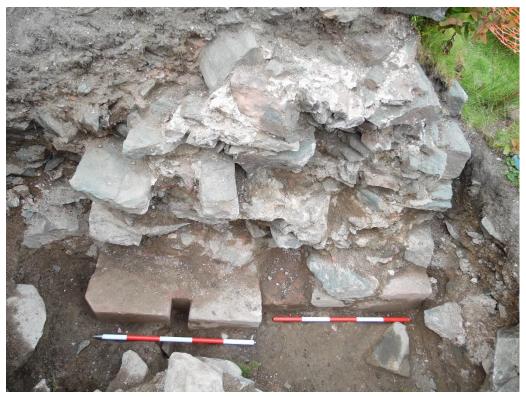
ILLUS S12 NW reveal of the outer bailey SW gate revealed by excavation. Note the dressed red sandstone external block with chamfered ariss and probable portcullis slot. Scales $2\ x\ 1m/200mm$.

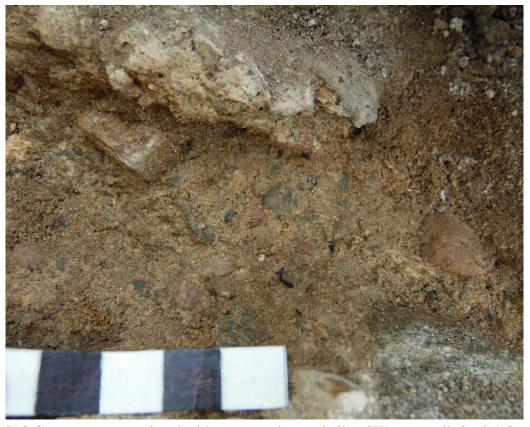
ILLUS S13 Core mortar associated with excavated outer bailey SW gate wall. Scale 10mm.

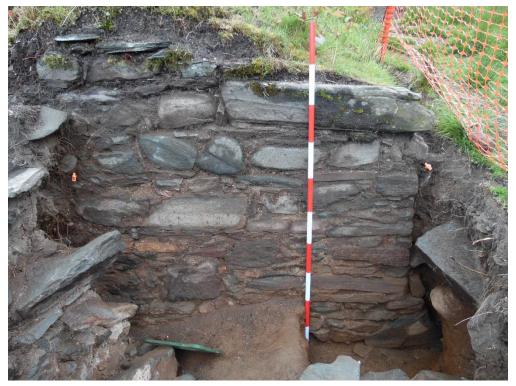
ILLUS S14 External face of excavated west tower SW wall. Scale 2m/200mm.

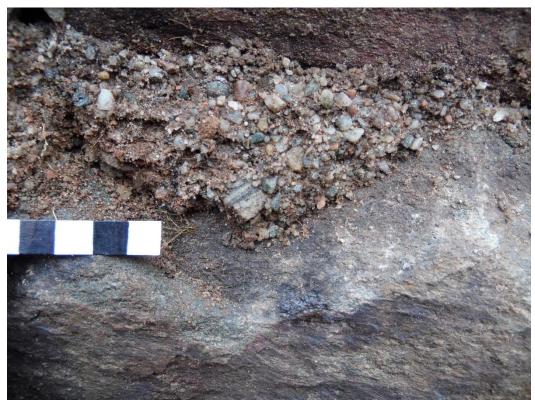
ILLUS S15 Dissolute mortar coating on the external face of west tower SW wall, exposed in trench 4. Scale 10mm.

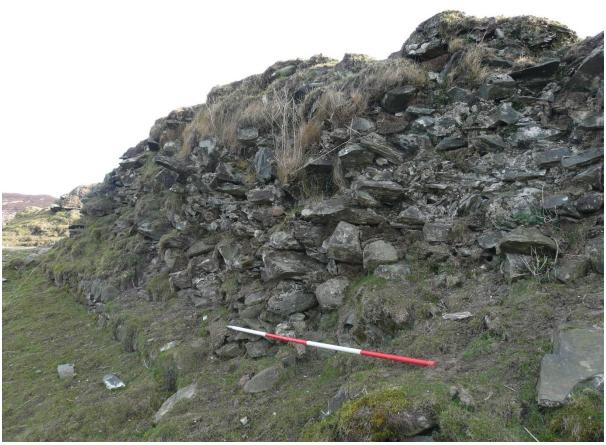
ILLUS S17 NW end of the cross-wall, highlighting extensive volumes of exposed upstanding core rubble and some wall facing. Scale 2m/500mm.

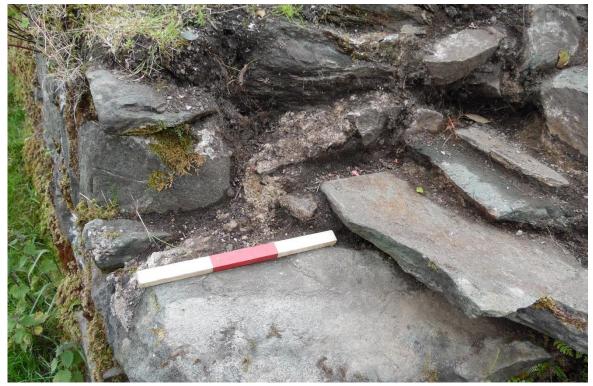
ILLUS S18 Highlighting that the core mortar associated with cross-wall abuts the fossilised internal face of the inner bailey NW curtain wall at Straight Joint 2. Scale 300/100mm.

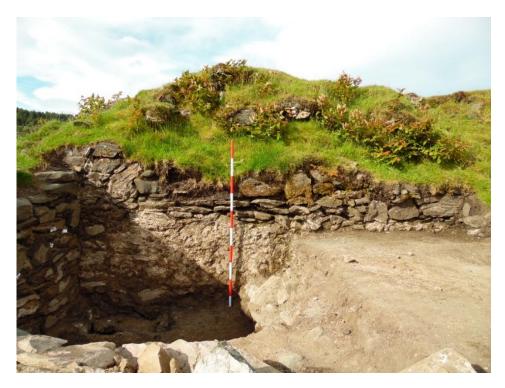
ILLUS S19 North-east face of cross-wall close to the south angle of the outer bailey. Scale 2m/200mm.

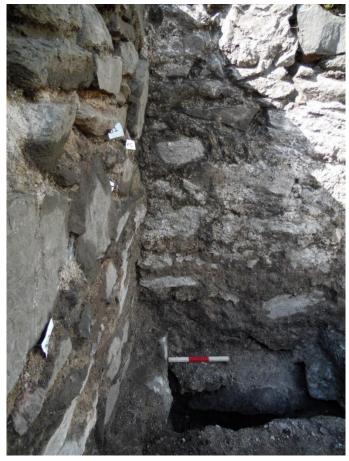
ILLUS S20 Straight Joint 1; highlighting that the cross-wall overbuilds the foundation scarcement and abuts the internal face of SE curtain wall. Scale 300/100mm.

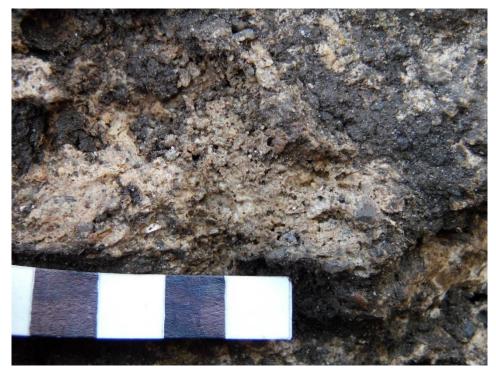
ILLUS S21 Mortar at face of crosswall exposed by excavation, partially obscured by soil. Scale 10mm.

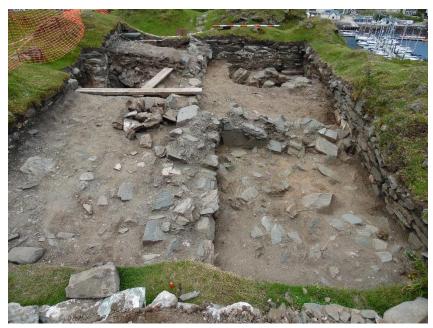
ILLUS S22 Part of inner bailey NE range exposed from the south-east in trench 2. Scale 2m/200mm.

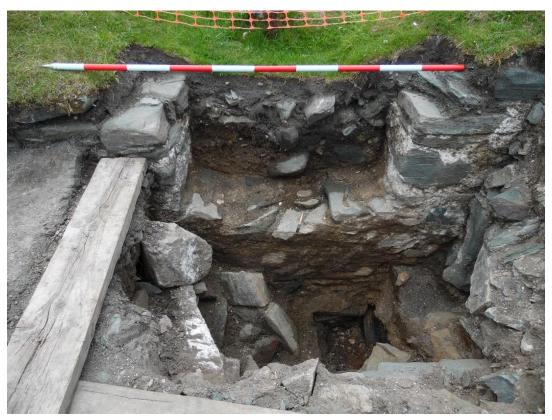
ILLUS S23 Intramural opening (probable doorway) in the SW wall of the inner bailey NE Range from the north-east. Scale 2m/200mm.

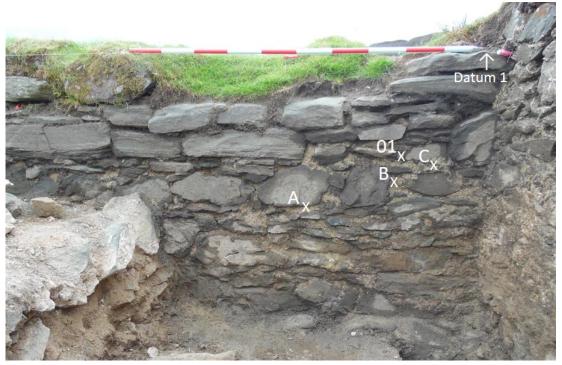
ILLUS S24 Locations of samples removed from exposed outer bailey SE curtain wall [047]; Trench 1.

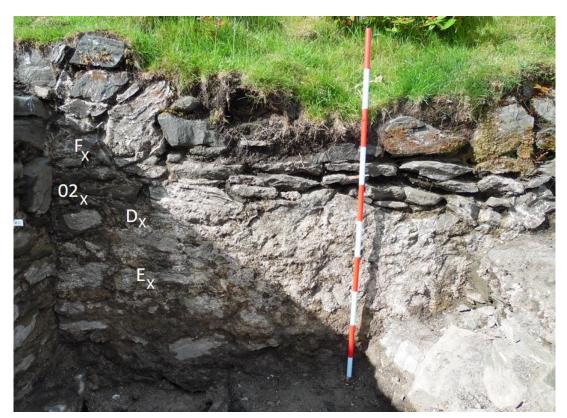
ILLUS S25 Locations of samples removed from exposed cross-wall [046]; Trench 1.

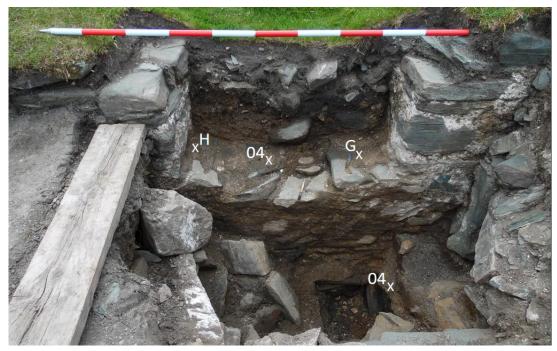
ILLUS S26 Locations of samples removed from exposed inner bailey NE range SW wall [044] and floor [035], Trench 2.

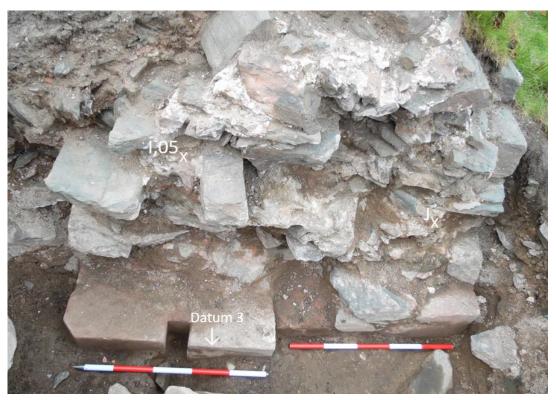
ILLUS S27 Locations of samples removed from the Outer Enclosure Gateway in SE Curtain Wall [043], revealed by Trench 3.

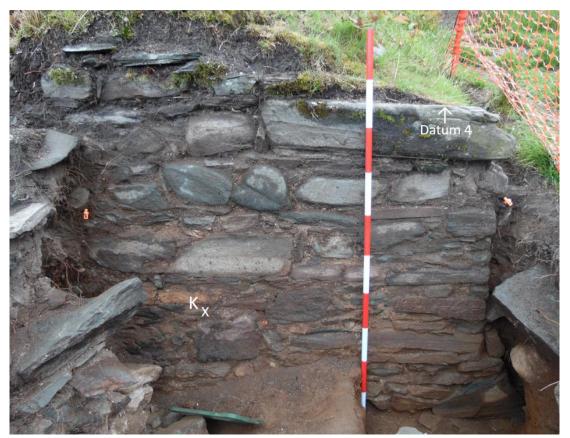
ILLUS S28 Location of the sample removed from West Block Wall [042], revealed in Trench 4.

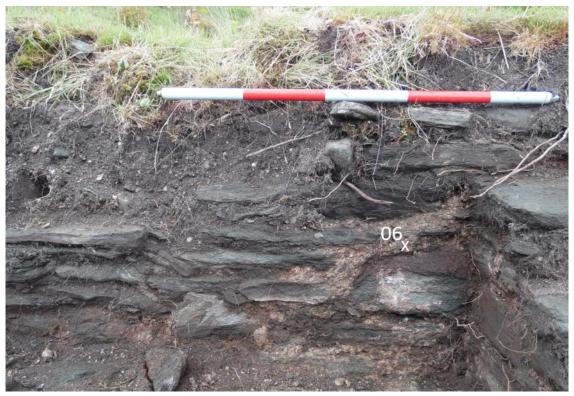
ILLUS S29 Location of the sample removed from West Block Wall [054], revealed in Trench 4.

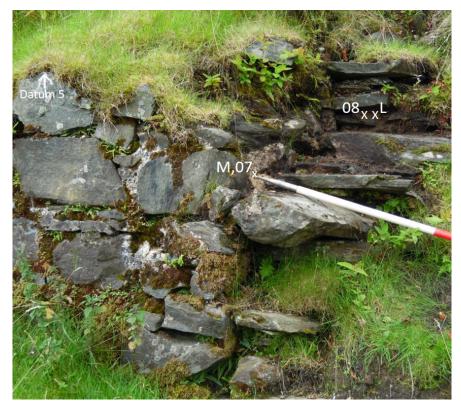
ILLUS S30 Locations of the samples removed from Abutment B.
