THE VITRIFIED FORT OF LOCHAN-AN-GOUR, ARGYLLSHIRE.

By ALAN REID, F.S.A. Scot.

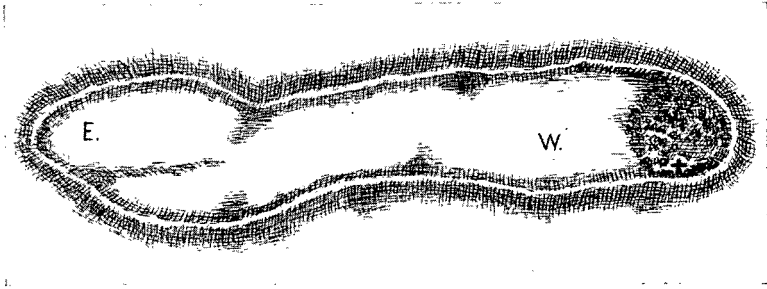
Fig. 3. Plan of the Fort of Lochan-an-Gour.

From the plan of the fortified area shown in fig. 3, the general appearance of the enclosure will be gathered. The growth of heath and fern is such as to make a clear view of the site impossible, but low mounds rising over buried stones and debris indicate the outlines fairly well. A little digging into several of these mounds brought to view the remains of walls built of waterworn and carried stones, of a texture foreign to the quartzite bed on which they lay. Where nature had indented the rocky sides of the knoll, courses of laid stones were found making good the deficiencies, so that the enclosing wall might run the straighter round the somewhat narrow area. On the lower knolls, lying westwards of the fortress proper, several similar mound-marked

Our serious investigation of the relic commenced at the point marked with a + on the plan, fig. 3. Here was the appearance of building in the shape of two courses of large stones, nearly hidden by heather, but showing plainly in their arrangement the hand of man. On clearing these of turf it was evident that they lay in an undisturbed position. Digging behind this fragmentary wall, we unearthed the first evidence of vitrification (specimen No. I.). The flux looked so pale, so milky-white among the dark turf in which it was embedded, that our first impression was that we had discovered a large agate or chalcedony. Soon all such ideas were dispelled, for behind that wall, as shown in fig. 4, lay tons, apparently, of vitrified fragments of every shape and size. Very carefully were these examined before they were lifted, ample time being spent in thought and remark. Search was made for an inner wall corresponding to that outside of the vitrification, but in vain. Our conclusion was that here an outer wall of built stones had been strengthened by a vitrified inner wall or lining. All around the Torr,

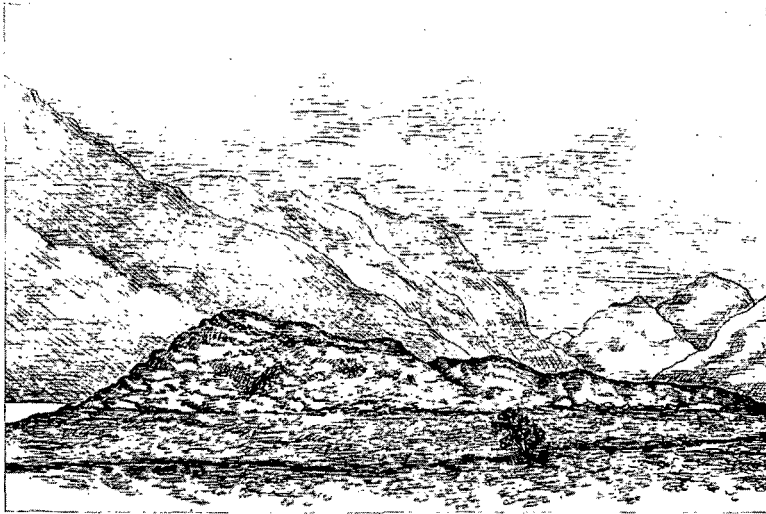
Fig. 5. View of Torr-an-Duin from the S. East.

The general appearance and character of the fort, and of Torr-an-Duin in its relation to the Lochan and the glen, will be gathered from fig. 5. From this point of view the fort, the fosse, and the contours of the site assume their most striking appearance. The waters of the Lochan are rapidly covering the marshy foreground, making access to the hill

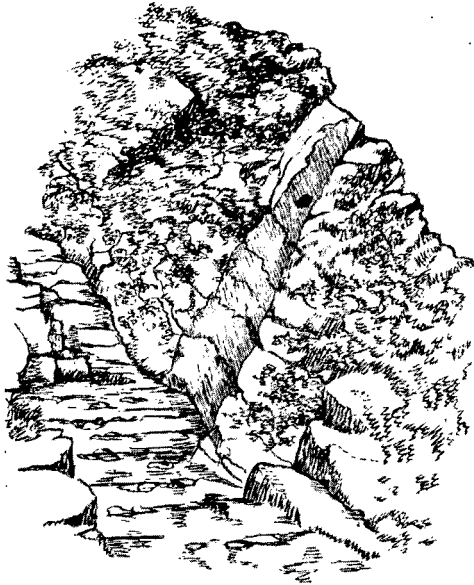
Fig. 6. The Post-cheek and Dook-hole.

top of the rock, interesting traces of a gateway appearing at a point about one-third up this ascent. On the right is the sharply cut recess for a gate-post shown in fig. 6, the chiselled hole for the dook to which the head of the post had been fastened appearing also in the drawing. This hole is no mere natural fault, for it pierces the quartzite to a depth of 6 inches, tapers in shape from mouth to socket, and bears the

marks of some sort of tool. Evidently, the flattened rocks on the left had borne the counterpart of this natural door-cheek in the form of a built wall, against which the door, swung on the post to the right, had closed. To the left, inside of this barrier, is a large quarry-like clearing, which, if used as a fold for animals, proves the necessity for a door at this particular point. These details are more curious than profound, and may, of course, belong to a period comparatively recent, though certainly not within living memory.
