EXCAVATION OF A GALLERIED STRUCTURE AT LANGWELL, CAITHNESS. By A. O. CURLE.

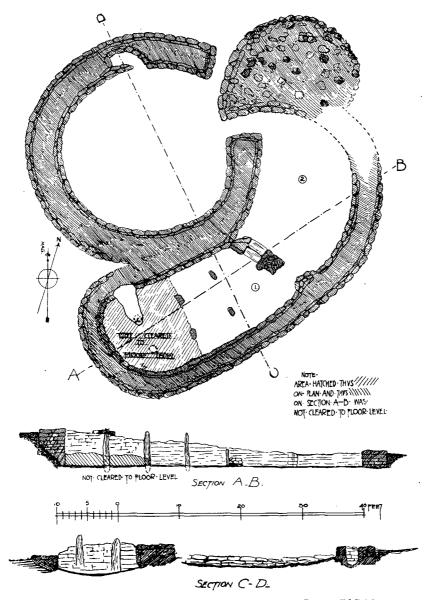
Fig. 2. Ground Plan and Sections of Galleried Structure at Langwell, Caithness.

Reference to the plan (fig. 2) will show the form of the construction with its two main divisions.

28 feet from front to back. It is surrounded by a low stone wall, with an average width of 6 feet, and completely overgrown with turf. The level of this wall is very regular at about the height of a single boulder such as is used to face it; that is to say, about 18 inches. On the north-west is a curved recess extending inwards for 6 feet, with a breadth of 2 feet.

From the north-east a passage through the wall, some 2 feet 2 inches in width, leads into the circle from the outside, while another passage from the circle itself communicates with the galleried

chamber at its lower end. The latter chamber did not appear to have had a separate entrance from outside, but the wall where left blank on the plan was untraceable, owing to the trees growing on the top of it. Lying parallel with the hut circle on its east side. with a common wall, is the galleried chamber, which has an extreme length from back to front of 48 feet. It is divided into two parts by a cross wall at about 21 feet from the lower end, pierced by a doorway. The outer division appears to have formed a courtyard, probably open to the sky, and slightly broader than the back division. with a greatest breadth of 16 feet. The inner division measures some 12 feet 6 inches behind the cross wall, and slightly expands towards the inner end, which is rounded. The general slope of the ground is towards the east, and the whole chamber has been to some extent dug out, so that, at its inner extremity, the floor level lies some 4 feet to 5 feet below that of the ground outside, while at the opposite end the difference in level is only about 2 feet. Commencing with the excavation of the outer division, we found the old floor level, at a depth of about 2 feet beneath the present surface, covered with an accumulation of soil and occasional large stones. One of these stones was deeply pitted with holes seemingly made by limpets, thus indicating the source from which it had been brought. Most of the larger stones appeared to have been quarried. The floor was firmly compacted and discoloured, and covered with a black deposit to a depth of from 1½ inch to 2 inches, containing numerous particles of charcoal, but no trace of shells or bones or of any food refuse or pottery were found in it. The light-coloured sand of the subsoil made the floor level easily distinguishable. Near the centre (2 on the plan) lay the upper half of a rotary quern, with two perforations in the axial line made from both sides, each showing a slight constriction near the centre, and there came to light, also, half of a flat disc-shaped stone, 7 inches in diameter, with a small concavity in the centre, measuring 21 inches across, marked with numerous small pittings. A view

blocks had probably been used to complete the roofing. As will be seen from the plan, the two rows of pillars do not maintain throughout the same relative position to the walls of the chamber, but deflect towards the entrance. These pillars stand each about 6 feet in height above floor level, are set from 2 feet 3 inches to 4 feet 7 inches distant from the walls, and leave a central nave between the rows, varying in width from 4 feet between the inner pair to 5 feet at the opposite end. On only one does the cap stone still rest (fig. 4). The wall of the structure, where remaining fairly complete, is well built, the stones increasing in size towards the top, some of them in that position measuring 2 feet to 3 feet in length by 1 foot to 1 foot 4 inches in thickness; this arrangement being evidently adopted to provide solid imposts for the ends of the roofing slabs. So massive were the stones which encumbered this chamber, that it was found impossible, towards the inner end where the wall was higher, to move them without the assistance of a crane. The area shaded on the plan was therefore not cleared, though the actual floor level was at one point exposed at the back for the purpose of obtaining a section. It was not possible to ascertain if the central nave had been roofed, but from the stones found I am inclined to think that if it had been so a stone roof was not used. In the front portion of this division, the area behind the wall, there were found a sufficiency of large slabs to admit of a partial roof, but not for a complete roofing, nor was there any indication of the removal of a pillar, and without some such support the span between the terminal pillar and cross wall on the east side would be too large to have been covered by stone in the method here employed. floor, as in the outer division, was covered with a black deposit containing charcoal, and at the spot marked (1) on the plan there was found in situ resting immediately on the uncontaminated sandy subsoil a saddle quern (fig. 5), measuring $18\frac{1}{2}$ inches in length by 14 inches in breadth at the upper end and 10 inches at the lower. At the latter extremity the stone was much worn away. Near it was found the

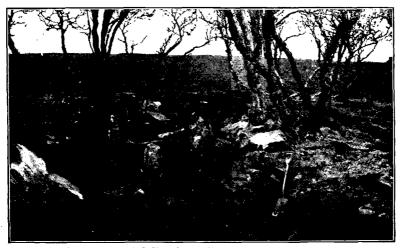
Fig. 3. Galleried Chamber at Langwell after excavation.

of the inner division is shown in fig. 3. The divisional wall was some 4 feet in thickness, and was much broken down. The entrance through it towards the west side, 3 feet wide, was flagged, and there stood on either side of it, at its inner end, an upright stone, 3 feet 8 inches in height, with a sharp-edged sill between, 5 inches in depth. Towards the east side there occurred a broad gap in the wall, some 3 feet in width, blocked with a mass of earth

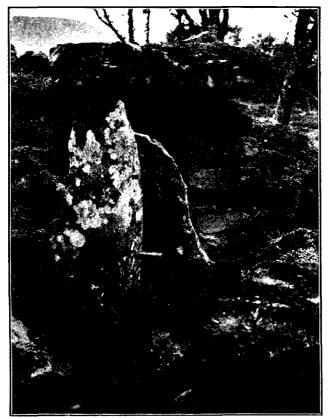
Fig. 4. Upright Pillar and Cap Stone in the Galleried Structure, Langwell.

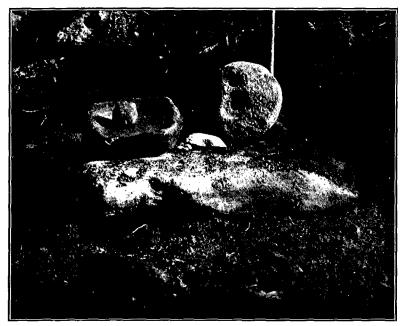
Fig. 5. Relics from the Galleried Chamber, Langwell.

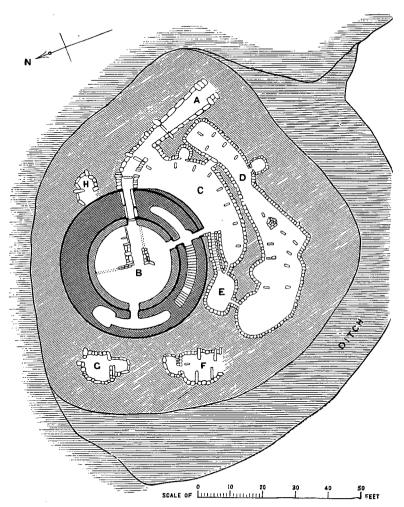
Fig. 6. Plan of the Broch of Yarrows, showing Galleried Structures alongside the Broch.

oblong form, there occurred along the side, set parallel to the walls, upright pillars, dividing the chambers as it were into stalls. These, I have no doubt, were the supports of roofing slabs of a galleried dwelling. The plan reproduced (fig. 6) indicates the arrangement very clearly, while the illustration (fig. 7) shows a number of the pillars now laid prostrate—a fate which has overtaken almost the whole of them, and fig. 8 shows their original appearance when the broch was excavated.

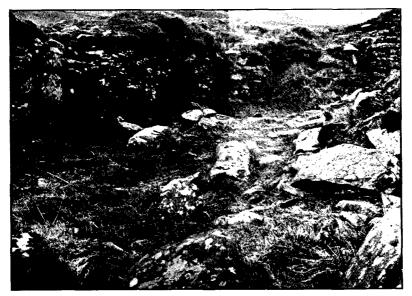
Fig. 7. Interior of Galleried Structure at Broch of Yarrows, showing fallen pillars.

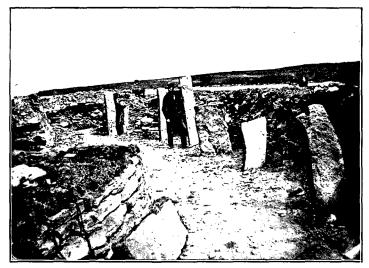
Fig. 8. Original appearance of the Pillar Slabs in the galleried structure outside the Broch of Yarrows. (From a photograph taken by Mr Johnston, Wiek, in 1867.)
