ACCOUNT OF THE RECENT DISCOVERY OF THE REMAINS OF DAVID'S TOWER AT EDINBURGH CASTLE. BY W. T. OLDRIEVE, F.R.I.B.A.,
Vice-President, PRINCIPAL ARCHITECT FOR SCOTLAND OF H.M. OFFICE OF WORKS.

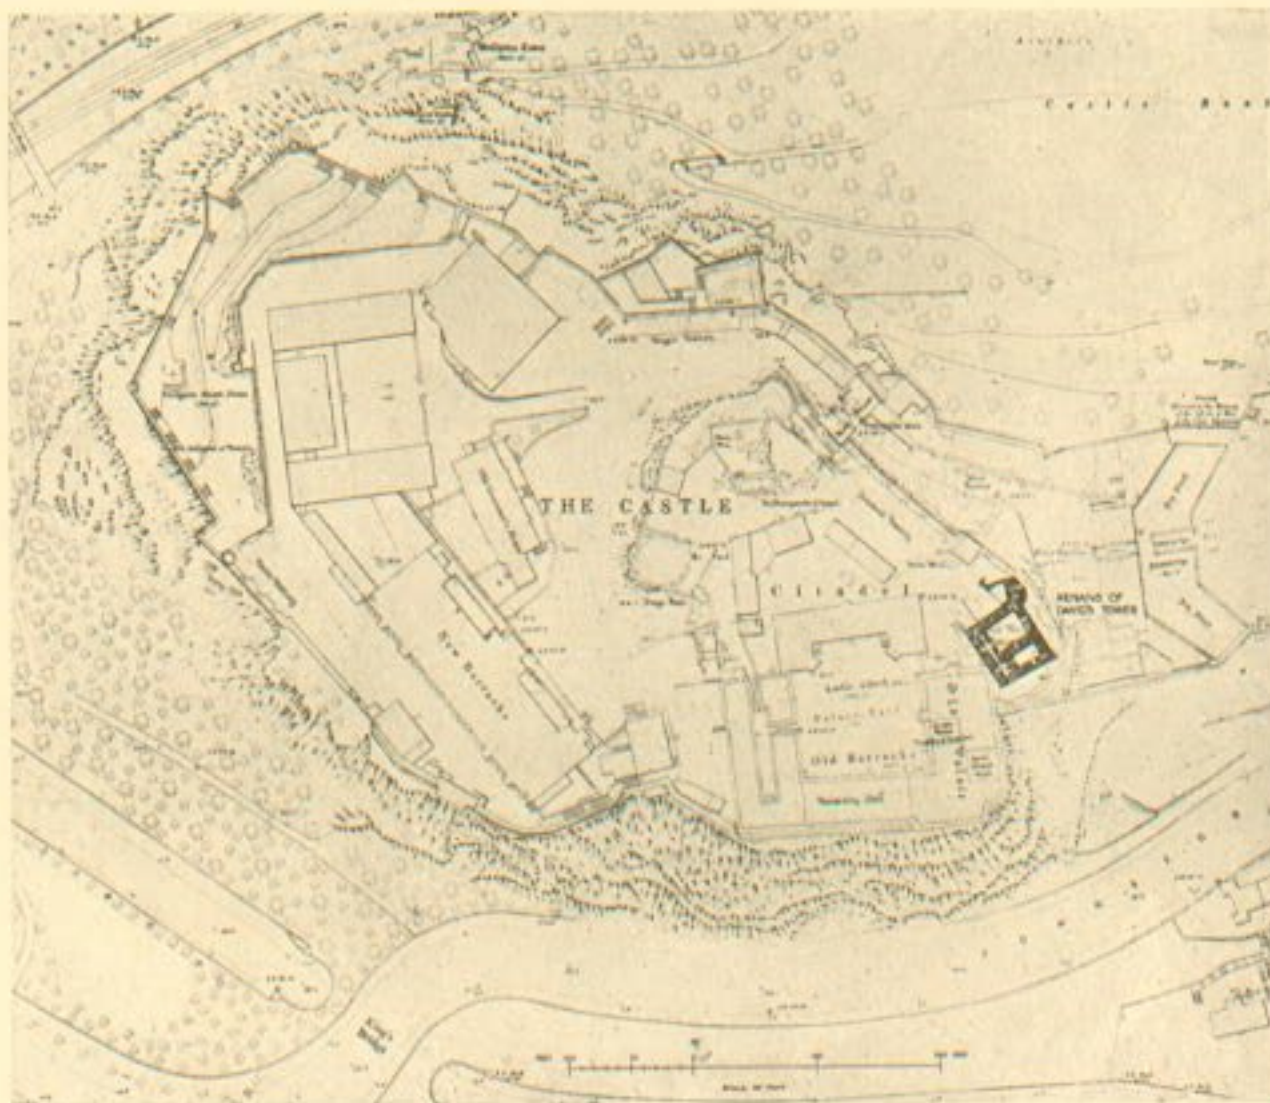
Fig. 1. Key-Plan of the Castle, showing the position of David's Tower.

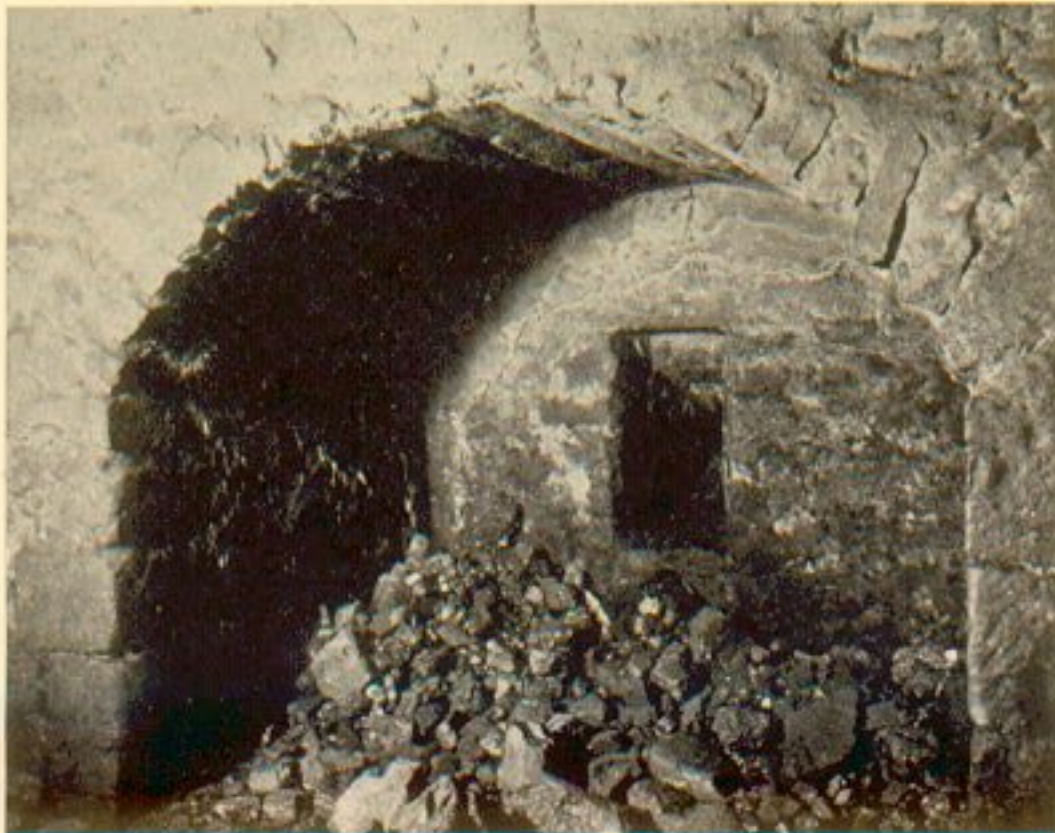
Fig. 5. Canteen Coal-cellar until 1912.

The work of exploration followed upon an inspection early in 1912 of the older parts of the Castle by a Sub-Committee of the Royal Commission on the Ancient Monuments of Scotland. This Sub-Committee was charged with the survey of the historical buildings of Edinburgh, and consisted of Professor G. Baldwin Brown, Dr Thomas Ross, and myself. We found in a coal-store (fig. 5), connected with

the soldiers' canteen at the north-east corner of the palace that the construction of the masonry indicated work of a much earlier character than that of the palace building. In particular, we noticed

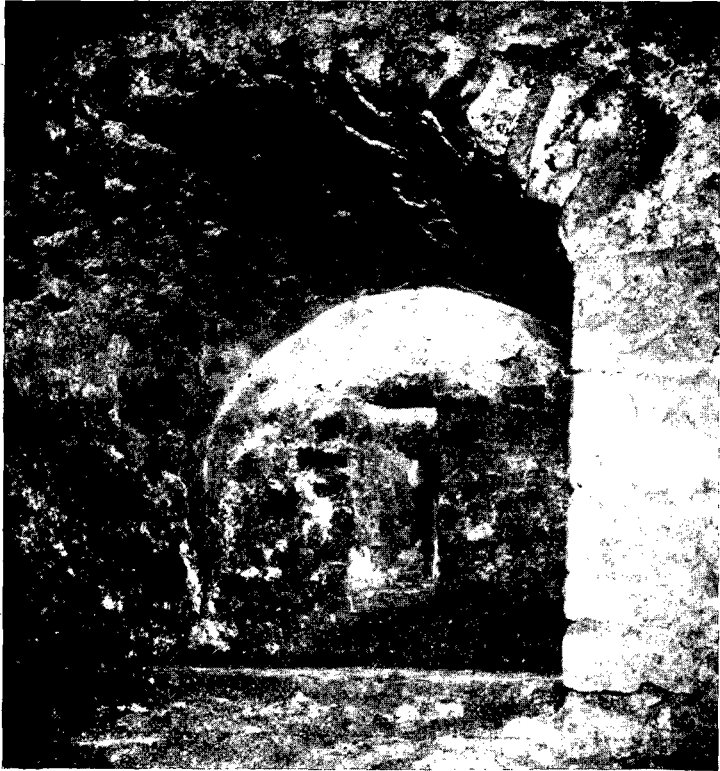
Fig. 6. Vaulted Recess with Shot-hole (after removal of coal-cellar floor).

the substantially constructed stone-vaulted recess in a wall 7 feet 6 inches thick, with the narrow window slit or shot-hole (fig. 6), which, though now below the level of the Half-Moon Battery, had obviously been above ground originally. It was suggested that this window

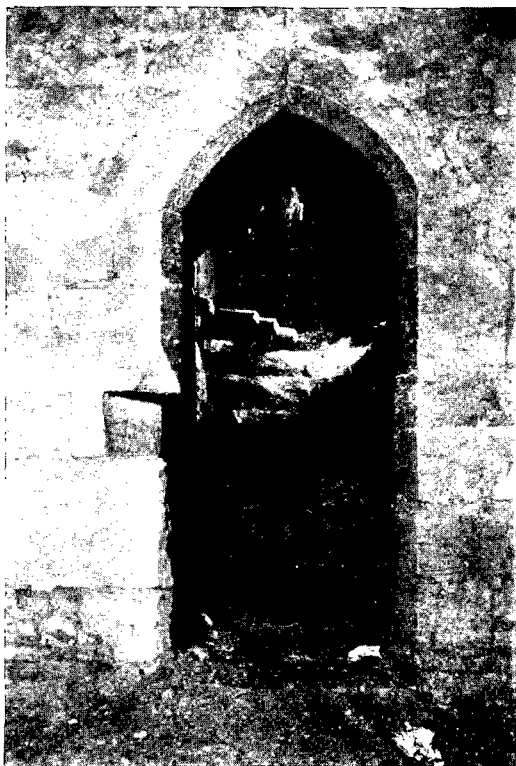
Fig. 8. Original Entrance to earliest part of Tower.

This entrance doorway is formed with a $3\frac{3}{4}$ -inch splay entirely round the outer edge, the check being $3\frac{1}{2}$ inches deep. A massive door once

protected the tower. Holes in the door jambs show that a bar—probably of oak—about 5 by 5 inches, sliding into a hole in the north side, served as a fastening on the inside.

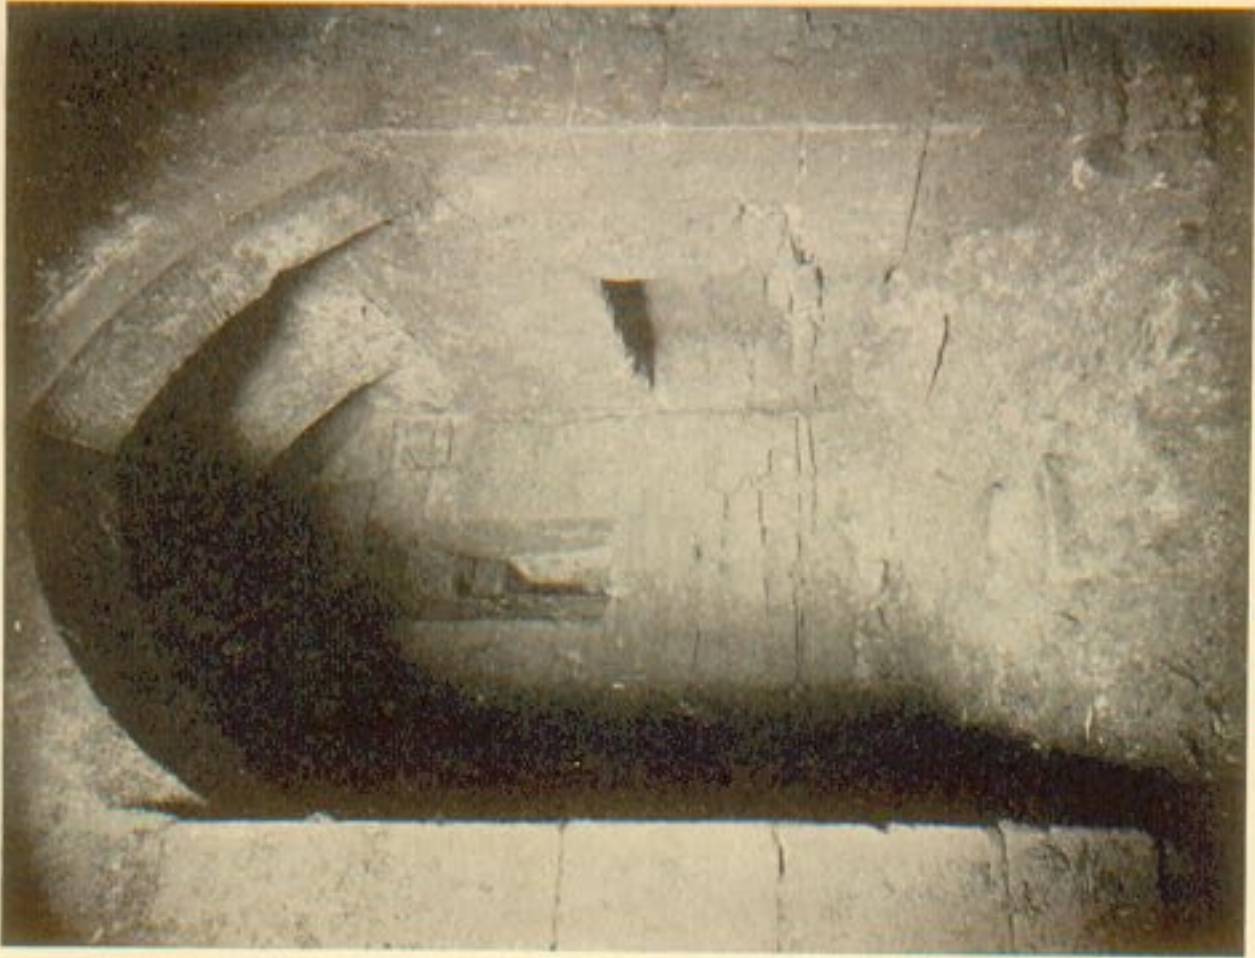
Fig. 13. Recess on west side of Hall.

On the west side of the entrance hall or lobby a recess was found (fig. 13) with narrow window looking westward, and with a lamp bole or cupboard as shown.

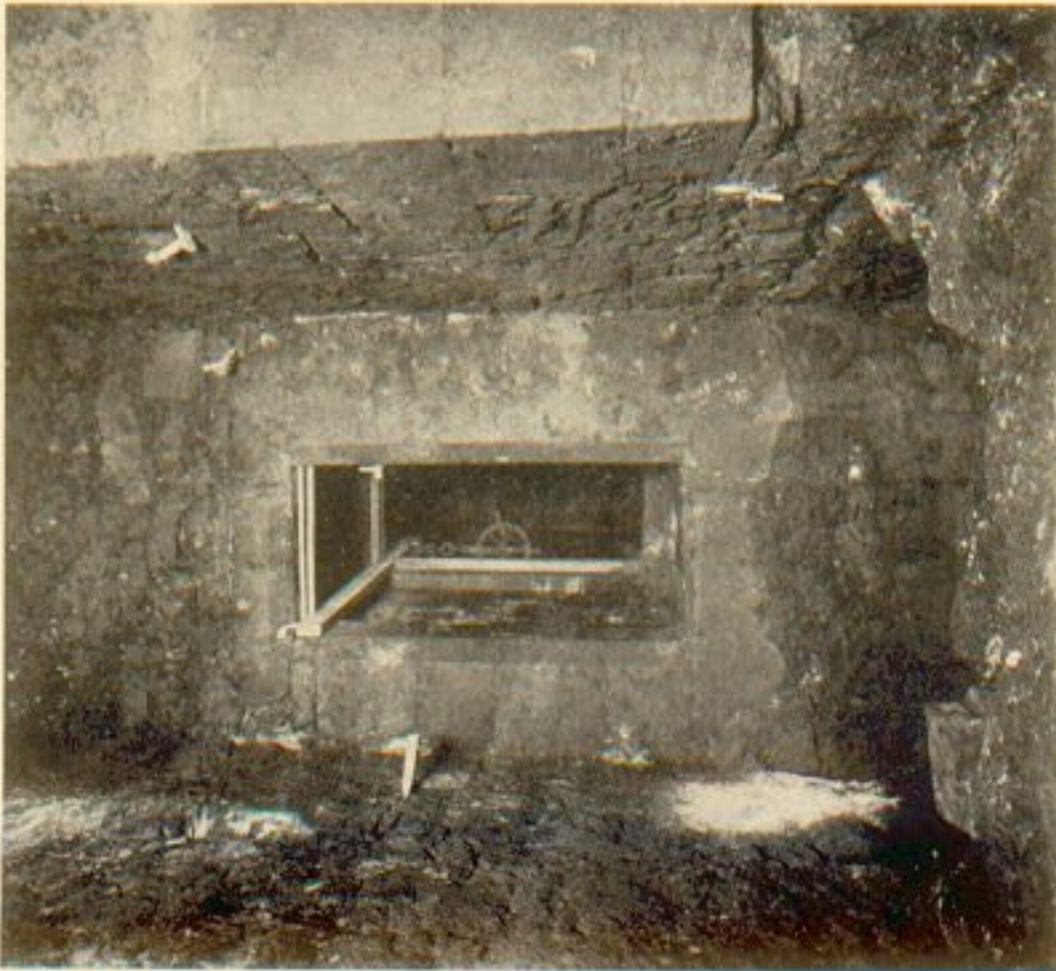
Fig. 12. Door on south side on higher level. (Believed to be later.)

In the entrance hall the doorway on the south side (fig. 12) was discovered on 5th September, and by this doorway access was obtained to the westmost of the outer vaults. This doorway is peculiar in its having three door checks. These checks indicate that two of the doors opened outwards, while one opened inwards. There are here no bar-holes in the stonework. There is a sunk pit 4 feet wide and 5 feet 6 inches deep, with rock floor immediately beneath on the inner side of the wall.

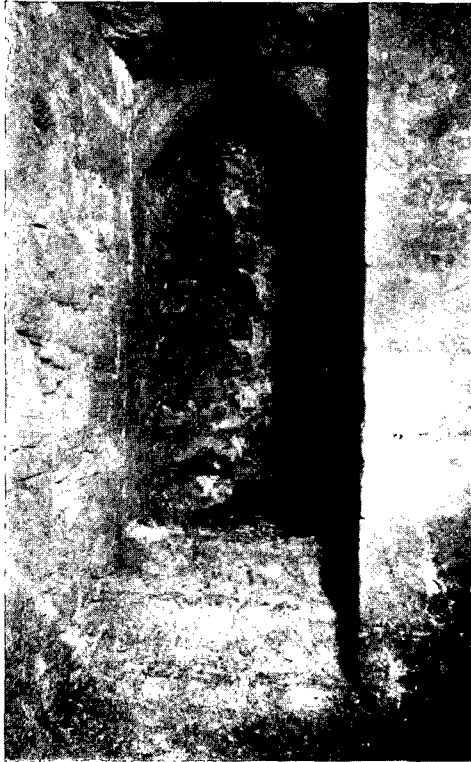
Fig. 14. Doorway on north side of Entrance Hall.

On clearing away the soil at the north end of the entrance hall a doorway (fig. 14) was found at the top of a flight of three steps, the doorway having been built up with rubble masonry.

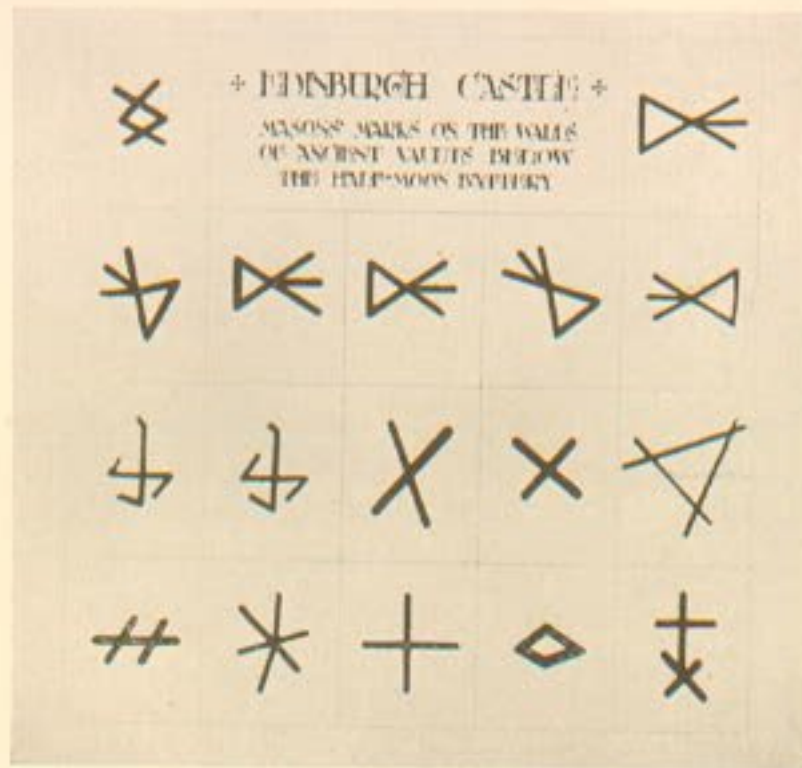
Fig. 15. Masons' Marks on stonework.

On the surface of the stonework of this part of the building a number of masons' marks were found (fig. 15). These masons' marks are similar in type to what have been found in many mediæval buildings, and so far as I am aware they cannot, though interesting in themselves, be relied upon to indicate the date of the building.

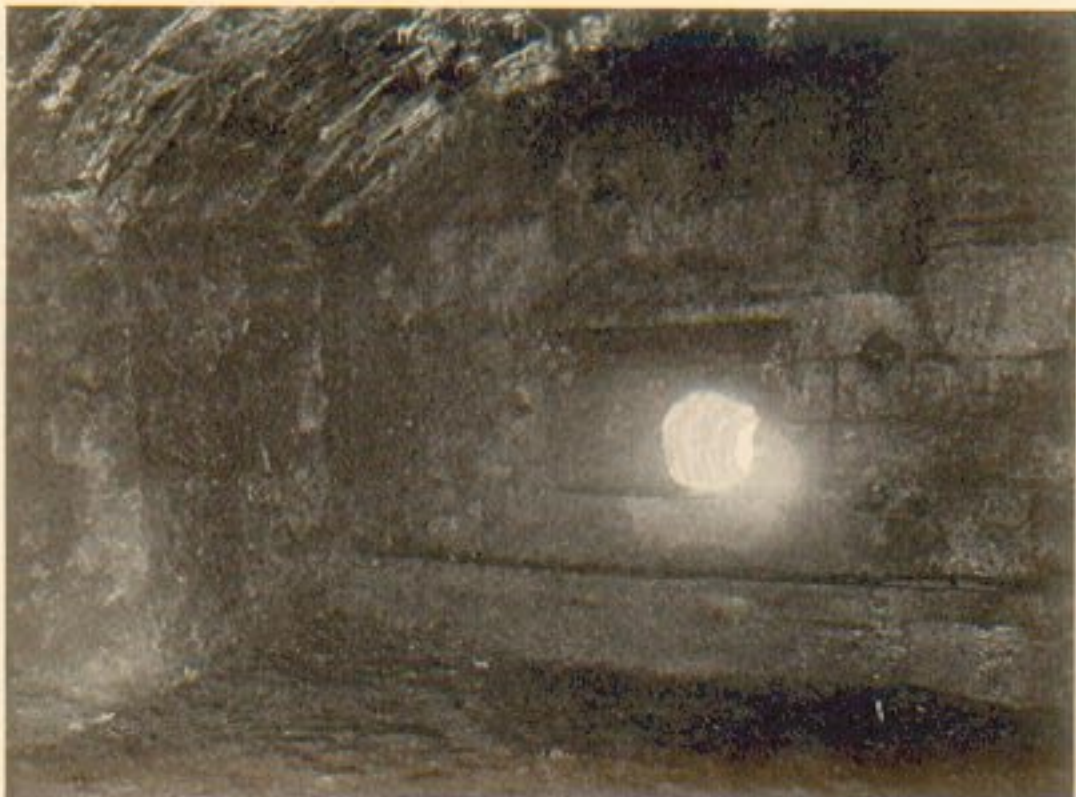
Fig. 16. Vaulted Recess of Battery with Shot-hole.

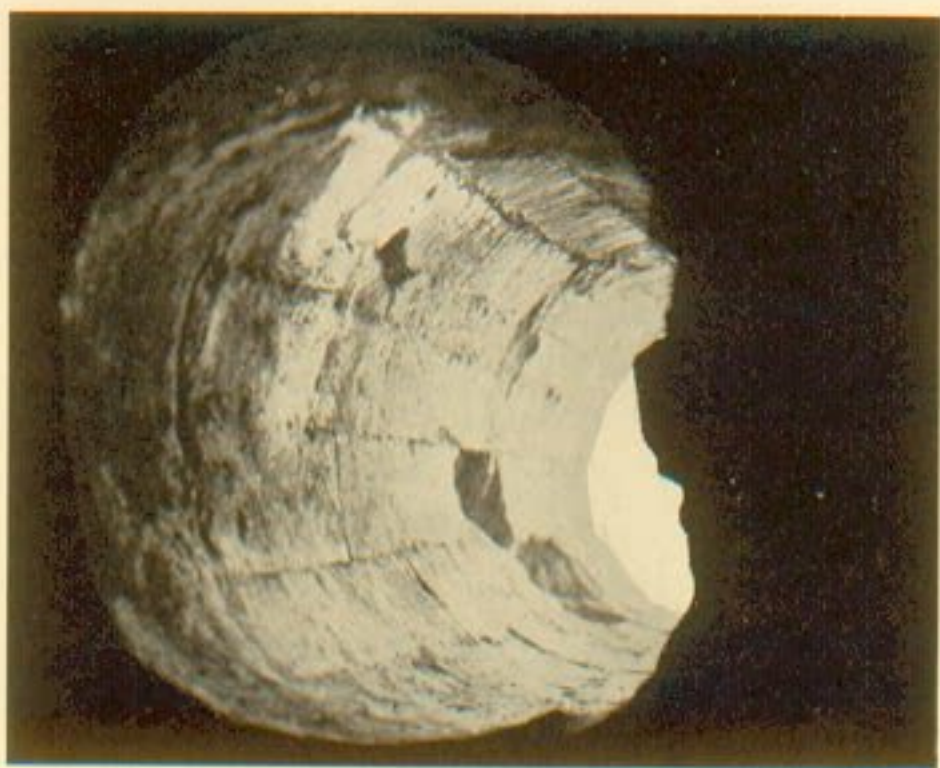
Fig. 17. Tapered Loop-hole of Battery.

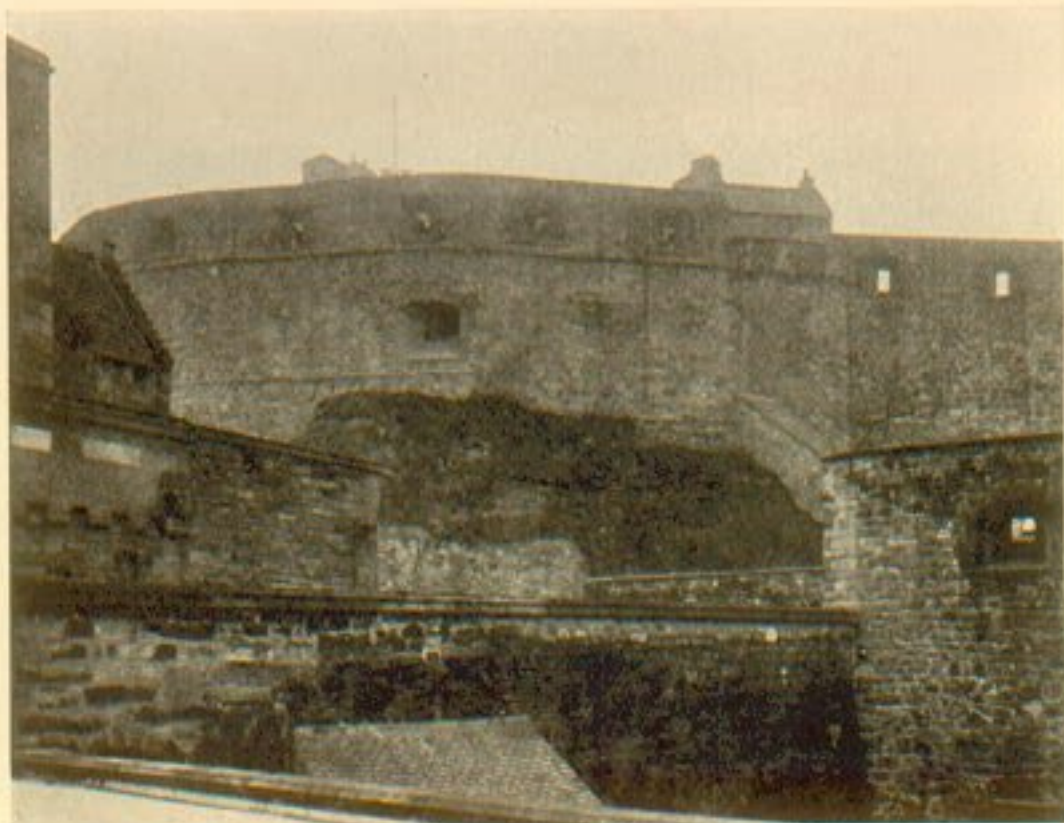
Fig. 19. Half-Moon Battery with the ancient Loop-hole exposed.

Outside the lines of the ancient tower, but joined to it at the north-east corner at an angle of 110 degrees with the north face of the tower, the remains of a massive masonry wall were revealed; within this is a vaulted recess (fig. 16), with a stone-built gun platform 5 feet above the present level of the floor of the tank. In the external wall, formed by carefully tooled ashlar, is a tapered loop-hole (fig. 17). It is oval in section and trumpet-mouthed at the interior face of wall. The axis of the loop-hole is carefully aligned so as to point directly down the High Street (fig. 18). The building of the Half-Moon Battery wall had covered up this ancient loop-hole, but it has now been exposed permanently to view (figs. 19 and 20).

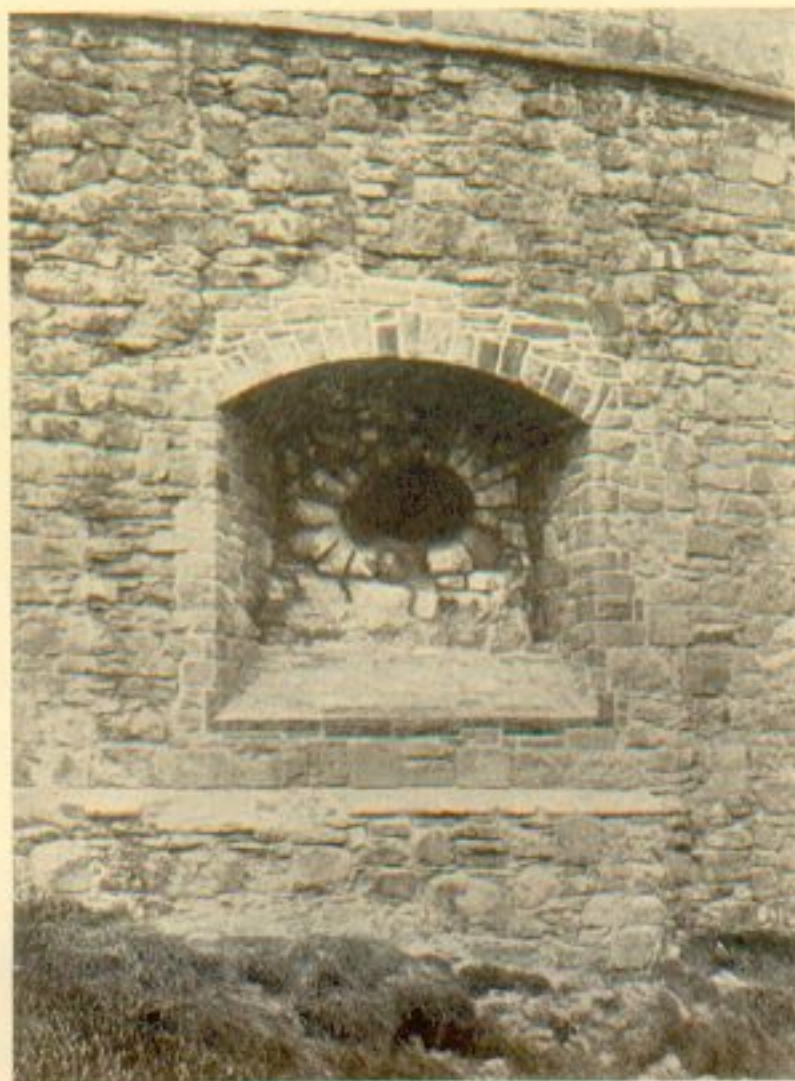
Fig. 20. Recess on outer face of Half-Moon Battery showing original Loop-hole.

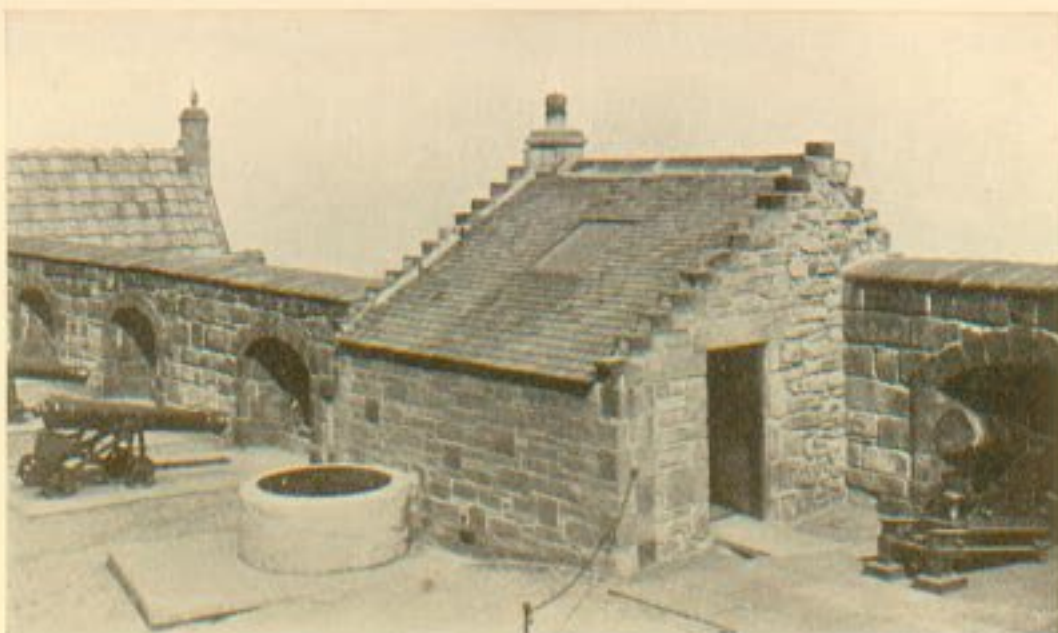
Fig. 34. View showing new Well-head to ancient Well.

raised stone parapet has now been provided, and a wrought-iron grille placed over the top (fig. 34).

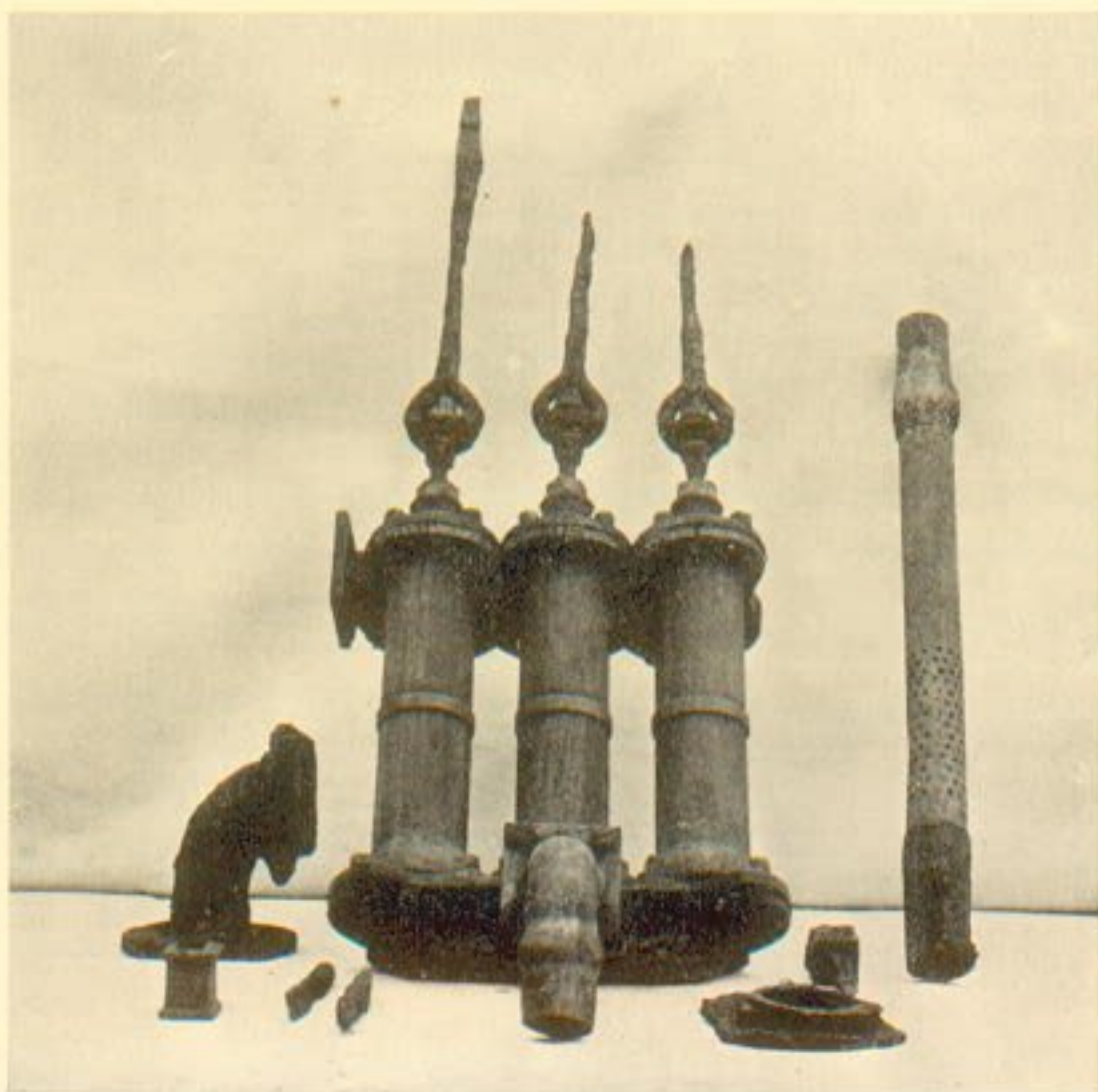
Fig. 35. Triple-cylinder Pump found at bottom of the Well.

One modern-pattern treble-barrel gunmetal pump, fixed on oak bearers about 85 feet from the surface, with 20 feet of 2-inch copper suction pipe (fig. 35).

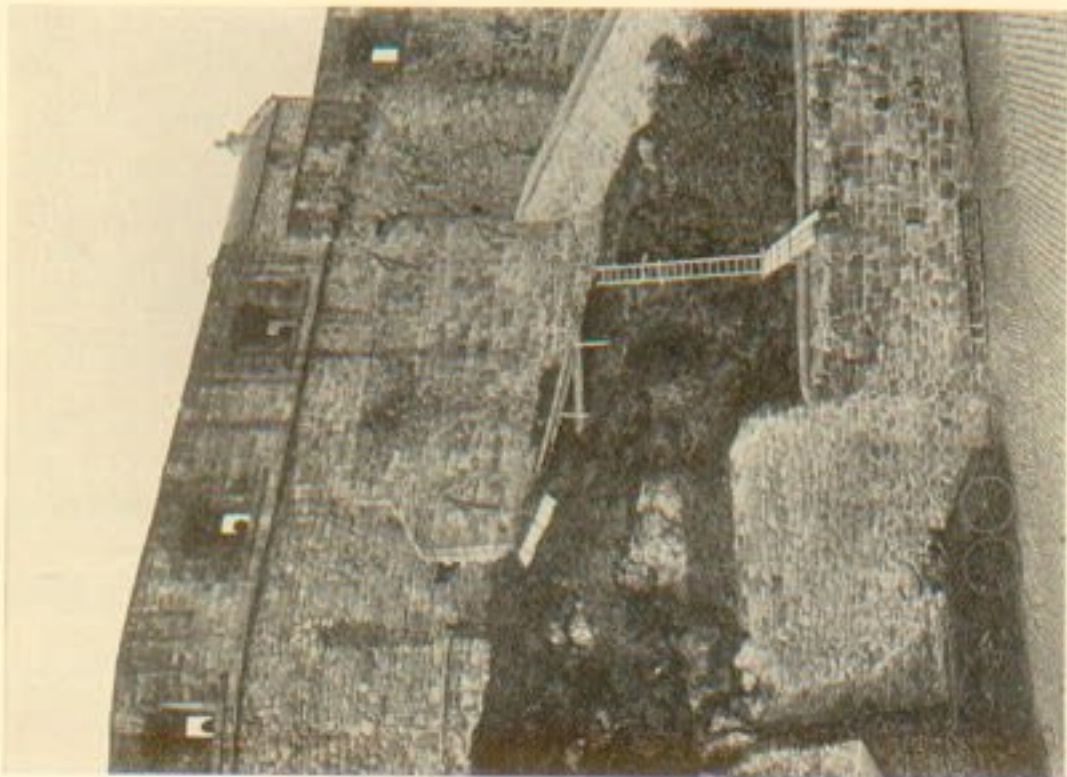
Fig. 39. North-east face of Battery Wall, showing part rebuilt with batter.

strengthened by a projecting batter, appears to me to probably account for a feature on the north-east face of the Half-Moon Battery wall (figs. 39 and 40) which has greatly puzzled architects and antiquarians. It was thought by some that this feature might indicate the position of a former important building, but in the light of the recent discoveries this now appears quite unlikely.

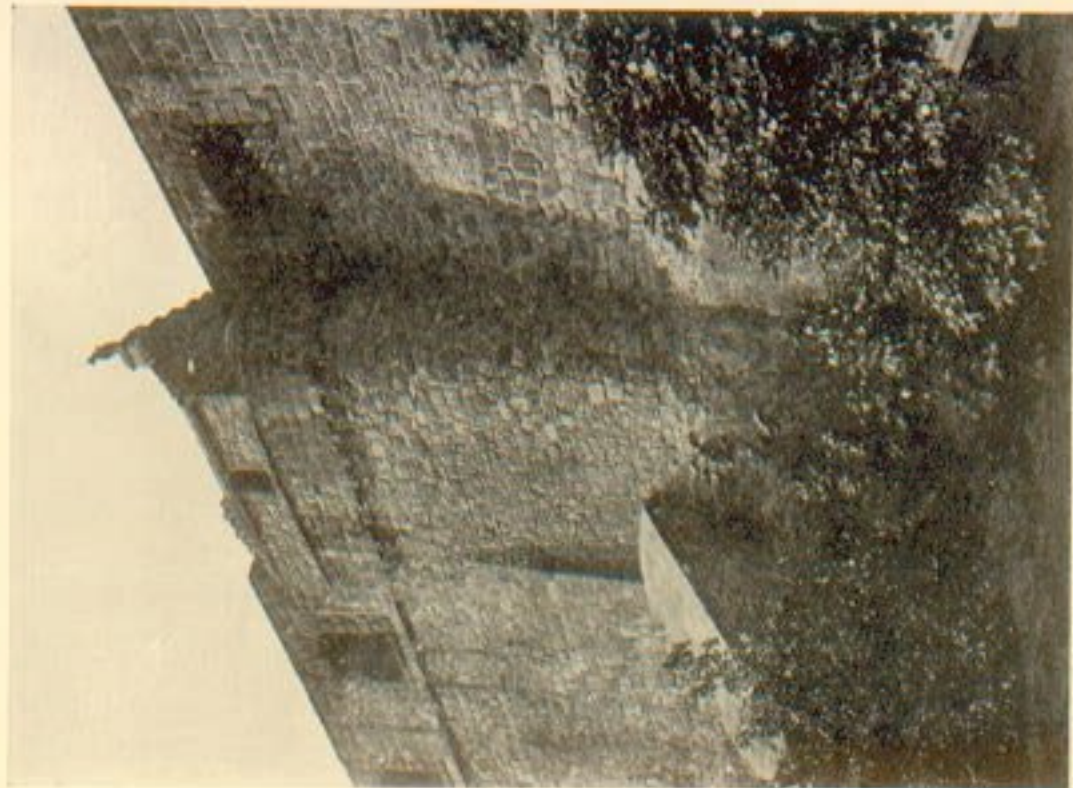
Fig. 40. View at junction of part rebuilt with older masonry.

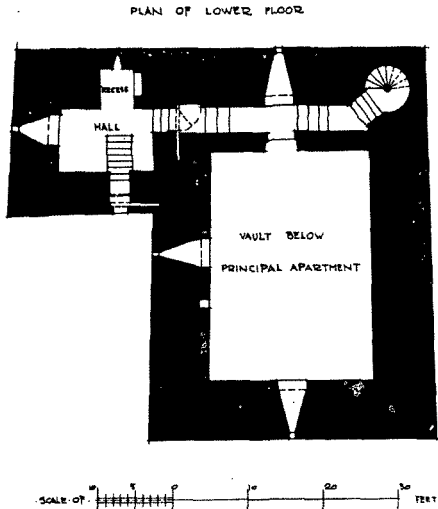
Fig. 41 Plan of David's Tower as it probably was originally.

Originally the tower was, I think, L-shaped on plan (fig. 41), having an entrance on the lower level at the re-entering angle, and with one principal apartment on each floor about 36 feet 6 inches by 22 feet. There may have been an entrance also to the lower floor from the higher level of the rock surface at the north-west corner, or more probably there may have been a spiral stair here connecting the ground floor with the floors above, as in the case of the keep of similar date at Craigmillar, which was built some ten years after the building of David's Tower, and of similar plan and size.¹

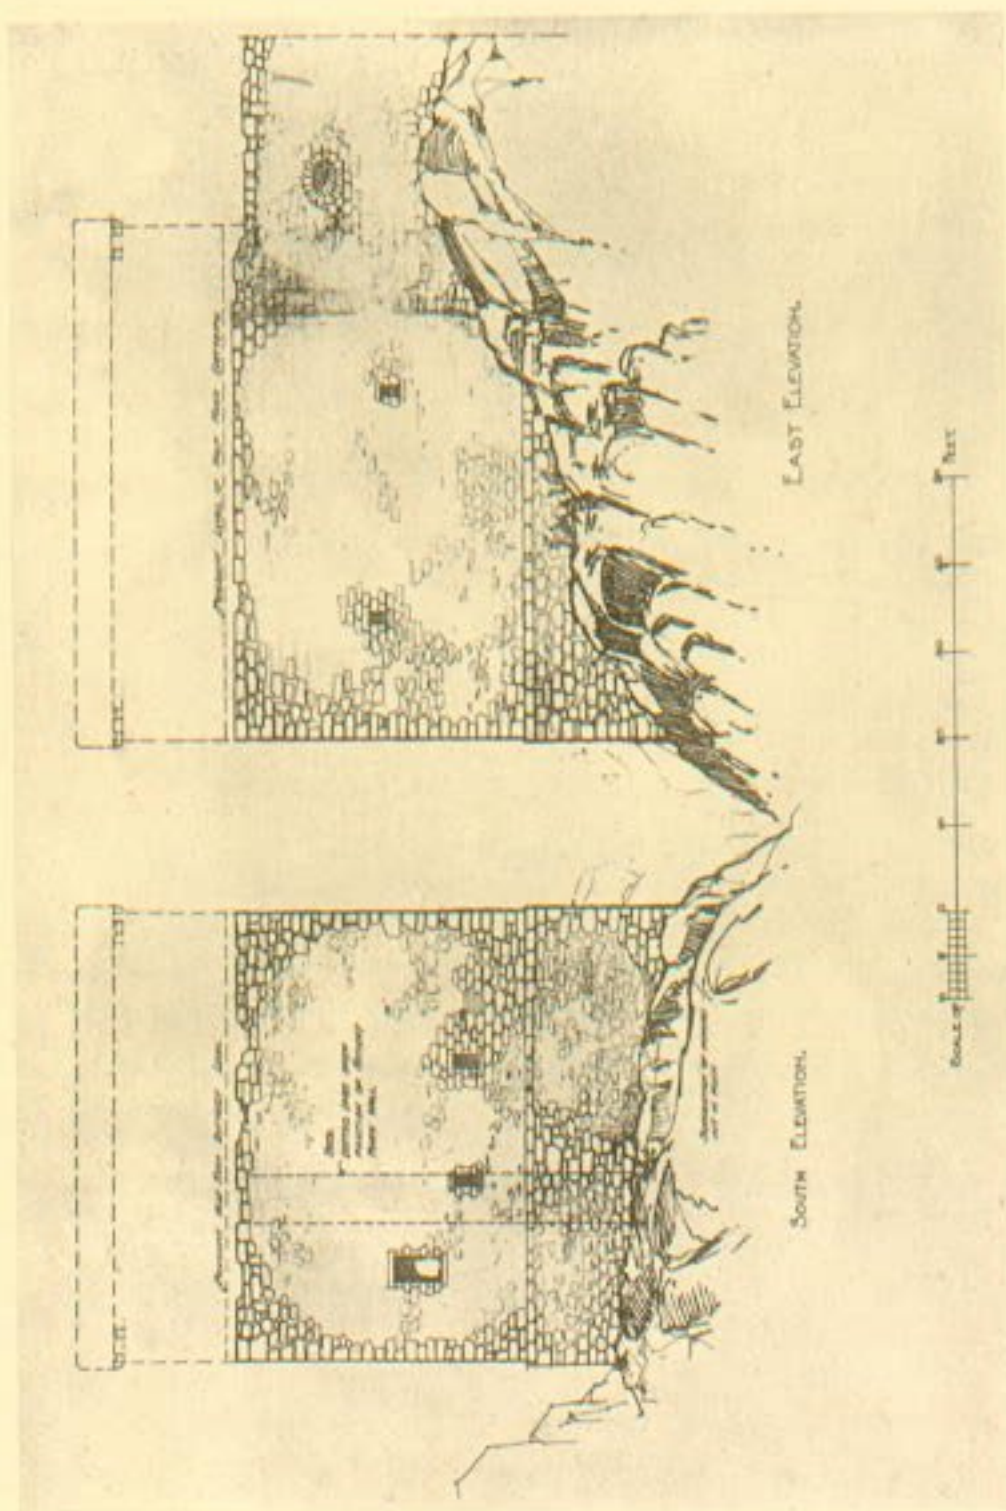
Fig. 43. View of the south and east elevations of David's Tower.

still remains is to show a view of the south and east elevations drawn to scale from actual measurements (fig. 43). Now that the actually existing remains of David's Tower have furnished a solid groundwork, it is to an architect a tempting subject for further studies of conjectural restoration. This is, however, neither the time nor the place to pursue the matter in that direction, but it is hoped that in future years other workers may be so fortunate in their researches that still more interesting discoveries may be made to illustrate and elucidate the chequered history of this ancient castle, so long the fortress, and still the pride, of our beautiful city.
