SOME RECENT DISCOVERIES IN ST ANDREWS. BY D. HAY
FLEMING, LL.D., F.S.A.Scot.¹

Of the discoveries which I am now to bring under the notice of the Society, one was made last month and two last autumn. Several of the others were made so long ago as the summer of 1910, but it is well that they should be recorded in our *Proceedings*.

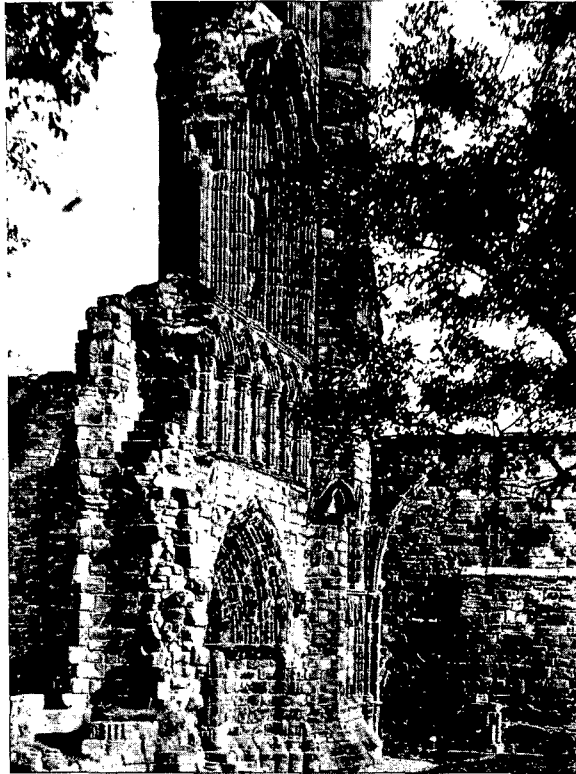
Fig. 1. West front of St Andrews Cathedral.¹

Evidence was also found that when the wall-passage did exist, there had been an open arcade between it and the interior of the church. Part of an Early English jamb was found, *in situ*, near the north end of the passage, and has been exposed. There is part of a similar jamb near the other end of the passage, but it might not be safe to clear away any of the surrounding masonry. From the well of the staircase six steps had led up to the north end of the floor of the passage. These steps are now exposed (fig. 1). The lower five are complete; only half of the sixth

¹ In fig. 1 remains of the vaulting of the galilee, or narthex, will be observed in its south-east angle, and also the base and lower part of the respond. About the middle of last century, a number of new stones were inserted in the west front, and on some of these the obliterated line of the wall-ribs was made continuous by a shallow incision.

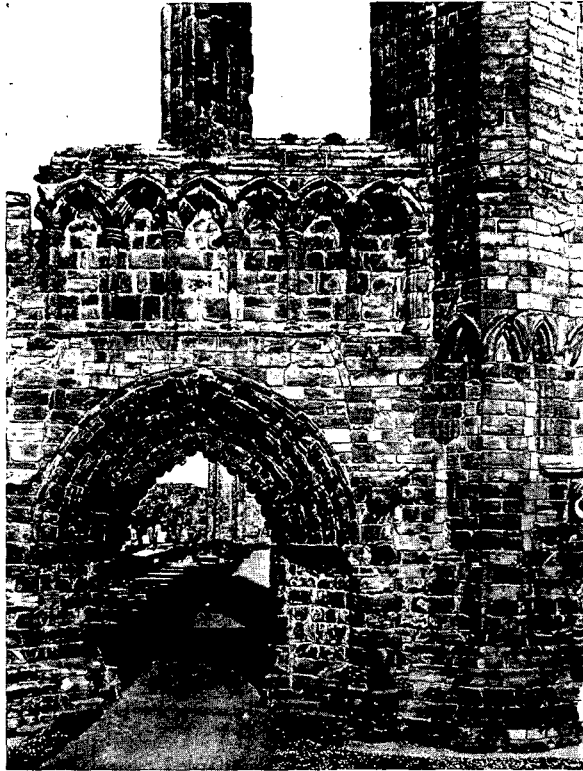
Fig. 2. West front of St Andrews Cathedral.

remains. From their appearance it may be inferred that they had not been much used. One of the stones which was built over them belonged to the Early English jamps, and was therefore placed on the one at the north end of the passage. The position of this jamb is shown on

fig. 2. The two windows which stood side by side, separated by a massive pier, cannot have been the original ones, and an examination of the remaining one shows that it had been "slapped" into the southern turret, as had also the window immediately above it, and the triangular window on the other side of that turret. The masonry on the east side of that triangular window, serving as a buttress, only dates from 1840.

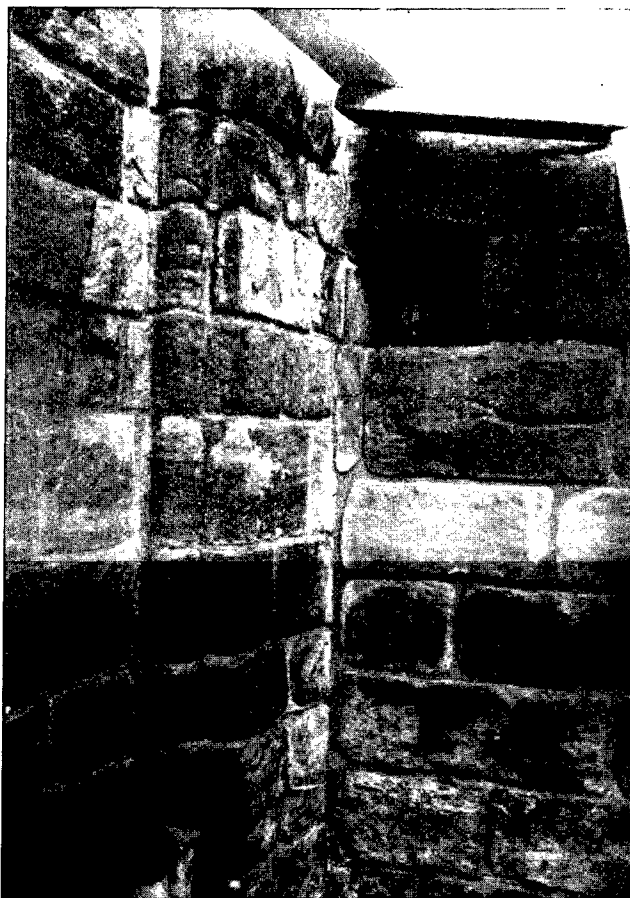
Fig. 3. Respond enclosed in south end of west gable of Cathedral.

distance from it is exactly double the distance between two in that aisle. This and some other details¹ led to the belief that at one time the Cathedral had been longer by at least two bays than it is now. In the summer of 1910 this was pointed out to the foreman mason. He afterwards took some measurements, and was satisfied that, if there was a respond hidden by the present west front, it could not be very far in. He therefore (on the 24th of August) took out a badly weathered stone with the intention of replacing it by a better one if nothing were found. To his delight he saw the long-lost respond only 8 inches from the east face of the wall (fig. 3). Needless to say, the stone he took out has not been replaced.

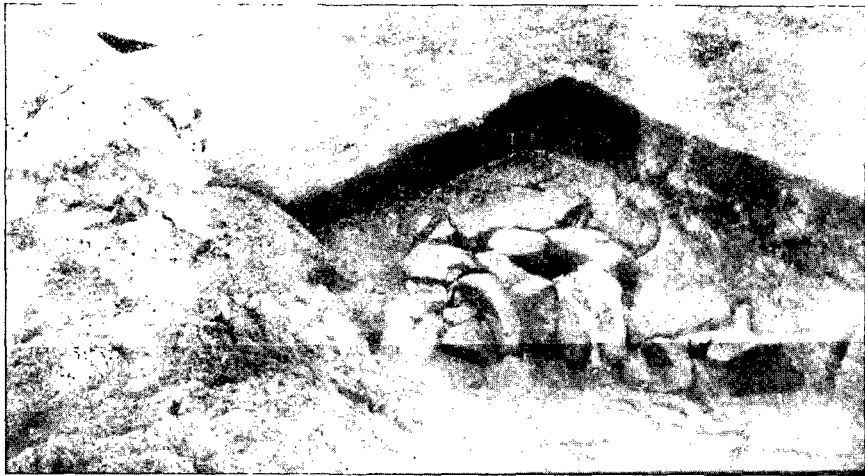
Fig. 5. Socket-hole, No. 1.

About the beginning of last month, the encroaching turf was removed from all that remains of two of the steps near the east end of the choir of the Cathedral. So far the only remarkable discovery at this point is what can perhaps be best described as a built socket-hole. It is nearly square, being $6\frac{1}{2}$ inches by $5\frac{1}{2}$, and is 16 inches in depth. There is a flag in the bottom; and the whole has probably been covered by a flat stone with an aperture on the top. The upper stones on the east, north, and south sides of this socket-hole are portions of Norman capitals; the one on the east, which is almost as fresh as the day on which it was hewn, has probably formed part of an arcade. The upper stone on the west side may have been either part of a base or of a capital (fig. 5).

[Other two of these built socket-holes have been since discovered in close proximity to the first, which I hereafter refer to as No. 1. The largest of the three, which I designate No. 2, is due east of No. 1; and the distance from the centre of the aperture of the one to the centre of the other is 2 feet $9\frac{1}{4}$ inches. The aperture of No. 2 is 9 inches square, and its depth is 2 feet $\frac{1}{2}$ inch. Four stones form a bottom to this socket-

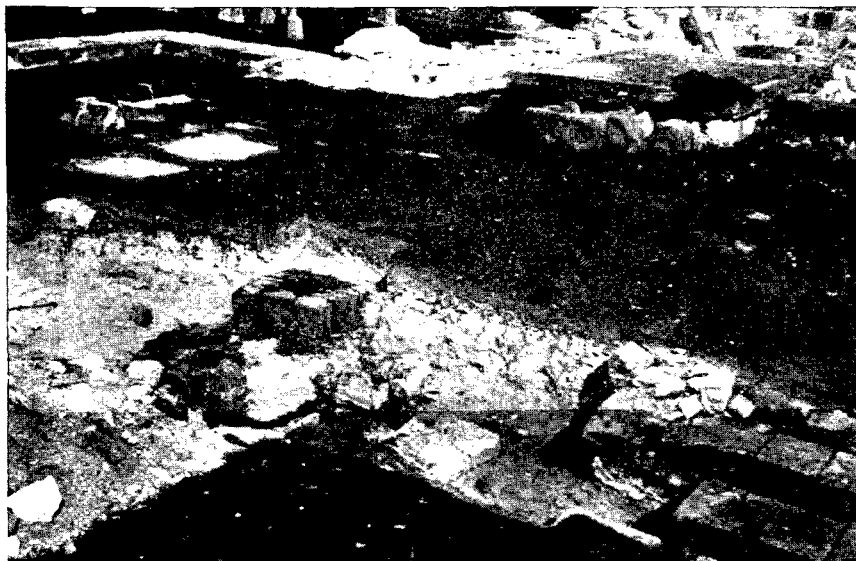
Fig. 6. Socket-holes, Nos. 1, 2, and 3.

measuring 4½ inches by 6½. The centre of No. 3 is 2 feet 7 inches further south than the centre of No. 2, and 1 foot 3 inches further west (fig. 6). No. 1 is on the line of the lowest step, and the aperture of No. 2 is immediately behind the line of the second step. Comparatively little of the steps remains, and it may be doubted whether that little is original. There must, however, have been steps there or thereabout. The height of the first step is 7 inches, of the second 6, and of the third 4. This last is on the level of and forms part of the paved floor long supposed to mark the site of the high altar. The floor is formed of freestone slabs. Of those uncovered the smallest has been 13¾ inches by 7, and the largest 18½ by 17. Some of the slabs have been badly smashed and sunk considerably below their original level. This was probably done by the fall of the vaulted roof. The socket-holes and

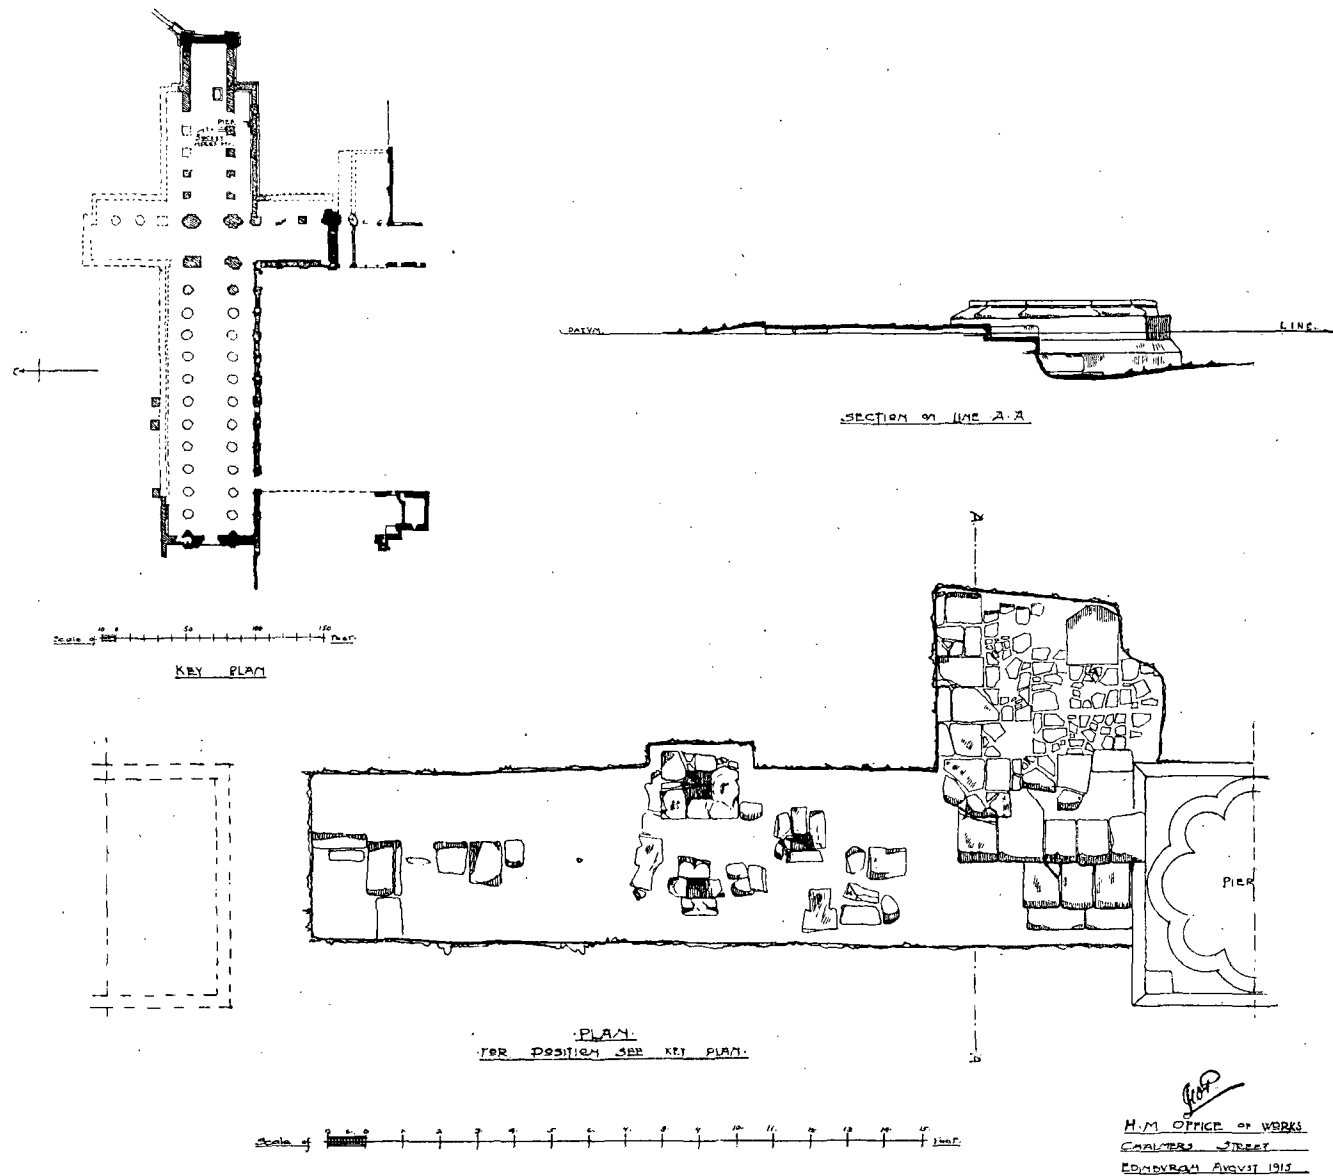
Fig. 7. St Andrews Cathedral, showing socket-holes, etc., as uncovered August 1915.

the choir."⁴ It has now been suggested that the socket-holes may be post-Reformation. Their position and details are shown on figs. 7 and 7A.]

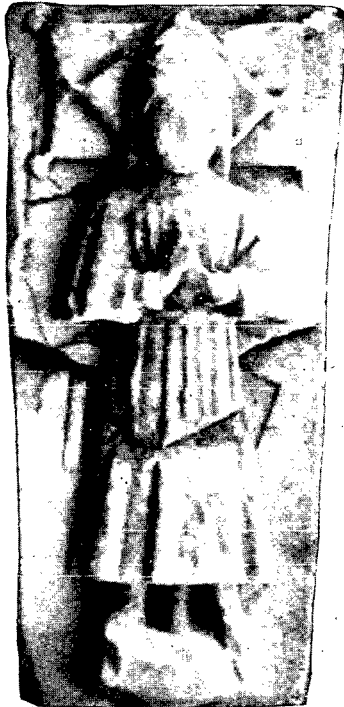
Fig. 9. Effigy of a Stonemason.

The stone effigy of a stonemason was found on the 19th of last September in the north-east tower of the Abbey Wall. The carved side of the stone was turned towards the heart of the wall, and the back of the plain slab on which the effigy rests was exposed to the outside. The mason is dressed in gown and hood, a hammer is on his right side, a square on his left, his feet rest on a mason's "mell," or mallet, and his head on two cushions, the one lying diagonally above the other, and having a tassel at each corner. The tapered slab on which the figure lies is $5\frac{1}{2}$ inches thick, 1 foot $6\frac{1}{4}$ inches broad at the top, and 1 foot $3\frac{1}{4}$ inches at the foot. The sides are not quite the same length, the one being 3 feet 1 inch, and the other $\frac{3}{4}$ of an inch more. The head of the figure is $6\frac{1}{4}$ inches in relief, and the "mell" $3\frac{1}{2}$ inches. The slab, therefore, has been practically a foot thick.

The general appearance of the effigy and the cushions in particular obviously indicate that it was intended to be recumbent; but on the back there are two dook holes, and the lower part of the dress does not sag in the centre. Cutts gives an illustration of a tapered slab at Bottesford, Notts., on which the head of the figure rests on two cushions, the one placed diagonally above the other, but these cushions have no tassels.¹ The upper cushion supporting the head of Philippa, Duchess of York, who died in 1433, has a tassel at each corner.² In Balmerino churchyard there is an incised slab showing a cross on a calvary of four steps, with a square, trowel, and two hammers, but no "mell."³

The St Andrews effigy apparently commemorates not a boy, but a man, though not an aged man, and certainly not a dwarf. A row of buttons, beginning at the neck of the gown, ends at the bottom of the skirt; and round the waist a cord is tied. The shoes are pointed (fig. 9). The dress does not necessarily indicate that the subject of the effigy was a monkish mason. This is evident from an indenture between the Abbot of Arbroath on the one part, and "William Plumer of Tweddale,

still in the wall many mullions of windows, and other moulded stones, from earlier buildings. Although this effigy is now in two pieces, it may have been quite whole when it was seized for building material. Had it been lying about in broken condition, it does not seem likely that the two pieces would have been carried to the same tower, and fitted together in the wall. That part of the tower from which it was taken is only a few feet above the present level of the ground; but formerly the ground at that point was much lower, as the heuch (known as the Kirk Heuch) led down there to the harbour. The slab may have been broken purposely for ease in handling, or it may have been accidentally broken when it was being put into the wall. Where it is broken through, there is a fault in the stone.

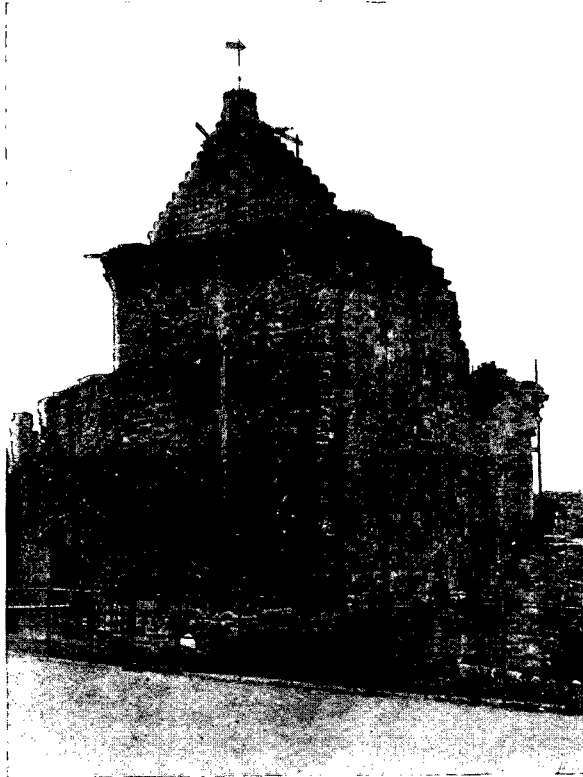
Fig. 10. Fore Tower of St Andrews Castle.

We turn now to the Castle. Looking at the fore-tower, either externally (fig. 10) or internally, no one can help noticing that it has been subjected to considerable alterations. Hitherto there have been differences of opinion as to what these alterations portended. Some insisted, Messrs MacGibbon and Ross for example, that at one time the entrance passed through this tower;¹ and, on the other hand, that opinion has been stoutly contested. The matter is now settled. There has been an entrance through this tower. Viewed from the interior, there has long been visible what appeared to be the upper part of the east jamb of this entrance, with the springer of an arch, and part of a relieving arch above it. Still more to the point, there is a broad sloping groove, or chase, higher up in the wall, in which one of the counterpoises of the drawbridge was believed to have worked. The flooring-flags in the southern end of this apartment were lifted last autumn and the packing underneath cleared out (fig. 11). The east jamb of the earlier entrance is now visible from top to bottom, and the west one from the recent floor-level to the bottom. The blocking of the entrance is rubble, while the jambs and adjoining walls are ashlar.² Looked at either from the interior or exterior, it is apparent that the centre of the larger windows in that tower is not in line with the centre of the

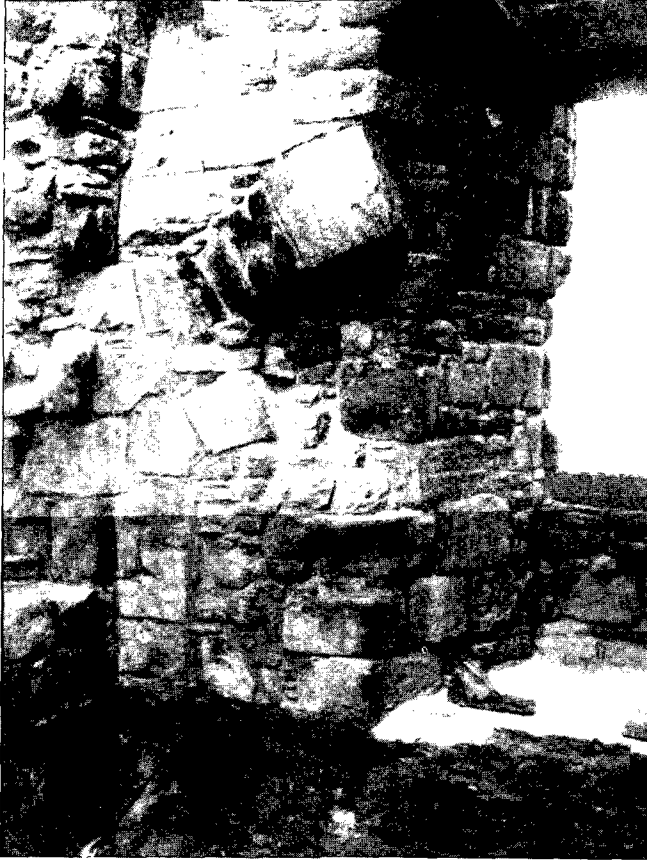
Fig. 11. Interior of Fore Tower of St Andrews Castle.

² Fig. 11 shows part of the east jamb, the springer of the arch, part of the relieving arch, and the lower end of the slot or chase for the counterpoise of the drawbridge. Three of the stones of the relieving arch have been recently inserted to sustain the superincumbent masonry.

On the inside face of the front wall the old entrance has been 10 feet wide. The height of the east jamb, from the bottom of the rybats to the spring of the arch, is 11 feet 7 inches; and from the floor-line a foot less. On the outer face of the wall the entrance seemed to have been 11 feet 6 inches in width; but last Thursday (4th March), when some defective joints were being raked out, it was found that there is a small chamfer and a check on the east side. The chamfer is about 2 inches broad and the check 12 inches. Assuming that there is the same on the west side, this would reduce the width of the doorway externally to 9 feet 2 inches.

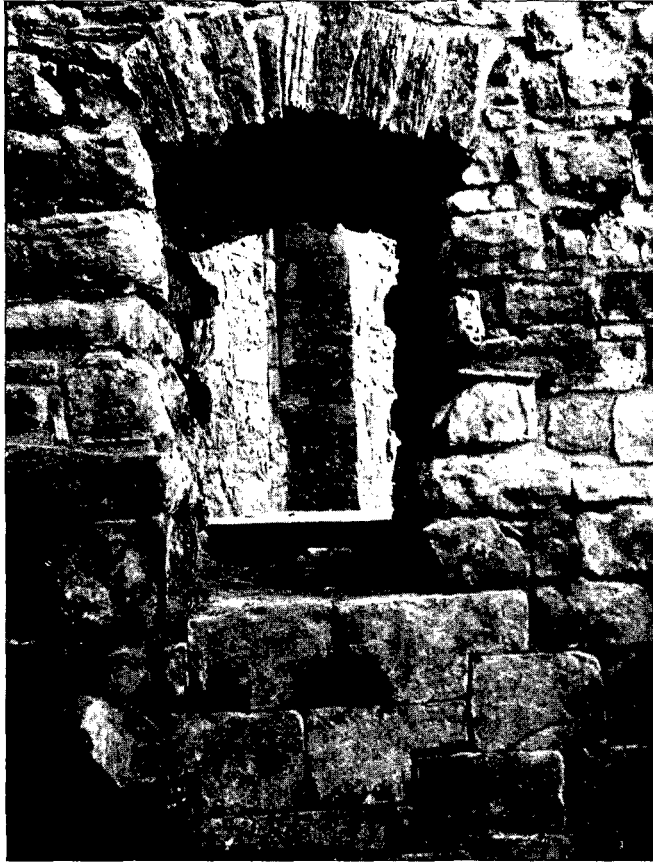
Fig. 12. Temporary Opening in the Castle, now re-opened.

In the same wall as the shot-hole, but higher up, an old arched opening has been re-opened. It is 5 feet 2 inches in height. The width varies from about 2 feet 10 inches to 3 feet 7 inches, the sides being rough, and some of the stones projecting beyond the others (fig. 12).

This was probably a temporary opening through which material was carried when the Castle was being built or extensively altered. Here the wall is 5 feet 11 inches thick. Access to the interior of the tower will, in future, be through this opening; and henceforth the long-buried inner face of the lower part of the tower will be exposed to view. The interior of the old entrance had been filled up with stones, not built in with lime, but laid in uneven courses with layers of sand between the courses. Of these stones, some were squared, some moulded, most were rough rubble. Below the old floor level several courses are built with lime. The elevation, plan, and sections of the fore tower, which Mr. J. Wilson Paterson, of H.M. Office of Works, has had prepared to illustrate these discoveries in the Castle, do so admirably (fig. 13). The Castle, it may be mentioned, was used as a State prison so late as 1646. The Town Council minutes show that ten years later the slates and timber were sold in order to repair the harbour. And Dr Skene's accounts, preserved in the Register House, show that, some thirty years later still, "ane hundred cart load of stones" were "digged out of the Castle walls," and that a number of men "wrought severall dayes in digging stones out of the spur before the Castle, and in carrying them to the top of the hill." This material was taken to repair St Salvator's College.

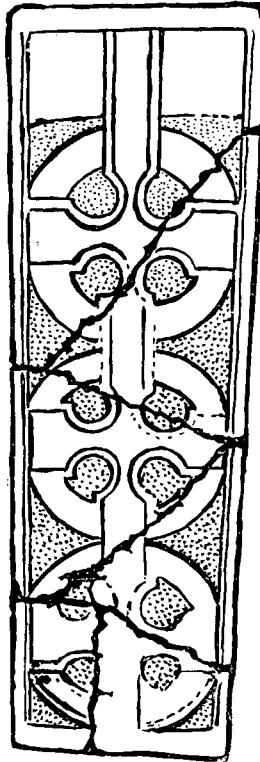
Fig. 14. Celtic Cross-slab.²

than longways. The crosses, circles, and background are undecorated. There is no trace of interlaced or fret or spiral ornamentation. The slab is 4 feet 11 inches long, 19 inches broad at the head, and 15 at the foot. The thickness varies from 4 to 6 inches. The back is rough and unequal, the broad end looks as if it had been finished by a pick, the narrow end is not so rough, and the sides are smoother. Tapering as it does, the slab

in shape is more akin to the medieval than to the ordinary Celtic slabs, and this may perhaps indicate that it is somewhat late in date (fig. 14). The only other Celtic cross-slab known to me which has had more than one cross on one of its surfaces is in Dunning Church.¹ It has had two crosses, each with a nimbus; but apparently not more than two. In the churchyard of Aylesford, Kent, there is a fourteenth-century tapered slab, with three floriated crosses graduated in size to suit the shape of the slab.²

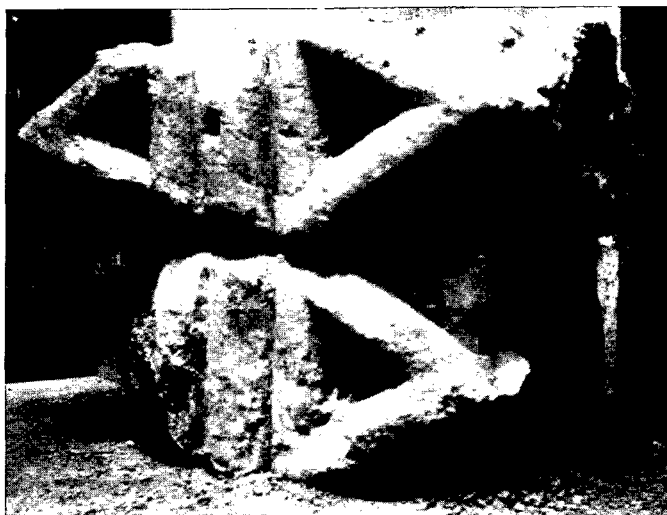
Fig. 15. Stones from the Harbour Gates.

Last year the harbour gates were reconstructed. In the course of the operations two large stones were found with massive Norman

mouldings. They may have belonged to an earlier building than the Cathedral, perhaps to the first parish church, which stood in close proximity to the Cathedral. The larger stone is 2 feet 6½ inches by 16 inches by 10 inches (fig. 15).
