## OPERATIONS AT SKARA BRAE DURING 1929.

BY PROFESSOR V. GORDON CHILDE, F.S.A. SCOT.

H.M. Office of Works continued during July and August of 1929 the conservation works at the "Pictish village" of Skara Brae, Skail, Orkney, whose initiation has been described in *Proceedings*, 1928-9, pp. 225 ff. Once again I was afforded facilities for observing and recording the archæological remains that might incidentally come to light. The actual work was again under the charge of the Department's contractor, Mr J. Firth, and we were fortunate in having the same foreman and labourers as previously. Mr J. Houston of the Office of Works once more took charge of the surveying—a very complicated matter—and rendered invaluable assistance in other directions. The Society owes to him the admirable plans and sections that illustrate this and the previous paper. The preservation of the buildings and many of the objects they contain is due to the able assistance of Mr Firth, his foreman Mr Moor, and the rest of the staff. During the excavation the site was visited by Mr Richardson, Inspector of Ancient Monuments, and Mr Paterson, Architect-in-Charge of Ancient Monuments. Both made invaluable suggesti

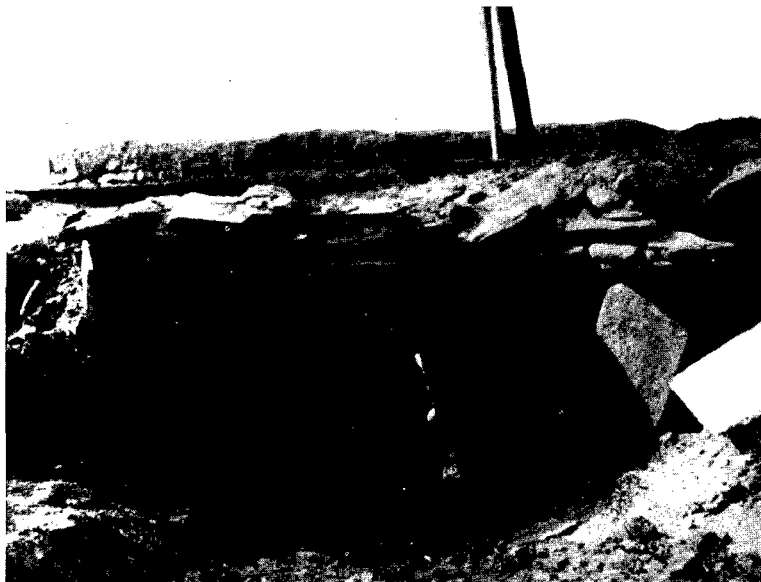
Fig. 1. Entry L from area of Hut 6.

6 inches below the threshold of doorway L. In other words, this box must have been one of the fixtures of the hut to which L gave access and whose incurving corbelled walls could be discerned on either side of that doorway. Hence it follows that the floor of Hut 6 lay approximately on a level with passage A and far above that of Hut 7 and the adjacent section of passage C. We must already have cut through it at several points to the south of L, and it may be that the low wall M, mentioned last year, rested on that floor. The west, south, and east

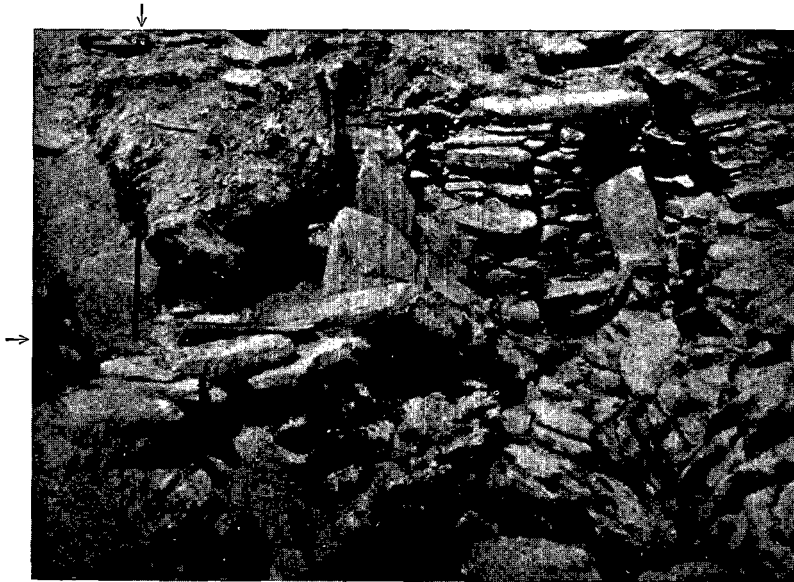
Fig. 2. Wall of Q under floor of 6, showing box.

the intervening space was found packed with midden. Wall Q itself was bedded carefully on a layer of blue clay, but was built above two earlier constructions, covered by the clay bedding, which are both necessarily anterior to Hut 5.

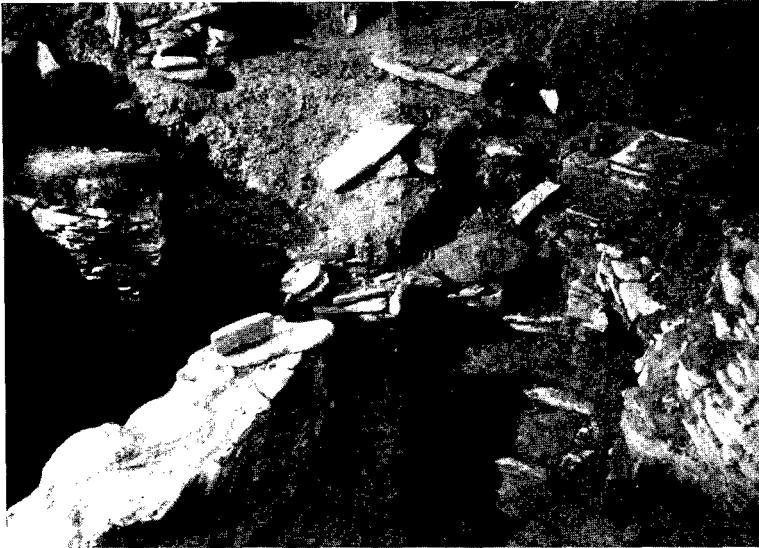
Fig. 3. Hut 6' and gallery outside Hut 7.

Its position shows that the floor of 6' sloped up northwards from passage C, from which the hut had undoubtedly been originally entered. On the west the wall U runs through into passage C, projecting into the passage with a sort of buttress resting, like a portal, on an upright slab (fig. 3) on the west side of T. But the supposed entry T had been completely blocked by a well-built buttress which is not bonded in to U. The eastern cheek of the real entry is, however, perfectly clear, as Mr Paterson pointed out to me; it is conspicuously visible to the left of the buttress. Between this cheek and the buttress comes a

piece of obvious rough infilling that presumably marked the position of the original doorway to 6'.

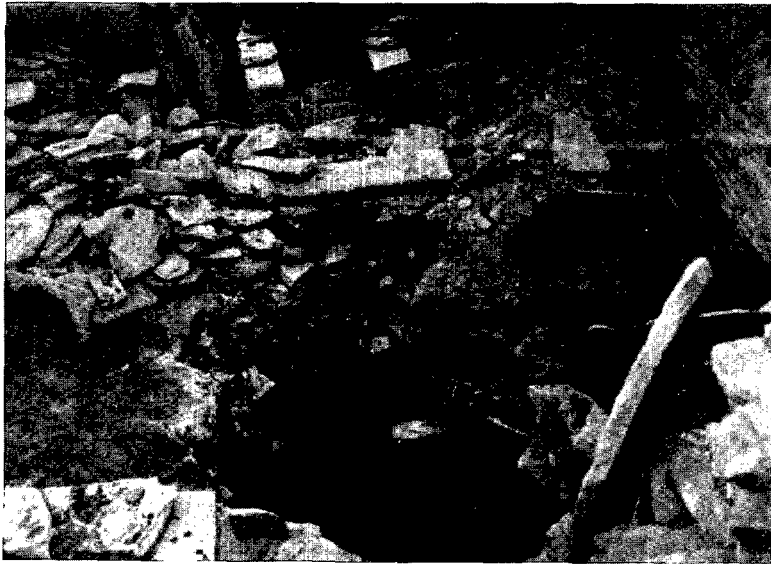
Fig. 4. Chamber 5' under hearth of 5, showing lintelling.

in that direction. To the east the deep passage D obviously passed under wall Q and under the parallel western wall of Hut 5. To disengage it, wall Q, of which only four or five courses survived here, was removed, and then shafts were sunk in the floor of Hut 5. Below this floor we found a confusion of interlocking lintel slabs, some of rotten slate, others of heavier flagstones, often big but all more or less broken. Some of these slabs may belong to the flooring of 5. The arrangement of the rest was compatible with the theory

that they had belonged to the corbelled roof, partly supported perhaps by a collapsed pier or pillar, of an irregular chamber 5'.

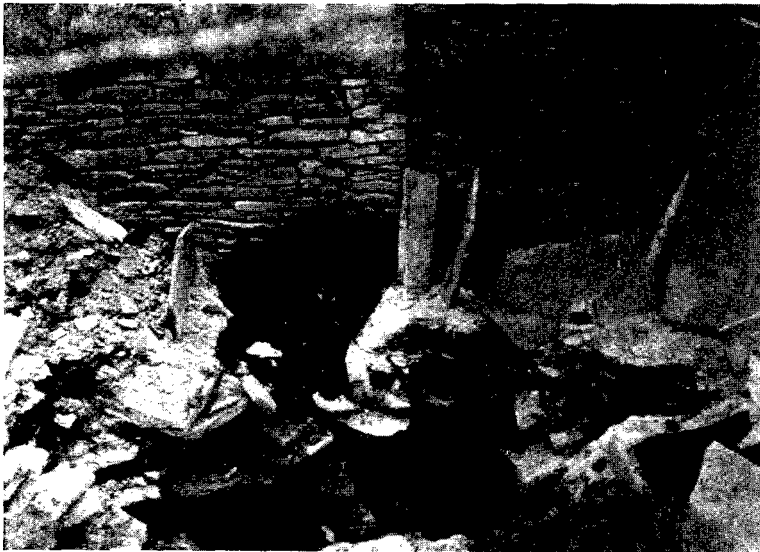
Fig. 5. View into 5' under hearth of 5.

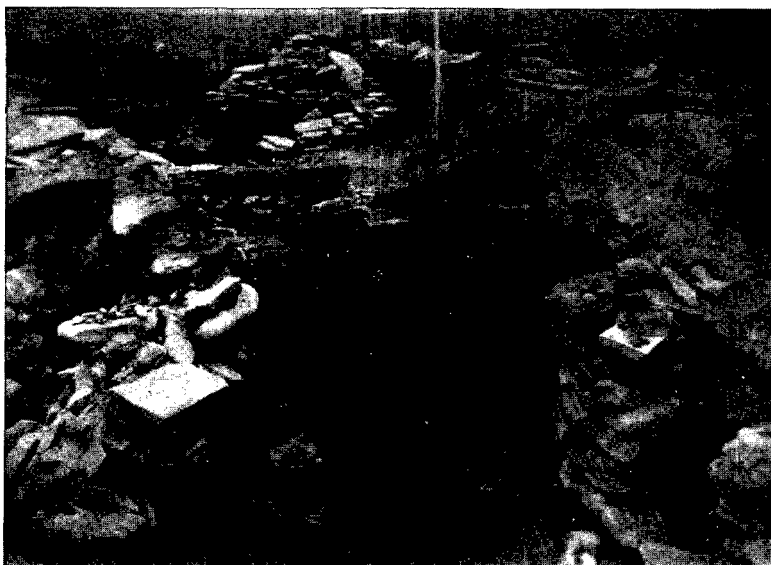
Fig. 10. Market place looking east along main street, showing the compound gate of the latter.

of dry masonry resting on slabs on end and projecting 5 inches and 1 foot 8 inches from the north and south walls respectively, thus leaving a fairway 1 foot 9 inches wide (fig. 10). Here, too, a stone on edge formed the sill. The outer cheek of this portal lacked upright jambs, and no sill corresponded to it. The aperture was, however, lintelled over with two heavy flagstones 3 feet 3 inches above the slate pavement.

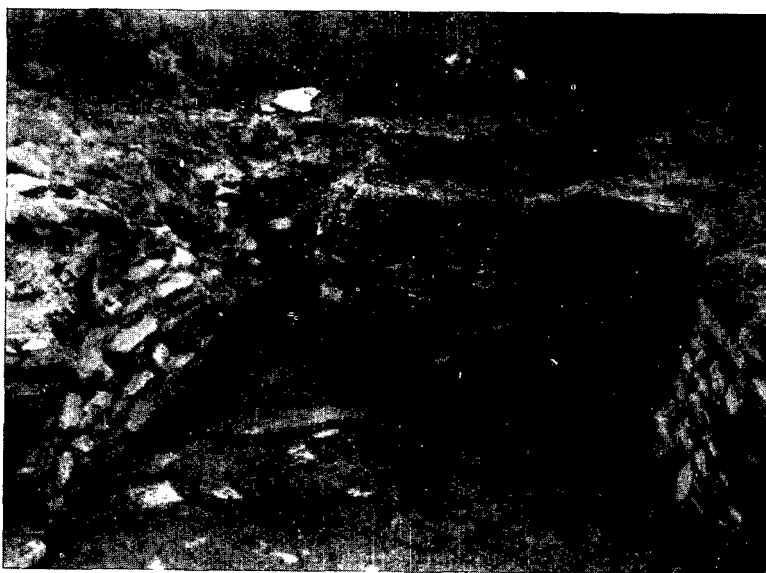
Fig. 11. Market place looking west, showing door of Hut 8 on right.

The north wall of the market place is a solid-looking mass with a distinct batter (fig. 11). It proved to be the external wall of a building, subsequently christened Hut 8. The wall stands to an average height of 4 feet 9 inches above the pavement, and below that is bedded on blue clay. The existing wall-top was covered with sand rather than midden, but a stone mortar and several bone implements were found upon it. This may indicate that it had never risen much higher. Near its western end there is a gap in the wall, filled up with rough patching, 3 feet 9 inches high by 1 foot 9 inches wide, as if an entry had once existed on that side. There is, however, at present no positive indication of the continuation of that gap through the inner wall.

The present entry to Hut 8 is the low doorway on the right in the western end of the market place. It is 3 feet 10 inches high and 2 feet wide, and is paved with slates like the market place. It is spanned by a solid flagstone lintel carrying six courses of dry masonry above it, so that at this point the west wall of the market place stands 5 feet high. It had probably never been any higher since the roof of the porch lay at the same level. The corner of the market place between the door and the north wall was sheltered by a verandah of slates laid obliquely across between the two walls (fig. 11).

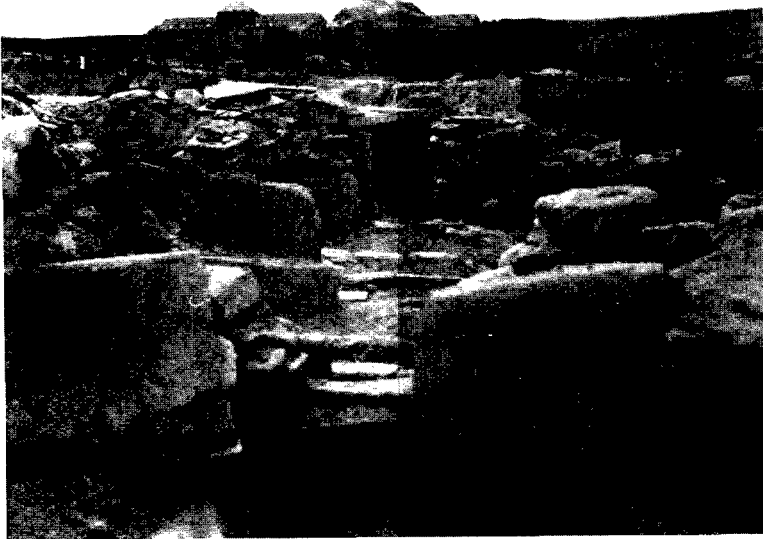
Fig. 12. Looking through flue across kiln into Hut 8.

cheek of the entry is marked by a slab on end, 1 foot 10 inches high, that supports five courses of masonry. Up to this point the whole entry had presumably been roofed with flat slates (fig. 12).

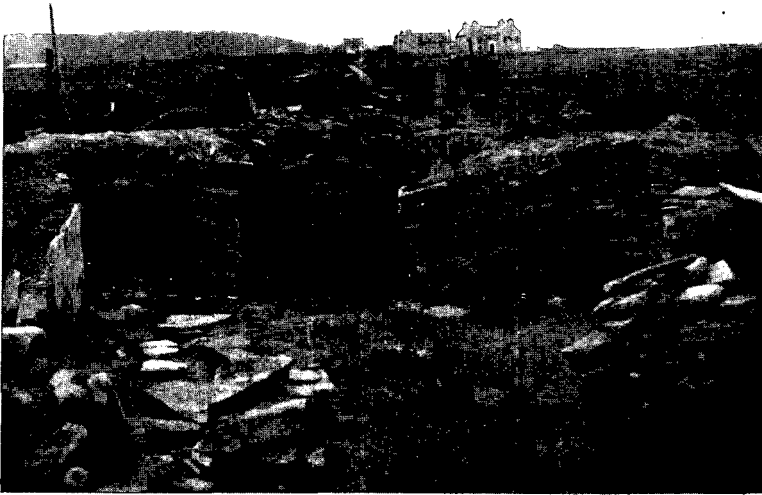
Fig. 13. Alcove with cupboards in Hut 8.

Here there is a wide alcove in the original wall (fig. 13). In its southern corner is a small niche, and further north a double-shelfed ambry. The shelves are formed of thin flagstone slabs, the uppermost

being carved along its edge with a rough chevron pattern. Beyond the wide recess is a two-storeyed cupboard let into the main wall. The slab forming the upper shelf is again carved with deep lines along its edge. The joints where the shelf-slabs fit the walls have been luted with yellow clay similar to that used for luting "limpet-boxes" in the normal huts. Just beyond this point a built wall projects at right angles to the hut's east wall, but not properly bonded in therewith. After 2 feet it turns north again, but its line is continued by a wall of thin slabs set on edge (fig. 14).

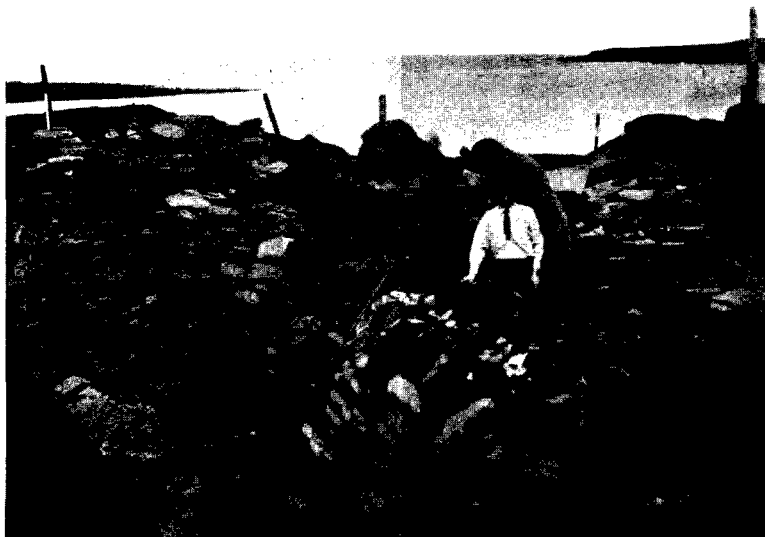
Fig. 15. Looking down passage F, showing cell F1 on right.

fine slate paving was intact before our shod feet began to tread it, and the left-hand (going from the market place) or north-eastern wall stands 3 or 4 feet high. The right-hand wall, on the other hand, had almost entirely collapsed outwards into the sand-filled area west of the passage (fig. 15). The roof of passage F, together with the upper courses of the left wall, and the midden that had rested on both, had slid forward in the same direction. Hence the passage is partly choked with slabs fallen from the wall and roof and with midden. But these are everywhere separated from the pavement by a layer of sand at least 7 inches deep. This collapse has produced a sloping deposit of midden and stones projecting into the sand west of passage F for some 6 feet.

Once the narrow but now ruined doorway has been traversed, cell F1 resembles a short passage terminating in converging walls and running nearly parallel to F in the direction of passage A (fig. 15). It is, however, cut short by an abrupt convergence of its walls. As in other cells, the walls are partly formed of slabs on edge supporting oversailing courses of horizontal slabs. Their projection, however, is not great, and the roof was formed of very large slates as in a normal passage. All had been broken before we disengaged them. The cell was largely choked with midden when we found it. The artifacts from this deposit may therefore in part have fallen in from above. Within the cell a fire had at some period been kindled against the south-east wall nearly opposite the door; fragments of a big pot and broken bones were found at this point. The corresponding stone in the opposite wall had been carved and pitted. From the very top of the midden above the entry to cell F1 we collected a fine stone mortar that was lying inverted close to the displaced lintel. Another mortar was found, likewise inverted, in the sand a little to the west.

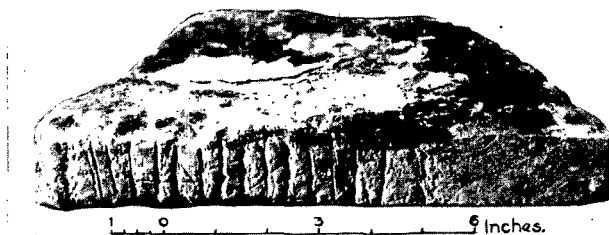
Fig. 18. Carved stone in structure in Hut 7.

(4) In built structure N, to left of doorway in Hut 7. Series of vertical strokes in technique (iii.), with lighter cross strokes. The marked surface was turned inwards and not exposed (fig. 18).

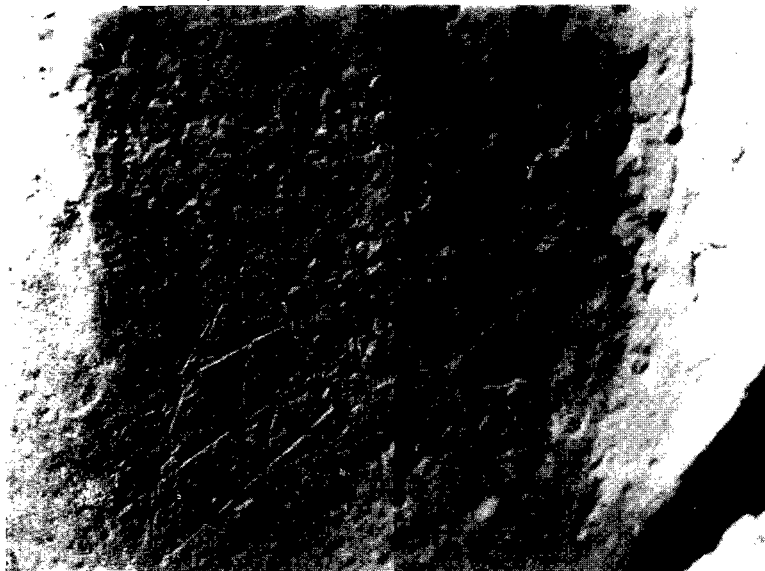
Fig. 19. Markings on stone in Cell F1.

(5) Slab standing on edge in cell F1 immediately on the left as one enters, two lightly and rather carelessly engraved triangles; to the right, series of pocked dimples like small cup-marks (fig. 19).

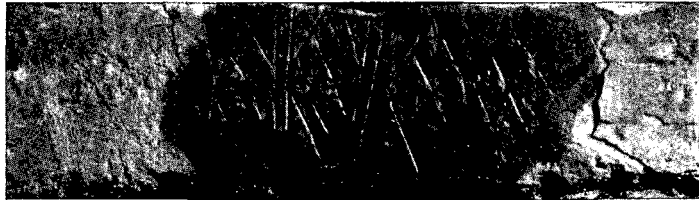
Fig. 21. Lozenge patterns on stone from Hut 8. (By courtesy of Royal Society of Edinburgh.)

(9) Smooth flagstone in original east wall of Hut 8, just within doorway before junction of secondary wall and one foot above floor. Series of hatched lozenges executed in technique (ii.) (fig. 21). One lozenge

is rather unsuccessfully fitted into a panel formed by two pairs of vertical lines. Some of the hatchings are shaded, with light strokes; and similar lightly shaded figures occur near the four corners outside

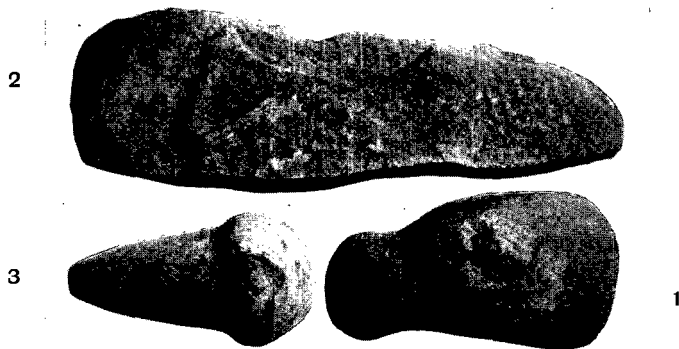
Fig. 24. Shale implements from Skara Brae.

(4) Three-spiked object of shale. It measures 7.40 inches long and 4.20 inches from the tip of the medial spike to the opposite surface of the convex band encircling the body. This band is marked off from the terminal spikes by two grooves and is decorated with a carved pattern (fig. 25, 1). On one side of the medial spike is a shallow depression, on the other a corresponding raised surface. Our object is undoubtedly allied to that from the chambered mound of Quoyness on Sanday, illustrated by Anderson as fig. 269. At the same time it

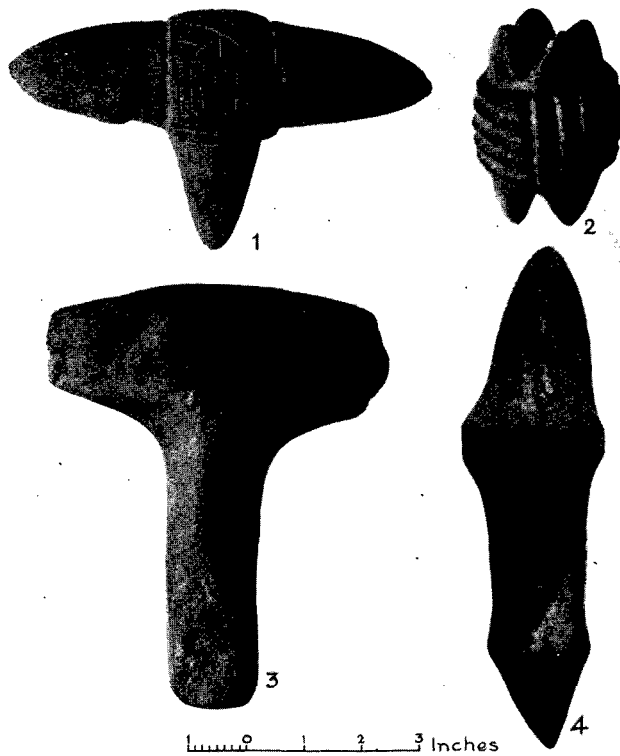
Fig. 25. Unusual stone objects from Skara Brae.

covered in Scotland. Though made out of hard volcanic stone (probably andesite), it has been brought to its present shape by grinding. The minute striæ left by the process are so irregular as to preclude the assumption of lathe-turning. Yet the proportions are extraordinarily accurate. In shape it is an ellipsoid truncated at both ends. The body is decorated by five horizontal ridges, interrupted and divided into two

groups by two groups of vertical ridges. The ends are divided by deep V-shaped notches, intersecting at right angles. The notches are not strictly in alignment with the vertical grooves nor with the notches at the opposite end. The object's maximum length is 3.60 inches, while that between the intersections of the notches is 2.35 inches. Its diameter on the plane of the middle horizontal ridge is 2.56 inches, a distance retained with incredible precision all round. Diameters taken along the terminal notches differ by only .08 inches from one another.
