NOTES ON THE ROMAN FORTS AT ROUGH CASTLE AND WESTERWOOD, WITH A POSTSCRIPT. BY SIR GEORGE MACDONALD, K.C.B., LL.D., D.LITT., F.B.A., F.S.A.SCOT.

I. ROUGH CASTLE.¹

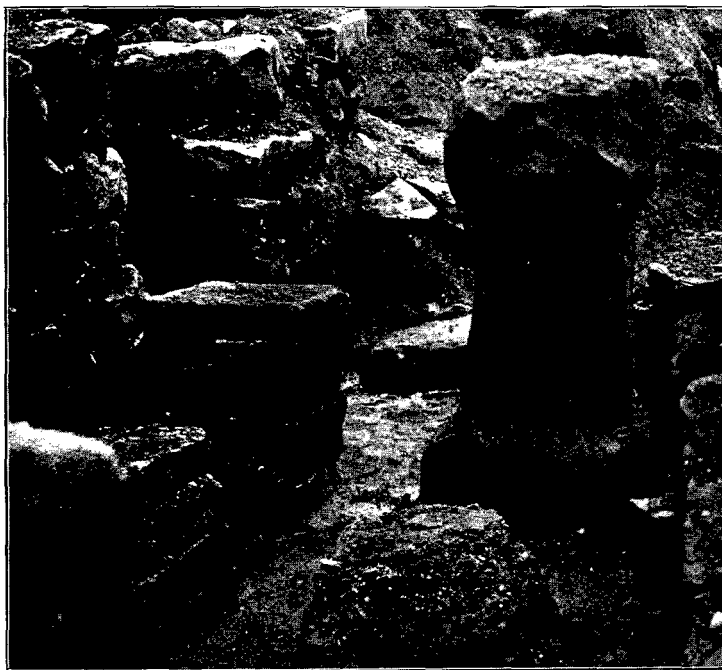
Fig. 2. South end of Caldarium, showing mouth of furnace.

a channelled hypocaust in the strict sense of the term. The supporting blocks of masonry are larger, and where they approach the walls they actually abut upon them. Thus the hot air could rise only at the ends of the narrow channels, and therefore in streams which would be quite ineffective for radiating purposes. It must have been introduced directly into the room. The furnace of the Sudatorium was evidently small, since all signs of it had disappeared. This points to charcoal fuelling.¹
