EXCAVATIONS AT CASTLELAW FORT, MIDLOTHIAN.

BY PROFESSOR V. GORDON CHILDE, B.LITT., F.S.A. SCOT.

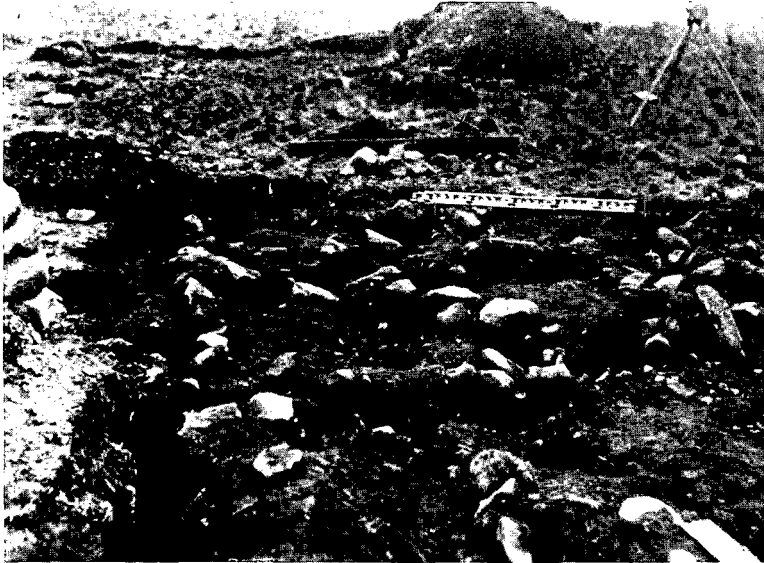
Fig. 4. Castlelaw Fort: House foundations looking west along ditch N. 4 and N. 1.

North of the fairway comparable remains survive in a less disturbed condition. A marginal ditch, N. 1, 10 to 12 inches wide by 7 to 9 inches deep, begins on the western edge of our trench, runs parallel to the axis of Inner Gate for about 5 feet (fig. 4), and then, crossing an

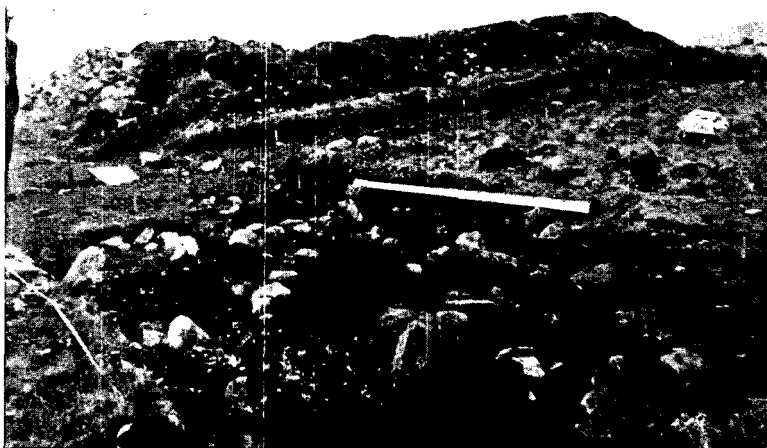
Fig. 5. Castlelaw Fort: House foundations looking south.

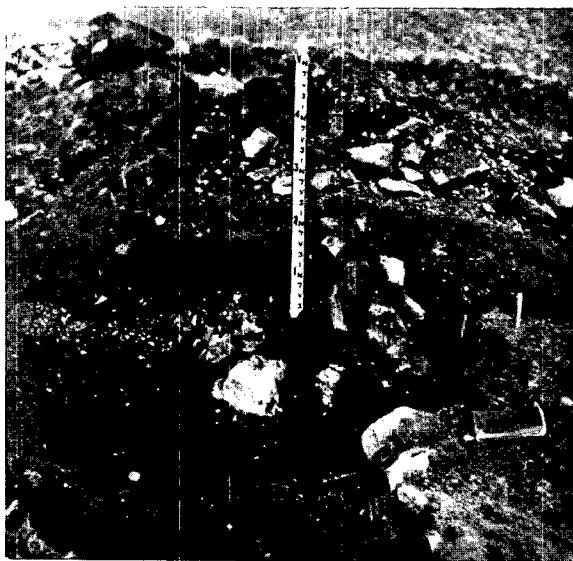
Fig. 7. Castlelaw Fort: Core of Middle Bank and scree resting on silt of Inner Fosse.

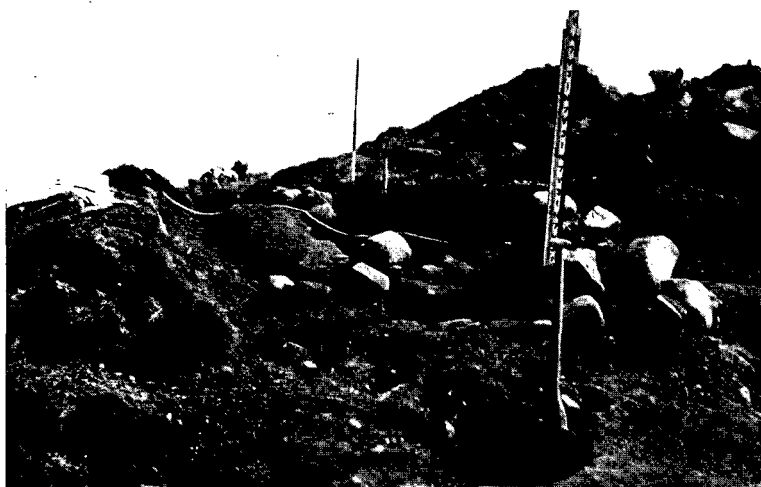
Fig. 8. Castlclaw Fort: Continuation of Middle Bank beyond end of Inner Fosse, looking south-east.

interpreted as the core of the rampart was found to continue in precisely the required direction for 15 feet (fig. 8). Here the line of stones abuts on ditch 4, which, as remarked on p. 372, turns southward after rounding the end of Inner Fosse. This ditch, now 1 foot 3 inches to 2 feet wide, and attaining a depth of 1 foot 9 inches, continues the line of the rampart for 23 feet till it peters out in the naked rock of the fairway. After a gap of 10 feet it is again lined or bordered with large boulders to within 6 feet of its end. This boulder-rimmed ditch looks like a counterpart to ditch *m* under the southern section of the rampart. Moreover, roughly parallel to it and from 1 foot 8 inches to 2 feet 8 inches outside it runs a shallow trench, only 5 to 10 inches deep, corresponding presumably to ditch *l* under the southern section of the rampart. Finally, cutting the inner (western) edge of the deeper ditch

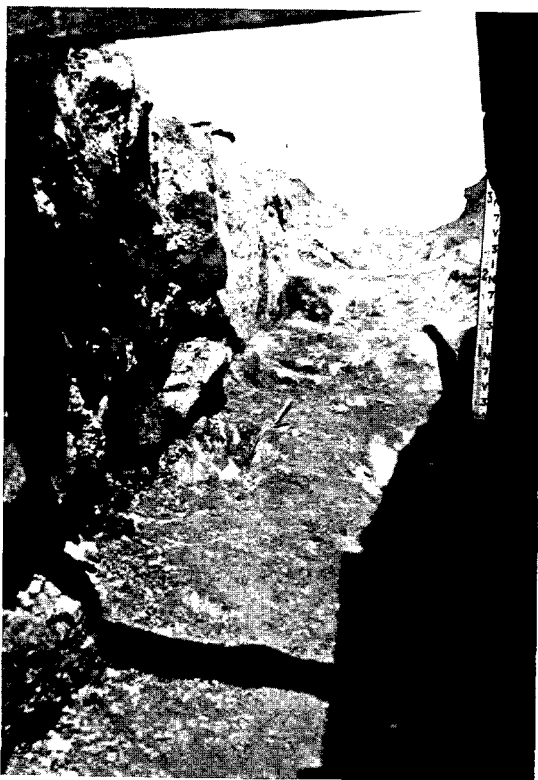
Fig. 10. Castlelaw Fort: Entrance to Earth-house looking towards stairs.

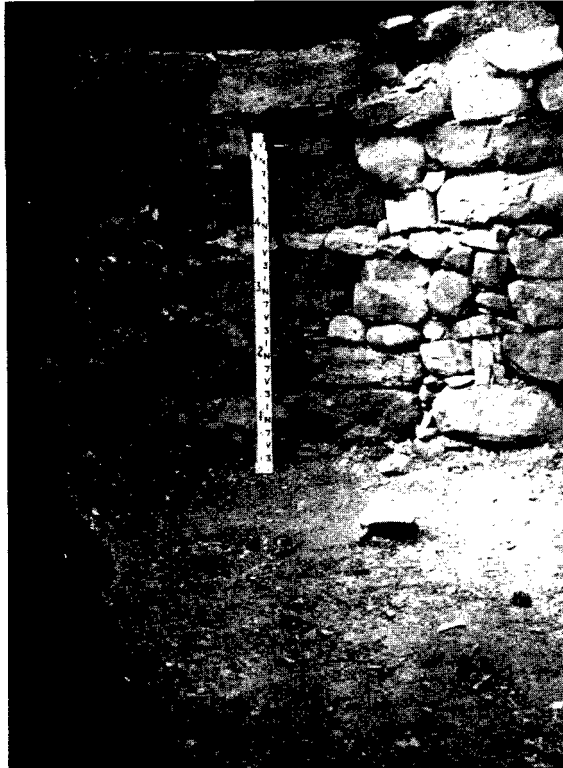
Fig. 12. Castlelaw Fort: Interior of Beehive chamber showing rock-cut hearth.
