AN ACCOUNT OF THE EXCAVATION OF A DWELLING OF THE VIKING PERIOD AT "JARLSHOF," SUMBURGH, SHETLAND, CARRIED OUT ON BEHALF OF H.M. OFFICE OF WORKS. BY ALEX. O. CURLE, C.V.O., F.S.A.Scot., F.S.A.

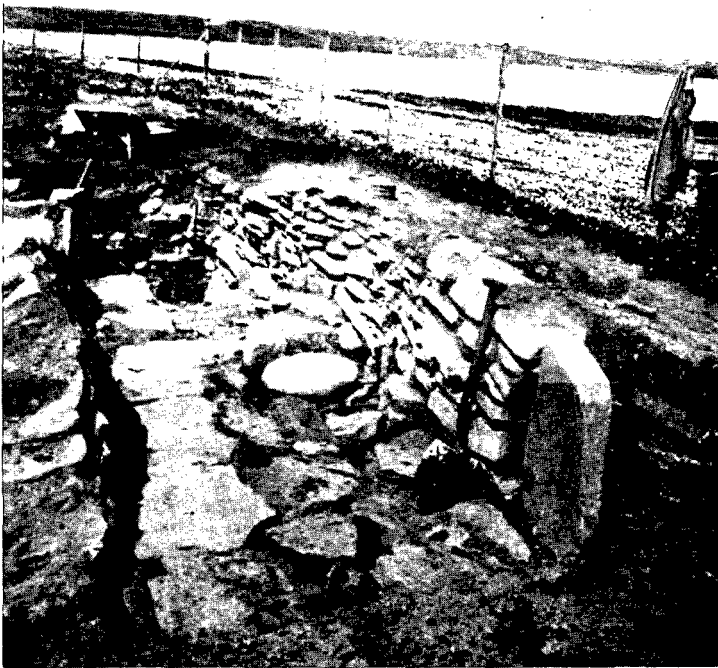
Fig. 1. The Alley-way between two Buildings.

Attention was then directed to the more southerly length of walling exposed in 1933, which trended in a direction from south-east to north-west. As the soil in front of it was removed, a wall parallel, and some 4 feet 6 inches distant, was exposed towards the south-west. Both walls stood to a height of about 2 feet 9 inches. Between them, at the spot where the excavation was being carried on, which was ultimately found to be in front of a doorway in the inner or south-west wall, lay a kitchen-midden containing fish and animal remains (the former greatly preponderating), many fragments of vessels of steatite, pins of bone, a conical whorl of lead, a typical Norse conical playing-piece of bone, and iron bolts with lozenge-shaped heads, such as were used in the construction of Viking ships. Eventually it was ascertained that the refuse had been thrown into a space which formed an alley between two buildings facing one another (fig. 1).

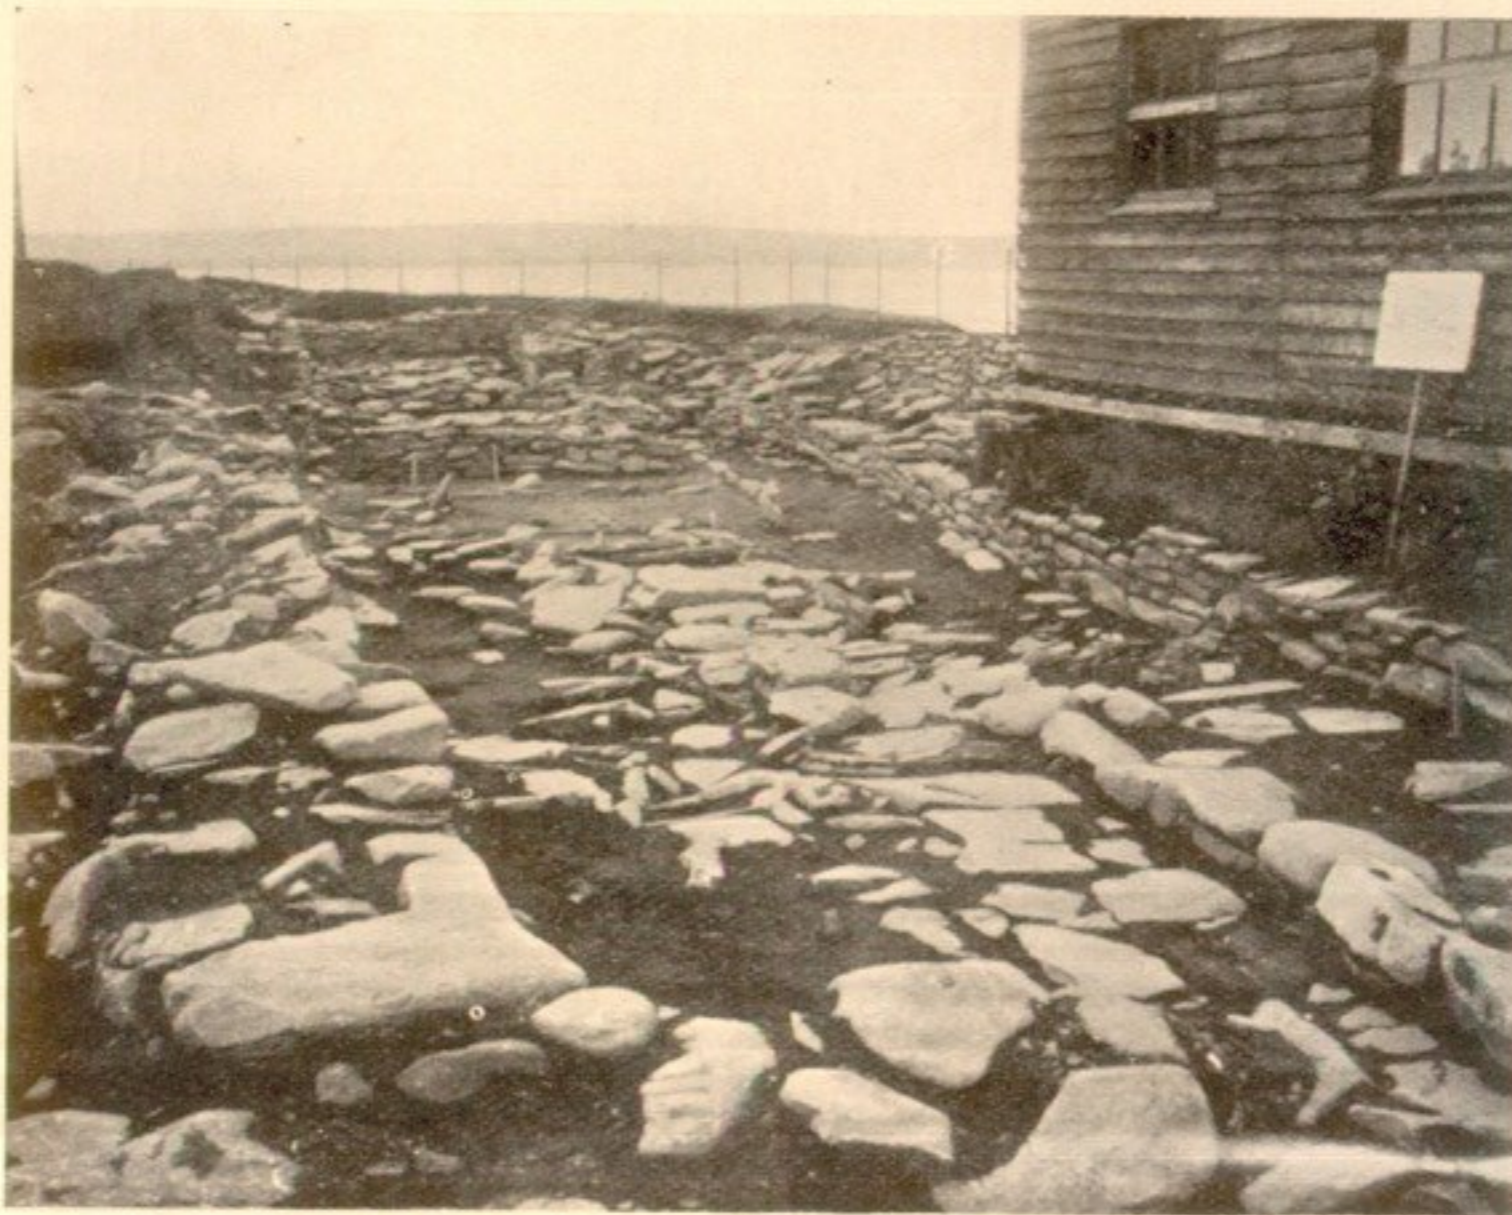
Fig. 2. The Interior from the South End after excavation.

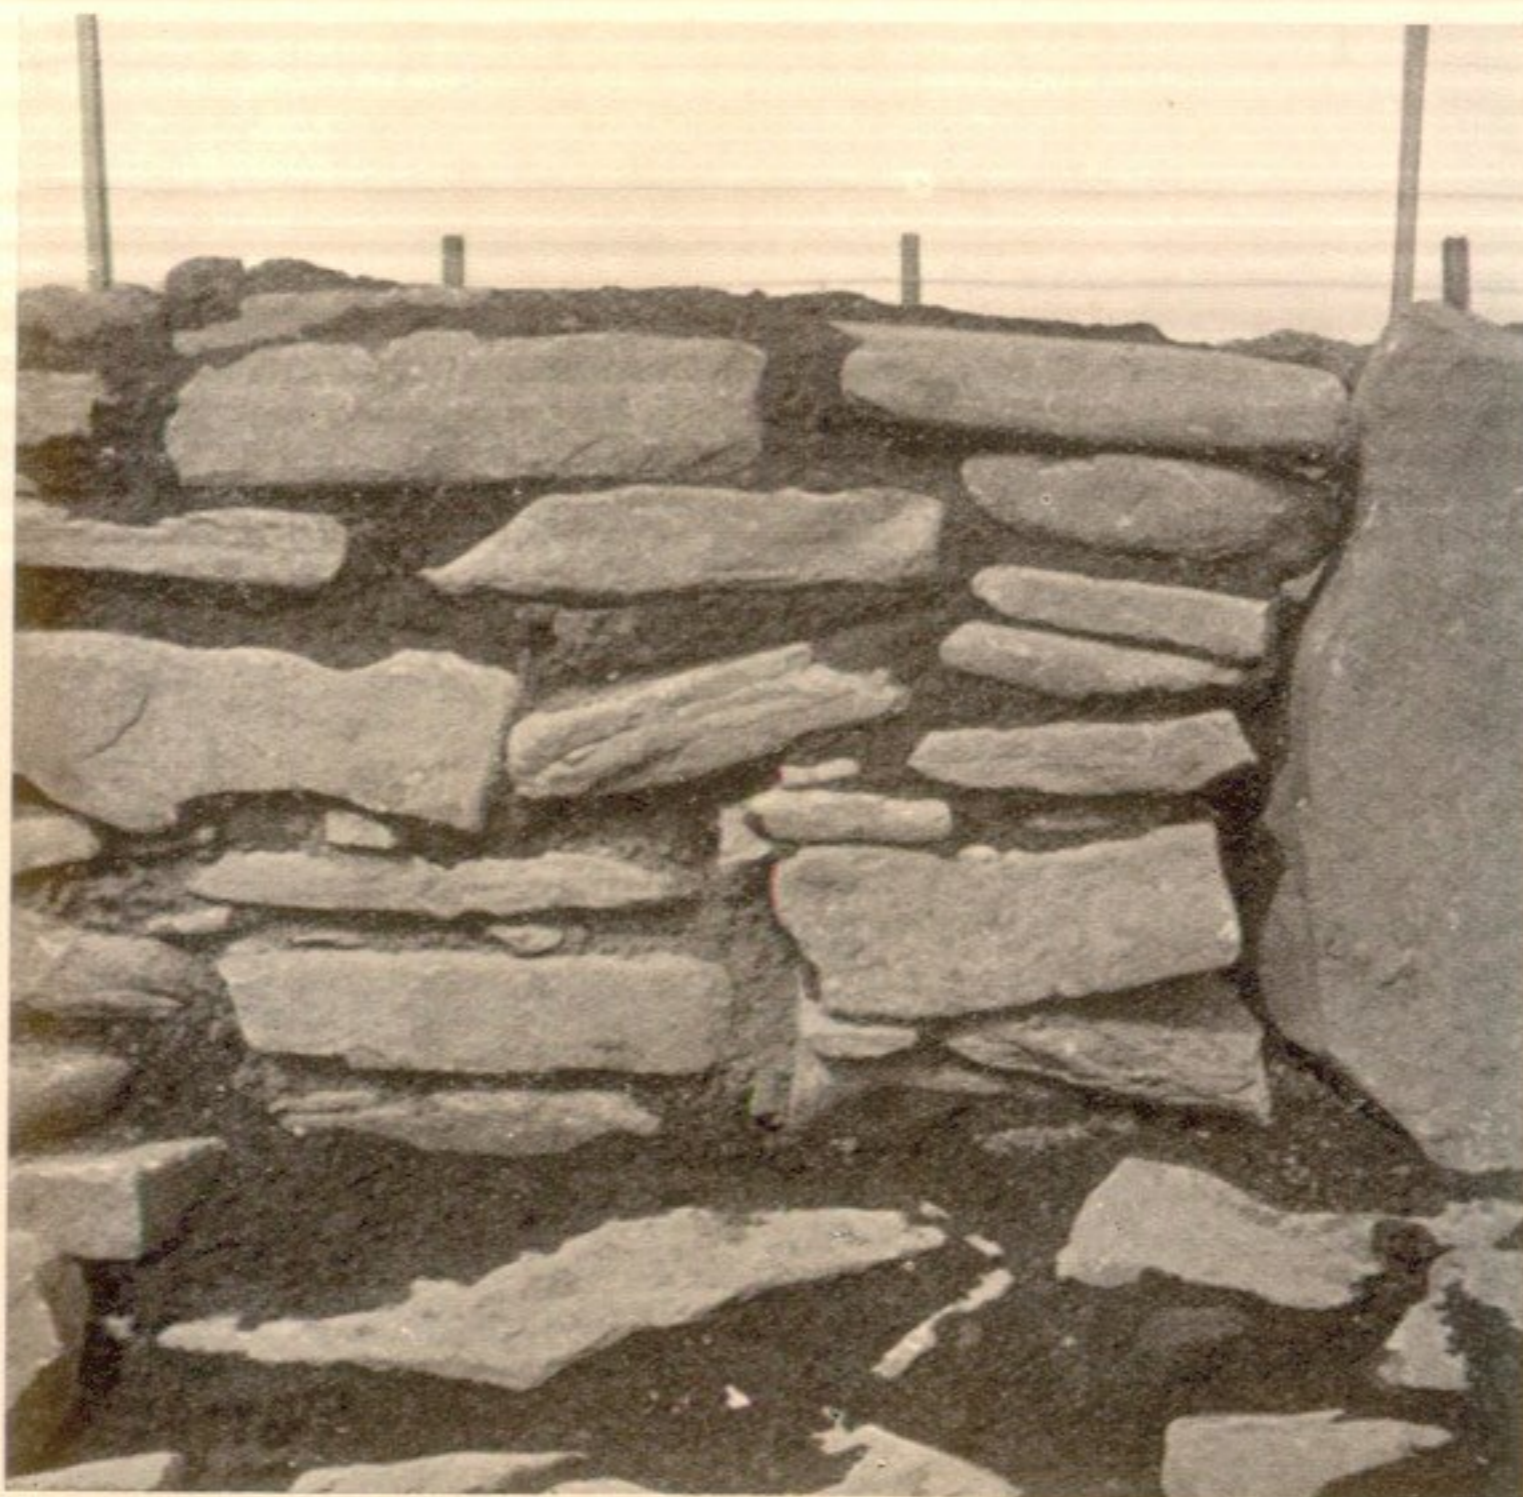
Fig. 3. Inner face of Wall showing Method of Construction.

bore evidence of having been constructed with alternate courses of stone and turf (fig. 3). This method of construction is that revealed in houses of the Viking times examined in Iceland, and there well shown in the ruins at *Áslákstunga hin innri*.¹

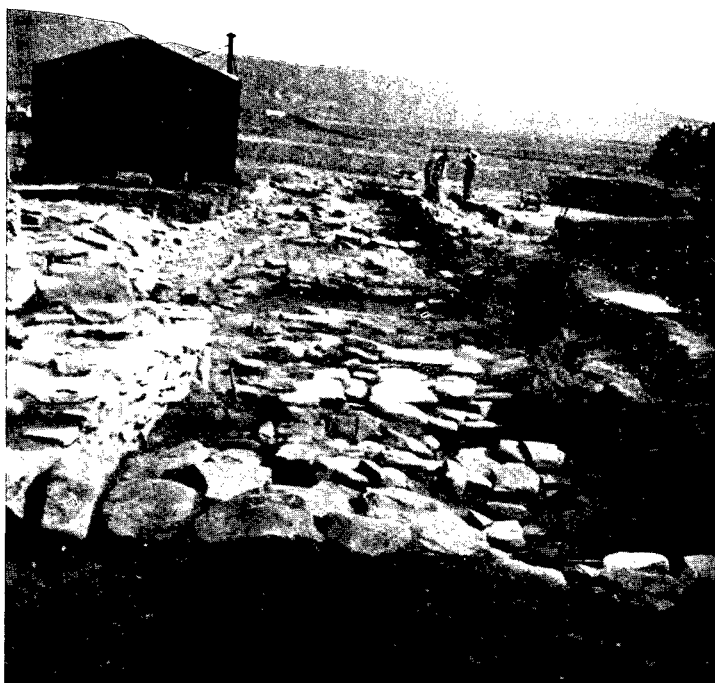
Fig. 4. The Interior from the North End.

against a bank. In the northern half it had been broken down in two places, and the existing wall in that section was in large measure a reconstruction (fig. 4). The lower course, however, of the original wall protruded from below the foot of the existing wall, as shown on the plan (see Plan), and formed a junction with the foundation of the primary end wall at a distance, on its inner face, of 11 feet from the inner face of the surviving

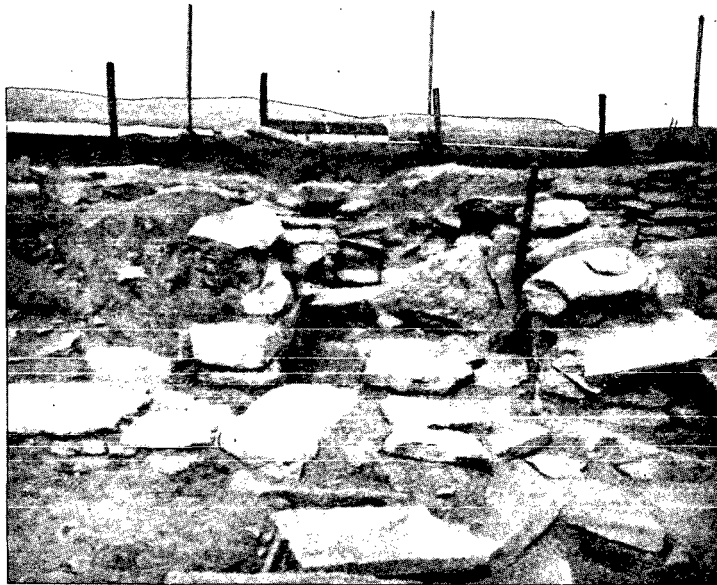
Fig. 5. The East Entrance from the Interior.

Partly covering the side entrance on the outside, and partly leaning against the face of the wall on the east, stood two large upright slabs, visible beyond the spade in fig. 5. They rested on a thin layer of soil covering the paving of the alley, which had been torn up in front of them. It was obvious that they had been erected in the position in which they were found to retain in place the refuse, consisting of fish-bones, peat-ash, broken steatite urns, etc., which composed the kitchen-midden filling the alley at this spot, and so prevent it falling back into the doorway.

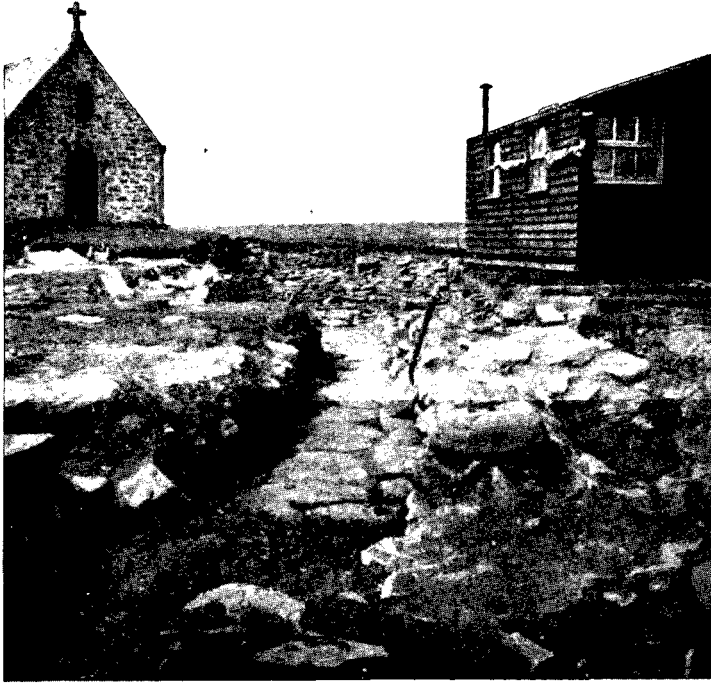
Fig. 6. Paved Passage on the Exterior at Southern End.

ing to the doorway. It curved slightly from the south and was paved throughout its length. Within the dwelling the line of the east wall of the passage was carried forward by a line of boulders for a distance of 14 feet, while the paving had probably been continued somewhat farther, but was confused in a mass of tumbled stones.

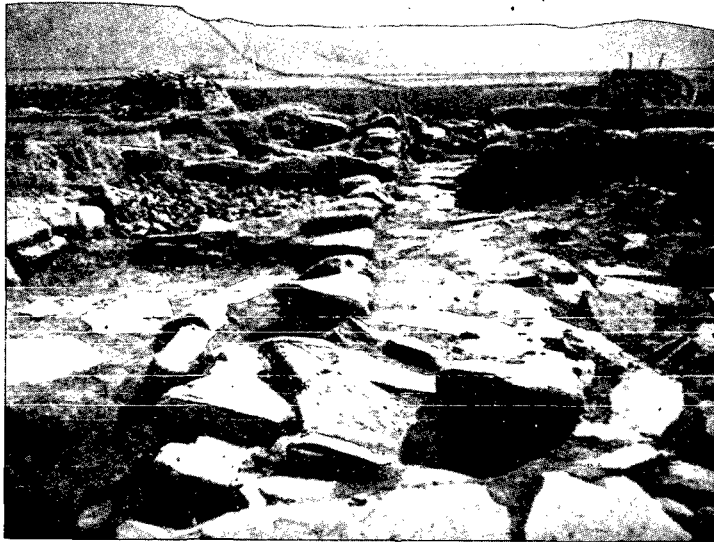
Fig. 7. Southern Entrance and Paved Passage in Interior.

At this end of the building, on either side of the passage, were large quantities of burnt broken stones which on the right appeared to have been within a compartment (see fig. 7), while on such material the end wall was actually founded.

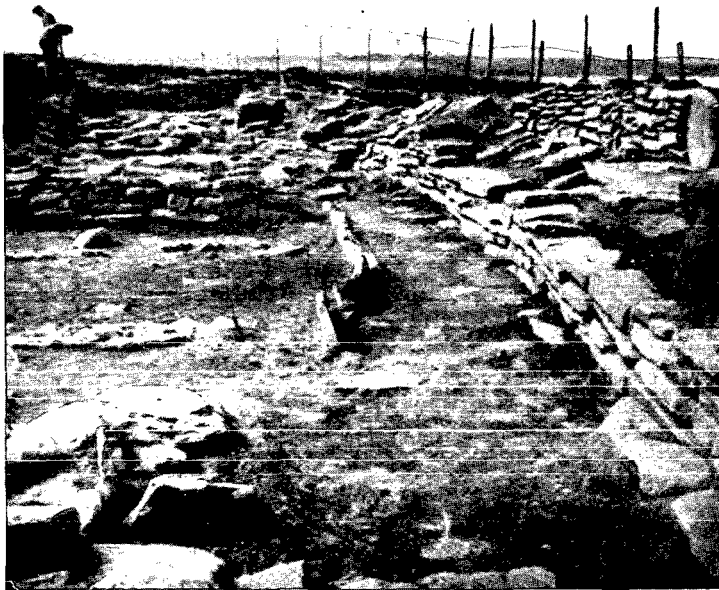
Fig. 8. Interior with Kerb of *Pallr* in centre.

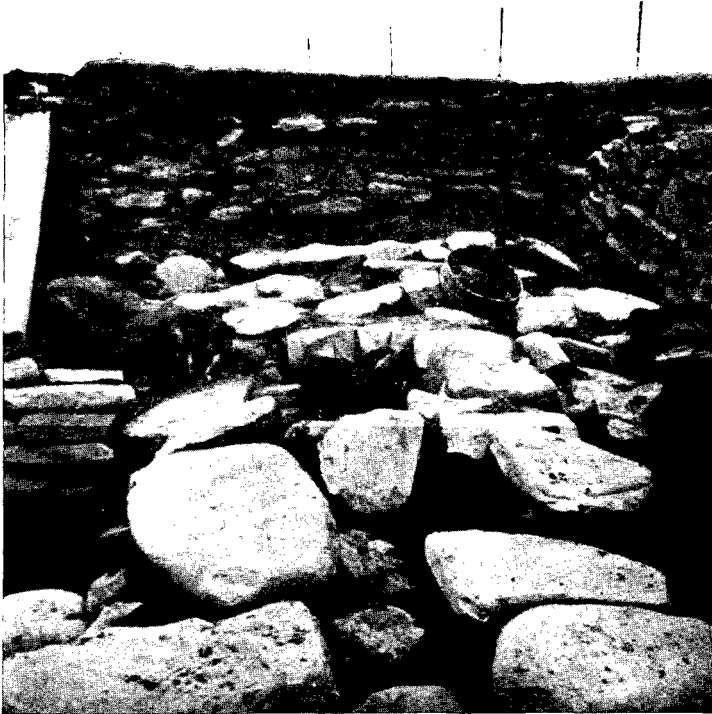
Fig. 9. Fireplace and Oven beyond.

suggested that a post had here been consumed by fire. The sites of the posts indicated on the Plan obviously belong to two periods, as previously stated, the two surrounded by stones on the floor of the *stofa* on the east side being secondary. A consideration of the others shows that while in the *stofa* the posts on the east side had been placed on, and at the edge of the *pallr*, those within the *eldhús* had occupied a more central position, the dwelling being narrower at that end. Within the *eldhús*, in the centre of the floor, was the fireplace, and beyond it the oven, partly inserted into the end wall as if to be surmounted by a chimney, or an aperture in the roof. The fireplace (fig. 9), which appeared to have been

constructed for the special purpose of heating stones to be used in the oven, was a small rectangular enclosure some 18 inches square, formed on either side with slabs of stone laid on the surface, and furnished with an opening in front for a flue, some 9 inches broad and 10 inches deep, paved on the bottom, and extending back for a distance of 4 feet 6 inches. The paving was in two layers, probably representing two periods of use. The

back of the fireplace was formed with a slab rising to a height of 1 foot above the sole of the hearth, and set sloping backwards at an angle of some 50° from the perpendicular. Peat-ash was found upon this fireplace, but no food refuse.

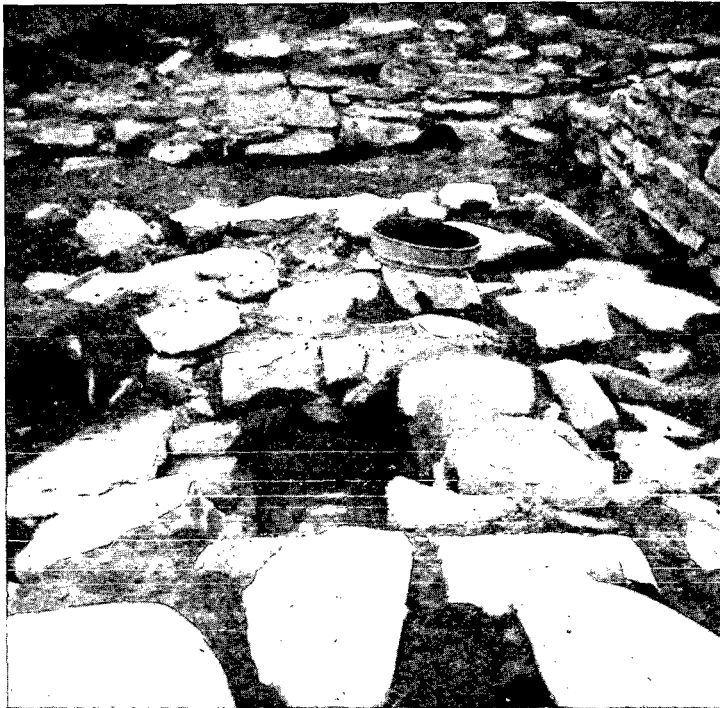
Fig. 10. The Oven.

apex, and at a similar angle. The floor of the oven was paved, and the walls were reddened and fractured by the action of heat. Within it were numerous burnt broken stones, of a size to be easily held in the hand, and a large quantity of fish-bones.

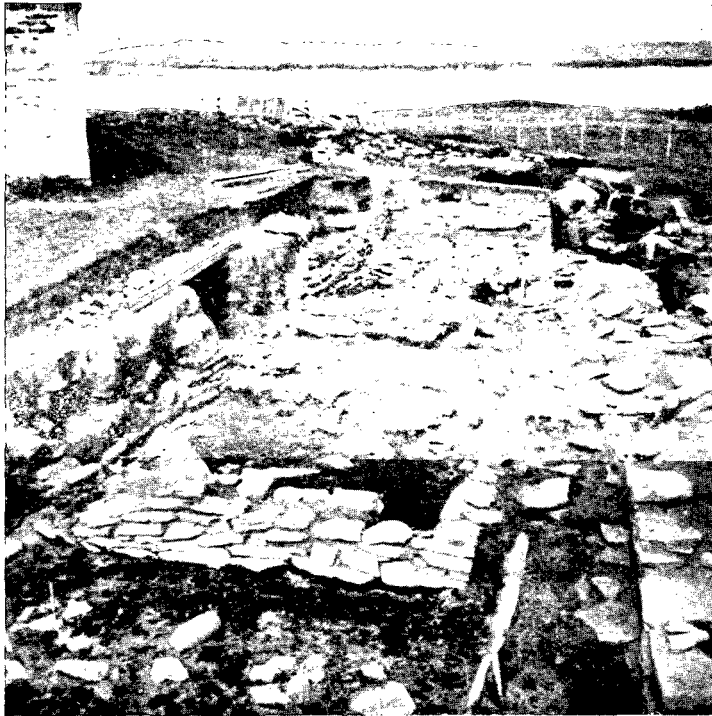
Fig. 11. Secondary Cross Wall in foreground.

north of the centre (fig. 11), and the removal of the wall which previously formed the south end of the *eldhús*. The result of this was to reduce the length of the *stofa*, and increase that of the *eldhús* by some 9 feet 9 inches, approximately 3 metres, which thereafter probably became also the *skáli*, or sleeping room. The north end wall was at the same time moved back some 3 feet.

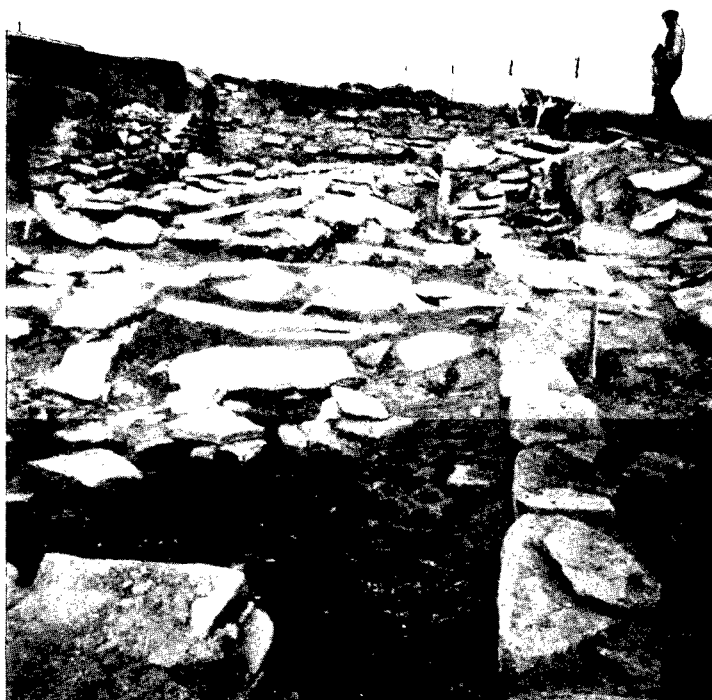
Fig. 13. Secondary Hearth in the *Skáli*.

The hearth in the *skáli* (fig. 13) was much smaller and measured only 1 foot 9 inches across, and, approximately, as the outer stones had been

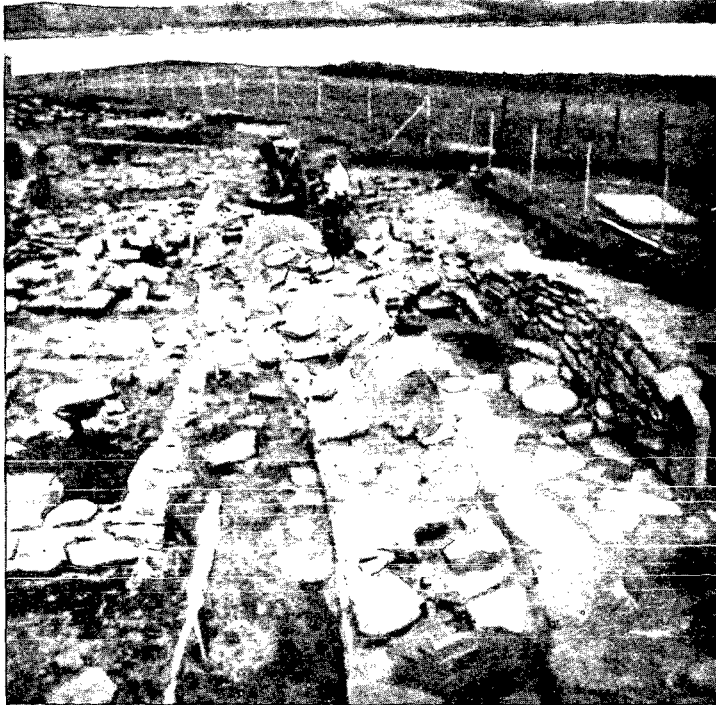
Fig. 14. Side Wall constructed upon the *Pallr* in the latest Period.

earth. A side wall (fig. 14) towards the east was built partially upon the *pallr*, extending from the end of the partition wall, and a new cross wall was constructed somewhat to the south of the centre of this new dwelling. The original entrance on the east side was still in use, but a fresh opening was broken out some 9 feet to the north of the former. A quartz pebble

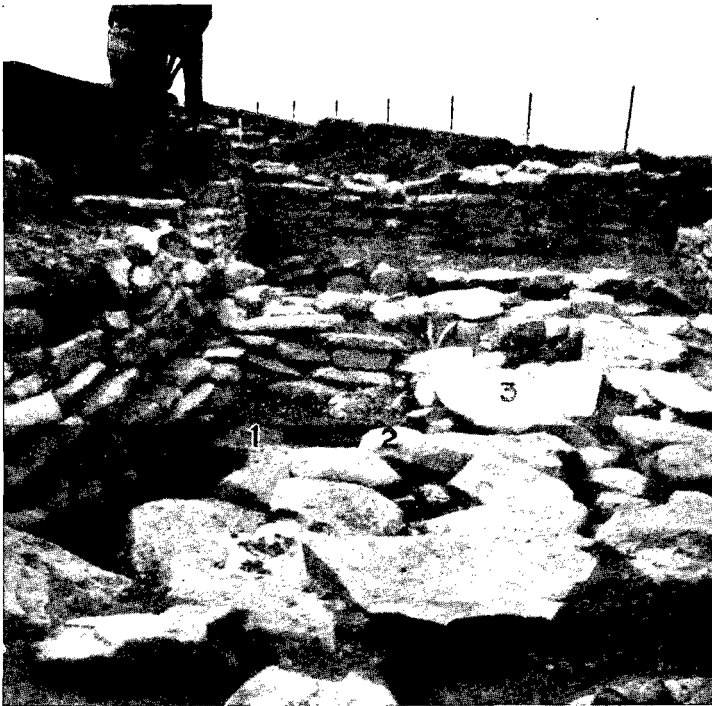
Fig. 15. The North End showing *in situ* Flooring Stones of each Period.

The three periods are clearly indicated in the construction of the wall along the west side at the original termination of each. Moreover, the floor-levels at the north end tell the same tale. The base of the late end wall lies at a level of 25 feet 9 inches above ordnance datum, the foundation of the wall of the second period at 24 feet 9 inches, and that of the

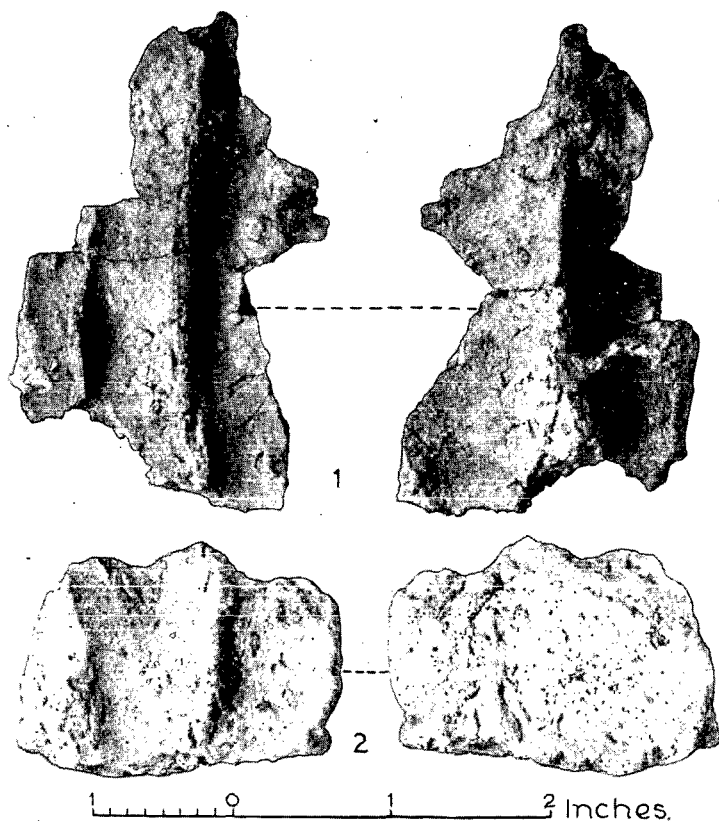
Fig. 16. Burnt Clay showing Impressions.

Among the relics recovered from the south end of the building were some two or three fragments of clay which had been transformed to a brick-like consistency by the action of fire (fig. 16). On one side these fragments bore deep parallel grooves, evidently produced by the action of human fingers pressed into and drawn along the material when it was soft. The smooth and slightly pitted appearance of the opposite face might well have been produced by the pressure of the clay against a built stone surface, and accordingly it seems probable that these pieces of burnt clay represented a lining which had been plastered on the interior surface of the walls to close the interstices between the stones, preserved in these

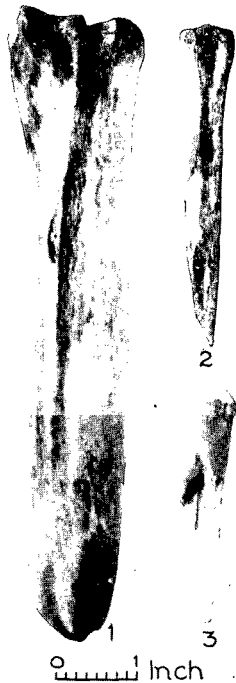
Fig. 29. Bone Implements from Interior of House.

Bone Implements.—The three bone implements found are illustrated in fig. 29. No. 1, which is made from the metatarsal of a small pony,

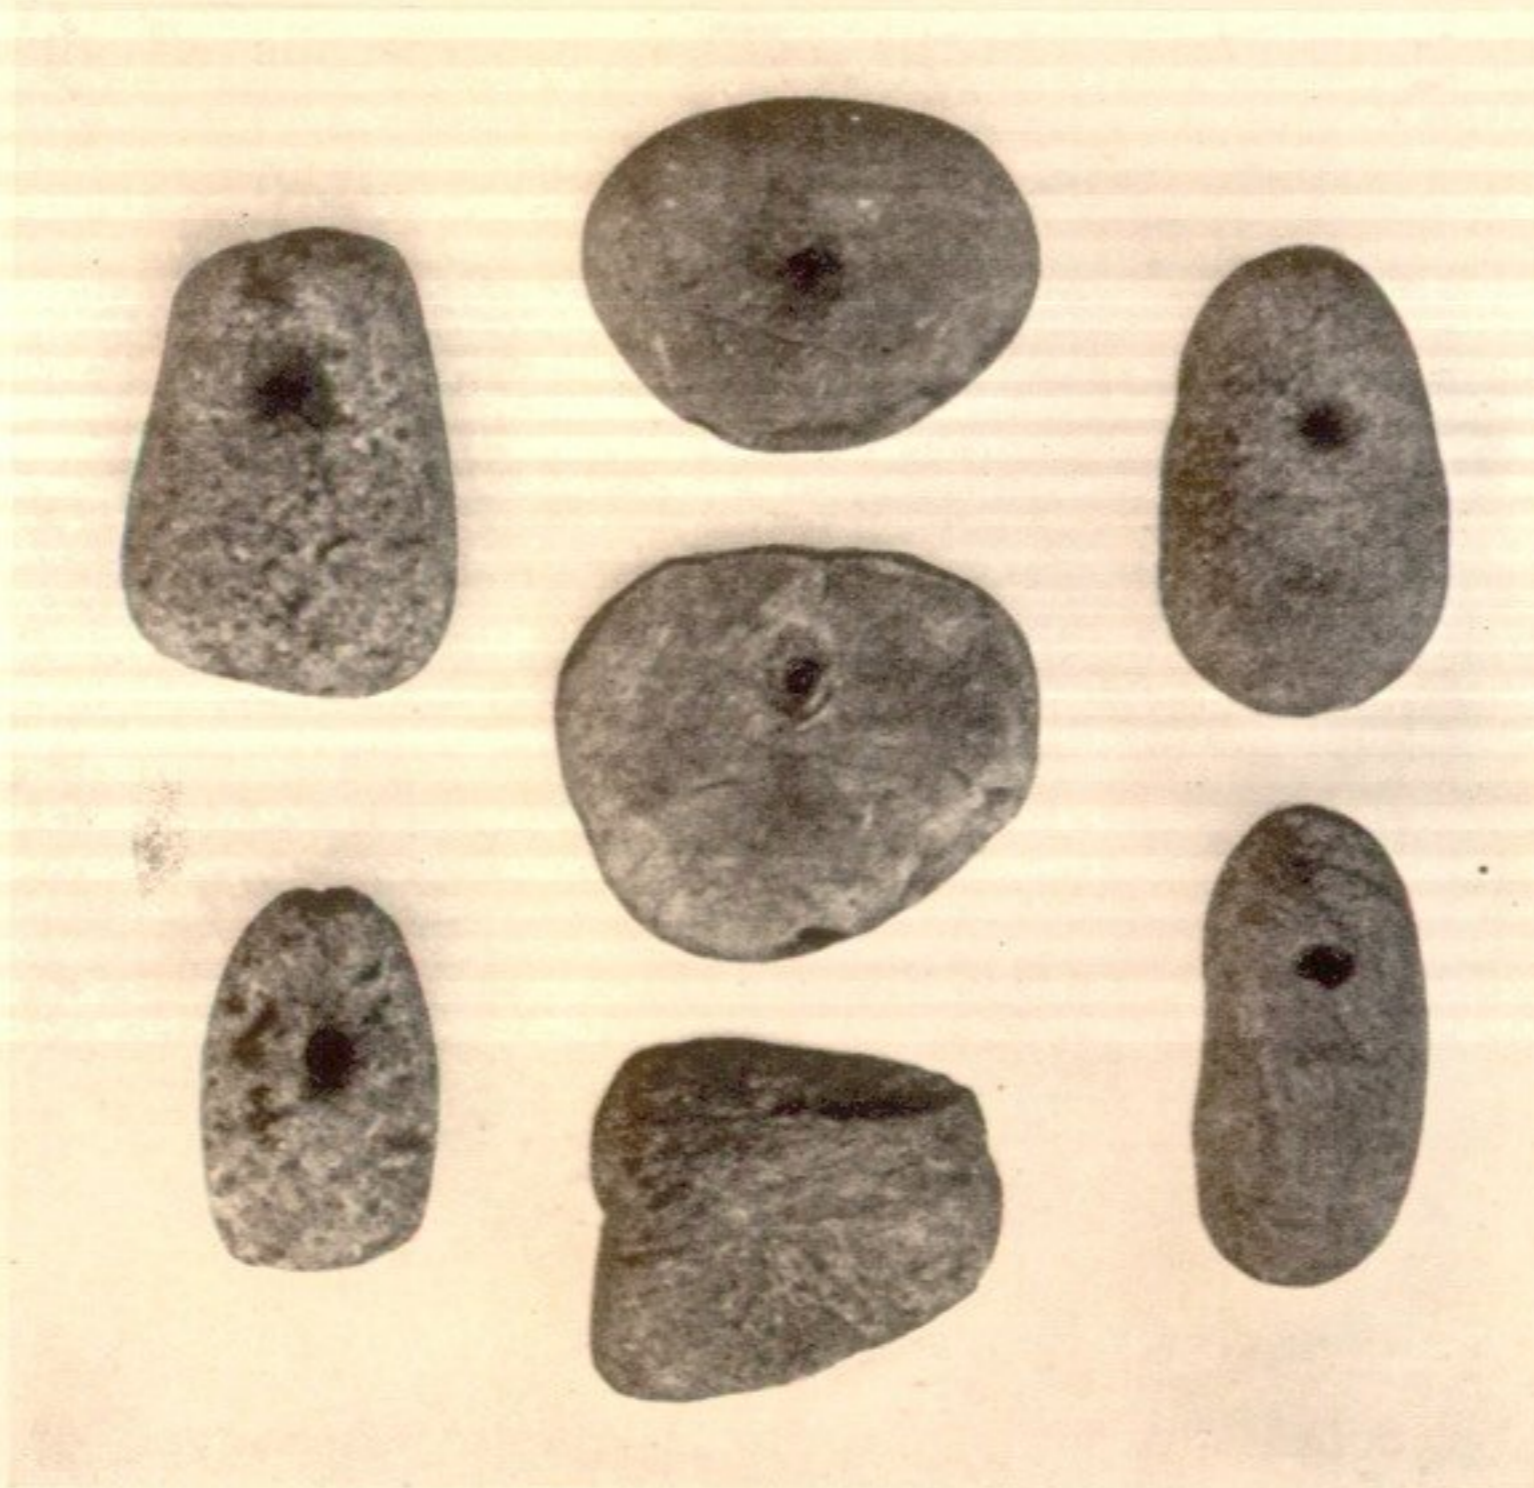
Fig. 38. Loom-weights.

4 were grooved for a cord. Some examples are shown in figs. 38 and 39. In the former are plain pebbles, in the latter examples showing distinct features. Fig. 39, No. 1, is imperforated, but has two encircling grooves

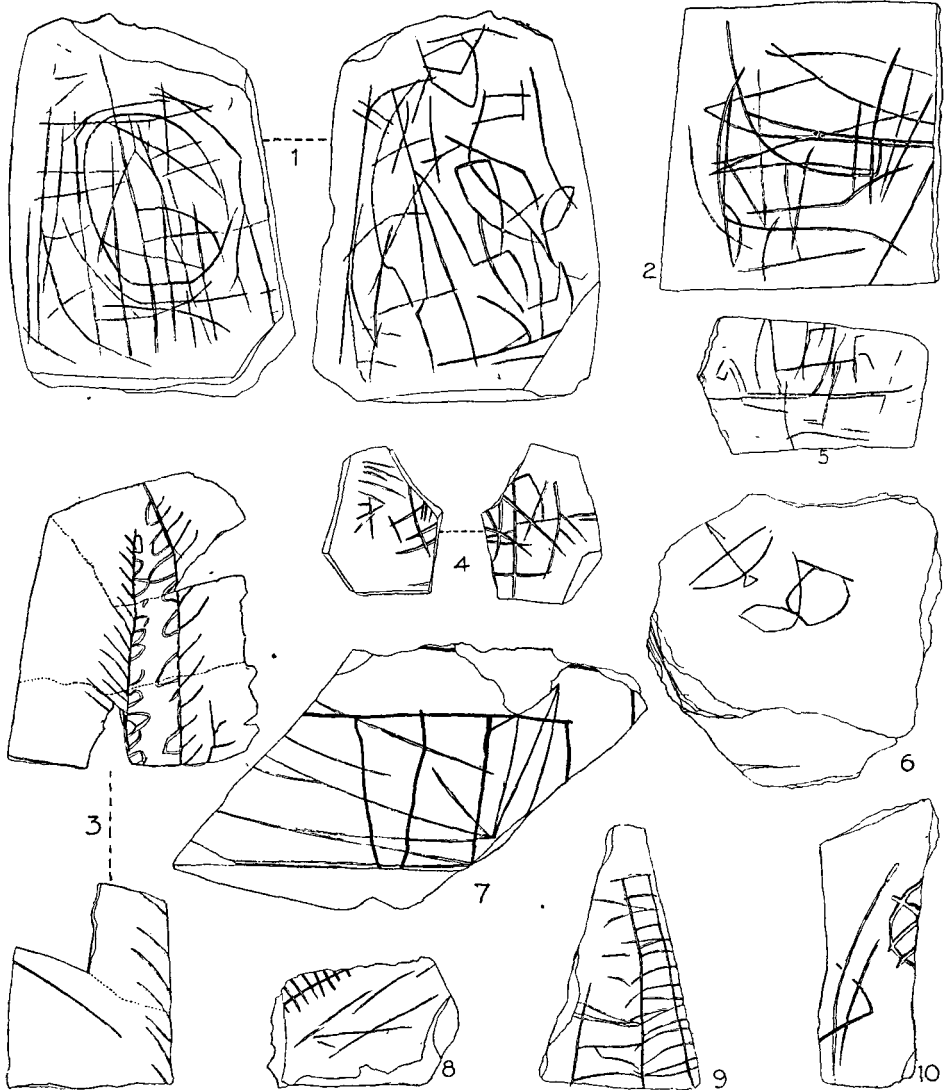
Fig. 49. Drawings of Tablets with Graffiti Markings.

One other tablet (figs. 48 and 49, No. 6) presents an unambiguous reproduction of two objects of everyday use of the time—a bow and arrow. This representation may be seen on the slate toward the upper left-hand corner. It will be noticed that the arrow is placed in reverse position with the point across the string and the head projecting beyond the bow. The significance attaching to this arrangement is not apparent. Equally cryptic are the two circular figures scratched behind the bow and arrow. Bows and arrows were in regular use by the Norsemen. There are few references to them in the Sagas, and it is inferred that their use was largely confined to the rich man's hunting.³ This example was found at floor-level in the southern section of the dwelling.

Less certain of interpretation is the design scratched on a small pentagonal fragment, figs. 49 and 50, No. 5. This bears a resemblance to another boat with a dragon-headed prow, and, more problematically, a representation of the tent, or awning (*tjald*), erected in the centre of the ship when at rest. Towards the bow in the drawing there appears to be a mast, while in the centre is seemingly another mast carrying a sail as if a second drawing had been imposed on an earlier one. The boat, if such it be, is represented as floating in the water.

The curved lines drawn on figs. 48 and 49, No. 2, viewed as placed on the plate, or sideways from the left, may also be intended to represent the bows of ships, but the intention of the draughtsman is less clear than even the previously described specimen. This slate was found at floor-level near the centre of the dwelling.

Another example represented by two detached fragments made up of several broken pieces (figs. 49 and 50, No. 3) is evidently intended to represent some definite object, or design.⁴ In the larger portion it will be observed that the representation is in duplicate. In general character the graffito bears some resemblance to a pine tree, on one side,

with branches radiating from a central stem and diminishing in length upwards. On the opposite side of the stem, however, the branches give place

to a series of loops, also diminishing in length towards the upper end of the stem. It has been suggested that the slender lines represent the branches of a spruce tree in summer, and the loops the branches covered with snow

Figs. 49 and 50, No. 9, show an example with scratchings along one
