THE DEFENCES OF KAIMES HILL FORT, MIDLOTHIAN.

BY PROFESSOR V. G. CHILDE, F.S.A.Scot.

*Read January 25, 1941.*

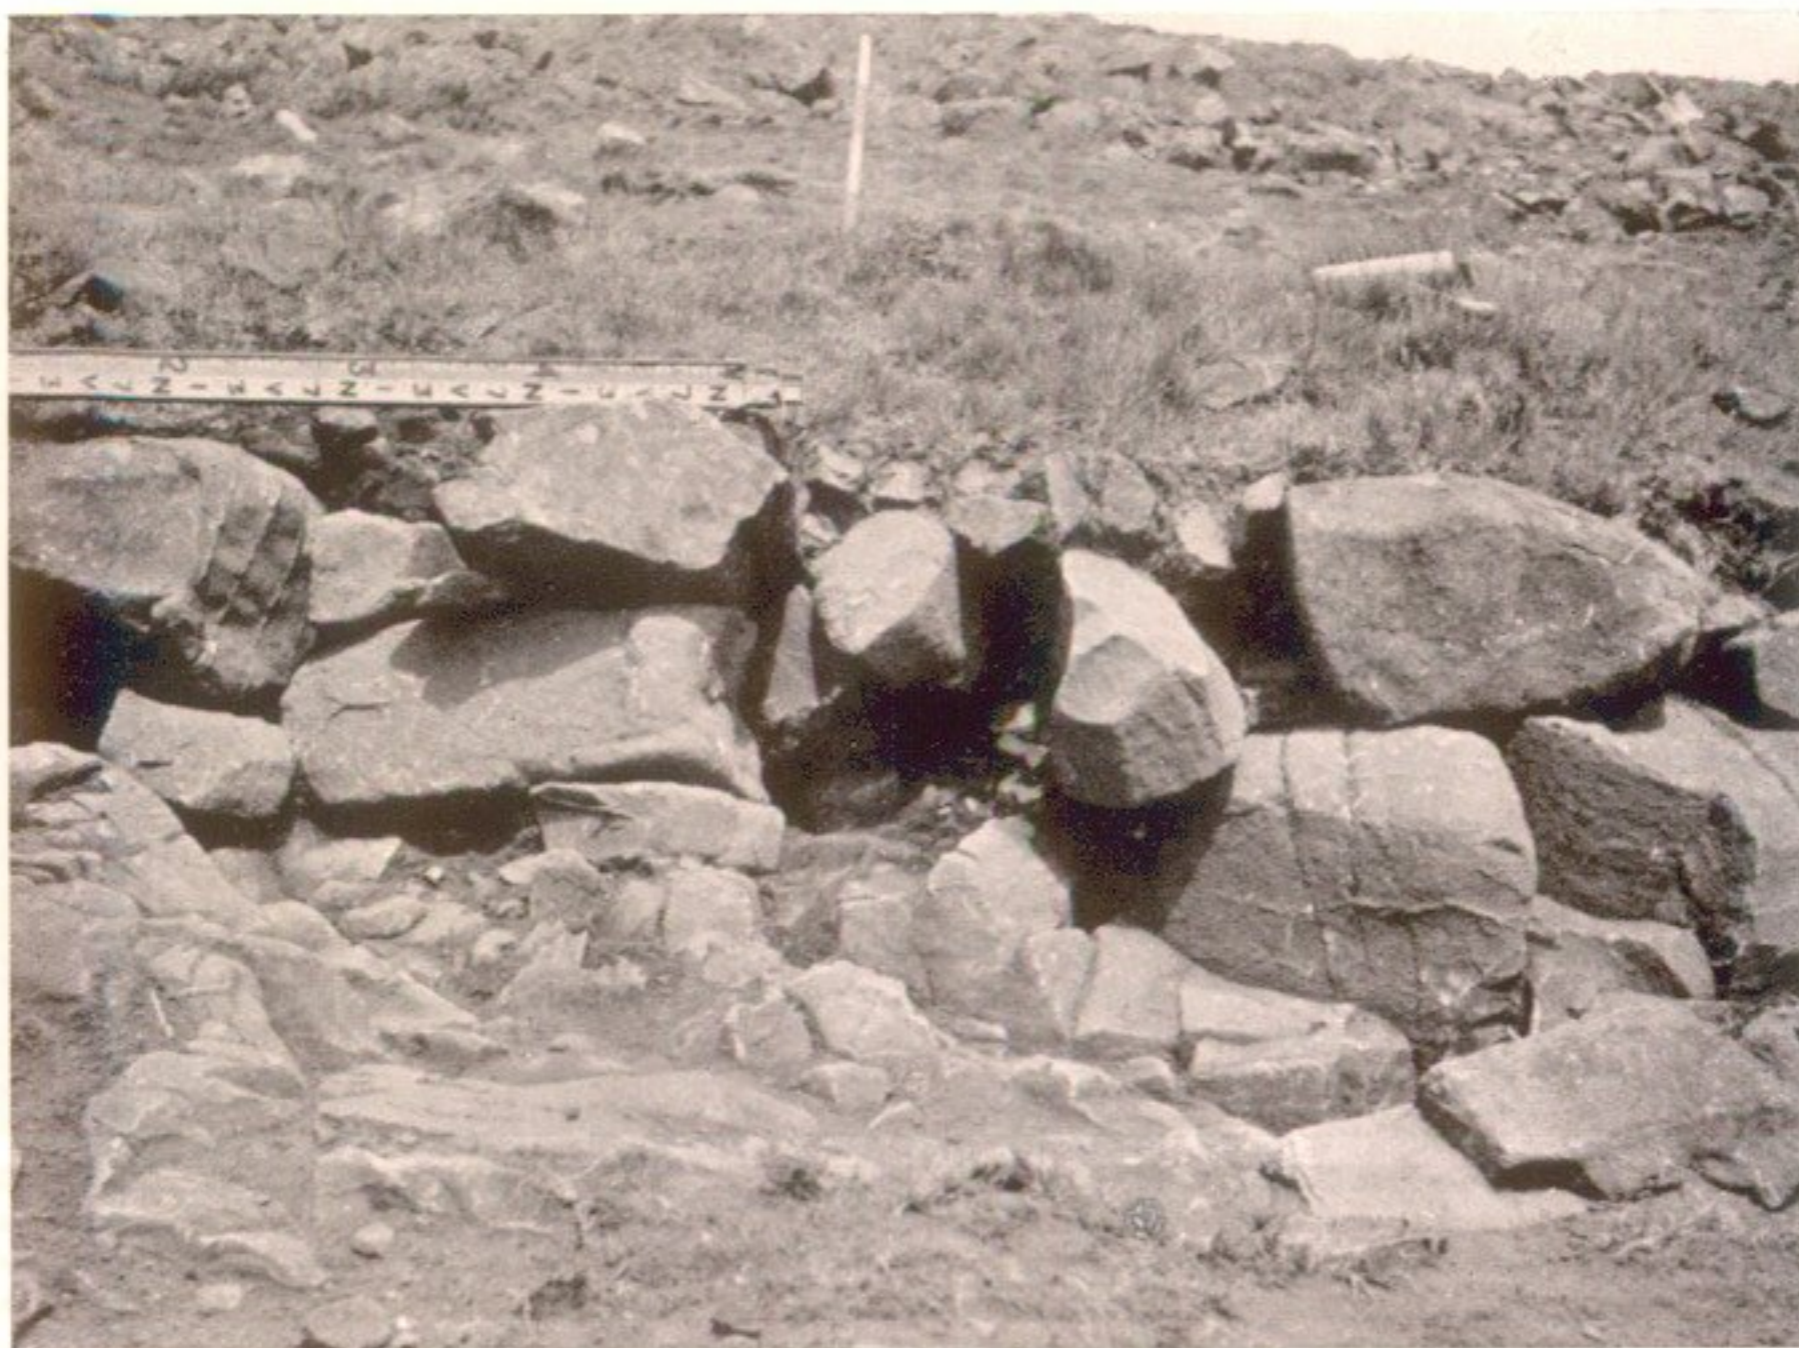
1. Rampart I, outer face.

*Rampart I* is clearly visible all round the south and east of the hill and is duly marked on the O.S. maps as well as in the Royal Commission's plan<sup>1</sup>; in our area its crest lies between 47 and 49 feet above our datum.<sup>2</sup> It was cut through by our Section AB, and its outer and inner margins were exposed for distances of 25 and 28 feet respectively west of AB. The outer "face" is formed of large blocks ( $1\frac{3}{4}$  feet long  $\times$   $2\frac{1}{3}$  feet high  $\times$  1 foot thick and  $2\frac{1}{3}$  feet  $\times$   $2\frac{1}{2}$  feet  $\times$   $1\frac{2}{3}$  feet are typical dimensions) entirely devoid of any sort of dressing. These are generally set upright, but in places two blocks had been piled one on the top of the other (Pl. XIII) rather than built in courses (the stones in question measure respectively  $2\frac{1}{2} \times 1 \times 1\frac{1}{3}$  feet and  $1\frac{2}{3} \times 1 \times 1$  foot). The facing blocks do not usually rest on rock, and in no case could a prepared rock-cut bed be detected for them. Packing-stones or wedgers have been inserted under several of the facers, but many have fallen forward or slipped down the hill. Our section utilised the gap left by one such stone which was lying prostrate in front of the line of the face (fig. 2). An accumulation of blocks in front of the facers may be just due to such slipping and collapse, but may partly have been deliberately piled up to strengthen the face; the small upright stone, shown in front of the face in fig. 2, is thus planted very firmly on the rock as if it were meant to stand where it does.

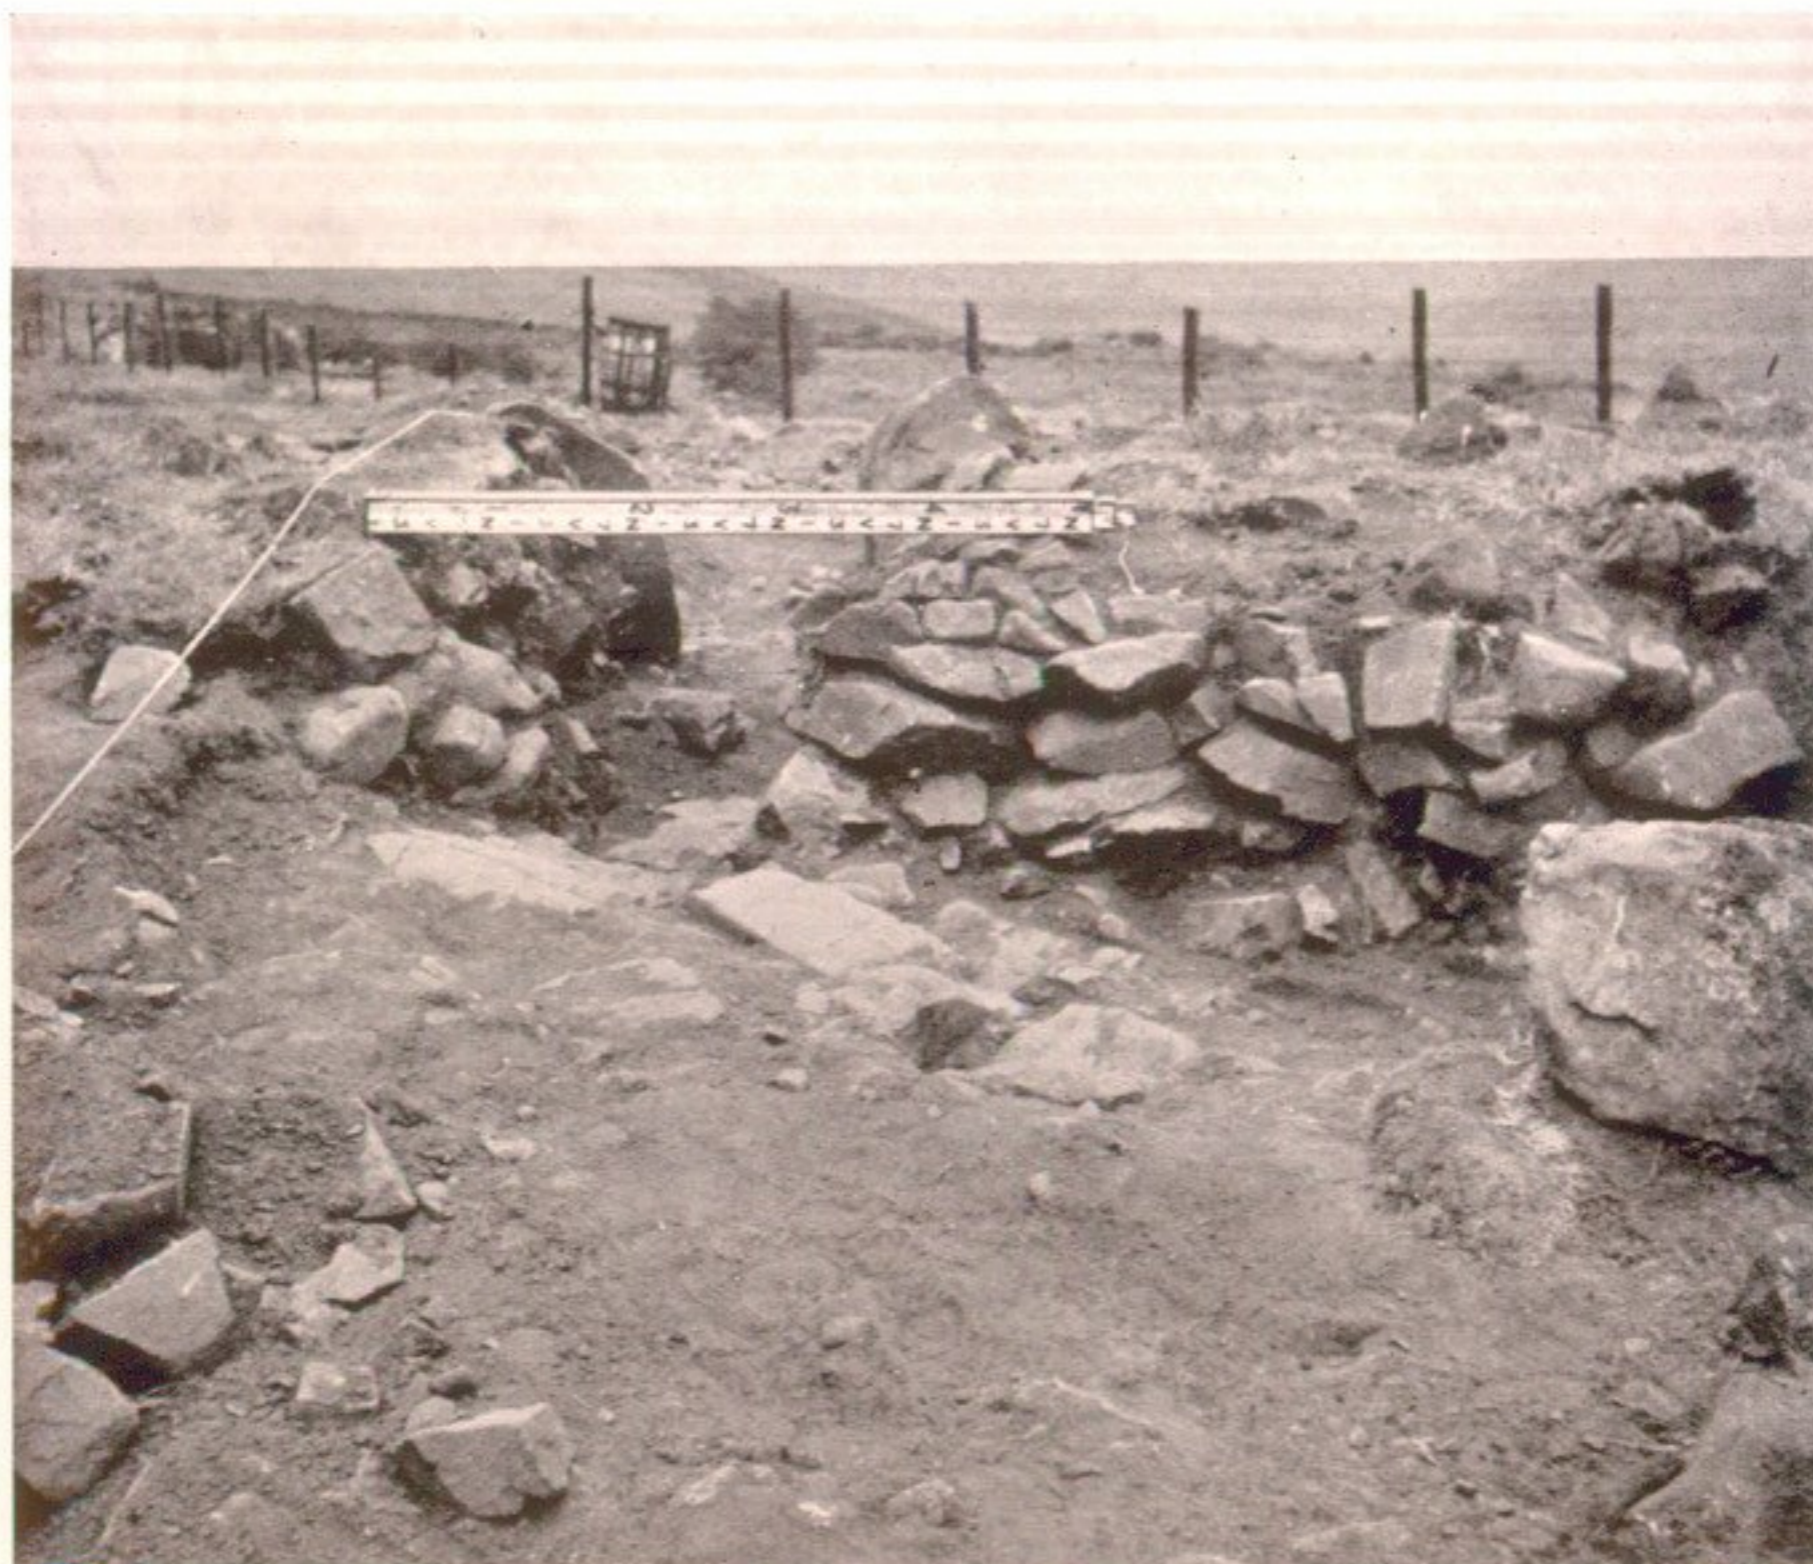
2. Rampart I, "inner face."

This rude face retained a core of earth mixed with broken rock which seemed to have been piled up against it. To form an internal support for this core small stones had been packed against it, forming a "back face" devoid of any regularity of coursing but yet capable of standing 2 feet high on the line of section (Pl. XIII). The total width of the bank is thus a little over 6 feet. The bank can never have risen very much higher than at present and would hardly constitute a formidable military obstacle. It was most probably designed to support a palisade of stout posts driven into the rampart core. The sockets for such posts probably would not penetrate to the rock—indeed on the theory the whole point of the rampart was to avoid the quarrying of post-sockets. None were observed in the section. But the basalt exhibits a columnar structure, and grass-roots soon work down along its fracture-planes so that it would be possible to make plausible-looking post-holes even by hard brushing!

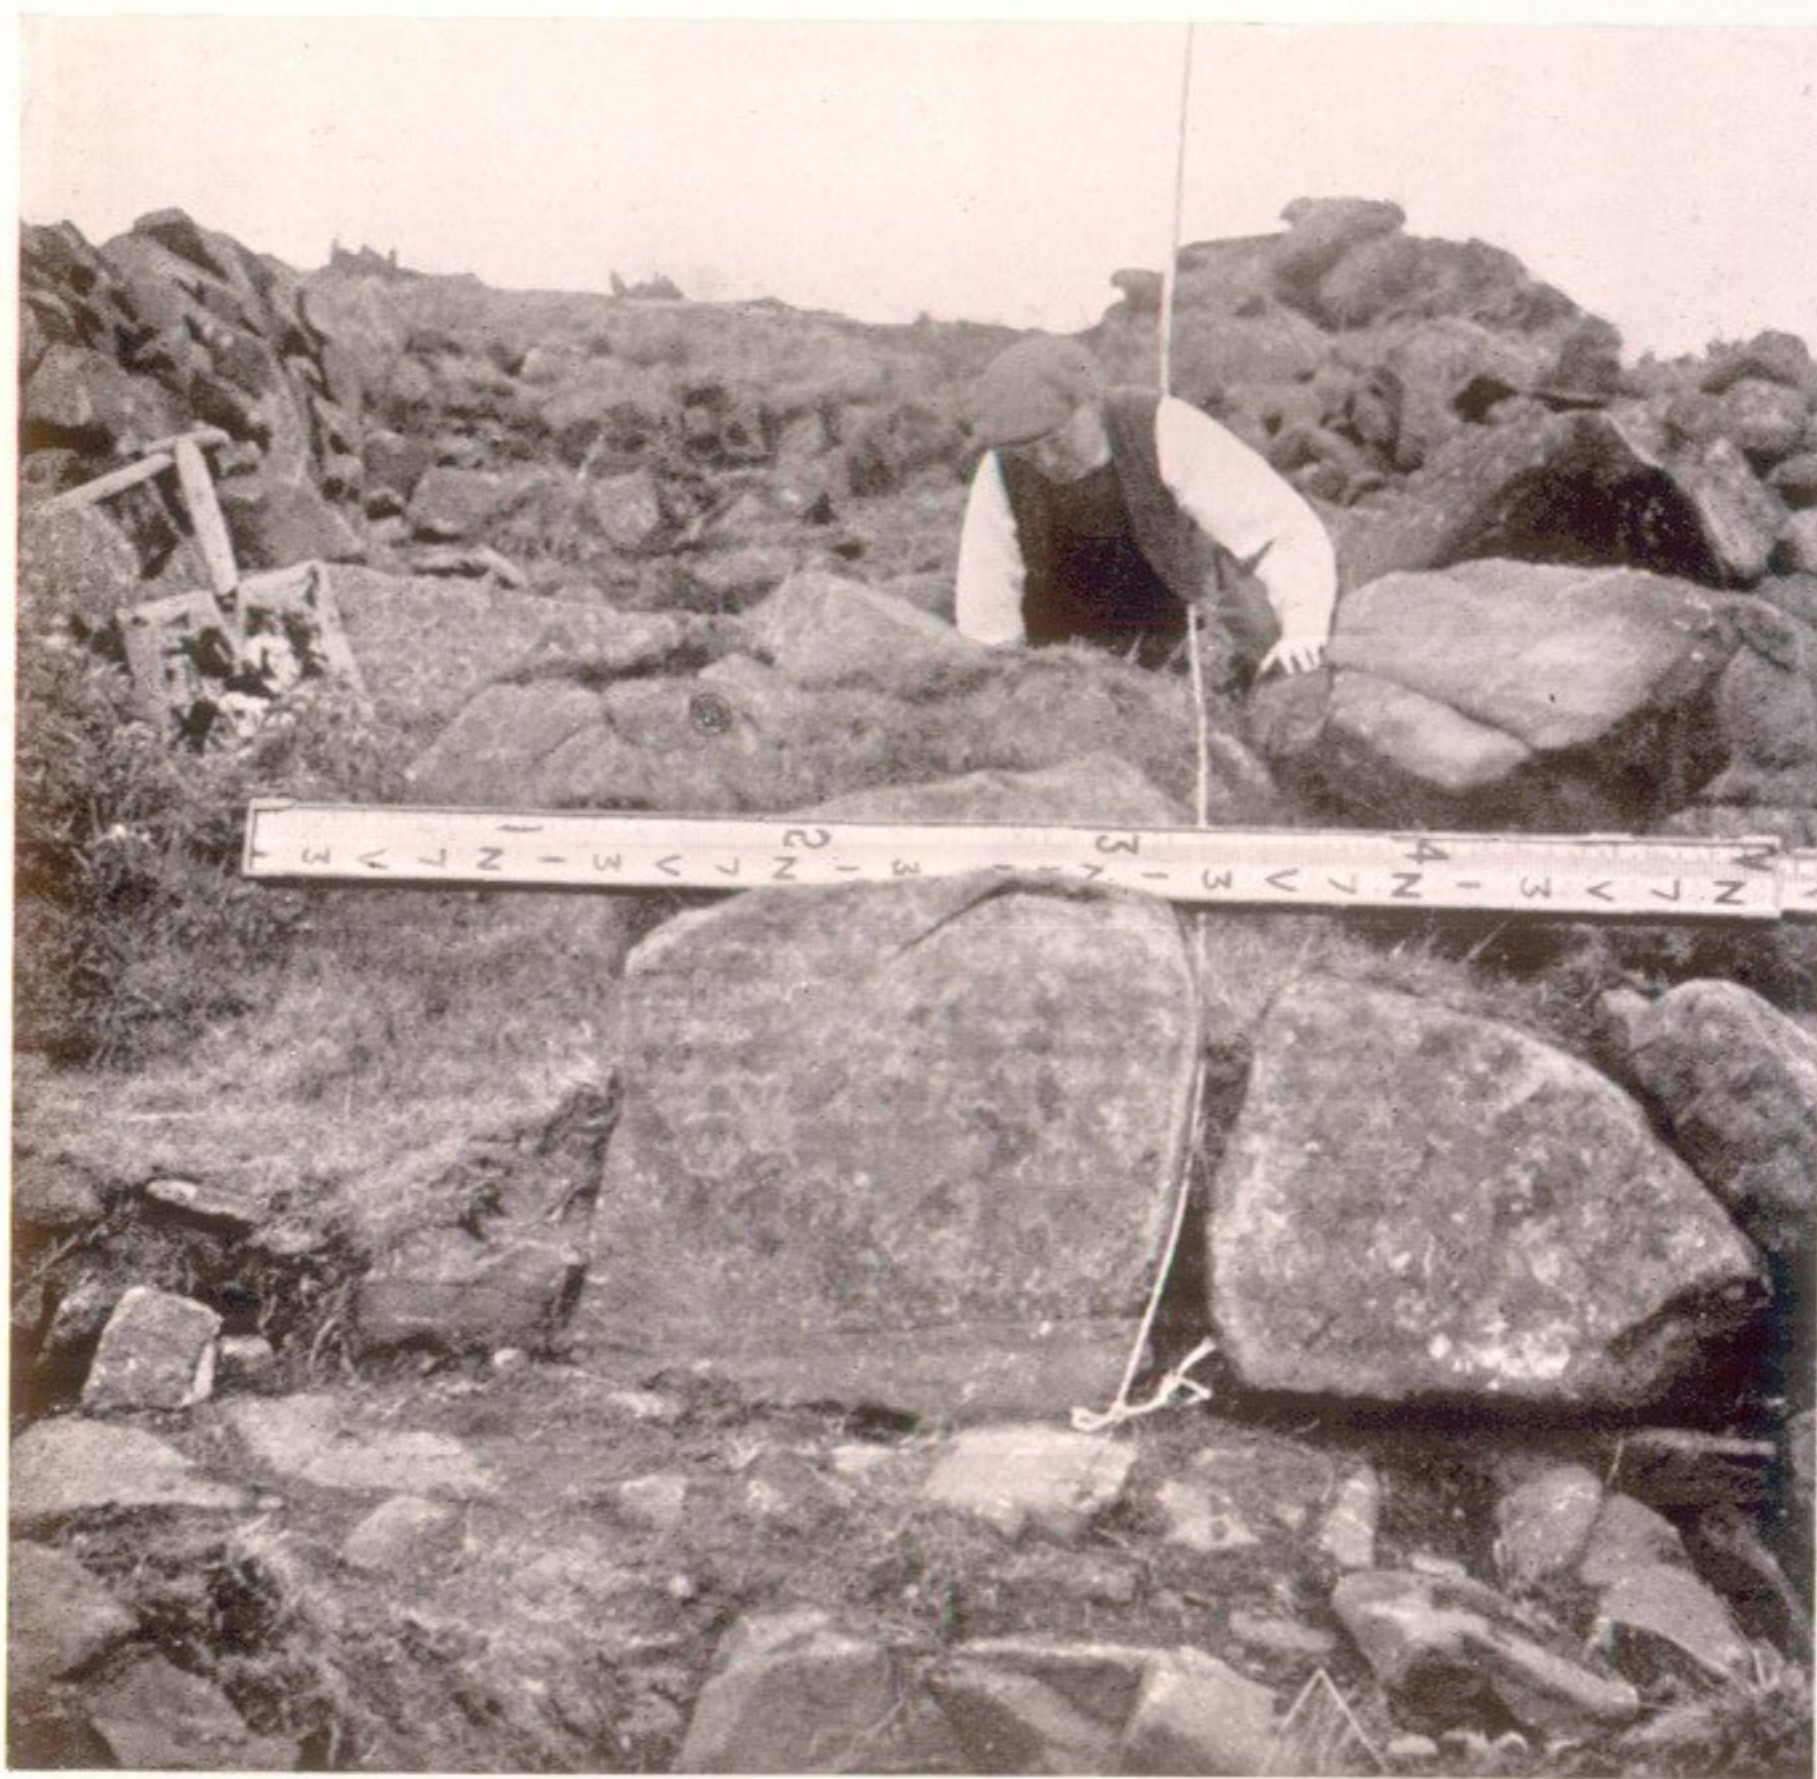
Rampart II, outer face.

*Rampart II* appears a little east of AB, as an inconspicuous terrace or step below the crest of III and some 12 feet above Rampart I on the 59-foot contour (Pl. XX, just above end of staff). On line of section it was scarcely perceptible, and west thereof it is masked by the scree of stones fallen from Rampart III. Three stones in line projecting through the turf on the lower margin of this scree gave the position of its outer face where Section FG started (Pl. XIV); the blocks in question, dressed flat on the top and outer face, rest firmly on the rock and measure respectively  $1\frac{1}{2} \times 1\frac{1}{4} \times 1$  foot,  $1\frac{1}{2} \times 1\frac{1}{2} \times 1$  foot and  $1\frac{3}{4} \times \frac{3}{4} \times 1\frac{2}{3}$  feet. AB was traversed by two lines of stones either of which might represent the outer face (fig. 2), but there are many loose stones both within and without these lines protruding through the thin turf or resting precariously upon the sloping rock.

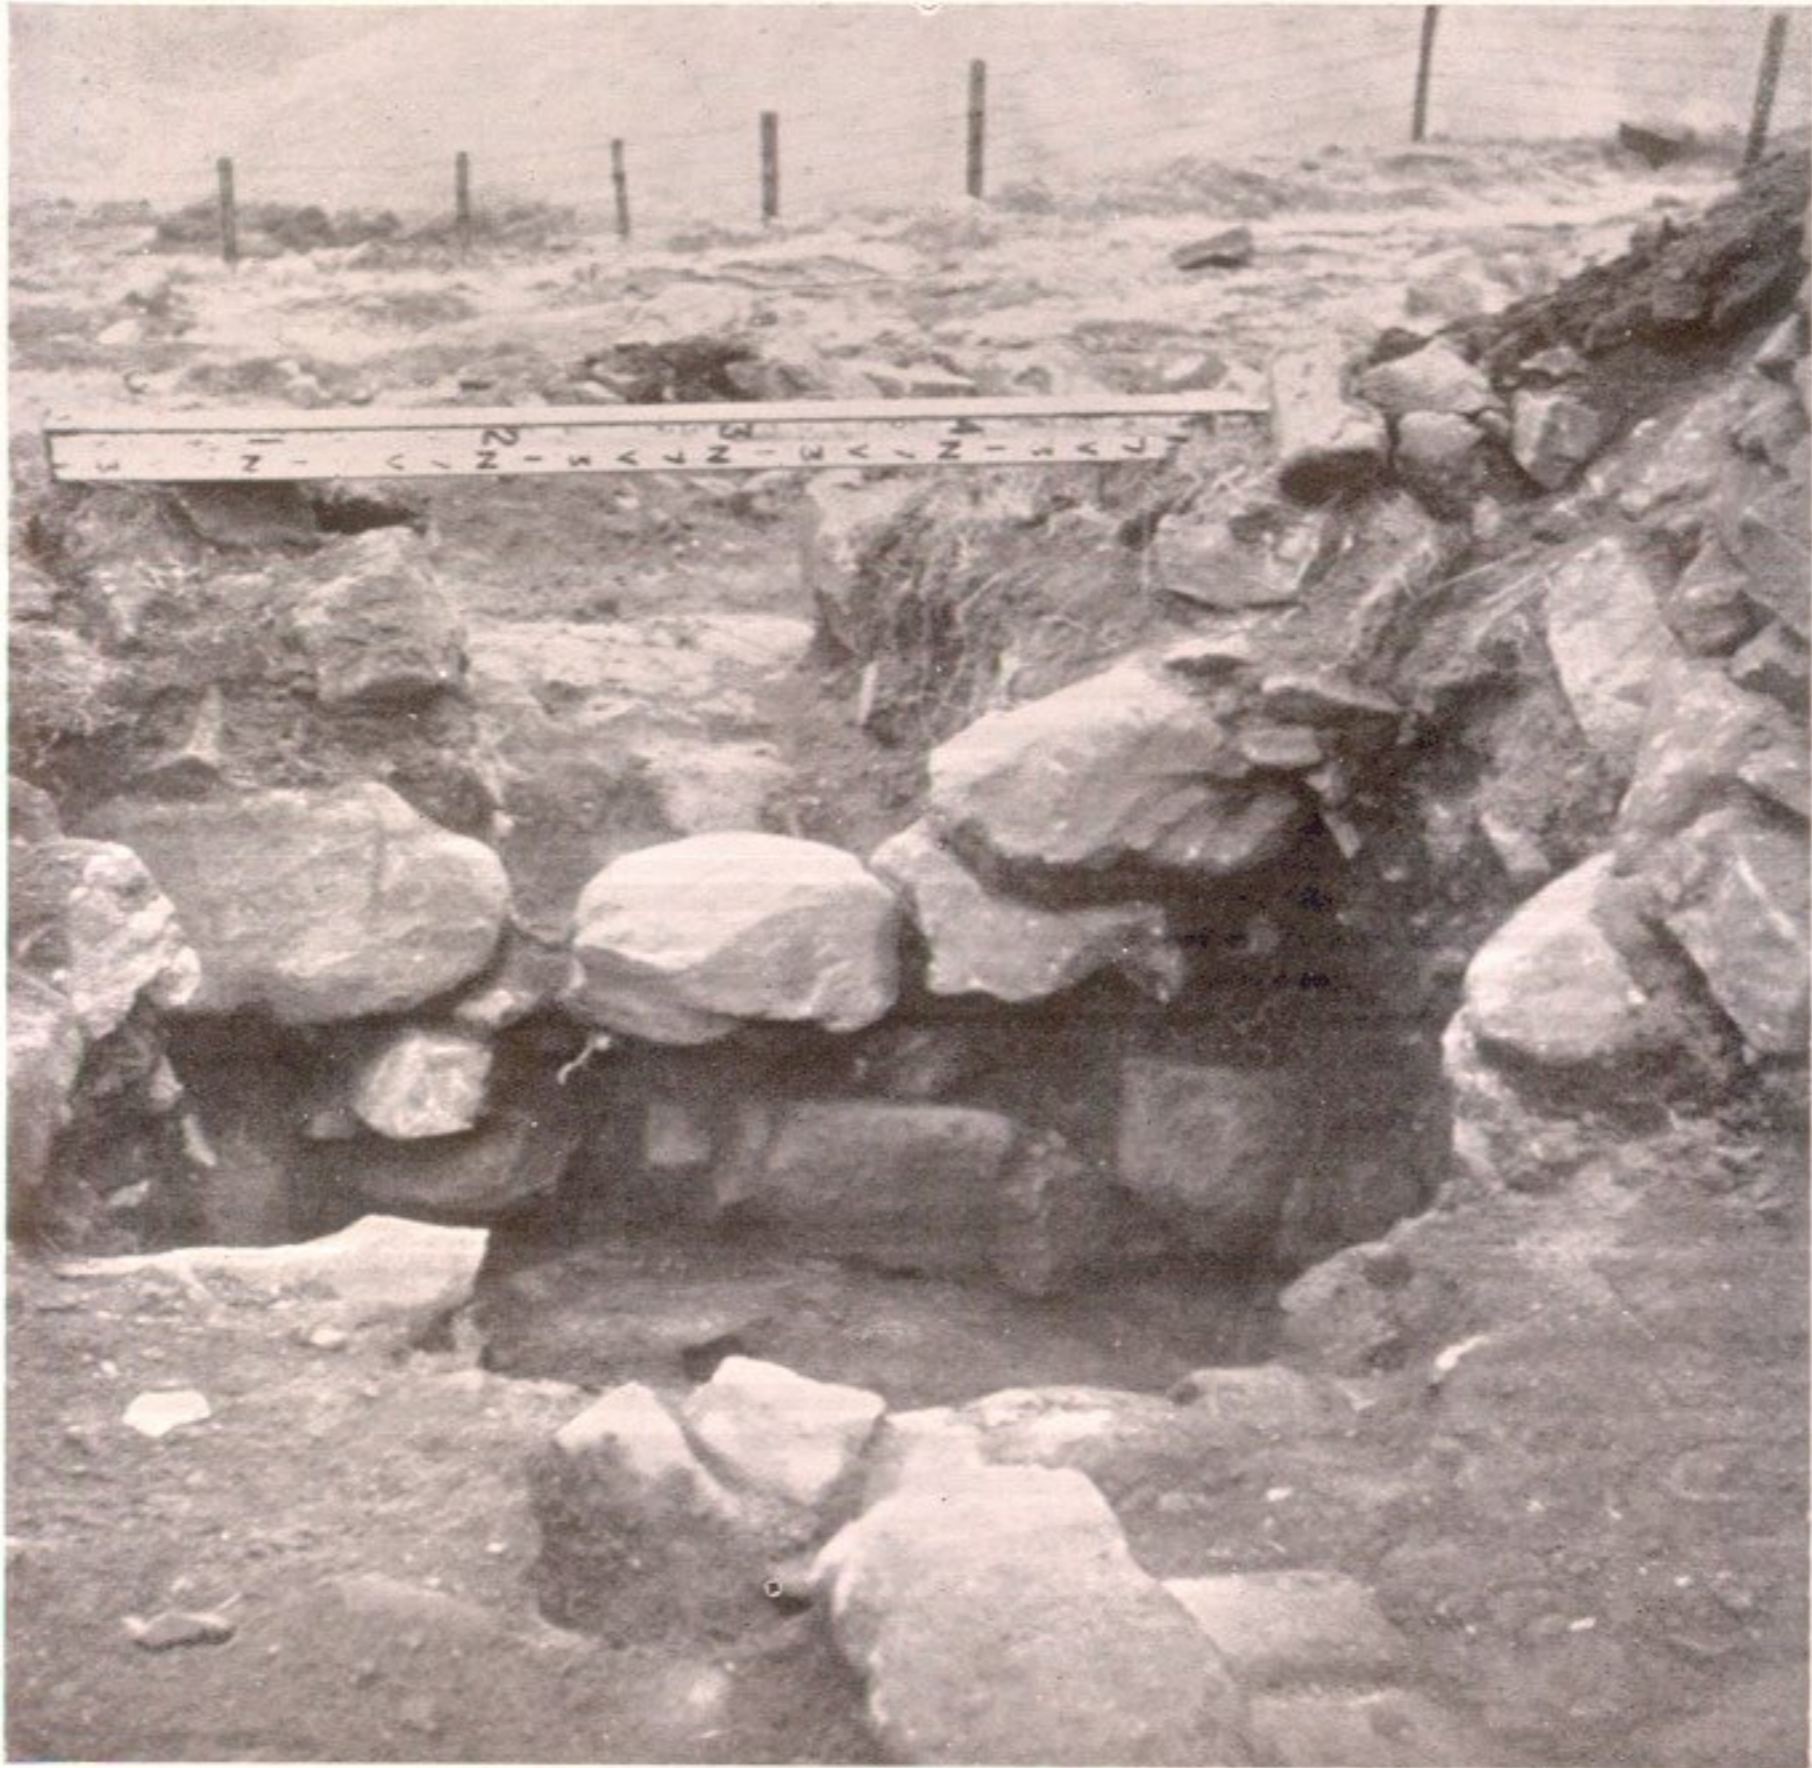
Rampart II, inner face.

In Section FG  $5\frac{1}{2}$  feet in from the outer face a fine inner face to Rampart II was discovered (Pl. XV). It still stands over 2 feet high and consists of two courses of medium-sized stones (*e.g.*  $1\frac{2}{3} \times \frac{3}{4} \times 1$  foot and  $1\frac{1}{4} \times \frac{3}{4} \times 1\frac{1}{4}$  feet), while a third course was represented by a stone 4 feet long (visible behind the staff in Pl. XIV) where it had fallen back outwards from the line of the face. The rampart's core consisted here of stones and earth and may, like Rampart I, have supported a palisade. In fact in the section a triangular hole, only 6 inches deep, was actually found in the rock, which is here flat; the hole may be natural but would serve to take the base of a post. The inner face was exposed in Section AB too, and was followed westward for 12 feet. Here, too, the face was fairly well preserved with two or even three courses in position and using stones as much as 3 feet long.

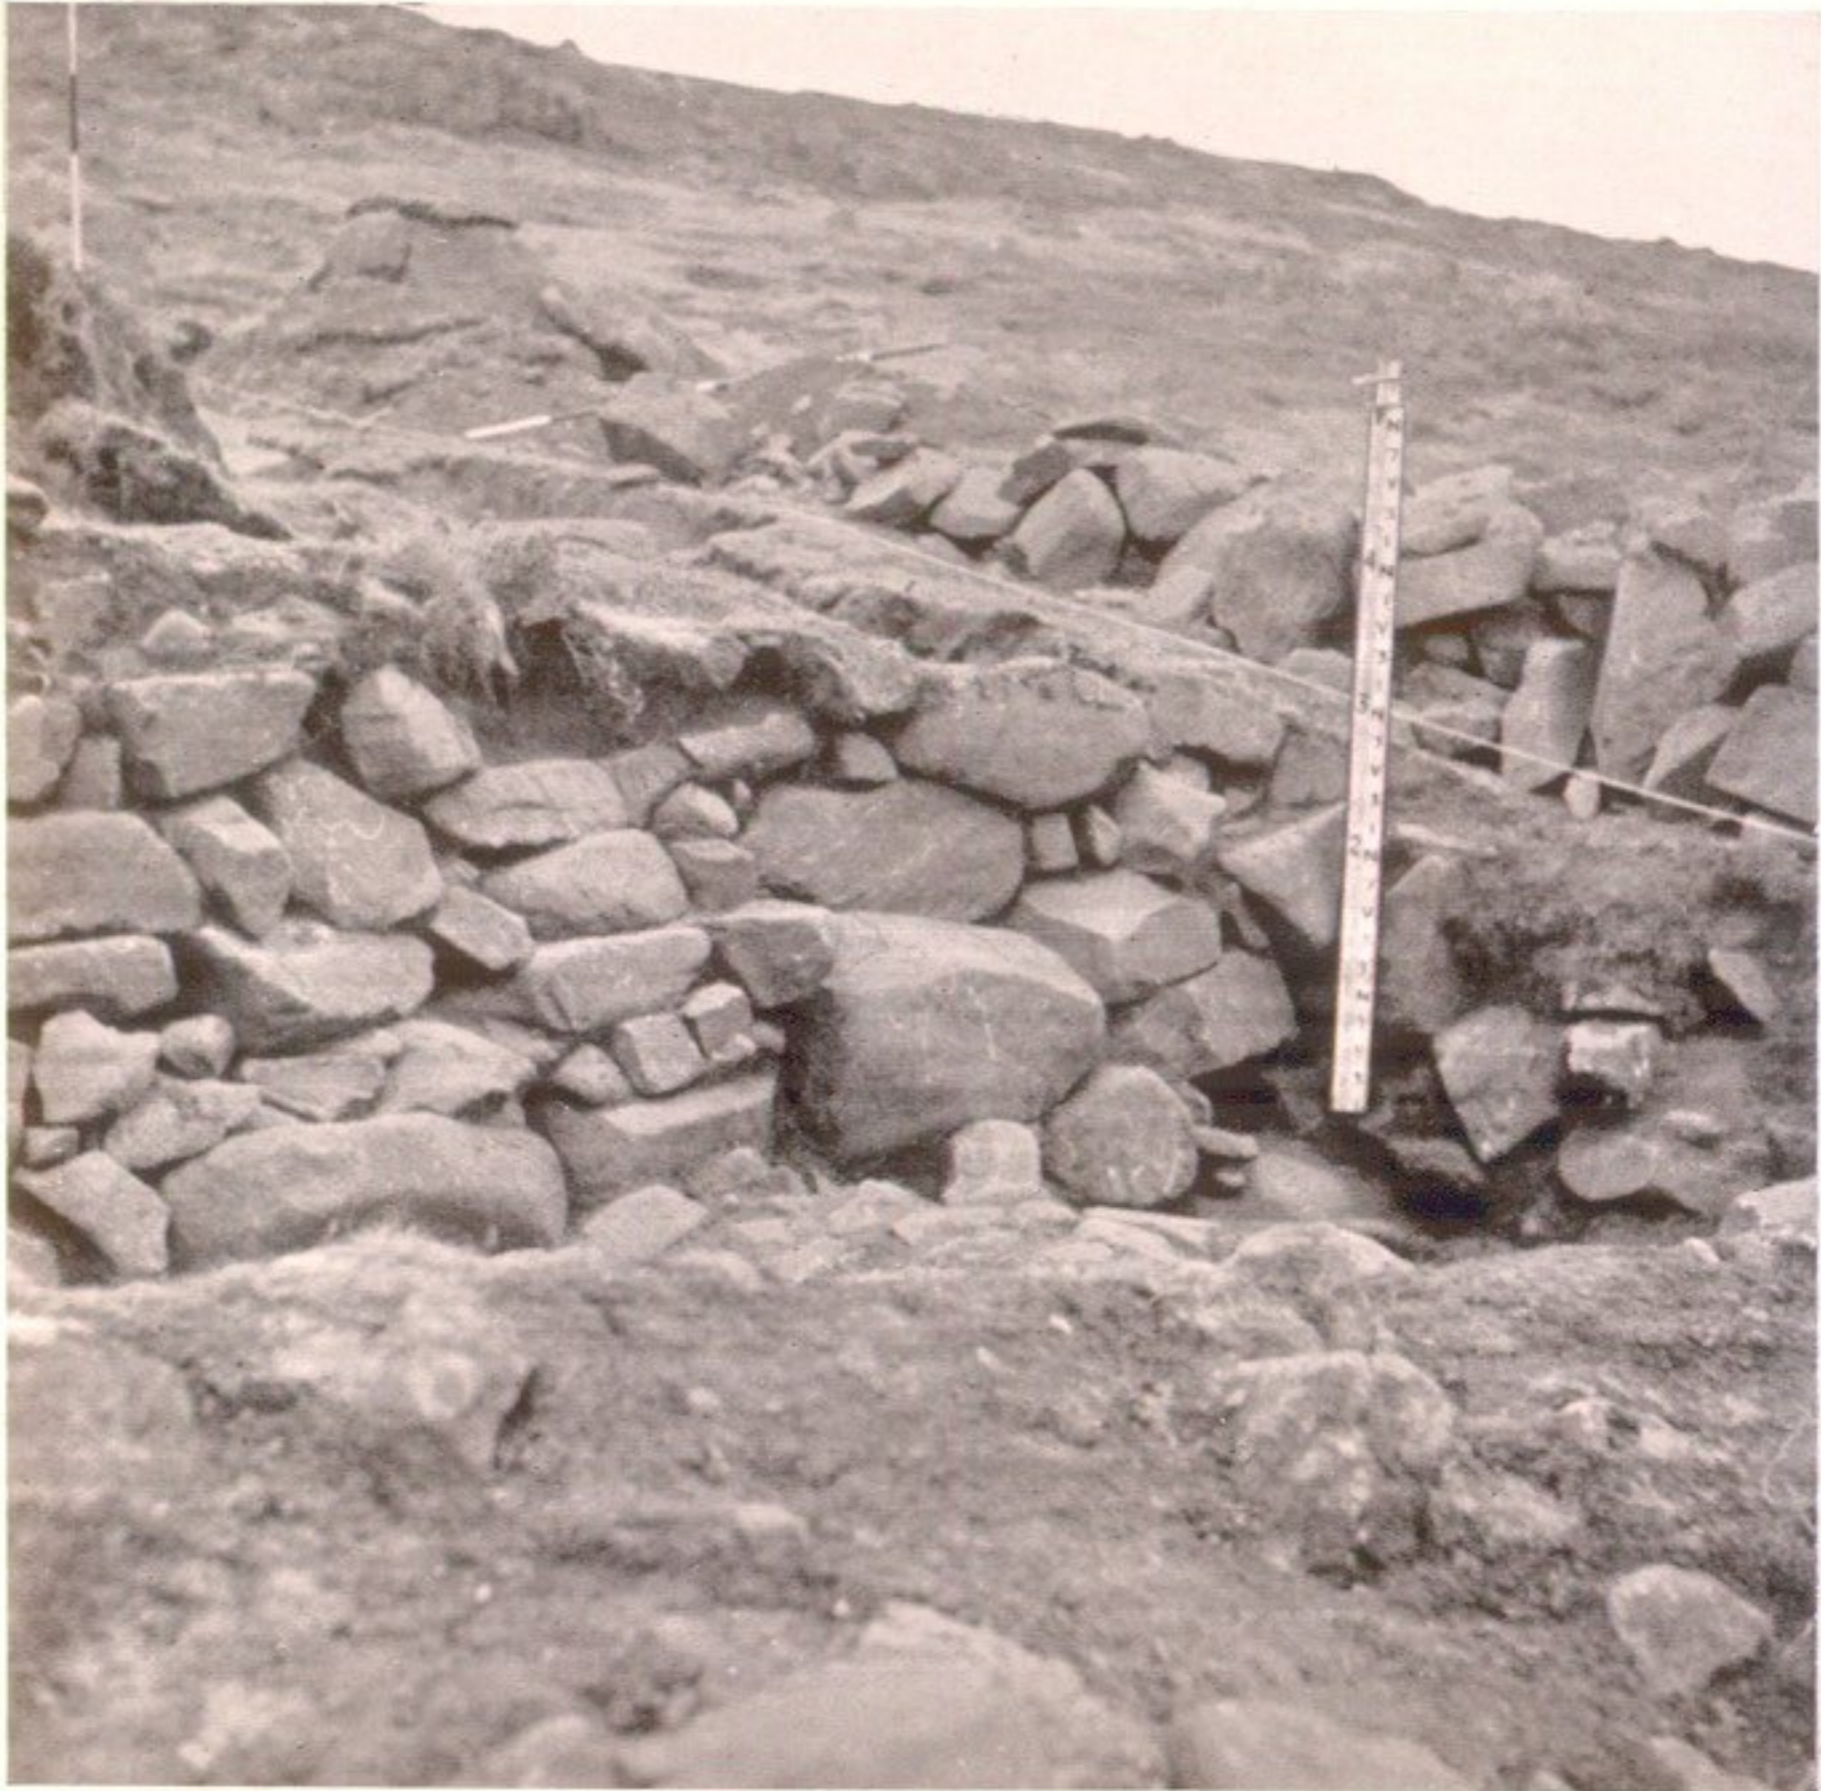
Outer face of Rampart IV on AB.

*Rampart IV* must be described before III as its construction is clearer and its presence has to some extent modified the lay-out of the later rampart. Its front face stands in Section AB some 25 feet back from the inner margin of Rampart II upon a terrace of rock on the 63-64-foot contours. It was preserved to a height of  $3\frac{1}{3}$  feet in places and was traced westward from AB for  $28\frac{1}{4}$  feet, but the preserved height diminishes in this direction as the level of the rock terrace rises as if the top of IV had been levelled off. The face is mostly built with flat slabs having straight outer edges, nicely coursed throughout and standing with a batter of 1 in  $3\frac{1}{4}$  (Pl. XVI; fig. 2, CD, JK). Wedging-stones have sometimes been inserted under

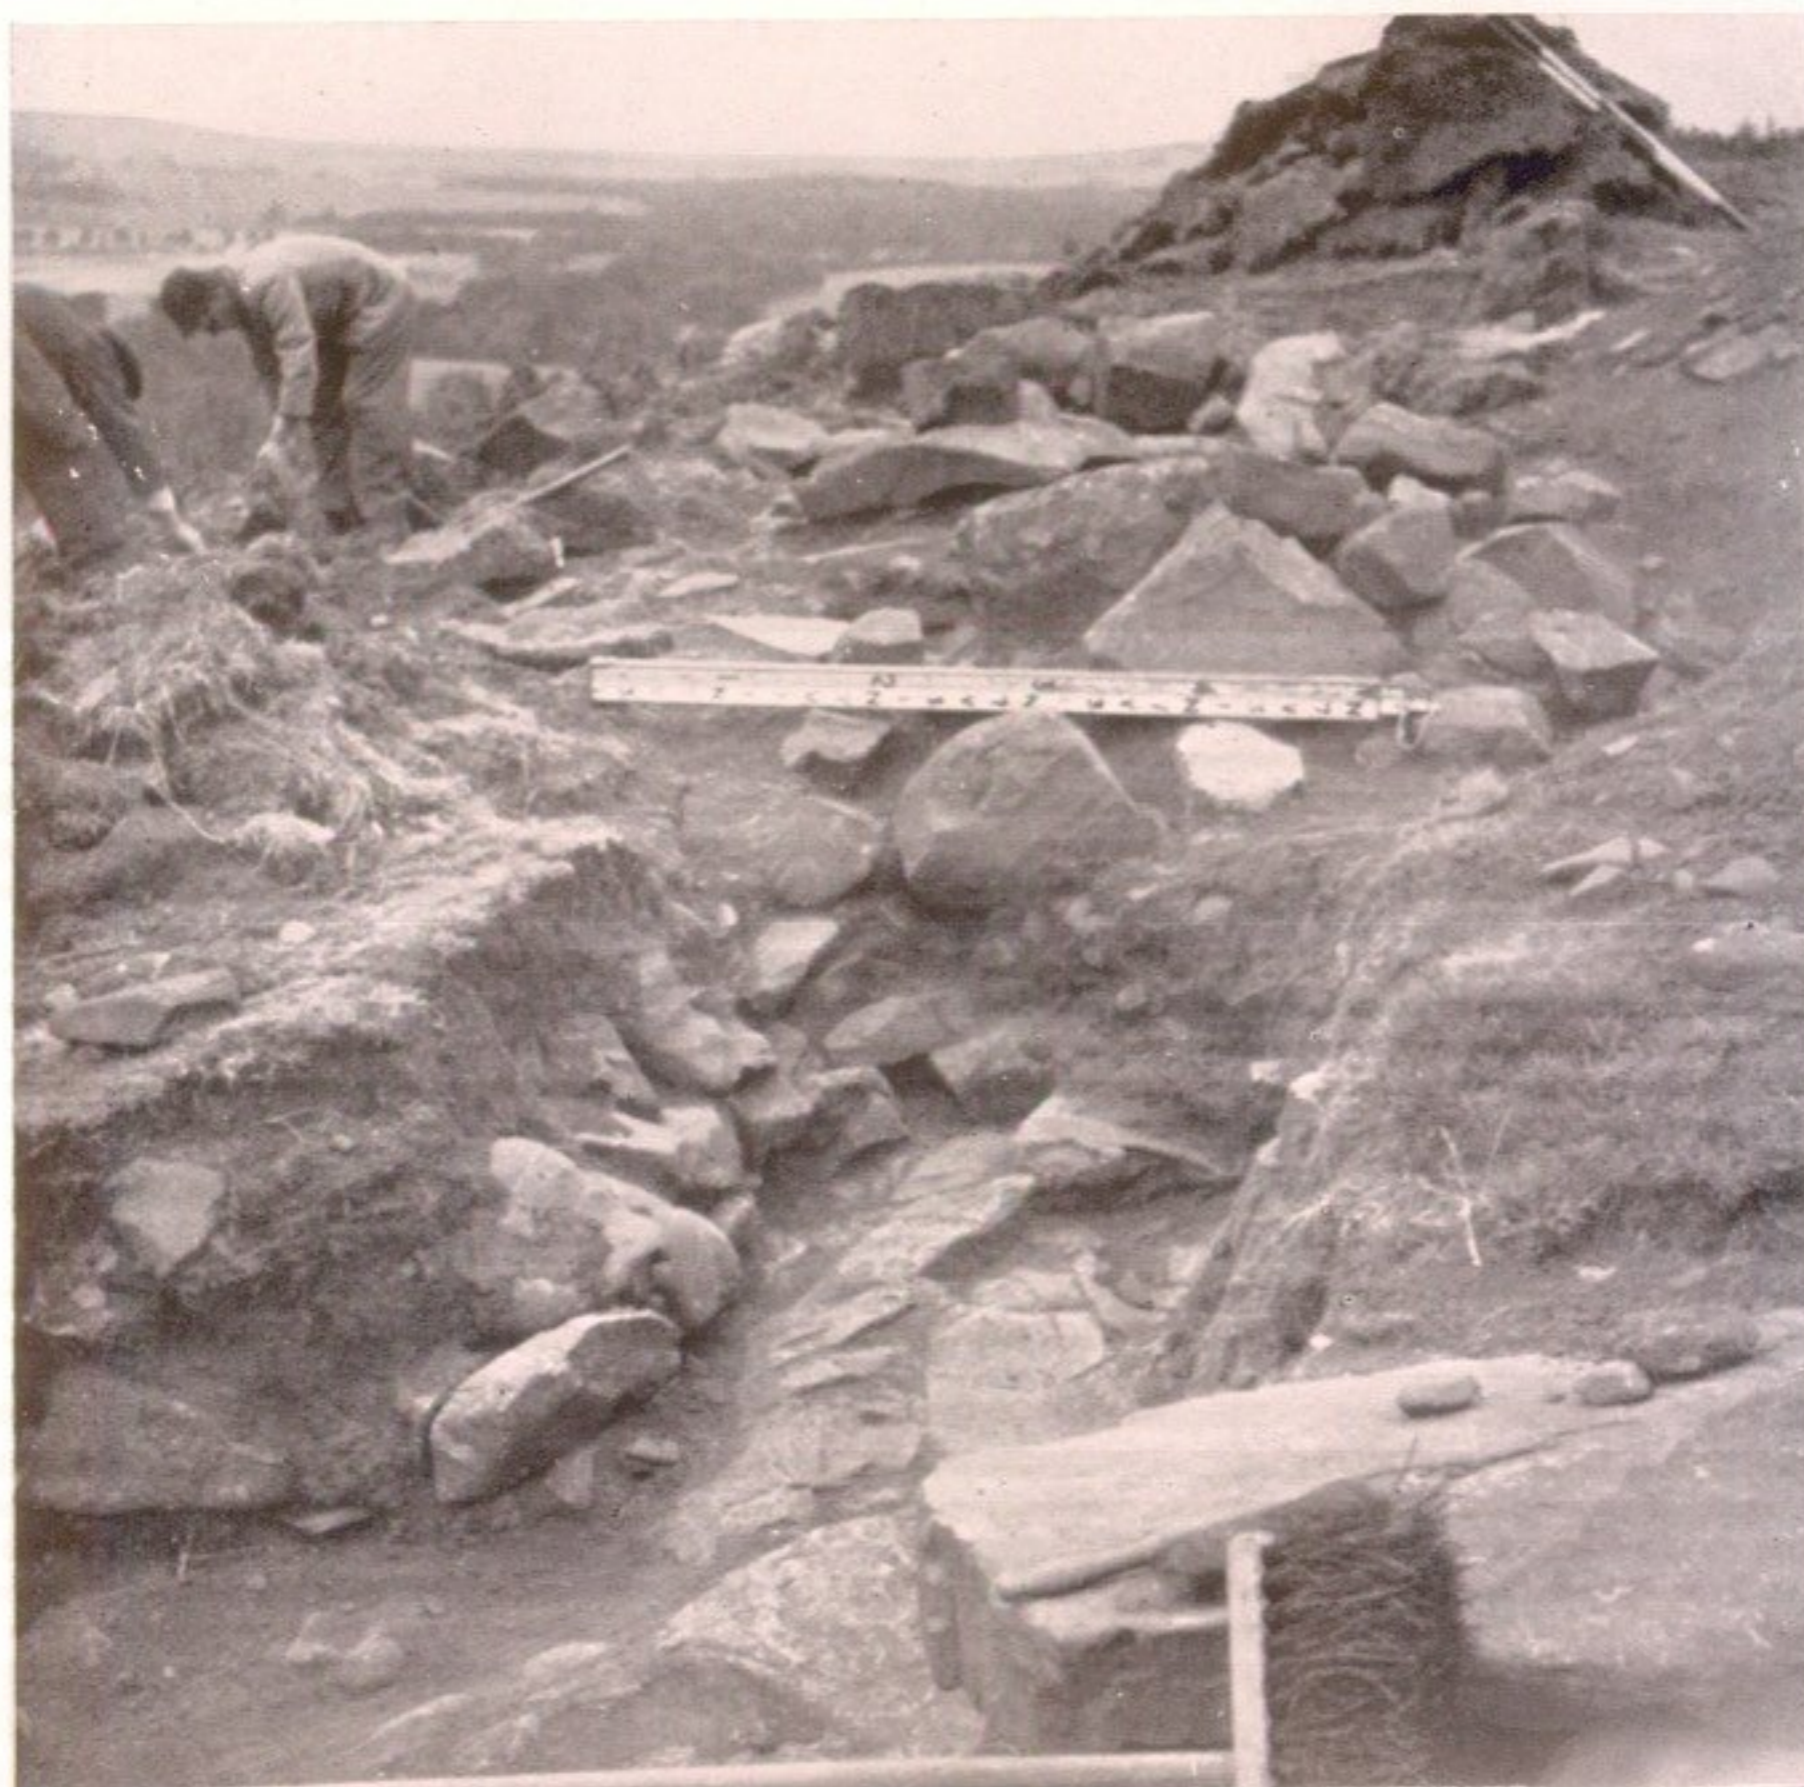
Back of Rampart IV and Hut-circle 1.

Hut-circle 2 is built right over the line of Rampart IV, the northern margin of which can be seen disappearing under the circle wall in Pl. XVII. Stones from the north face have been displaced to form the circle wall, while its floor is just the stump of the rampart core. There is thus no doubt that Rampart IV had gone out of use before the hut-circle was built. It had in fact been long previously replaced by Rampart III, to make room for which the older work had been partly demolished. Twenty-eight feet from AB the outer face of Rampart IV stops abruptly to make room for Rampart III (Pl. XXI). In Section FG only one stone that might have belonged to the foundation of IV could be detected. The inner face still survived in the eastern part of this section, but seems already disturbed on the west (Pl. XVIII, right). In Section LM instead of the inner face of IV we encountered on its line the collapsed Rampart III. This rampart is accordingly later than IV.
