THE DEFENCES OF KAIMES HILL FORT, MIDLOTHIAN.

BY PROFESSOR V. G. CHILDE, F.S.A.Scot.

*Read January 25, 1941.*

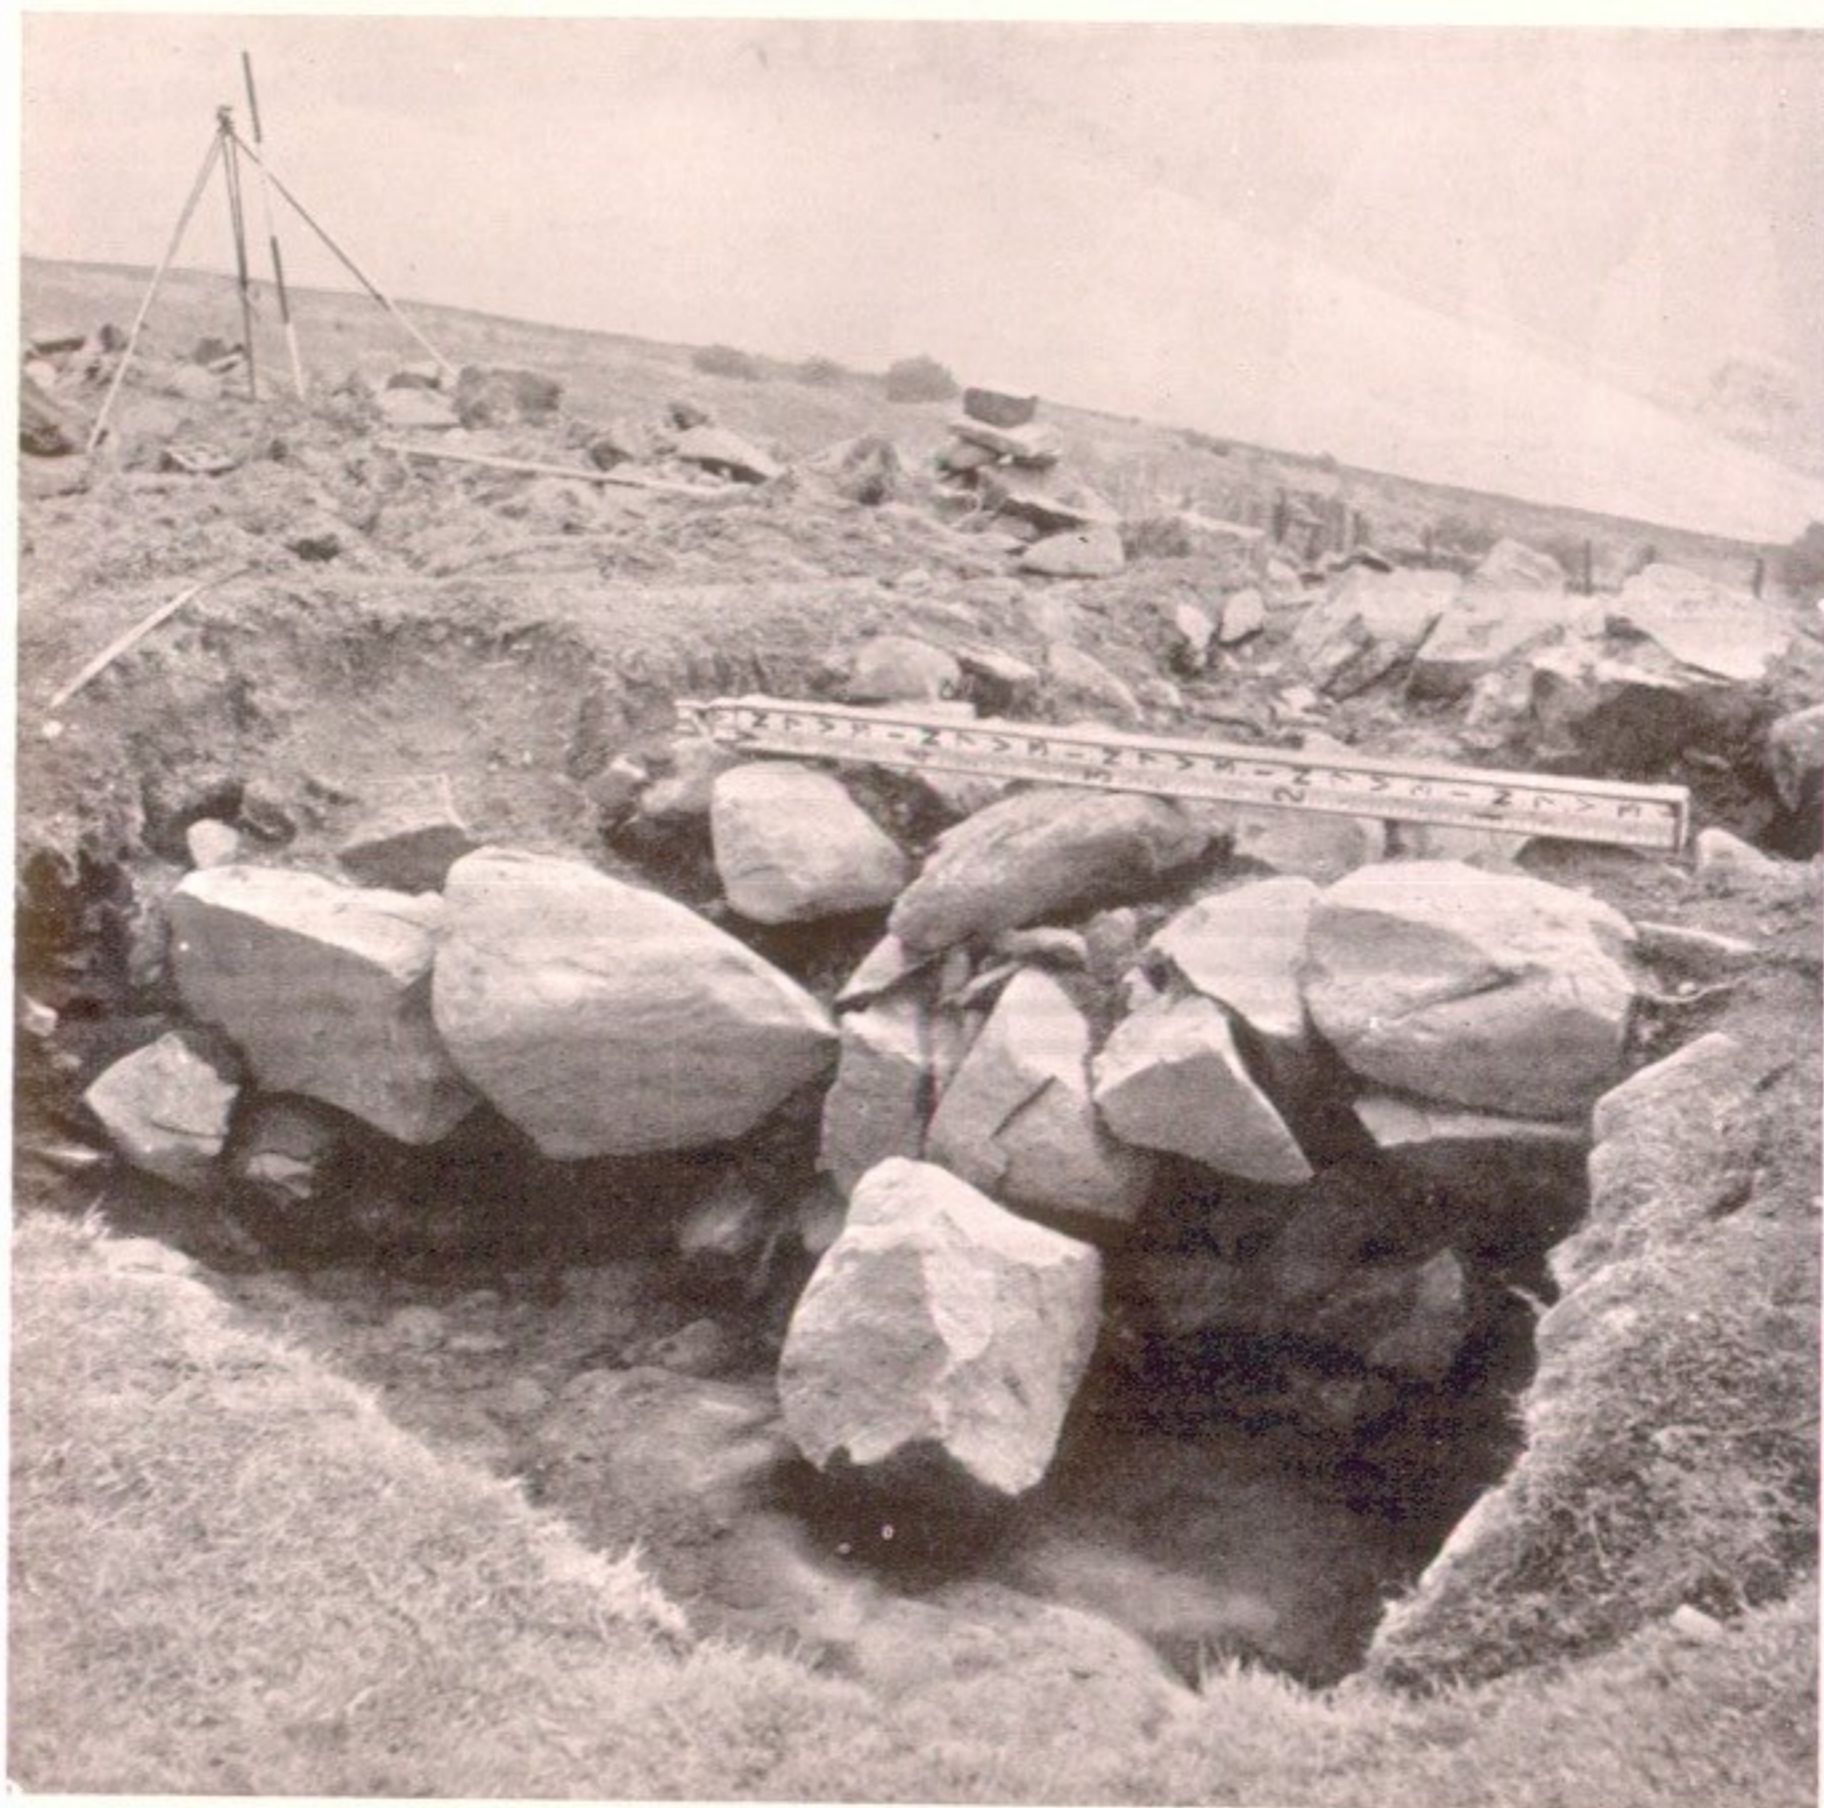
Rampart IV, inner face in FG.

In Section FG an enormous boulder measuring over  $4 \times 3\frac{1}{2} \times 2$  feet had been incorporated in the core of Rampart IV (fig. 2). Between this boulder and the facing slab shown on the left in Pl. XVIII was a space over 6 inches wide filled only with black earth free from any stones, and at its base the rock dipped steeply as if quarried. So the masonry Rampart IV, too, may have been reinforced near its inner margin by a timber breastwork.

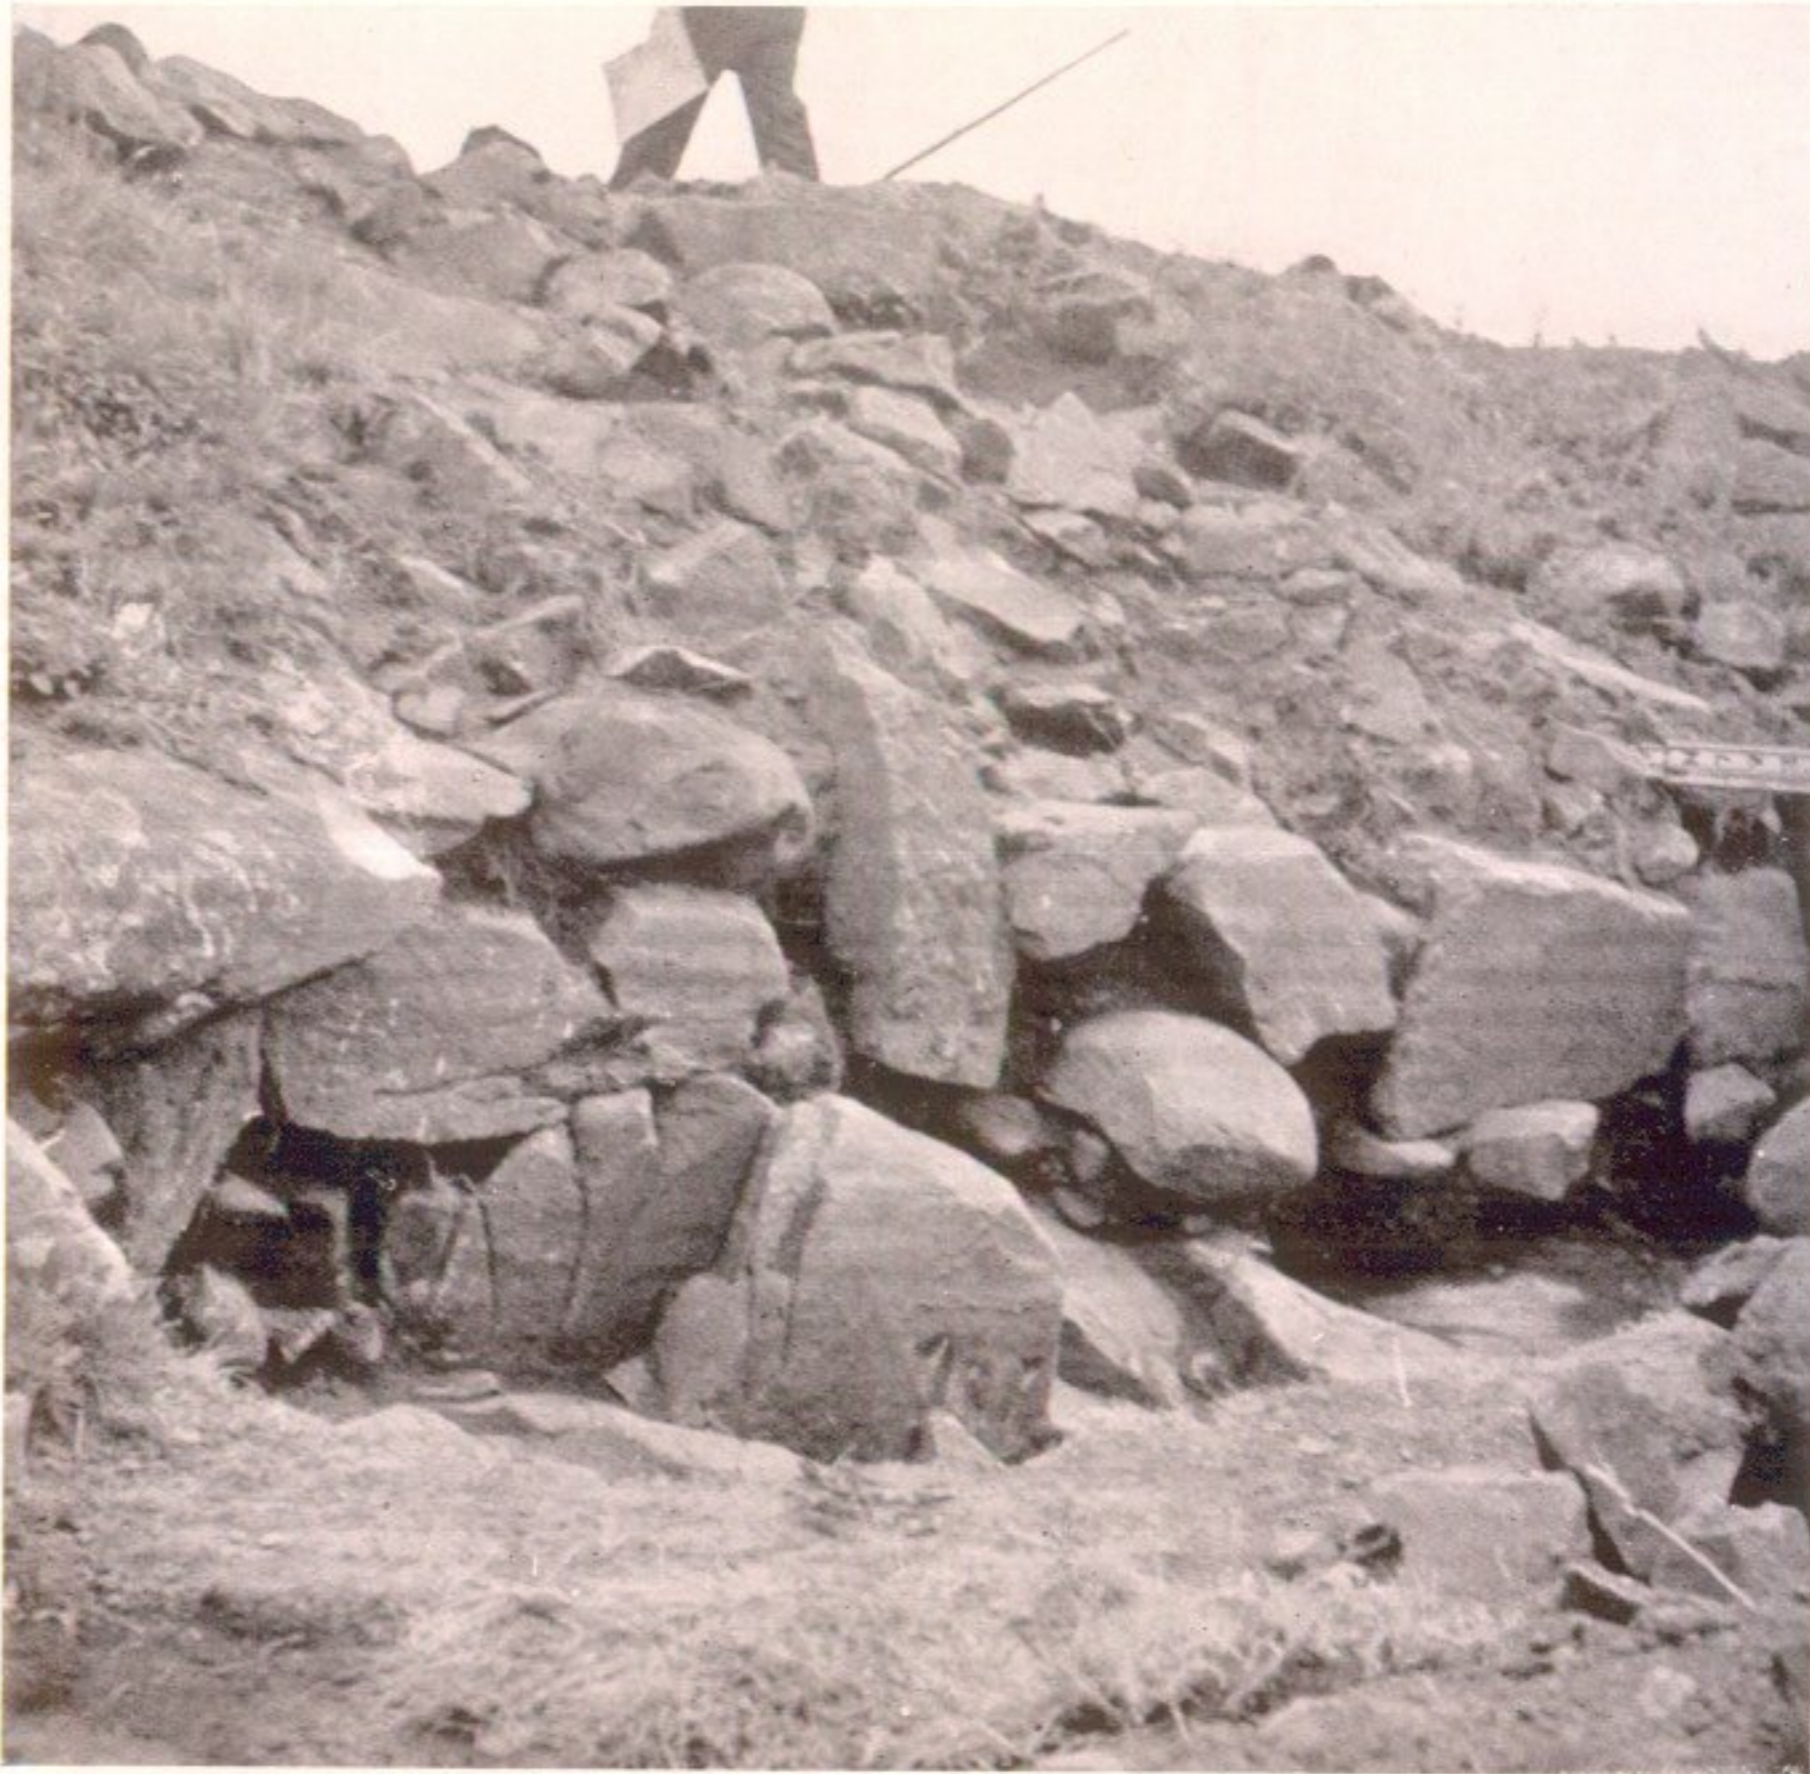
Rampart III, face in AB.

we were exceptionally fortunate in finding the foundation of the outer face in position 8 feet from the back of Rampart II and preserved over a distance of nearly 12 feet (Pl. XIX). At both ends of this strip the foundation blocks had slipped, and no corresponding face remained in position in the 10-foot wide Section FG.

The basal course of the rampart face in AB consists of quarried blocks, squared in front and on top, of lengths  $2\frac{3}{4}$ , 1,  $2\frac{1}{2}$ , and  $1\frac{1}{2}$  feet and heights 1,  $2\frac{1}{4}$ ,  $1\frac{1}{2}$ , and  $1\frac{1}{8}$  feet. Three are lying horizontally, but the second is set on edge, being  $2\frac{1}{4}$  feet deep (fig. 3). Only one block was resting directly on a boss of rock, the rest on soil generally with wedging-stones under them. No further courses of masonry rest in position upon this foundation. Hardly any stones, fallen outwards, were found outside, *i.e.* south of, the line of face just described. But above and behind it was a stony slope on line AB culminating 7 feet above its base and 8 feet behind it in a crest of stones projecting through the turf (Pl. XX), which can be followed all round the western part of the hill.

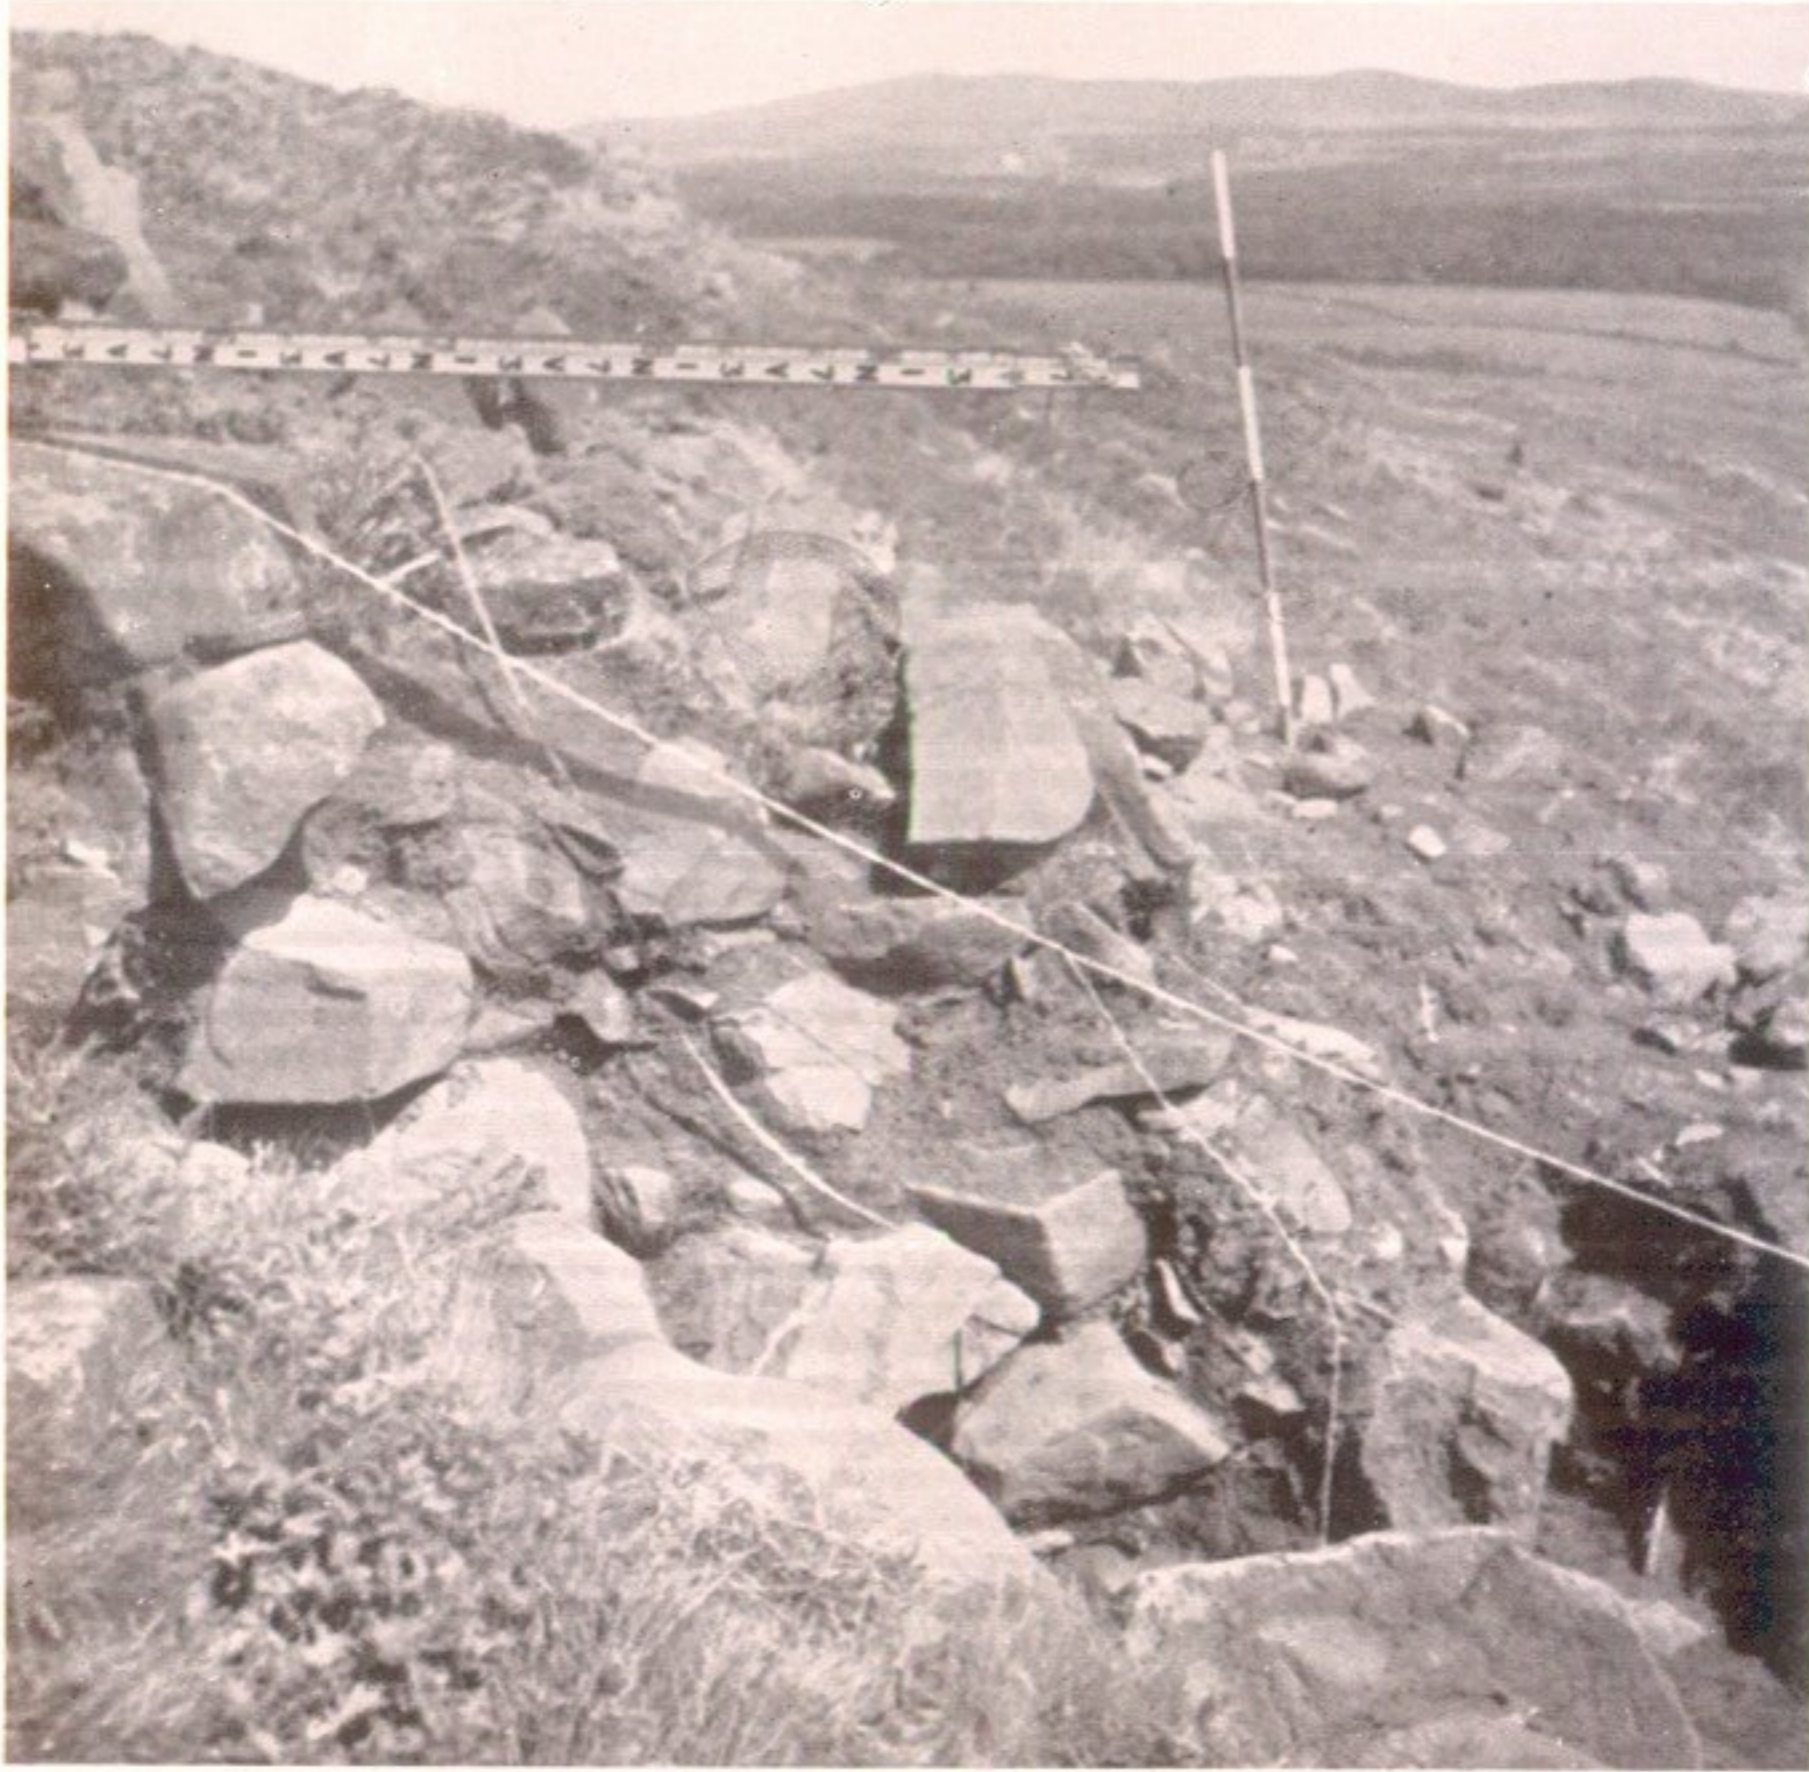
Debris of Rampart III.

In Section AB the slope was found to be formed of an accumulation of stones, mostly 1 foot cube or larger, lying in disorder with much earth between them against the rock which rises in steps 3 feet (from 57.5 to 60.5) in the 8 feet of section (figs. 2, 3). The stones definitely gave the impression of having fallen back inwards from one or more faces in which they had once formed southward-fronting courses. But no foundations for an inner wall were discoverable in the chaos.

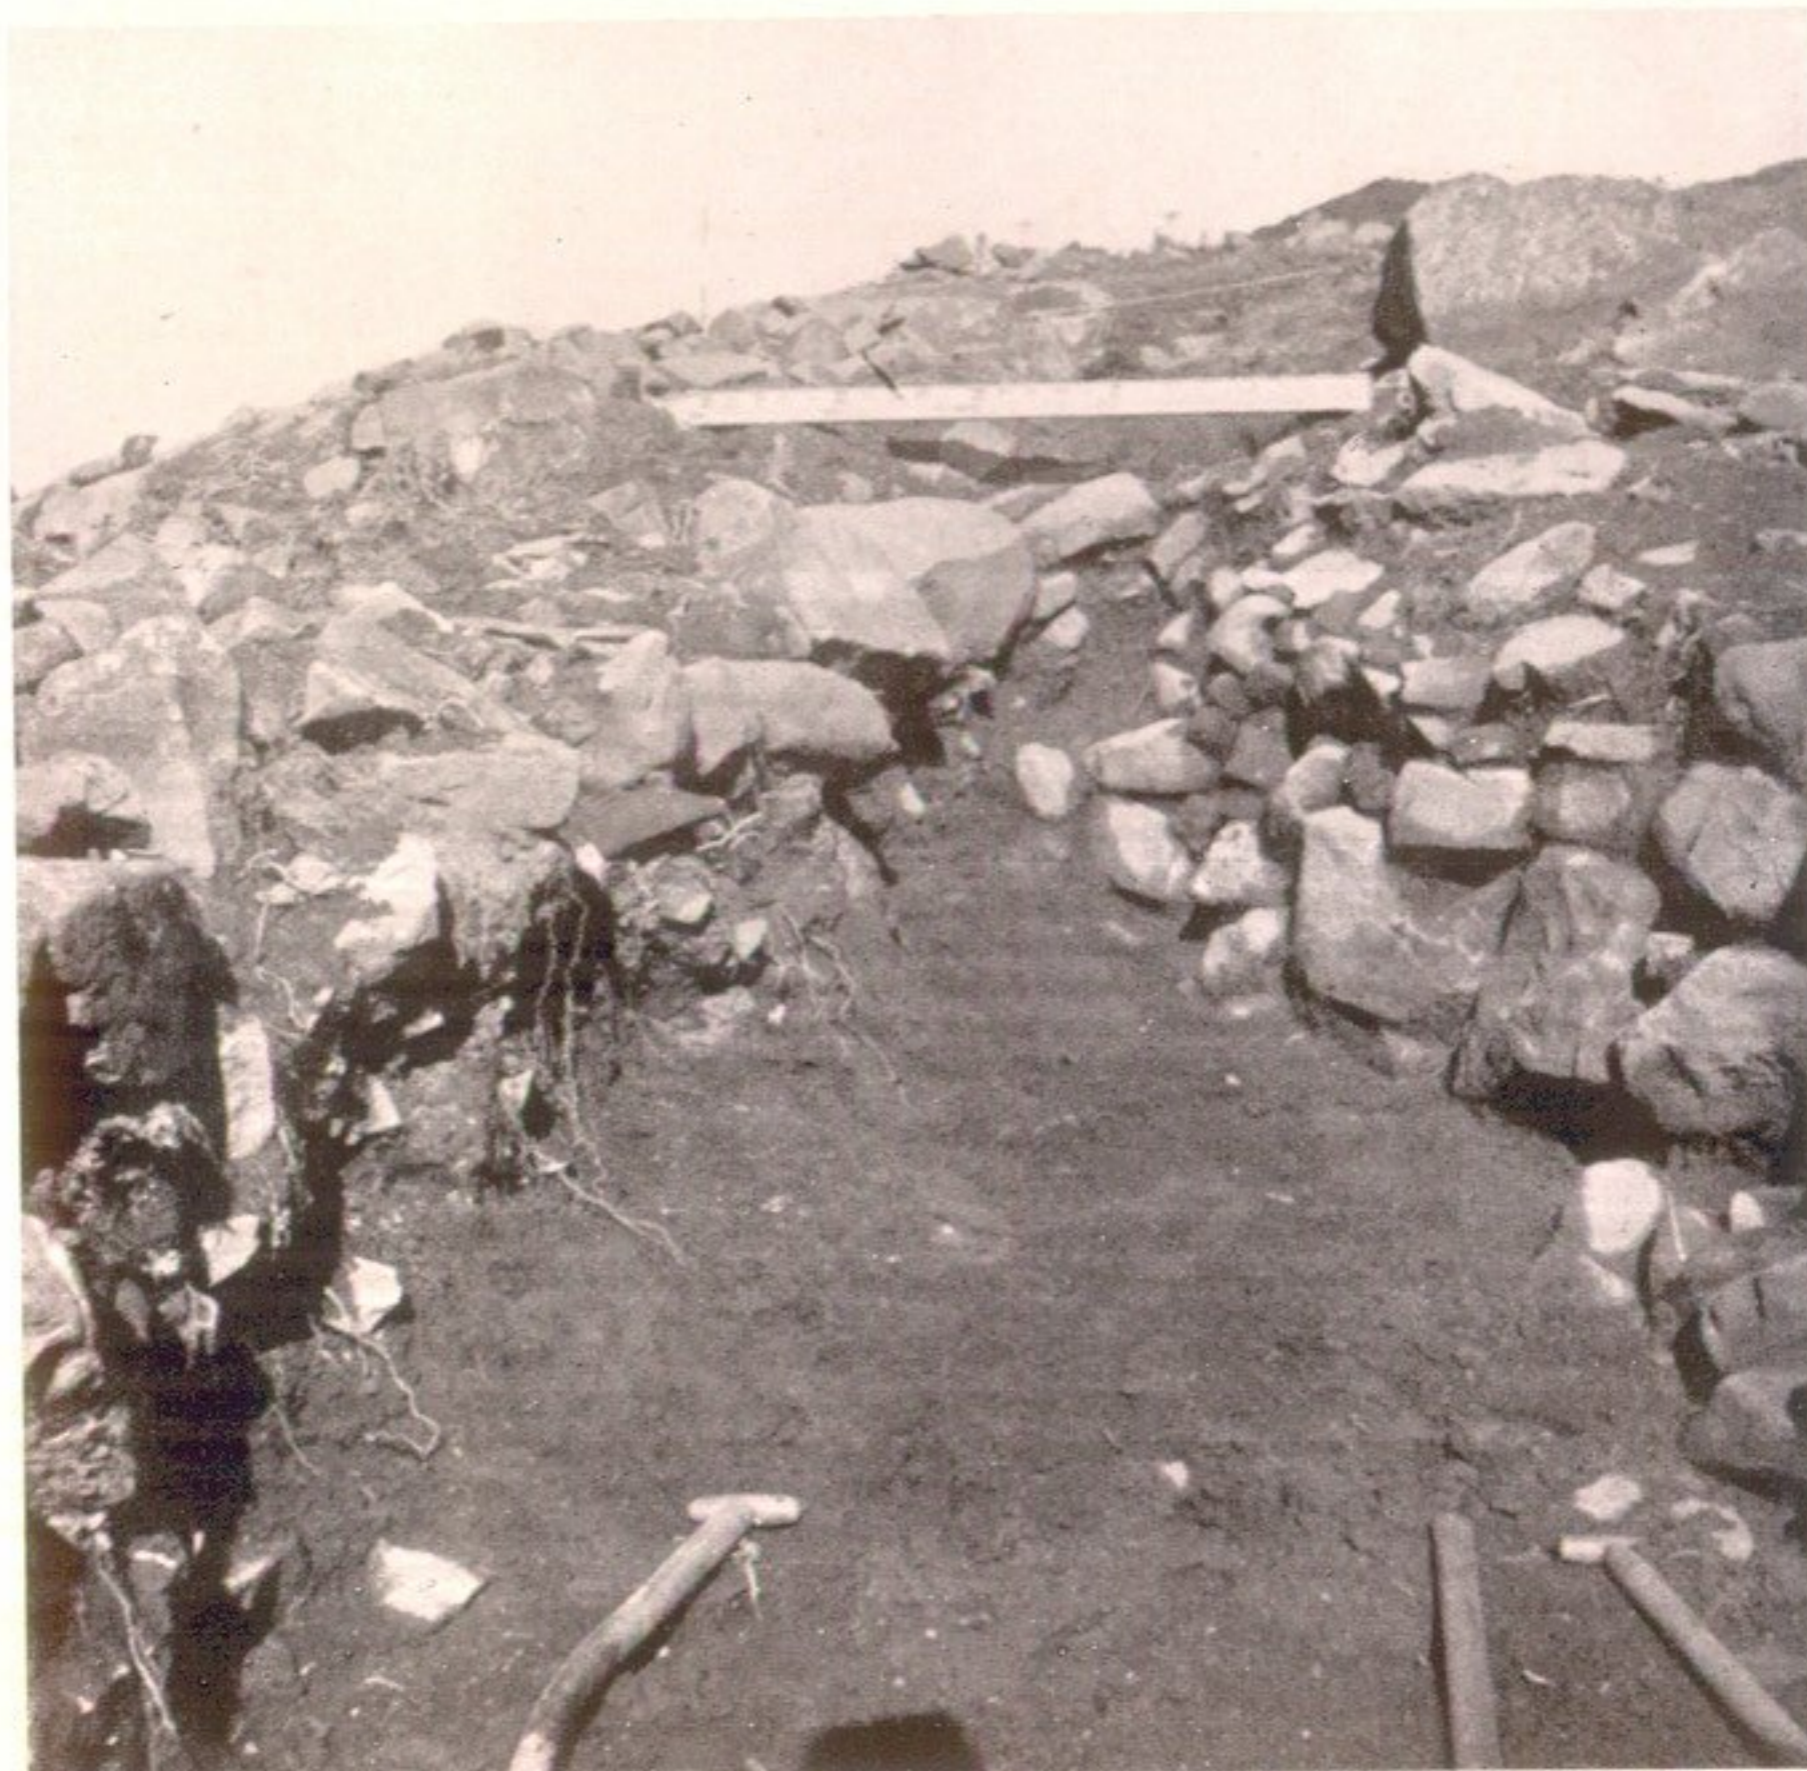
Back of Rampart III and end of IV.

Removing the loose midden, beginning at the face of IV, we found stones increasingly numerous as we approached the crest of III, and at the crest-line the stones would in fact stand upright in a sort of breastwork, 2 to 3 feet high (Pl. XXI, left). In part of this area we exposed at the base of Rampart IV and roughly level with the rock terrace on which this stands a well-made pavement in and under the midden deposit (Pl. XVI). There was a layer of midden under the pavement, and below

The breastwork is clearly not an "inner face" to Rampart III. The component stones are not laid in courses but are resting at all angles, and there is midden between and under them. It is rather the result of the collapse of some structure which has simply fallen backward on to an already existing accumulation of midden in such a way that its topmost courses have fallen furthest northwards and become embedded in the midden (fig. 2, J-K). Nevertheless this "breastwork" can be followed westward to Section FG and beyond. Some  $17\frac{1}{2}$  feet west of AB the topmost stones that have slipped backwards from the crest are resting partly as usual on midden but partly against the disturbed upper courses of Rampart IV's south face. Eighteen feet from AB Rampart IV breaks off altogether, its line being occupied with loose stones and midden material till at 20 feet distance the stony "breastwork" itself actually crosses the line of Rampart IV to reappear in Section FG (Pl. XXI).

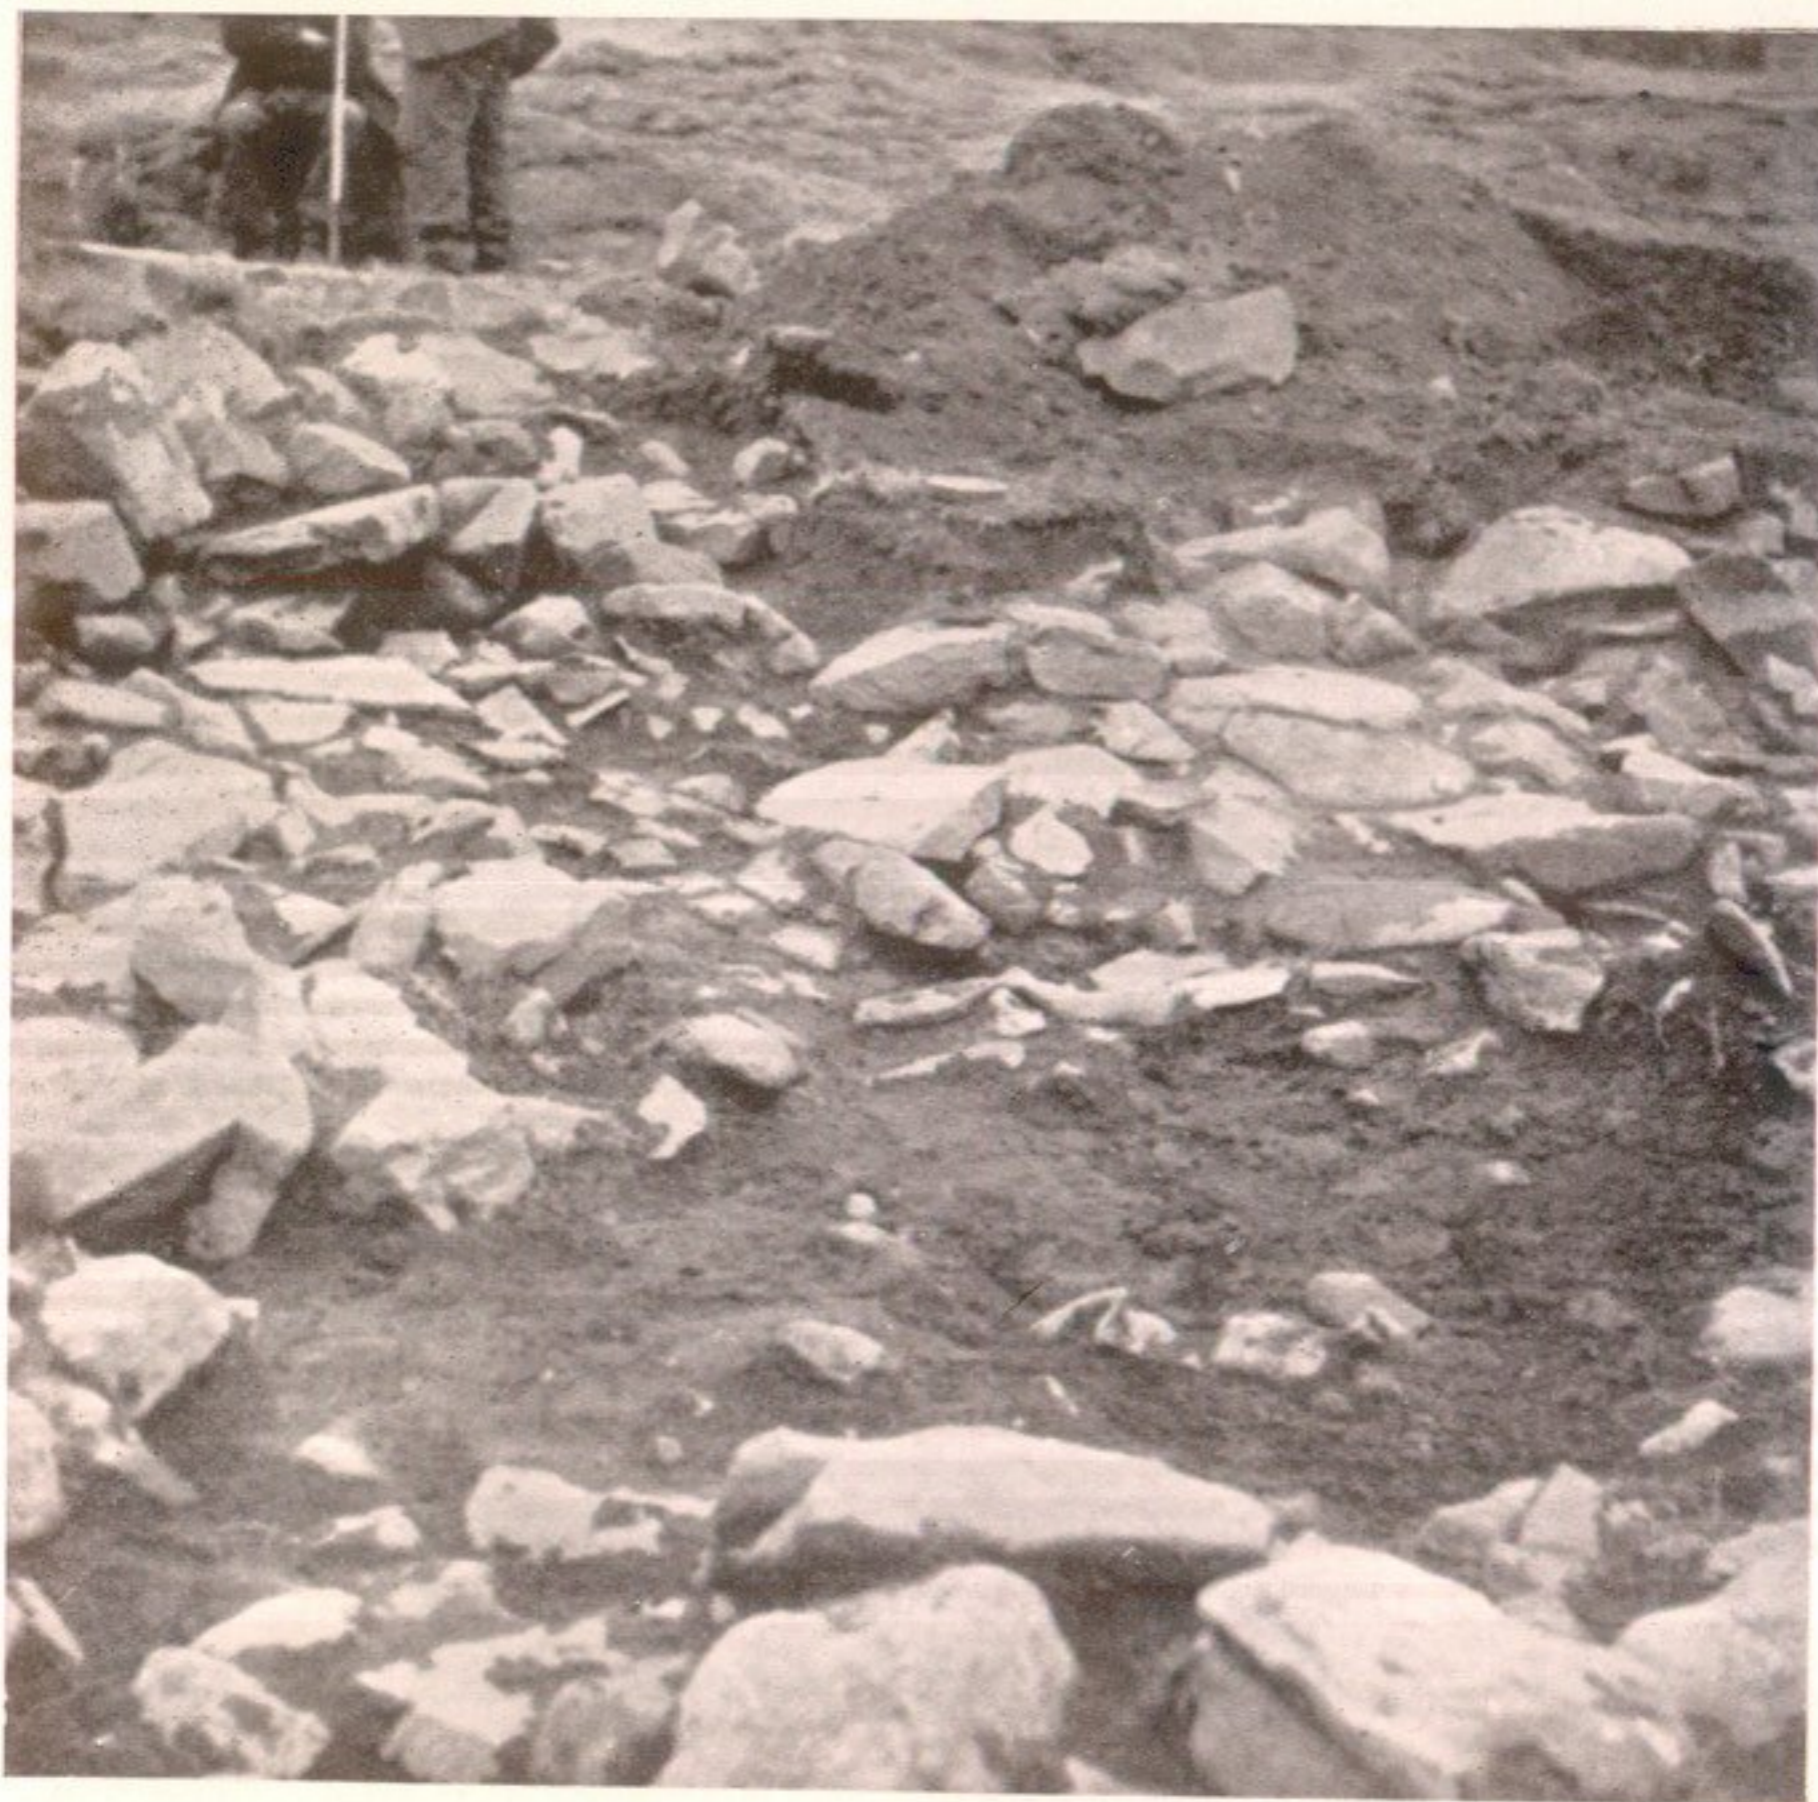
Hut-circle 2 looking north-west.

*Hut-circle 2*, situated 76 to 90 feet west of AB, was better preserved than No. 1. The stones of the wall indeed are less substantial than those forming the north wall of Circle 1, but a sufficient number could be recognised to define a circle 12 to 14 feet in diameter. The northern half of the circle had been paved, largely with small thin slabs that had been split and displaced by grass roots. The floor, thus defined, slopes down north to south at least 1 in 6 feet. In the southern half of the circle hardly any paving survived and the floor level had to be defined by the bases of the boundary slabs.

found resting upon the western kerb (Pl. XXIII) may have stood upright to form a fire-back on the north. To the north and north-west were vague suggestions of a bench or daïs—note particularly the horizontal slab in front of the wall shown in Pl. XXII, upper left. East of the hearth four solid slabs served as lintels to a drain (Pl. XXII). Under these slabs the channel was found empty but not lined with stones. It runs north and south almost parallel to line of Section LM. South of the hearth only a few lintels survived, but the exit of the channel through the southern wall was quite clear and is visible in Pl. XXIII.

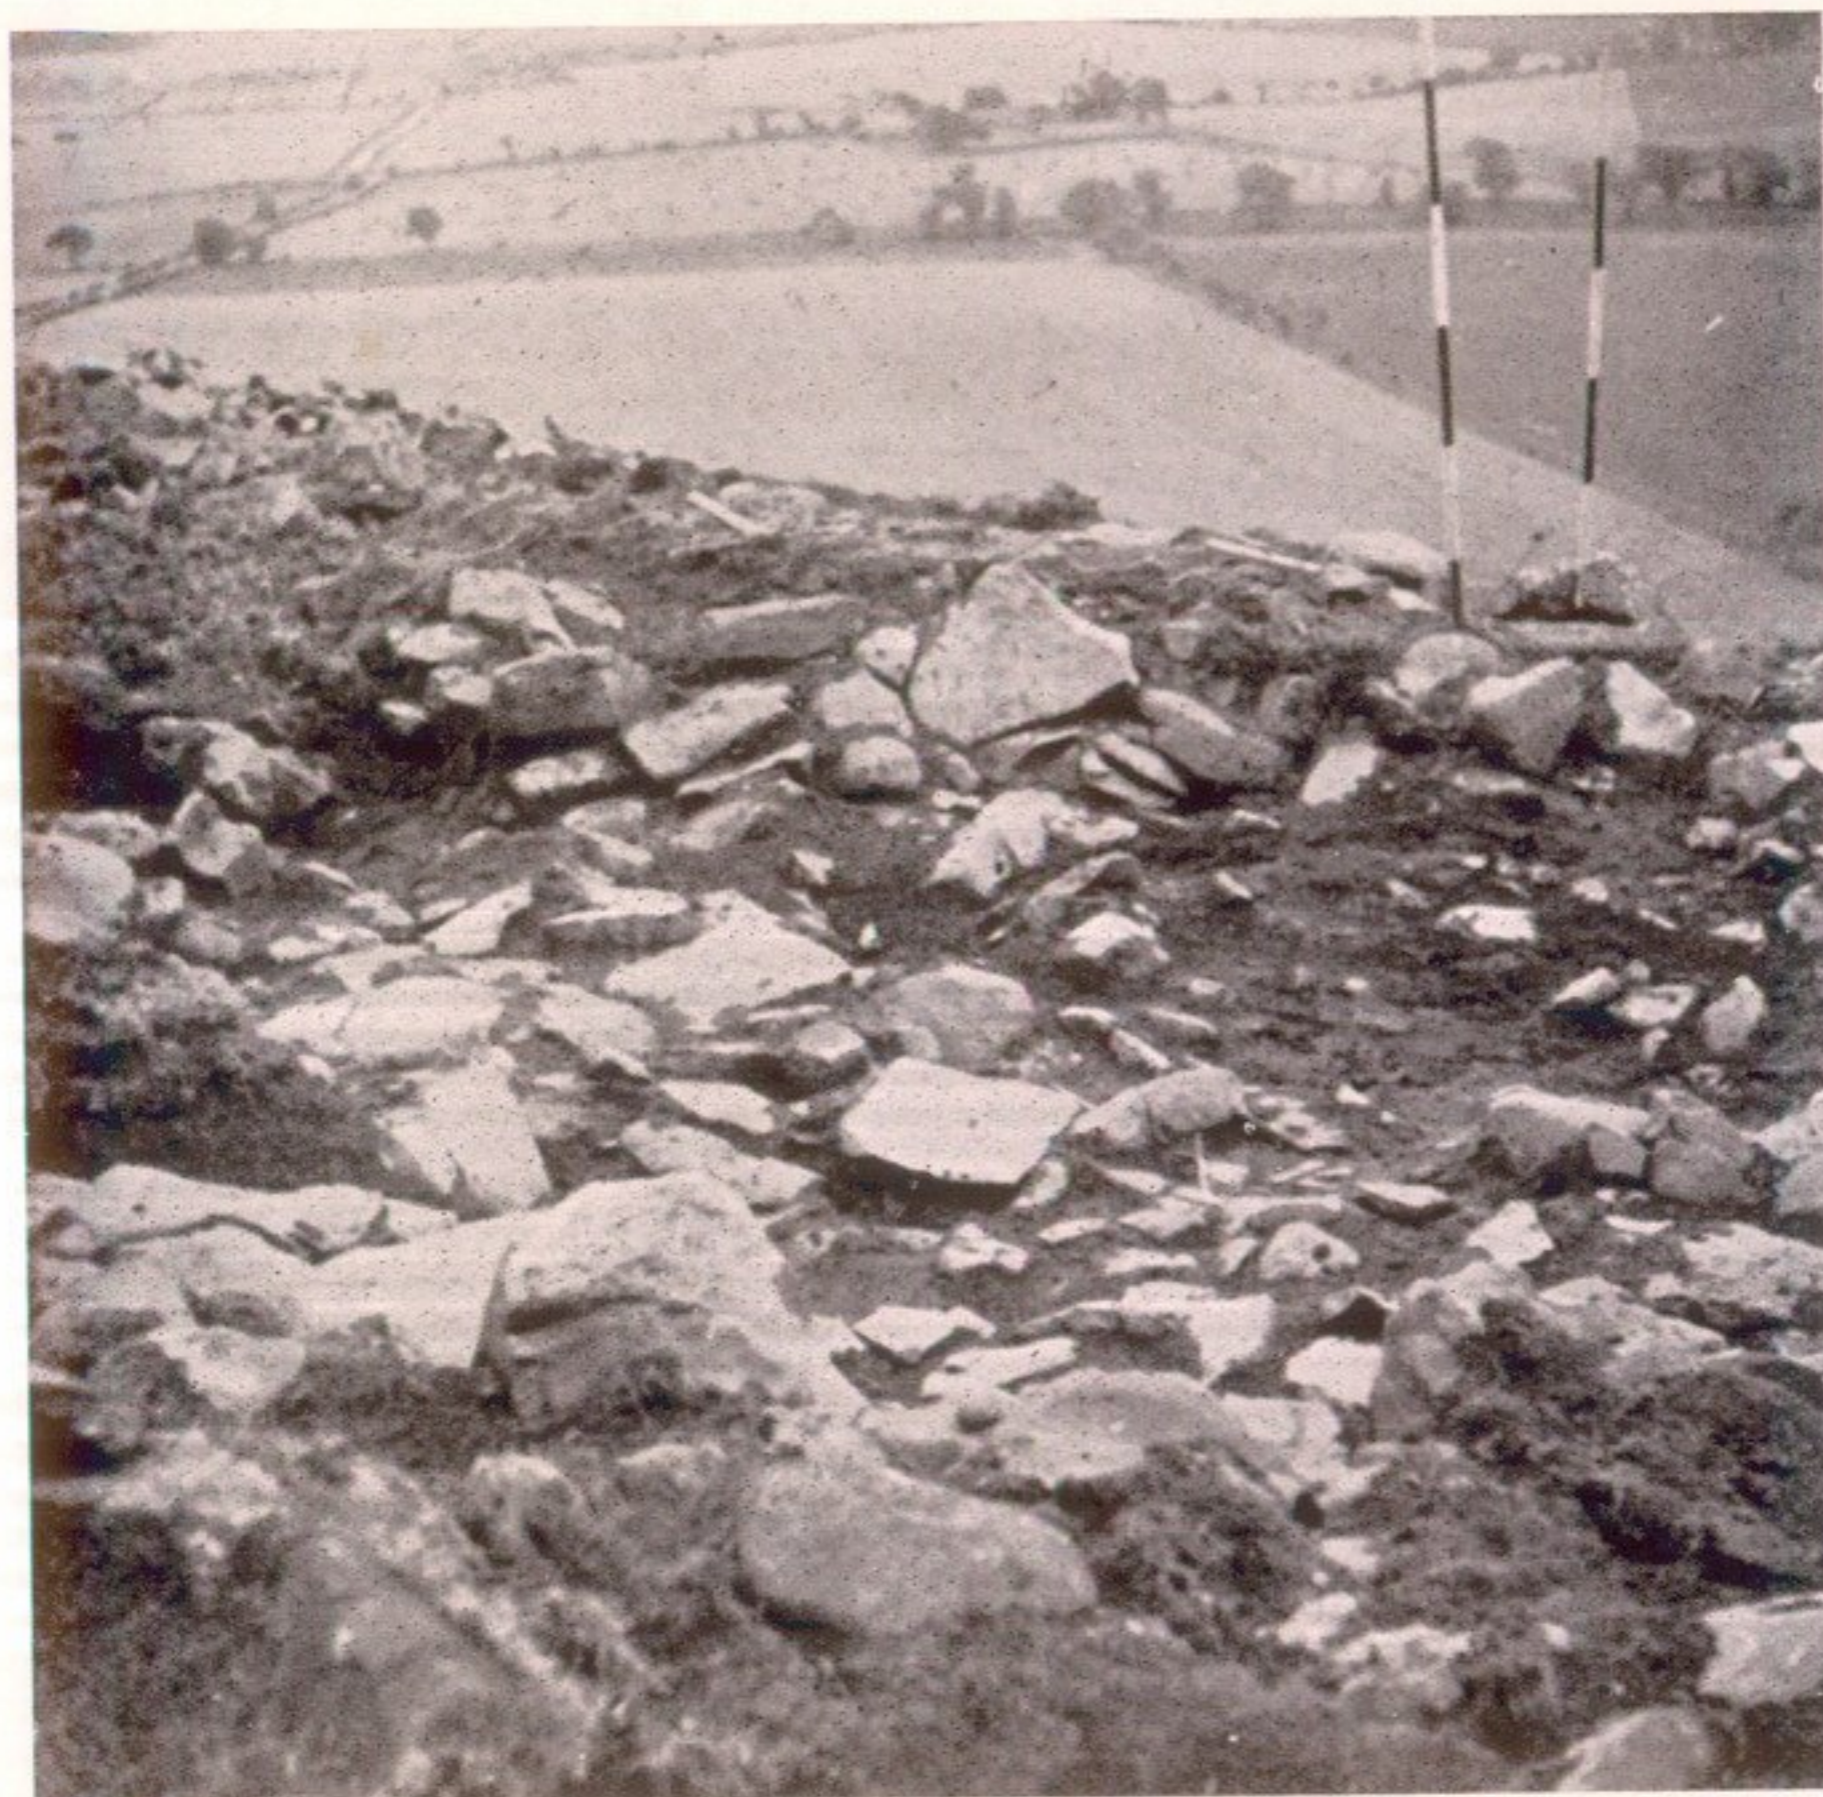
Hut-circle 2 looking south-east.

Near the centre two kerbs, set at right angles, and each about 2 feet long, define a paved area, presumably the hearth (Pl. XXIII). The flat slab

On the east of the circle a gap,  $3\frac{1}{4}$  feet wide, marked the site of the doorway. The northern cheeks of the entrance passage were traceable for a distance of 4 feet (Pl. XXIII), but the paving had gone. On the south the stones had been so badly disturbed by rabbits and nettle roots that the line of the passage wall was doubtful. The stones of the south wall of Circle 2 abut against or mingle with others which, diverging from them, connect up with the crest of Rampart III exposed in Section FG, and carry on the same line westward from Section LM. The arrangement gives the impression that the rampart crest was already very much in its present condition when the hut was built.
