DUN LAGAIDH AND FOUR OTHER PREHISTORIC MONUMENTS NEAR ULLAPOOL, ROSS AND CROMARTY. By C. S. T. CALDER, A.R.I.A.S., F.S.A.SCOT., AND K. A. STEER, M.A., PH.D., F.S.A., F.S.A.SCOT.

I. VITRIFIED FORT AND BROCH, DUN LAGAIDH (fig. 1, 1).

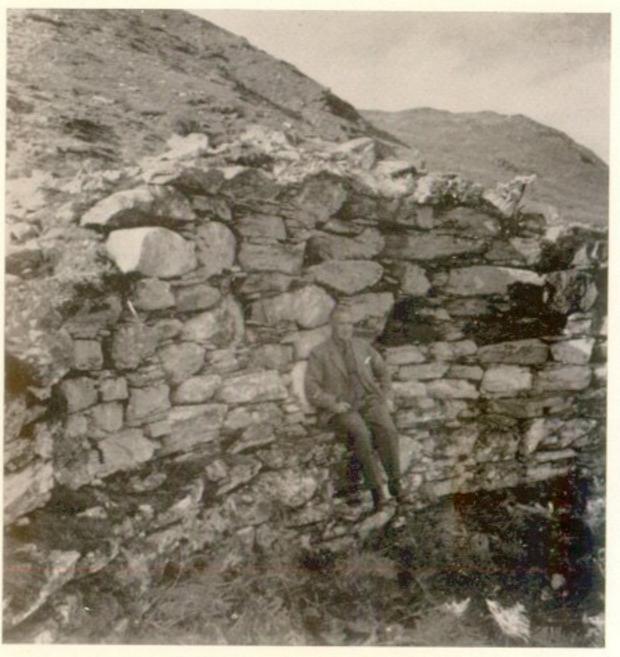
1. Broch, Dun an Ruigh Ruadh, Rhiroy: interior, showing scarcement.

Roughly one-third of the broch wall on the north-east arc has fallen over the edge of the bluff (fig. 3), but the remaining two-thirds still stand to a maximum height of 7 feet 9 inches externally and 9 feet 6 inches internally: the depth of masonry beneath the present surface may be as much as 4 feet. It is unlikely that the vertical cliff on the north-east has been affected to any extent by erosion since the broch was built, so that the tower will have been slightly oval on plan, measuring 65 feet over the walls from north-west to south-east by 56 feet at the most from north-east to The missing segment of walling must have been somewhat flatter than the rest. The wall varies from 12 feet to 14 feet thick at the present ground-level, and is reduced in thickness by an internal scarcement (Pl. XVI, 1) at a height of 3 feet 8 inches above the debris which chokes the interior. This scarcement projects 2-5 inches from the under face, and is 1 foot 4 inches wide on the top. Above it the wall converges inwards in beehive fashion, developing an overhang of 1 foot 5 inches in a height of At this point there may have been a second scarcement, as at Mousa, although no parallels have been found for the convergence of the inner face immediately above the first scarcement. The outer face is vertical (Pl. XVI, 2).

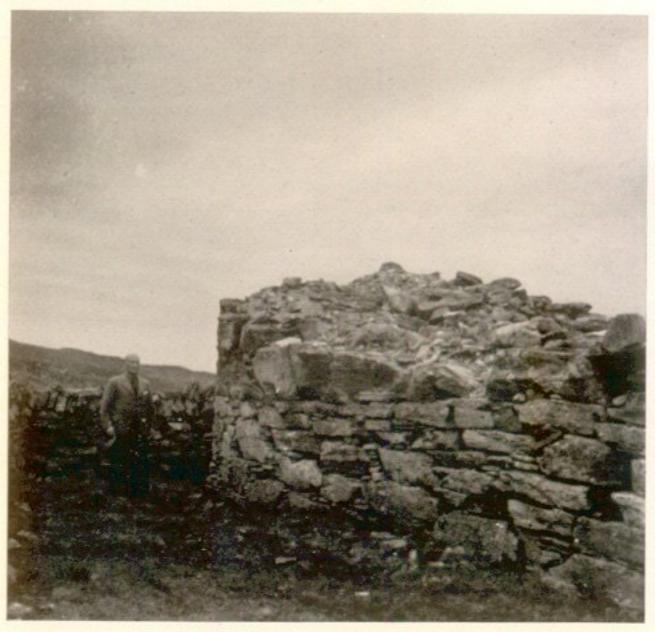
2. Same, showing outer face.
