AN AISLED FARMHOUSE AT THE ALLASDALE,
ISLE OF BARRA.

BY ALISON YOUNG, F.S.A., F.S.A.Scot.

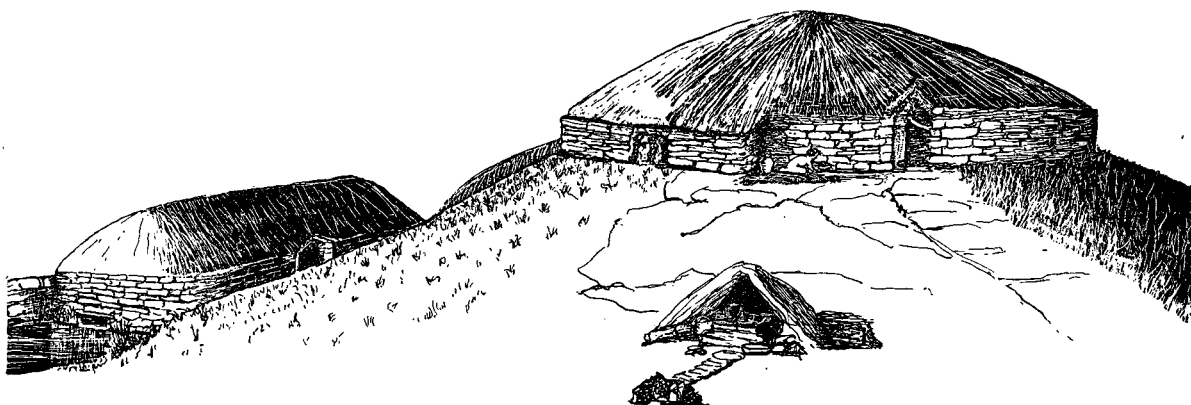
Fig. 2. Conjectured reconstruction of farmhouse.

The farmstead, known locally as Tigh Talamhanta ("The house under the ground"), was built with the entrance at the highest point of a rocky knoll steeply scarped on three sides. On the fourth, to the east, a gentler incline of gravelly soil overlies schistose rock (figs. 2, 3, 4).

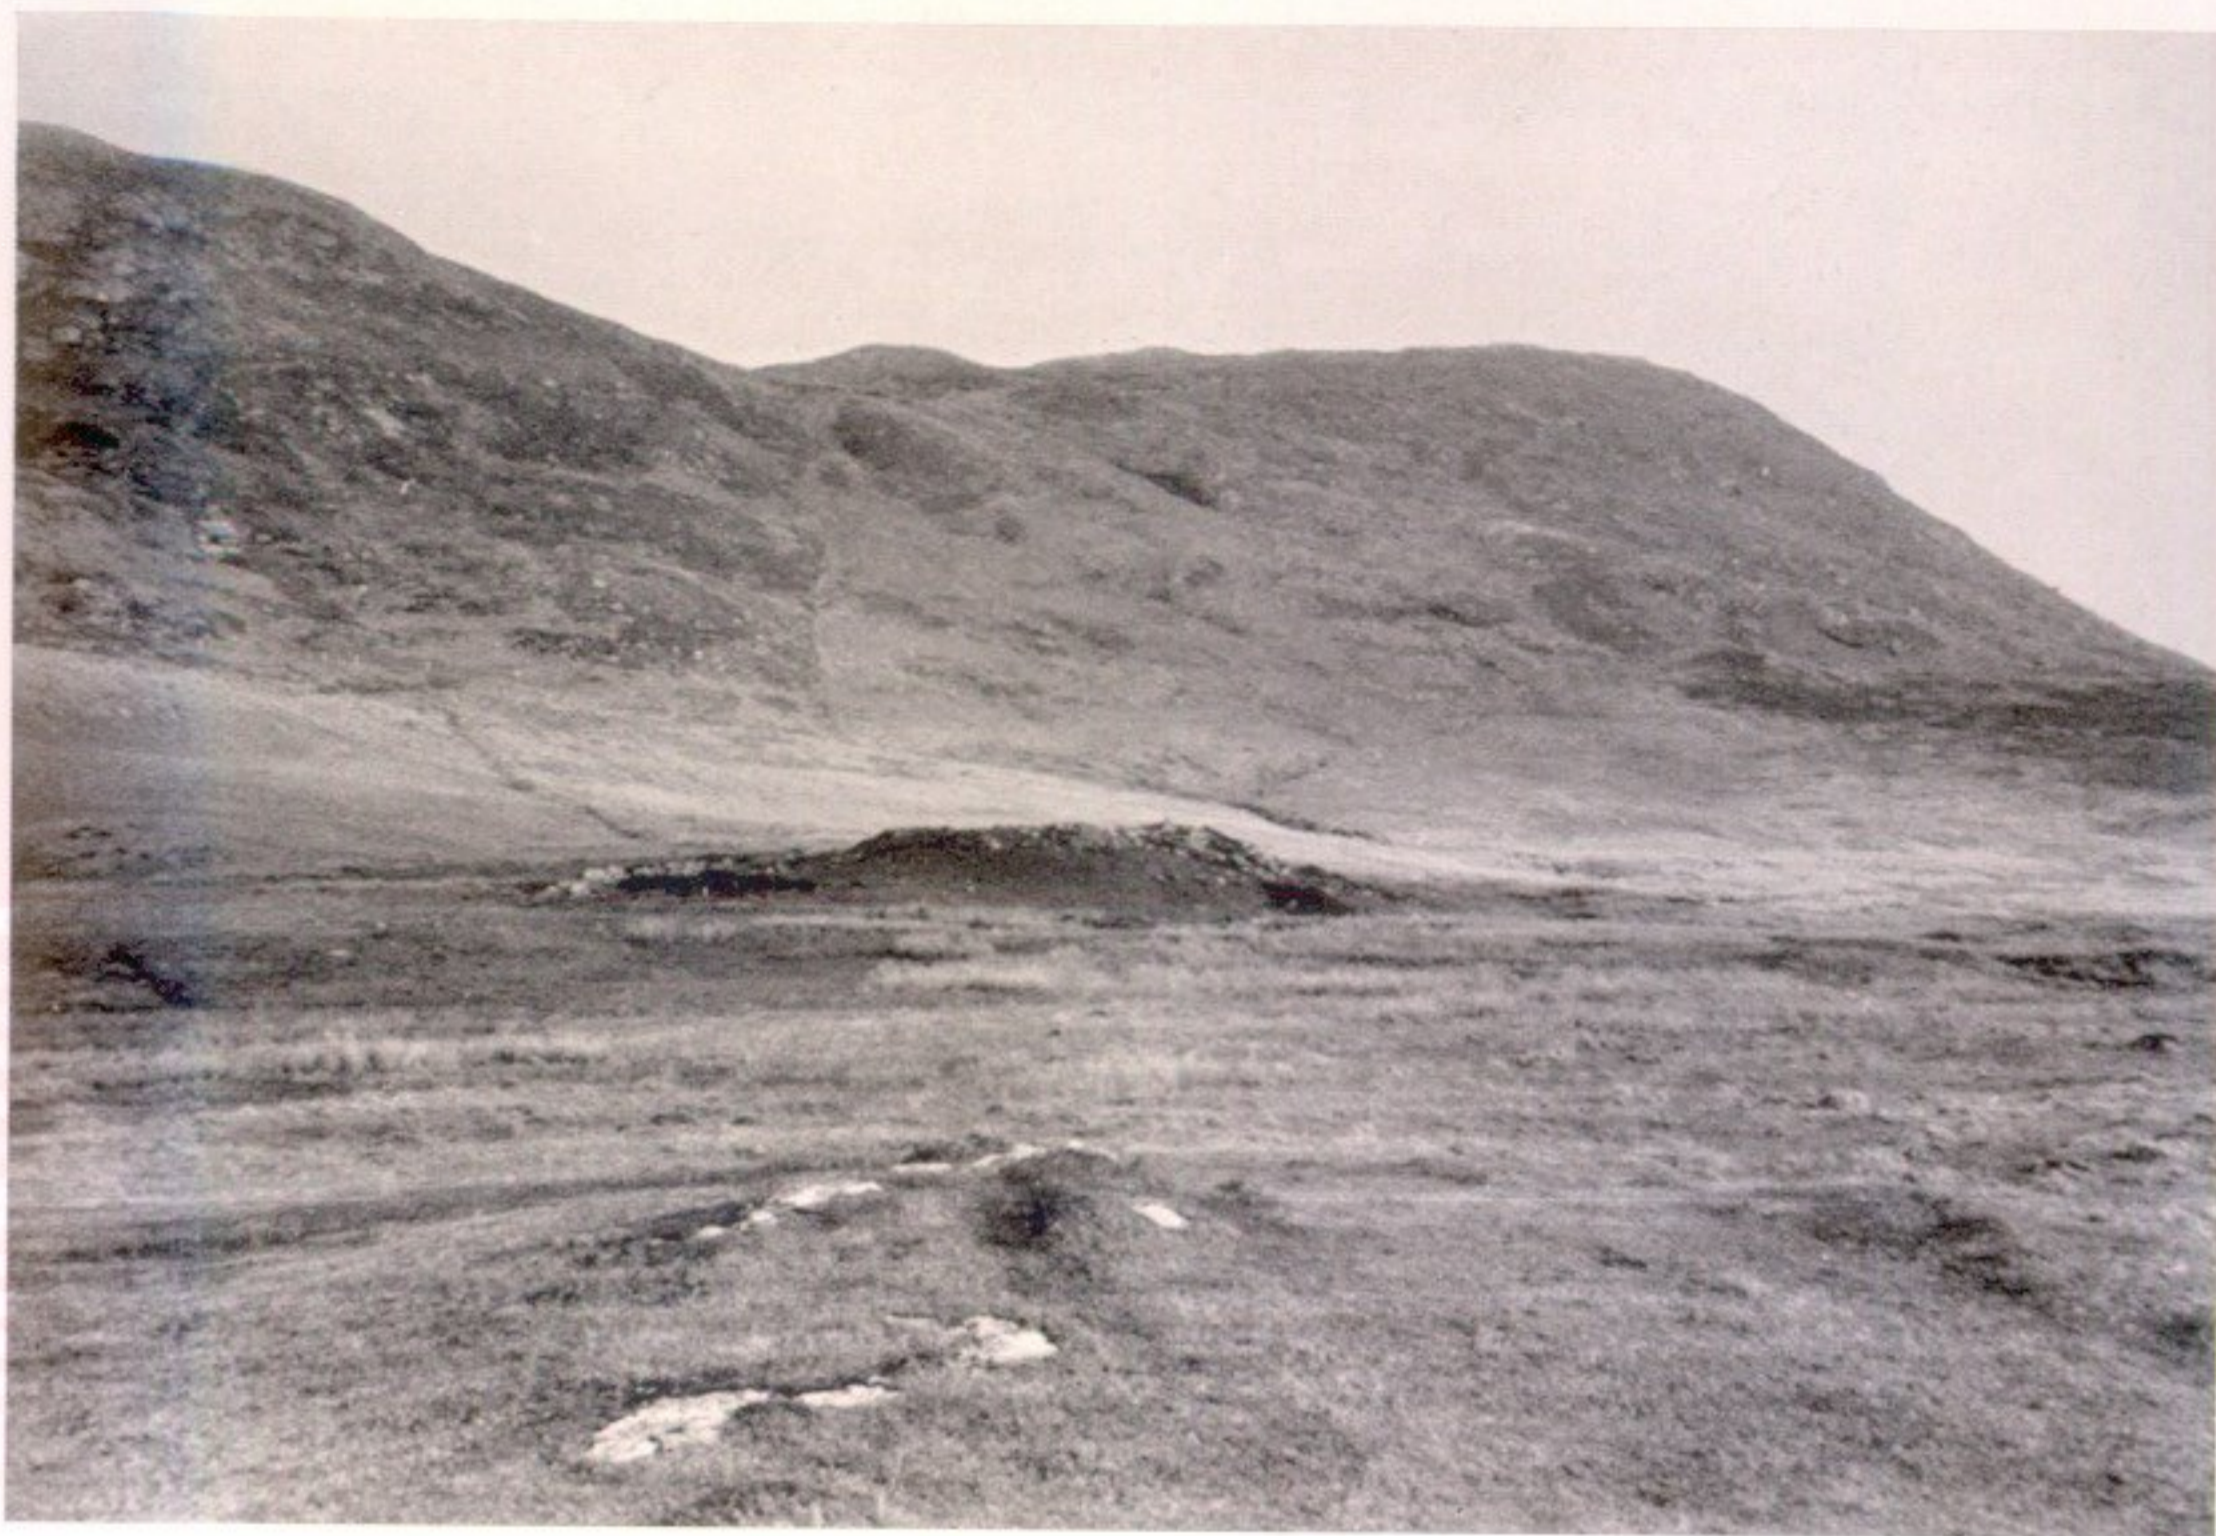
1. Site from NW., before excavation.

The site, described by Lindsay Scott as an aisled farmhouse, is built on a knoll of rocky outcrop 400 ft. above sea-level, where the steeply slabbed hill of Cora Bheinn, so characteristic of the Hebridean landscape, flattens into a series of terraces, also typical of the terrain (Pl. V, 1).

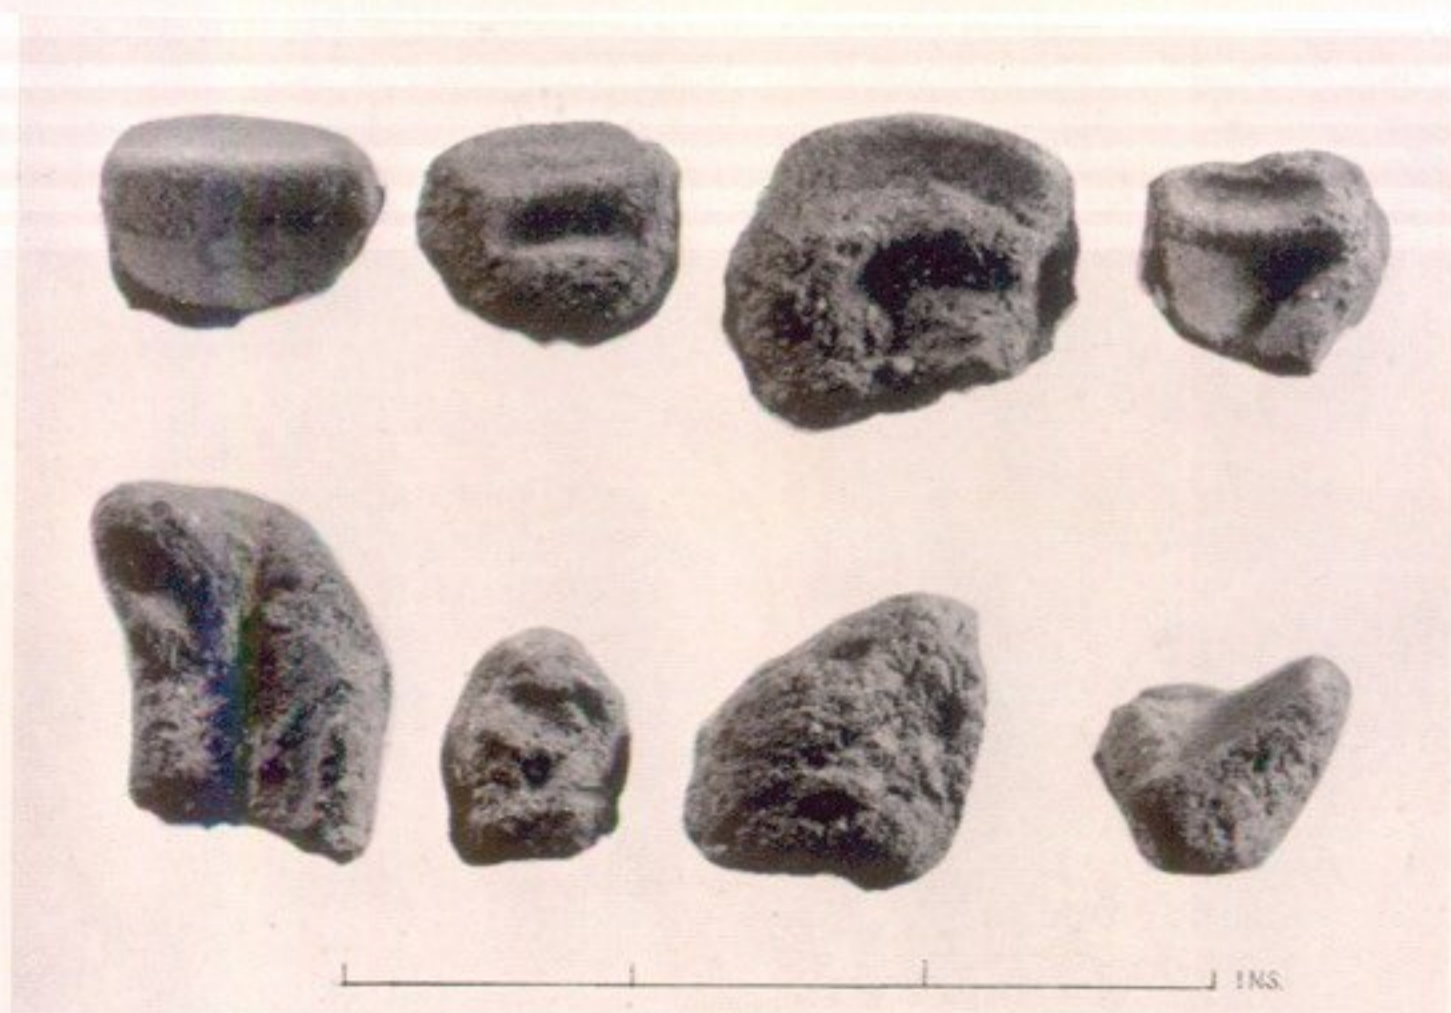
2. Clay moulds.

7-10. Fragments of clay moulds (Pl. V, 2, and fig. 9, 7-10) were found in the central area; most of them had been used, but one of these had been broken before use. Unfortunately, the pieces recovered are too small to identify the object for which these moulds were made, but the smooth surface of the unused example suggests that the mould itself was made by pressure, possibly from a metal or wooden pattern. Iron slag and broken crucibles were also among the finds.

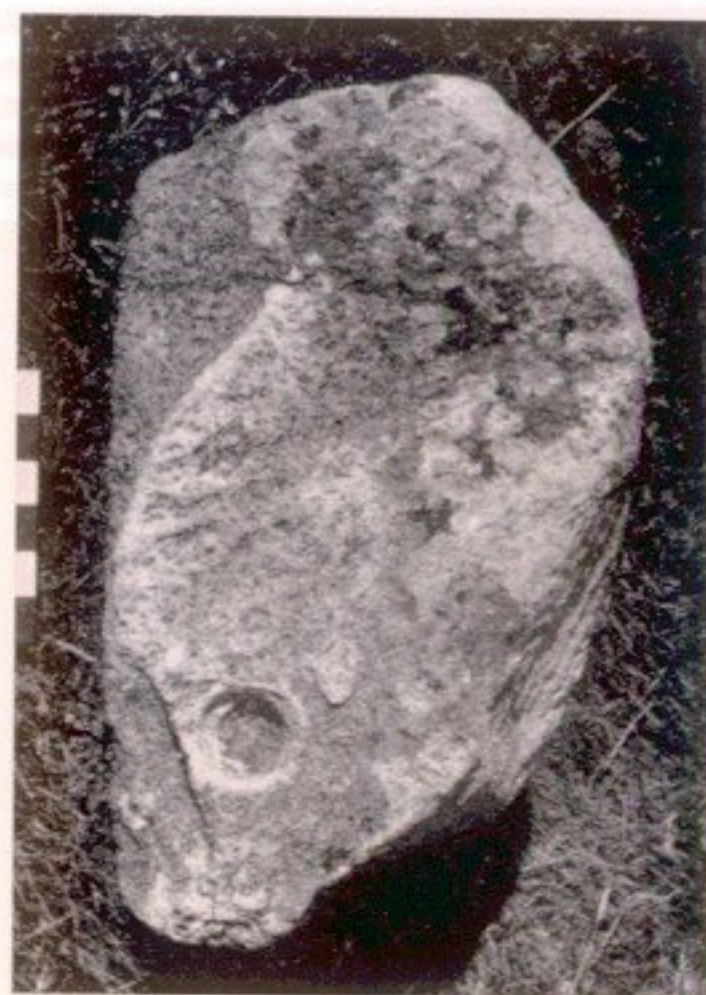
3. Pivot stone, from Barn entrance.

A drain 24 ins. wide (Pl. VI, 3), cut in the soft rock, surrounds two sides of the steading and leads out below the farmyard wall. Built into the entrance of the barn, a holed pivot stone apparently carried the framework of the door (see Pl. V, 3).¹

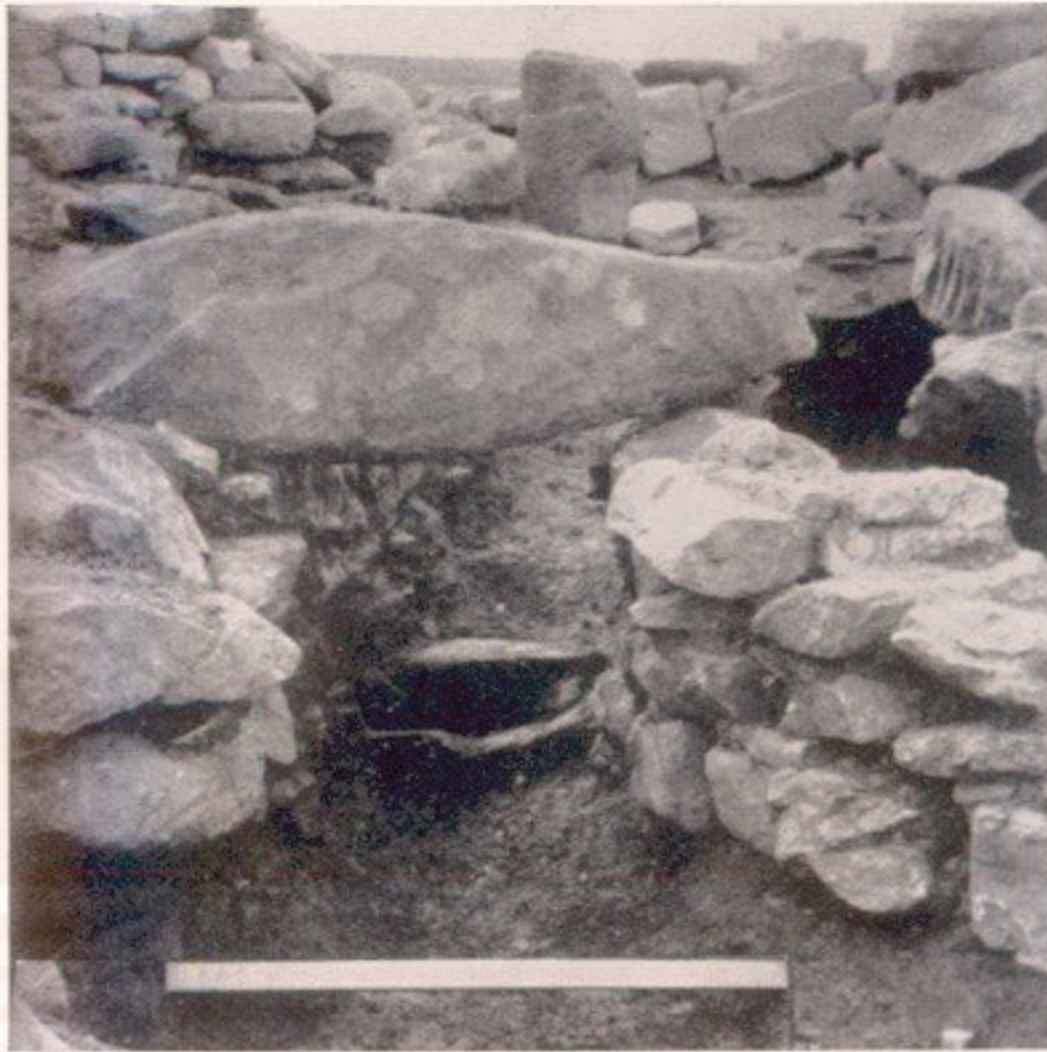
1. The souterrain, Lintel 2 (fig. 1, no. 2).

walling was backed by earth, reinforced by a peat stack or midden dump, streaked by tips of shell debris. No pottery was found in the space between the second (Pl. VI, 1) and outer lintel, and it is possible that this chamber, with its airflow, which could be controlled from the main souterrain, was used for drying and storing winter provisions.

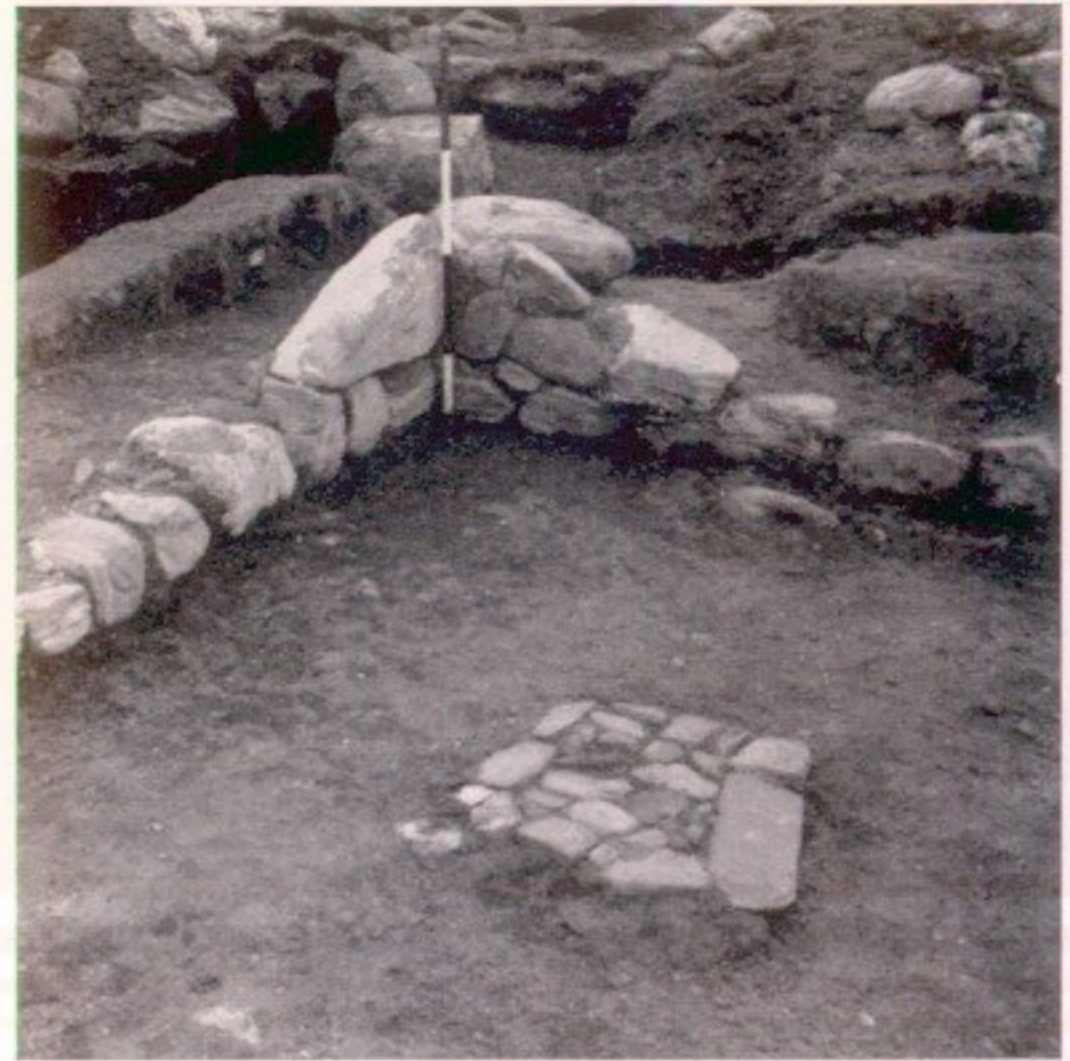
2. The steading, Barn hearth (fig. 1, no 5).

The barn has a square-paved hearth (Pl. VI, 2) laid on the gravel floor; a dump of peat ash filled the angle of the inner wall. Apart from the farm wall which formed the north side of the steading, and was at this point stone faced and rubble filled, the outer walls were of stone with an earth core.

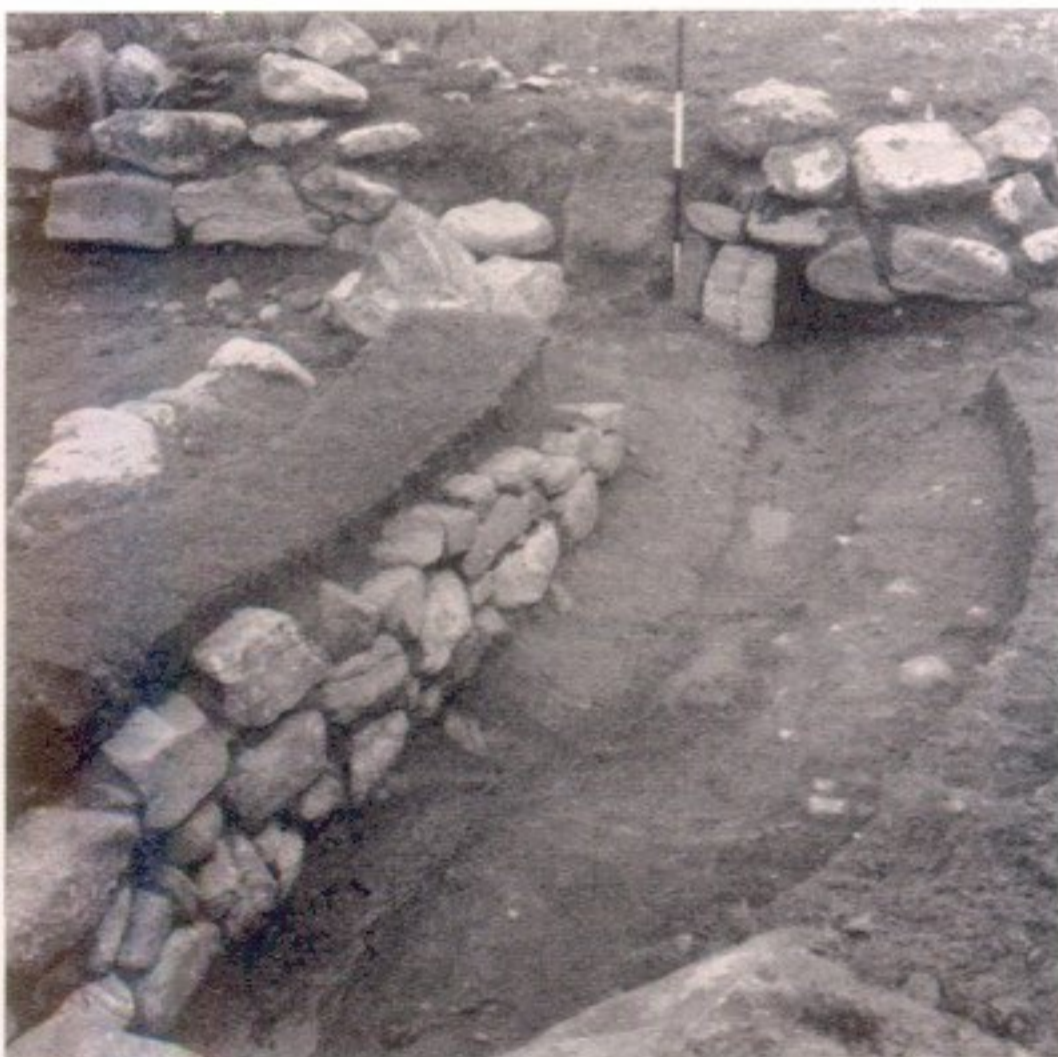
3. The steading, outside drain (fig. 1, no. 5).

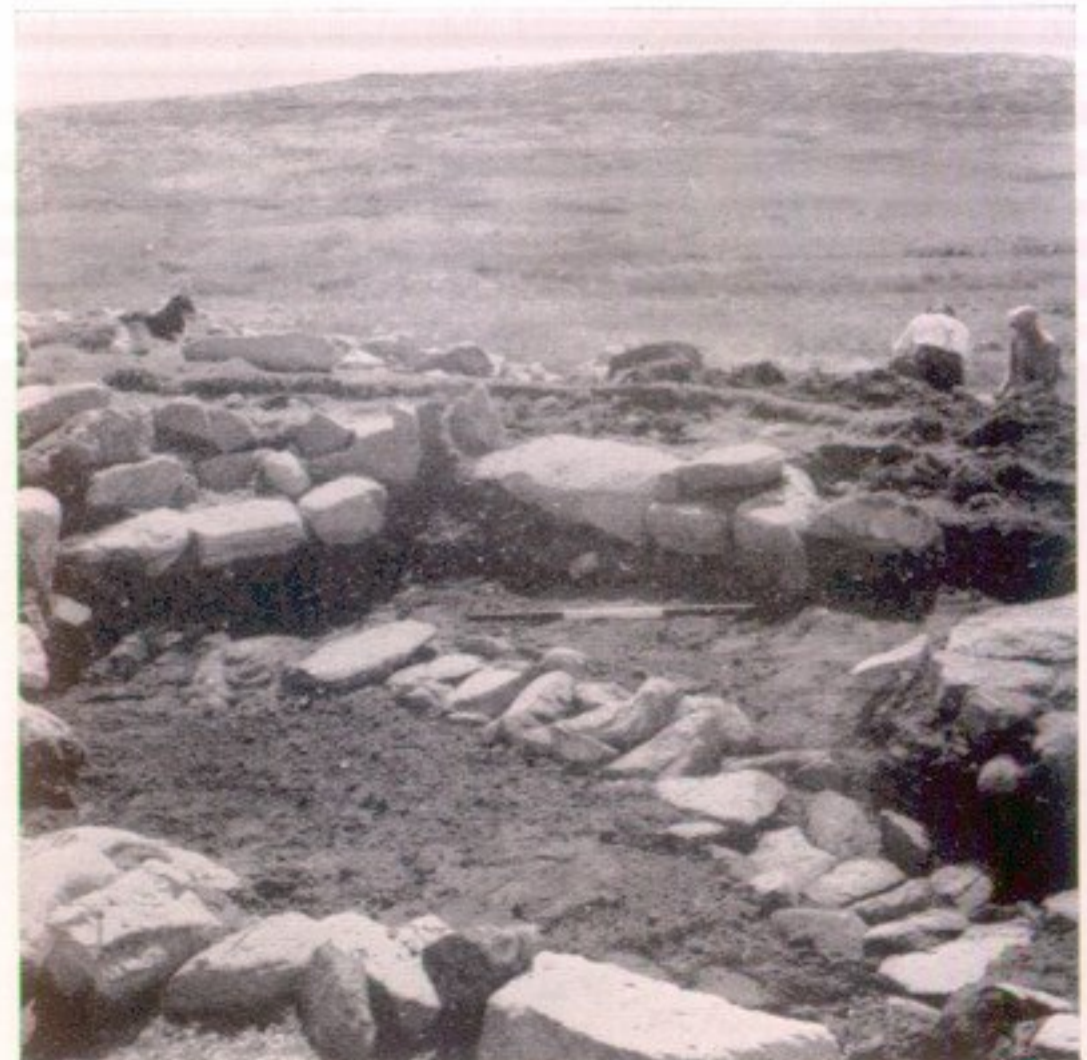
4. Outside working place (fig. 1, no. 4).

The working-place to the west of the farmhouse (Pl. VI, 4 and fig. 1, 4) was constructed against the edge of hard rock outcrop. A stone-built seat, backed on to the natural rock, was further heightened with upright slabs and banked with earth so stoneless that a turf construction is indicated. This shelter was probably only partly covered, and a paved drain runs down the centre and under the hearth which was built against upright stones. The cover from the upper end of this drain, which was of the local stone, was smoothly hollowed, and may have been a discarded saddle quern re-used.

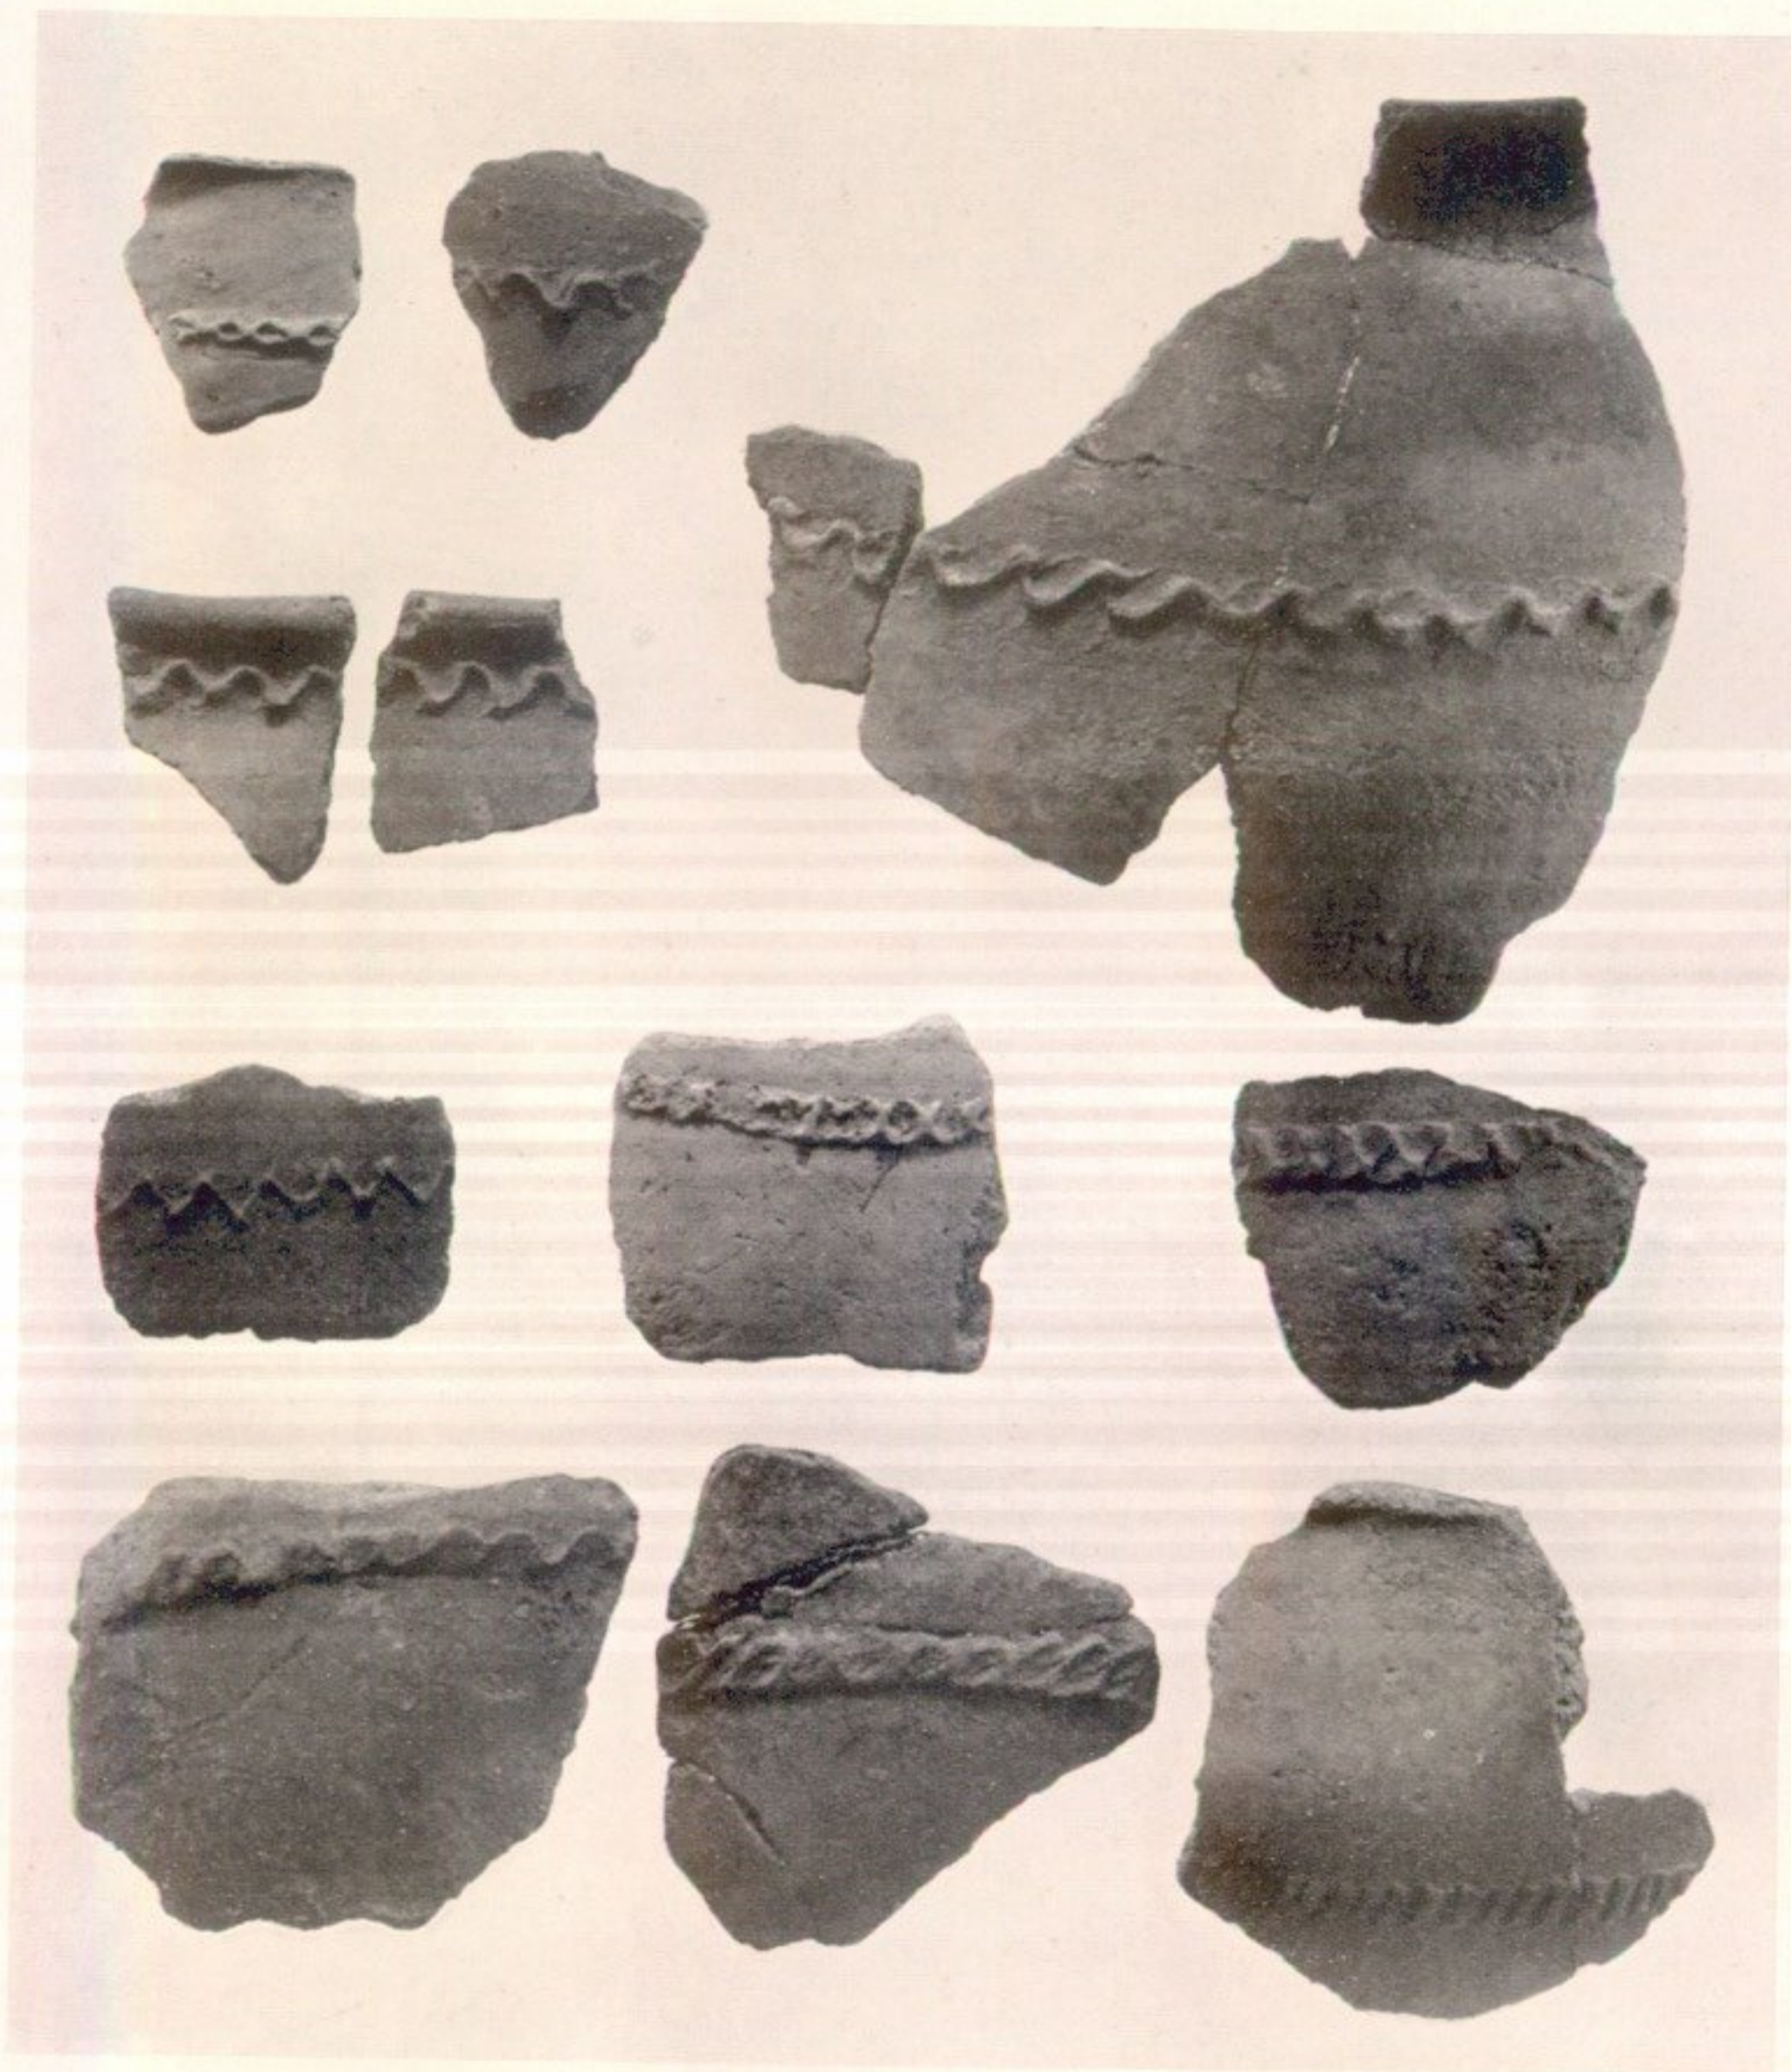
Applied decoration. (Scale $\frac{1}{2}$.)

(See fig. 5, nos. 58, 45; fig. 4, nos. 15, 19; fig. 5, nos. 54, 51, 52, 60.)

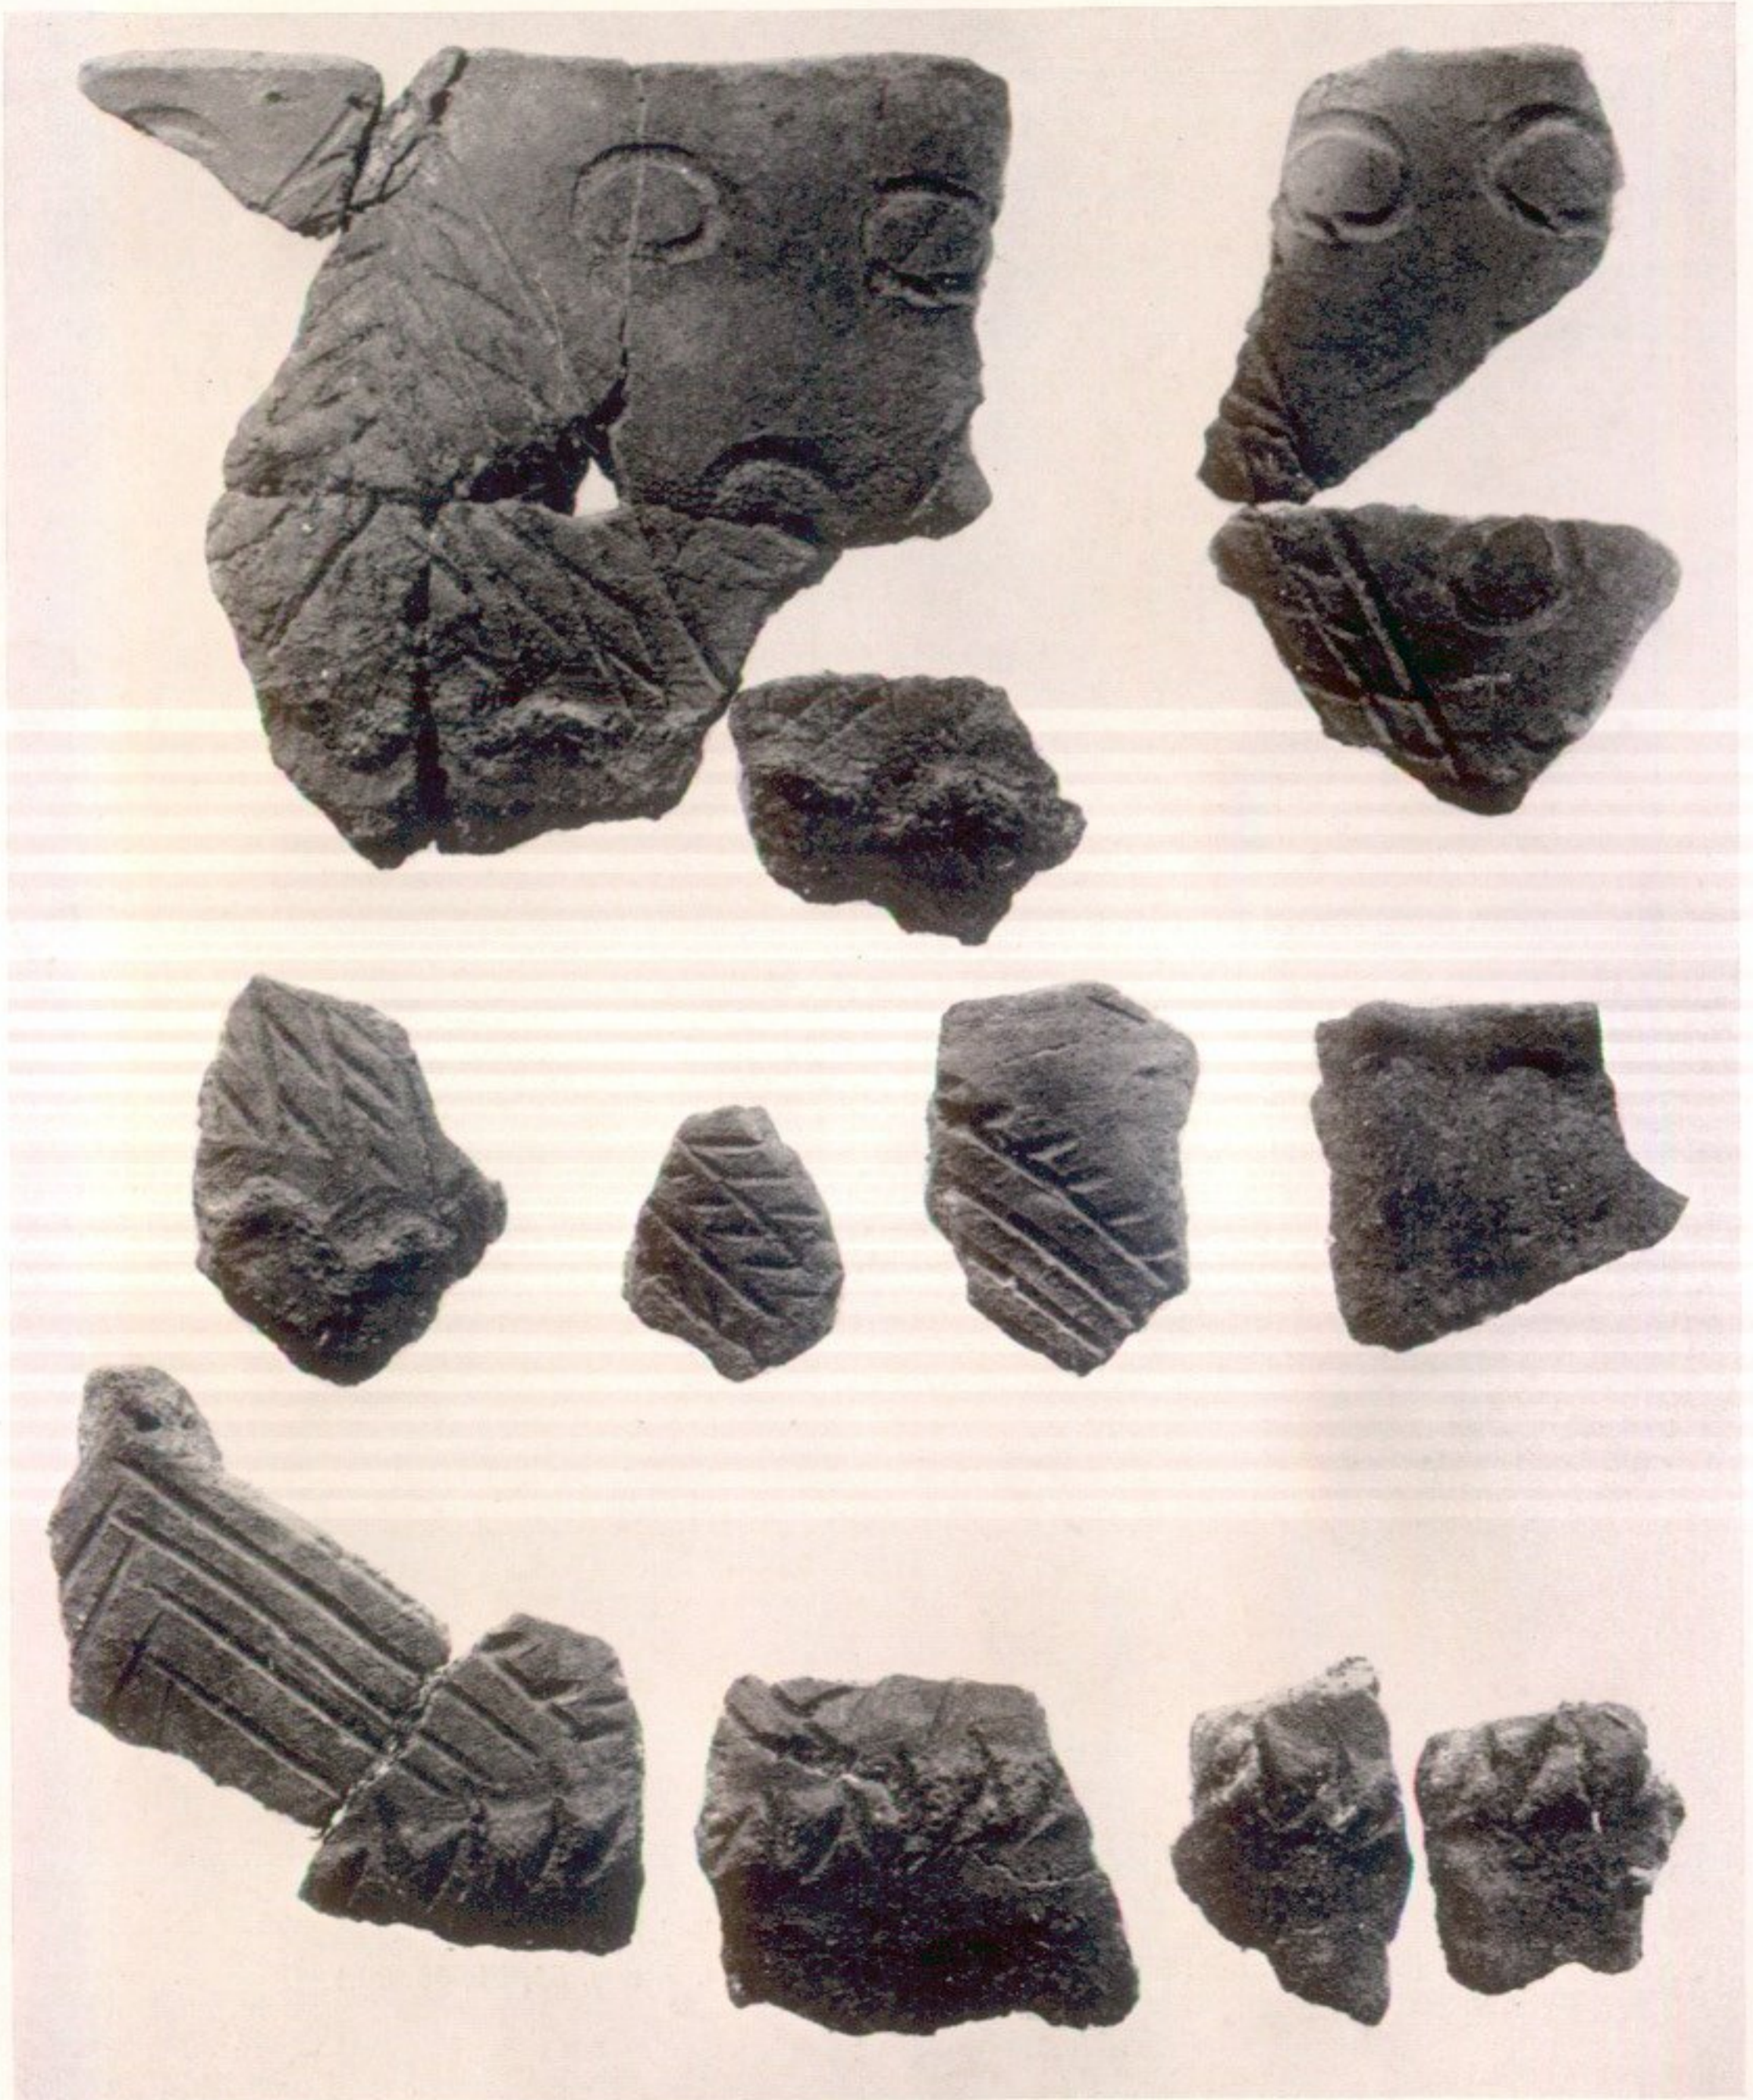
Stamped and Incised pottery. (Scale $\frac{3}{4}$.)
(See fig. 6, nos. 6, 64; fig. 7, no. 84.)

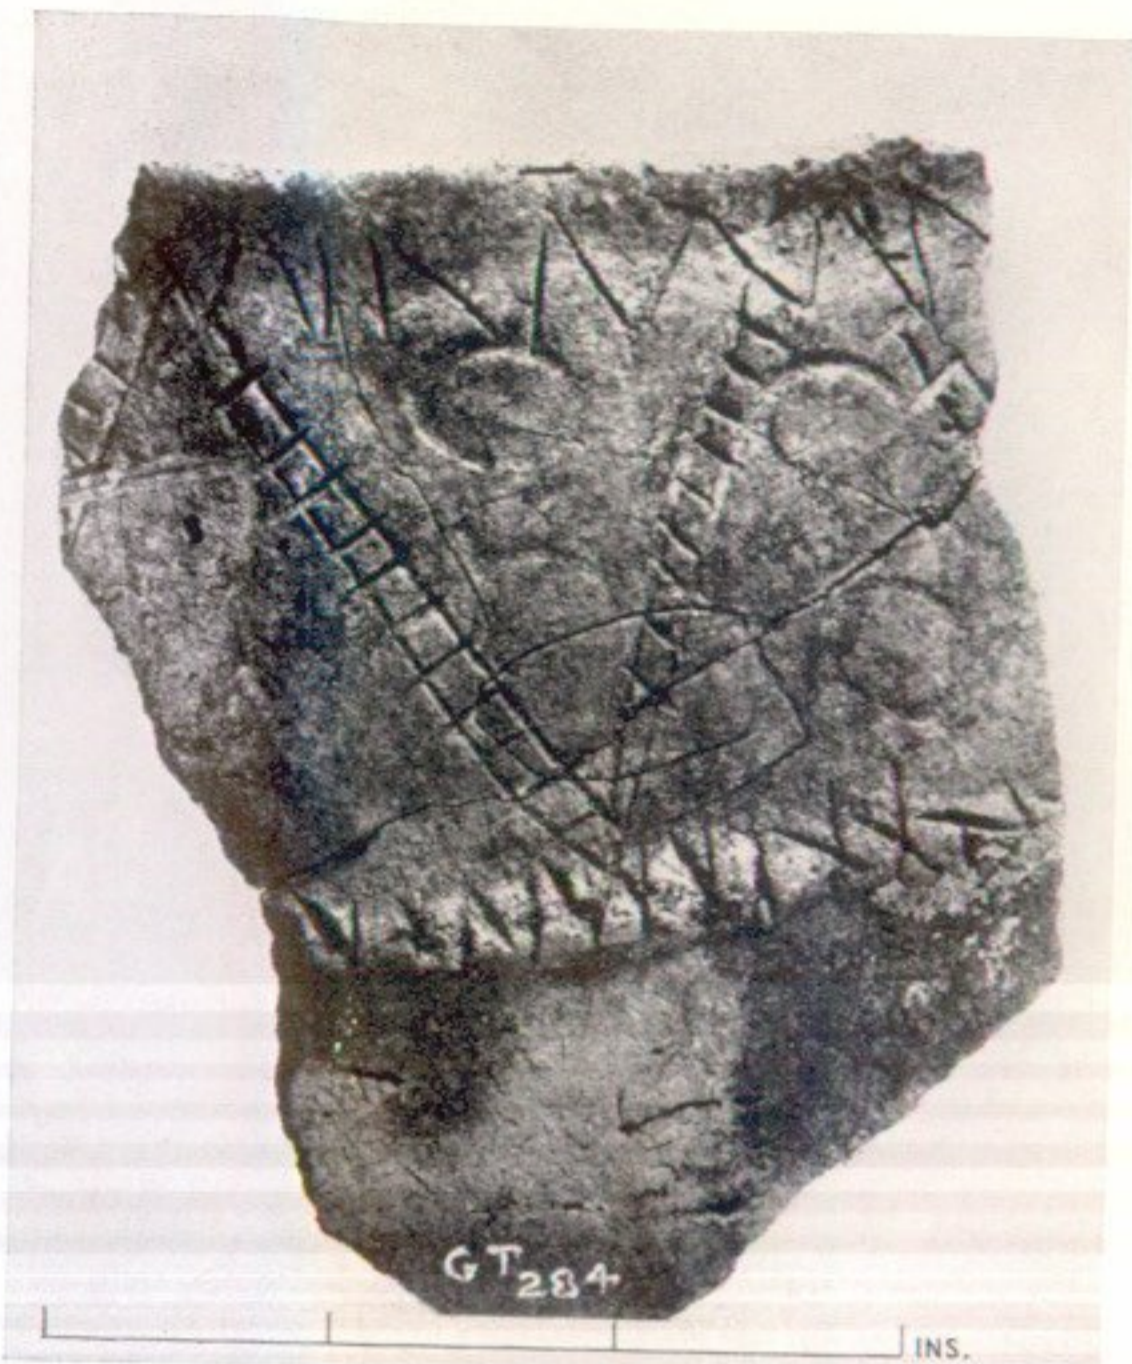
1. From Cnoc a' Comhdhalach, Griminish, N. Uist.

I am indebted to Mr R. B. K. Stevenson for the excellent photographs of unpublished comparative material from the National Museum of Antiquities. The sherd from Cnoc a' Comhdhalach, Griminish, North Uist (Pl. IX, 1), is the closest analogy to the ring-stamped ware from Tigh Talamhanta, with its chevron pattern of double incised lines, rather carelessly cross-hatched, spacing the stamped decoration. The raised band of slashed ornament closely resembles nos. 64 and 71 (fig. 7 and Pl. VIII) in technique. Two Orkney examples are shown (Pl. IX, 2) from the Broch of Lingrow,¹ also ornamented with incised lines forming a chevron pattern in which the pin-stamping is centralised. This pot has a slashed cordon immediately below the rim, which recalls a sherd from Corent in the Auvergne, figured by Professor J. B. Ward Perkins.² From the Broch of Ayre, Orkney, another more crudely executed example is shown (Pl. IX, 3), the incised chevron being unevenly executed and the pin stamp incomplete; the sherd is nevertheless reminiscent of the Hebridean series. In addition to these parallels, a sherd from Eye Peninsula, in Lewis (Pl. IX, 4), shows a further development of the stamped motif recognised by Mr Stevenson, who has kindly included impressions of the pattern, which give the clue to the stamp used, a ring-headed pin with movable head. This form is regarded as a later development of the shouldered pin, and suggests that the method of treating pottery persisted. The brushed surface of the pot from Eye Peninsula resembles sherds from Tigh Talamhanta, which are noted as later than the main group of the pottery from that site. With the exception of the last quoted, these sherds also combine the chevron motif with ring-stamping.

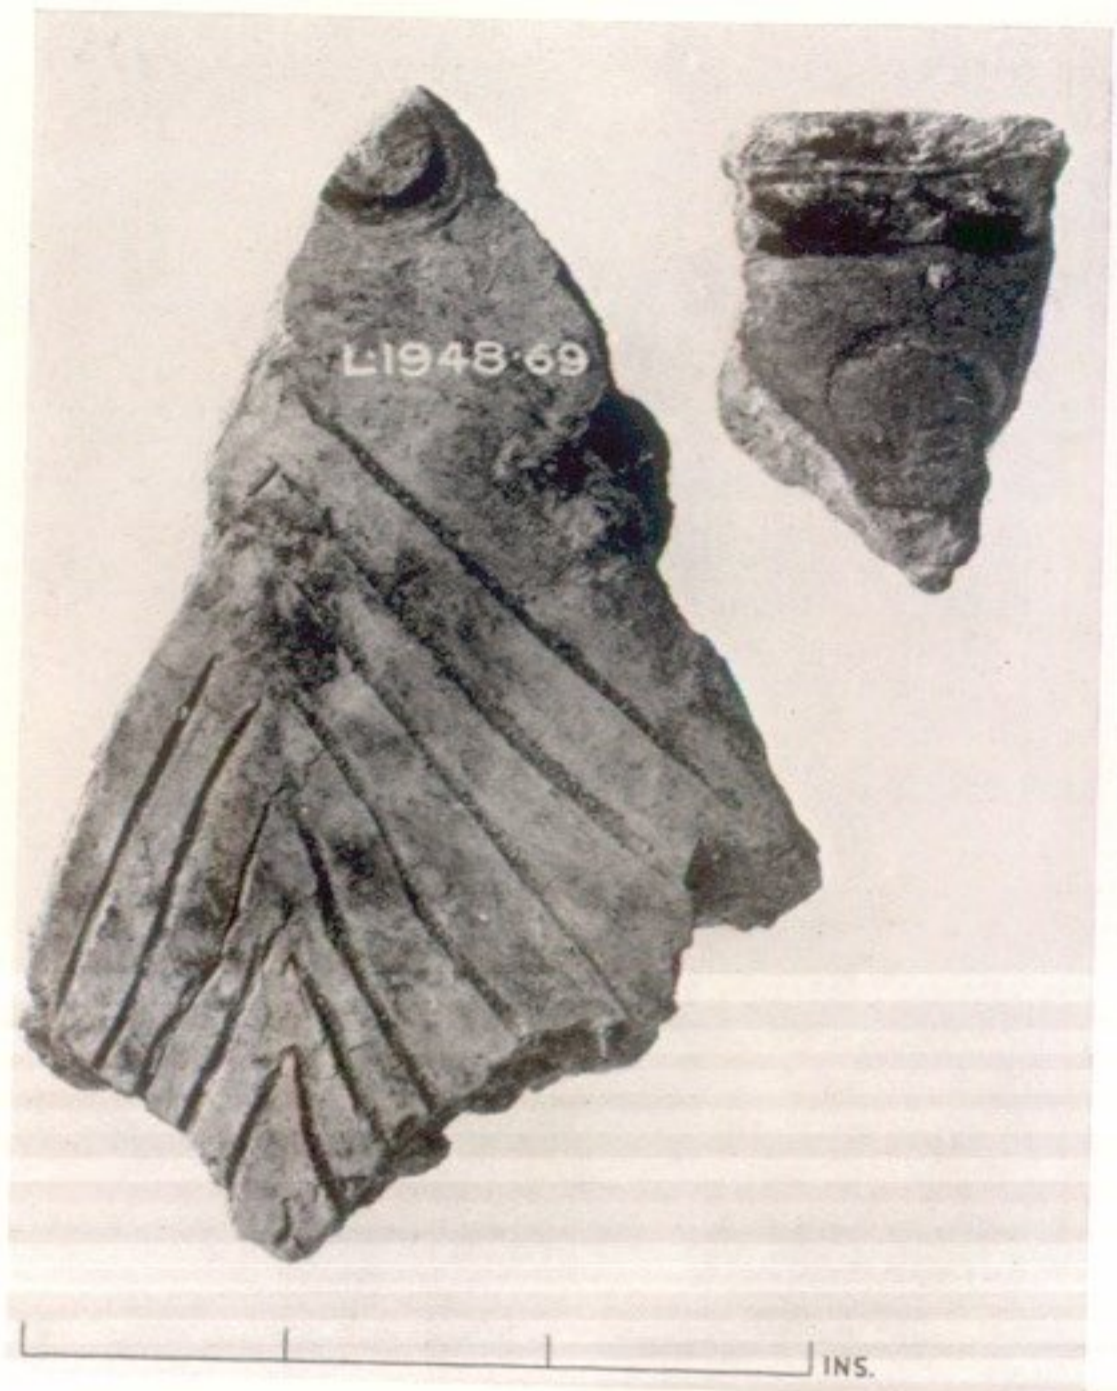
3. From Broch of Ayre, Orkney, and Broch of Lingrow.
