AN AISLED FARMHOUSE AT THE ALLASDALE,
ISLE OF BARRA.

BY ALISON YOUNG, F.S.A., F.S.A.Scot.

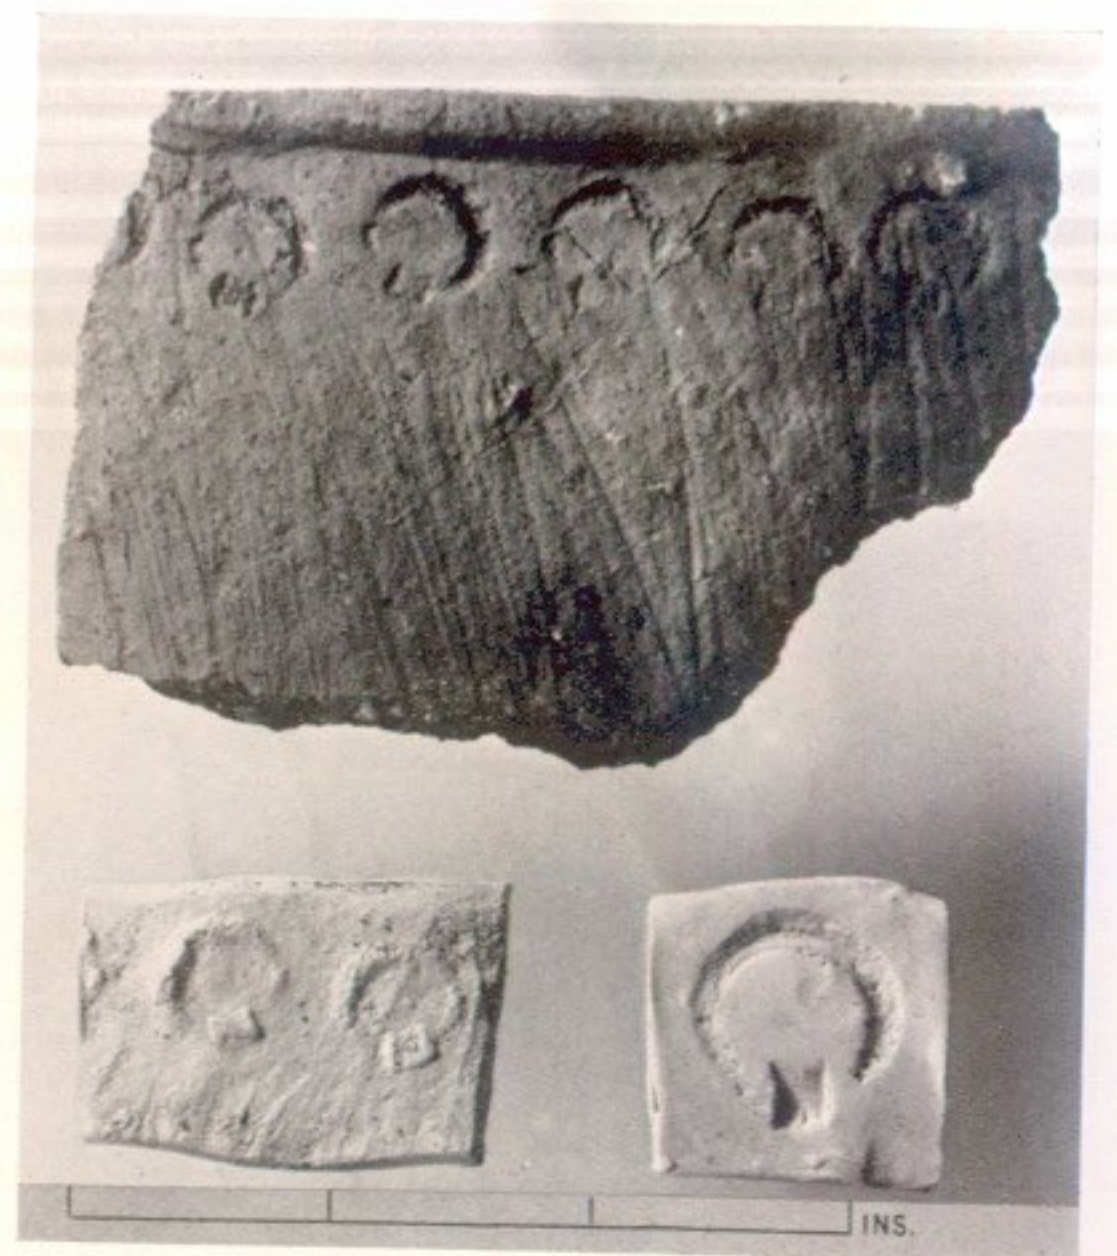
4. From Eye Peninsula, Lewis.
