7. ST MARY'S CHURCH, ST ANDREWS, FIFE.

Discovery of Early Christian Cross-slabs.

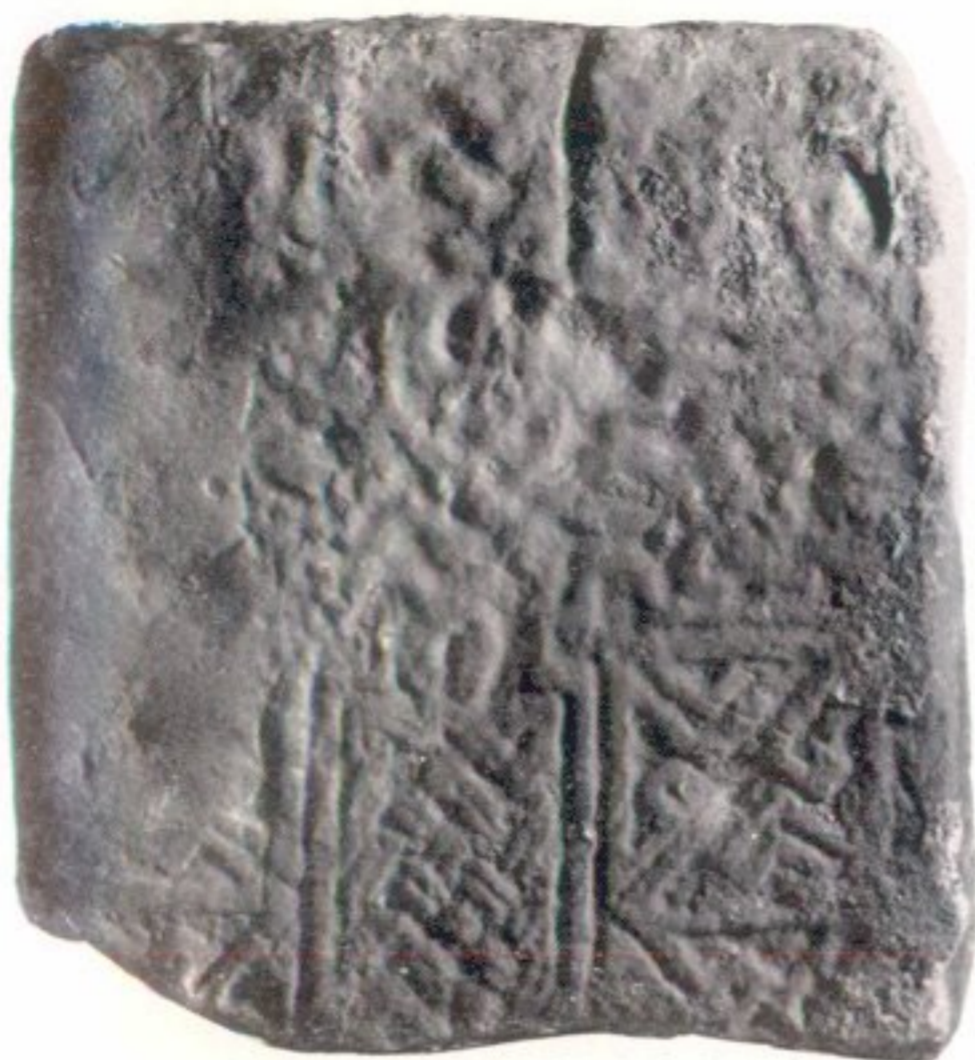
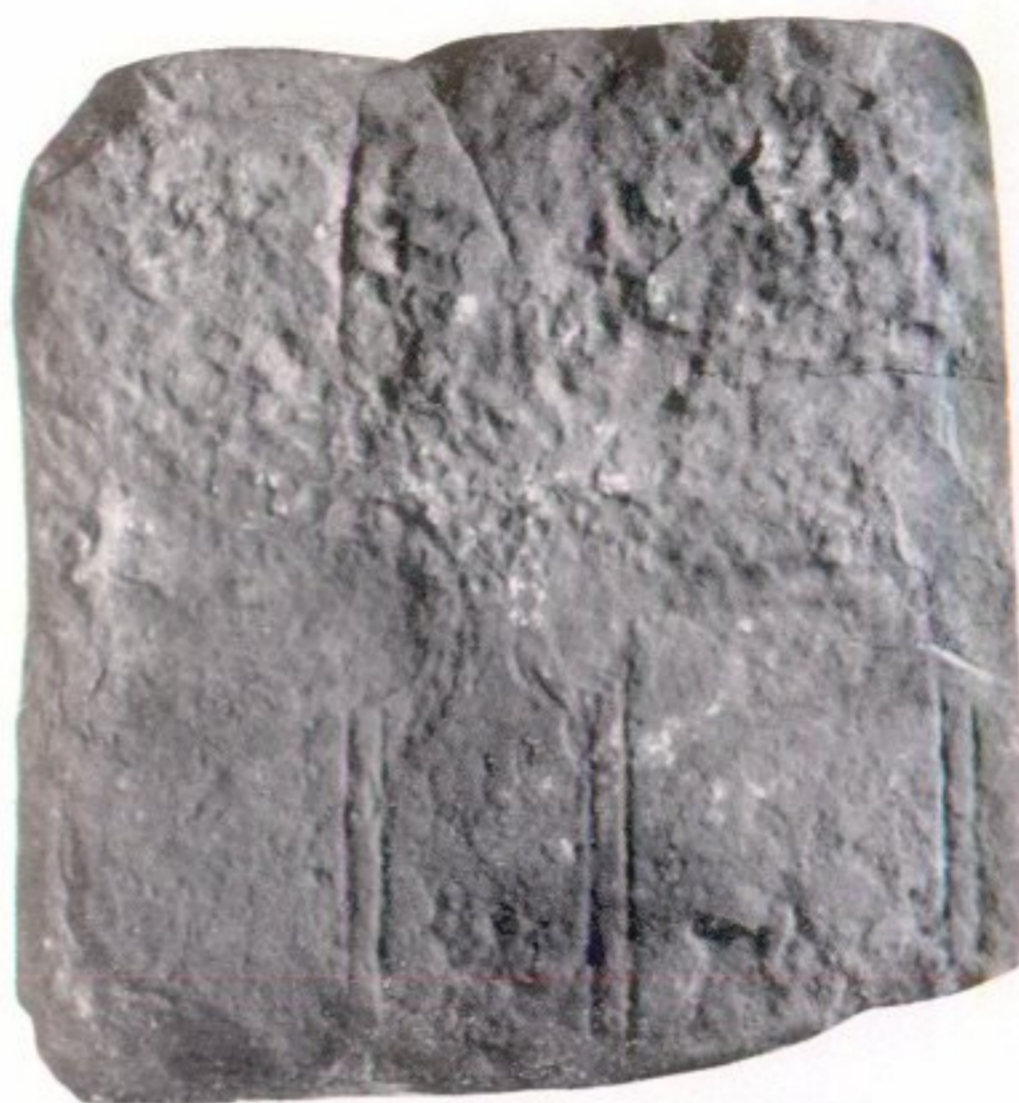
(a)

The first stone (Pl. LXVII *a*) is the upper part of a cross-slab measuring $20 \times 18 \times 4\frac{1}{2}$ ins. One narrow side is badly weathered by exposure. On the front there is a cross within a narrow margin, the shaft and arms of which were filled with interlaced work. A diagonal key design is discernible within the panel to the right of the shaft. The reverse side displays a cross with circular interstices enclosed within a rectangular panel, all without ornamentation.

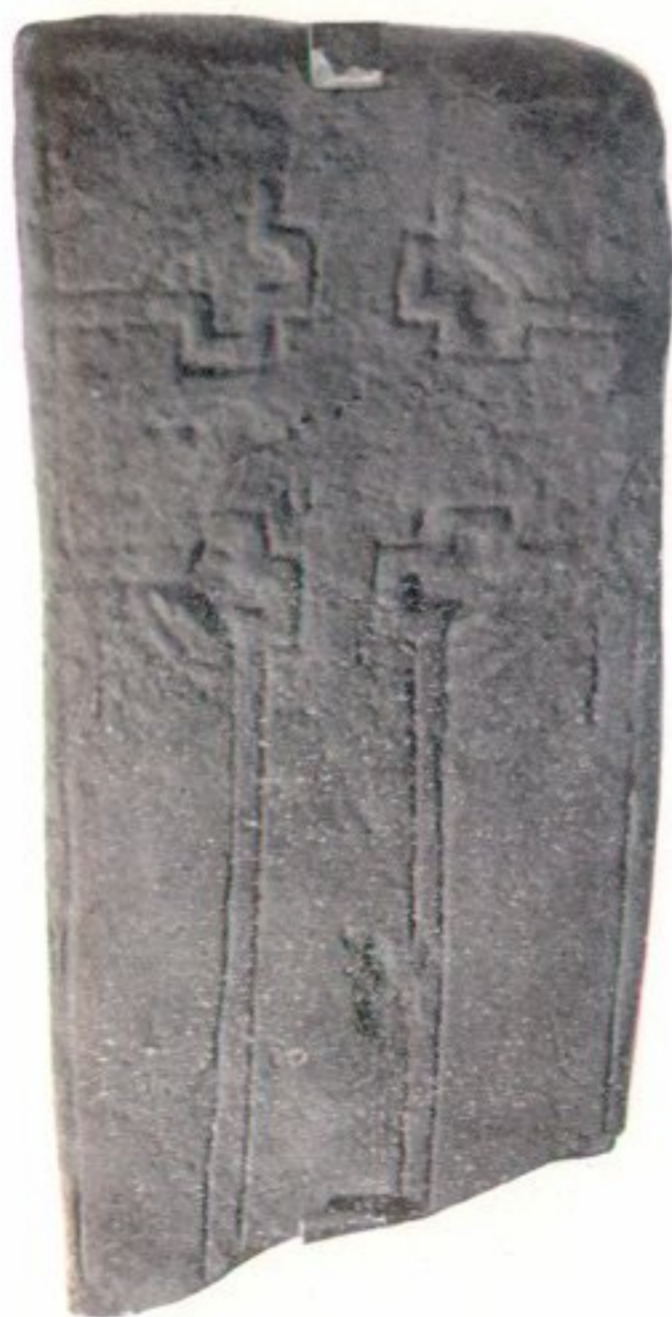
(b)

The second stone (Pl. LXVII *b*) appears to be more or less complete in length. It is 2 ft. long and tapers from 12 ins. wide at the top to 10 ins. at the bottom; its character implies a probable recumbent use. Only the front has been worked, the back is rough hewn and the stone measures about $5\frac{1}{2}$ ins. thick. A narrow margin runs round the contour of the stone, and inside this is a cross occupying the full length and width of the stone. The limbs of the cross are connected with four incised quadrant lines, suggesting a nimbus with a central bead. The field of the nimbus is recessed and a square check is cut out at either side of each arm at the intersection.

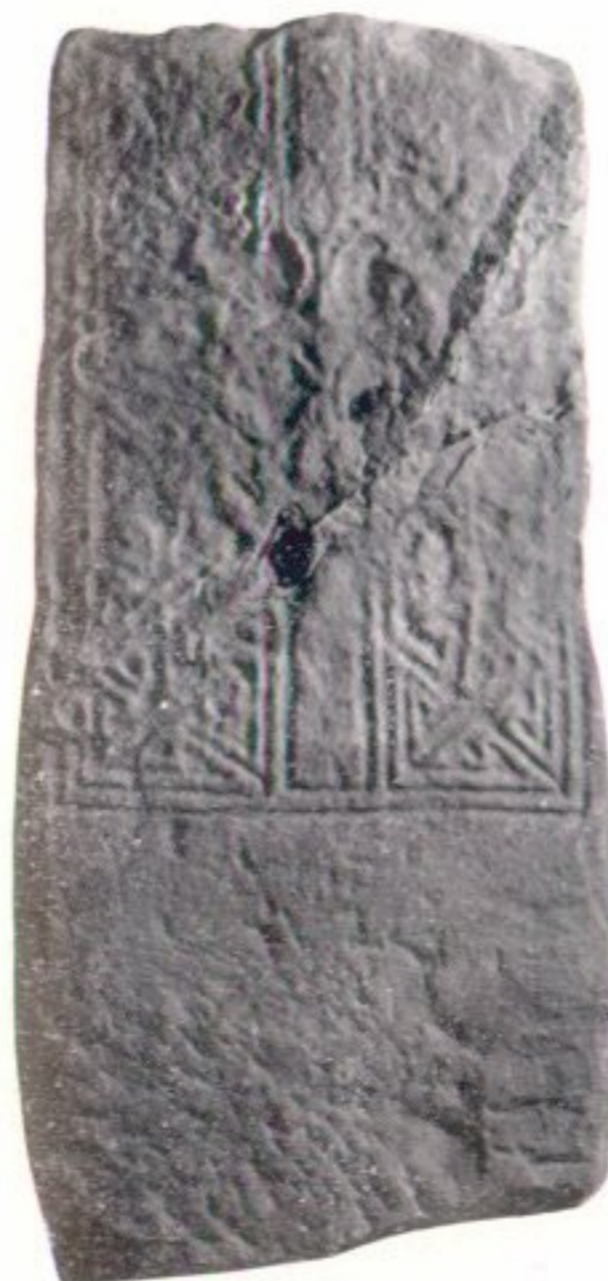
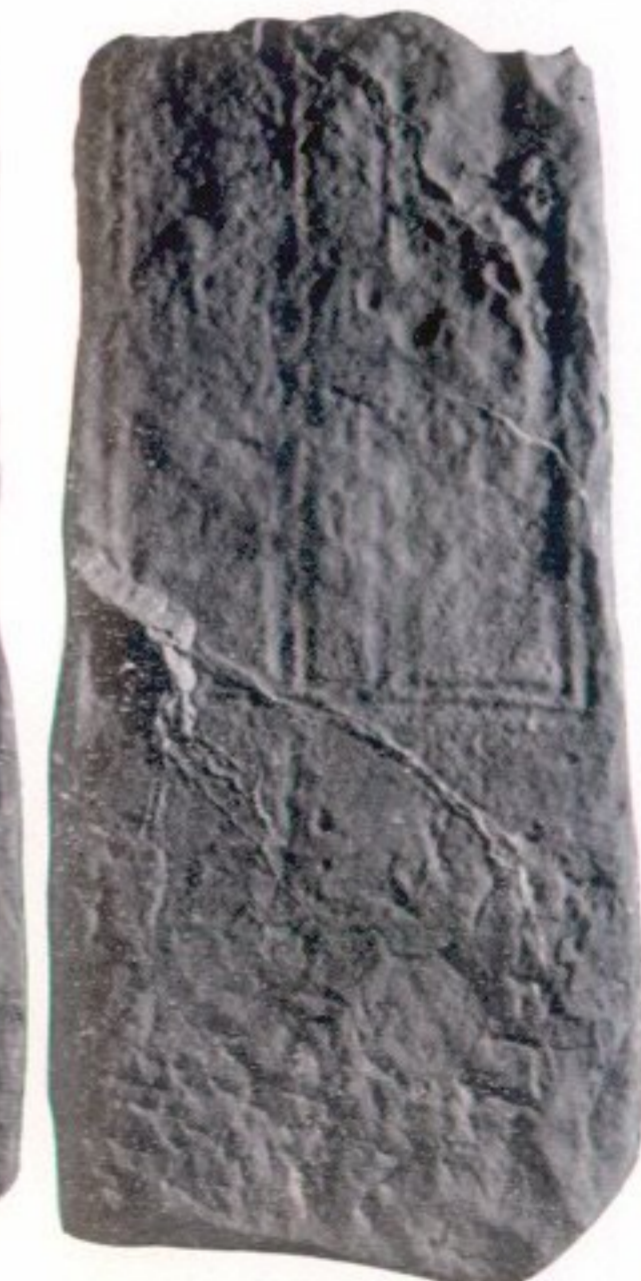
(c)

The third stone (Pl. LXVII *c*) was discovered in the following season in the ground on the outer side of the doorway in the north wall of the sanctuary. When found, this stone was lying flat, under a covering of clean soil at approximately 9 inches below the level of the threshold. Despite its situation, however, its general condition indicates weathering and suggests abandonment rather than use as a flagstone. It is a complete upright cross-slab, sculptured on both sides, and measures $41 \times 20 \times 5\frac{1}{2}$ ins., the carving covering 2 ft. of the length. The surface of the monument is badly eroded, particularly the top edge. The front is in fair condition showing a plain cross, with circles at the angles of intersection and set against a field of zig-zag pattern. On the back, it is still possible to distinguish the characteristic cross, with its nimbus and diaper pattern on either side of the cross-shaft at the base of the panel.
