# EXCAVATIONS AT UNDERHOULL, UNST, SHETLAND

by ALAN SMALL, F.S.A.SCOT.

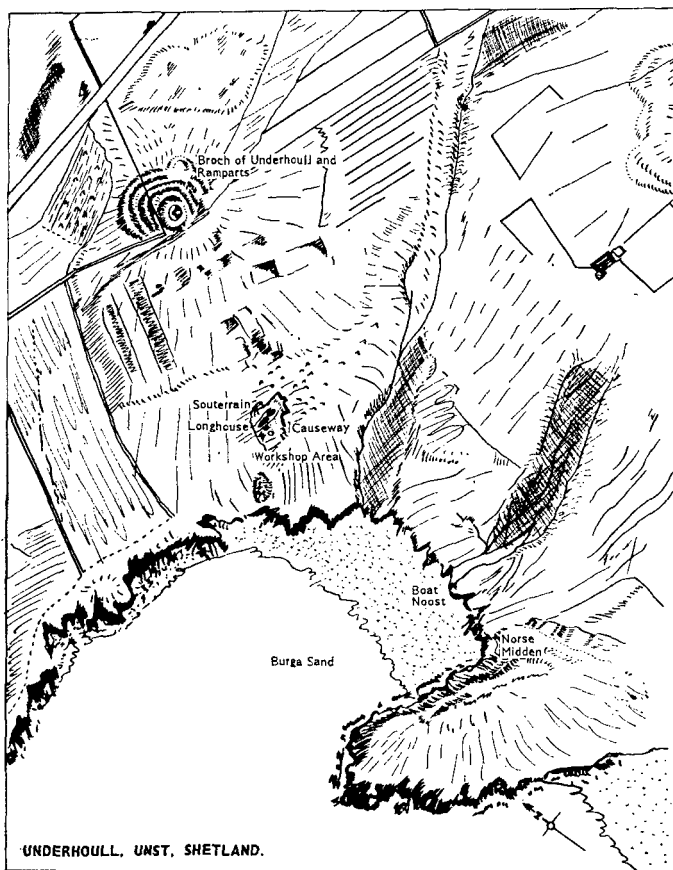
FIG. 2. Sketch plan of site area. (Scale approx. 1 in. = 400 ft.)

The Broch of Underhoull (fig. 2), occasionally known also as the Broch of Overbrough, stands on a rock outcrop some 250 yds. to the E. of Burga Sand, about 160 ft. above sea-level and commanding extensive views in all directions although somewhat restricted by rising land towards the NE. On the SW. the steepness of

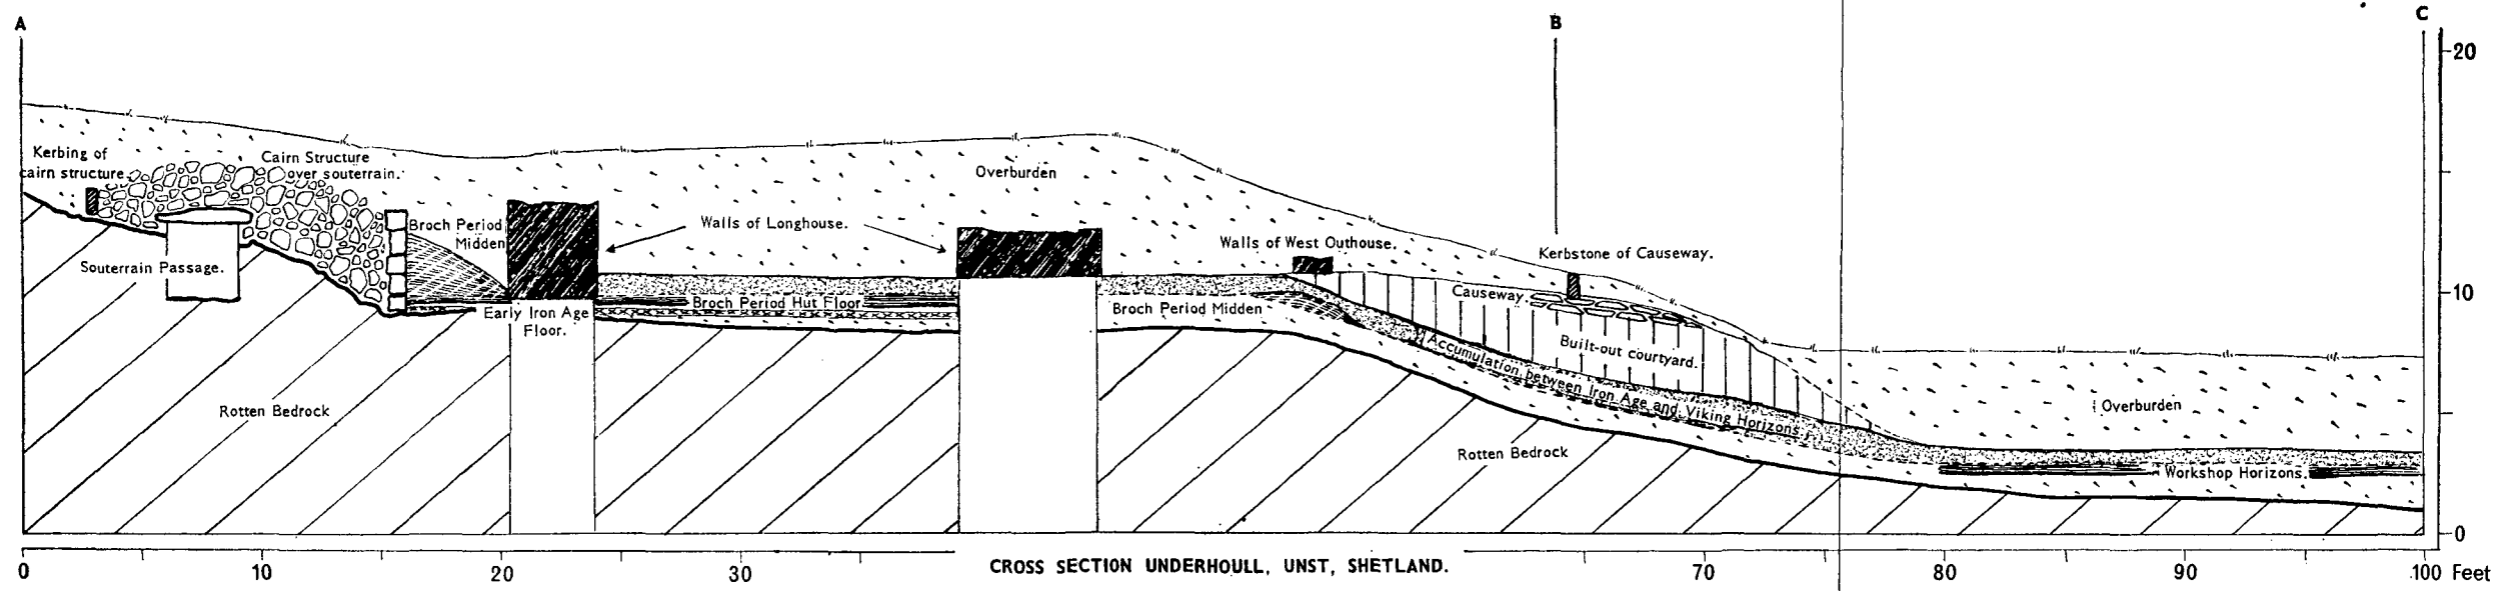
FIG. 3. Cross-section of site (N.-S.) along line shown in fig. 10

After four seasons' excavation, three distinct periods of occupation have been recognised on stratigraphical evidence supported by an abundance of small finds. The earliest occupation of the site is associated with a hut floor and attached souterrain datable to the early Iron Age. The second occupation, indicated by a hut floor and workshop, has revealed broch period artifacts, while a Viking farmstead was established on the deserted ruins of this settlement in the ninth century and survived for some considerable time before it became ruinous<sup>3</sup> (fig. 3).

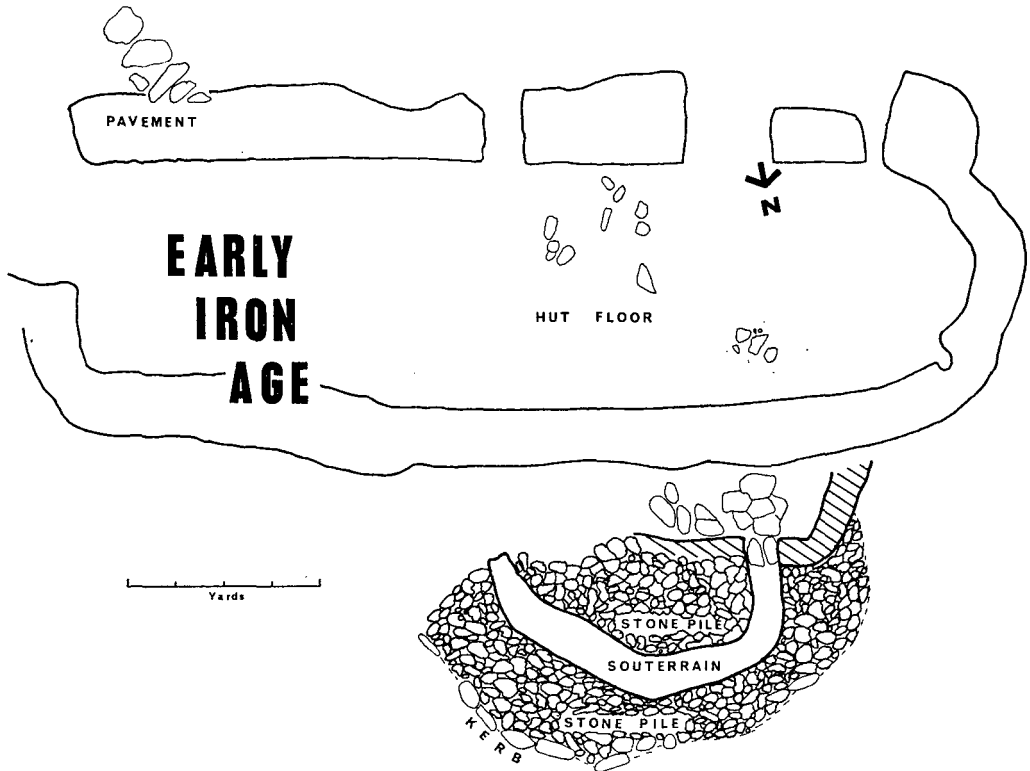
FIG. 4. Early Iron Age structures with longhouse outline superimposed

On a site where sequent occupation covers some two thousand years, where the rate of build up of overburden is small and where building stone is none too easily obtainable, it is natural to expect the extensive destruction of the remains of the earlier periods. Further, the massive remains of the Viking period are some of the finest of their type in Scotland and the necessity to preserve them has prevented the full excavation of the Iron Age horizons. However, the fragmentary remains of the primary occupation suggest a hut with a flat floor paved with flagstones. This structure is apparently approached by a kerbed pathway 39 in. wide, some 7 ft. of which has been exposed to the SE. of the hut (fig. 4).

To the NW. of the hut and apparently attached to it lies a souterrain which sweeps round for 26 ft. in an almost complete semicircle. The W. end has been very much destroyed by quarrying for building stone for the Viking longhouse. In fact there can be little doubt that the unusually large boulders used as foundation stones in the Viking structure at the point nearest the souterrain are either roof or side-wall stones plundered from the earlier structure. The earth-house has been constructed by digging a trench some 2 ft. into the rotted bedrock of the hillside sloping gently up from the hut floor. Large stones were then used to cover this trench which is about 3 ft. in average width. Where the loosely compacted material would not support the weight of these stones, large side stones or three courses of flattish stones were occasionally used to support the roof stones. An elaborate entrance was constructed protected by two pillars on either side with well coursed neat dry-stone walling sweeping outwards with a sharp curvature to left and right

(Pl. XXXII, 2). A double wall existed on the W. side. The forecourt and the entrance to the souterrain are roughly paved but there is hardly any paving in the interior. The construction was completed by covering the souterrain cairn-fashion with a mound of smaller stones retained by a kerbing of large stones set on edge.

The diameter of the area enclosed by this outer kerbing had been approximately 24 ft.

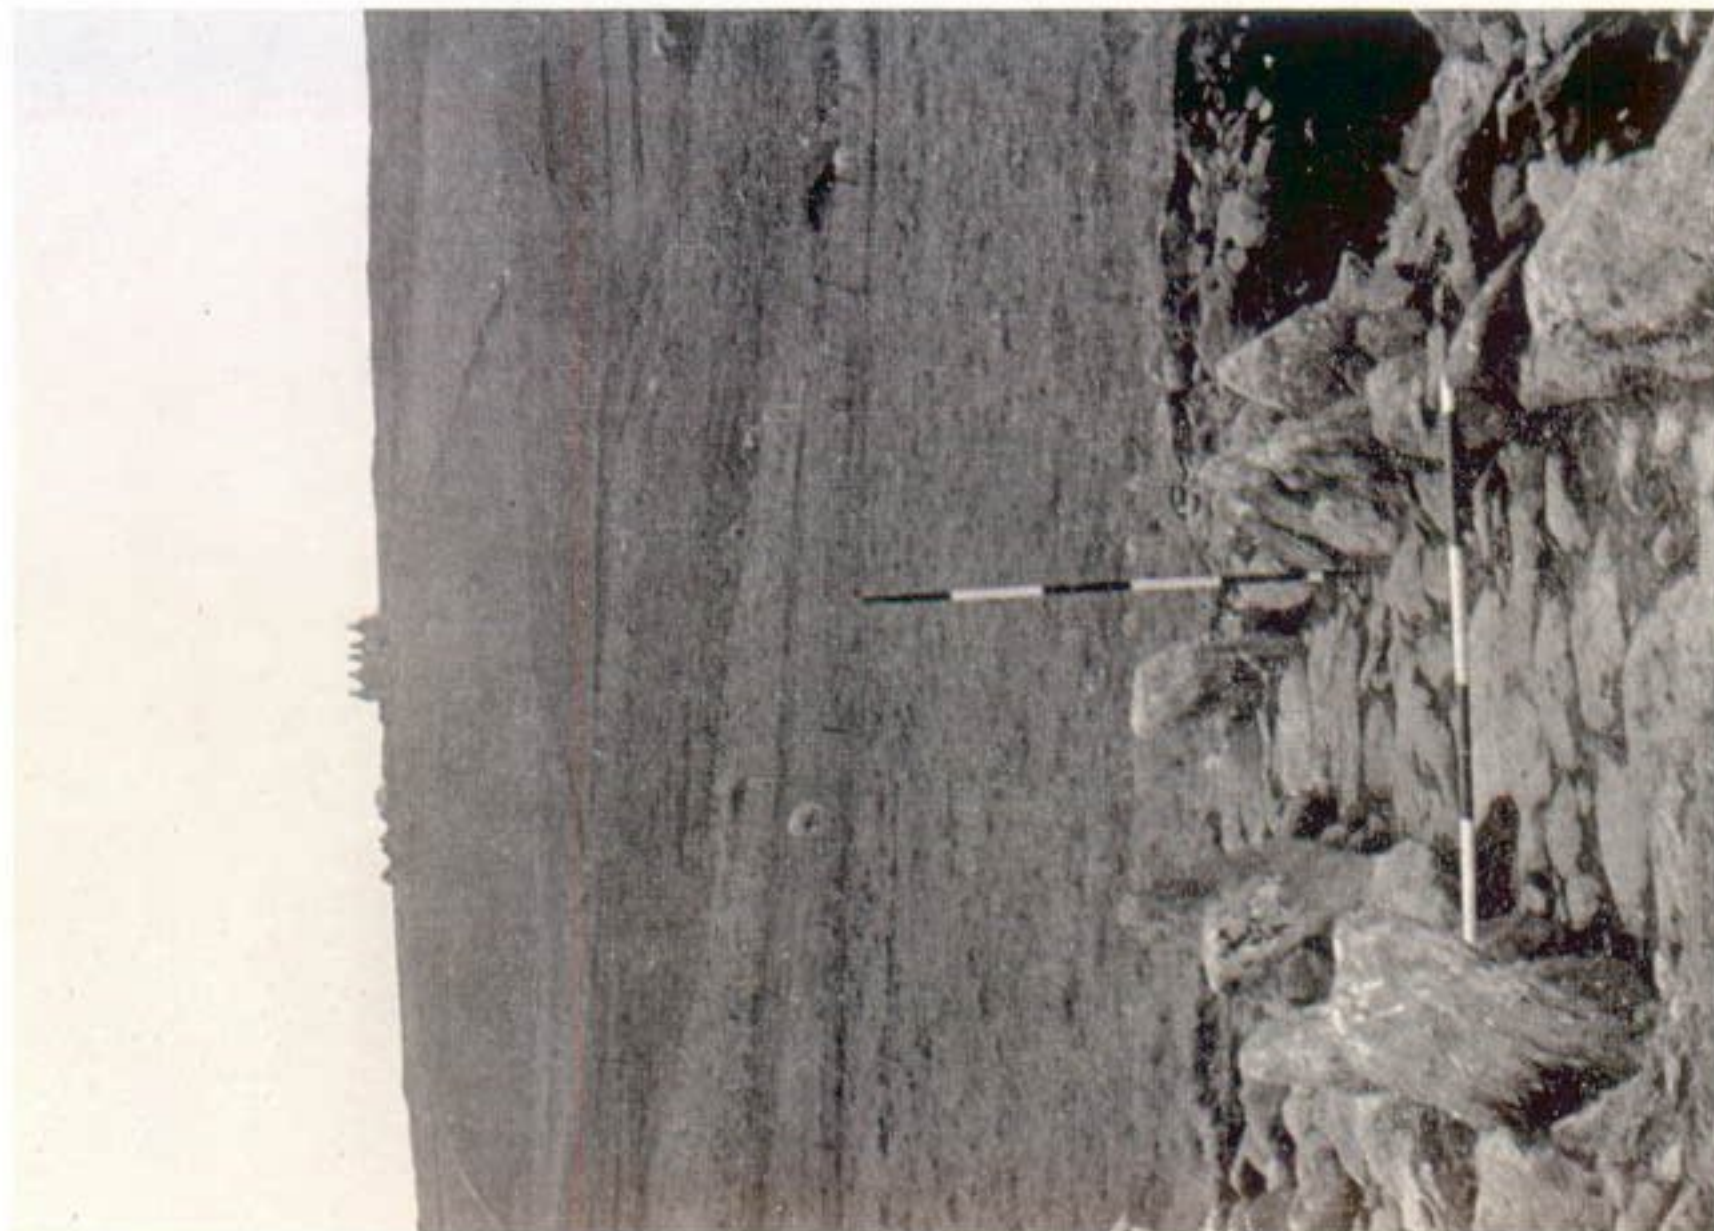
3. Kerbed causeway leading down to cultivatable land from the Viking longhouse

The flat paved forecourt of the house to the S. is approached by a long kerbed and paved causeway (Pl. XXXIII, 3). With the building out of a flat courtyard during the initial levelling of the site, the causeway, mounted on a matrix of stone and earth, was essential to give a reasonable slope for animals to negotiate. One of the kerbstones of the causeway is the fractured trough quern mentioned above<sup>1</sup> (see p. 235). The unconsolidated nature of this built-up forecourt led to problems of subsidence and the paving had been relaid several times. In places where it was subjected to particularly heavy wear and subsidence, as in the approaches to the doorway, there are signs of three levels of paving being needed to maintain a level approach.

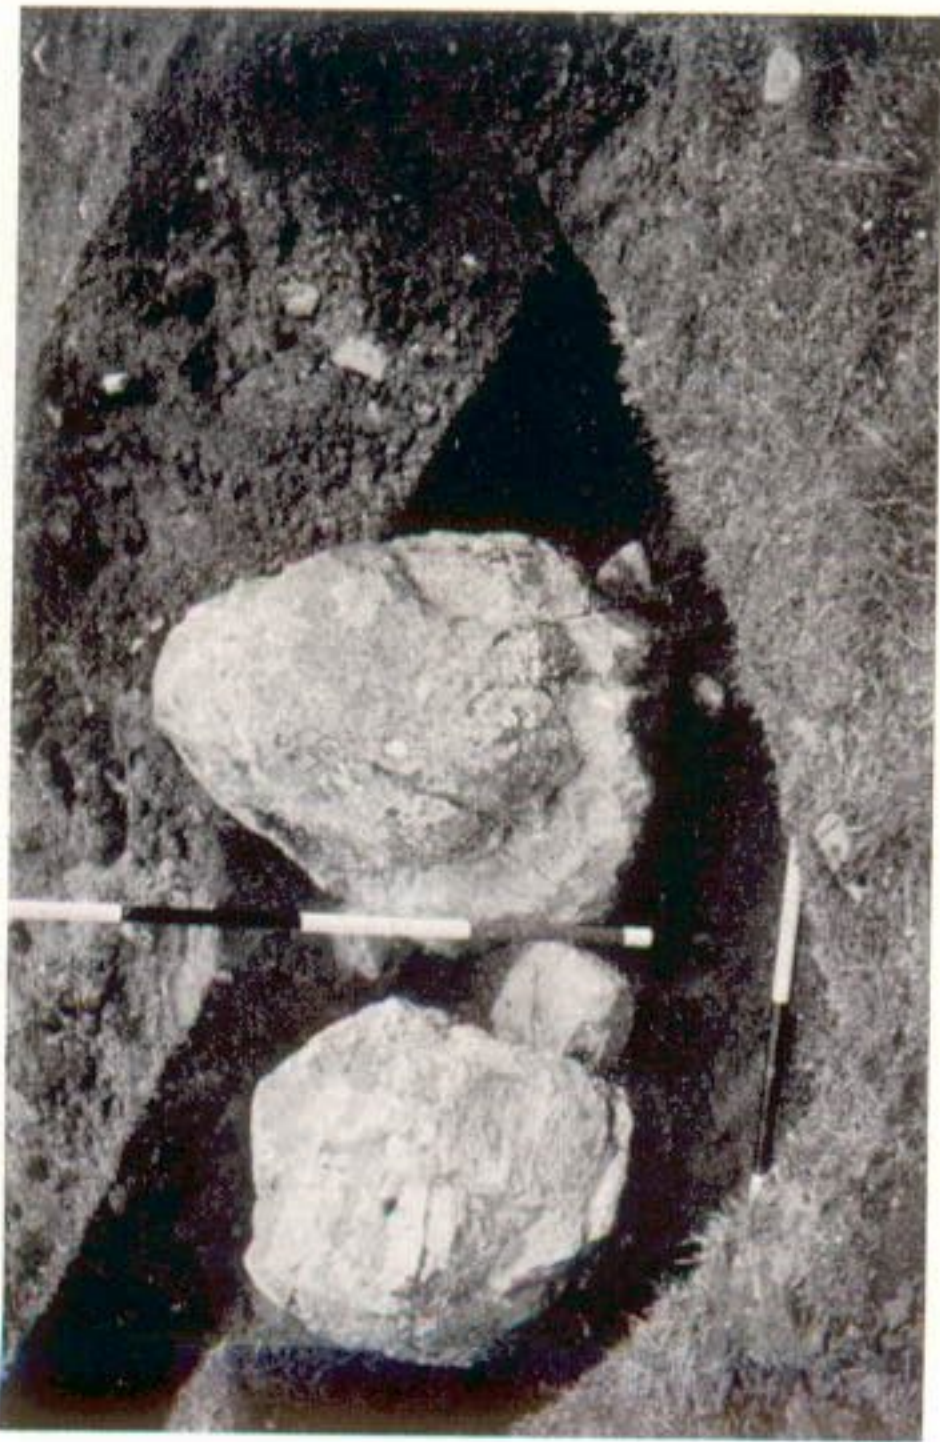
1. Large stones on a base of small flat stones which were revealed in a number of mounds surrounding the site

livestock were slaughtered and the meat salted down as provision for the winter months. Other summer occupations included peat cutting and the preparation of the wool for weaving. In practically every area of flat ground around the house and in the areas intervening between the probable field strips hay was cut. A considerable number of small mounds encircle the site. Excavation of two of these revealed that they were earthen mounds with a scatter of field clearance stones on top but others showed a core of one or two large stones often 3 to 4 ft. high set on end on a platform of smaller stones. These appear to have been hay-drying ricks<sup>1</sup> (Pl. XXXIV, 1).

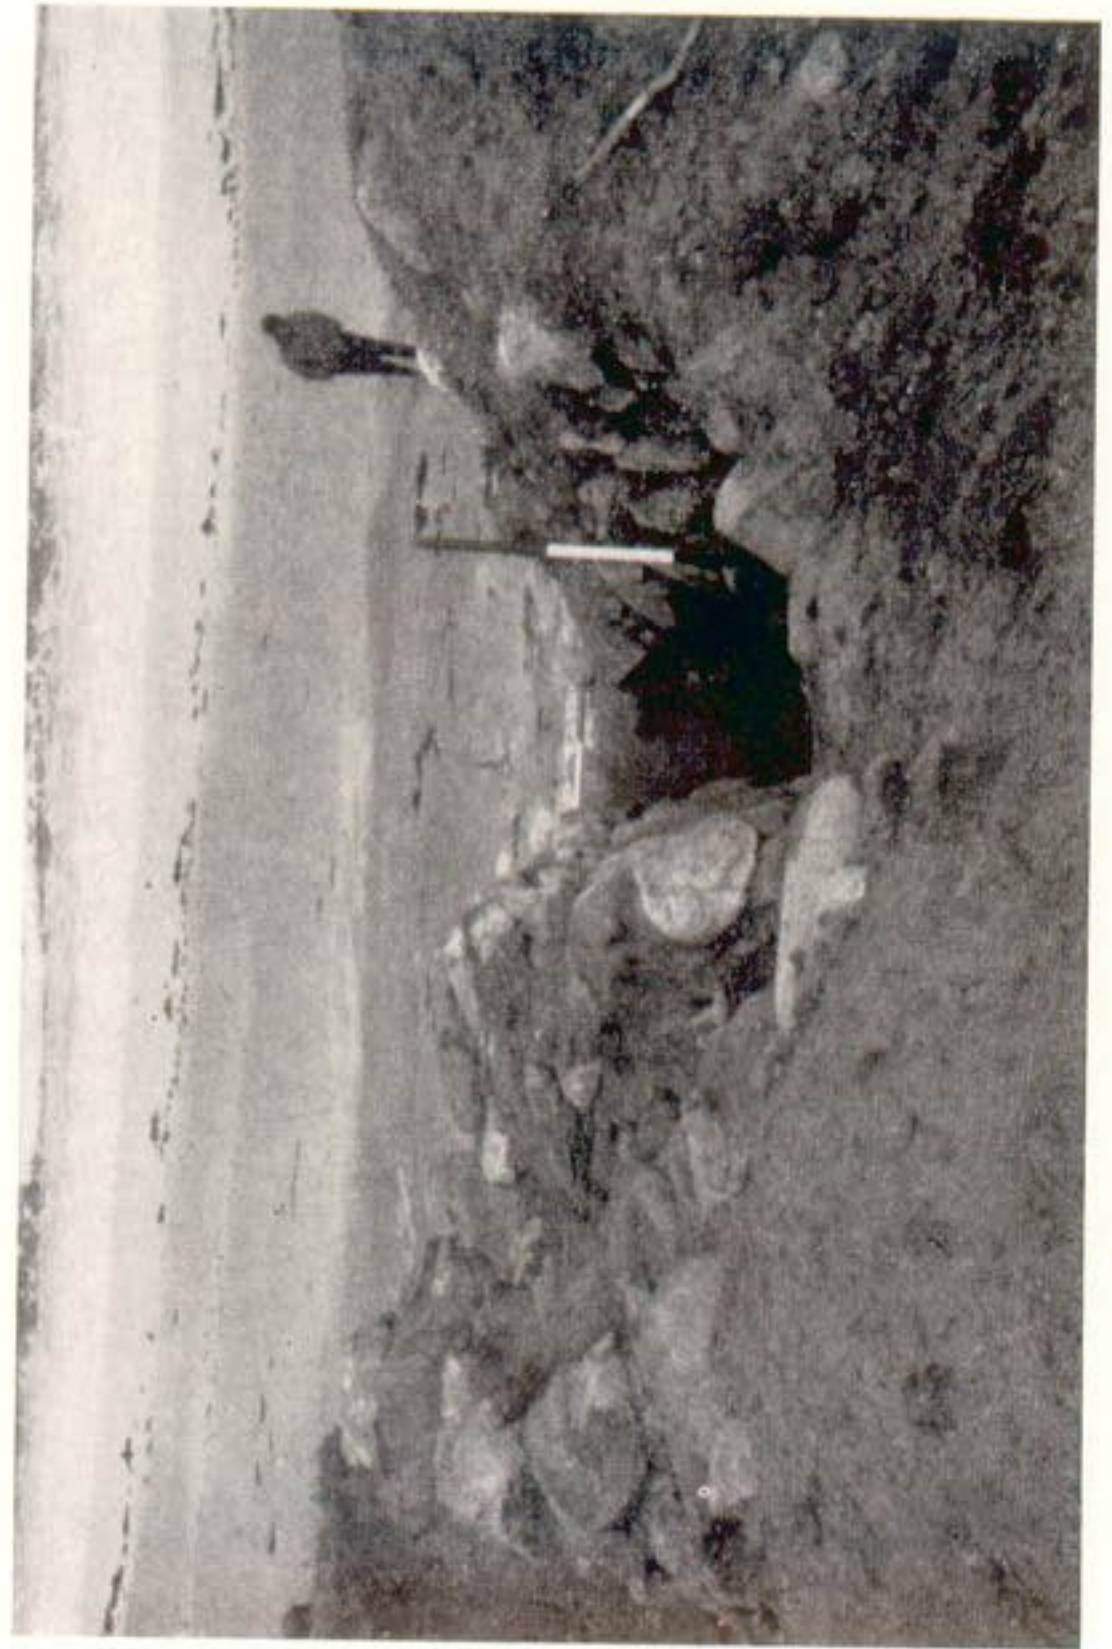
3. Boat noost near the centre of Burga Sand Bay

The sands at the head of Burga Bay below the site permit the pulling up of a small boat, but conditions are not ideal. However, it has been used in the past as the remains of a small boat noost partly eroded by the winter storms were discovered near the centre of the bay head (Pl. XXXIV, 3). The noost, with curved end, was 4 ft. deep and the same width and could probably, in its original state, have taken a boat up to about 18 ft. long. Into the noost a lean-to wall had been built almost halving the width so that it could be used for sawing driftwood lengthwise. A layer of rotting sawdust on sand inches above the roughly cobbled floor confirmed this. Sand blows into the noost very rapidly and it has no doubt been cleared out many

times and there is no means of dating its construction. A section outside the noost, however, revealed one fragment of a soapstone vessel very similar in shape and character to those found in the longhouse and stratigraphically this was on the same horizon as the noost floor. Boat noosts of similar proportions are known in all the Atlantic Island groups with perhaps the nearest parallel at Uti í Grøv in Borðoy, Færoe, where the method of construction is similar. The discovery of the steatite fragment on the exterior of the noost suggests that the noost was originally free-standing and as such has many parallels in the North Atlantic Islands. Although the noost is being eroded at present, and consequently valueless, it was probably in an extremely safe position in Norse times as there is a growing corpus of evidence supporting a rising sea-level in Shetland.<sup>1</sup>
