Excavations at Lochmaben Castle, Dumfriesshire

by A D S Macdonald and L R Laing

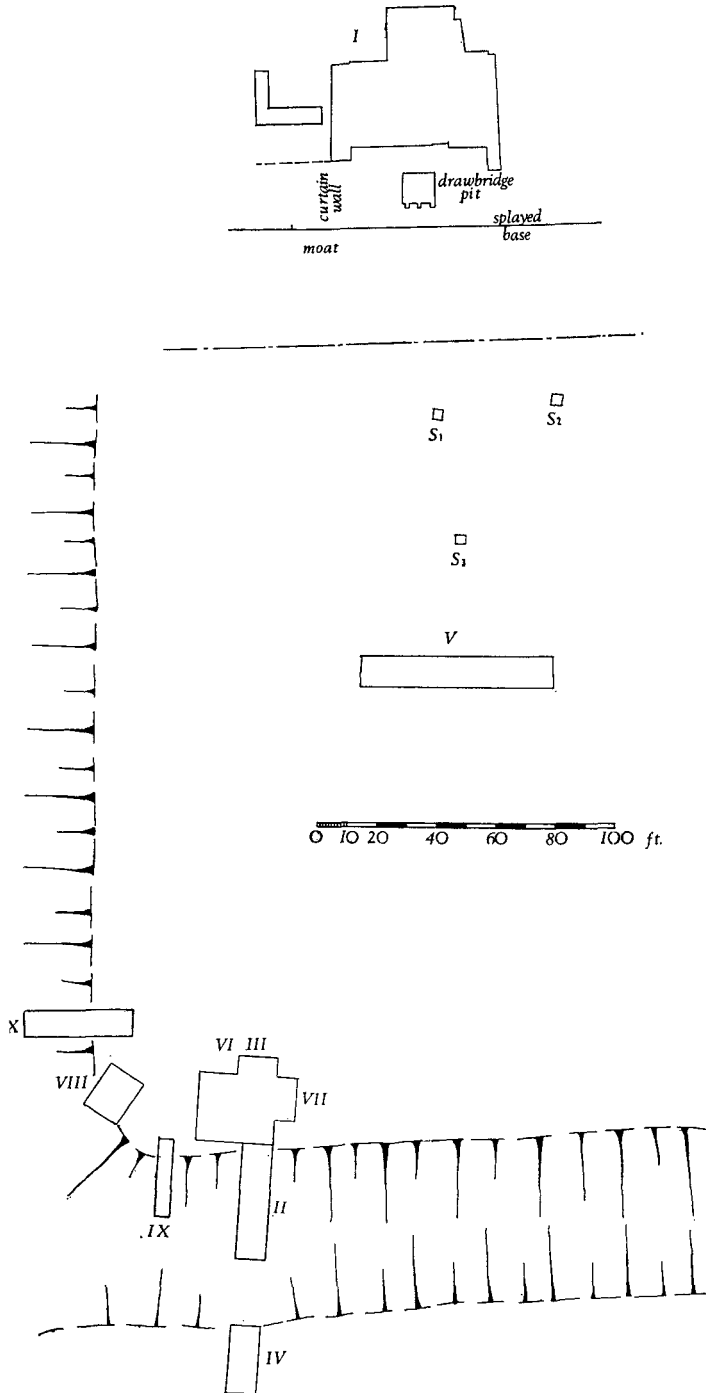
FIG 2 Plan of excavated areas

The excavations were concentrated in two main areas, the outer ward of the stone castle and the SW angle of the outer plateau or 'bailey'. Area excavation was employed in the castle due to the fact that the site had apparently been robbed down to foundation level in this area, and probably 'tidied up' for Queen Victoria's Jubilee in 1887. This was designated Area A. On the plateau the depth of deposits necessitated trenching, but trenches were amalgamated and extended to examine the features at the highest medieval occupation level. To facilitate this, an area was stripped mechanically in 1972. This was designated Area B.

(S1, S2, S3) dug to test the extent of the cobbles located in Cutting V. The relative position and dimensions of these cuttings and sondages is given in fig 2.

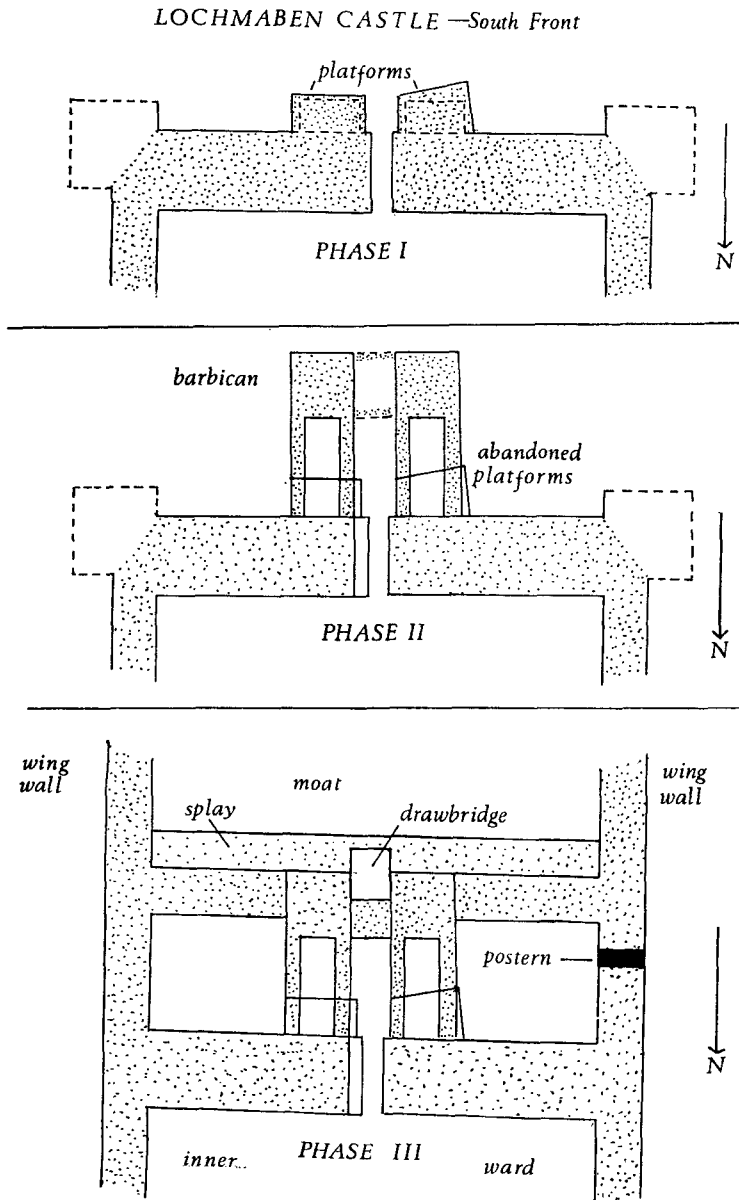
FIG 5 Area A: interpretation

The conclusion seems unavoidable, therefore, that the wall 5/5A was originally intended to

be the S curtain wall of the castle and that the 'platforms' carried towers, probably rectangular, flanking the gateway. It is further possible that wall and towers contained accommodation in their upper levels and thus that the primary plan was for a gatehouse keep, somewhat on the lines of Caerlaverock. Certainly, the other walls of enceinte are comparatively thin.

The N end of the W curtain wall is of one build with Wall 5. This, taken together with the butt-joint in the bottom five courses of the W curtain to S of the junction and the distinct change in the quality of the foundation stonework immediately to S, suggests that (probably) square corner towers were envisaged at this stage. The fact that no corresponding butt-joint was found on the outer side of the W curtain indicates that the building of this corner tower at least did not proceed very far.

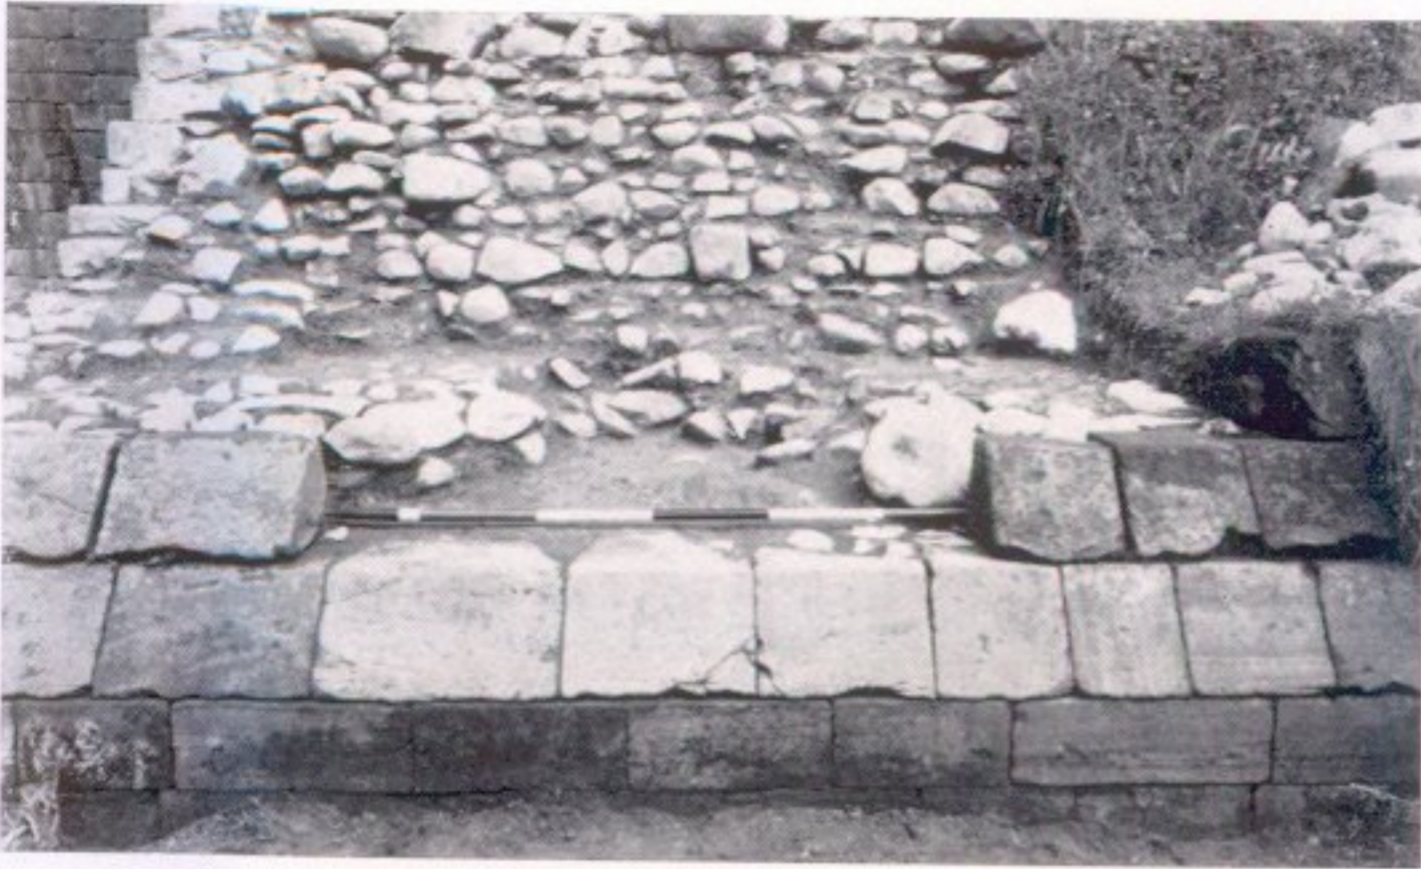
a Ashlar splay of moat with robbed core of wall, E of counterweight pit

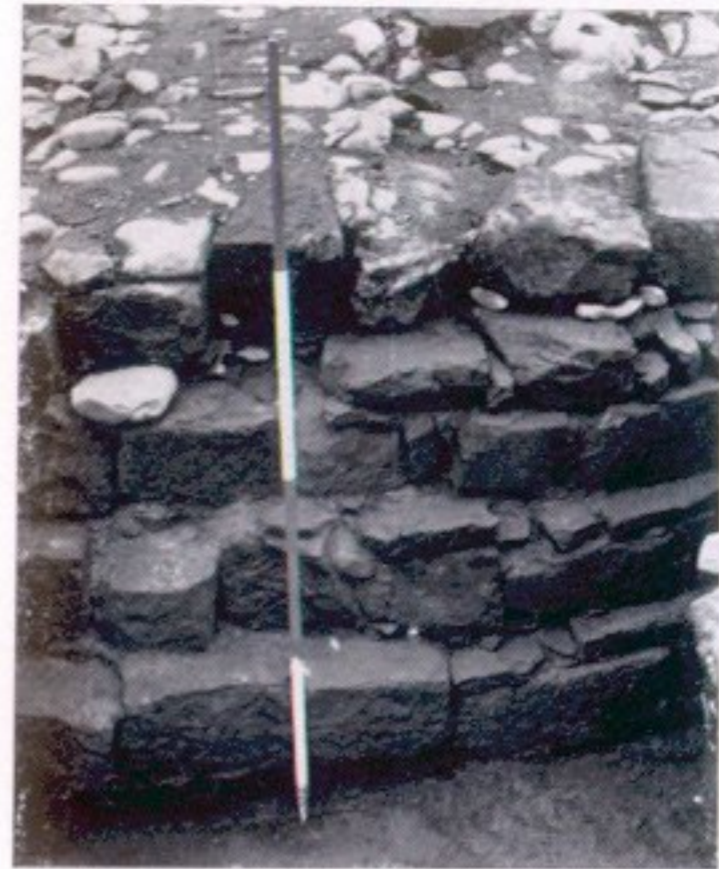
b S side of AI platform

Walls 1 and 2 were bonded into the return of the S curtain wall. At the N, the surviving footings of both walls terminated on the line of the S side of an irregularly shaped masonry 'platform' (4 on plan), whose dimensions at the top were 5.6 m (S side) by 4.1 m (W) by 2.8 m (E). This 'platform' was strongly built and deeply founded. It was cased both with big, roughly dressed blocks and with large rubble and boulders and infilled with rubble. It was five courses deep and stepped on its S side – the footings of Walls 1 and 2 abutting and overlying the lower four courses. (Both walls and 'platform' had been robbed to approximately the same level.) The bottom course of the casing on this side rested in part directly on the natural, though a thin deposit of gravel appeared below some of the stones in the central section, between Walls 1 and 2. On the W, the casing was sheer, five courses deep at the SW, but only three to four to N of the break. (In fact, the bottom course appeared only at the SW corner.) The SW corner stone of the bottom course rested on natural and the next to N probably did partially; but on this side the casing was largely founded on deposits of gravel which sloped down from N to S, the courses being stepped down with the slope. The central section of the casing and part of the rubble core behind it had been robbed. On the E side, the second course of the casing was stepped out from the top course, as on the S, but the casing was sheer from there down: four courses in all. At the N end, the bottom course of this side rested on gravel for about a metre, otherwise on the natural: it was thus graded down from N to S rather like the W side. The top course of the 'platform' casing was bonded with buff lime mortar; the lower courses with grey clay. Similarly, the 'platform' had a more or less level surface of rubble and mortar, the rubble containing some large stones, some faced. This top surface was fairly loosely packed and some 0.25 to 0.3 m deep at the E edge of the robbed area on the W side. Below it was rubble and loose grey clay.

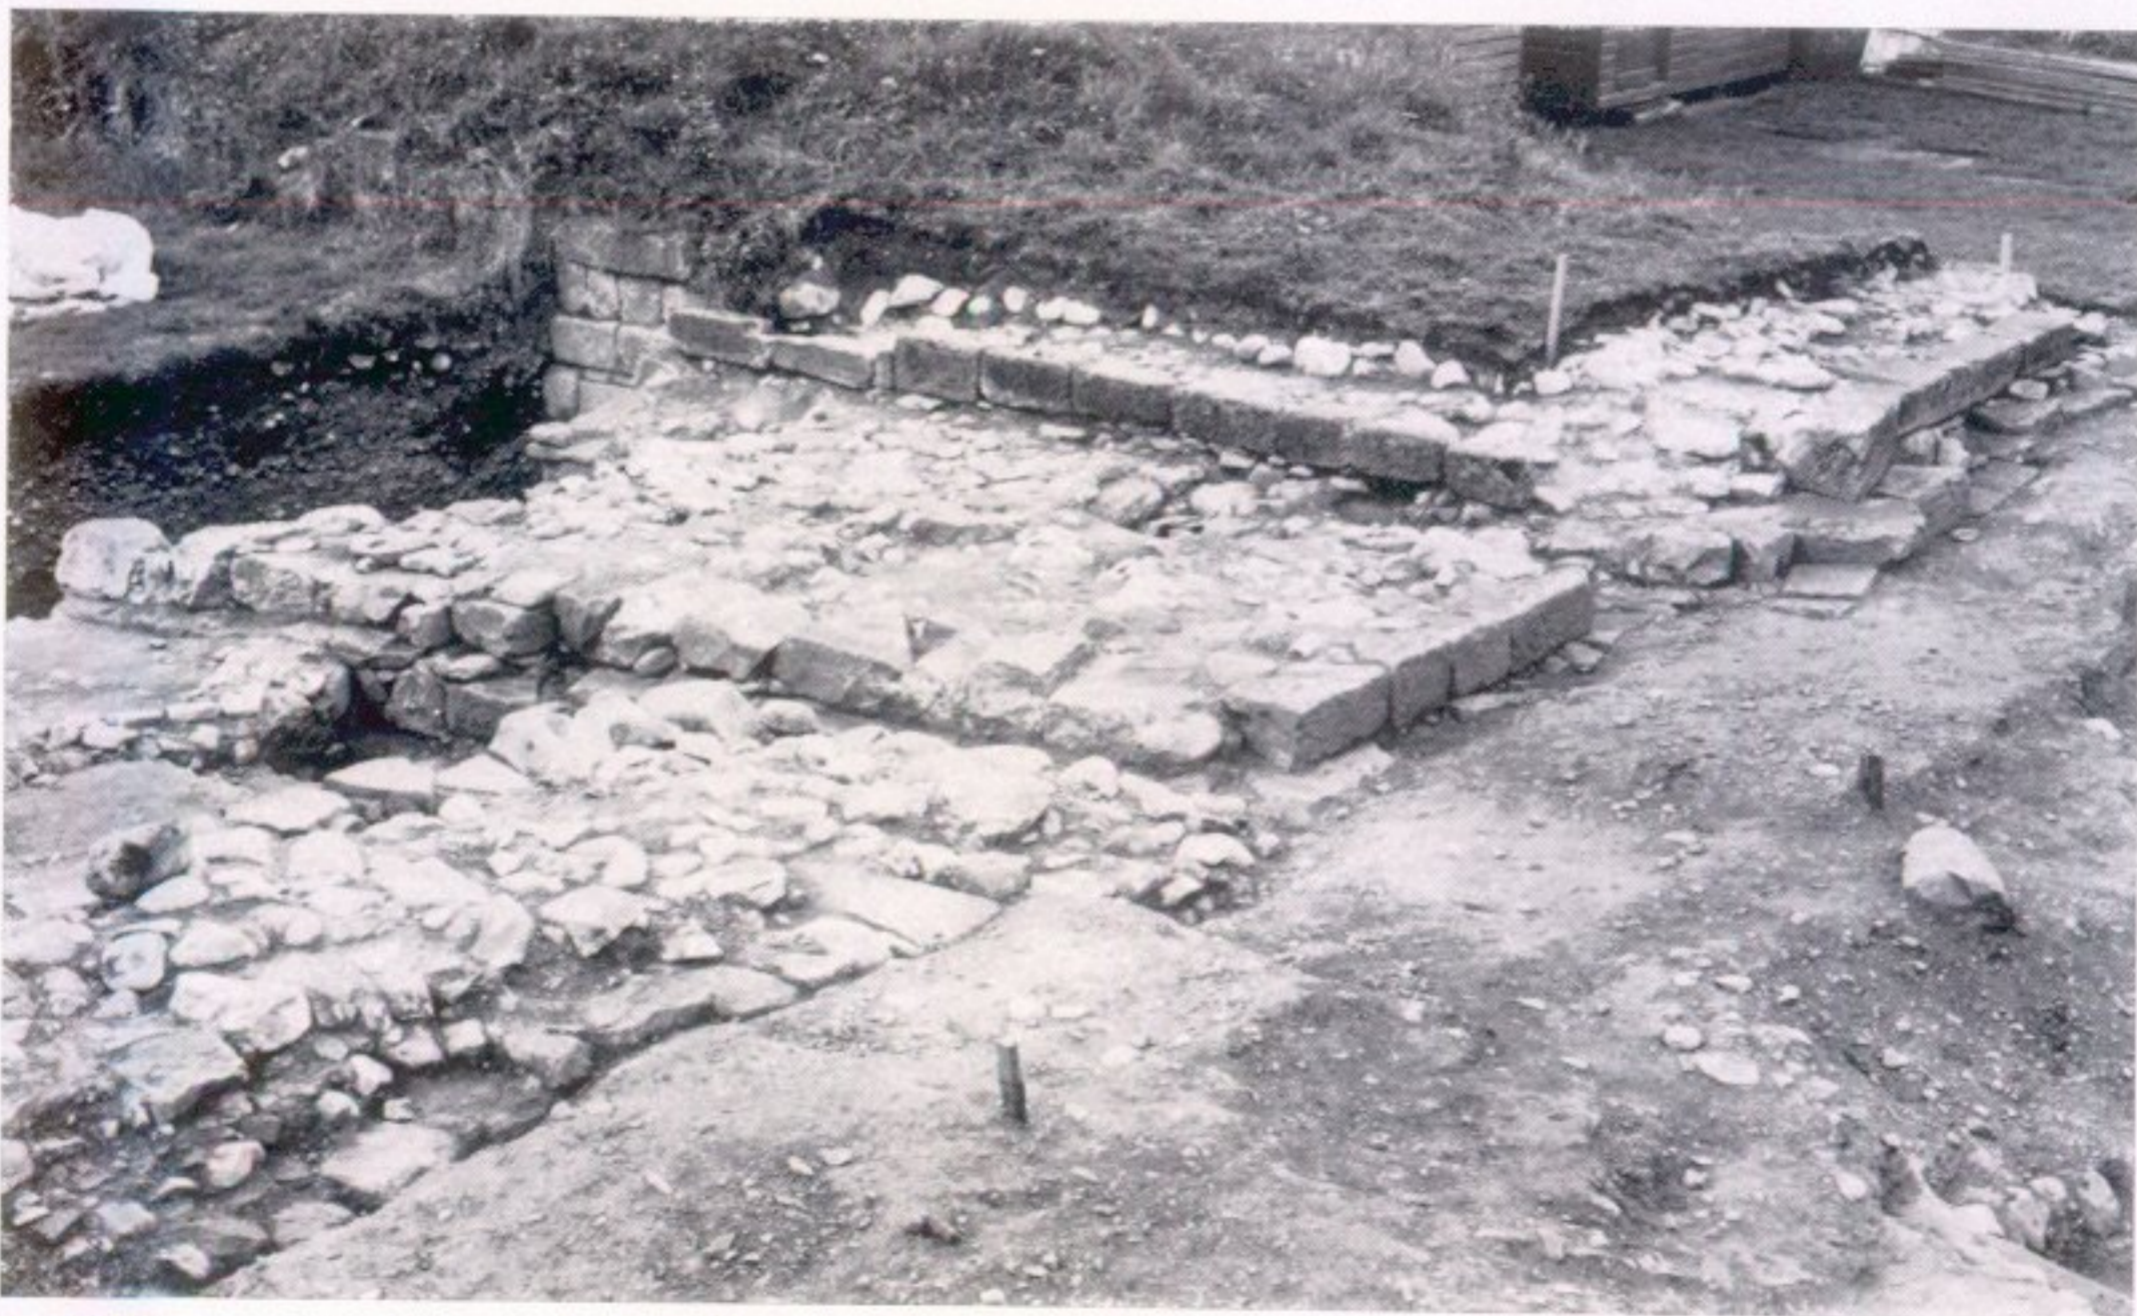
c Platform and wall 5, AI, from SE

On its N side, the 'platform' was bonded into an E-W wall, parallel with the S curtain wall, very well built and of great width (5 on plan). Its N face was missing in the excavated area, but the distance from the outer edge of the ashlar blocks facing its S side on the 'platform' to the probable line of the N face (the line of the N face of the built threshold across the roadway) was approximately 6 m. Its S side, in the short distance between the W side of the 'platform' and the W limit of main area AI, was faced with large ashlar, the bottom two courses both being stepped out slightly from those above. No footing material was visible here: the bottom course of the wall
