The charcoal-fired blast furnaces of Scotland: a review

John H Lewis*

This paper attempts to up-date W I Macadam's survey, published in 1887, of the early iron industry of Scotland. The majority of the article comprises reports of recent excavations at Red Smiddy, Glenkinglass and Bonawe furnaces but short notes on other sites are also included.

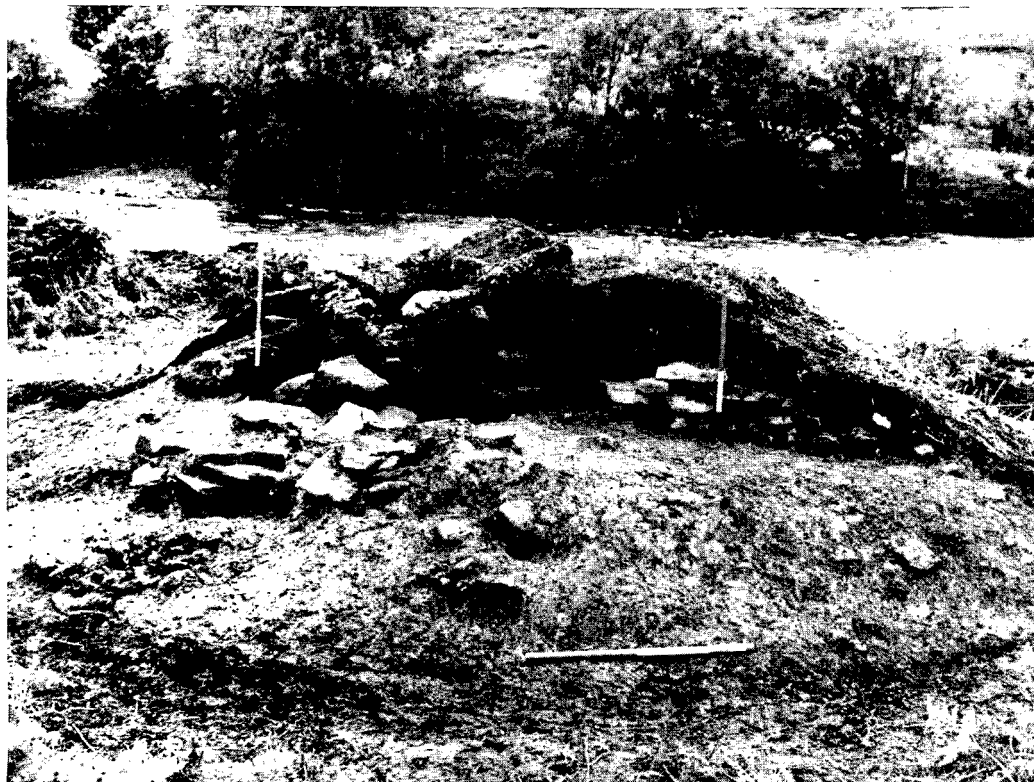
ILLUS 4 Red Smiddy 1980: furnace during excavation, from the N. *Crown copyright*

Within the 5.90 m square furnace the rectangular hearth measured 1.70 m N to S by 1.60 m E to W. Internally it was 900 mm N to S by 740 mm E to W. The casing was of water-washed granite boulders, set in a light grey brown clay, and faced on all sides with squared sandstone blocks, also bonded with clay. There was no evidence anywhere of mortar bonding. The hearth lining was built of

red sandstone, generally about 350 mm thick but over 500 mm in places. It was more or less intact although heavily vitrified: the vitrification penetrated well into the facing, suggesting that the hearth had been in use for some time after its previous relining. Erosion of the inner casing of the hearth had altered its original rectangular plan into its present subcircular form. Separating the hearth from the outer casing was a cavity, up to 400 mm wide, which had been filled with a clean coarse sand. As well as providing direct insulation against the intense heat of smelting, this sand may have helped counter the forces produced by expansion and contraction of the inner stonework during campaigns (Glenkinglass was found to have a similar arrangement). No evidence has been found so far to suggest that further protection for the furnace building, such as timber bracing, was used.

The blowing and tapping arches, on the east and north sides respectively, were separated by a slender pillar measuring only 600 mm to 1.15 m wide and almost completely robbed out above the foundation level. A risband joint near to the hearth showed the hearth to be a free-standing structure, the stonework between it and the pillar being merely a rubble infill with a distinctly bluish coloured clay as a matrix in contrast to the usual grey brown clay of the main body of the furnace.

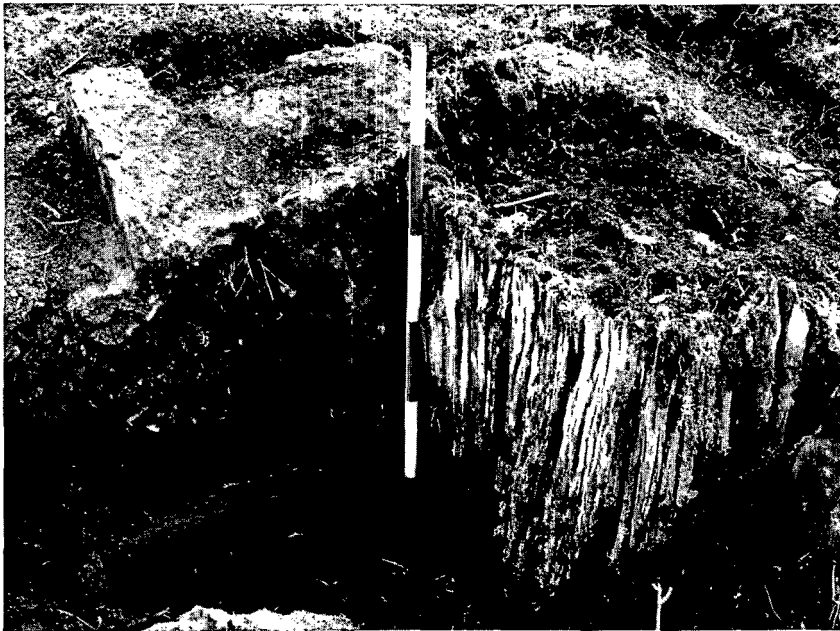
ILLUS 6 Fasagh: anvil setting

Slag analysis, the absence of any ore other than bog ore (Macadam 1887, 109) together with the anvils and their associated stringhearths all point to Fasagh having been a bloomery. Its size and sophistication would tend to indicate it being later rather than earlier. There is nothing to suggest a direct connection with either Red Smiddy or Letterewe but the idea that Hay was influenced in his choice of location by a viable works already in existence in the area is an attractive one.

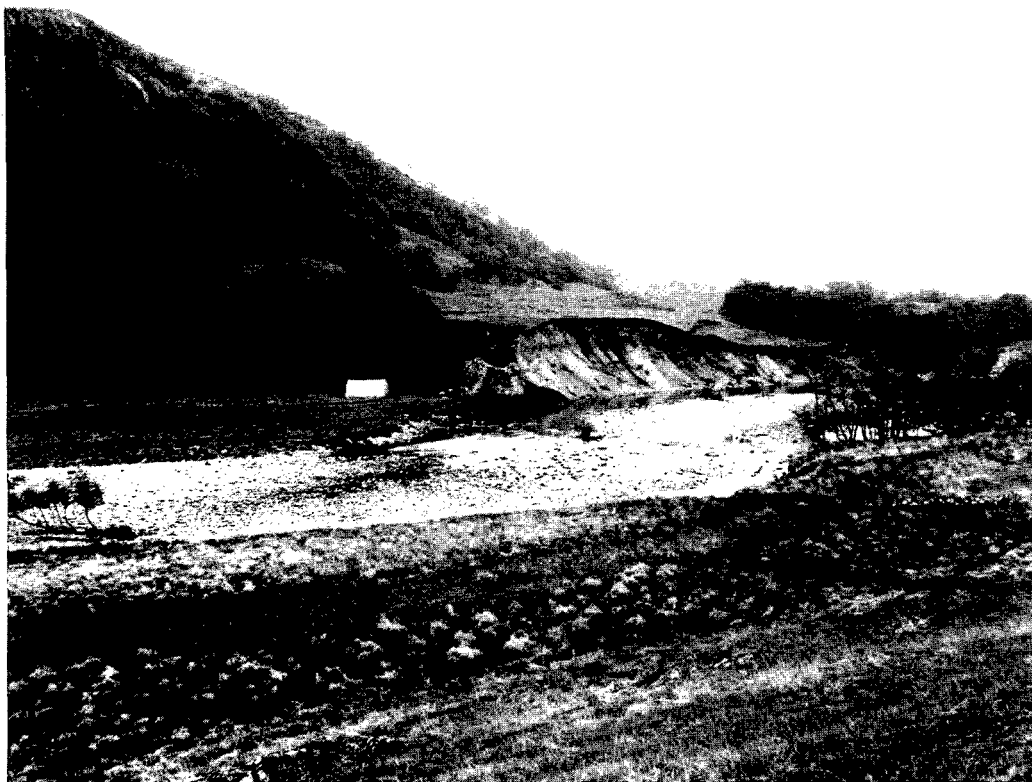
ILLUS 10 Glenkinglass: general view from the W. *Crown copyright*

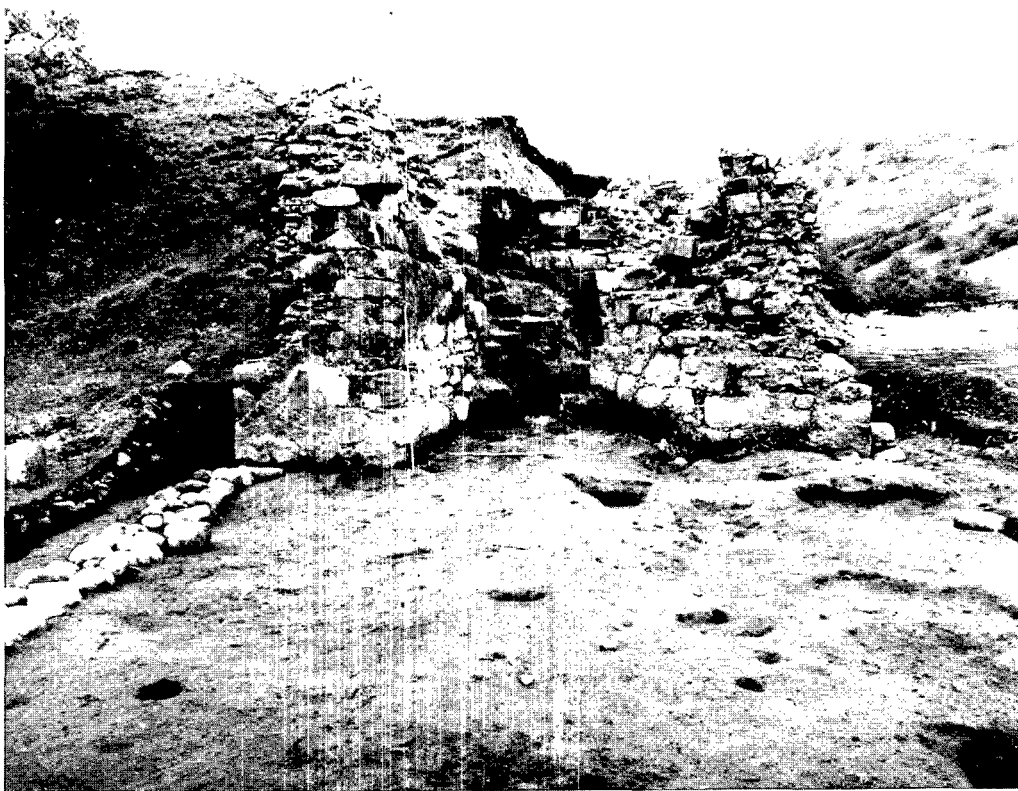
ILLUS 11 Glenkinglass: furnace and casting house from the NW. *Crown copyright*

Although the upper part of the building was badly damaged there was still evidence of springers within both the tapping and blowing apertures. This suggested that these openings had been arched, unlike the corresponding structures at the later Bonawe and Cralekan furnaces, where they are lintelled. At Duddon, in Cumbria, both the tapping and blowing apertures were originally arched but the collapse of the blowing arch resulted in its being replaced by a lintelled arrangement. The tapping arch remained barrel vaulted. Lintelled openings did not necessarily replace earlier arched ones, as the tap-arch apertures at the early 17th-century site of Red Smiddy has shown.

Between the outer casing and the inner core of the furnace, around the whole circumference of the inner structure, was a 200 mm gap filled with coarse red sand. Similar material was found at Red Smiddy and similar functions of insulation against heat and protection against stress are assumed.

The hearth measured 700 mm square at its base, widening slightly to 800 mm at the junction with the boshes 1.60 m above the hearthstone. Unlike the hearth the boshes were circular in cross section (circular boshes generally replaced square ones in the mid-17th century), widening out, like a truncated and inverted cone, to an estimated maximum diameter of 2.20 m. Estimation was necessary here because of the severe damage suffered by this part of the furnace. The east corner of the boshes was intact and from this point upwards the furnace tunnel continued for a further three or four courses;

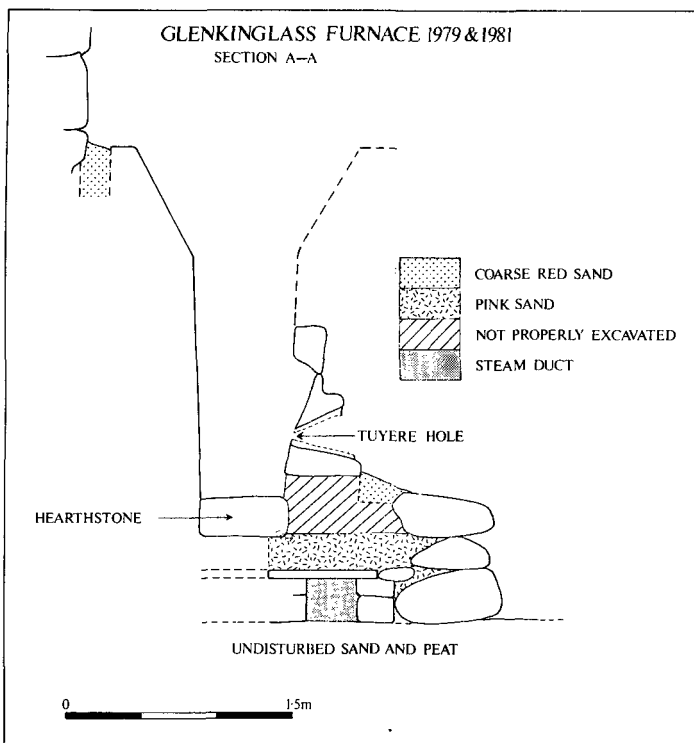
ILLUS 13 Glenkinglass: section A-A through the furnace

thereafter the remainder of the stack had been entirely destroyed. The angle against the vertical of these few surviving courses suggested the conventional slight upward narrowing of the tunnel. Contact metamorphism had altered the gross structure of the quartz crystals in the sandstone of the boshes and where the slag covering was absent this was apparent, the stones resembling the granite of the outer casing of the building.

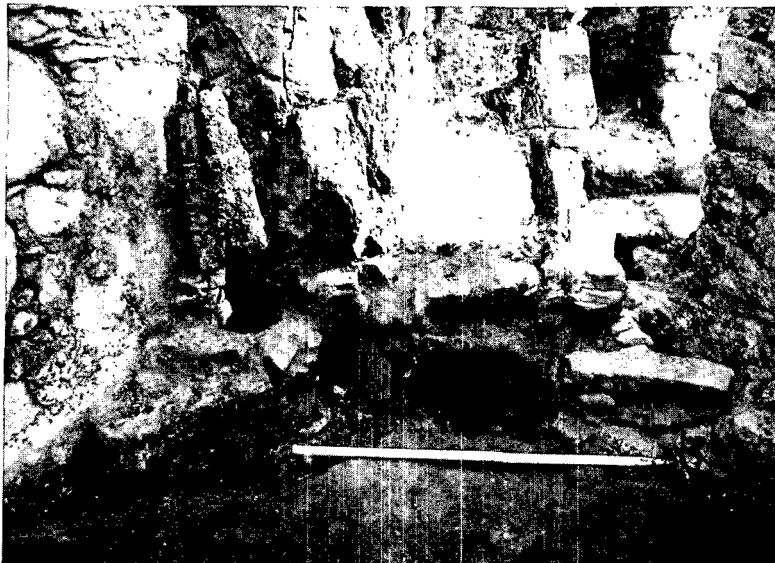
ILLUS 15 Glenkinglass: hearth after the removal of the tuyère setting. *Crown copyright*

to excavate the area to the back of the hearth or below the hearthstone itself, it is assumed that at least one more duct ran below the furnace base. Steam was vented to the open air by means of pipes set on either side of the taphole, but only one of these pipes still survived, this being adjacent to the north face of the tapping arch (illus 15).

The tapping procedure of early blast furnaces is described in some detail by Schubert (1957, 238-43) and a few aspects of particular relevance to Glenkinglass are described below in the section on the casting house. Structural details of the area of the taphole, however, were few since much of this part of the furnace had been badly damaged, leaving a gap (which would have been partially covered by the damstone) 700 mm across by 800 mm high, in the north-west face of the furnace hearth. To prevent any molten metal or slag percolating down through the casting floor sands and running below the hearth, a large deposit of grey clay was positioned against the hearth base (illus 14, 15).

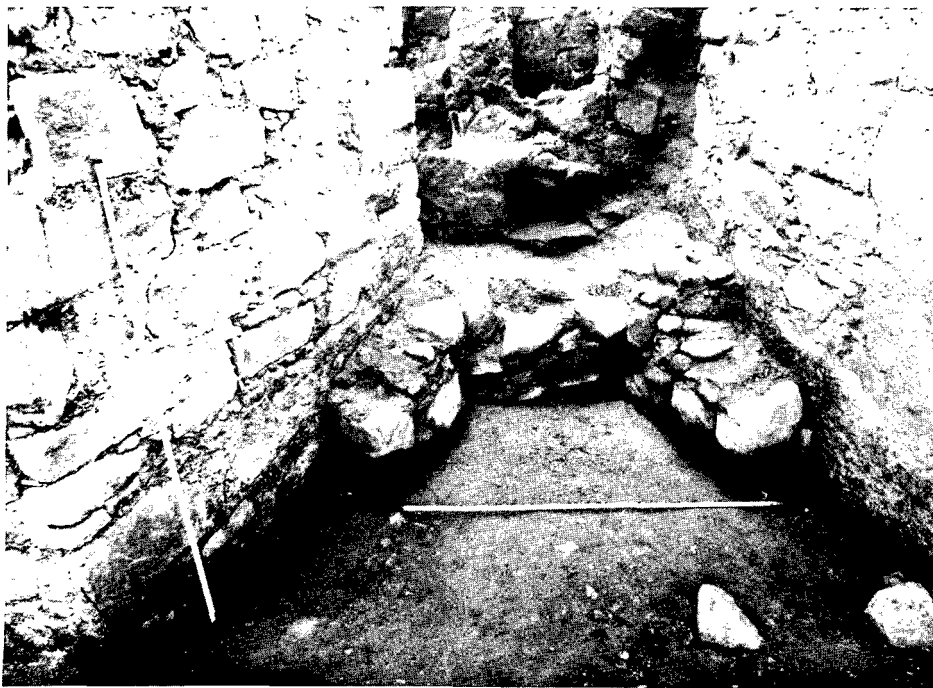
ILLUS 16 Glenkinglass: blowing arch. *Crown copyright*

The only surviving remains of the blowing apparatus, found within the blowing arch, were the tuyère setting and part of the support for the front of the bellows. This support was a rather crudely built structure of mortar-bonded granite rubble, three courses high, butting against both splays of the arch (illus 16). It was built on a series of sands and gravels, 300 mm to 400 mm deep and heavily contaminated with ash and charcoal which, in turn, overlay undisturbed fluvial sands. This indicates that the support was not a primary feature but had, at some time, replaced an earlier structure. 370 mm above the level of the hearthstone was the tuyère hole, externally 500 mm and internally 110 mm in diameter, its setting being of well tooled sandstone. Within the blowing arch, intermixed with contaminated sands, were deposits of grey clay, probably that used to seal the gap between the blow

hole and the tuyères when in blast. Similar material was also found in the tapping arch where its uses were many.

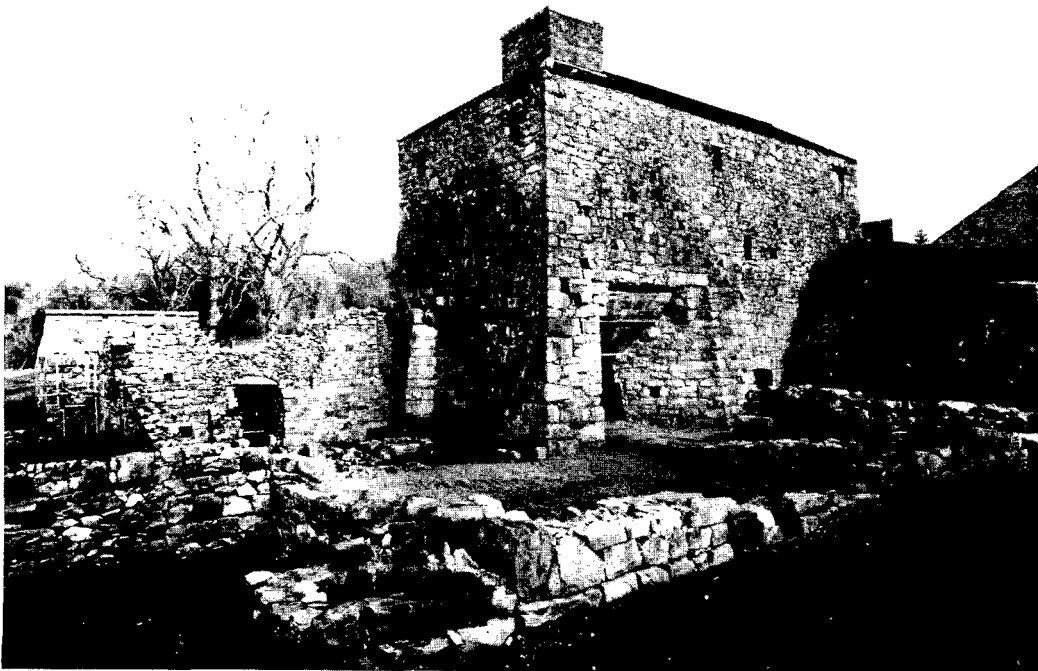
ILLUS 20 Bonawe: general view of furnace from the W. *Crown copyright*

EXCAVATIONS AT BONAWE FURNACE (illus 20, 21, 22, 23, 24)

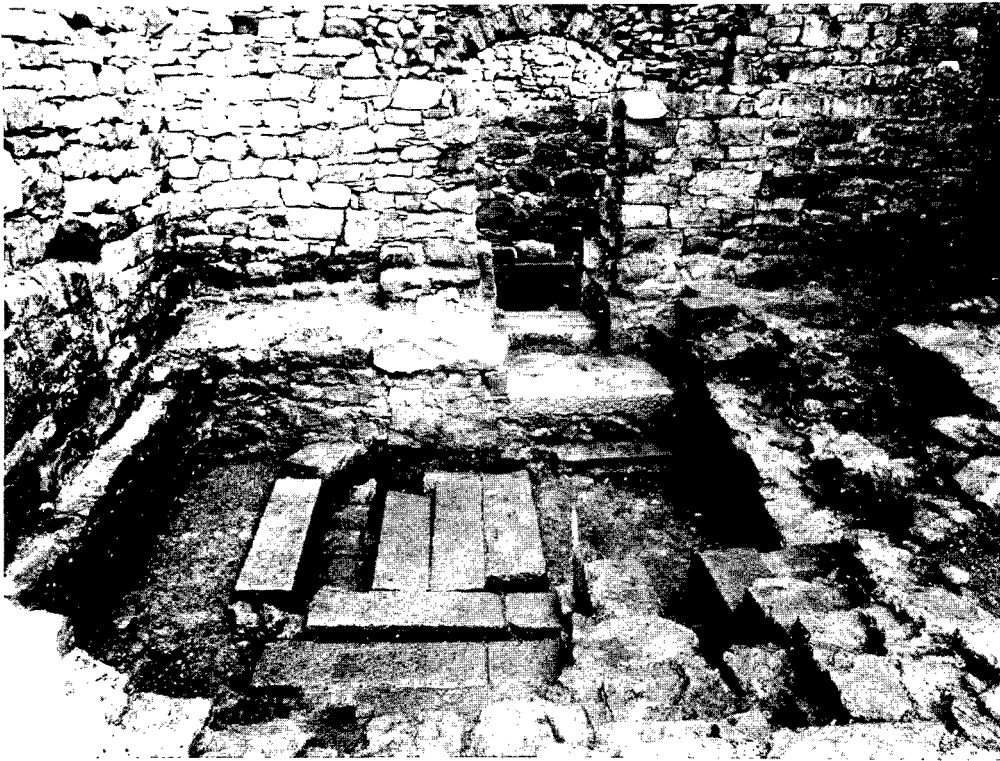
ILLUS 21 Bonawe: blowing house showing the granite mounting blocks. *Crown copyright*

Midway along the east wall of the blowing house was a brick arched opening through which the drive shaft connected the waterwheel to the blowing mechanism. The excavation provided no clue as to the nature of the blowing apparatus during the early period but it may have comprised either wooden box bellows or the more primitive leather bellows of the type believed to have been used at Glenkinglass.

Whatever its nature may have been, the original blowing apparatus was later stripped out to accommodate a new blowing mechanism. A 3 m wide opening through the north wall (since blocked) may have been forced through to admit the new machinery. In 1876, when the furnace was finally out of blast, the blowing apparatus was removed to the parent company's operations at Newland, Cumbria and only the granite blocks, each measuring 1.40 m long and 250 mm square in section, upon which the blowing apparatus was mounted, remained (illus 21). These were insufficient in themselves to reveal the identity of the apparatus they supported but it is likely that cast-iron blowing cylinders were used throughout much of the 19th century.

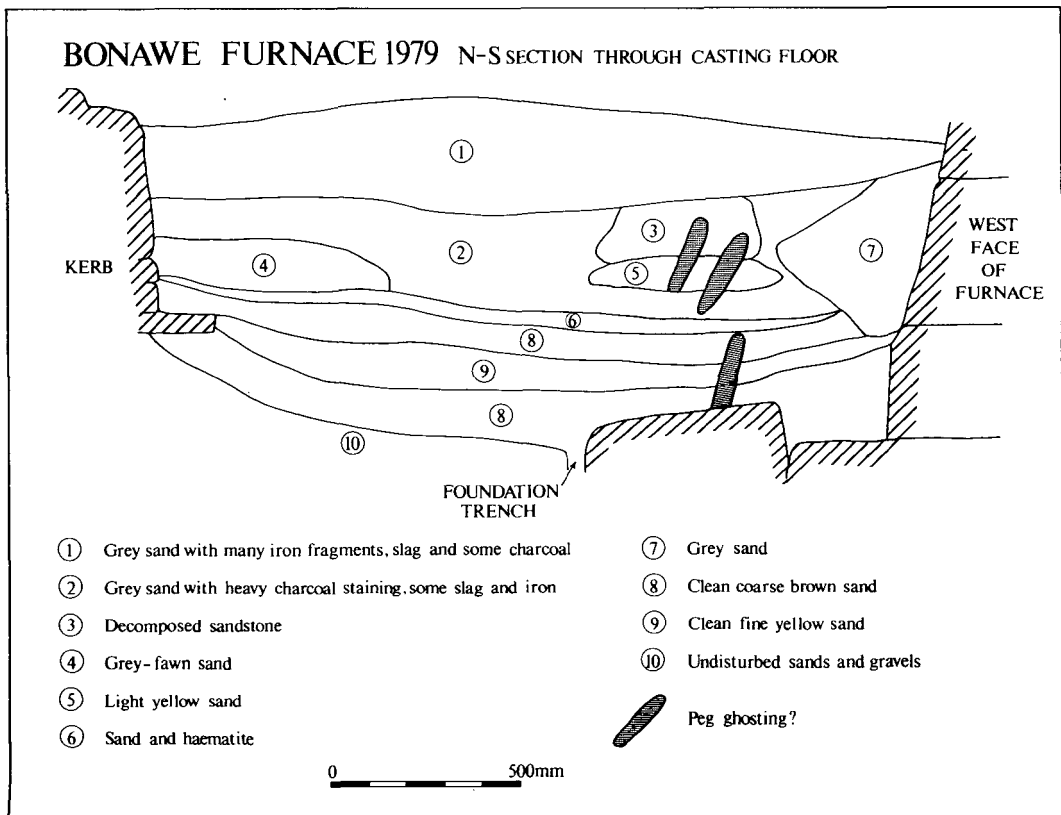
ILLUS 23 Bonawe: N-S section through the casting floor

The decision to leave the well preserved later floor intact allowed only the briefest glimpse of the early floor levels in the section cut through the casting sand. The original floor consisted of assorted fine sands in which was traced the ghosting of another timber(?) peg, 250 mm long and 40 mm in diameter. The fragments of worn sandstone beneath the granite kerb of the later floor suggests that the casting house had always been divided into two halves – the working surface on the N, the casting floor on the S.

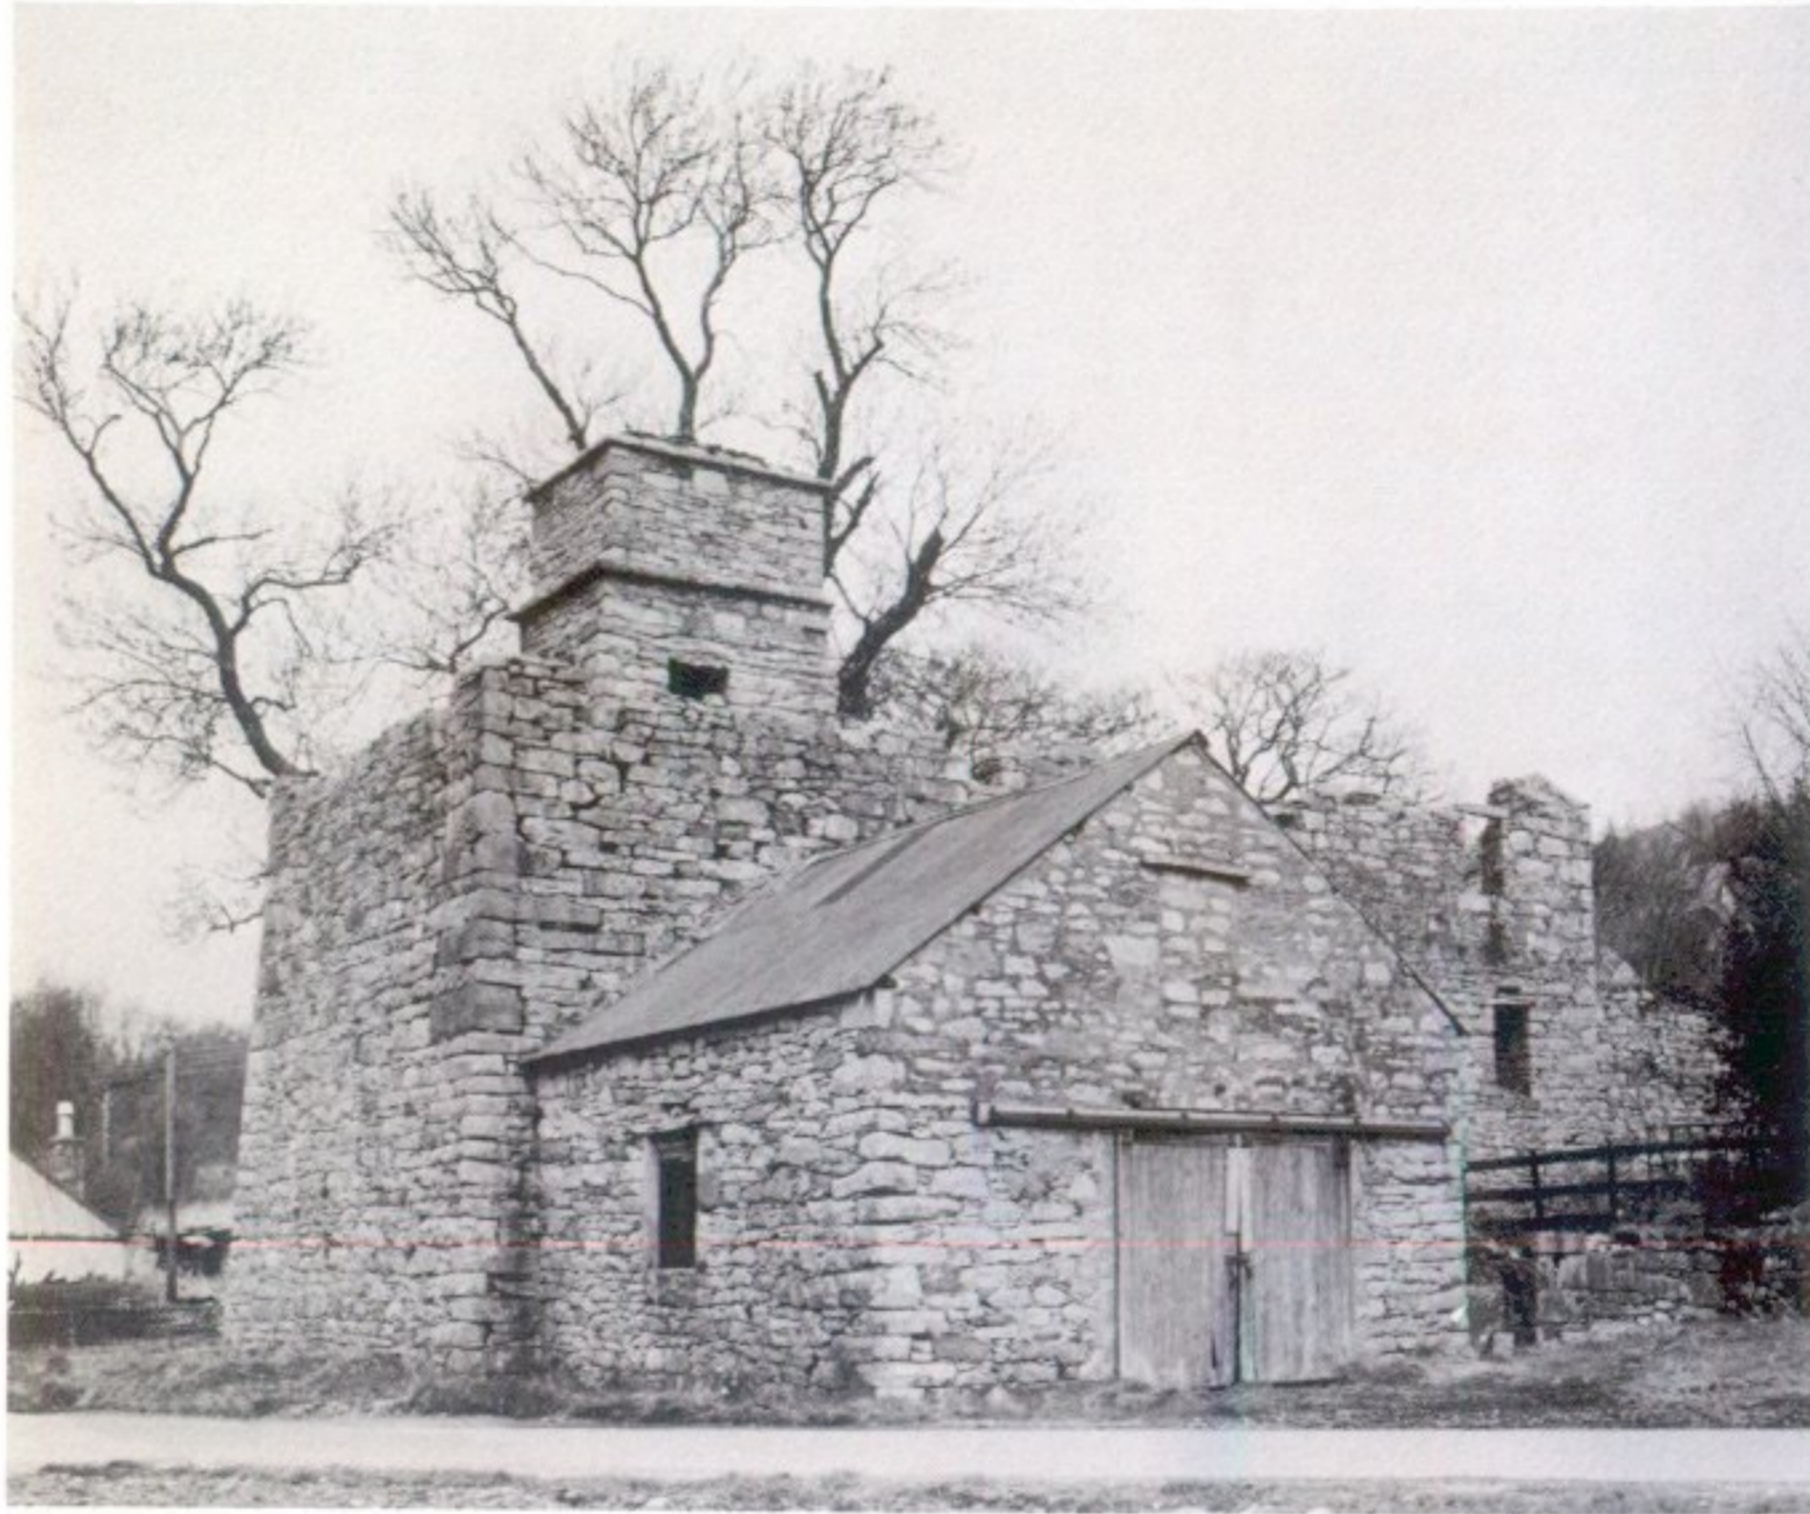
ILLUS 25 Craleckan: furnace, from the S. Crown copyright

CRALECKAN FURNACE (illus 25, 26, 27)

Craleckan furnace (NGR NN 027 001) was built near the hamlet of Inverlacken on the north shore of Loch Fyne, 12 km SW of Inveraray, Argyll in 1755 (not 1775 as is often quoted).
