The chapel and enclosure on the Brough of Deerness, Orkney: survey and excavations, 1975–1977

Christopher D Morris* with Norman Emery*

ABSTRACT

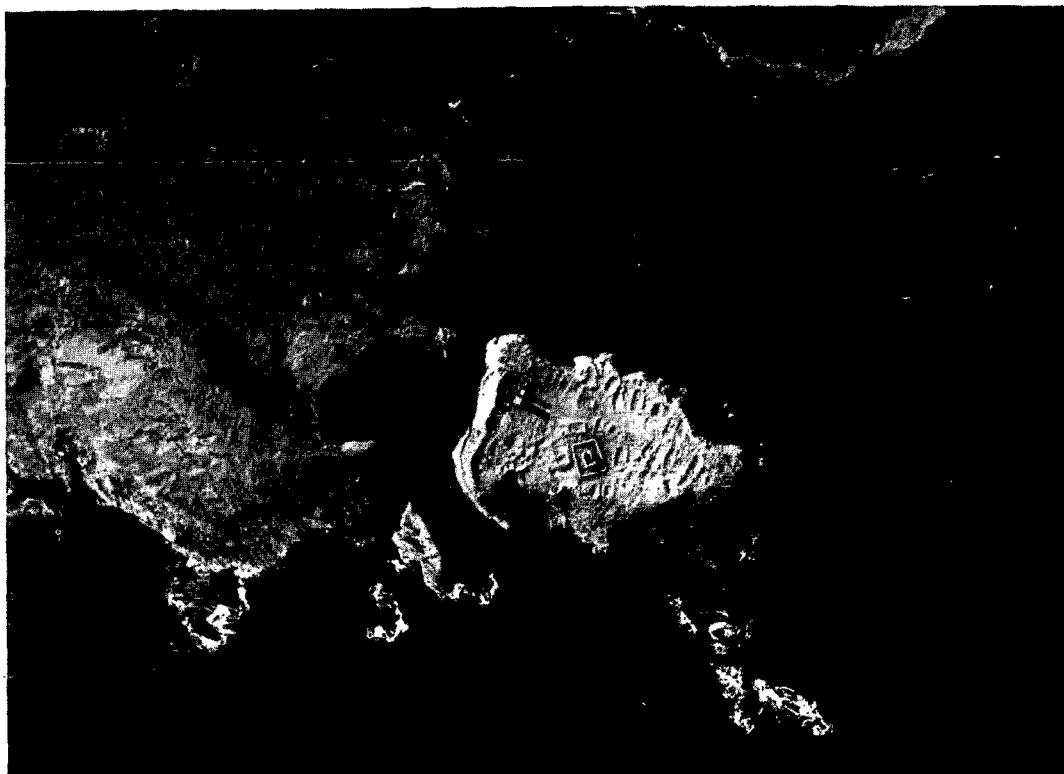
ILLUS 5 The Brough of Deerness and its environs: vertical photograph (J D H Radford for Sea Mammal Research Unit – copyright)

Large Burra Geo is an open bay, capable of allowing boats to beach, and there are still the remains of a noust above the shingle (no 9: fiche 2: A8). Little Burra Geo is sheltered by the 'Keirling', a rocky extension of the Brough to the south, producing a narrow entrance to the bay (illus 5). To the north-east of the Brough is a further stack, known as 'Castle of the Brough'. The Brough is 1 km south-south-east of Mull Head, the most northerly tip of the peninsula of Deerness.

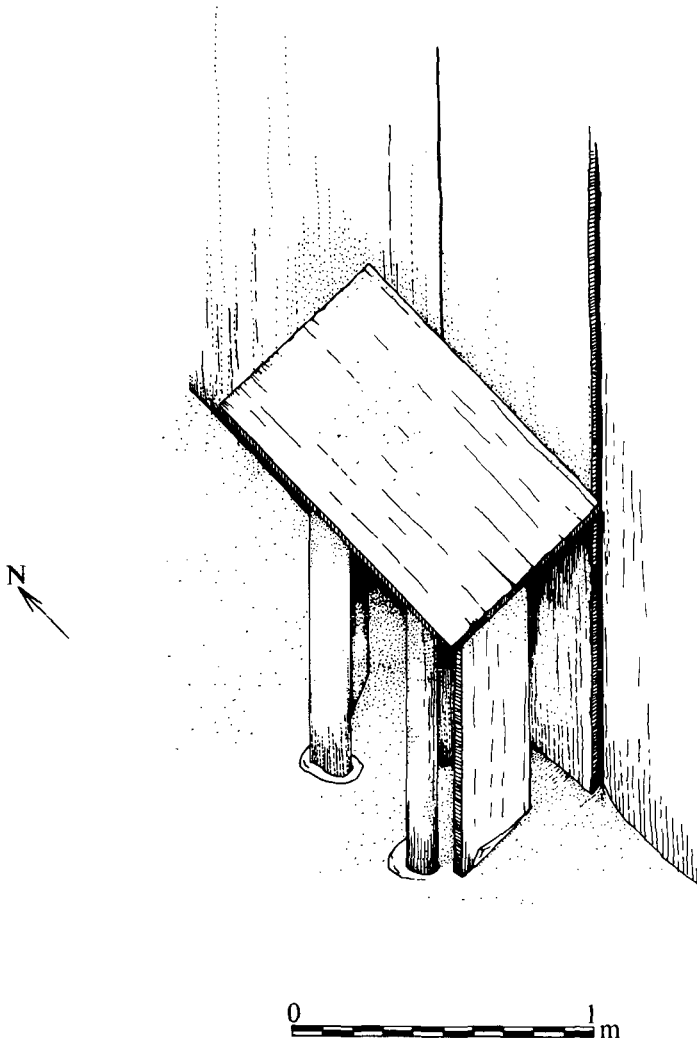
ILLUS 9 Isometric reconstruction of timber altar, against east wall

to north and south: these were taken to represent an eastern timber wall or screen against which the postulated timber altar was placed, and the isometric reconstruction of this can be compared with the original features as excavated (illus 9). There are some further postholes at north and south, as well as immediately to the east which *may* be related in constructional terms, although the evidence *might* be interpreted as indicating this to be secondary.

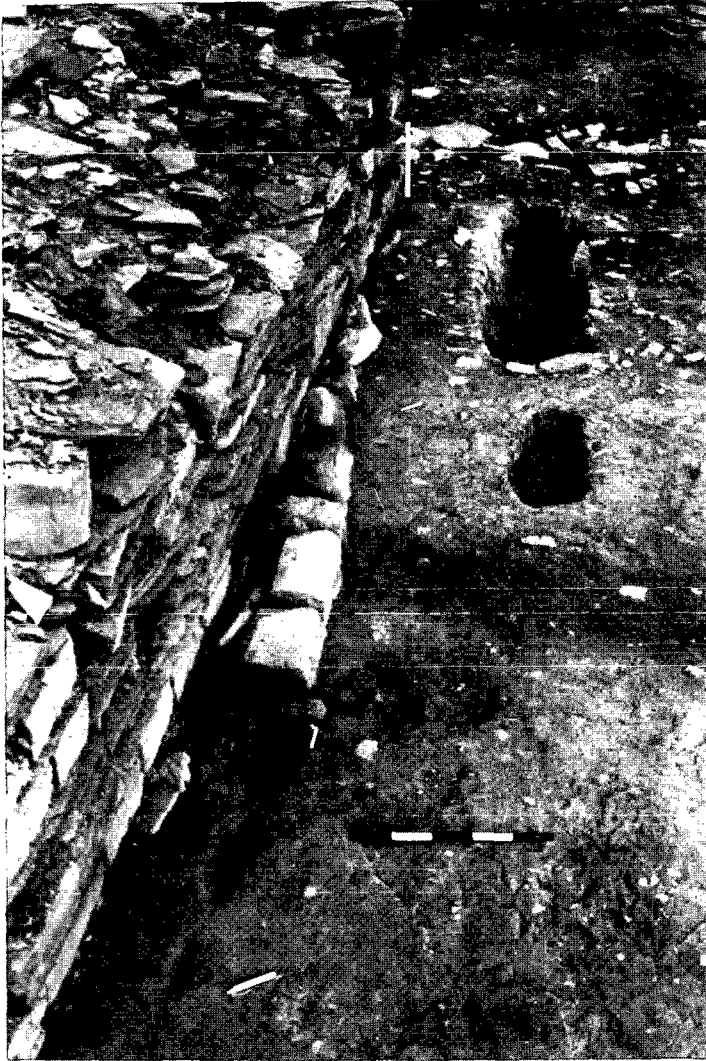
ILLUS 11 Early wall foundation, below stone Chapel south wall, from west
(D Jeffrey)

An alternative hypothesis would be that these elements represent a separate building intermediate between the postulated timber chapel and the existing stone chapel, but largely demolished. There would be no stratigraphic objection to this for either the southern wall or the northern 'robbing', and even the absence of evidence for another altar is not conclusive, for it would presumably have been under the present east wall and/or stone altar. The evidence (albeit negative) that inclines the writers to propose the association, rather than separation, of the two groups of features, is the absence of any clearly associated intermediate stratum/occupation layer but it is accepted that there is an alternative constructional sequence that can be postulated.

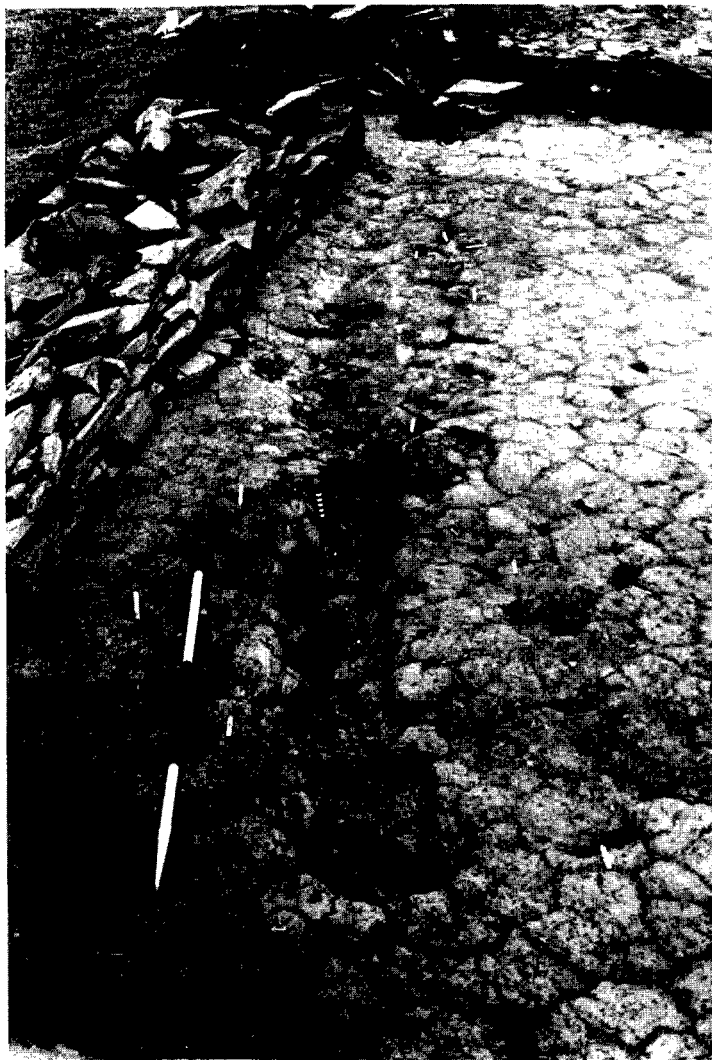
ILLUS 12 Enclosure area: north gully from west-south-west

The most prominent group of features outside the postulated timber chapel with its stone cladding was a set of gullies. The clearest evidence comes from the northern part of the area with a gully some 40 cm wide cut into the natural clay for a continuous length of some 3 m, together with an extension of just over 1 m. After a gap of c 1.25 m. The curving line is continued by another gully whose inner (southern) edge could be traced for some 2.5 m: most of it underlies the later stone enclosure wall, which partially sank into it (illus 12). It may be that this gap represents an entrance, but as the overall evidence is so partial, it is only one of several possible locations. Along the inside (south) of this gully were found a number of postholes, possibly representing a fence-line. Other stretches of gullies were found both to east and west of the postulated chapel, as marked on the plan (illus 8), together with two grooves, whose purposes cannot be hazarded. The eastern gully was 6.90 m long and 32 cm wide. A number of small stake- and postholes were excavated within the area enclosed by these northern, western and eastern gullies, but as with those to the

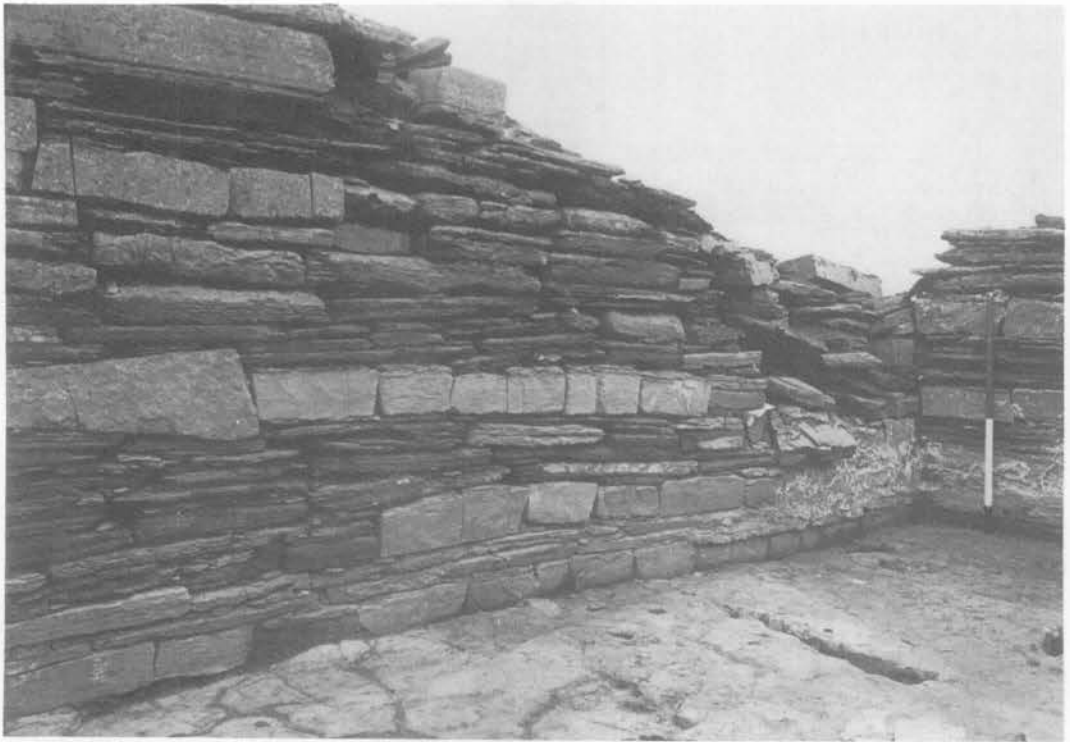
ILLUS 16 North wall of Chapel, from south-west (D Jeffrey)

In 1867, Sir Henry Dryden noted the presence of an aumbry in the north wall, and a window in the east wall, which evidently had been splayed (see fiche 2: C9–14). Also he noted the western entrance standing considerably higher than in 1975, and possibly with a square head to the doorway. Dryden undertook a small amount of excavation in this entrance, which splayed from 0.83 m externally to 0.65 m internally.

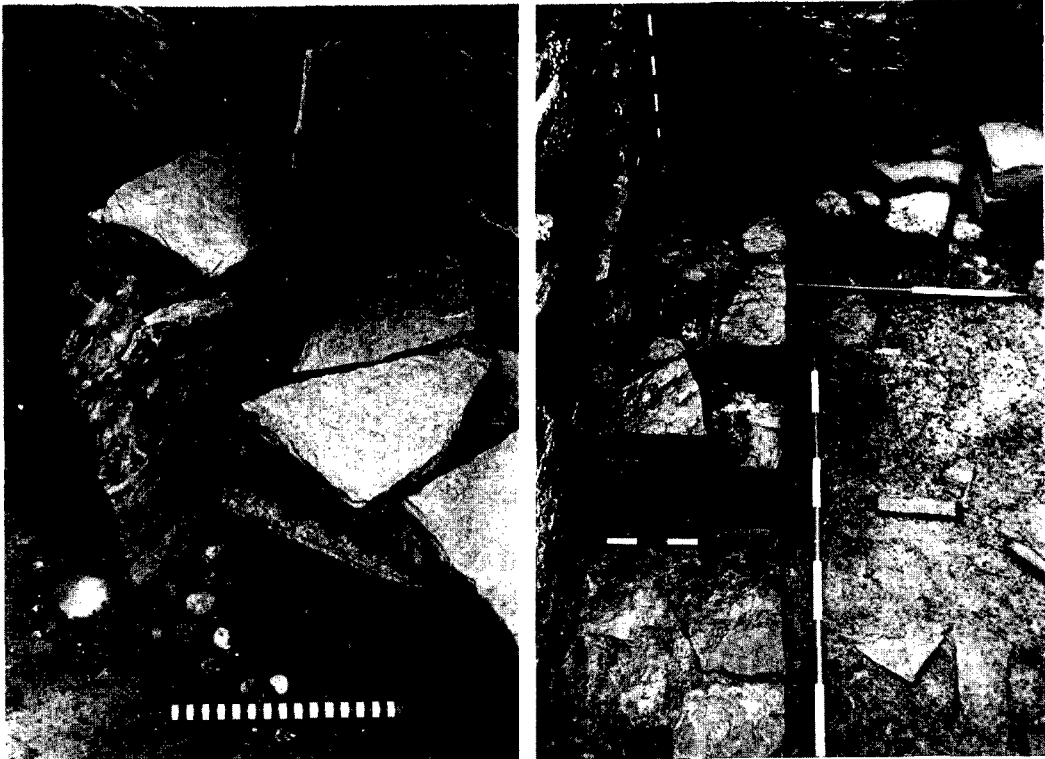
(a) (b)
ILLUS 17 a, Pebbles, ?floor, below south bench, upright stone and ?seat, from north-west. b, Stone altar and settings, from north

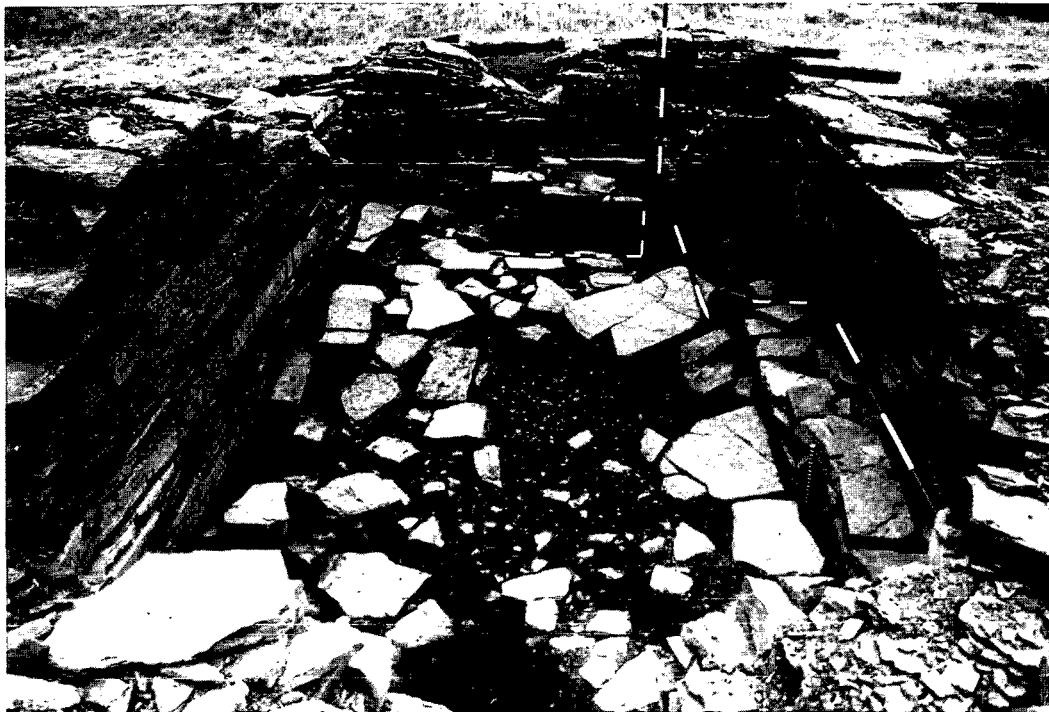
ILLUS 18 Rubble, including *mensa*, inside Chapel, from west

Phase D2 shows a progression from decay to collapse with large stones, presumably from walls, lying on top of a thick brown clay (illus 18). One particularly large stone, unfortunately too cracked for preservation, was recorded, and it is considered likely, from its dimensions, to have been the *mensa* for the altar (however, no crosses or other markings were on it). Various metal objects were amongst the debris (RF 35–7, 165), together with a range of other material, both man-made and biological (including RFs 145 & 146).

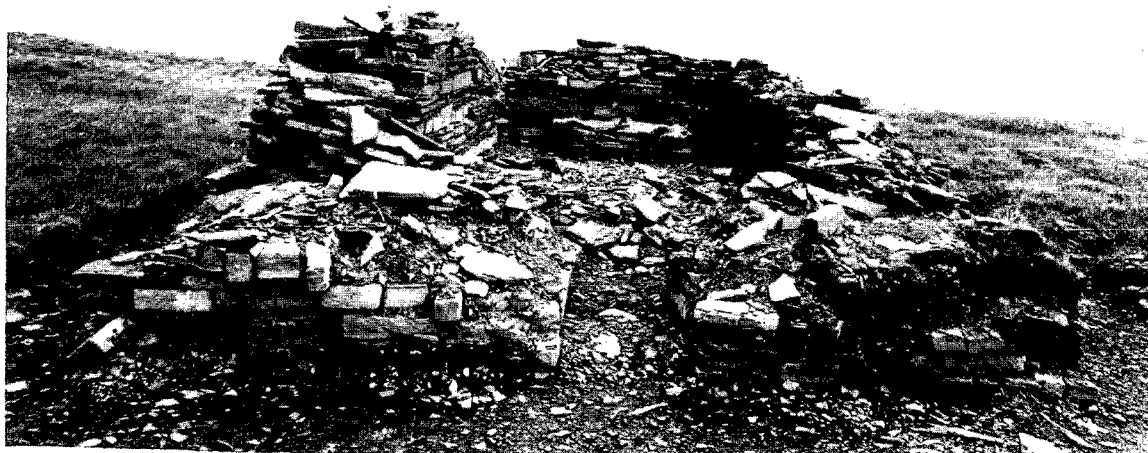
ILLUS 22 Chapel from west, June 1974 (S D D)

the dereliction (illus 22, 52, 53). It is likely that much of the west wall, as well as the east collapsed as a result of the military activity, for Dryden's description and drawings from 1867 indicate the walls to have been upstanding far more then (see fiche 2: C9–14). Some makeshift repairs seem to have been effected by occasional visitors – particularly to the east wall (illus 54), and a 1971 new penny (RF 3) was found amongst such a repair. Within and outside the enclosure wall, sub-turf and turf developed beyond the recent stone collapse, and covered the earlier tumble from the enclosure wall.

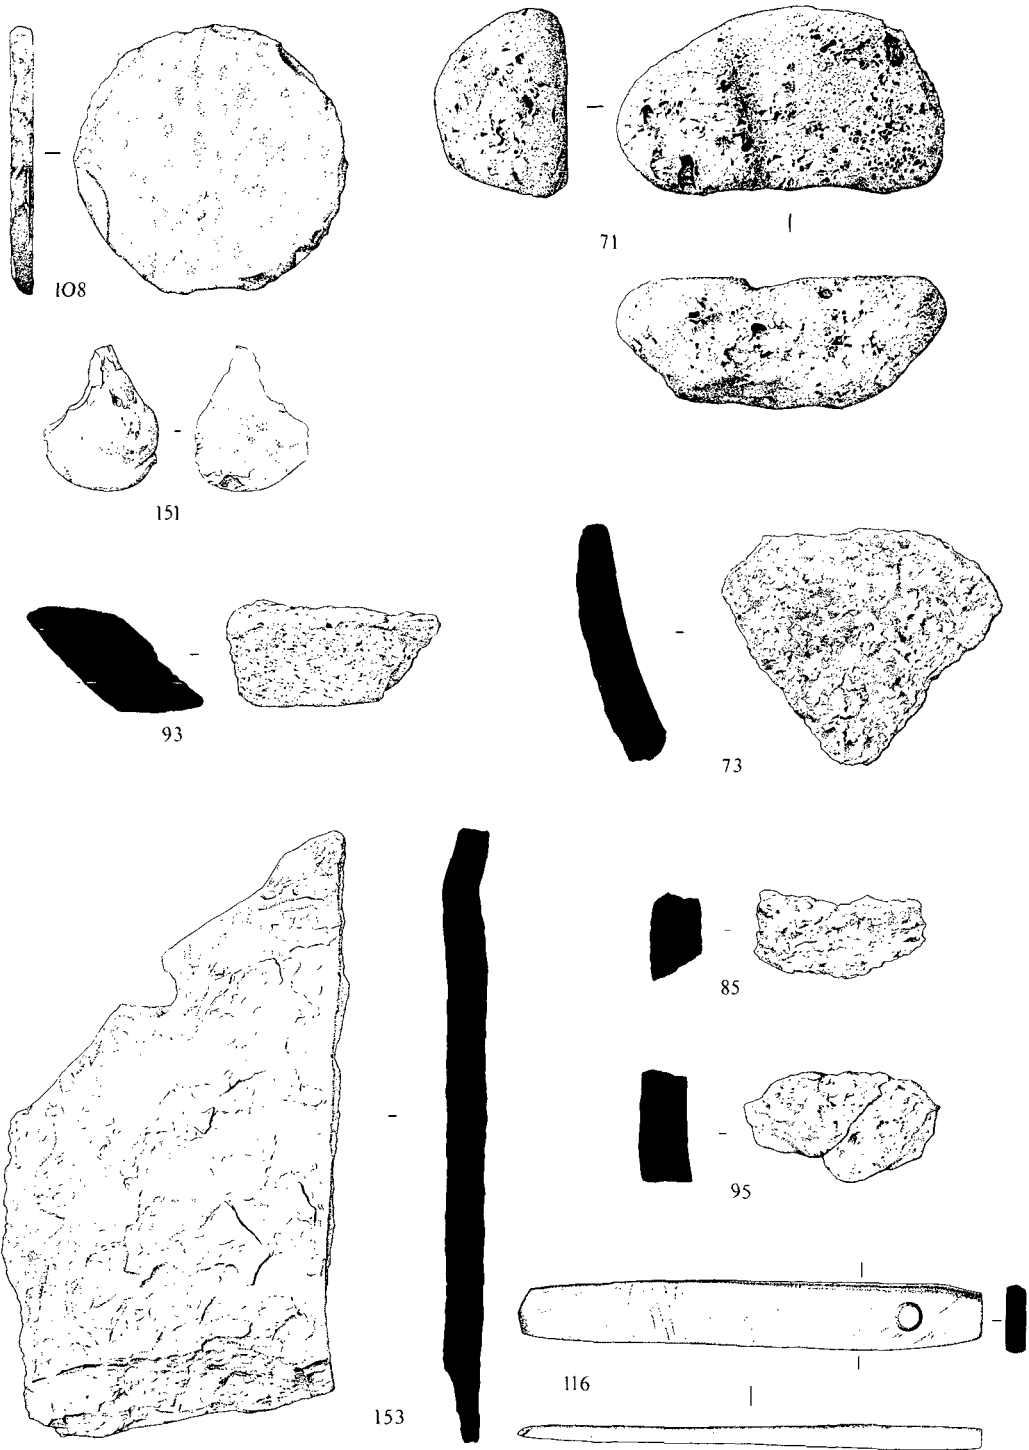
ILLUS 23 Stone objects, scale 1:2.5; stone object (116), flint (151) and pumice (71), scale 1:1.25 (K McBarron)
