# Isbister, an Orkney Islands Council Guardianship Monument

Beverley Smith\*

*Excavations conducted in order to allow the consolidation, roofing and display of this chambered tomb are described.*

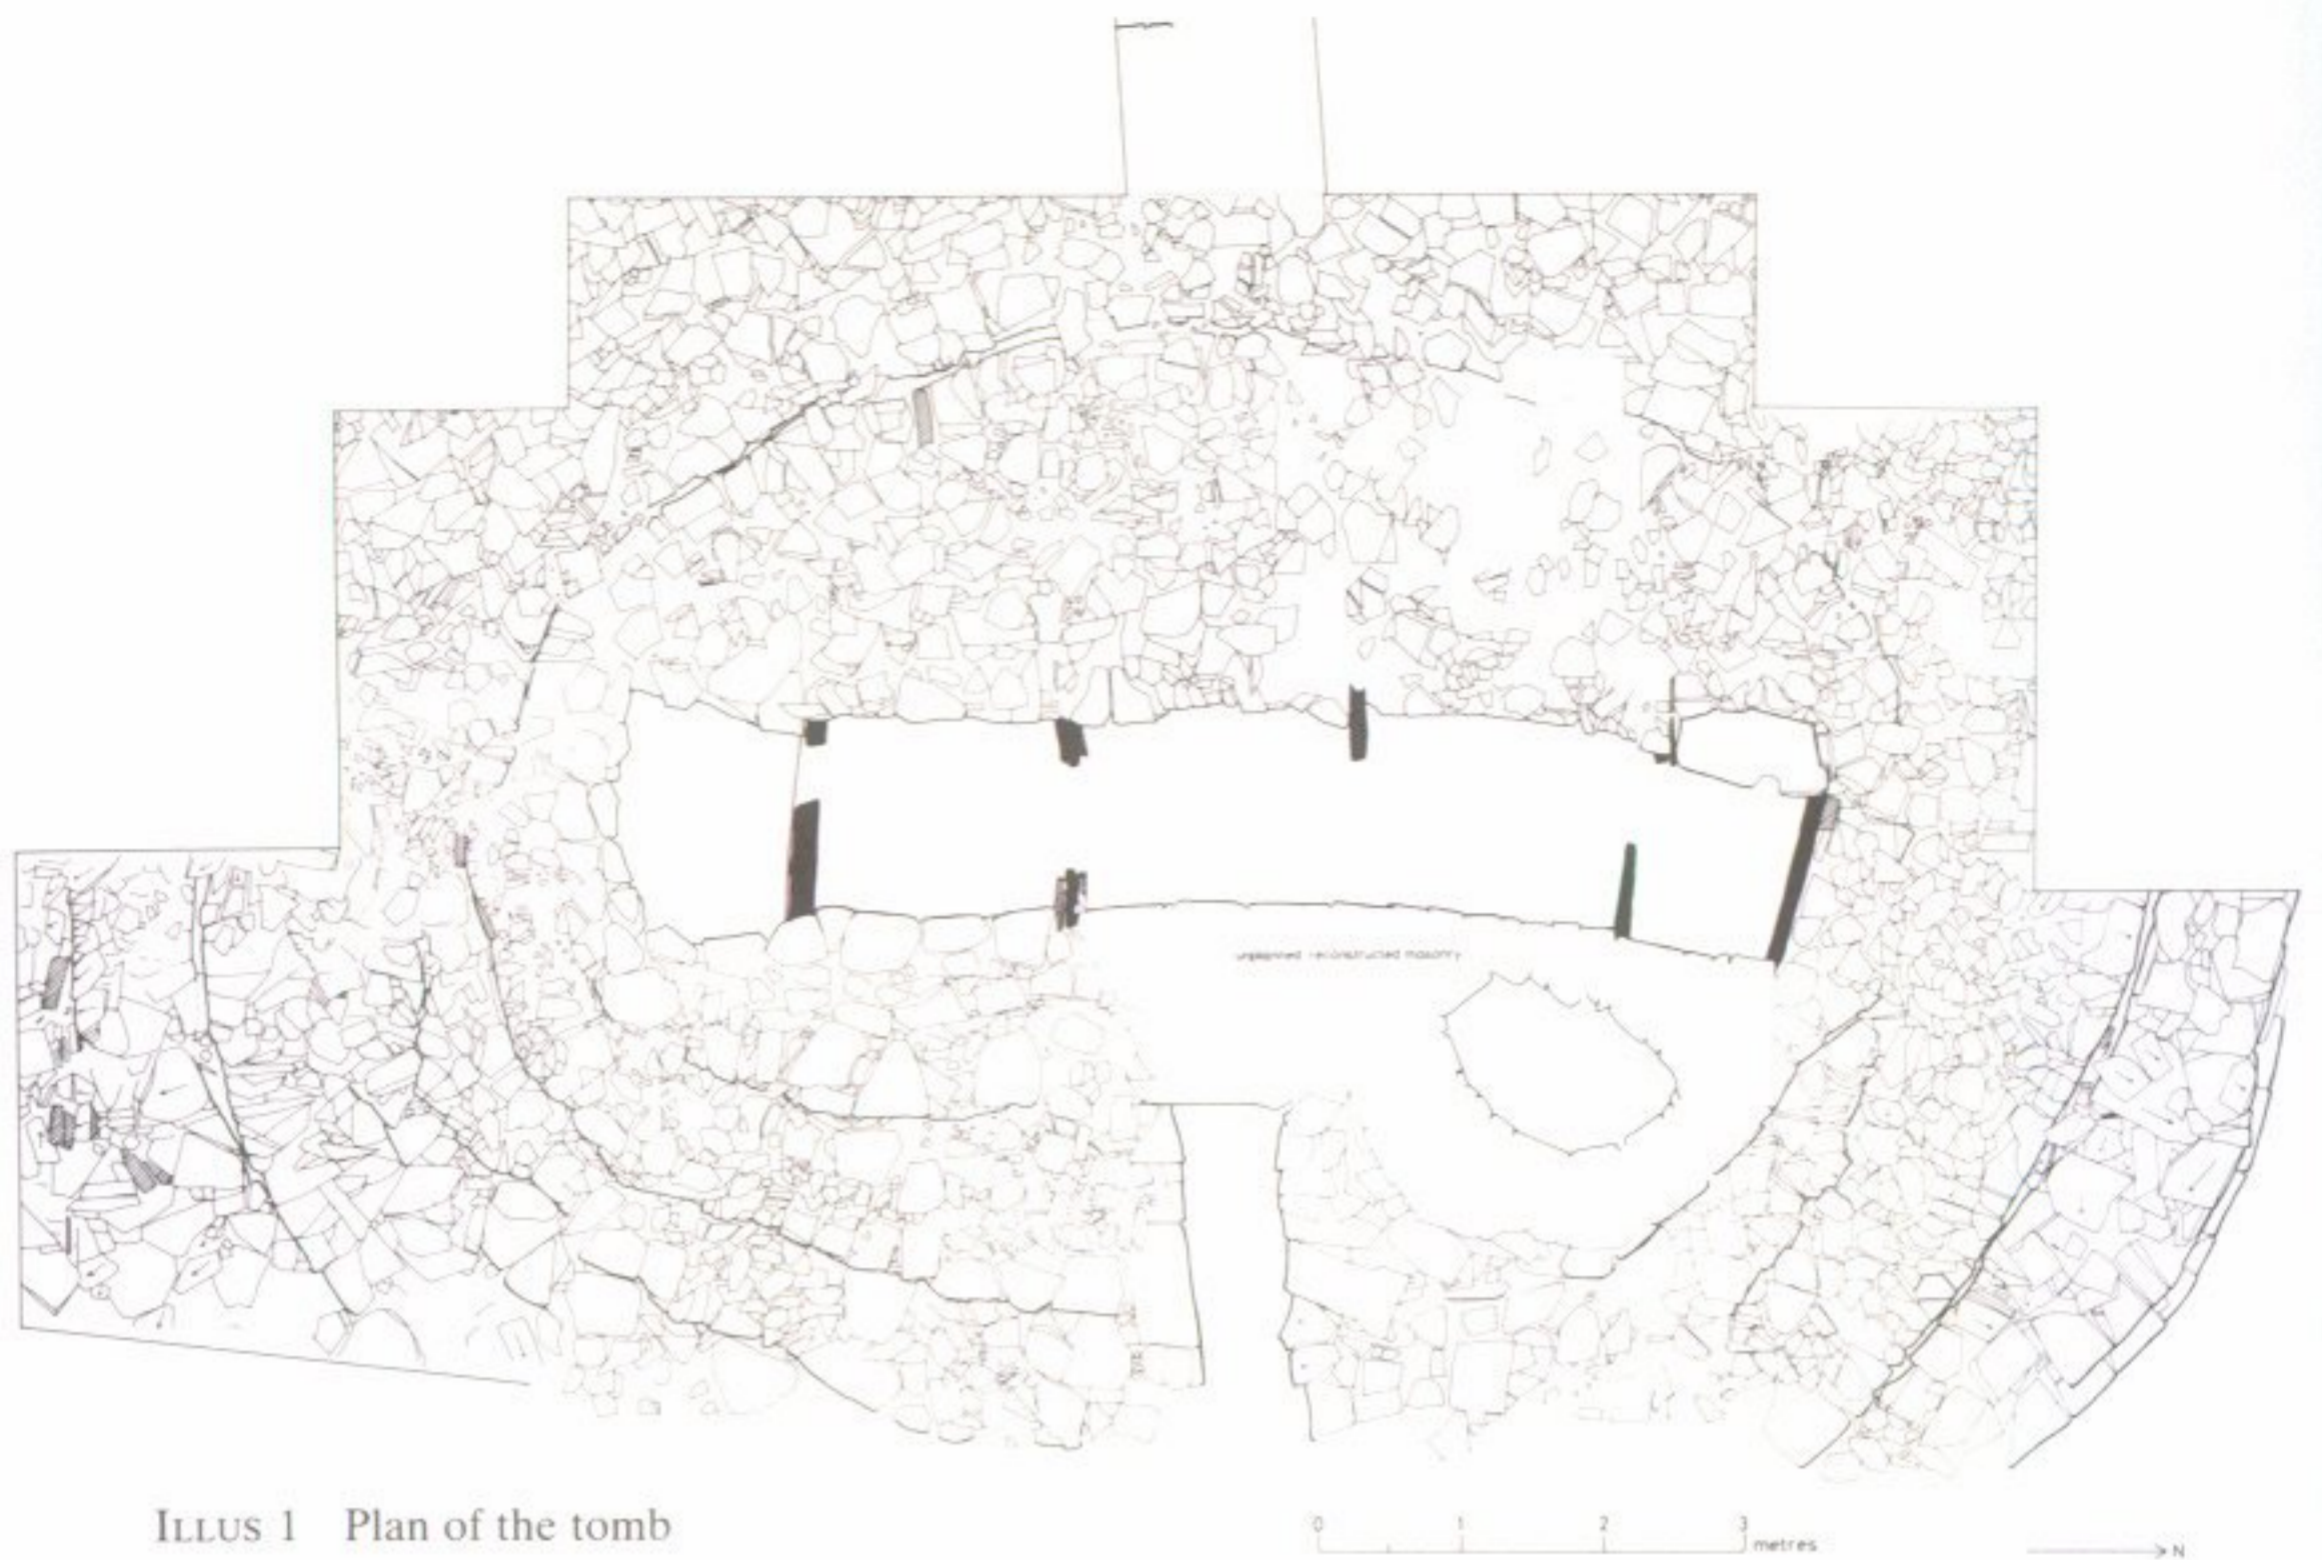
ILLUS 1 Plan of the tomb

Through this excavation further details of the construction of the tomb came to light (illus 1). The tomb chamber and cells were situated within an oval cairn of masonry c 10 m by 7 m broken only by the entrance passage. West of the main chamber the cairn was composed of repeated layers of flat overlapping flagstone with larger stones used for the cairn facings. East of the chamber and to either side of the entrance, the construction was slightly different due to the presence of the cell north of the entrance. South of the passage the foundations of an intervening wall were noticed (illus 2 & 3). The alignment of this wall continued across the entrance passage as a lintel and was then lost in the rebuilt masonry of the east cell. Its south end also disappeared and merged into the cairn material.

The central cairn was enlarged by the addition of an encircling wall c 2 m in width (illus 1). This was part of the original design of the tomb as evidence of ties which joined the two walls together were

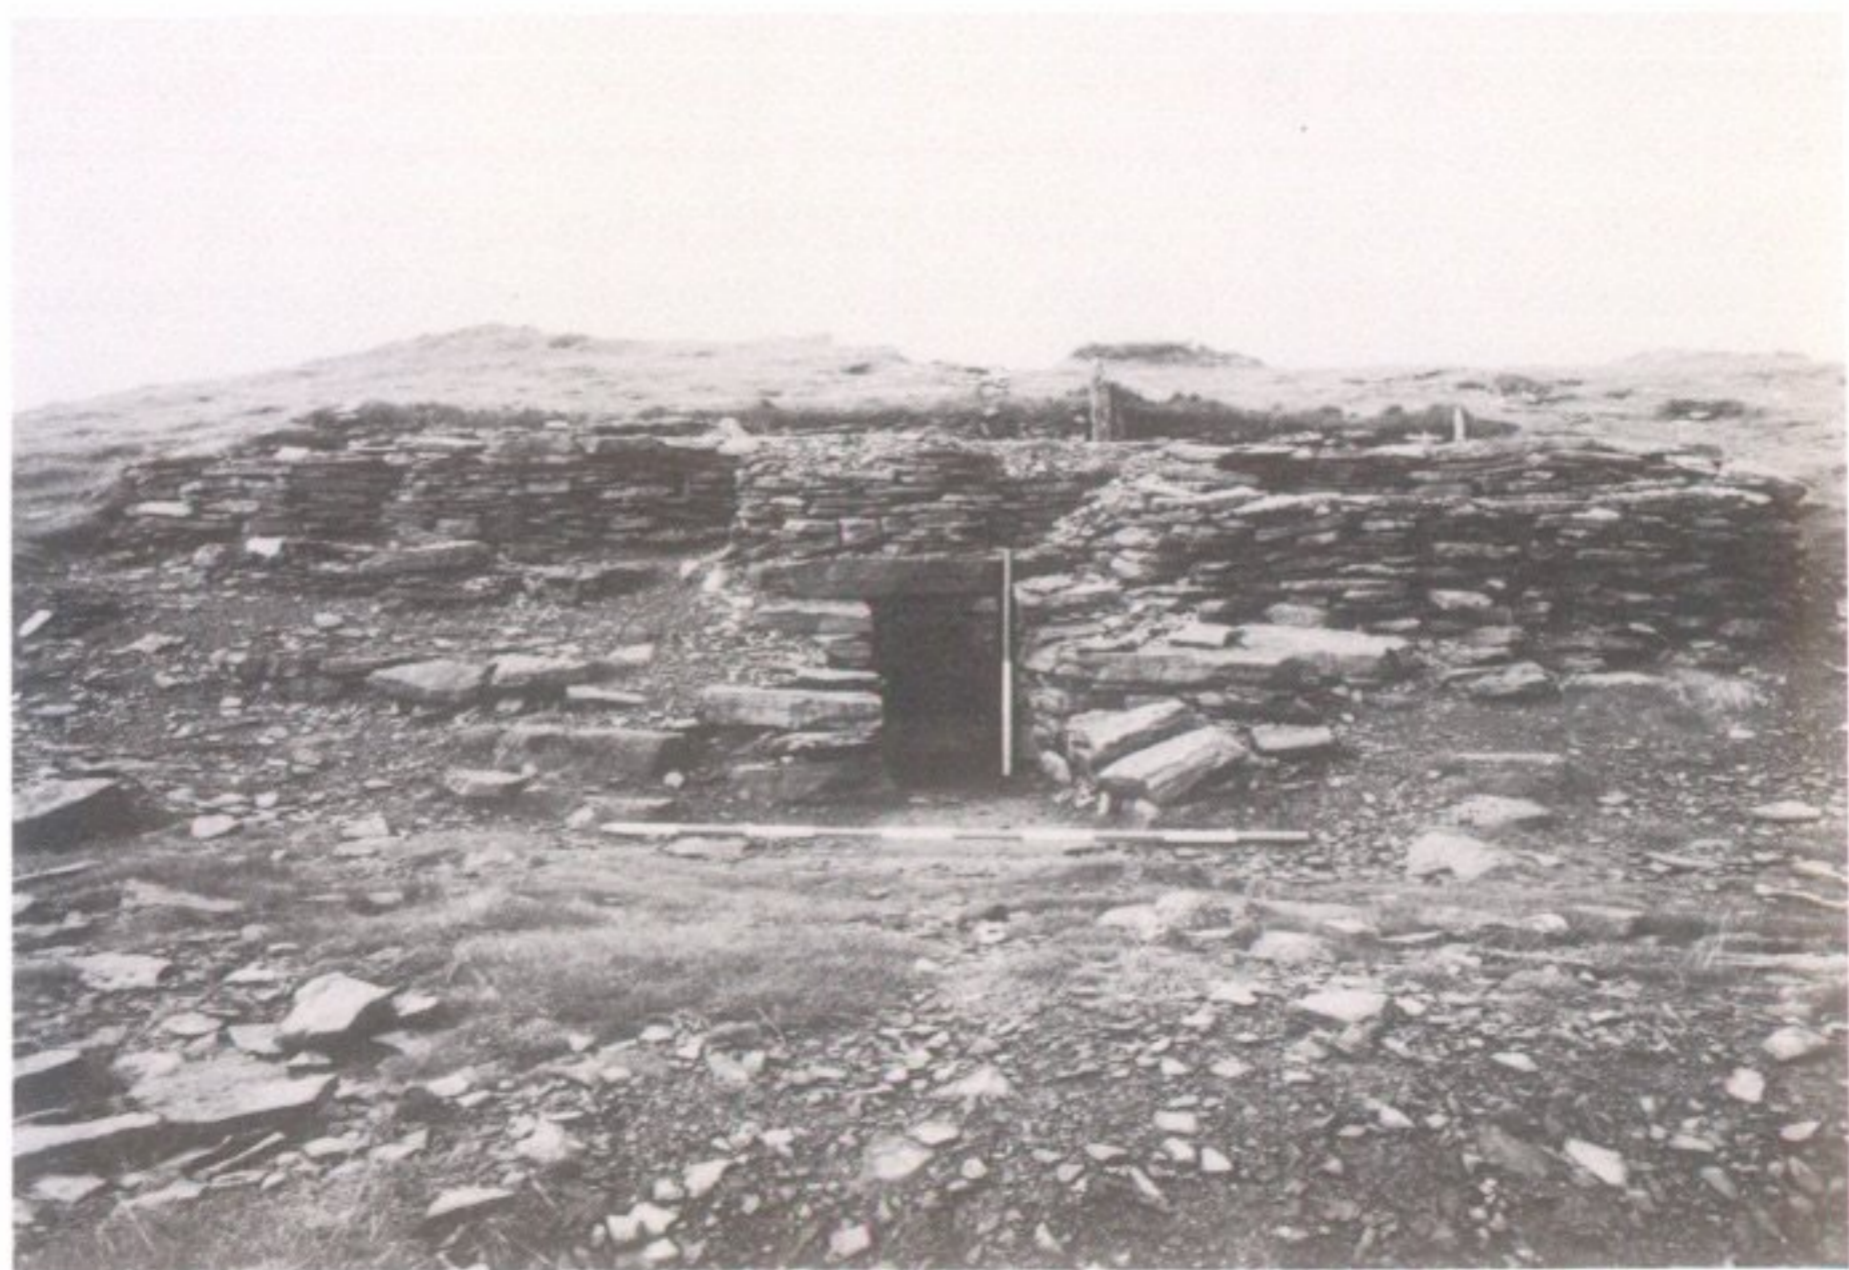
ILLUS 2 General view of tomb entrance

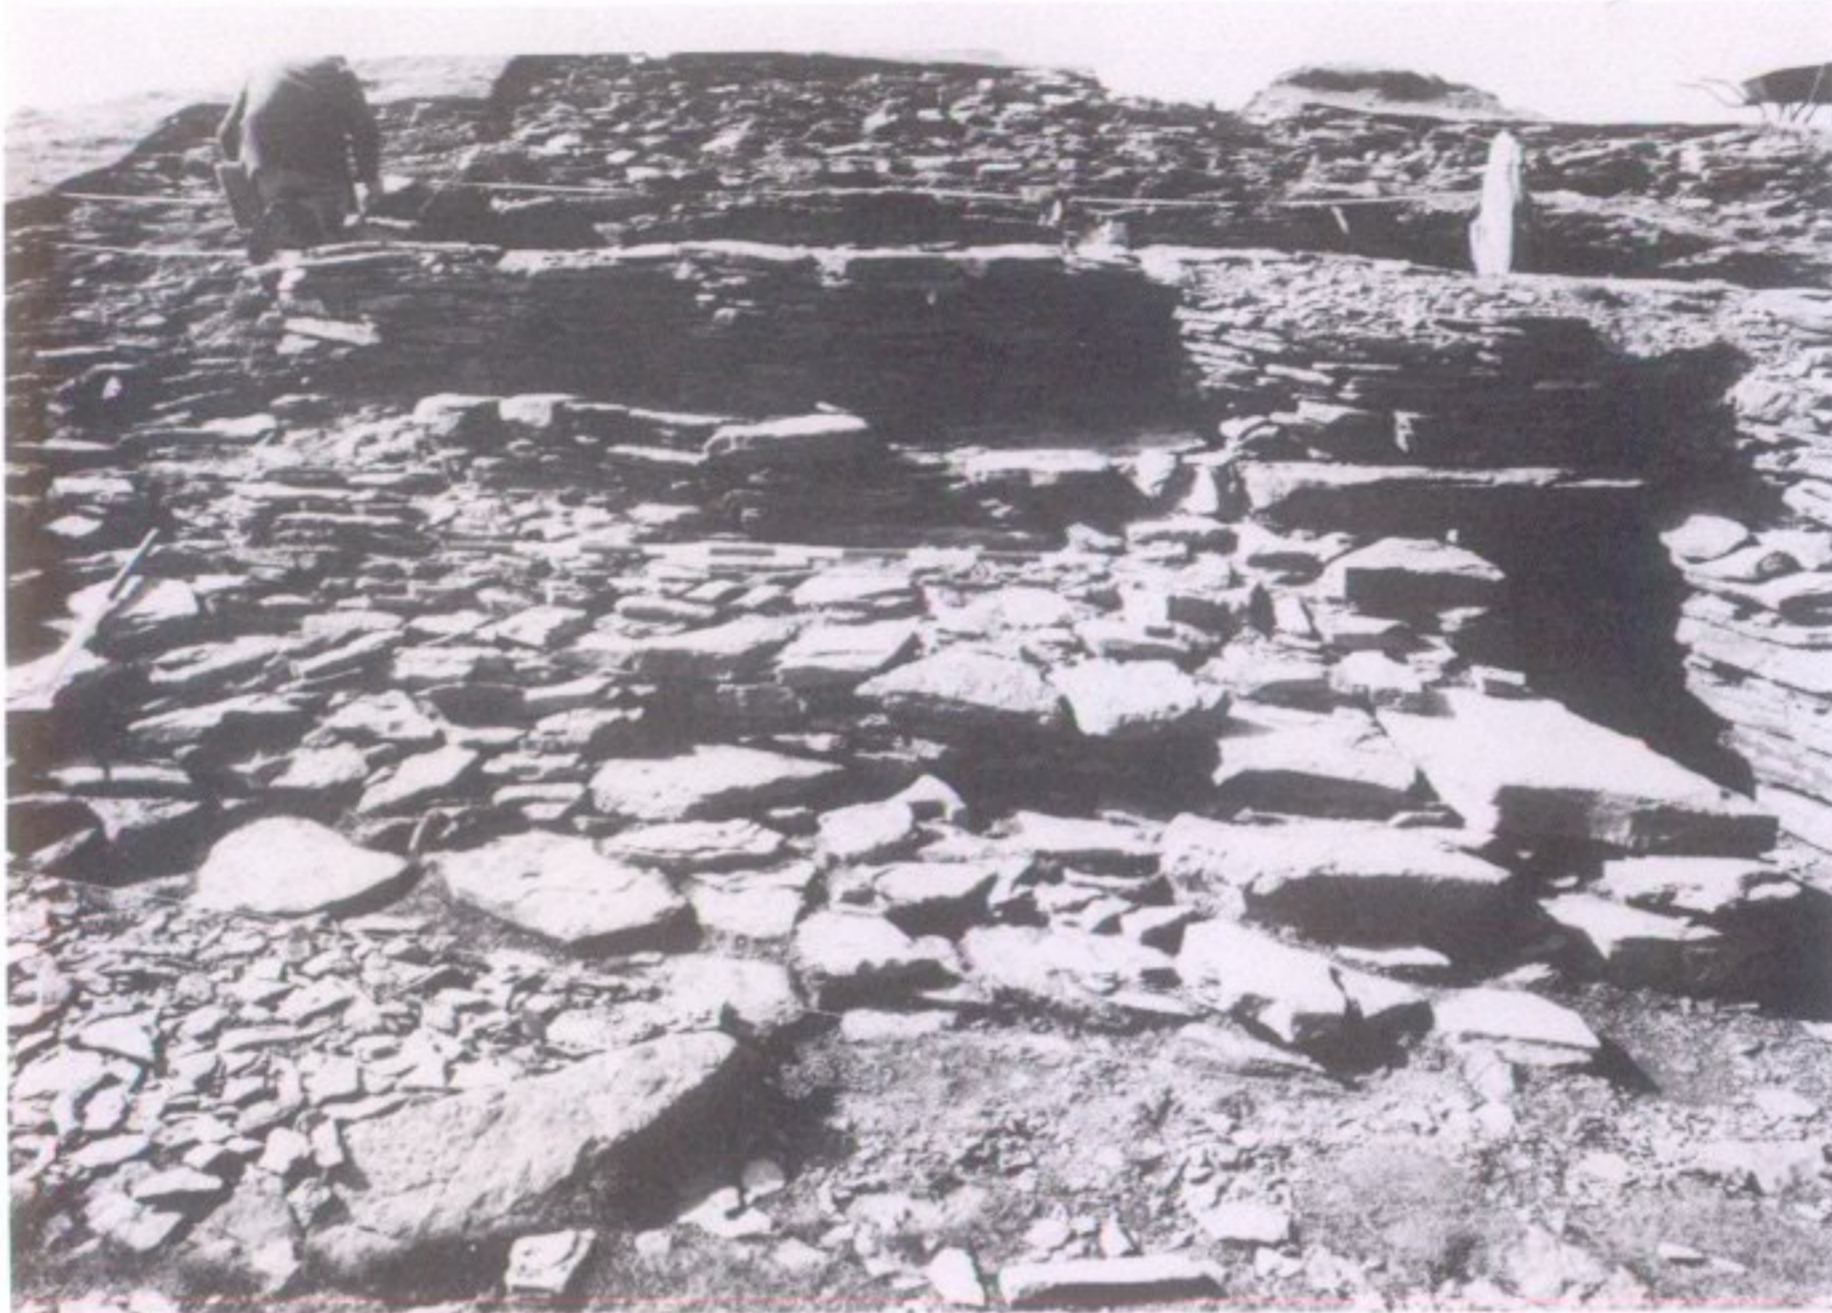
ILLUS 3 View of south-east corner of tomb and the entrance after cleaning to reveal stonework

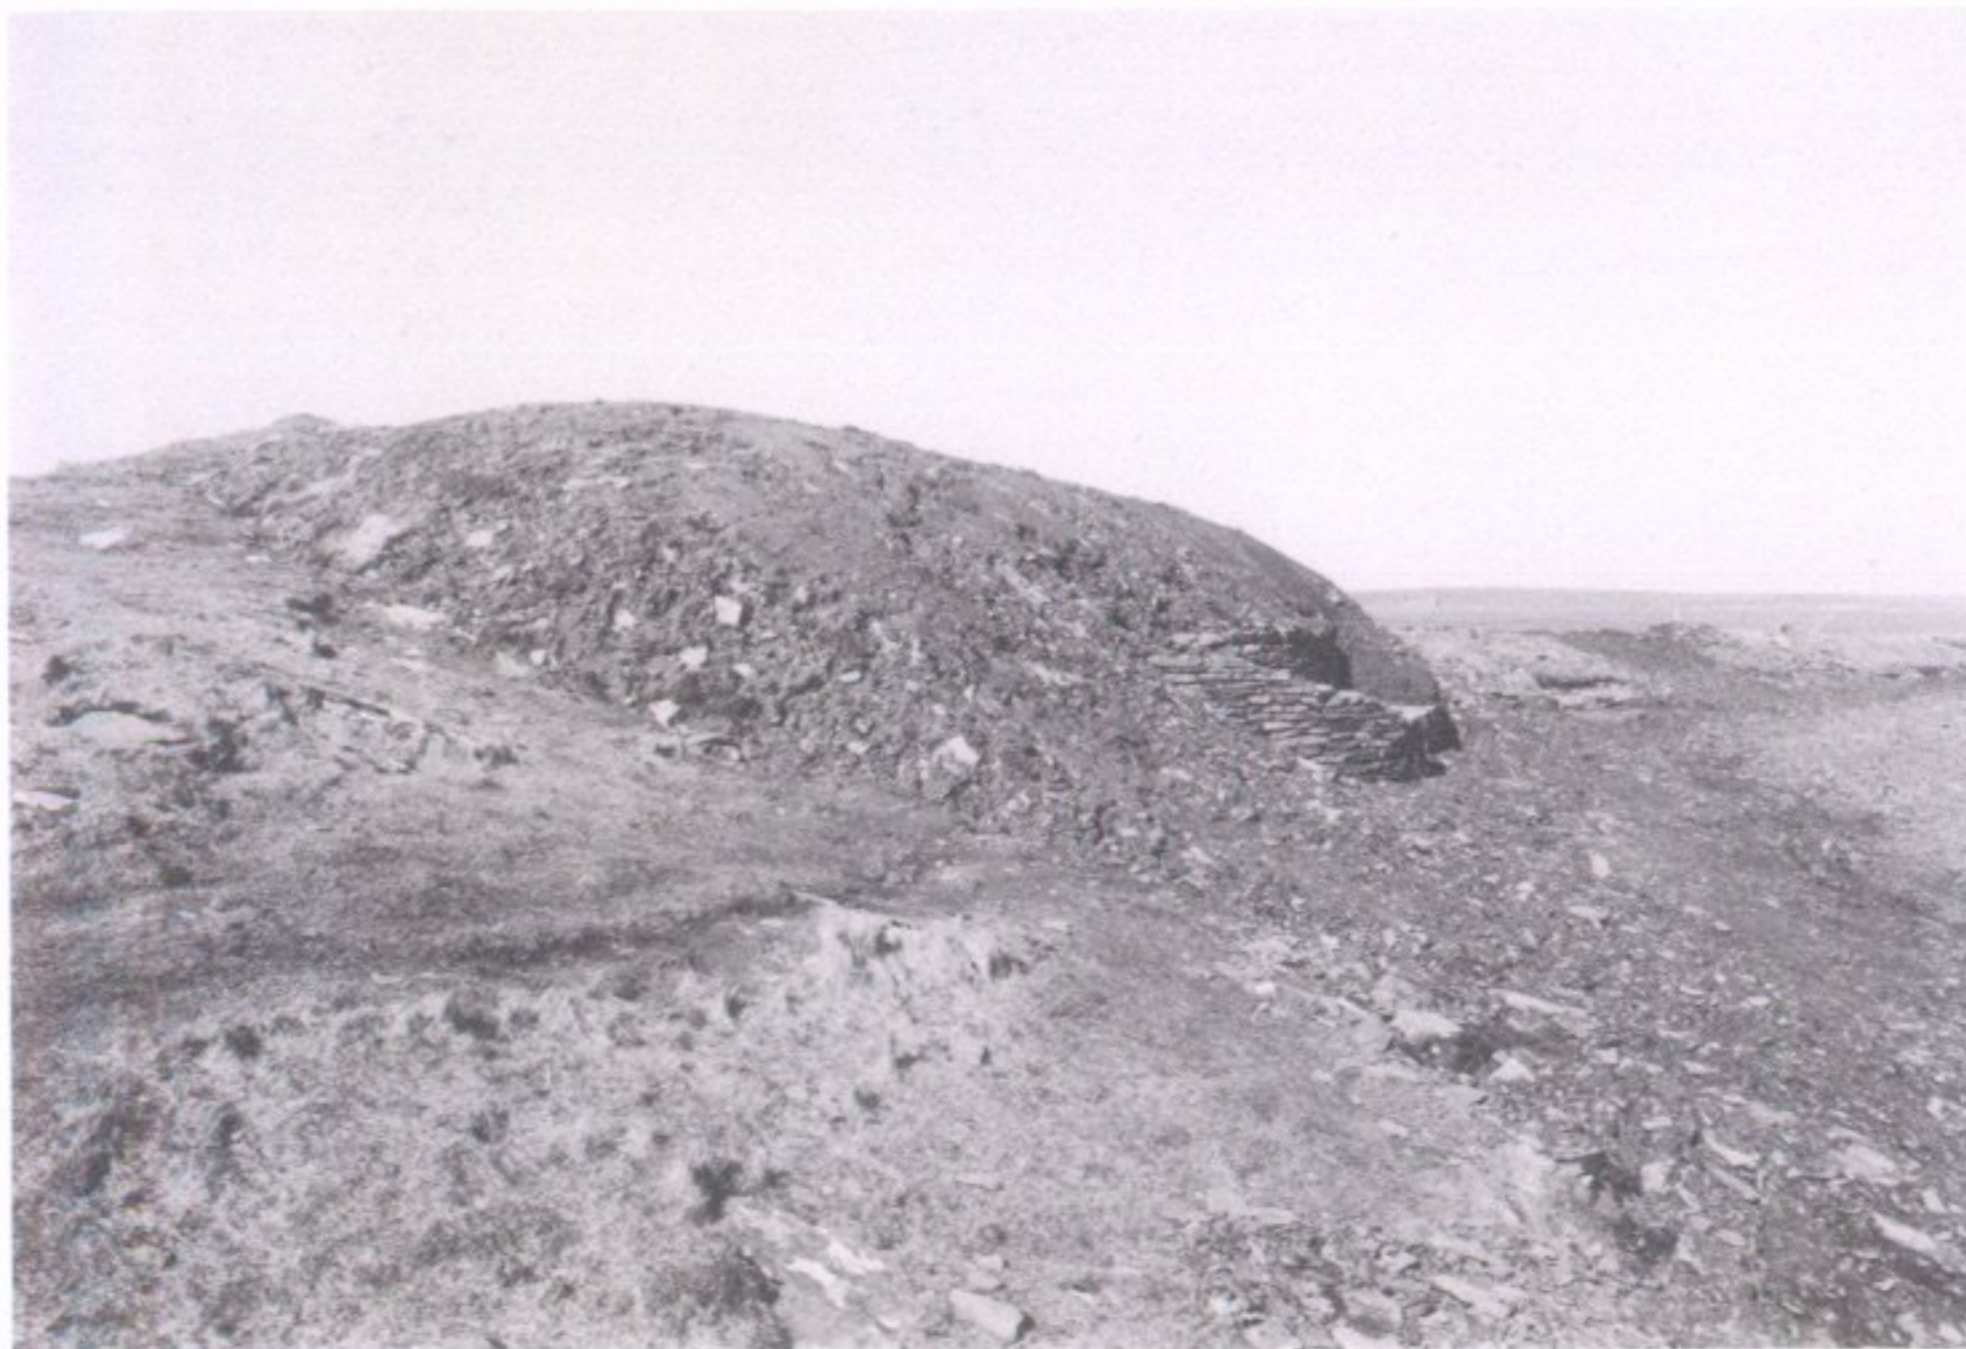
ILLUS 4 Tomb and north horn after roofing

The excavated details have been preserved where possible, in spite of the constraints of the new tomb roof, and the entrance area has been partly rebuilt (illus 4). A course of slate was used to mark the division between old and new masonry. Intact floor deposits were found within the main chamber and side cells and have been left. Reconstructed funeral deposits have been placed in one cell and should give the visitor a better understanding of one aspect of the Orcadian Neolithic.
