The clearing and partial excavation of the cairns at Balnuaran of Clava, Inverness-shire, by Miss Kathleen Kennedy, 1930–31

G J Barclay*

Miss Kennedy's brief summary report is transcribed. Contemporary drawings and photographs are reproduced and set in context. There is a brief discussion on the tidying and reconstruction of the monument and of the significance of Miss Kennedy's results.

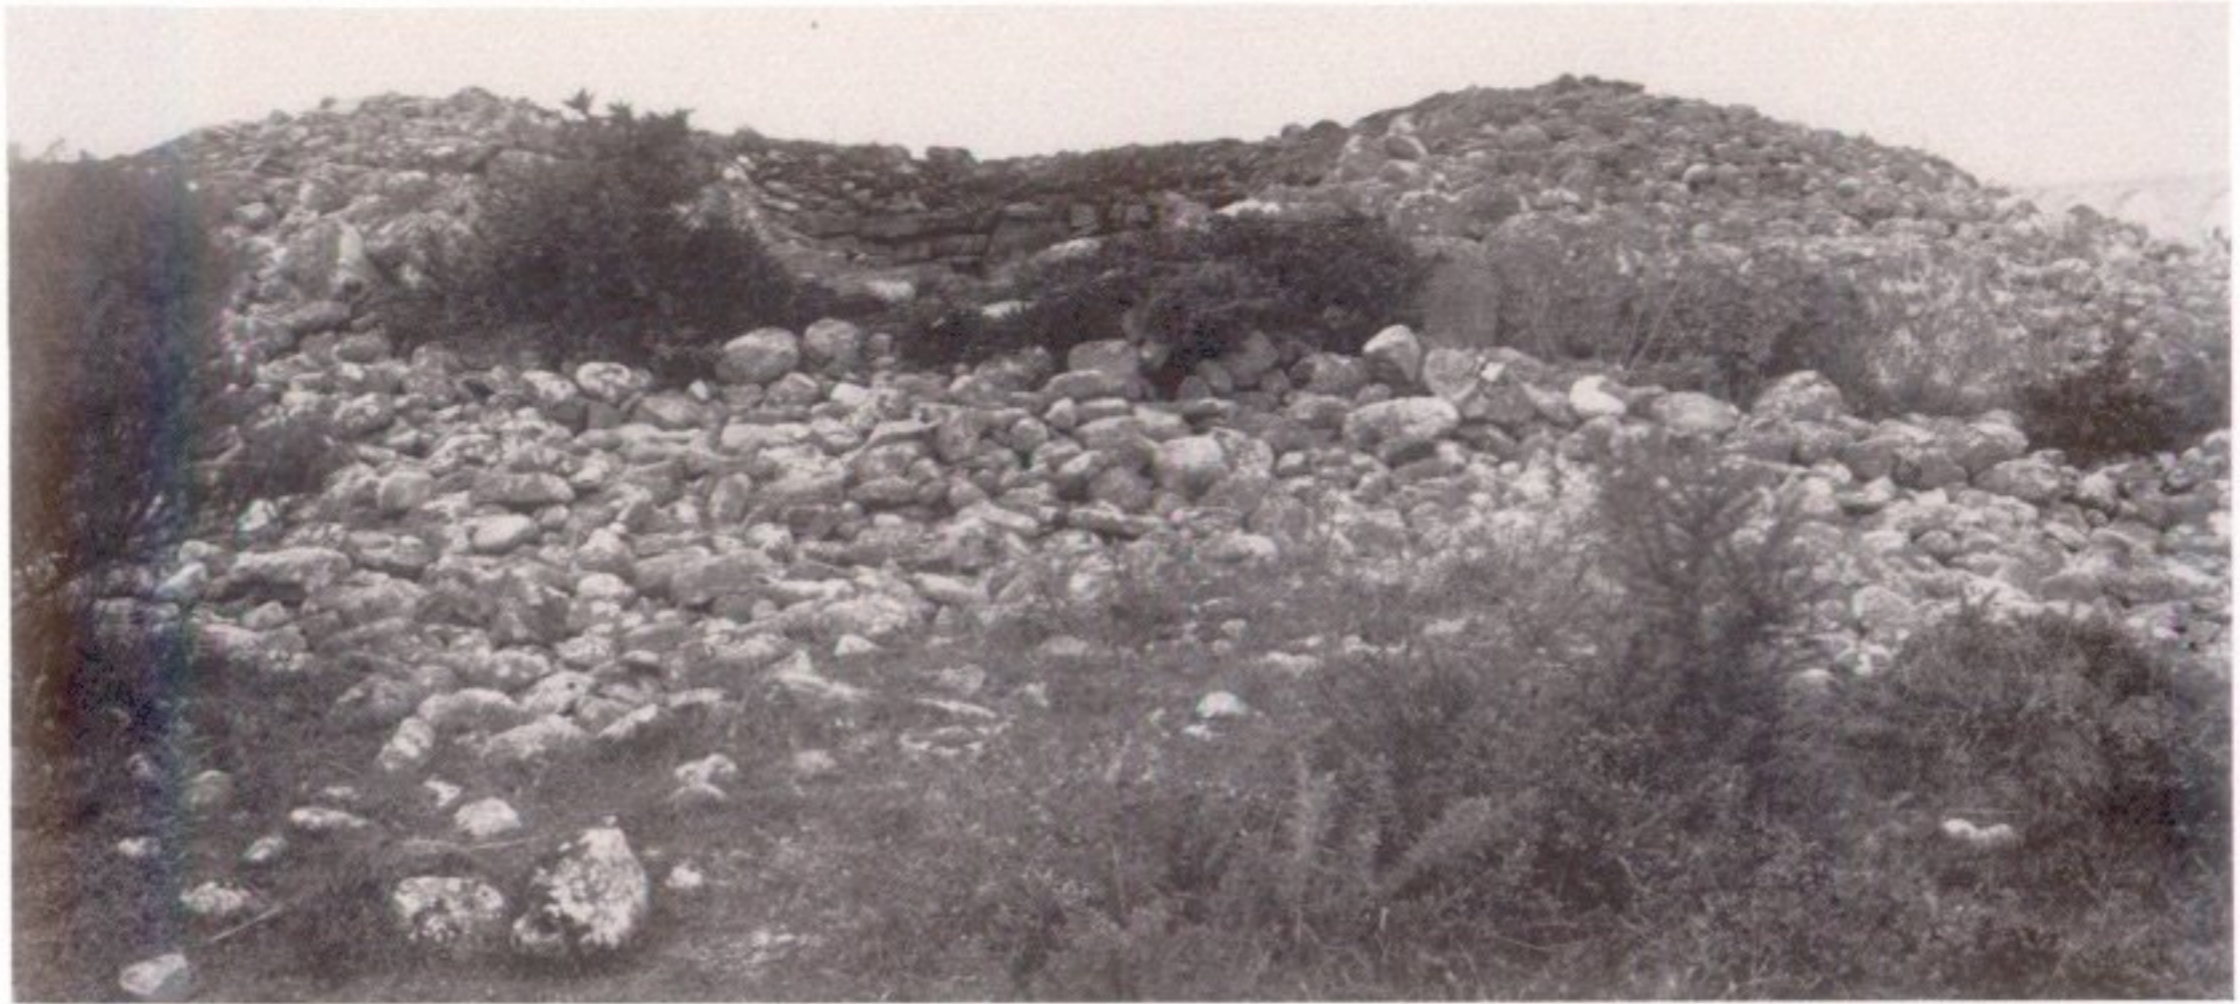
ILLUS 7 The north-east cairn in 1924 (NMRS no A48005)

The sequence of three plates in illus 7, 8 and 9 shows the north-east cairn in 1924, probably in 1930 and probably in 1931, respectively. The increasing prominence of the kerb is clear. It is clear that the prominent flat tops of the ramps of stone surrounding the kerb are the result of selective removal of material and that the kerbs were originally less prominent.

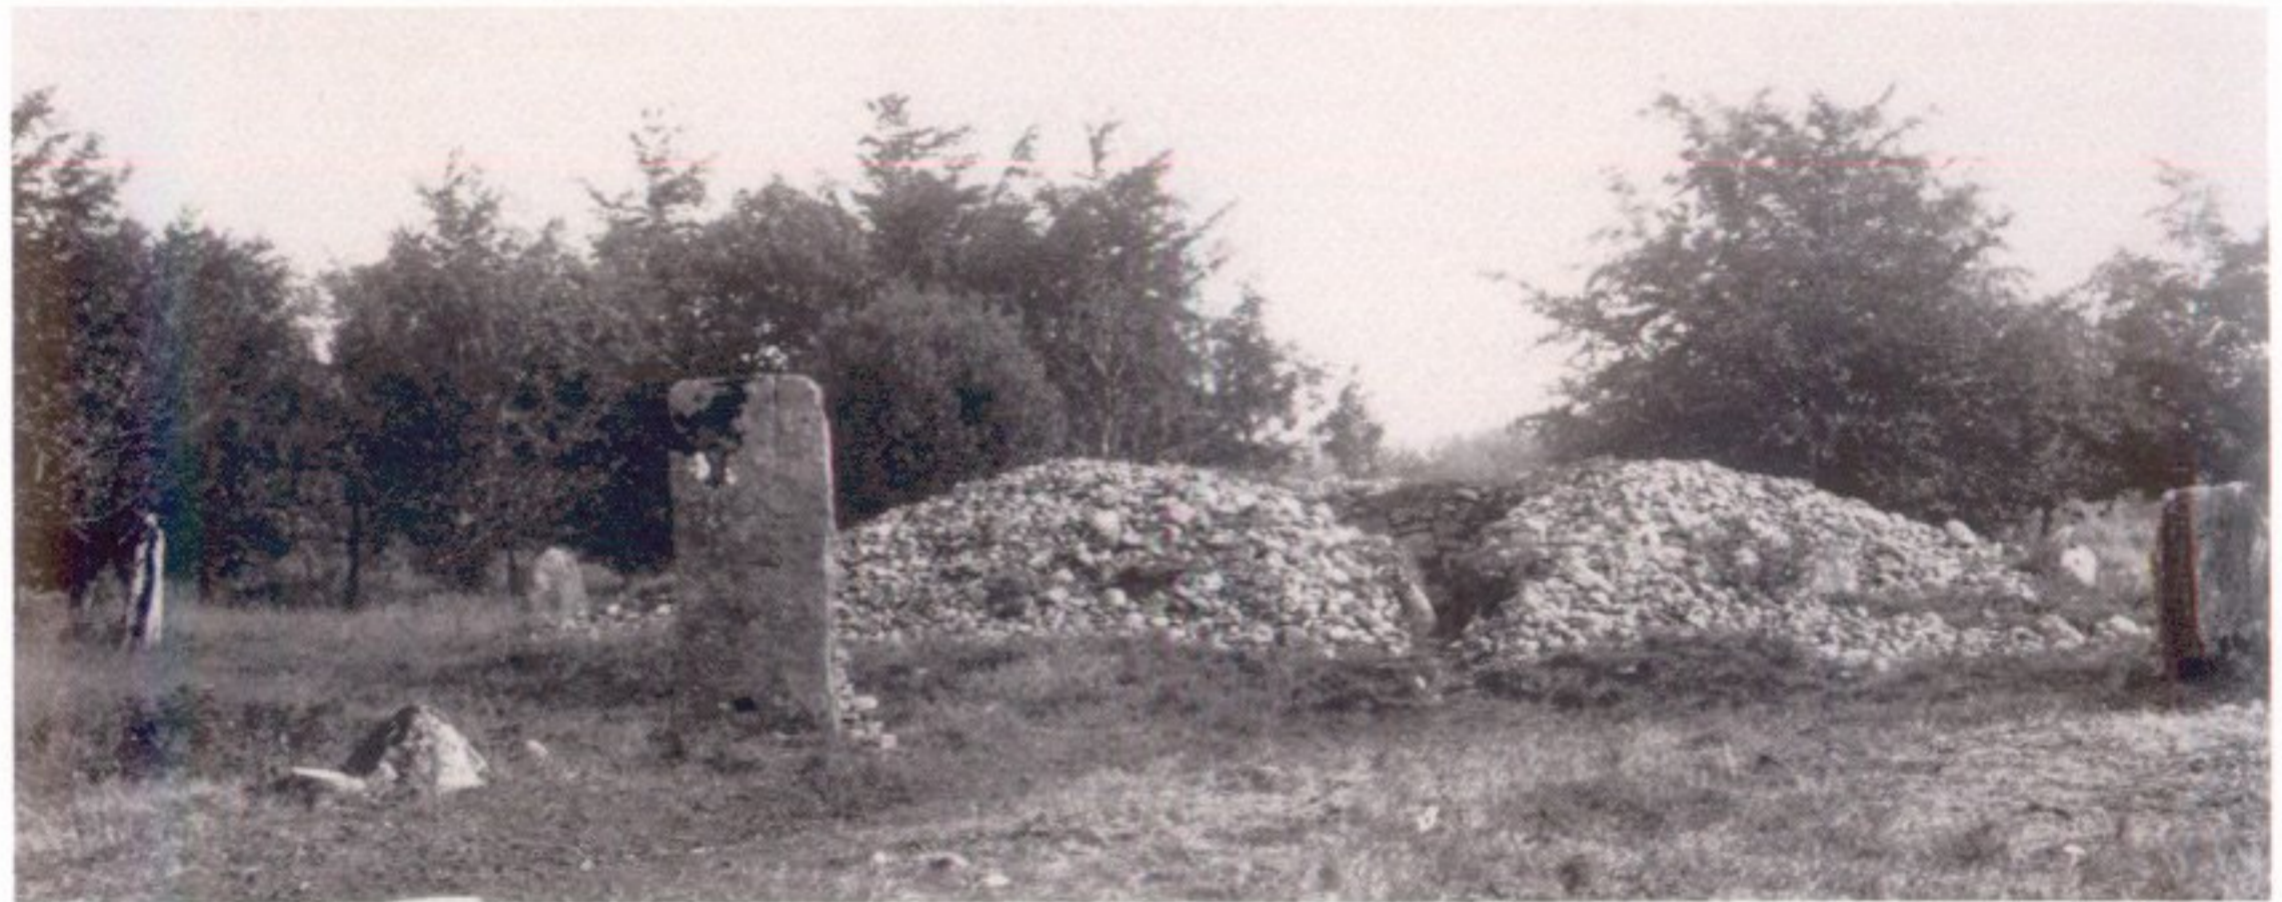
ILLUS 8 The north-east cairn in 1930/1 (NMRS no A48004). Some clearing has taken place but the kerb is still hardly visible

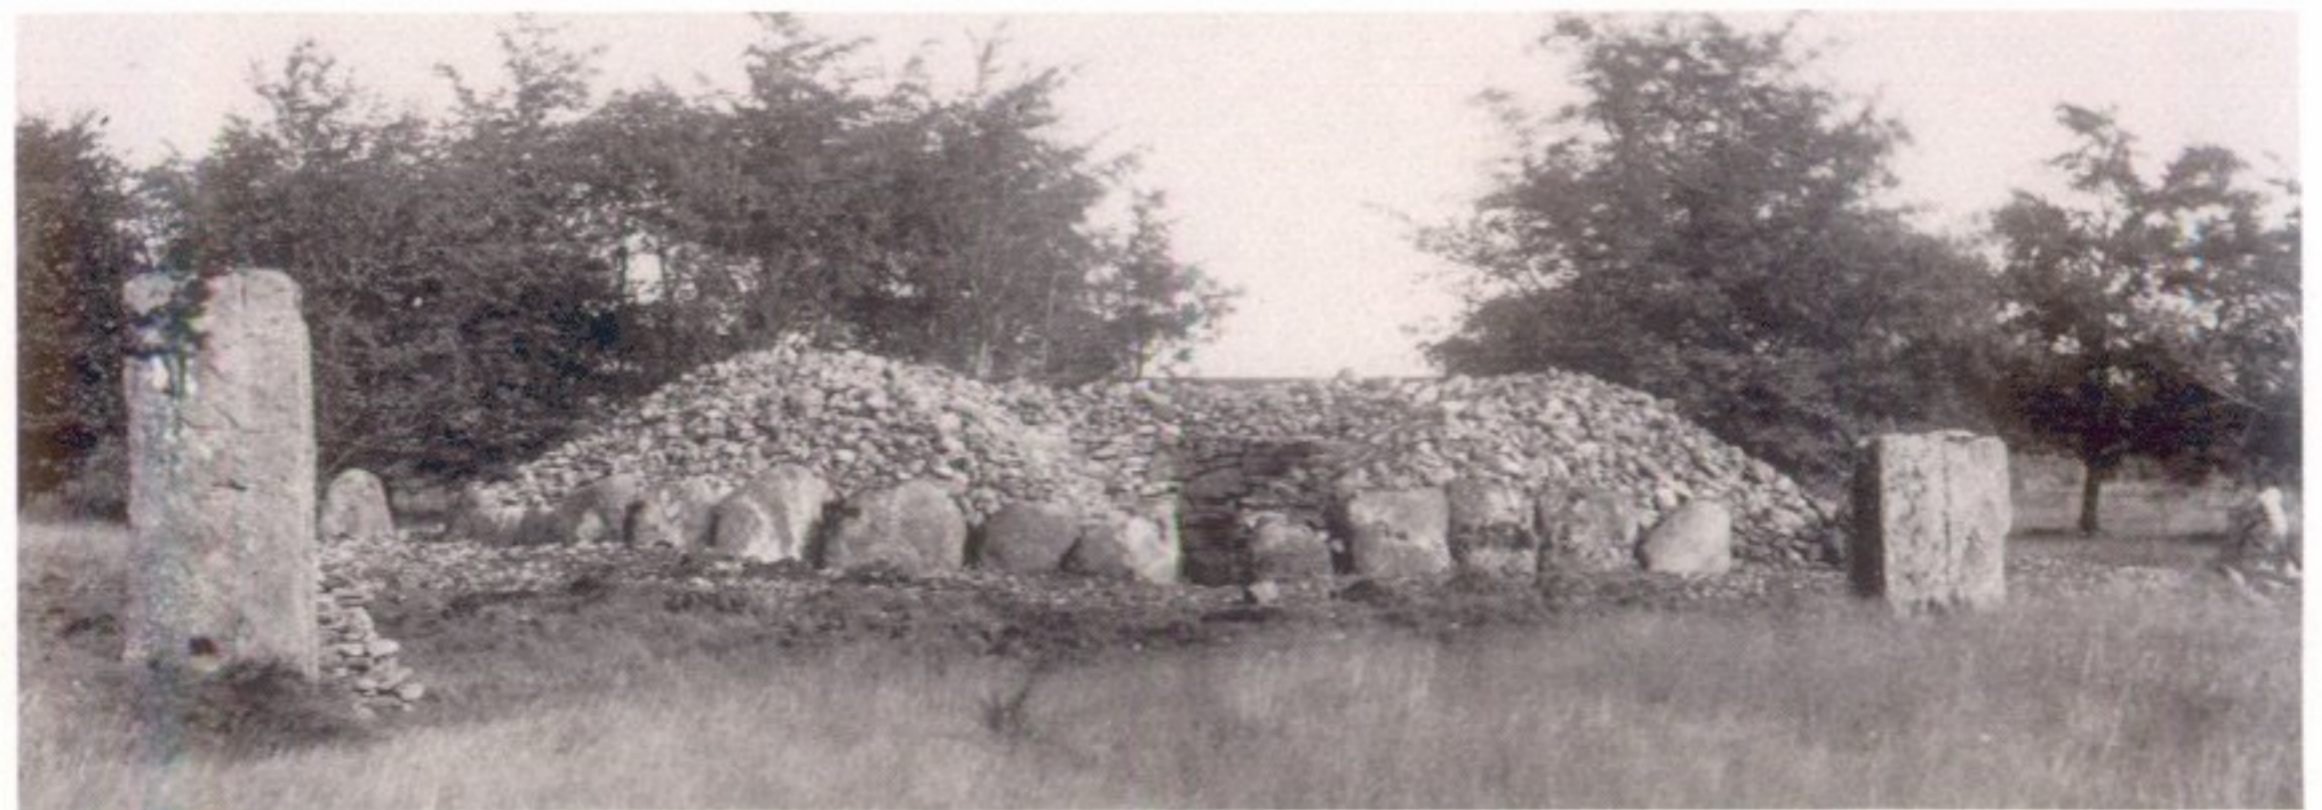
ILLUS 9 The north-east cairn in 1931 (NMRS no A48018). The cairn has been cleared and the kerb has been exposed by removing some of the ramp

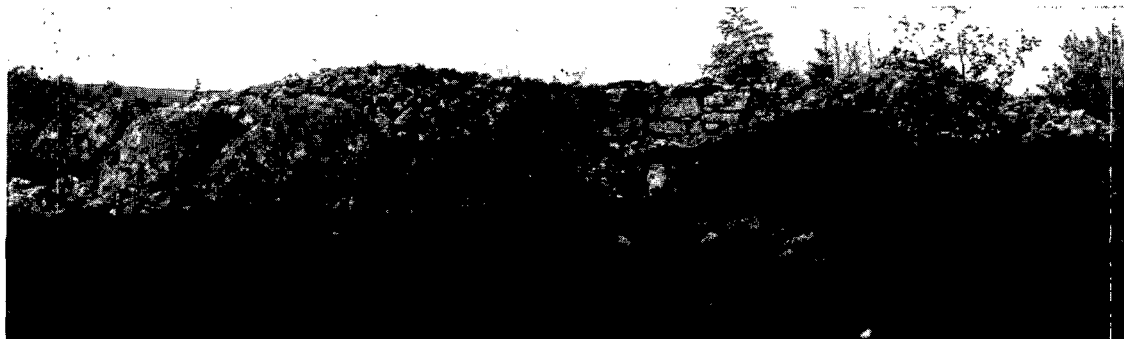
ILLUS 12 The south-west cairn in 1924 (NMRS no A47997)

The two prints in illus 12 and 13 show the comparable progress of Balnuaran south-west from 1924 to 1931. The stages of raising the cairn material to a higher level while moving it back from the edge of the chamber can be seen very clearly in the area above the wall at the back of the chamber, to the right of the axis of the passage. Over 0.3 m has been added and the profile of the cairn has been very much smoothed.

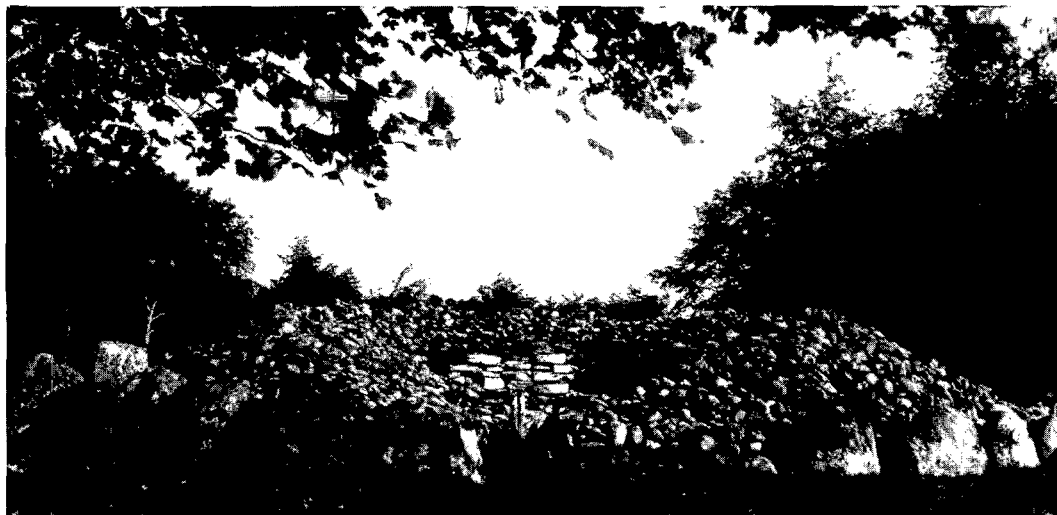
ILLUS 13 The south-west cairn in 1931 (NMRS no A48019)

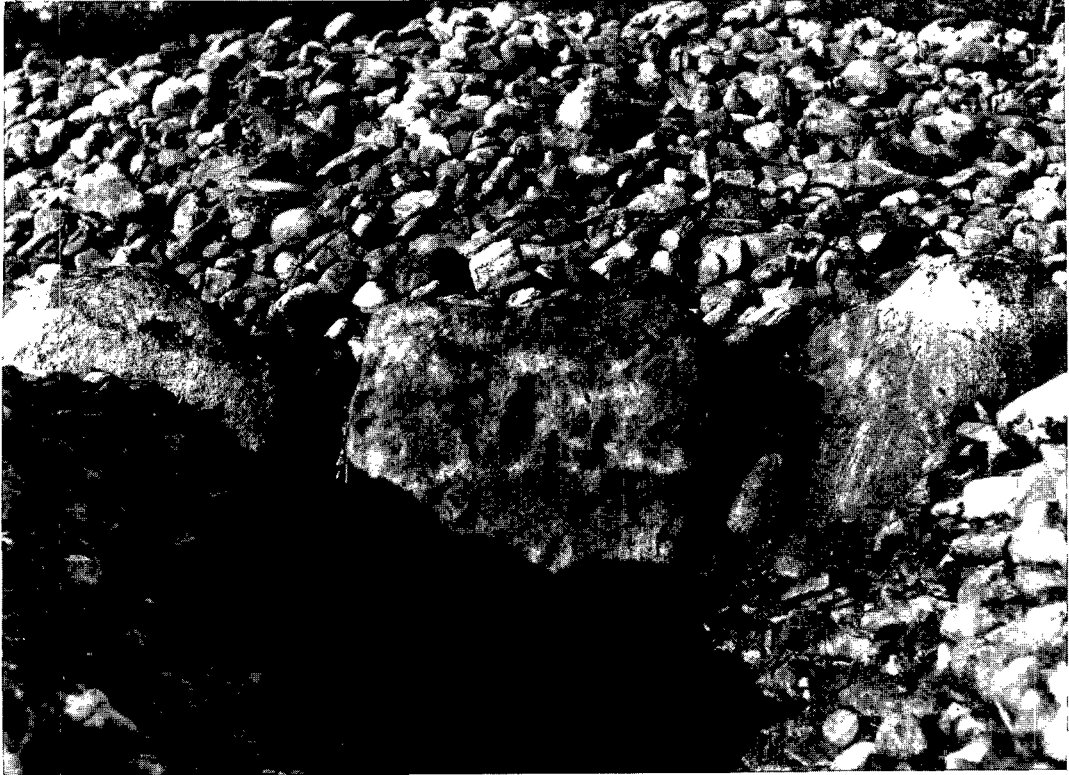
ILLUS 15 Miss Kennedy's section through the ramp of the south-west cairn, showing one of the cup-marked stones (NMRS no A48026)

A second cutting was made to show the face of the only slab set in the kerb [illus 15]. It faced 111° E. of N., and was about 3 ft square and 1'9" in thickness. The outer face was covered with cup-marks which seemed to be made in sets of three.

Miss Kennedy's account suggests that the ramp was made up of two distinct materials: stone of similar size to the cairn material and smaller stones (grading to larger near the outer edge) mixed with shells and soil. The Balnuaran cairns show most clearly the blocking of the entrance by this ramp of material; at Corrimony Piggott suggested that the gap in the ramp in front of the entrance had been filled in as part of the closing of the tomb. It might be suggested though that the erection of the stone bank as a whole was part of the closing of the cairn, especially as the cairns often survive with the kerbstones largely hidden from view. The results of Miss Kennedy's investigations indicate only that there were two distinct materials in the ramps, not how the upper, generally larger stone had got there (illus 14 & 15).
