Excavations at Balvaird Castle, Perthshire

John Lewis*

ABSTRACT

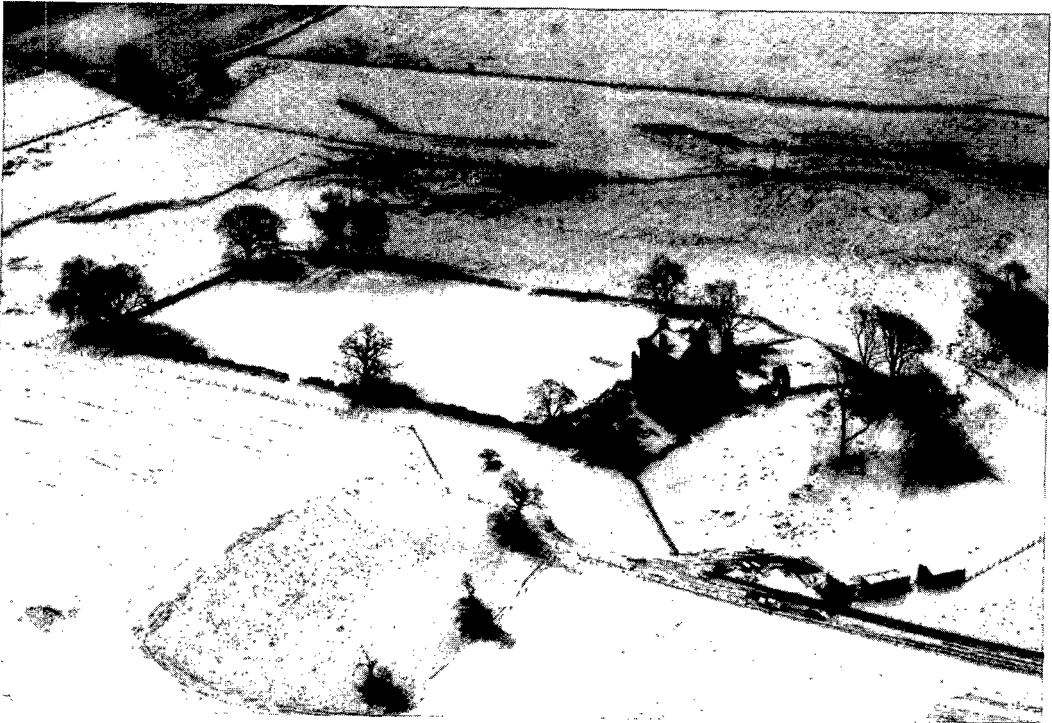
ILLUS 1 Aerial view of Balvaird Castle from the north-west. *Crown copyright: RCAHMS*

Balvaird Castle (NGR NO 169 117) is situated near the head of Glen Farg, immediately to the north of the border between Tayside and Fife and 6 km west of Auchtermuchty. Standing at the east end of the Ochil Hills on an outcrop of undifferentiated Devonian andesitic or basaltic lava (Cameron & Stephenson 1985, 37 & fig 1), the castle commands impressive views in most directions and, although the ground rises slightly towards the north-east, visitors approaching from that direction could have been easily seen from the top of the tower.

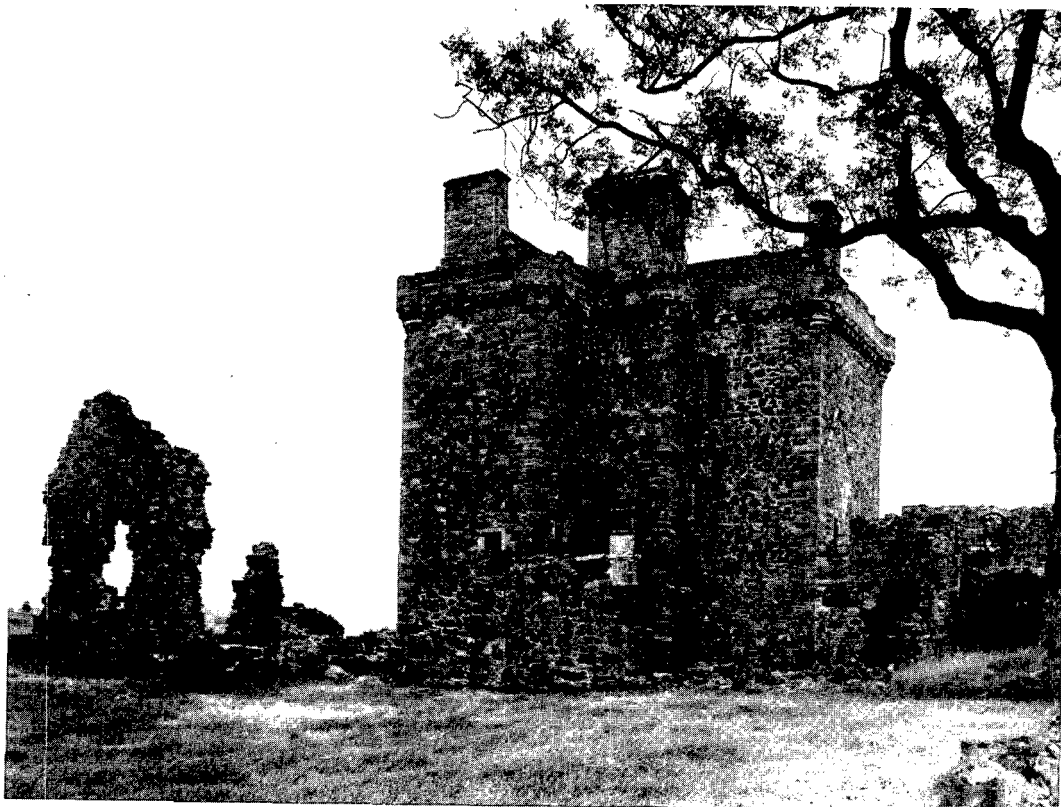
ILLUS 3 Balvaird Castle from the south

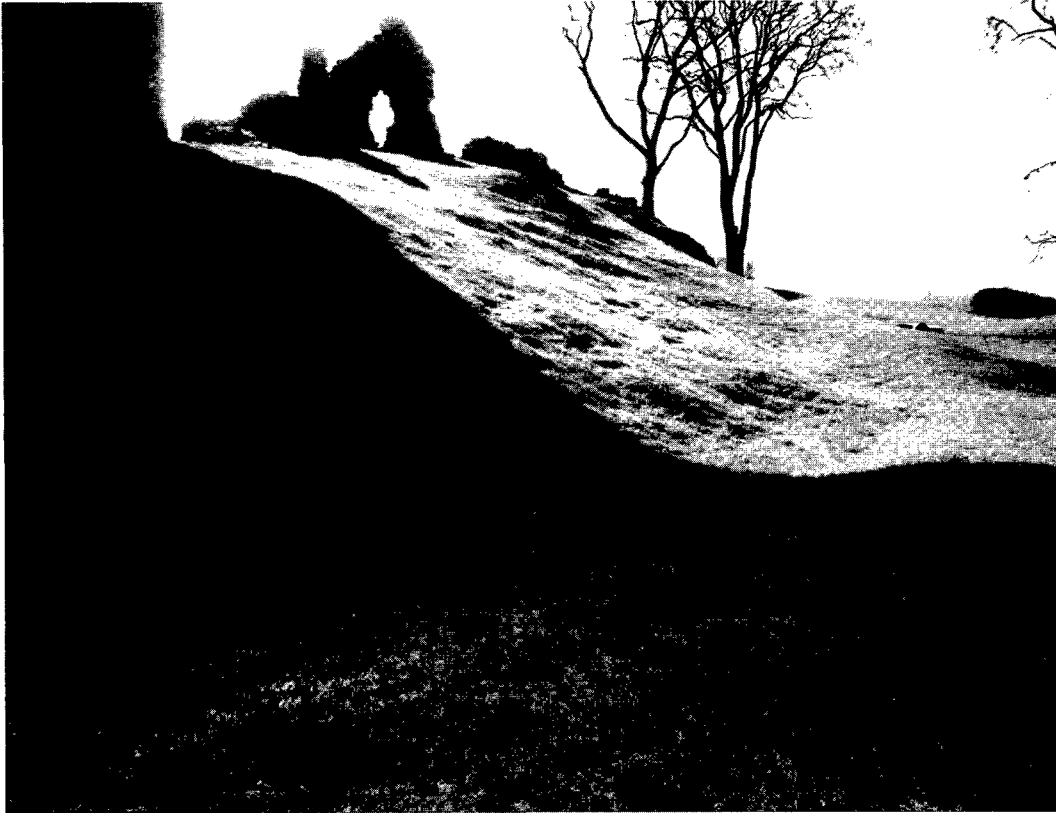
ILLUS 4 The ditch to the west of the castle, viewed from the north

On the sloping ground to the west of the castle is a partially infilled ditch. Its course is now visible only for a length of about 50 m, from a small cliff face (probably an abandoned quarry) outside the walled garden to its present terminus beyond the north court; thereafter it peters out. The age and original extent of the ditch are both unknown although its infilling may have been contemporary with the construction of the castle's north entrance and/or the creation of the orchard.

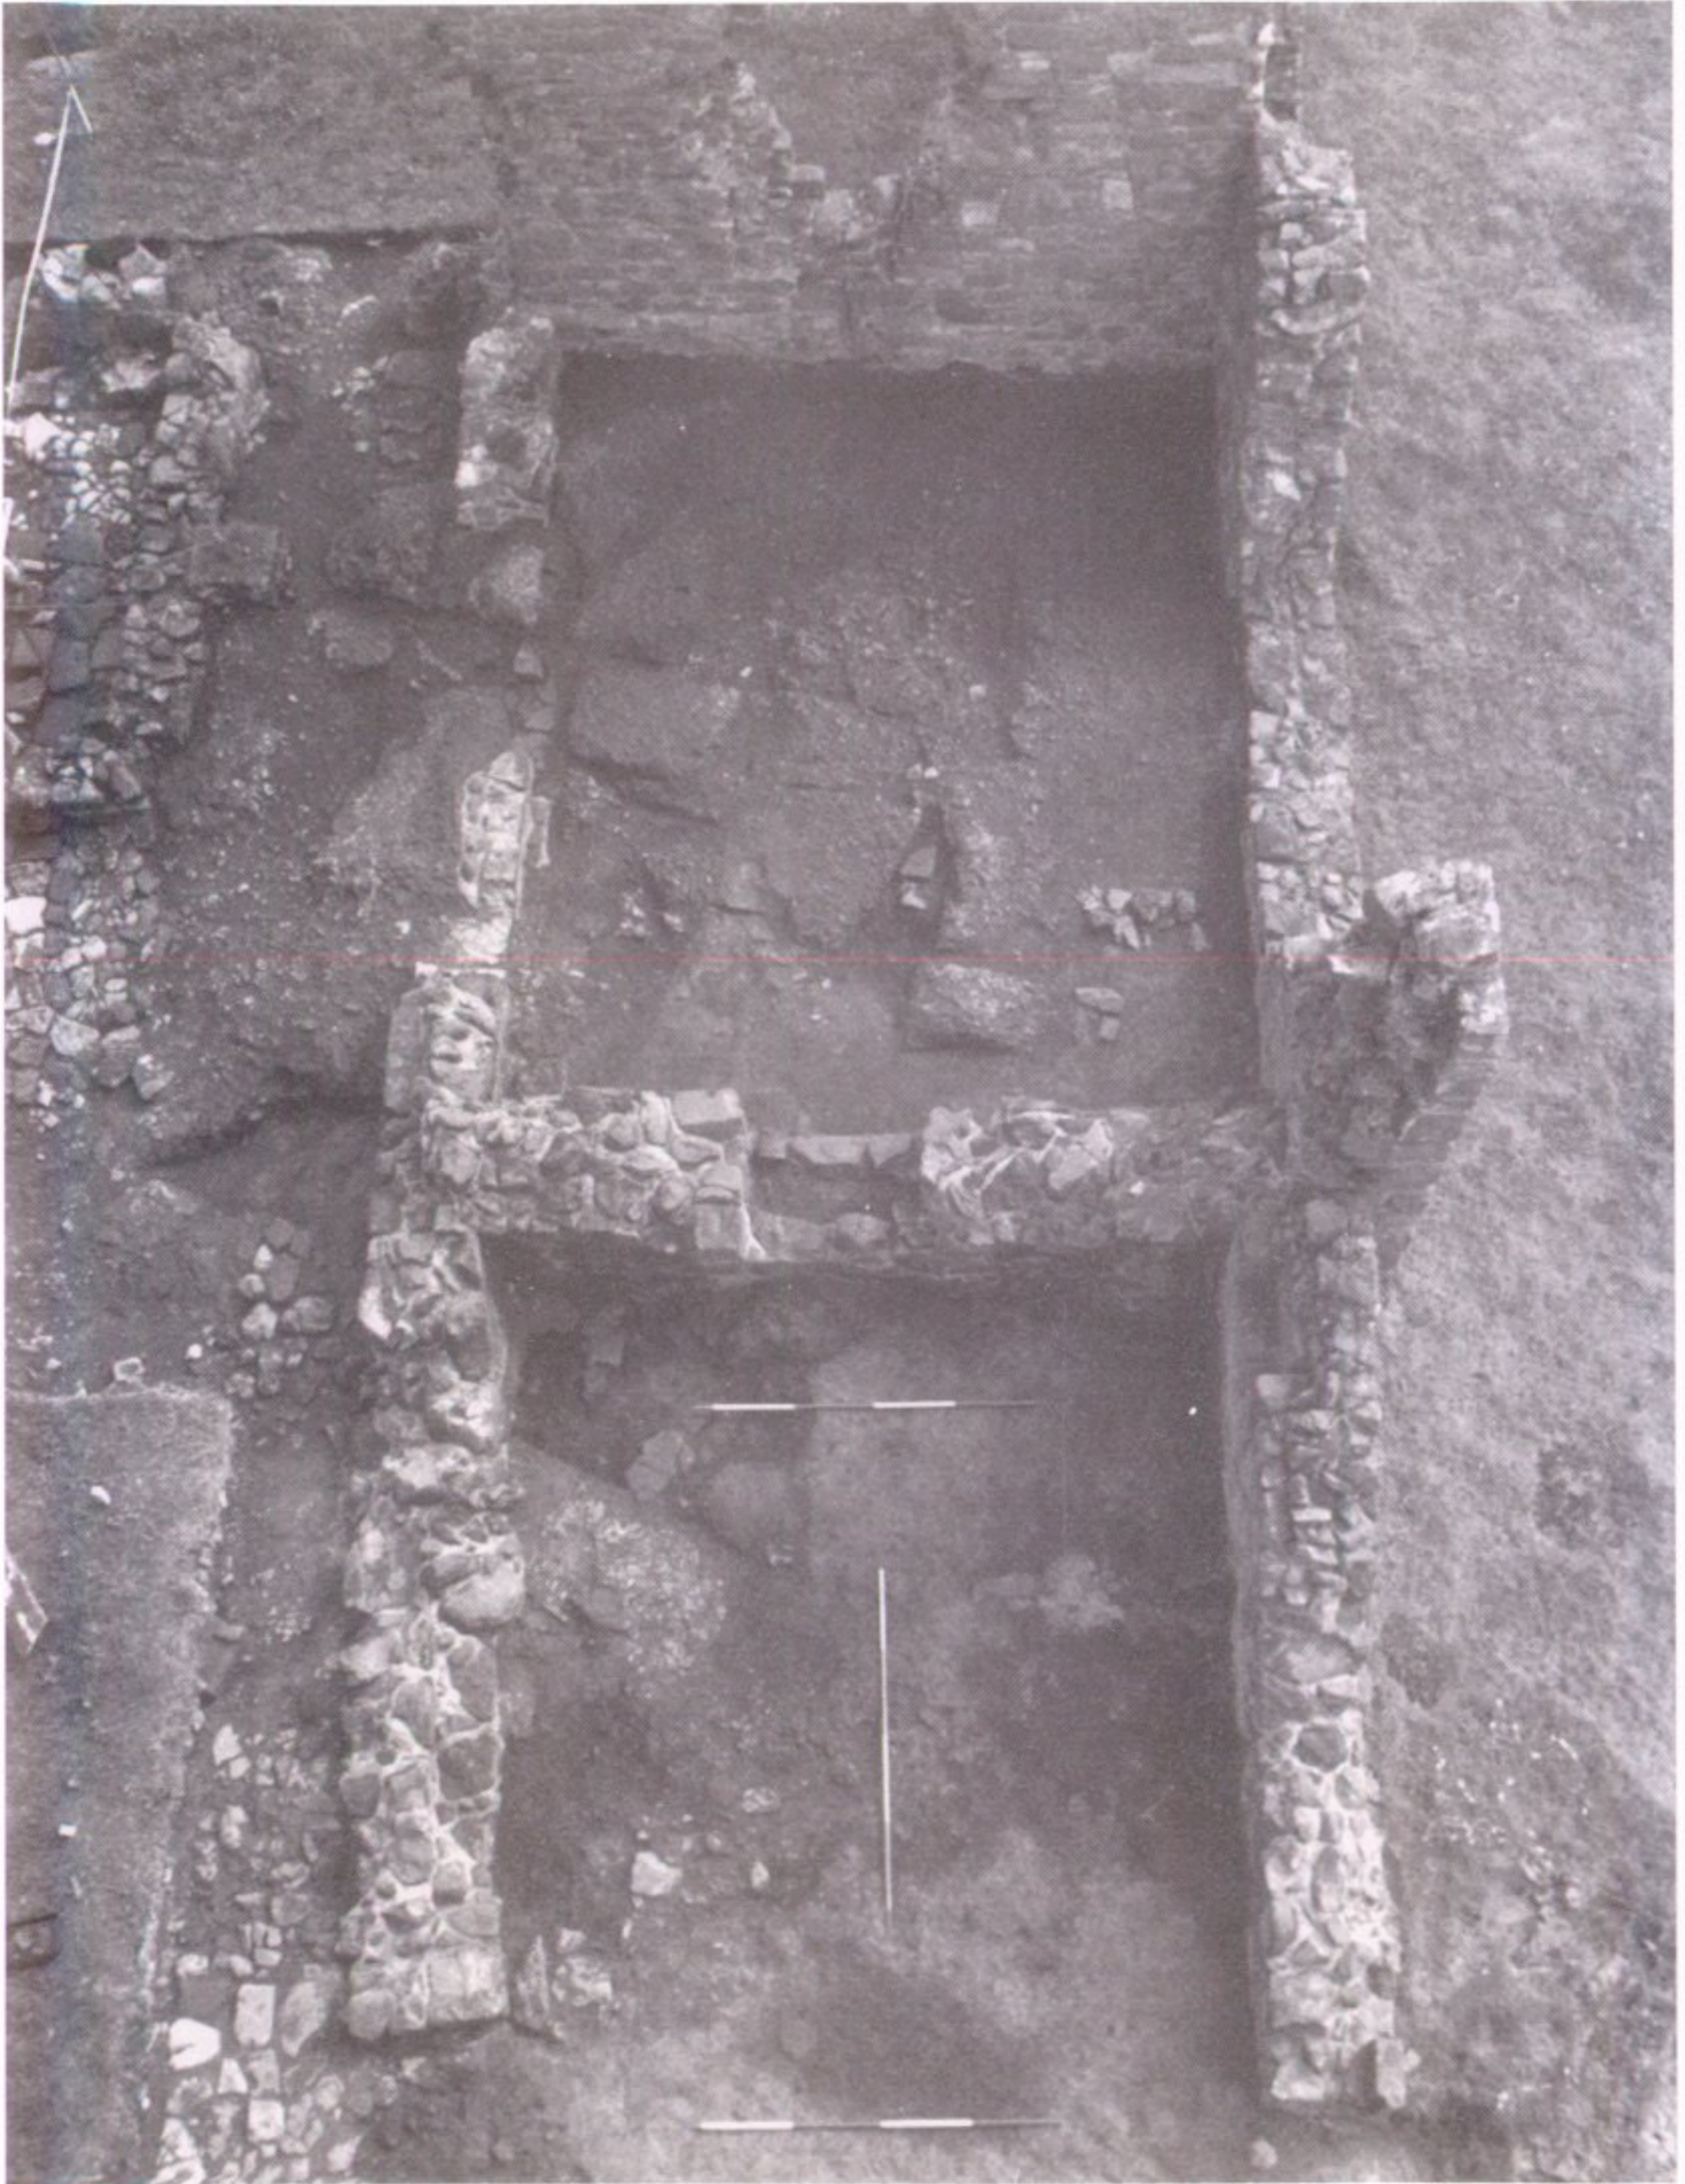
ILLUS 7 The west range from the north

The range measured 14.3 x 6.3 m overall with walls 4.0 m high and there was a loft contained within its roof space. The roof line is indicated by a raggle cut at an angle of 45° into the south wall of the tower and by the near intact profile of the south wall of the range. Access to the loft was by a doorway (presumably an insertion) in the south wing of the tower. At some stage, probably when the west range went out of use, the doorway was blocked and its internal recess converted into a wall cupboard. The south and north chambers measured 6.7 x 5.0 m and 5.8 x 4.3 m respectively.

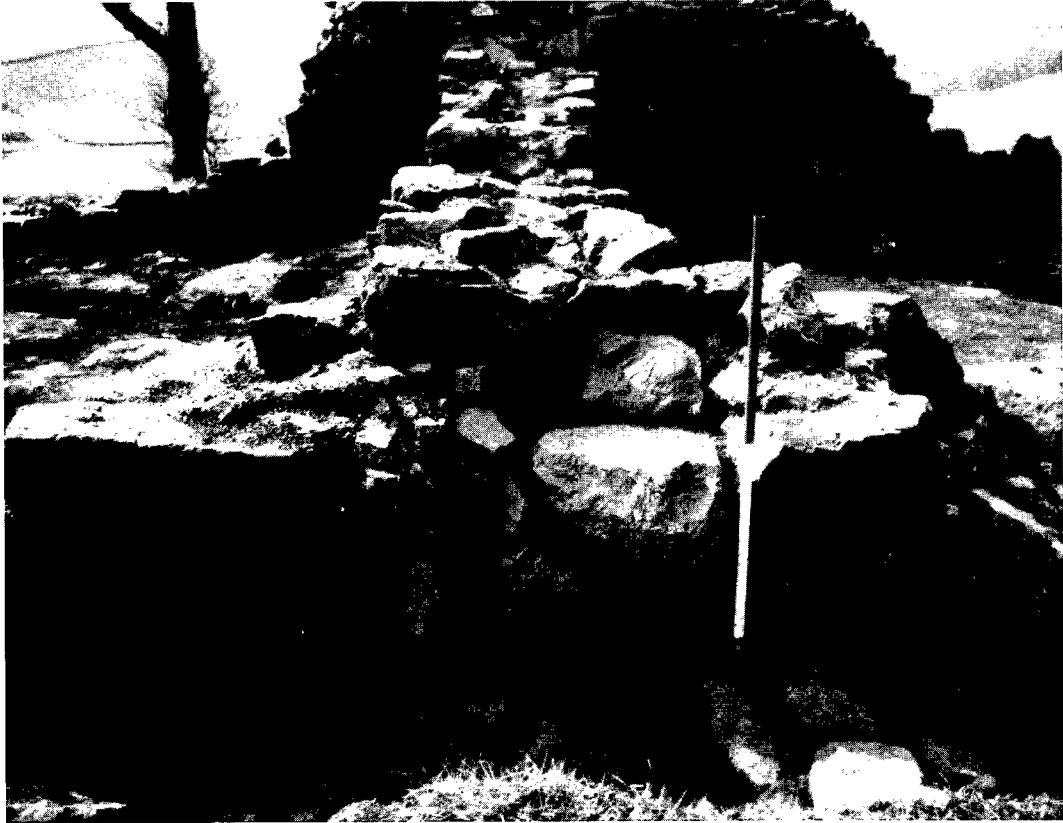
ILLUS 8 Wall F102 from the east, showing truncated masonry

The partition wall (F102) dividing the ground floor of the west range into two chambers was the reused, partly demolished, north wall of an earlier building (Building 1) which had probably been aligned east/west. Little effort was made to smooth off the truncated end of this wall and its rough masonry was evident among the facing stones of the new east wall of the west range. Although the full extent of Building 1 was not determined, its north-west corner can be seen projecting beyond the outside wall of the west range; parts of the west and, probably, the south barmkin walls were also elements of this building. However, piecemeal masonry consolidation during the present century has probably destroyed much useful evidence within these walls.

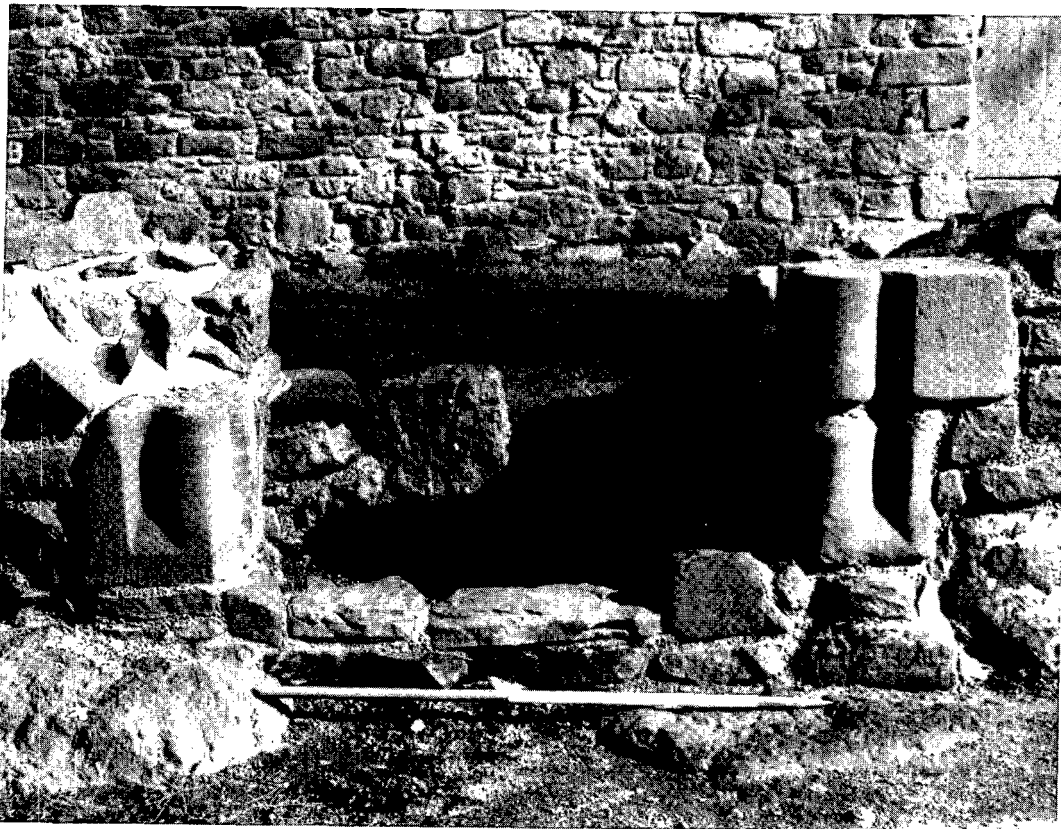
ILLUS 9 Fireplace F104 from the south

Midway along wall F102 was a fireplace (F104), 1.15 m wide and recessed 0.70 m into the wall. Little more than a single course of each of its roll-moulded jambs and part of the sill (all of red sandstone) survived; the hearthstone, sides and fireback all being missing. The remainder of its stonework was mortar-bonded rubble which contrasted with the clay-bonded masonry of the wall itself. This indicates that the fireplace was most likely an insertion and probably contemporary with the west range rather than with Building 1. Ashes and coal fragments filled the adjacent fissures in the bedrock, perhaps a particularly large cavity having been extended to serve as an ash pit. The high quality of the mouldings in the fireplace points to this room having been, at least primarily, a residential apartment. No debris associated with occupation or stratified artefacts of any sort were recovered from within this room; the fireplace, while 16th-century in style, might have been in a secondary context.

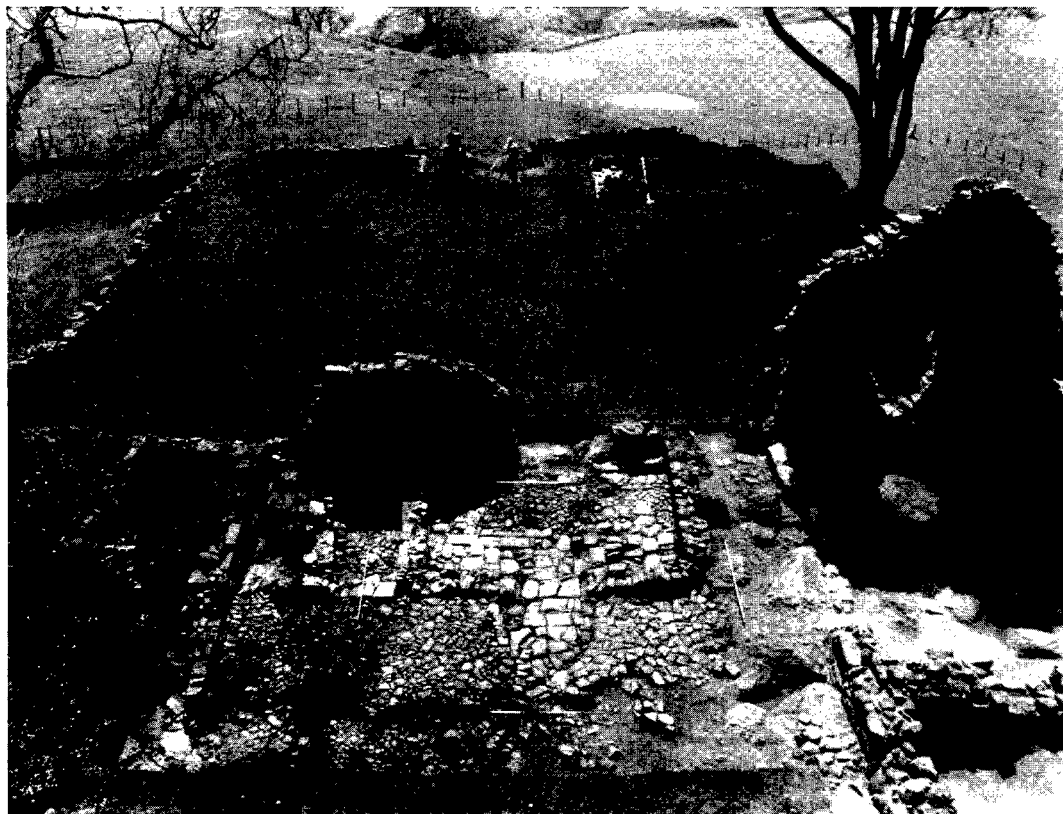
ILLUS 10 The south range and garden viewed from the north

The original building comprised a single chamber, measuring 5.20 x 3.0 m internally, and was built against the south barmkin wall which stood to a maximum height of 3 m at the time of the excavation. The remaining three sides of the range were defined by narrow rubble walls of which no more than three courses survived. Midway along the north wall was a doorway, 1.00 m wide, which gave access over a threshold of large sandstone flags to the ground-floor interior. The well-worn floor surface consisted of squared sandstone flags and neatly laid cobbles, the boundary between the two perhaps indicating a change of function at some time although there was no evidence as to what those functions might have been. There was no evidence of a fireplace within the building, perhaps suggesting that it was merely a store.

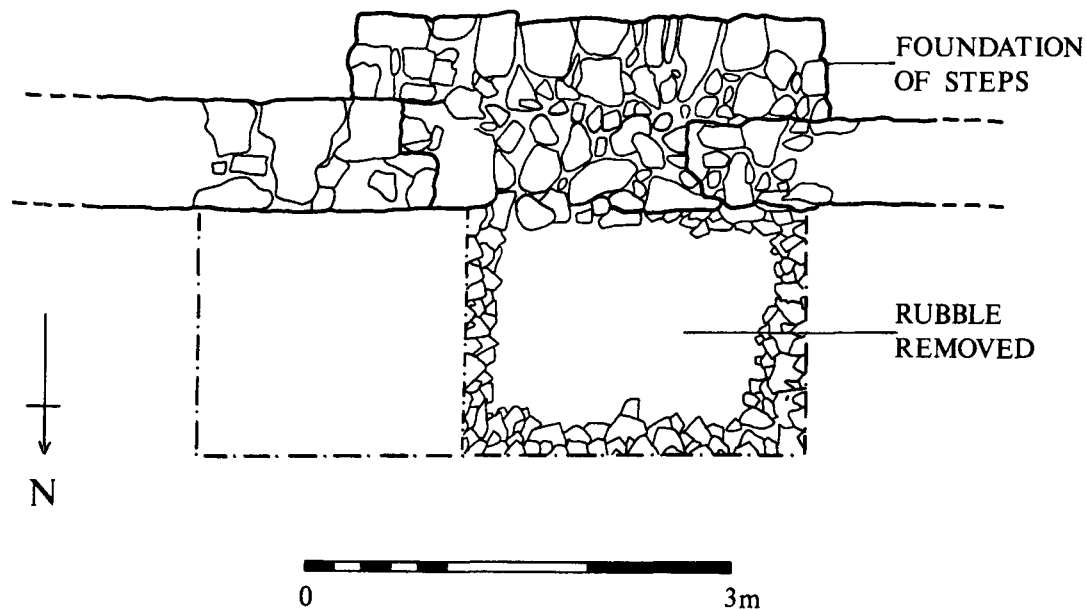
ILLUS 11 Plan of excavated features at the south end of the garden

The garden to the immediate south of the main courtyard measured 22 m square and was enclosed by rubble walls which are now totally ruinous. A small trench was opened midway along the enclosure's south wall to establish whether a breach in the wall and an adjacent platform of masonry were associated with a doorway and a stair beyond it.

Investigations in this area were very limited and the findings were far from conclusive. It seems unlikely that the voided rubble that covered the whole trench, both to the interior of the wall and below its foundations, was all contemporary although no boundary was evident within the material. Although the evidence was certainly not irrefutable, it may be reasonable to speculate that most of the rubble was deposited after the garden wall was built, perhaps as a base for a walkway around the garden's perimeter, and that the masonry platform beyond the garden formed the foundation of a stone stair, the steps themselves having been removed.

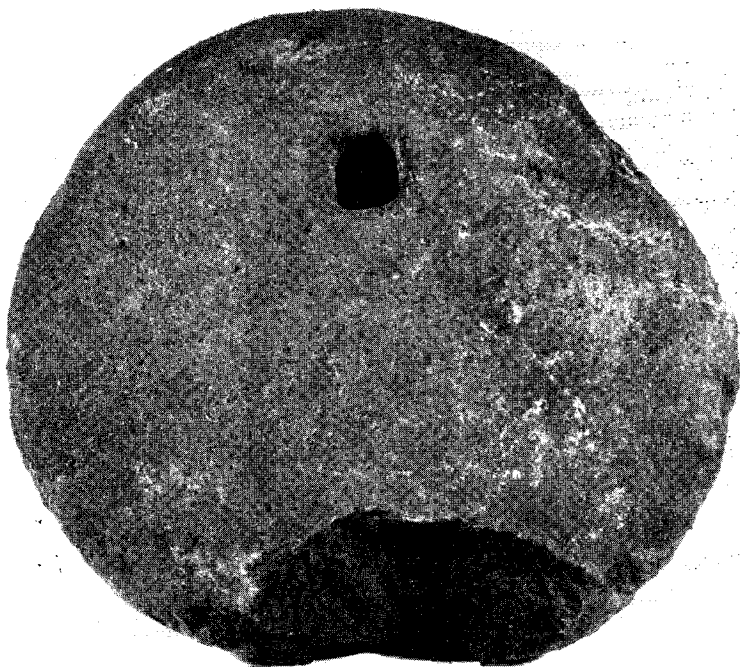
ILLUS 12 The curling stone

Within the rubble that overlay the floor of the south range was a flat, rounded boulder of dark grey basaltic lava measuring 260–280 mm in diameter and 70–90 mm thick, and weighing 12.8 kg. On its upper surface, 55 mm from the edge, was a rectangular hole, 30 mm by 25 mm across and 25 mm deep, where the handle, probably of iron secured with lead, would have fitted. The loss of a large fragment from the upper surface may have led to the stone's abandonment.

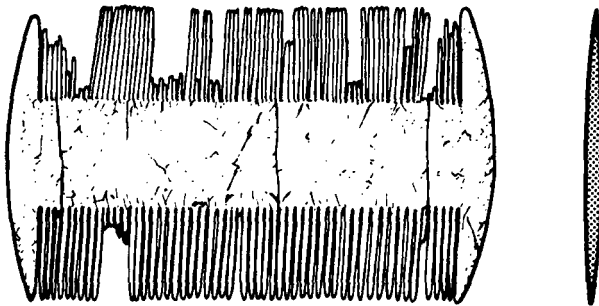
ILLUS 13 The bone comb, length 64 mm

Within the fill of a presumed 19th-century pit in the north chamber of the west range was a nearly complete bone comb measuring 64 mm long, 38 mm wide and 1.5 mm thick with convex ends. On one side of the plain, rectangular central plate were 65 teeth (12 per 10 mm); opposite were 88 smaller teeth (16 per 10 mm), each row being 12 mm long. This type of comb was common throughout the medieval period and into the 18th century although this example was of higher quality than most recovered from early post-medieval contexts (for comparisons see Grew 1984, 110 and Fox & Barton 1986, 240).
