Stone emplacement in early Scottish churches: evidence of Early Christian craftsmanship

John F Potter*

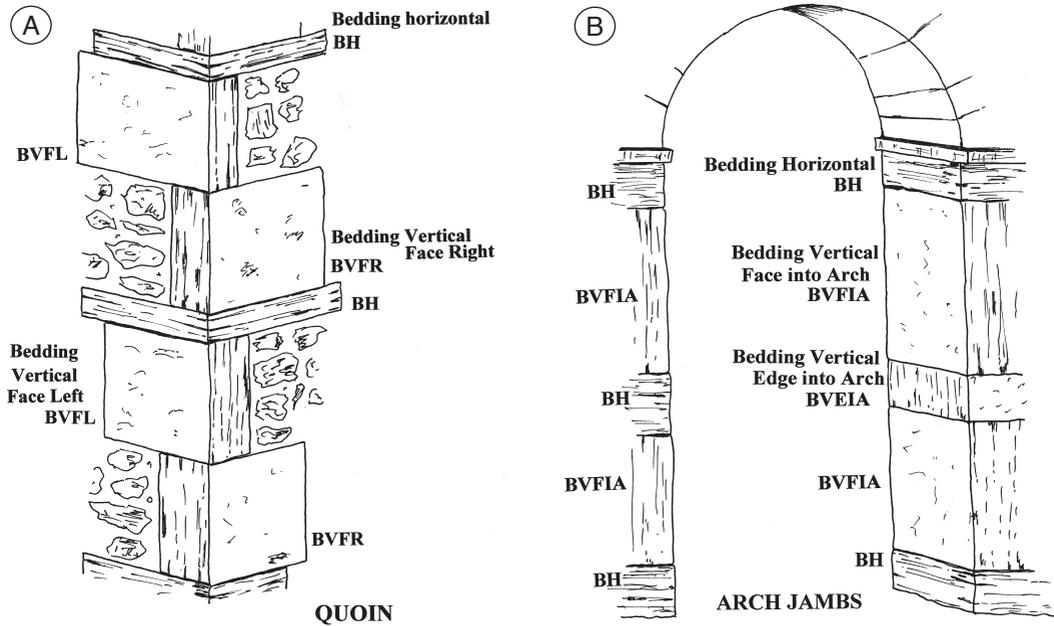
ILLUS 1 Possible stone bedding orientation in (A) quoins and (B) jambs of arch structures, and an abbreviated nomenclature for their description. Stones in both are normally emplaced with their bedding horizontal (BH). However, stonemasons in the Saxon period, probably for decorative reasons, frequently placed stones vertically in both quoins and jambs. As a result, in quoins, the bedding could either face to the left (bedding vertical face left, or BVFL), or to the right (bedding vertical face right, or BVFR). In vertically bedded stones used in arch jambs, the bedding face could either face into the arch (BVFIA), or be parallel to the wall containing the arch (bedding vertical edge into arch, or BVEIA). Evidence from England, which appears to be equally applicable in Scotland, indicates that the Saxon-style for arch jambs was to use only stones emplaced BH and BVFIA. Norman masons preferred BH, but sometimes used BH and BVEIA constructed jambs

A recent examination by the author of all customarily recognized Anglo-Saxon churches in England (Potter 2005b), confirmed an earlier hypothesis that pre-Conquest church builders in ashlar stone used the stone for certain structural features in unusual and specific styles (Potter 2003; 2005a). Their techniques of stone emplacement prove sufficiently distinctive for their craftsmanship to be distinguishable from the work of others. In particular, the Saxon use of stone in quoins, arch jambs and pilaster strips followed characteristic patterns (Potter 2005b; 2006). For the benefit of Scottish readers of this paper these patterns are very briefly described below, and more especially in *illus 1*.

probably relates to the lack of suitably fissile and easily worked rock-types for pilaster creation. In Scotland, however, it would seem likely that both the orientation of stones in early quoins and those in arch jambs would follow the patterns observed in the early Christian, pre-Norman, churches of England. This would involve many of the stones in quoins being set with their bedding planes vertical; possibly, for example, when the quoin is viewed (illus 1A), with the bedding plane face alternately to the left (BVFL) and to the right (BVFR) (illus 2). Similarly, the Anglo-Saxon style of erecting arch jambs might be expected to involve only two types of stone emplacement (illus 1B), that is, stones with their bedding horizontal (BH) and others with their

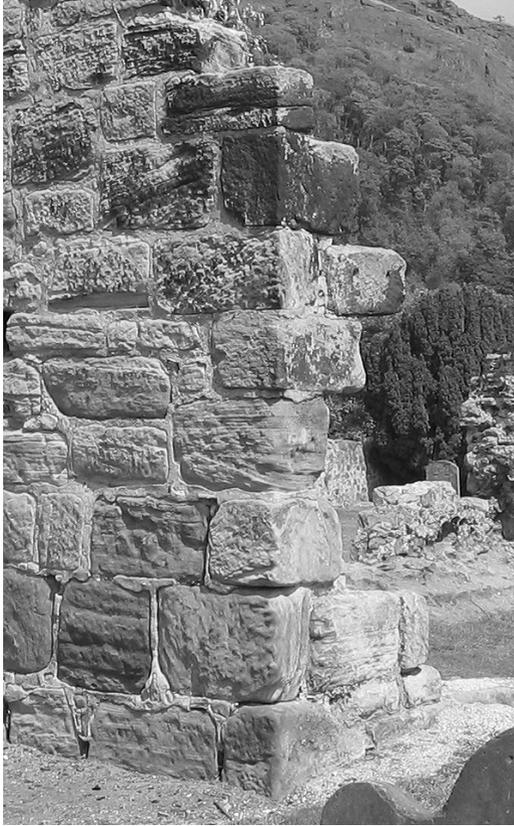
ILLUS 2 The south-west quoin of St Serf, Kirkton, Burntisland (Table 1), is built of relatively large, side-alternate quoin stones. From the ground level upwards the bedding orientation of these stones may be read with a hand lens as; stone 1, ?; BVFL; stone 3, ?; BH; BH; BVFL; BVFR; BH. The whole quoin structure is representative of Saxon-style workmanship

Kildalton, Islay	NR 458507	North-east, south-west, south-east quoins (each in part)	Lower Devonian arkosic sandstone	Other rock types in quoins as replacements
Kirkton, Burntisland, St Serf, Fife	NT 232864	South-west quoin (part)	Lower Carboniferous sandstone	RCAHMS (1933) 'consecrated 1243'

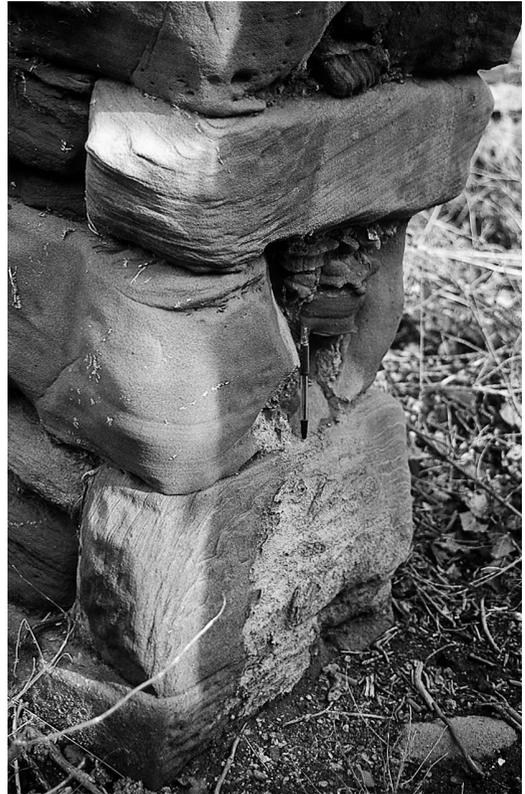
ILLUS 3 The northern jamb of the chancel arch of the ruined Preston church (Table 1) viewed from the nave. Constructed of well-bedded Upper Devonian sandstone, the visible jamb stones, from ground level upwards (pen for scale), can be read as BH, BVFIA (through stone), BH, BH (through stone). The arch stones have been replaced and are probably of Post-Reformation date

bedding-plane face directed into the centre of the arch (BVFIA) (illus 3).

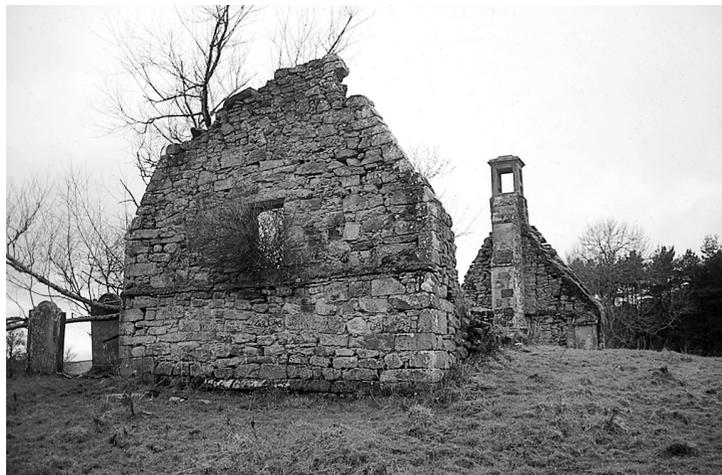
ILLUS 4 What remains of the east wall of Abbotrule ruined church (Table 1) displays some interesting modifications. The string course fails to run parallel to the wall plinth (the south-east corner is 0.17m shorter between the two than the north-east corner). Stones above the string course are smaller and less well coursed, suggesting that the wall has been rebuilt above that level. This is confirmed when the quoin stones are examined. Below the string course at least three of the stones in each quoin have been emplaced vertically in Saxon-style. The absence of both the string course and the plinth in the north and south walls does, however, pose the possibility that the quoin stones may have been re-set

<i>Church or Chapel/Locality</i> ¹	<i>Grid Ref</i>	<i>Pre-Conquest style stone emplacement detail</i> ²	<i>Rock types of quoin stones</i> ³	<i>Notes</i> ⁴
Abbotrude, Borders	NT 615217	North-east, south-east quoins below string course	Upper Devonian sandstone	Illus 4
Abernethy Round Tower ⁵ , Perth & Kinross	NO 190165	4 belfry windows (interior, north-facing repaired), main doorway (repaired)	Upper Devonian sandstone	And possibly Lower Carboniferous sandstone
Auld Cathie, West Lothian	NT 078760	South-west quoin	Lower Carboniferous sandstone	RCAHMS (1929) 'may be late 14th century'
Ayton, St Dionysius, Borders	NT 927609	South-west quoin below string course	Lower Devonian sandstone	Church much repaired/ altered ⁶ Ferguson (1890–1) 'before the close of the 12th century'
Borline, Loch Eynort, St Maelrubha, Skye	NG 375260	South-west, south-east quoins	Vesicular basalt	Side-alternate
Brechin Cathedral Round Tower ⁵ , Angus	NO 579602	Doorway	Lower Devonian sandstone	–
