# Medieval timber-lined wells in Elgin

H K Murray,\* J C Murray\* and W J Lindsay†

*This report is a brief summary of the results of a series of excavations on three medieval backland properties behind the High Street in Elgin, Morayshire. It includes a full analysis of an important group of timber-lined wells dating from the late 12th/early 13th century to the 14th century. Exceptionally good preservation due to waterlogged conditions has allowed detailed recording of the carpentry and methods of assembly.*

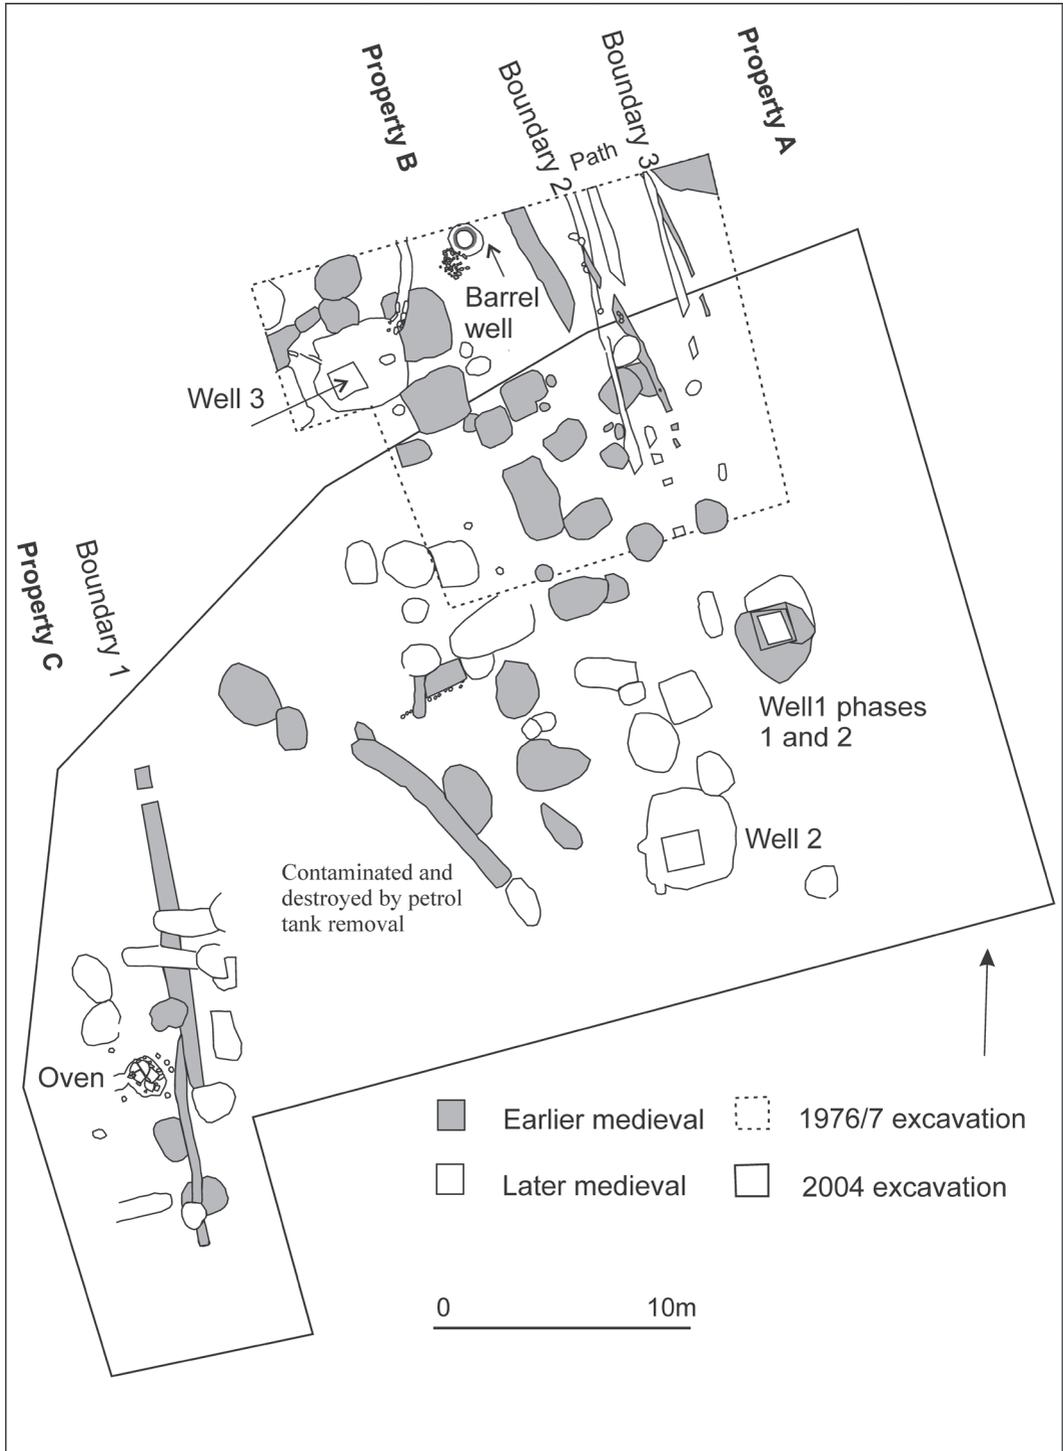
ILLUS 2 213-25 High Street Elgin. Medieval backlands

In the late 12th and 13th centuries the site appears to have covered parts of three backland properties divided by shallow boundary ditches (illus 2, Properties A–C). At the north end of the site, between Properties A and B, there was a path bordered by fences that were later removed. The earliest of the wells (Well 1) was built at the west edge of Property A in the late 12th or early 13th century. Subsequently, the lining partially collapsed and was replaced, probably later in the 13th century. The only other surviving features from this period were a number of highly truncated pits filled with predominantly domestic rubbish and cess.

Well 3 had two associated drains extending from the north-east and north-west corners of the well construction pit (illus 2). Little evidence of their form survived, and most of the alignment of the eastern drain was represented by silty staining, although for *c* 1.3m, stone slabs formed

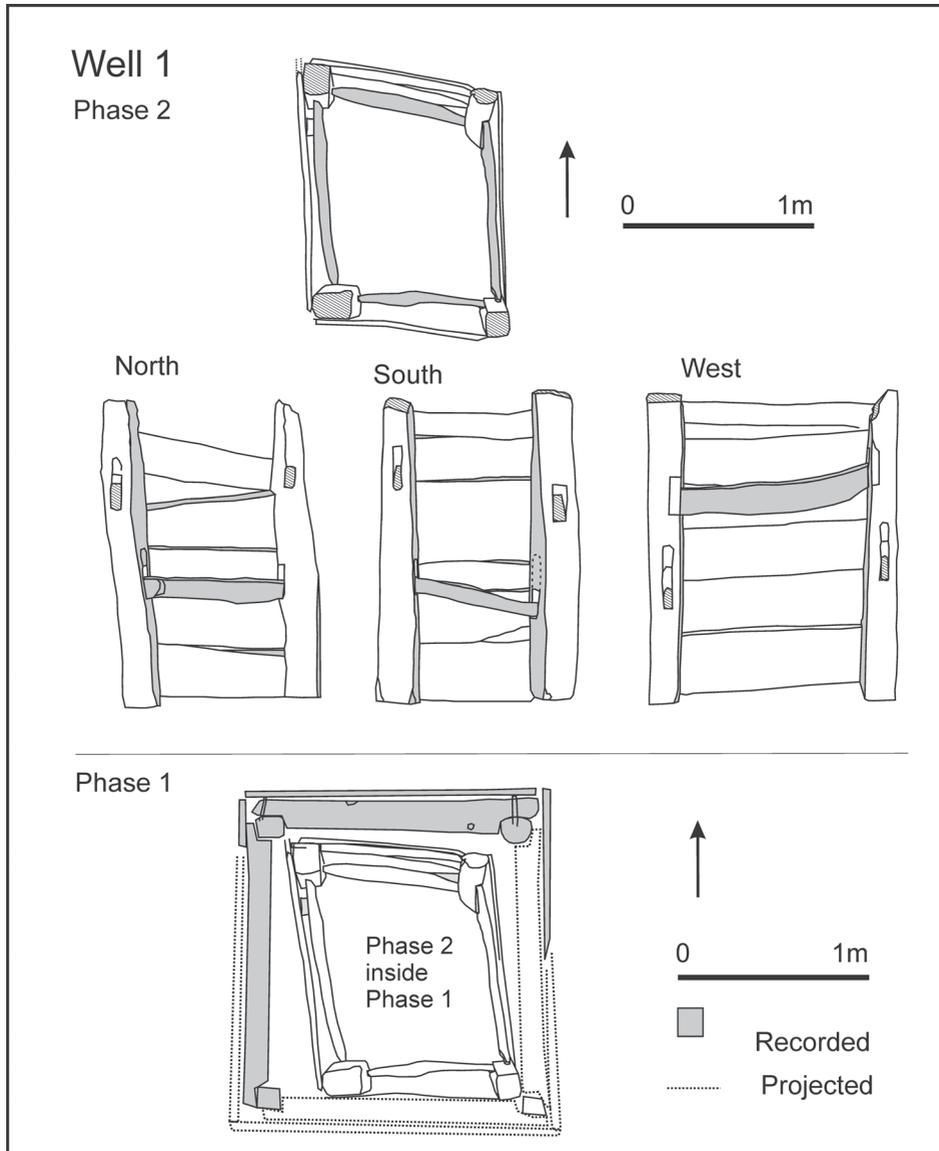
ILLUS 3 Well 1 (2004, F12). Due to collapse, the east side of Phase 2 and parts of Phase 1 could not be fully recorded

#### *Well 1, Phase 1 (illus 3)*

This well was set in an ovoid pit *c* 2.9m × 3.5m, with a surviving maximum depth of 1.9m.

Within this was a timber-framed lining (*c* 1.3m × 1.3m), only part of which could be excavated or fully recorded as it collapsed when the later inner lining (Phase 2) was removed. The well lining had four corner posts, one of which was roundwood (diam 150mm), the others roughly squared (90mm × 130mm). At the surviving top level these were held apart by four bracing timbers, each lap-jointed and dowelled (from the outside) to the outer sides of the corner posts. Horizontal planks that formed the well lining lay against the outer faces of the bracing timbers. They were held in position by earth backfilled behind them in the construction pit. There is some evidence for re-use of timbers: the north-west post appeared to have a groove; the north brace had a non-functional dowel hole near one end.

At some point, the north-east post appeared to have become unstable with the east side of the lining beginning to collapse inwards. Rather than abandoning the well, a second lining (Phase 2) was constructed. Clay up to 300mm thick sealed

the timbers of Phase 1 on the east side of the well – possibly an attempt to consolidate this side.

*Well 1, Phase 2 (illus 3, 4)*

The Phase 2 lining had been built inside the existing well; as a result it was smaller and of slightly irregular shape (1.04–1.11m × 1.28–1.32m). The maximum surviving depth was 1.9m, with the timbers surviving to 1.7m.

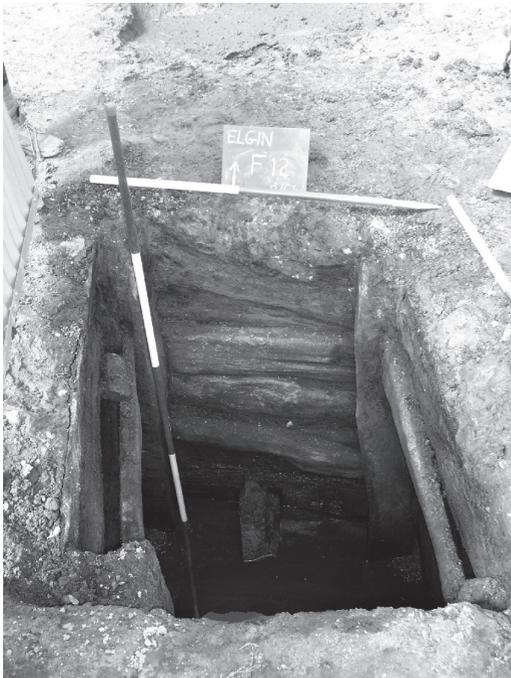
ILLUS 4 Well 1 (2004, F12), Phase 2, north side

It had four roughly squared corner posts (130mm × 160mm to 190mm × 200mm) which rested on the base of the pit and were held apart by four bracing timbers set in mortises in the inner faces of the posts. The braces were not fully horizontal but were in two opposing pairs, one set higher than the other. They were irregularly-shaped timbers roughly tapered at the ends; the south brace had been charred prior to being used in the well and would therefore appear to have been re-used. For each brace, the mortise in one end of the post was a regular rectangular mortise, usually about twice the size of the end of the brace – however, the mortise in the other end of the post was of similar size but with a long shallow groove above it. This appears to have been a solution to the difficulties encountered when constructing the lining within the earlier well as one end of each brace could be inserted and the other end then hammered down the groove into the

opposing mortise. No wedges or dowels were used in these joints. This could only have been assembled in the pit – it could not have been pre-fabricated and lowered in. Planks (150–460mm wide and 45–80mm thick) formed the sides, set behind the Phase 2 framework, supported by the earlier (Phase 1) outer lining. In time, the instability of the east side of the earlier lining appears to have caused this secondary lining to begin to collapse inwards.

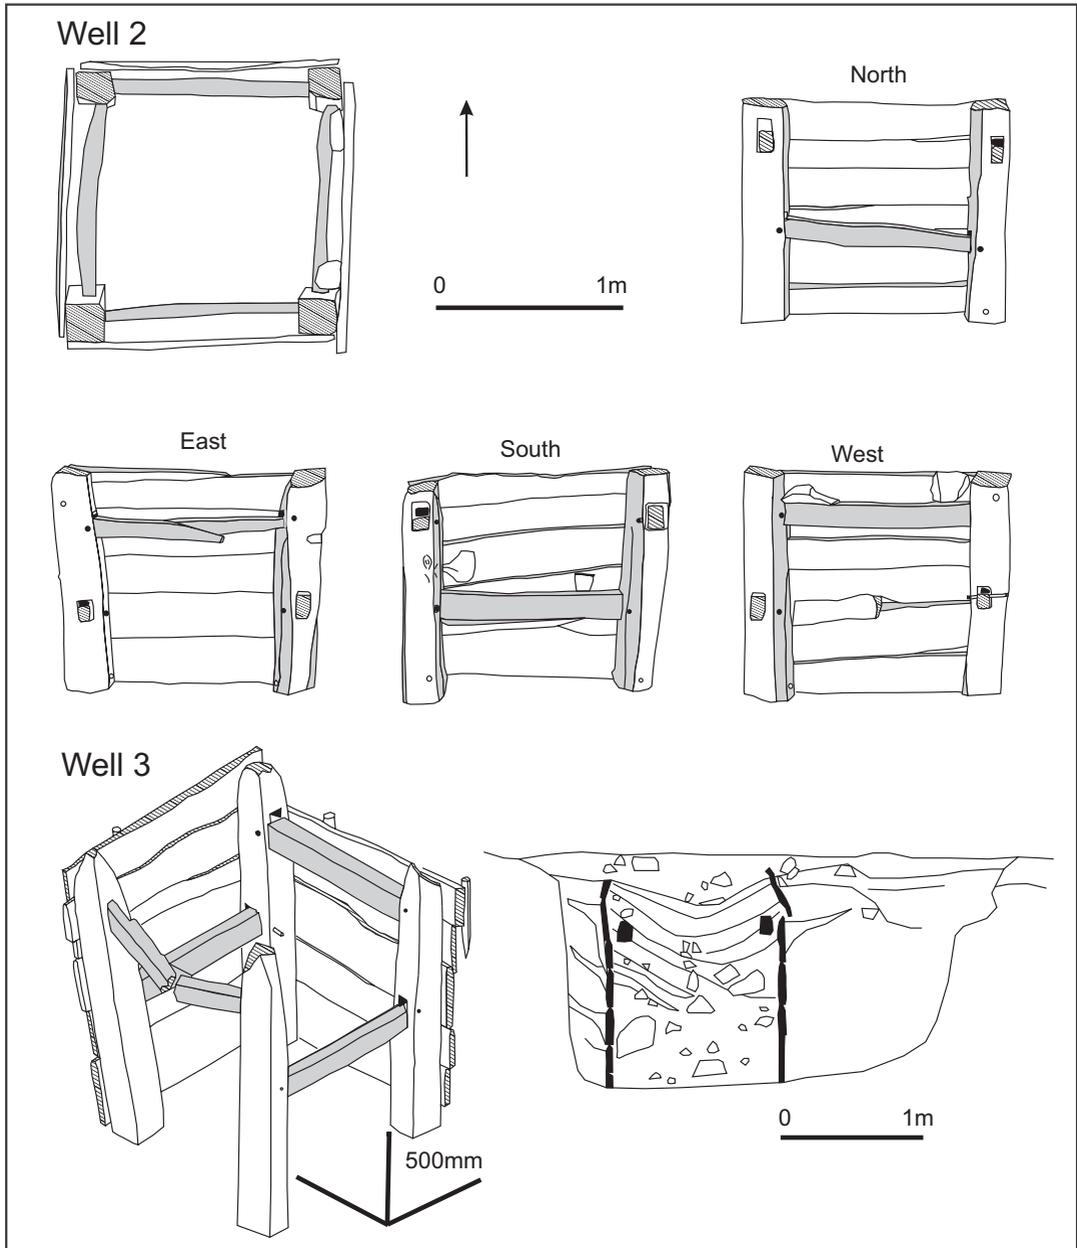
ILLUS 5 Well 2 (2004, F1) and Well 3 (1976/7)

#### *Wells 2 and 3 (illus 5–7)*

Wells 2 and 3 were set in roughly square construction pits 3.4m and 3.8m across with surviving depths of 1.6m and 1.2m respectively. Within each pit there was a timber-framed lining (Well 2: 1.45m × 1.45m; Well 3: 1.15m × 1.15m) – in Well 2 this lining was backed by <400mm of clay. Each of the linings had four squared corner posts (150mm × 180mm to 210mm × 230mm) held apart by four bracing

timbers set in mortises in the inner faces of the posts. The braces were in opposing pairs, two set roughly one-third and the other two *c* two-thirds up from the base of each well. The ends

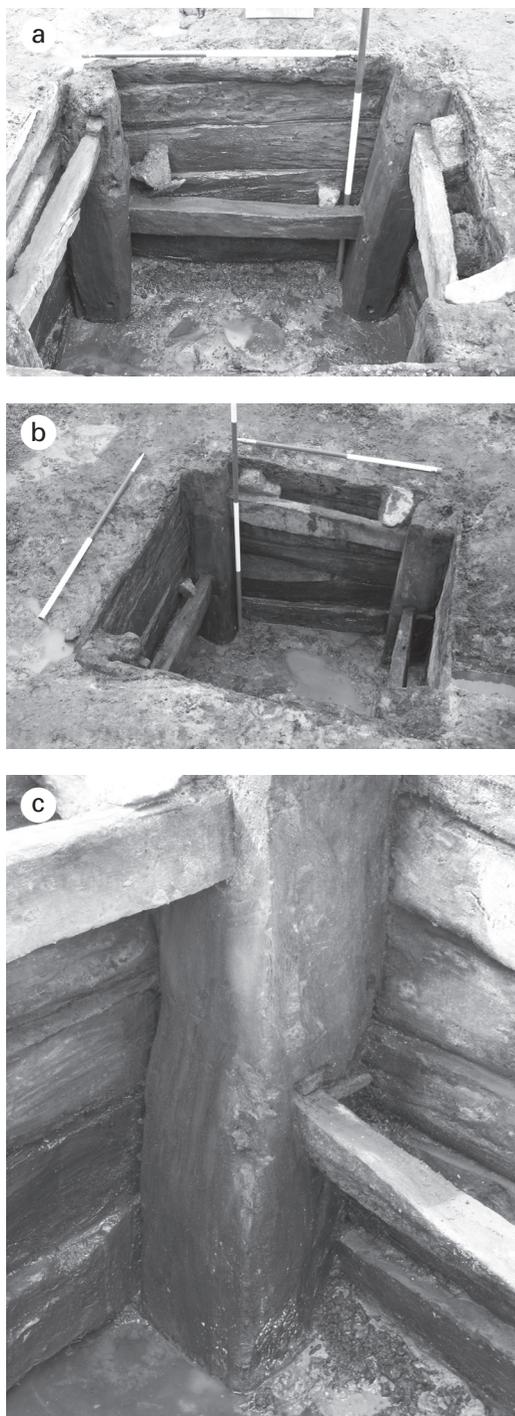
ILLUS 6 Well 2 (2004, F1). From top to bottom: (a) south side; (b) looking west; (c) detail of lower brace and north-west corner post

of the braces were adzed to a roughly tapered shape to fit into the mortises. The mortises were rectangular and often larger than the ends of the braces – in Well 2, for example, the south end

of the east brace was 40mm × 70mm, set in a mortise 130mm × 70mm. In Well 2, three of the mortises had wedges above the brace. All the braces were held in position with dowels, in some cases the angle of the dowel hole was awkward and did not go right through the corner post. Some of the dowels had clearly been driven in from inside the well, the tapered end of the dowel facing the outside. However, when Well 3 was excavated it was considered that the dowels had been driven in from outside the framework before the construction pit was back-filled. In both wells, the horizontal planks which formed the well-lining were set outside this framework, held in position by the earth back-filled behind them. In both wells, stones had been used as wedges between the planks and the outer edge of several of the bracing timbers. In Well 3, small stakes *c* 50mm in diameter had been driven in behind several of the upper planks to secure them further.

Three of the corner posts in Well 2 (SE, SW, NE) had non-functional dowel holes <75mm deep, near their bases. This might suggest re-use, but similar non-functional holes were found in the base of jambs in early medieval Dublin where they were interpreted as being associated with the handling of heavy timbers (Murray 1983, 36; Wallace 1992, 28). It is possible that the Elgin examples may relate to the process of securing timbers during preparation or even during movement to the site – it is unlikely that they relate to lowering the posts into the well, as in that case they would be expected on all four uprights and on the uprights of the very similar Well 3. An empty dowel hole near the rotted, surviving top of the SE post is the only other possible evidence of the timbers of Well 2 being re-used. It was originally suggested (Lindsay 1977) that the over-large mortises in the Well 3 uprights were evidence of re-use but by comparison with Well 2, it is perhaps more likely that this was done to facilitate the assembly of pre-fabricated joints. The ambiguity of the evidence indicating the use of salvaged timbers is important in considering

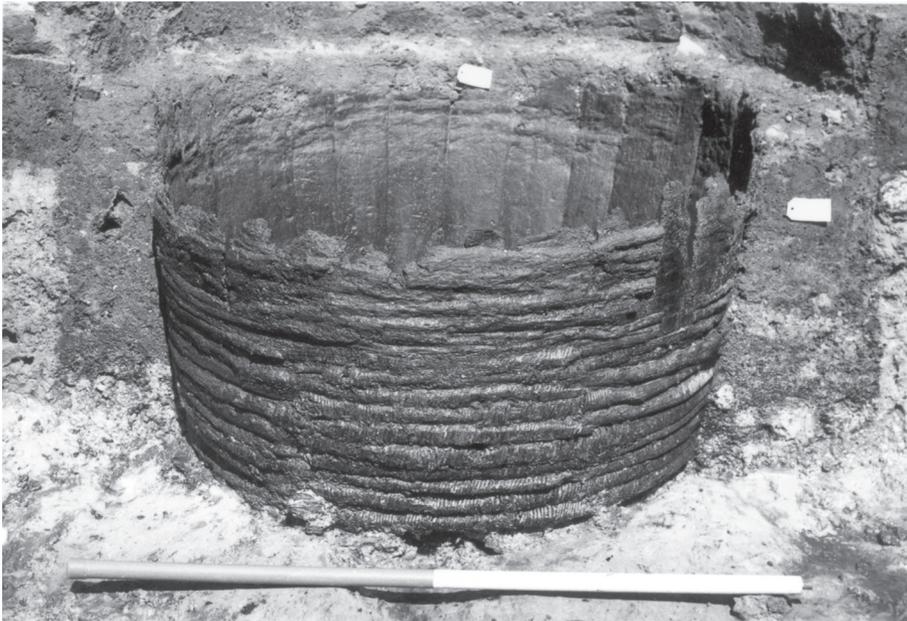
ILLUS 8 Barrel well (1976/7)

A barrel well (illus 8) was found in 1976/7 inserted into a pit *c* 1.25m in diameter and *c* 0.76m in surviving depth with sand, gravel,

clay and small rounded pebbles backfilled around the barrel (Lindsay 1977). The barrel, which was of oak and slightly distorted, had an upper diameter of *c* 0.95m and a basal diameter of *c* 0.80m. The average surviving length of the 28 tapering staves was 0.55m, while their thicknesses varied from *c* 2mm at the top to *c* 10mm at the bottom. Although there was no base in the barrel, a V-shaped rebate, *c* 5mm wide, cut to take a bottom was present *c* 40mm above the angled basal edge. The staves were held in place by a series of 13 closely arranged withies made from quartered birch saplings with finished widths of *c* 30mm. The tapered ends overlapped and were tied tightly together with birch bark bindings. The joins were positioned one above the other on the south side of the barrel.

Inside the barrel, softwood fillets, triangular in section, had been nailed near the bottom, presumably to give added strength. Scores and indentations compatible with wear caused by

a lid being pushed into the vessel were visible on the inside of the barrel near the top of the surviving section, and part of an oak lid large enough to seal the opening was found in the fill. Twenty-six stave offcuts, almost certainly cut from the upper-part of the barrel, were also discovered in the fill. As the upper part of the barrel was tapered, the lid could not have been used at the level of the wear marks until the tops of the staves had been cut off, possibly when the function of the barrel may have been changed.

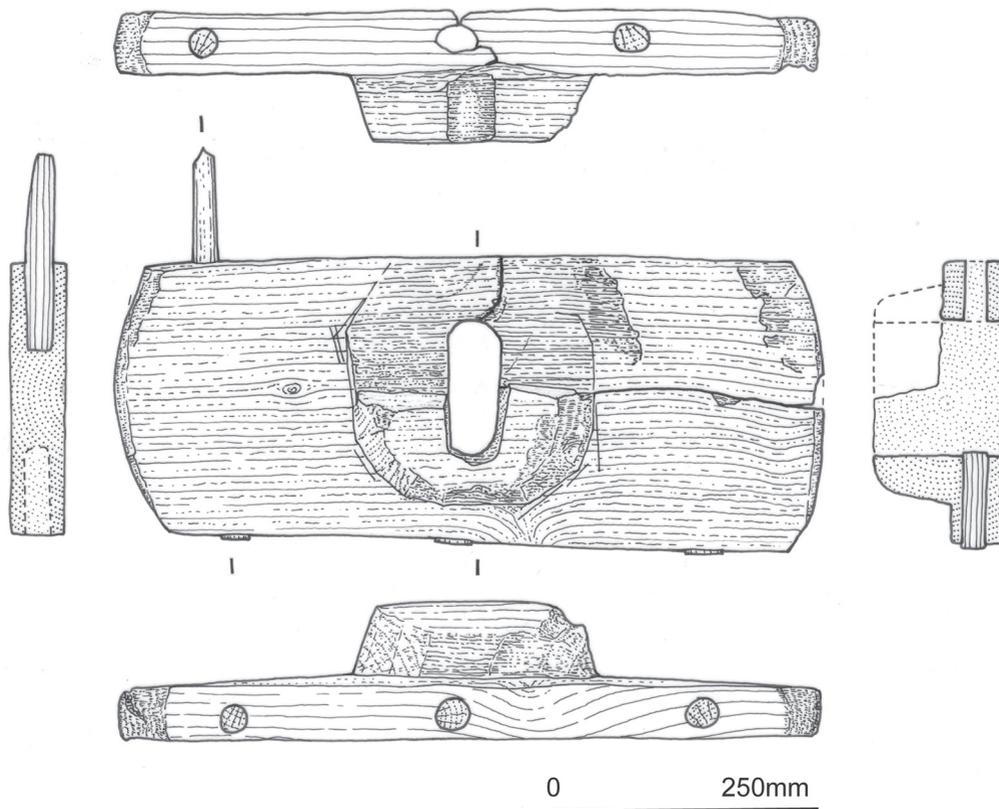
ILLUS 9 Wooden wheel from Well 2

Wooden wheel (illus 9) from the fill of Well 2. The central plank from a solid tripartite wheel of composite construction. Parts of the dowels which had attached the missing outer planks to the central plank survive. There is a raised central axle boss (diam 220mm) with an ovoid central hole 55mm × 130mm. Wheel: *Alnus* spp. Pegs: *Quercus* spp. Wheel: 655mm diam; 120mm thick.
