A 1st millennium BC Atlantic roundhouse in Argyll: survey and excavation at Loch Glashan

Jon Henderson* and Simon Gilmour†

A detailed survey of the Atlantic roundhouse at Loch Glashan (NMRS: NR99SW 8; NR 9227 9301) was carried out over two weeks in June 2003 alongside a small-scale excavation to assess the extent of damage caused by encroaching vegetation and to obtain dating evidence. The structure is a large dry-stone circular building located above Loch Glashan, and the excavations produced architectural evidence suggesting more than one phase of occupation, alongside Iron Age artefacts and radiocarbon dates. These reinforce the argument that circular Iron Age structures in Argyll belong within the wider Atlantic milieu of brochs or Atlantic roundhouses dating to the second half of the 1st millennium cal bc.

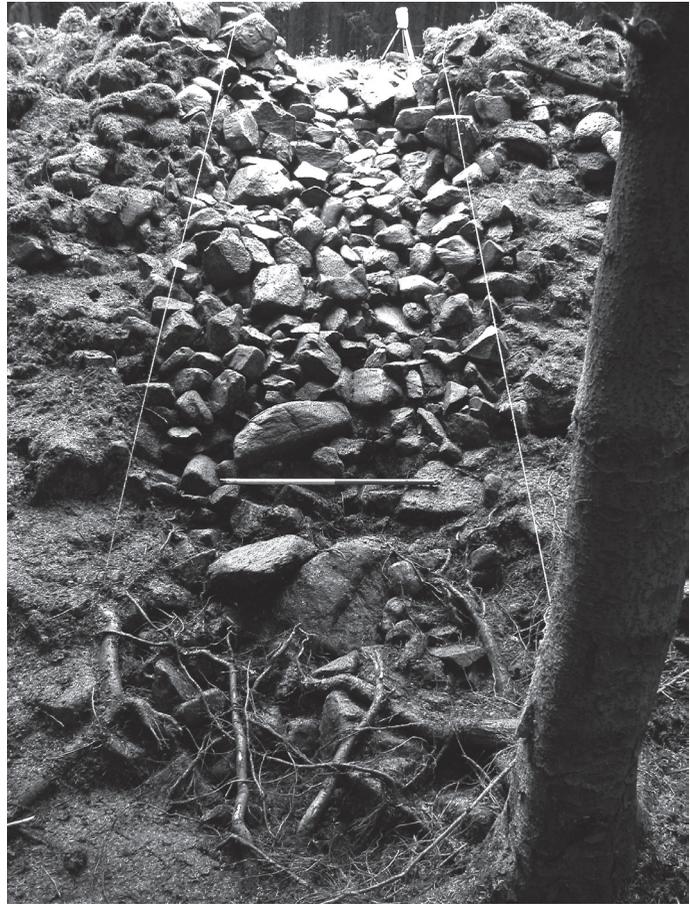
ILLUS 7 De-turfing of the exterior (southern) side of the trench revealed a densely packed layer (C008) of boulders. No outer front face could be detected at this time. Note the penetration of tree roots into the external stonework. Scale 1m

(C008) of boulders (illus 7). None of these stones were dressed and they were similar to the stones used in the main wall core – albeit some were smaller – based on an examination of that core material. It seems likely that the smaller stones had been placed here, amongst already existing collapse from the wall, as the result of later agricultural clearance in the surrounding area. No front face to the wall could be detected until these stones were removed (illus 8). The face survived only two to three courses high and was located some 2.7m from the southern edge of the trench. The full width of the wall in the excavated trench was thus 5.14m (the ‘median’ wall face occurring 3.7m in from the outer face). No other significant features were recorded in the exterior part of the trench.

When the area around the site was forested in the 1960s, trees had been planted very close to the walls and, as a result, tree roots were observed during the excavation undermining the walling at the site (illus 7). A tree root discovered crossing the trench in the interior of the site had penetrated from the exterior

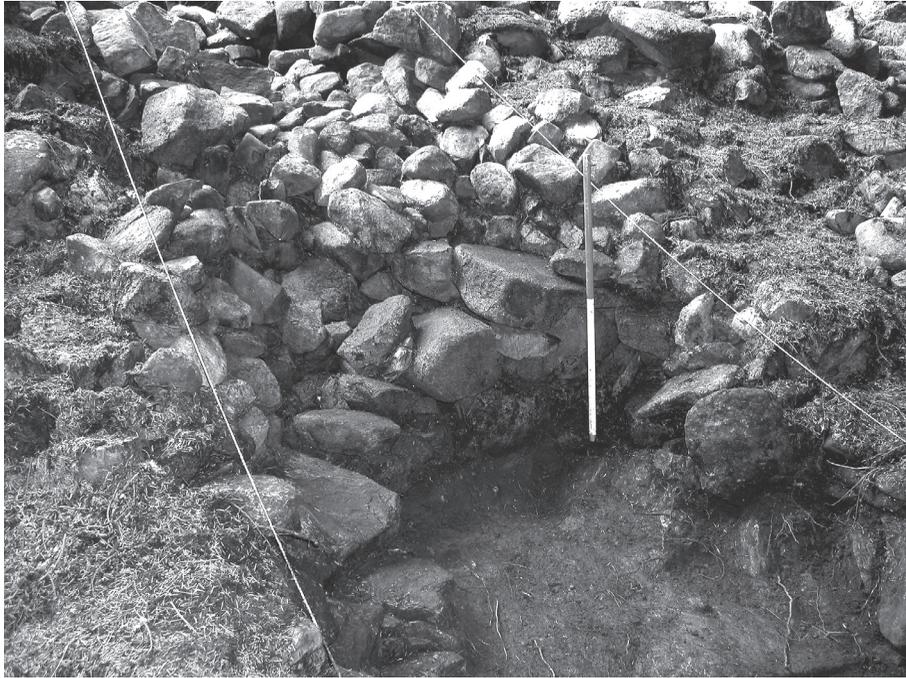
ILLUS 8 Removal of C008 revealed the outer front face of the main structural wall (001). Scale 1m

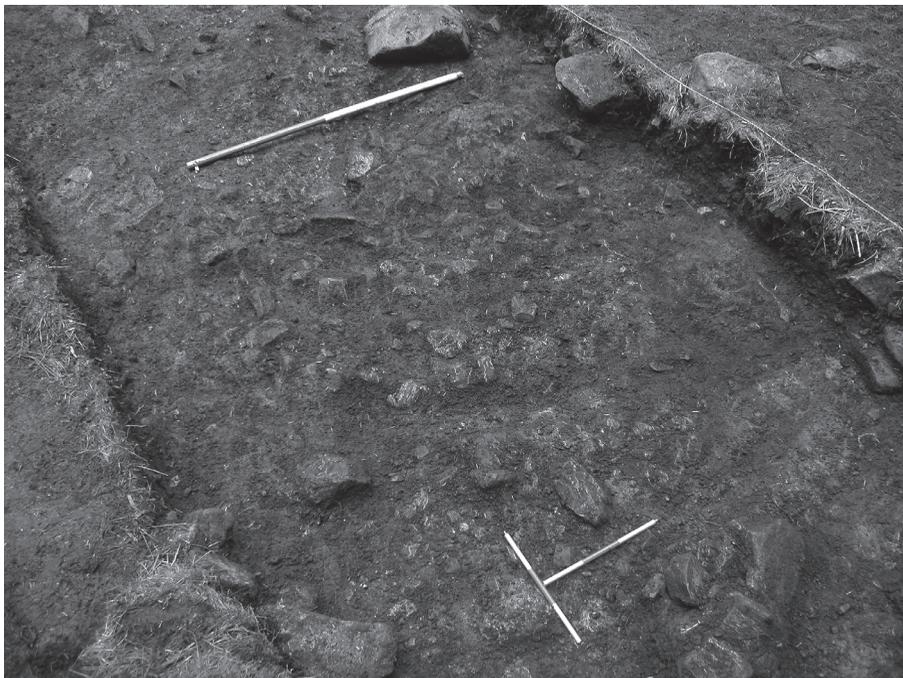
ILLUS 10 Context 022 with gully feature (C024) located in the centre of the picture. Looking north.
Scale 30cm

Under the paving stones were the remains of a small closely packed area of cobbling (C022) measuring some 1.86m north-west/south-east and covering the full width of the trench (2m). The cobbling (C022) certainly predated wall (C012) and paving (C010) and comprised a series of relatively discrete areas of small angular stones that were compressed into the subsoil. However, at least one gully filled with compact dark brown silt clay soil (C024) may have been cut through the

cobbling, although it is also possible that the cobbling was placed around this feature (illus 10).

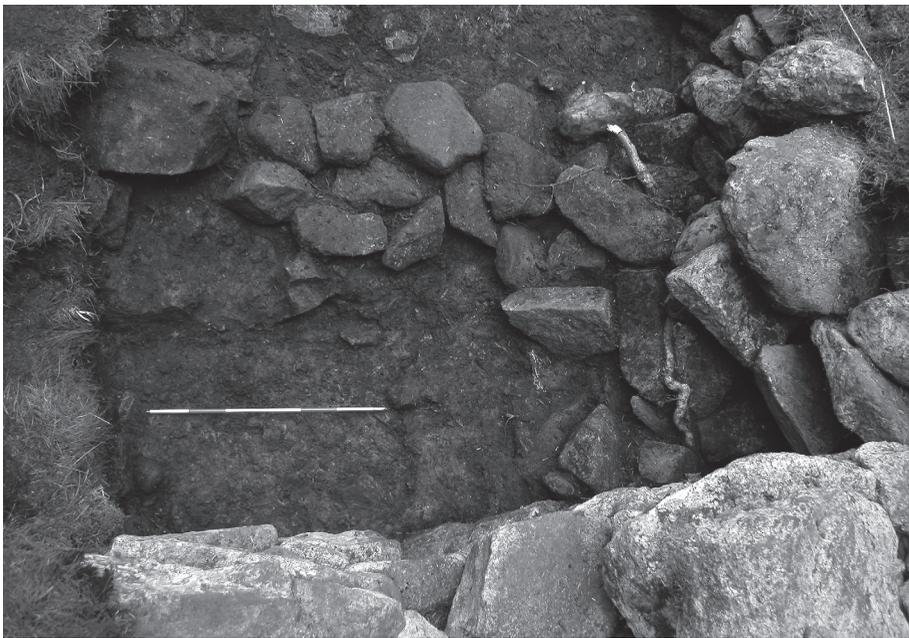
The most important deposits in terms of obtaining dating material were found between the rubble wall (C012) and the main structural wall (C001). Below and among the stonework of the wall (C012) was a grey mineral-rich deposit (C017) that could also be traced to the north-west of the wall under the paving (C010). Context 017 produced half a small yellow glass bead in post-excavation (SF 3). A rectilinear pit (C023) located between the secondary wall (C012) and the main wall (C001) was found to underlie context 017 (illus 11). Significantly, the lower fill of this

pit, a very dark brown compact soil (C021), appeared to both abut and underlie the main structural wall (C001), although removal of the wall would be required to confirm this. A partially overlying fill in pit 023 comprised a layer of packed small stones (C020) that rose to the west to abut the secondary wall 012. The uppermost layer of pit fill (C016) was also found to abut wall 012 and was certainly secondary to it. Above this deposit was a very mixed context (C013) that lay under the turf in this part of the trench. That the upper fill of pit 023 abutted the secondary wall 012 suggests it was either deposited after the construction of wall 012 or that the secondary wall cut the deposits associated with the upper fill of the pit. It was not possible in the small area excavated to be absolutely certain whether the packed stones of fill 020 also underlay wall 001. Neither could any cut be discerned

ILLUS 11 Rectilinear pit (C023) located between the secondary wall (012) and the main roundhouse wall (001). Top of frame north. Scale 30cm

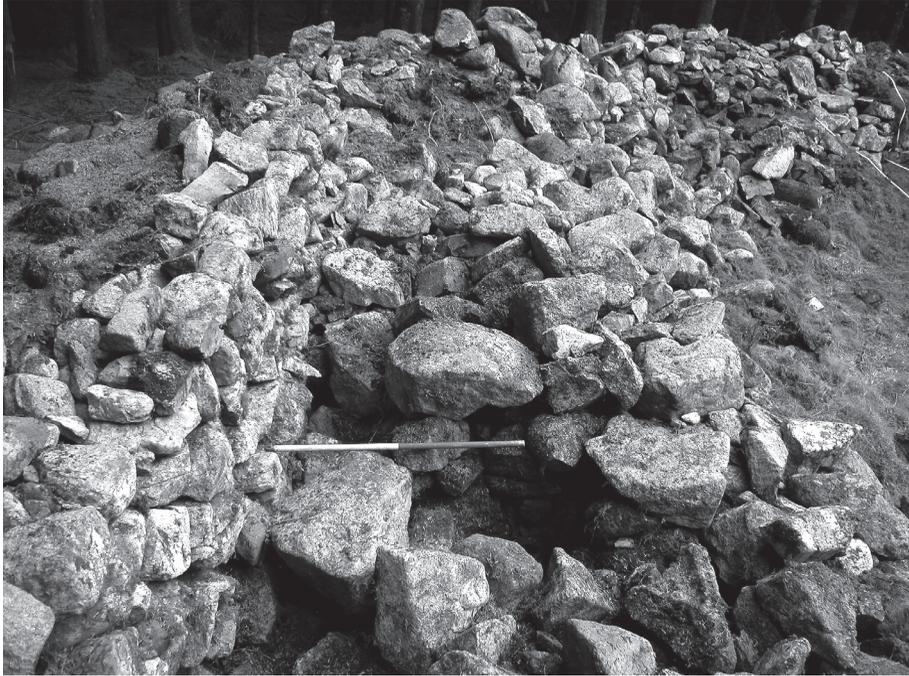
ILLUS 14 Median wall to the north of the trench (looking south) after clearance of vegetation.
Scale 1m

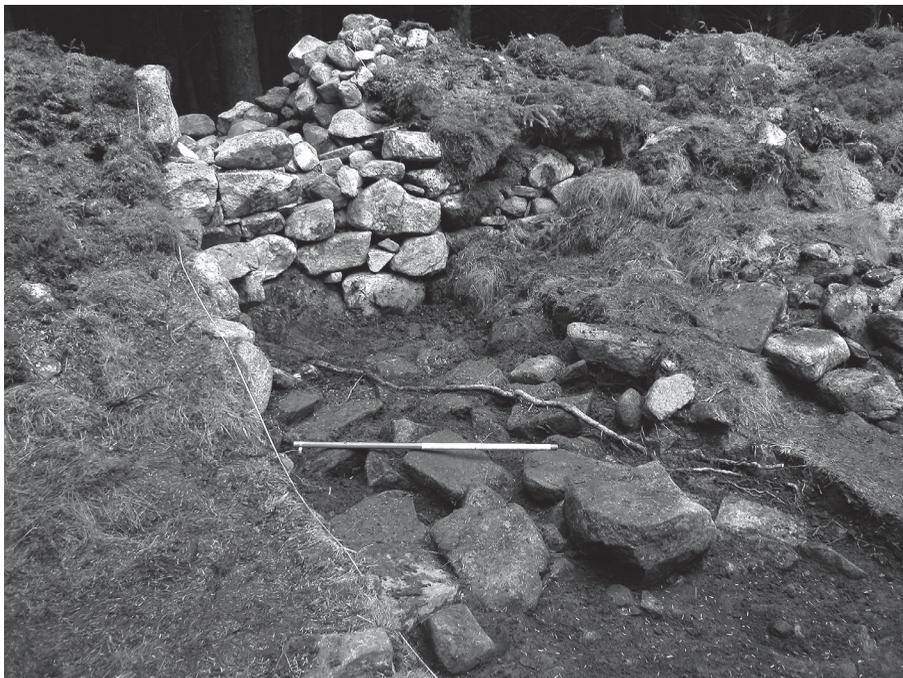
ILLUS 15 Interior trench showing root penetration into the internal deposits. Looking south-west.
Scale 1m

all the way through the 5m-thick wall (illus 15). Left unchecked, tree root encroachment of this nature has the potential to severely damage archaeological deposits and could have had potentially disastrous effects on the stability of the walling. It is currently unknown whether the catastrophic collapse of the external walling in the investigated area was due to tree root encroachment, although the fact that the roots appeared to overlie at least some of the resultant rubble suggests not. In addition, the close proximity of the surrounding trees also resulted in natural re-seeding occurring on the site with new tree growth occurring within the interior, on the walls and along the exterior circuit of the site (illus 16). This further threatened the integrity of the interior archaeological deposits and the stone walls (illus 15).

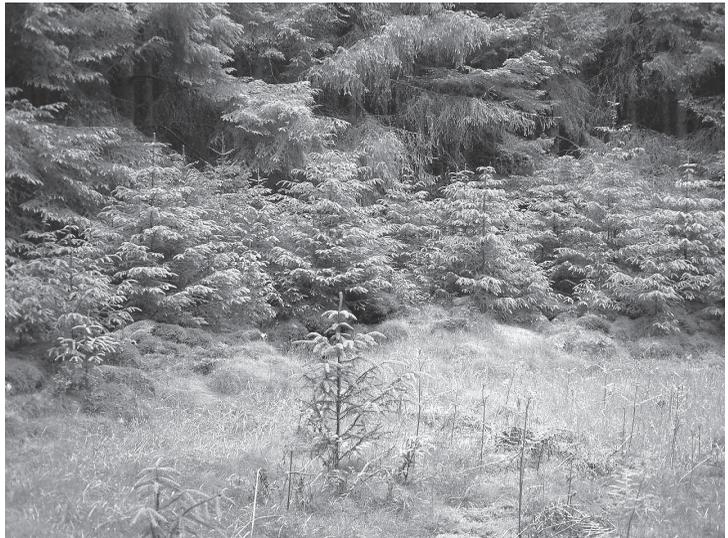
ILLUS 16 Natural re-seeding on the site with new tree growth along the main walls and saplings in the interior

supervised clearance of internal tree growth and the cutting of overhanging branches with high pruning machines. Trees were sawn off to ground level with roots left intact to minimise disturbance to deposits and the locations of all encroaching trees on the site were recorded prior to their removal (illus 17). This relatively small-scale work had an immediate and dramatic effect on the visual impact of the site, and allowed the detailed examination and survey of previously obscured architectural features. In addition, moss was removed from some parts of the main wall. It was felt that the occurrence of
