# The survey and analysis of brochs

Graeme Cavers,<sup>\*</sup> John Barber<sup>†</sup> and Matthew Ritchie<sup>‡</sup>

*Developments in surveying technology over the past decade have facilitated new approaches to the survey and presentation of complex upstanding archaeological sites. Recent surveys carried out on behalf of Forestry Commission Scotland, allied to ongoing research into the architecture and engineering of brochs – or complex Atlantic roundhouses – across Scotland, have prompted a reassessment of approaches to the recording and interpretation of brochs as structures and a reconsideration of the information required to record their character. This paper highlights the importance of archaeological measured survey and explores the influence of zeitgeistic preconceptions, not only on the survey itself but on its interpretation. Pre-survey analysis, selection of evidence to be surveyed and post-survey analyses are intimately interlinked. While modern survey techniques address some of these issues, improvements in recording must be matched by improved interpretational models to maximise their benefits to broch studies.*

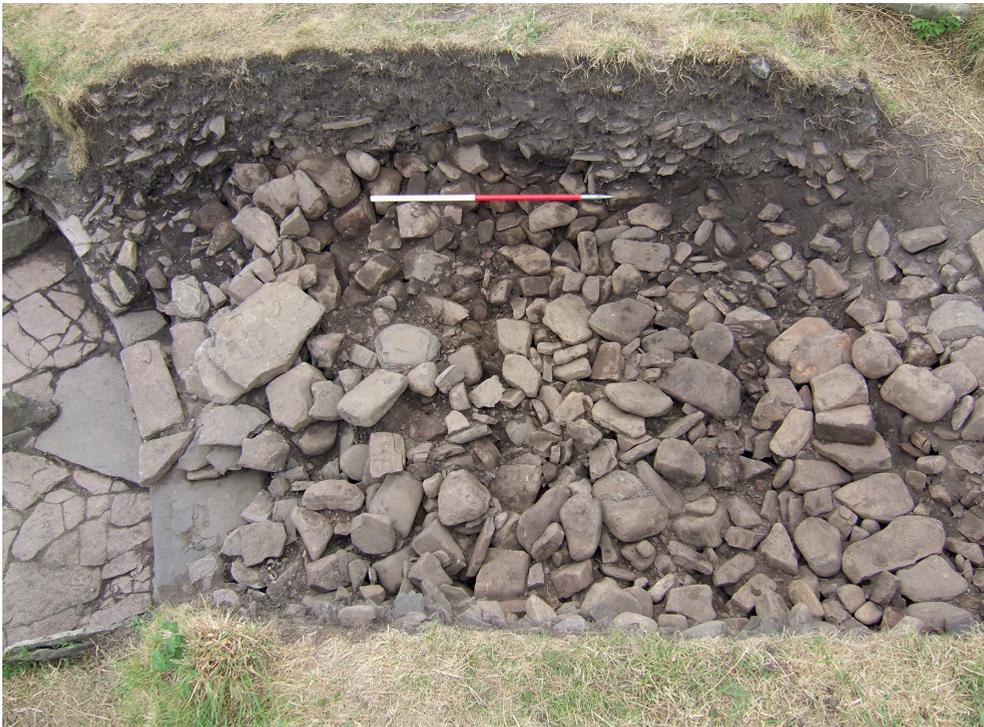
ILLUS 1 The wall of Whitegate broch, Caithness, comprised rounded beach cobbles retained by facing blocks and could not have been intended to carry the weight of a tower-like superstructure

a high wall, or, more correctly, the absence of horizontal placement of the building elements between retaining walls is a counterindication for tower construction. Thus, Whitegate broch in Caithness, for example (illus 1), was not intended to be and could never have been a tower.

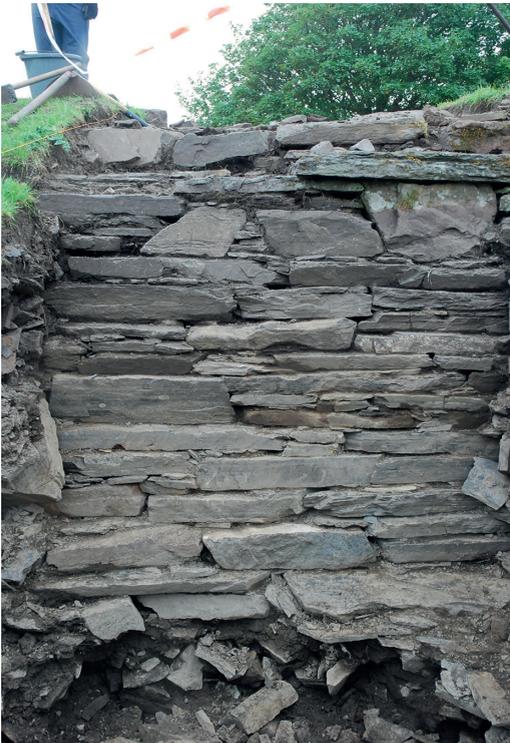
ILLUS 2 The infilled gully beneath Thrumster broch: a rare example of prepared foundations for a broch wall

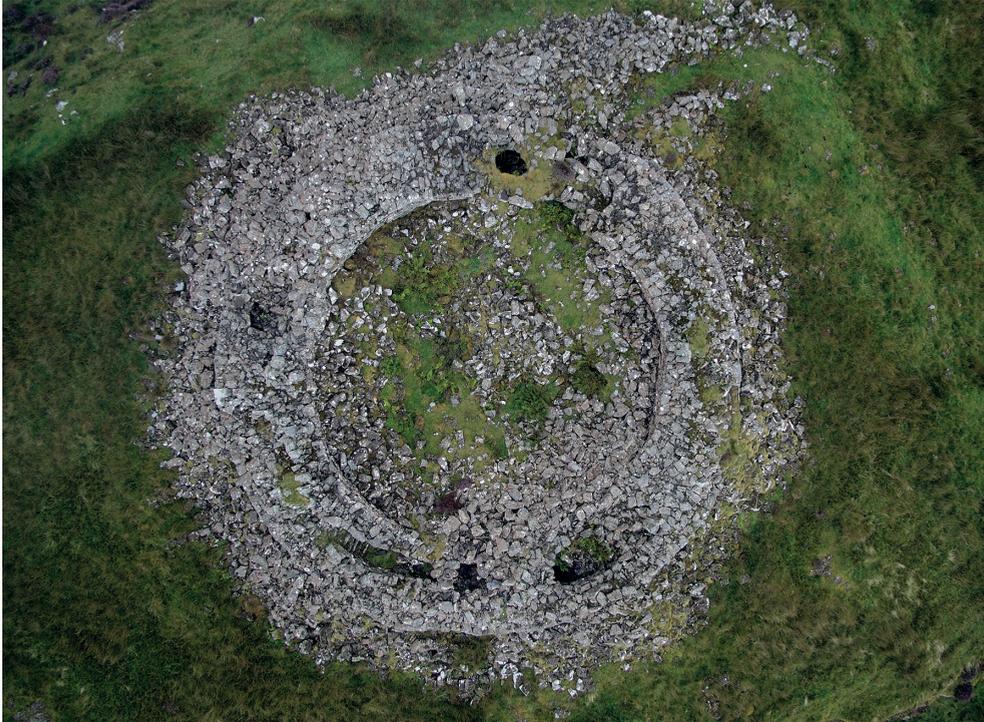
ILLUS 4 Low altitude vertical and oblique aerial photography uses a remote controlled microcopter equipped with a digital camera. This rectified vertical image captures the structural plan of Dun Suladale on Skye (NG 374 525)

photography, flown using a remote controlled microcopter equipped with a digital camera. The technique has proved remarkably adept at capturing images for illustration, site condition monitoring and for conservation management purposes, particularly in regard to upstanding masonry structures and large scale earthworks. The technique can be used to provide both detailed images and landscape setting (captured with 360° flexibility); and rectified vertical images can be used to support archaeological measured survey (illus 4).

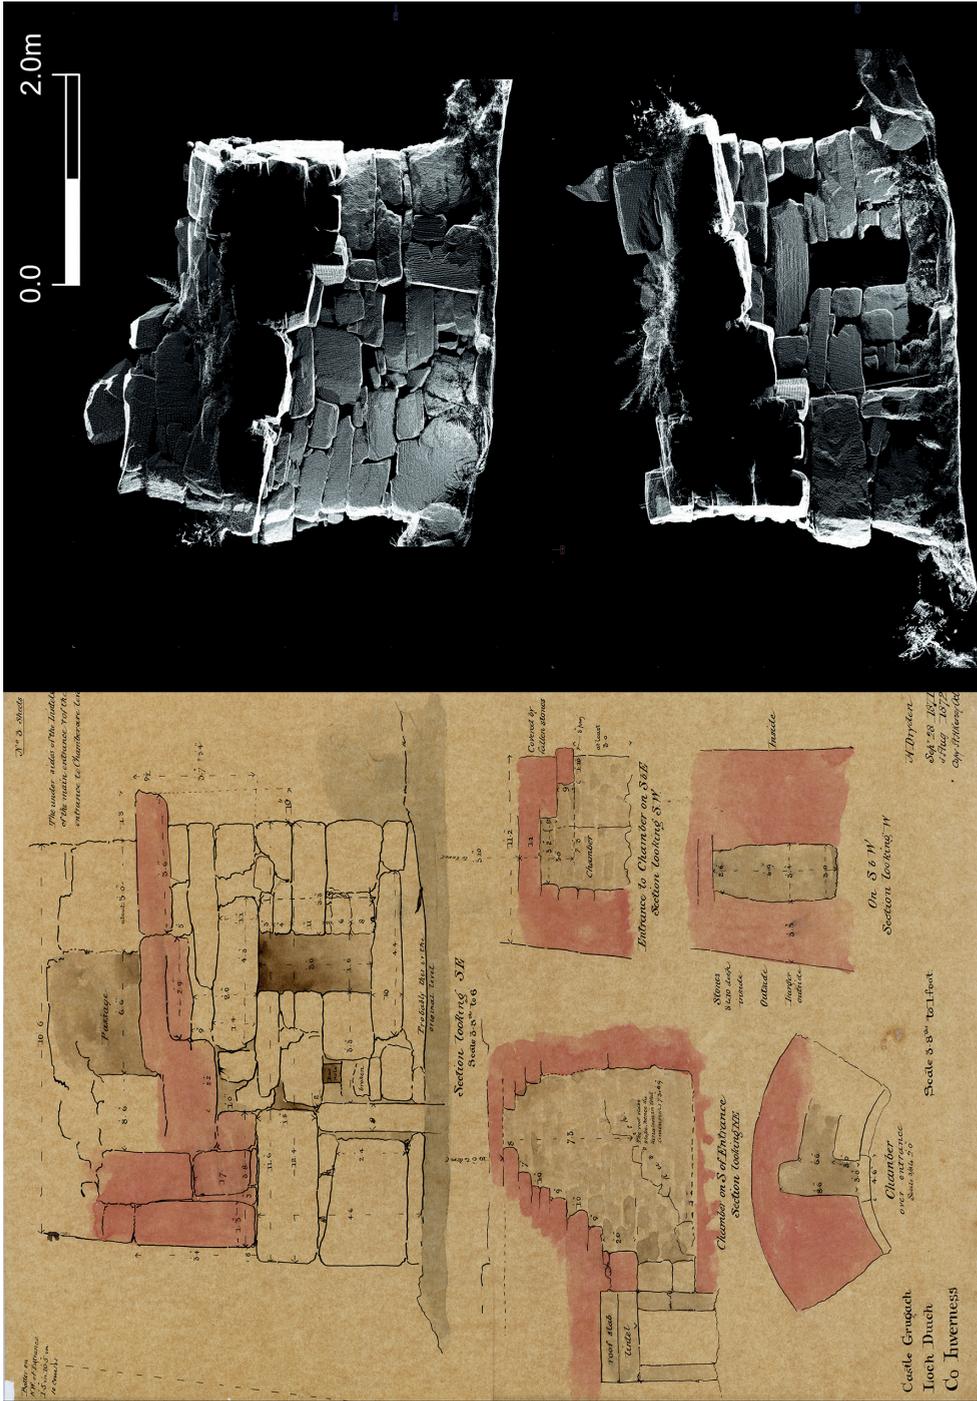
ILLUS 5 The broch of Caistalet Grugaig was the subject of several very attractive unpublished measured drawings made in 1871 and 1872 by Henry Dryden. He recorded the broch on plan and produced a series of annotated elevations and sections. This elevation of the south-east side of the entrance passage depicts the door check, barhole and guard chamber (presented alongside the corresponding point cloud elevations derived from the laser scan). (© Courtesy of RCAHMS (Society of Antiquaries of Scotland Collection). Licensor www.rcahms.gov.uk)

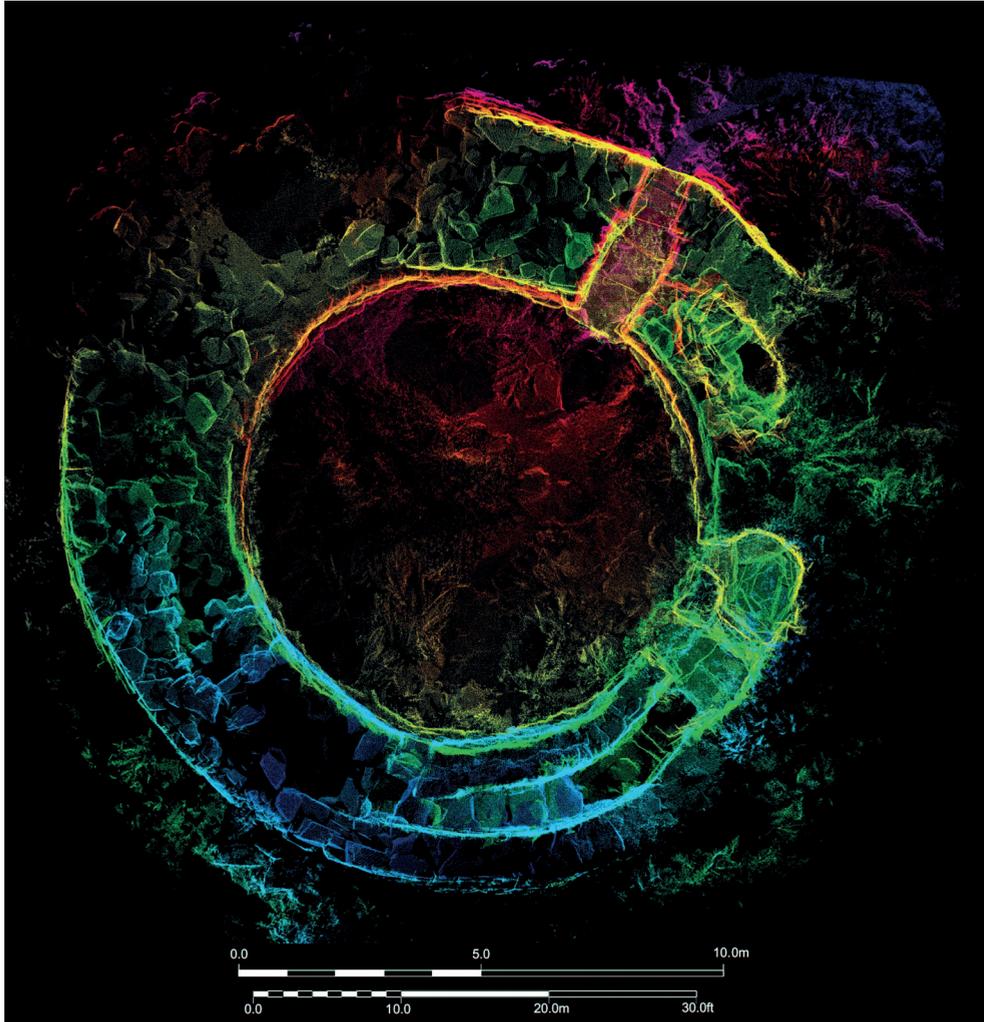
ILLUS 6 The orthographic plan of Caisteal Grugaig, derived from a laser scan, allows the depiction of the variable levels throughout the structure, and the position and heights of the intramural cells (purple/reds indicate low areas, light blue indicates high areas)

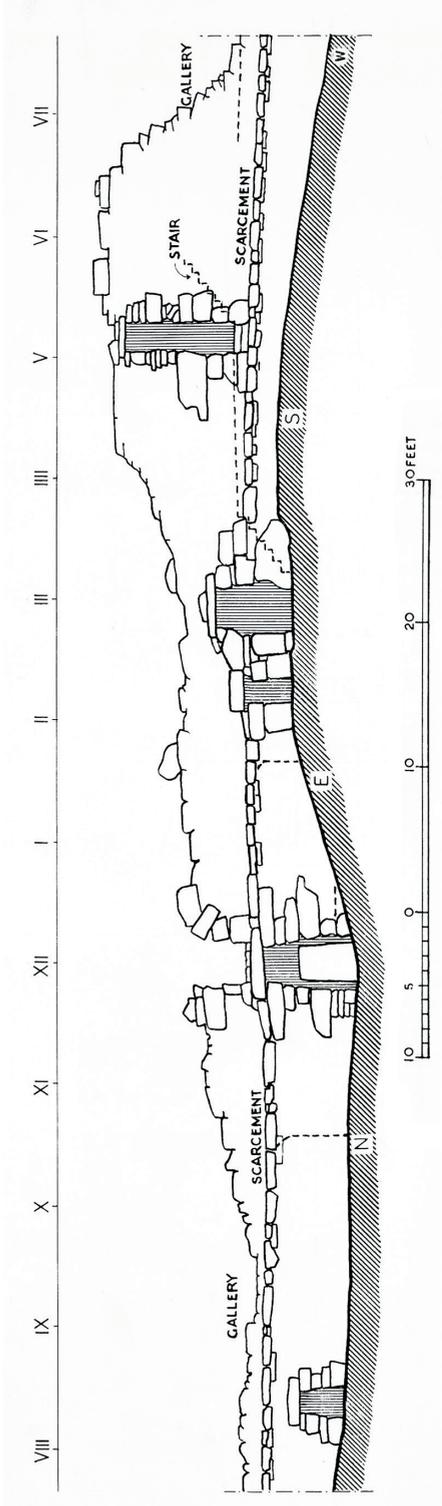
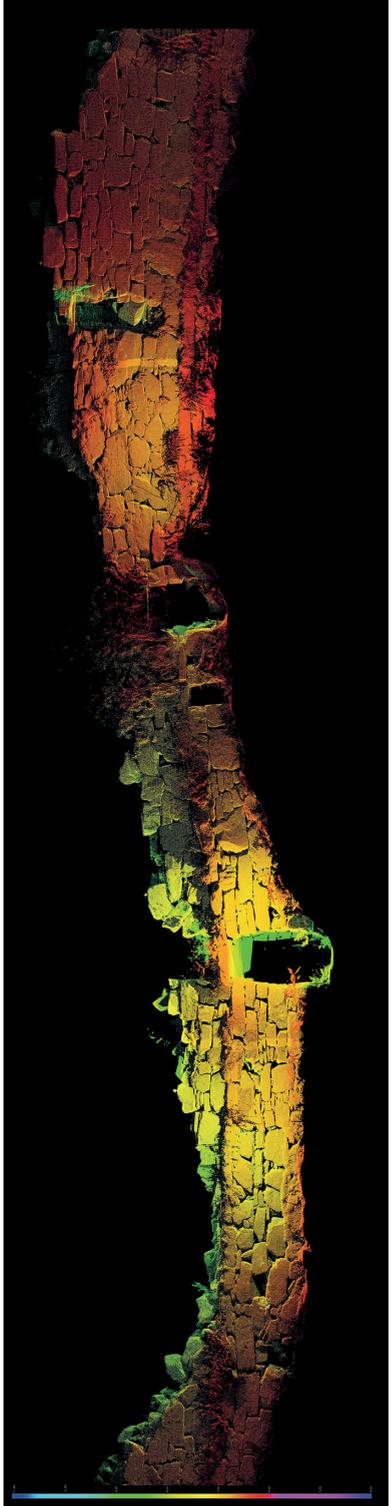
ILLUS 8 Caisteal Grugaig. Above: The innovative 'elevation of the interior developed on the flat' produced by Graham (1949) remains a very useful illustrative style, highlighting architectural features such as the scarcement. Below: the equivalent image produced by 'unrolling' the 3D point cloud and projecting onto a flat plane (© Crown Copyright: RCAHMS. Licensor: www.rcahms.gov.uk)

Caisteal Grugaig during the summer of 1949, the written description augmented by a measured survey and photographic record (Graham 1949: 12–24). The innovative ‘elevation of the interior developed on the flat’ used by Graham, a keen proponent of raising standards in archaeological recording and publication, at Caisteal Grugaig (1949: 15) and at Dun Telve (1947: 83) remains a very useful illustrative style, highlighting the entrance passage and scarcement (Dunbar 1992: 37).

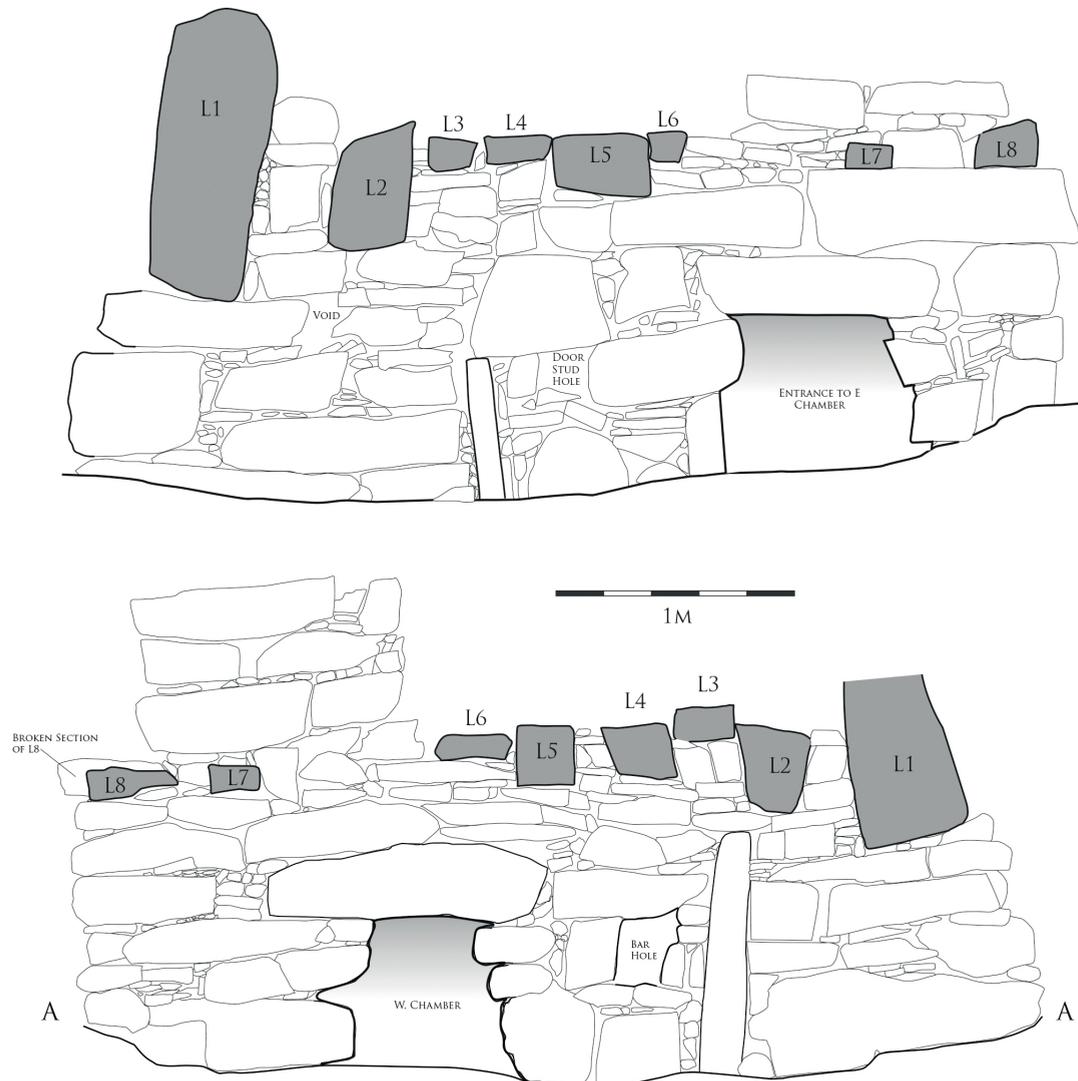
ILLUS 10 Elevations of the entrance to Clachtoll broch

There were probably 11 lintels over the entrance passage of which eight survive. The two outer lintels taken together form a compound beam structure designed to cope with loadings

associated with the mass of the thick outer wall. The outermost, a triangular lintel (L1), forces the wall mass to corbel either side of it. Between this and L2, the next lintel, a gap some 300mm wide occurs into which a corbelled arc has been built across the passage. L2, a massive stone, is set with its longest cross-sectional dimension in the vertical plane; it is edge-set. Lintels L3, L4 and L5 are also relatively massive. Re-excavation to the tops of the lintels for conservation purposes (Barber 2011) revealed an arrangement interpreted as provision for an upper set of lintels. Whatever the details of the original arrangement, it was clearly intended that the outer five lintels should carry the mass of the outer wall. The inner lintels were flattened slabs of limited carrying capacity (illus 10).

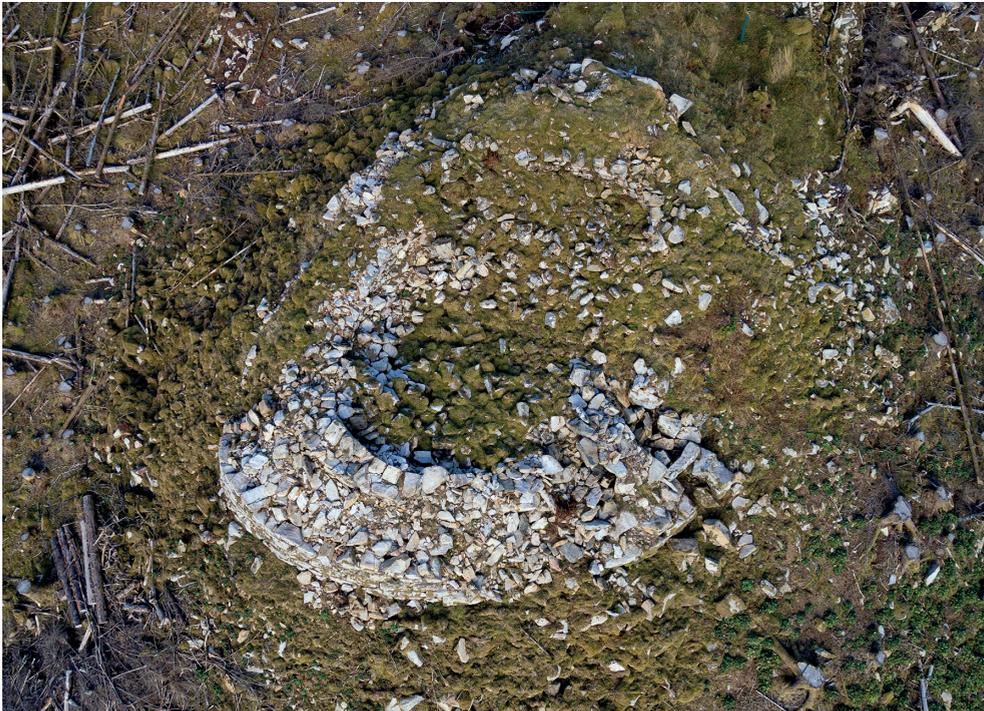
ILLUS 12 Dun Boredale, unrectified vertical low altitude aerial photograph

circular, rather forming an irregular oval plan, so that the site has tended to be considered a 'dun' rather than a true 'broch' (illus 11 and 12). Dun Boredale is not, therefore, a broch tower as defined by MacKie (above).
