Dunstaffnage Castle, Argyll & Bute: excavations in the north tower and east range, 1987–94

ABSTRACT

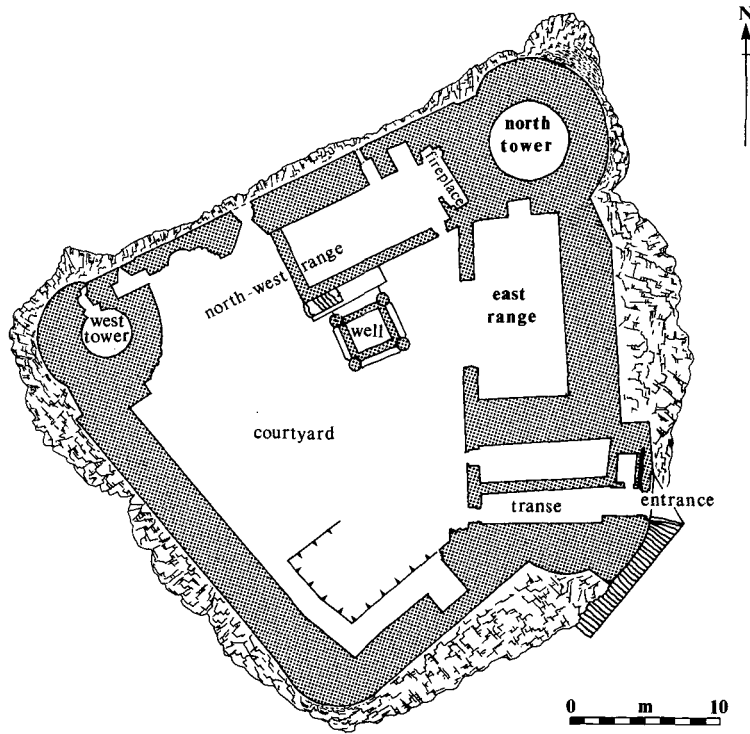
ILLUS 4 Plan of Dunstaffnage Castle

This castle of enclosure comprises an irregular quadrangle (illus 4), measuring approximately 35 m by 30 m, with towers at its west, north and south-east angles linked by a massive curtain wall which still stands to parapet level along most of its length. The entrance into the castle is through the south-east tower which appears originally to have had a curved outer face projecting slightly from the curtain wall in a manner similar to the north and west towers. At a later date (probably in the late 15th century) the gatehouse was pushed farther outwards to form the arrangement that survives to this day. It is purported that the entrance was reached by a drawbridge (whose mechanism is not understood fully), spanning the gap between the entrance doorway and a forestar, which was rebuilt between 1850 and 1863 (Simpson 1958, 23). There have been several modifications to the gatehouse, including the addition of more floors during the 16th century and the division of the transe into a narrow passage and a cellar during the 17th century (RCAHMS 1975, 202). Both Simpson (1958, 78) and Cruden (1960, 41) describe the west tower as the donjon, although this was

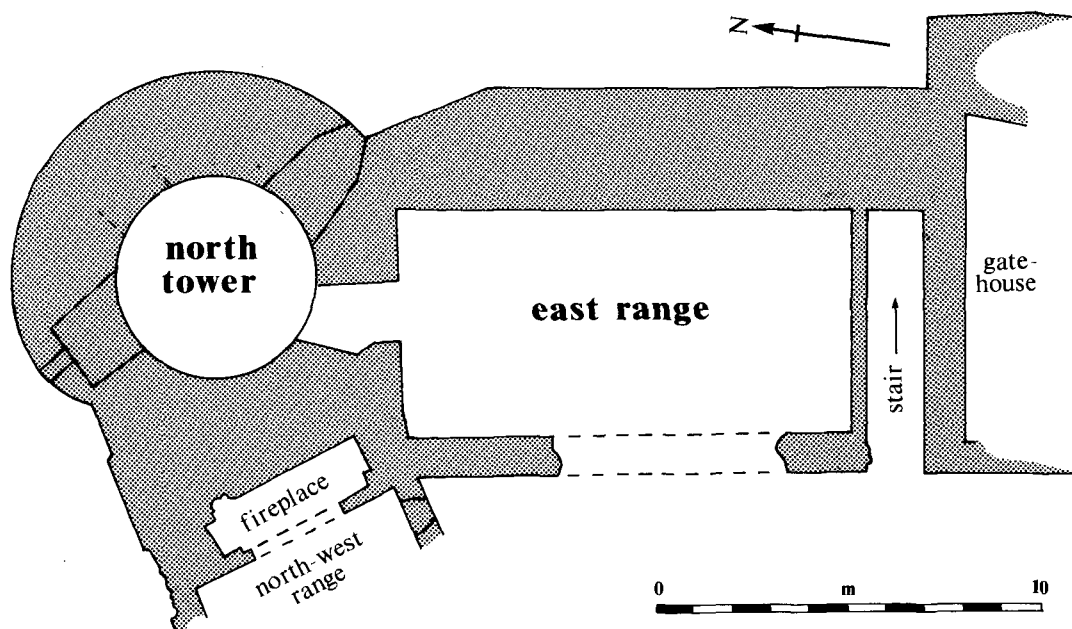
ILLUS 5 Schematic plan of the north tower and the east range

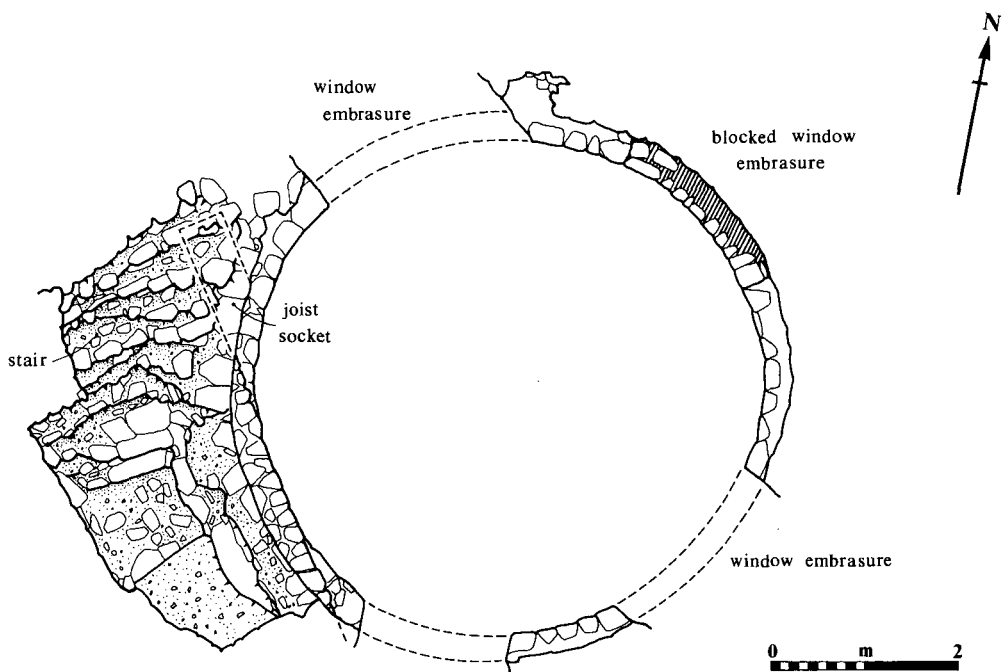
ILLUS 7 The Period 3 features surviving at first-floor level in the north tower

The first floor of the tower appears to have been supported on massive timber beams set into its east and west walls: the only surviving evidence of the floor was a beam slot, 0.50 m wide and 0.25 m high, along the west side of the tower and extending 1.1 m into its north wall. At some stage the tower appears to have been demolished to the level of the first floor or lower; on the east side of the tower the stonework was dismantled beyond the levels of the (probably timber) lintels of the north-east and south-east window embrasures whereas the masonry survived a little higher on the

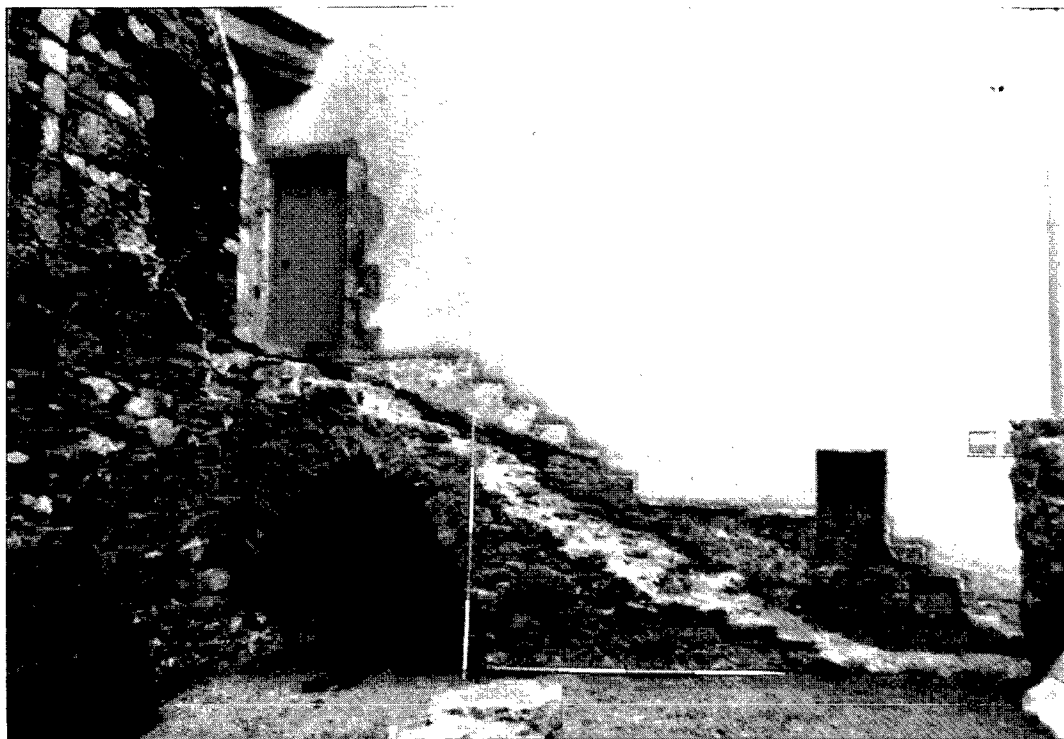
ILLUS 11 The foundations of the stair built over a small, arched recess at the south end of the east range. Viewed from the north-west

It is thought likely that the original access to the first floor of the range, the probable site of a hall, was by an external stair, possibly of timber. At some stage this putative structure was replaced by a stone stair, located at the south end of the range and accessed from the courtyard through a doorway in the west wall. A check on the wall face indicated that the door had opened into the courtyard. On the left side of the stair, which was 1.35 m wide, were the sparse remnants of a narrow retaining wall. It is not known whether this wall had extended up to the ceiling of the ground-floor chamber. The stair also led to the first floor of the adjacent gatehouse, although the doorway leading into that building is probably not the original one. Although the stair was built against the north wall of the gatehouse, its masonry was continuous with the inside face of the east curtain wall which, it can probably be assumed, was at least partially refaced at some point. Only the stair's bottom tread, a sandstone slab 30–45 mm thick, remained: the rest of its treads and risers had been removed, as had the flags from between the stair and the doorway in the south wall. These flags had been bedded onto a layer of substantial, drystone rubble which extended below the foundations of the stair. It also appeared to continue beneath the west wall of the east range and the north wall of the gatehouse: however, the investigation of this part of the range was unfinished and it remains incompletely understood. Although the steps had been removed, their impressions could still be discerned in the heavily mortared rubble upon which they had been set. Near the base of the stairs there is a blocked doorway in the north wall of the gatehouse. The bottom of this opening was at least 0.8 m below the base of the stair, indicating that the two features could not have functioned contemporaneously. If the floor of the east range had been reasonably level over its whole length, there must have been a few steps leading upwards into it from the gatehouse. About 1 m west of the doorway is a niche, 0.6 m wide and 1.0 m high, formed when a splayed opening (perhaps an arrow slit) in the south wall of the range was sealed on its north side. This slit would have looked into the gatehouse or perhaps into open ground prior to the construction of the gatehouse. Below the east end of the stair was a small alcove, 1.25 m wide and 1.7 m deep, its back wall being the north wall of the gatehouse. Its roof was a pointed arch, built mainly of schistose rubble, which reached a maximum height of 1.65 m. The alcove and the adjacent flight of stairs had been sealed by a masonry lining in relatively recent times, probably during the early years of the 20th century when the Duke of Argyll refurbished parts of the castle.

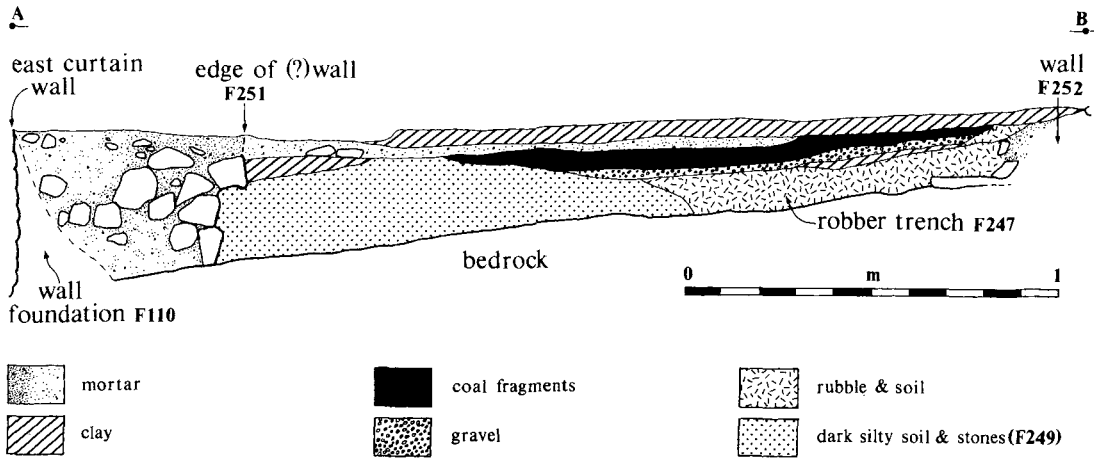
ILLUS 12 Section through the remnants of floors and associated levelling deposits in the north chamber of the east range

Only in the northernmost 3 m of the east range were floor surfaces and associated deposits investigated in any detail: only modern debris was cleared from the remainder of the building. Within the northern trench there were remnants of several clay floors and numerous other lenses of the same material, some probably originating from earlier floors, others perhaps used to repair worn surfaces. This was particularly evident near the fireplace where there were also several deposits of coal. The clay floors tended to overlie levelling deposits of small rubble and soil, sometimes intermixed with mortar, gravel, sand, ash and other burnt materials. In one of these deposits there were large quantities of charcoal, most of which appeared to be derived from squared timbers, including planks. It was not possible to say whether this material was the result of a conflagration within the range or whether it was simply demolished timber used as fuel. Perhaps the presence of a small amount of roundwood nearby indicates the latter. The overall depth of these materials was about 0.6 m. Some of the lenses of burning may have been occupation debris, although these materials could not be distinguished easily from some of the levelling deposits. There was no evidence of any floor surfaces, other than of clay, within the range.

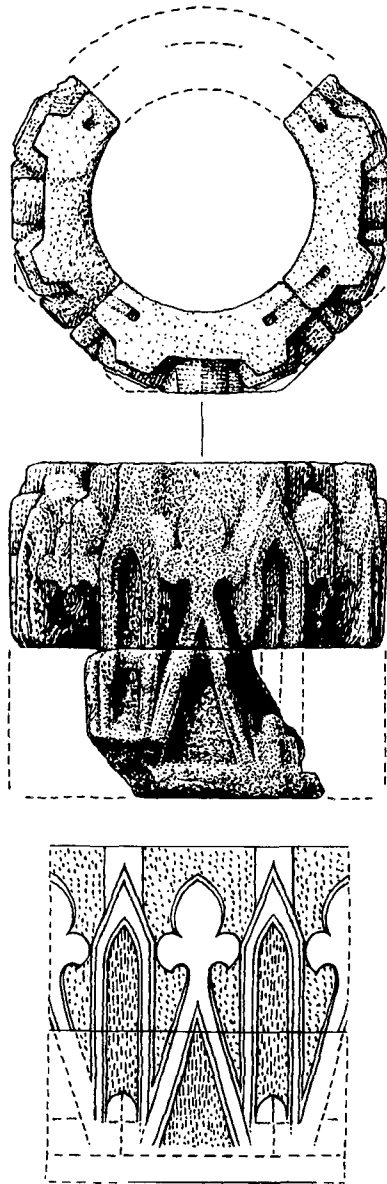
ILLUS 15 The carved stones retrieved from the north tower and Dunstaffnage Chapel (scale 1:15)

Four joining fragments, each a segment of a hollow octagonal shape, were recovered from Dunstaffnage: two were excavated from the north tower of the castle and two were found elsewhere, on the floor of Dunstaffnage Chapel. Together they form elements of two successive courses of what is interpreted as a font. Three of the fragments are approximately 0.37 m high, 0.16 m thick and form a single course. They each have angled cramp sockets and channels retaining lead and iron corrosion products in the upper beds to hold the pieces tightly together. The fourth fragment is about 0.30 m high and 0.10 m thick: it must have come from the course below the other three because the sculptured design continues without a break. The internal face of each fragment has been tooled to a smooth surface and together they describe a circular hollow 0.43 m in diameter. Externally, the fragments are decorated with shallow and blind, lancet-shaped niches within plain, acutely pointed gables, and with simple curved stops at the base of each niche. These are interspersed with simple fleur-de-lis finials to what also appear to have been pointed gables. The only moulded decoration is a plain chamfer to the inner and outer edges of the niches. The decoration is therefore a surface patterning based on architectural motifs.

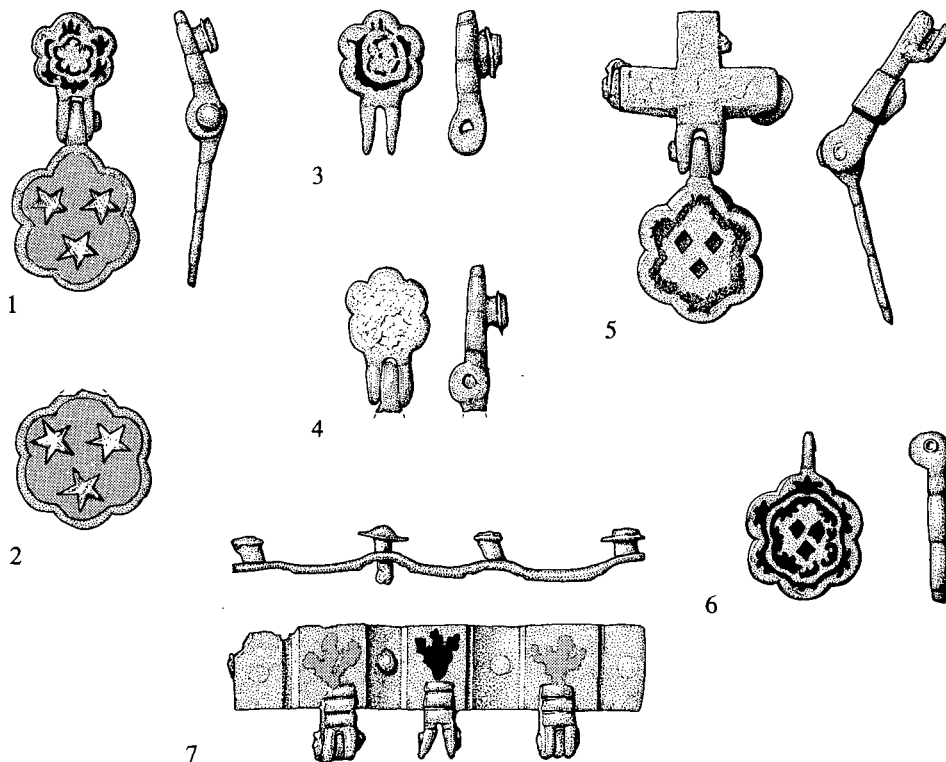
ILLUS 16 Copper alloy objects: decorative mounts (scale 2:3)

- 5 A decorative mount, in poor condition, consisting of an hexagonal plate hinged to the broken remains of a cruciform mount. The plate has a coat of arms argent, three cushions lozenge-ways, gules, with a tressure flory-counter, gules. The gules is represented by red enamel.
Passage between north tower and east range: basal midden deposit.

- 6 A decorative mount with red enamel, consisting of a detached hexagonal plate with the same arms as no 5. There are no traces of the silver (argent) presumed to be the colour of the field.
Found during clearance work at the castle.

- 7 A decorative mount consisting of a strip of metal with three raised panels, each with an enamelled design of a three-leaved plant, two of them in blue, flanking a central one in red. A hinge attachment is fixed to

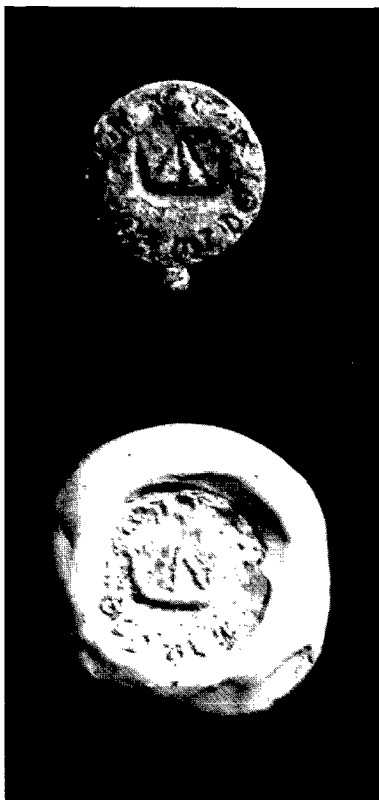
ILLUS 18 The lead seal and its impression (actual size)

- 20 Lead seal matrix found on the shore beneath the castle in November 1991 and claimed as treasure trove. It is now in the collections of the National Museums of Scotland.

It has a circular face, 24 mm in diameter, with a simple design of a galley of West Highland type with mast supported by fore and back-stays. The inscription in Lombardic capitals around its circumference can be read as . . .MARI DE IN. . . Its back is crudely incised with a five petalled flower from which the handle rises as a stalk, pierced at the top for suspension. It is now bent out of shape. The letters DE IN. . . signal the designation *De Insulis* (of the Isles) used by members of the chief families of the branches of Clan Donald. A galley, or more correctly a lymphad as it is known armorially, was the device on the coat-of-arms of the MacDonalds. The smallness and crudeness of this matrix may indicate it belonged to a lesser member of the family. It has been suggested that . . .MARI could be the genitive ending of the name Imarus, the latinized form of Gaelic *Imer*, modern Gaelic *Iomher* (in English, Ivor); or else *Molmarus* or *Gilmarus*, latinized forms of *Mael-Moire* and *Gille-Moire*, both meaning 'devotee of the Virgin Mary' (J Bannerman, pers comm). It is not possible to make a positive identification of the owner of the piece; and its exact date must also be in some doubt. The simplicity of its design could allow a date in the 13th century or, perhaps less likely, the 14th century. Certainly by the 14th century it would have been more usual for the galley to be shown upon a shield. A 13th- or 14th-century date is consistent with the style of the lettering.
