The excavation and restoration of the Camster Long chambered cairn, Caithness, Highland, 1967–80

Lionel Masters*

ABSTRACT

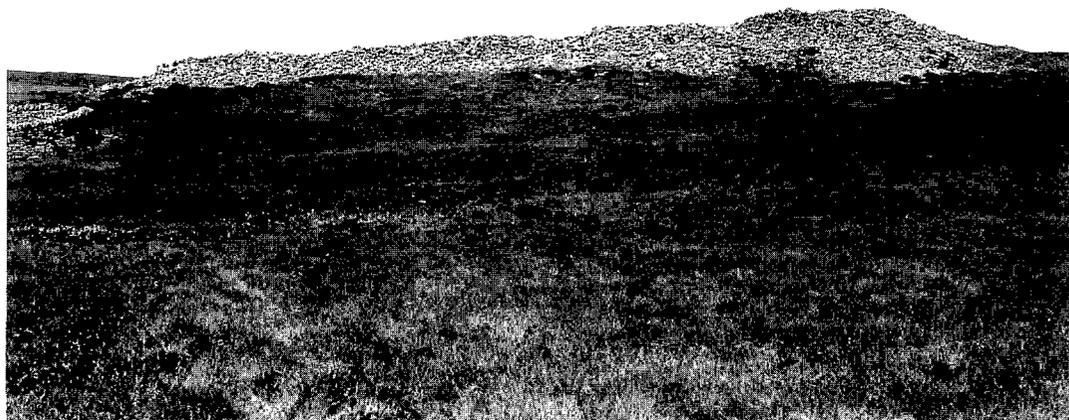
ILLUS 2 Cairn in 1966 before excavation, from south-east

The long cairn lies at the south end of a low north/south ridge at an elevation of OD 115 m (illus 2). With a major axis orientation of 25° east of True North, its alignment is close to NNE/SSW: for convenience of description, however, the axis will be taken as NE/SW. To the north of the site, the land rises slightly, but falls away moderately steeply to the south. The north-west side is almost level in the vicinity of the cairn, before falling away steeply to the valley of the Camster Burn. The site is at its most impressive when viewed from the south-east or east, having taken maximum advantage of the slightly higher altitude provided by the ridge. Camster Round lies some 200 m to the SSE of the long cairn and, in direct line, is separated from it by a shallow gully. The circular cairn, about 19 m in diameter, covers a long passage leading to a Camster-type tripartite chamber (Henshall 1963, 263–6; 1972, 548; Davidson & Henshall 1991, 102–4).

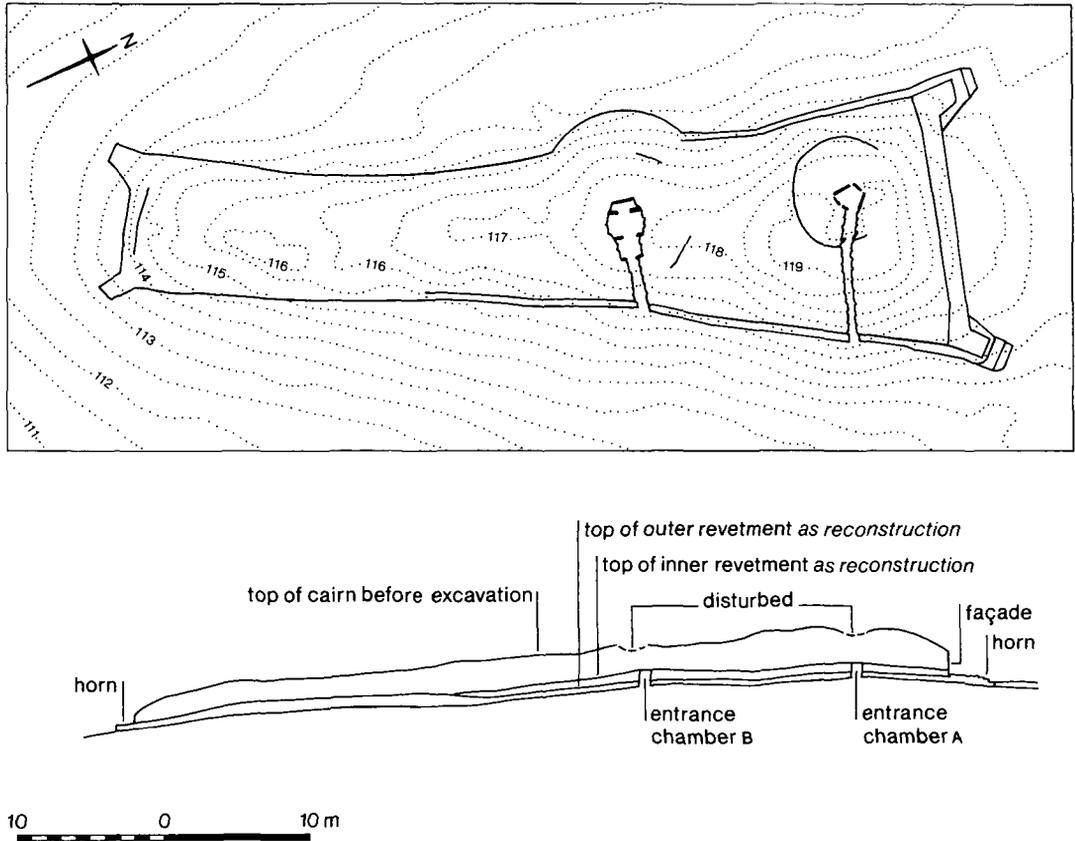
ILLUS 3 Contour plan and simplified longitudinal profile

(illus 3). Further trenching along the south-east side led to the discovery of the passage to chamber B, and both sets of passages and chambers were excavated. Anderson found the passage to chamber A to be almost intact, as was the chamber itself. Roofing survived over the passage and outer compartment of chamber B: the rest had collapsed. Apart from some human and animal bones, no other finds were made in the chambers.

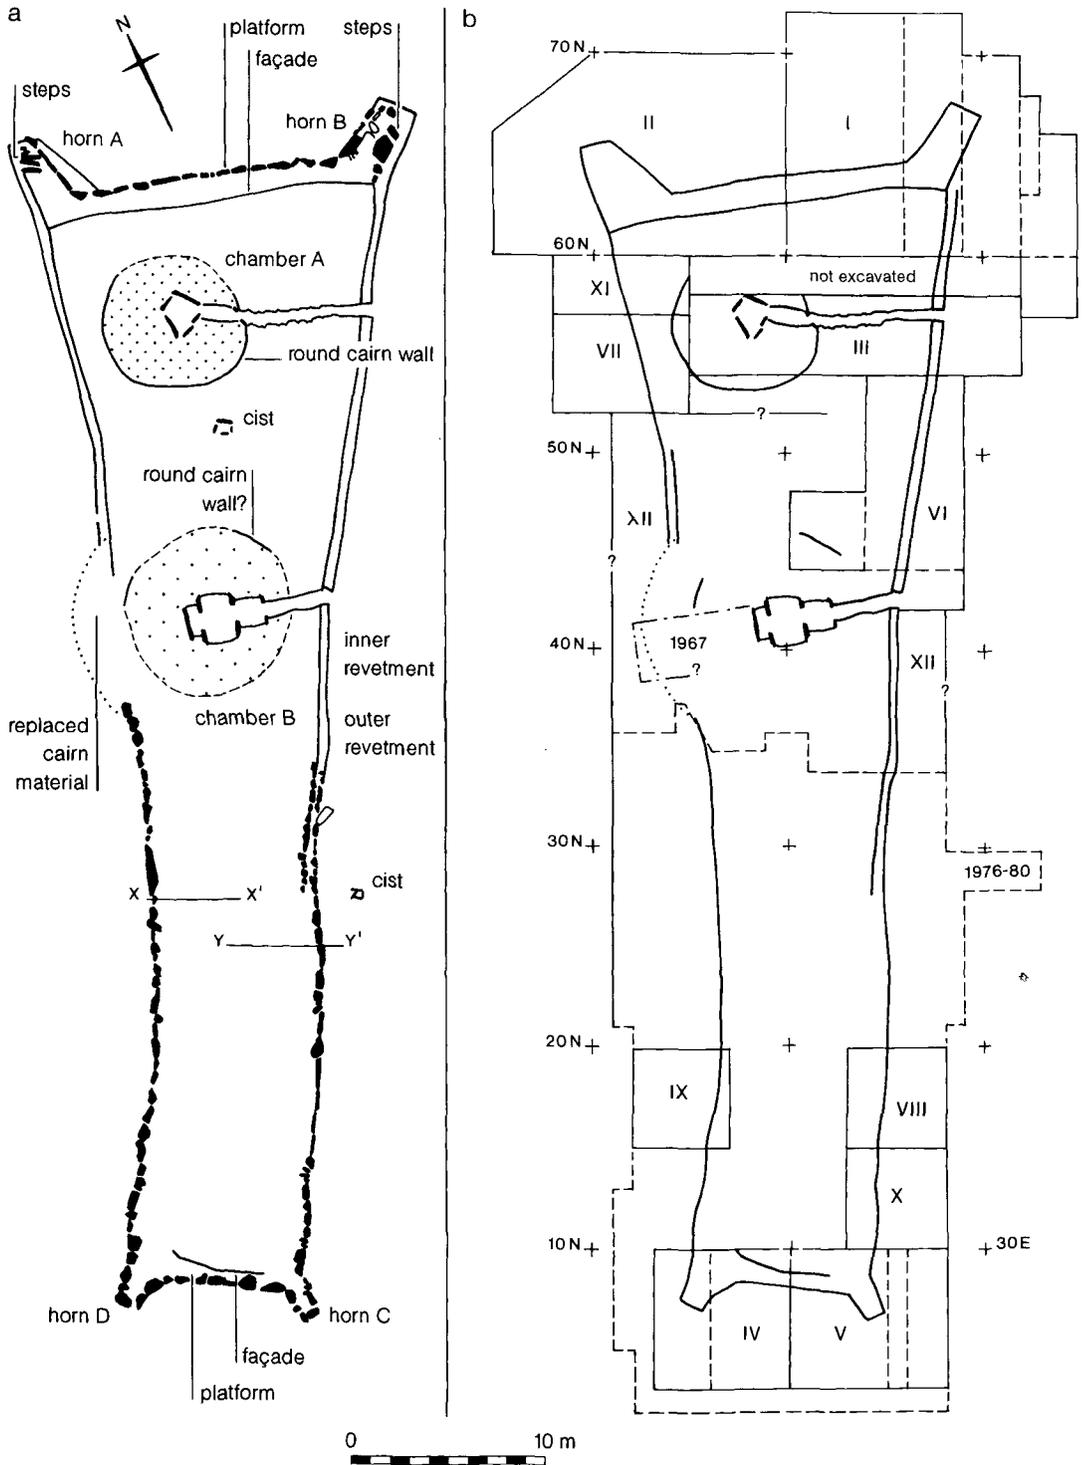
ILLUS 4 (a) Outline plan showing revetments as presently reconstructed.
 (b) Layout of trenches (1967 — P R Ritchie; Roman numerals — J X W P Corcoran; 1976-80 — L J Masters);
 cairn revetment as suggested by LJM

publication. Fortunately, the archive comprises a large collection of photographs and slides. Corcoran kept daybooks for his three seasons but these are sometimes deficient in crucial aspects of interpretation; that information was, no doubt, in Corcoran's mind. In 1971 detailed plans were made of the blocking in the north-east forecourt, and a start made on the plan and elevation of chamber A. Little detailed planning was undertaken in the later part of the excavation, resulting in complications in interpretation of the long cairn revetments on the north-west side, in the relationship of chamber A to its round cairn, and between the putative circular revetment around chamber B and its relationship to the long cairn revetment (illus 4).

The site grid, which is used to describe the location of some features, has its point of origin to the south-west of the cairn and is divided into 1 m squares to north and east. The grid was established by Corcoran, and it must be noted that in measurement he gave Northings before Eastings, the reverse of a normal grid reference; the procedure was followed in the writer's excavation for the sake of consistency. Reference is also made to the series of cuttings established during Corcoran's excavation (illus 4).

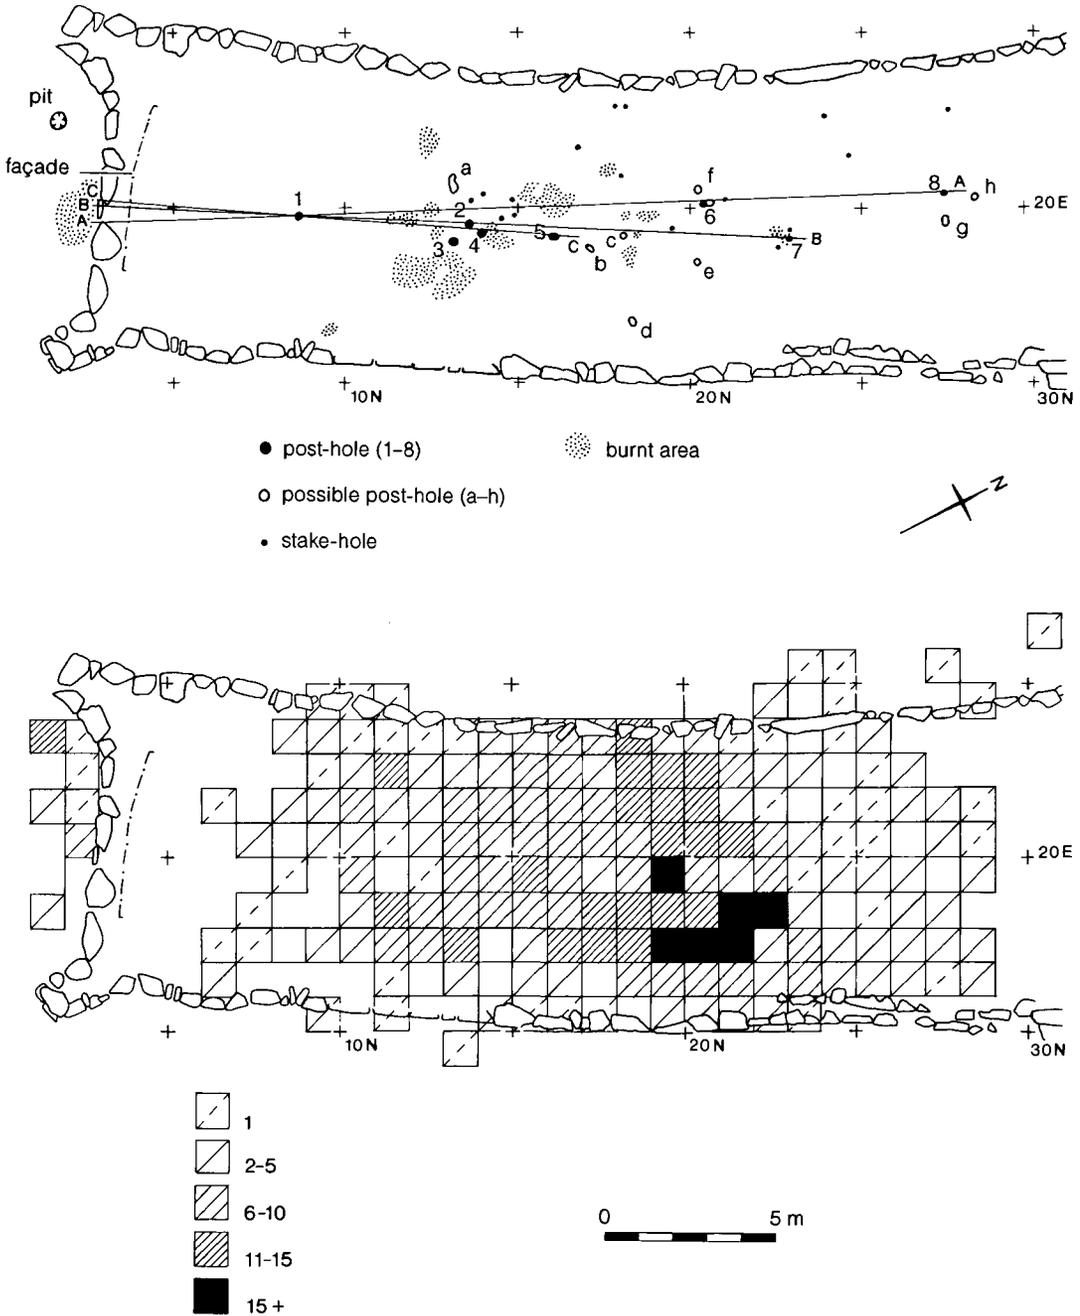
ILLUS 5 The south-west part of the cairn: (top) pre-cairn features; (bottom) density of finds per sq m

A number of burnt areas were located both under the cairn and in both forecourts (illus 5). The majority lay close to the main axis of the cairn and varied in size from small spots, 0.3 m in diameter to much larger areas up to 2.3 m by 1 m. Colour varied from black to bright red and

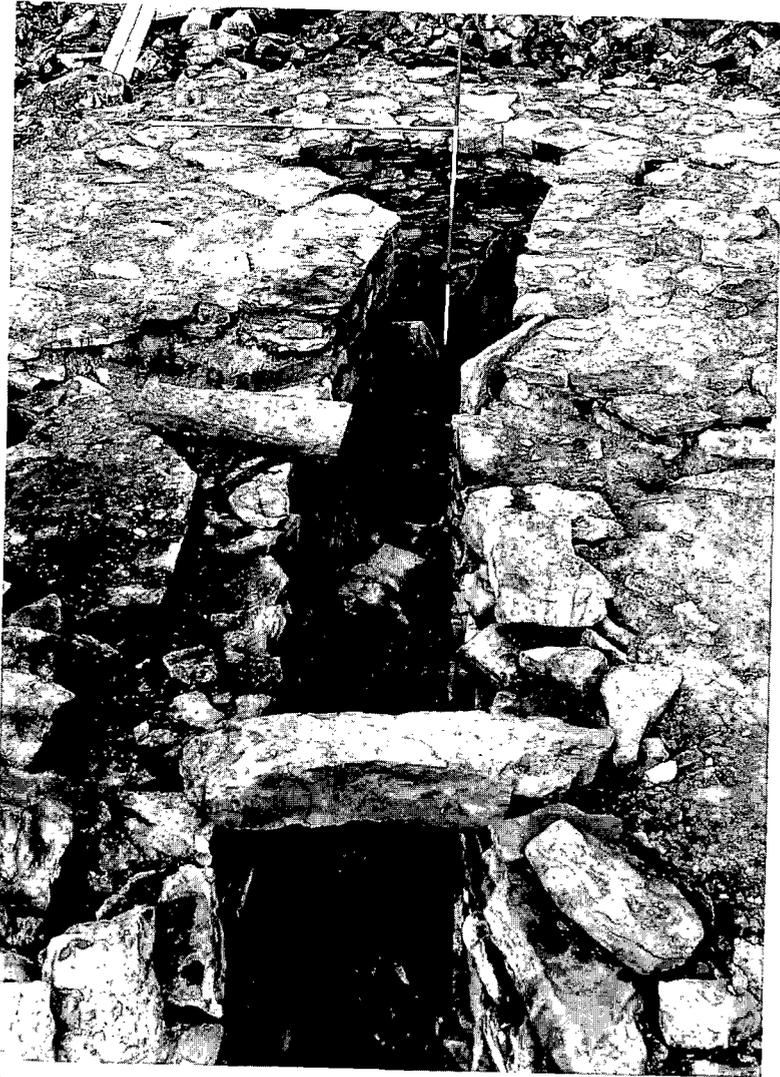
ILLUS 6 Passage to chamber A: passage lintels removed and chamber partly consolidated; from south-east

The passage entrance was located 30 ft (9.14 m) down from the end of the north-east horn, and was little more than 2 ft (0.61 m) high and wide (illus 4, 6 & 7). The first 17 ft (5.18 m) of the passage ran straight into the cairn, at the end of which the passage turned 45° or 50° towards the north-east end of the cairn between 'a flat stone set up on either side' (Anderson 1869a, 222). It then continued for a further 6–7 ft (1.83–2.13 m), where it entered the chamber by means of an irregularly arched doorway 18 in (0.46 m) wide. The outer part of the passage, as far as the two orthostats, was roofed by substantial lintels: the remainder of the passage was unroofed and

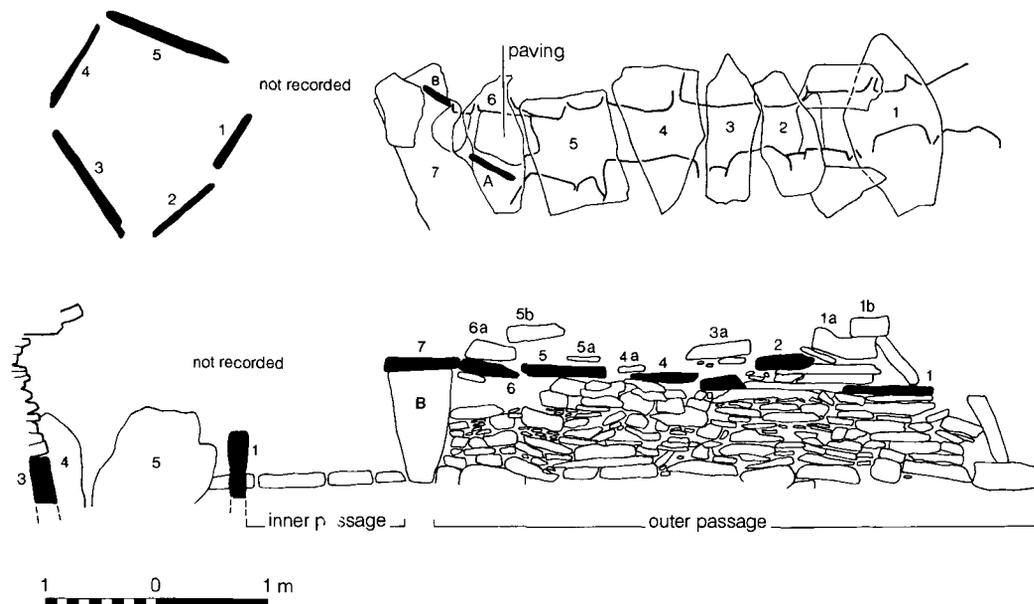
ILLUS 7 Plan and elevations of passage and chamber A

The chamber is described as being irregularly pentagonal in form, comprising five orthostats with dry-stone corbelling above. The chamber was found to be intact and, after clearing out the rubbish, the floor comprised two large and heavy overlapping slabs. The height of the chamber is given as 6 ft or 6 ft 6 in (1.83–1.98 m) and a single stone, 9 in (0.23 m) square, formed the apex of the roof. Apart from one large animal bone (since lost), nothing was found in the chamber. The two floor slabs were lifted, but the soil beneath (described as the undisturbed clay of the ridge) was similarly devoid of finds.

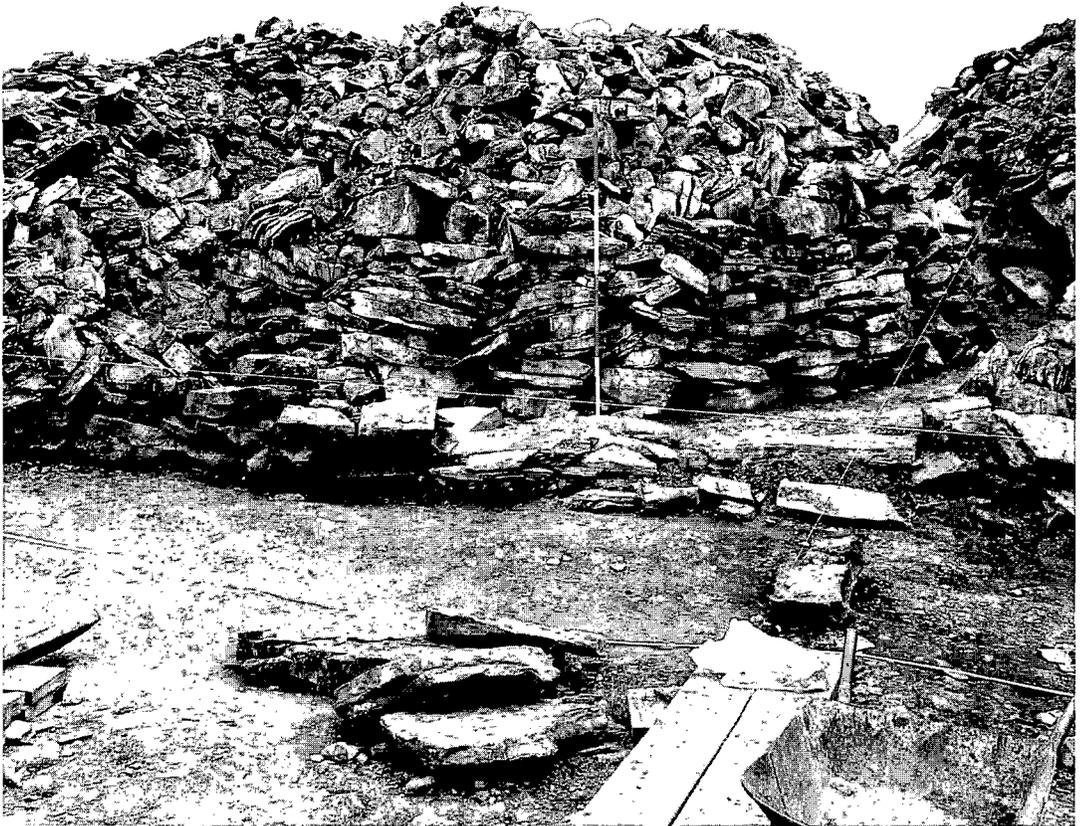
ILLUS 8 Round cairn revetment of chamber A with single long cairn revetment in foreground; from north-west

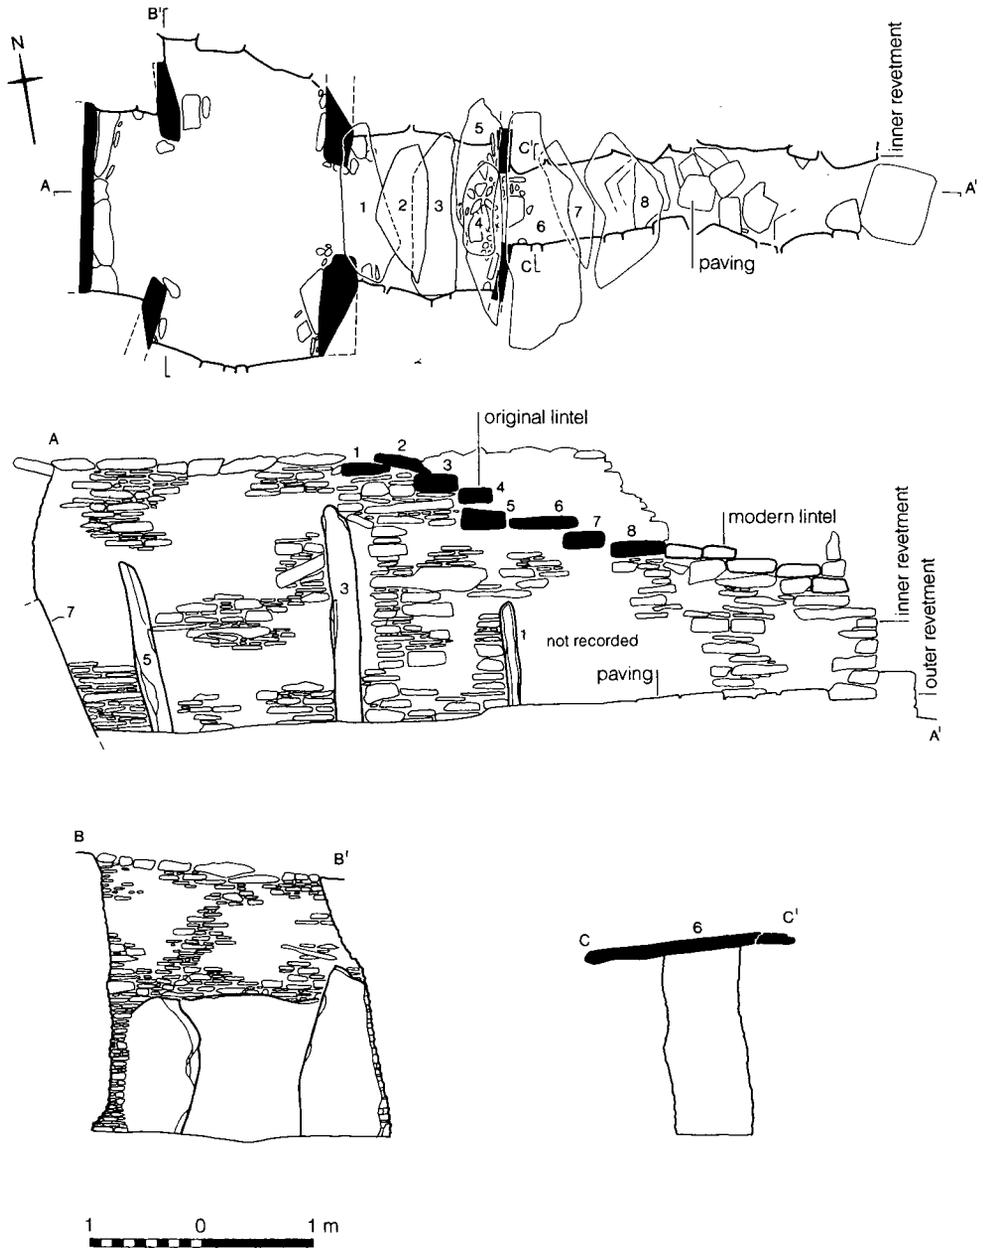
ILLUS 9 Plan and elevations of passage and chamber B

The passage and chamber are aligned at a slight angle to the main axis of the long cairn, and the entrance corresponds with a directional change in the line of the double revetment of the long cairn. The entrance area had been somewhat disturbed, probably by MoPBW consolidation in 1967. Corcoran's excavation in the area indicated that the outer revetment ran across the front of the entrance; the presence of two straight joints, however, indicated the possibility of a later blocking inserted in line with the outer revetment. Photographs indicate that three courses of

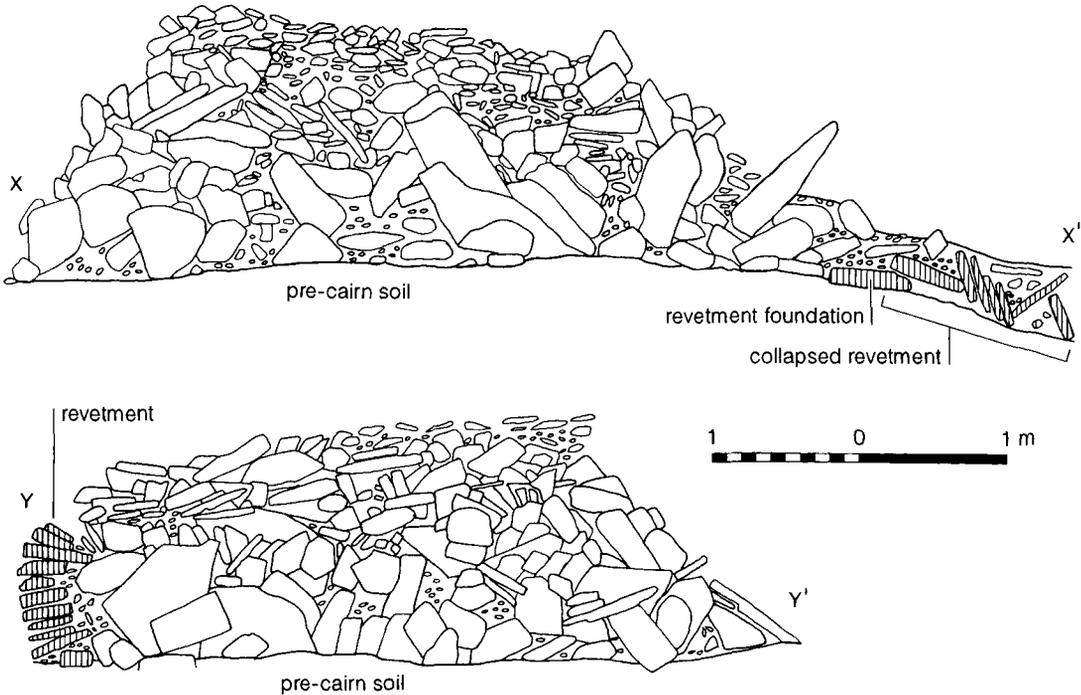
ILLUS 10 Partial cross-section of long cairn

There were occasional vague lines of semi-upright large slabs running across the cairn. The most evident of these occurred at 10mN, where some of the stones were earthfast or were at least resting on the pre-cairn land surface; it is most likely that this line was designed to prevent cairn pressure on the dry-stone south-west façade. Other lines, which occurred between 13–14mN, 16mN, 26–27mN and 30mN, were not so clear: in many cases the vertical or near-vertical slabs were located in the upper part of the cairn, and did not penetrate to the pre-cairn land surface. These lines can in no way compare with regular gang divisions seen elsewhere. While no conclusive proof could be derived from the excavation of the cairn alone, it is the present writer's opinion that it was built in sections from chamber B to the south-west façade. This is suggested by the slightly radial pitching of the stones in the vicinity of the south-west arc of the putative

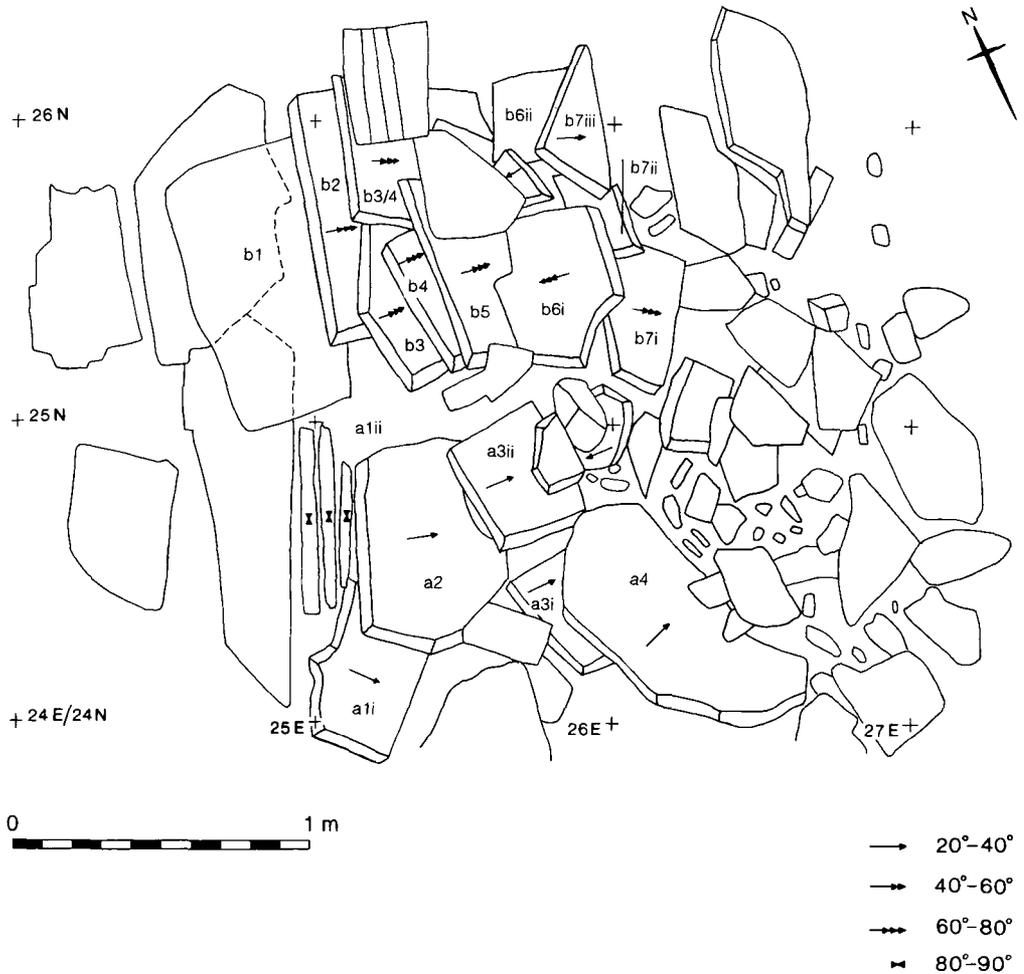
ILLUS 11 Plan of collapsed long cairn revetment between 24mN and 26mN

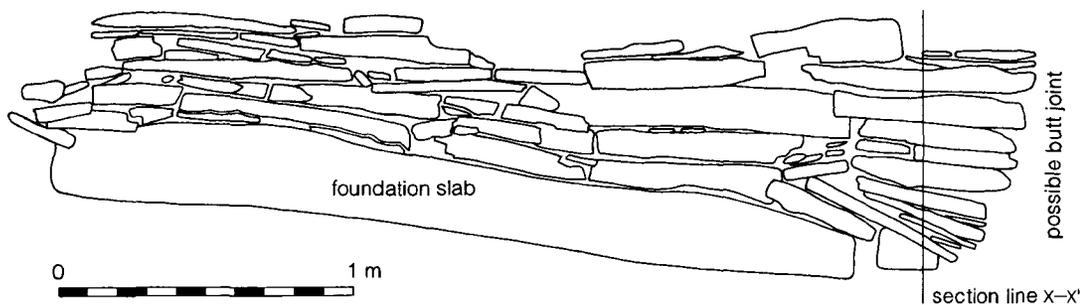
ILLUS 12 Elevation of standing section of long cairn wall on north-west side between 22mN and 25mN

In order to satisfy the twin aims of archaeological information and restoration, two strategies for excavation of the extra-revetment were attempted in 1976. The more successful was undertaken on a small area of extra-revetment on the south-east side near the end of the cairn, which had been left relatively undisturbed in cutting X. As the line of a single revetment was clearly visible, Corcoran having removed most of the surrounding extra-revetment, it was decided to replace the pitched and stacked stones of the extra-revetment directly onto the already visible foundations. Beginning with the first stone in contact with the foundation, each successive course was excavated and replaced on the preceding one. While it was not particularly difficult to achieve a direct estimate of revetment height, the interbedding of courses was more difficult. Nevertheless, this was possible in some cases when, as here, the revetment seemed to have collapsed as a complete unit. Thus reconstructed, the revetment stood to a height of 0.7 m and there was no indication of a second revetment either in front or behind. This method of working was found to be most satisfactory for revetment reconstruction, and also had the merit of forcing consideration of the position of virtually every stone. With only one or two small exceptions, this method was adopted for the excavation of the remaining extra-revetment. An example of the detailed planning is given in illus 11, and an elevation drawing of the only standing section of the revetment in the tail of the cairn in illus 12.

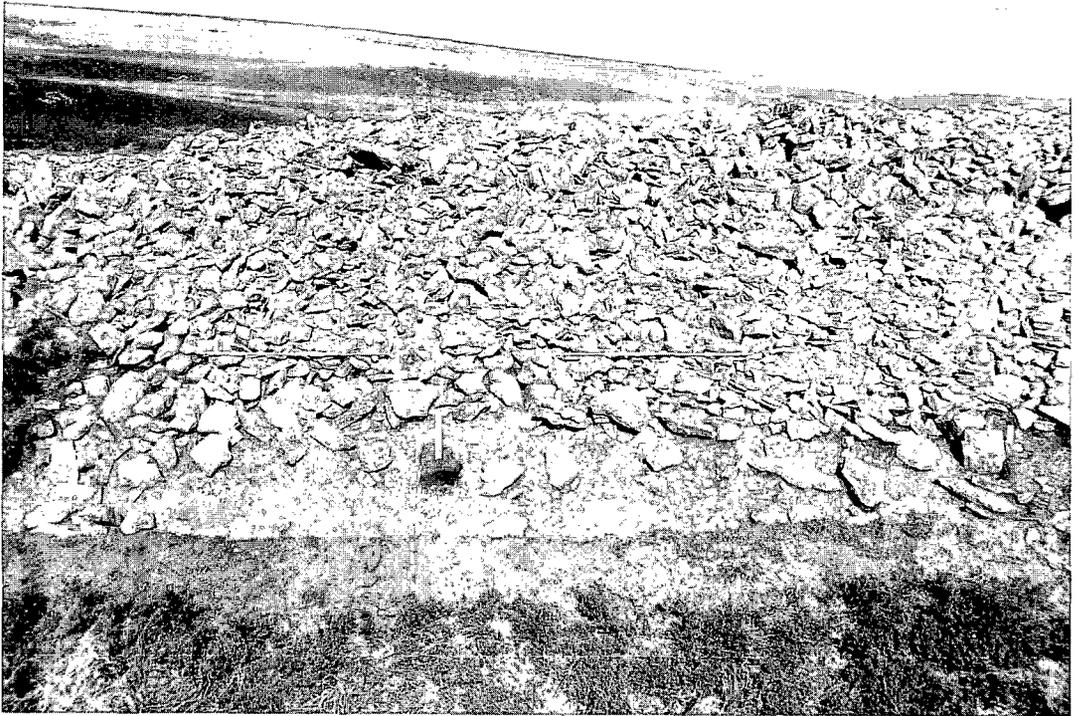
ILLUS 13 South-east side of cairn between 20mN and 30mN including extra-revetment

The area between 26mN and 33mN on the south-east side was crucial in covering the change from a double to a single revetment (illus 13). This section was divorced from the already restored north-east half of the cairn by an unrecorded area, probably dug in 1973. After the removal of loose surface stones, it became clear that the characteristic tilted stones of the extra-revetment lay further into the cairn than those visible to the south-west. The line of the inner revetment was first established by removing cairn material from behind it, and was found to be still standing to two or three courses in height (max height 0.36 m). As there were still a few slabs in contact with the *in situ* courses, these were slid back into position. Fortunately, this had the effect of revealing the bottom courses of the collapsed outer revetment which, again, had two to three courses more-or-less *in situ*, but only 0.15 m in height. The difference in height between the

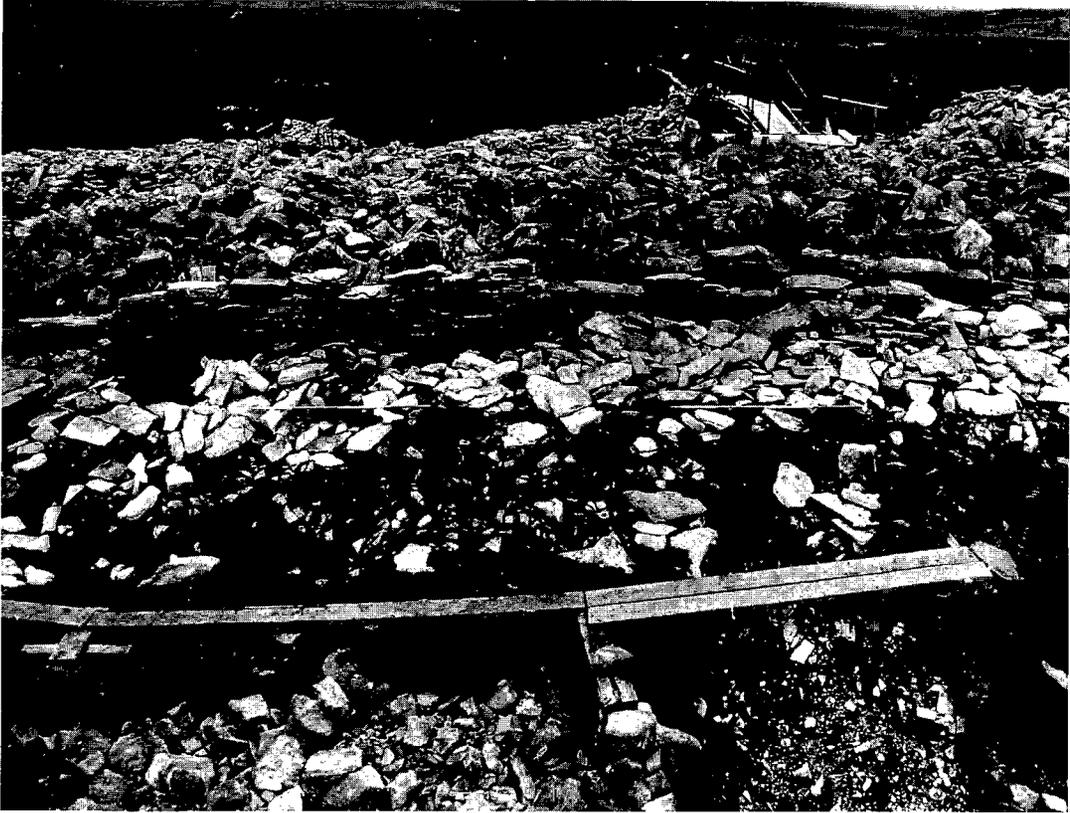
ILLUS 14 South-east side of cairn between 20mN and 30mN showing (*left*) reconstruction of single revetment and (*right*) partial reconstruction of inner and outer revetments; from south-east

The effect of this reconstruction was to produce an inner revetment around 0.8 m in height at 32mN, decreasing slightly to about 0.7 m at its termination at 28mN (illus 14). The outer revetment could be reconstructed to 0.4 m at 32mN but increased in height until it reached 0.9 m at 27mN. The visual effect, therefore, was for the inner revetment wall, consistently higher than the inner on this side in the north-east half of the cairn, gradually to disappear behind the increasingly higher outer revetment (illus 3). The visual effect was further enhanced by the different colours and thickness of the stones used. There was no positive archaeological evidence for the original appearance of the junction at 27.5mN between the outer revetment and its continuation as the only revetment. There must have been a marked visual contrast, in that the single revetment was built with thick, light-coloured slabs and blocks, whereas the outer revetment was composed of thinner, darker-coloured slabs. The difference in thickness suggests that it would not have been very practical to interleave the courses: accordingly, it has been

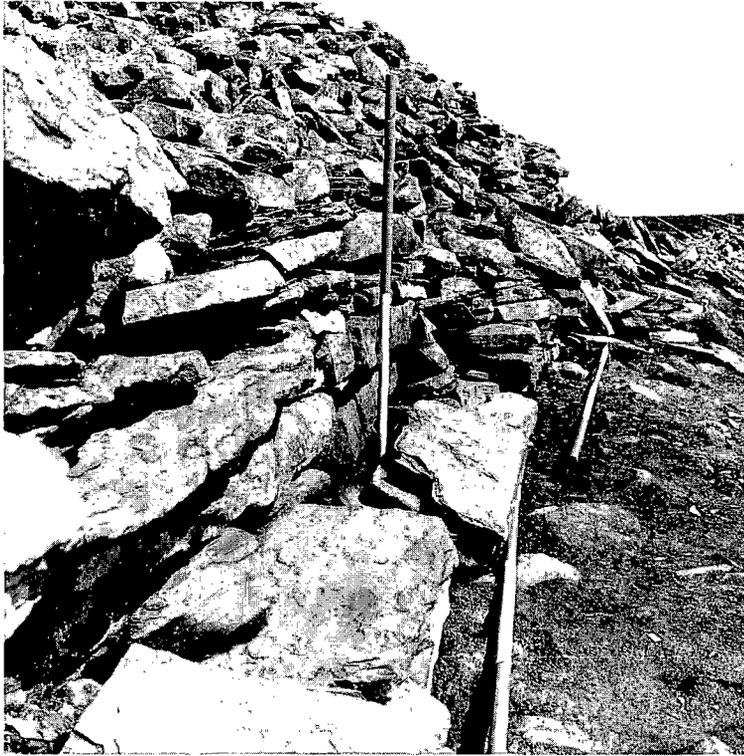
ILLUS 15 Inner and outer revetments on south-east side between chambers A and B; from north-west

with the entrance to chamber B, where the inner revetment was still standing up to 1 m high and with up to three courses of the outer revetment still in situ (illus 15). The restoration of the inner revetment at a height of 1 m and of the outer revetment at a height between 0.3 and 0.35 m seems satisfactory on the basis of the photographs. The final appearance of a strongly built inner revetment and a less substantial outer revetment, perhaps more decorative than functional, is substantially in accord with the archaeological evidence. Corcoran noted that there was no bonding of the outer with the inner revetment. This was confirmed by what remained of the double revetment between 28mN and 33mN.

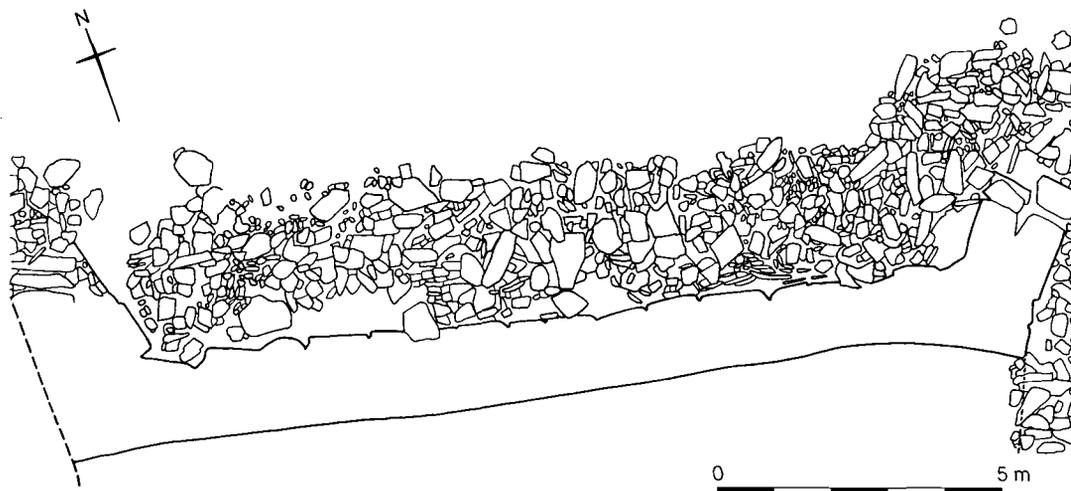
ILLUS 16 Plan of north-east forecourt and blocking

Despite the considerable disturbance in its centre, the top of the façade could still be seen to rise in a smooth curve from the side revetments. The space between the horns was filled with slabs, generally tilted with the long axes perpendicular to the line of the platform and façade. This uniformity was broken in the areas immediately adjacent to the inner faces of the horns, particularly horn B, where the tilt of the stones ran parallel with the splayed line of the horns (illus 16 & 17).

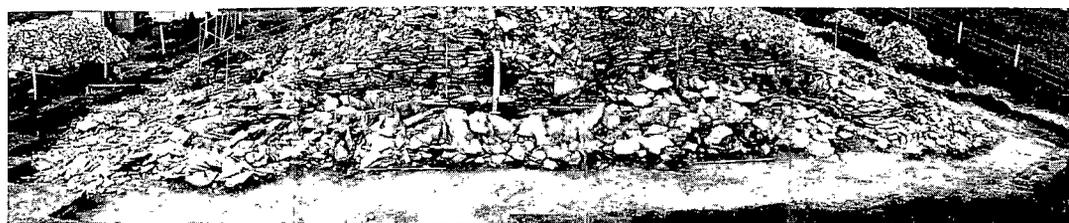
ILLUS 17 North-east forecourt with blocking *in situ*; from north-east

Photographs of the façade taken during Corcoran's excavation clearly show a major disturbance in the centre (illus 17). Assuming this to be Anderson's trench, it was about 4 m wide at the top and 2 m wide at a level just above the platform. It is debatable whether Anderson's trench was dug 'on the level of the ground' as there appears to be no major disturbance of the stones in the forecourt, apart from a small area immediately in front of the platform. There is also

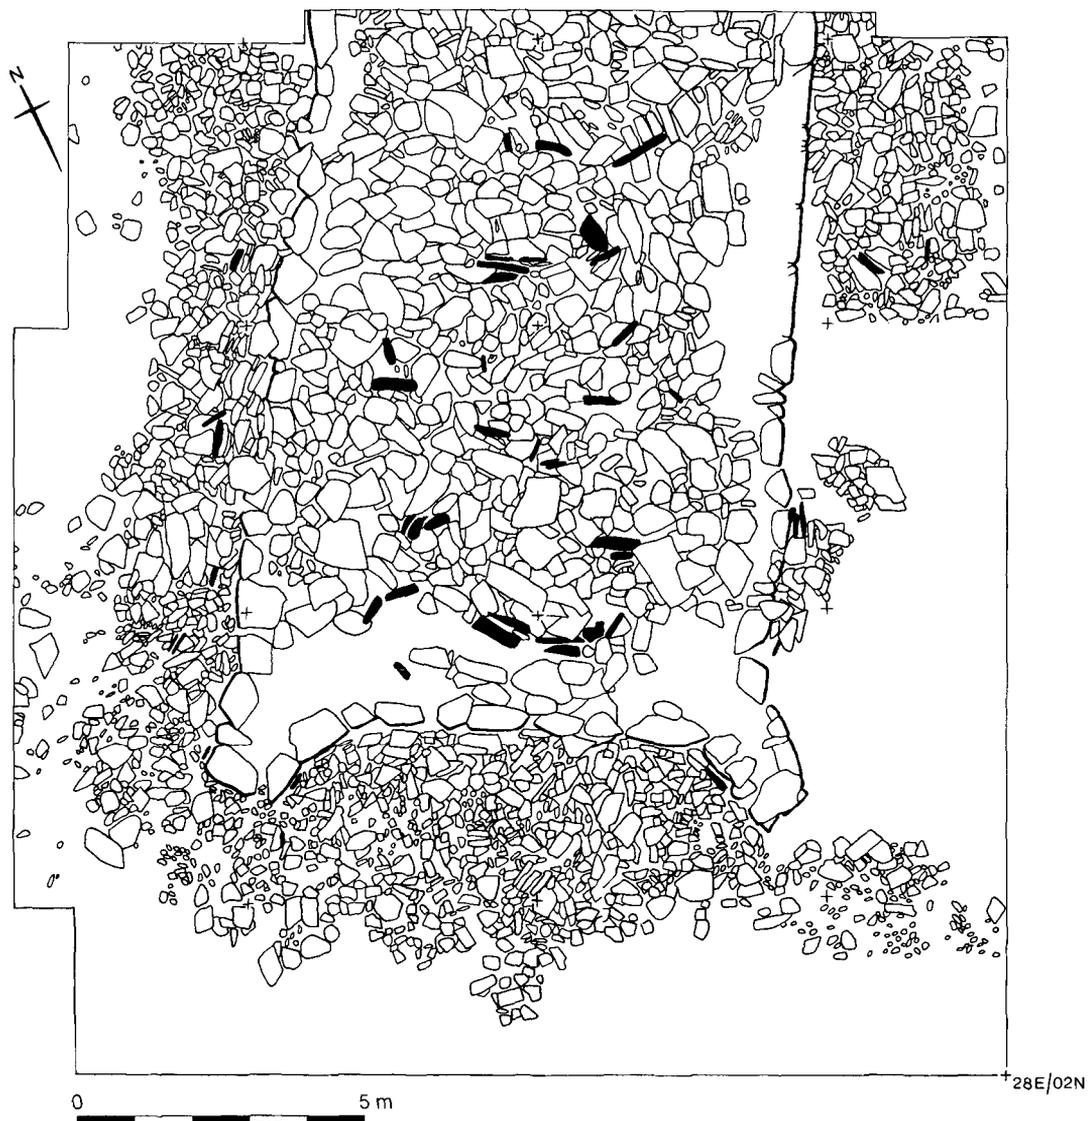
ILLUS 18 Plan of basal layer of cairn between 02mN and 21mN, extra-revetment and south-west forecourt and blocking

The forecourt measured 8.5 m wide between the inner ends of the horns and only 1.6 m in depth (illus 18 & 20). The outline, as defined by the foundation blocks of the horns and platform, ran from gently concave along the inner edge of horn D to fairly straight along the centre, but with a sharper angle join for the inner edge of horn C. The foundation blocks were variable in size, but generally large, ranging in length from 0.5 m to 1.4 m, and up to 0.5 m in thickness. The dry-stone walling had tilted forward so that it partially overhung the forecourt blocking, which provides a further indication that the stones in the forecourt were a deliberate blocking and not collapse.

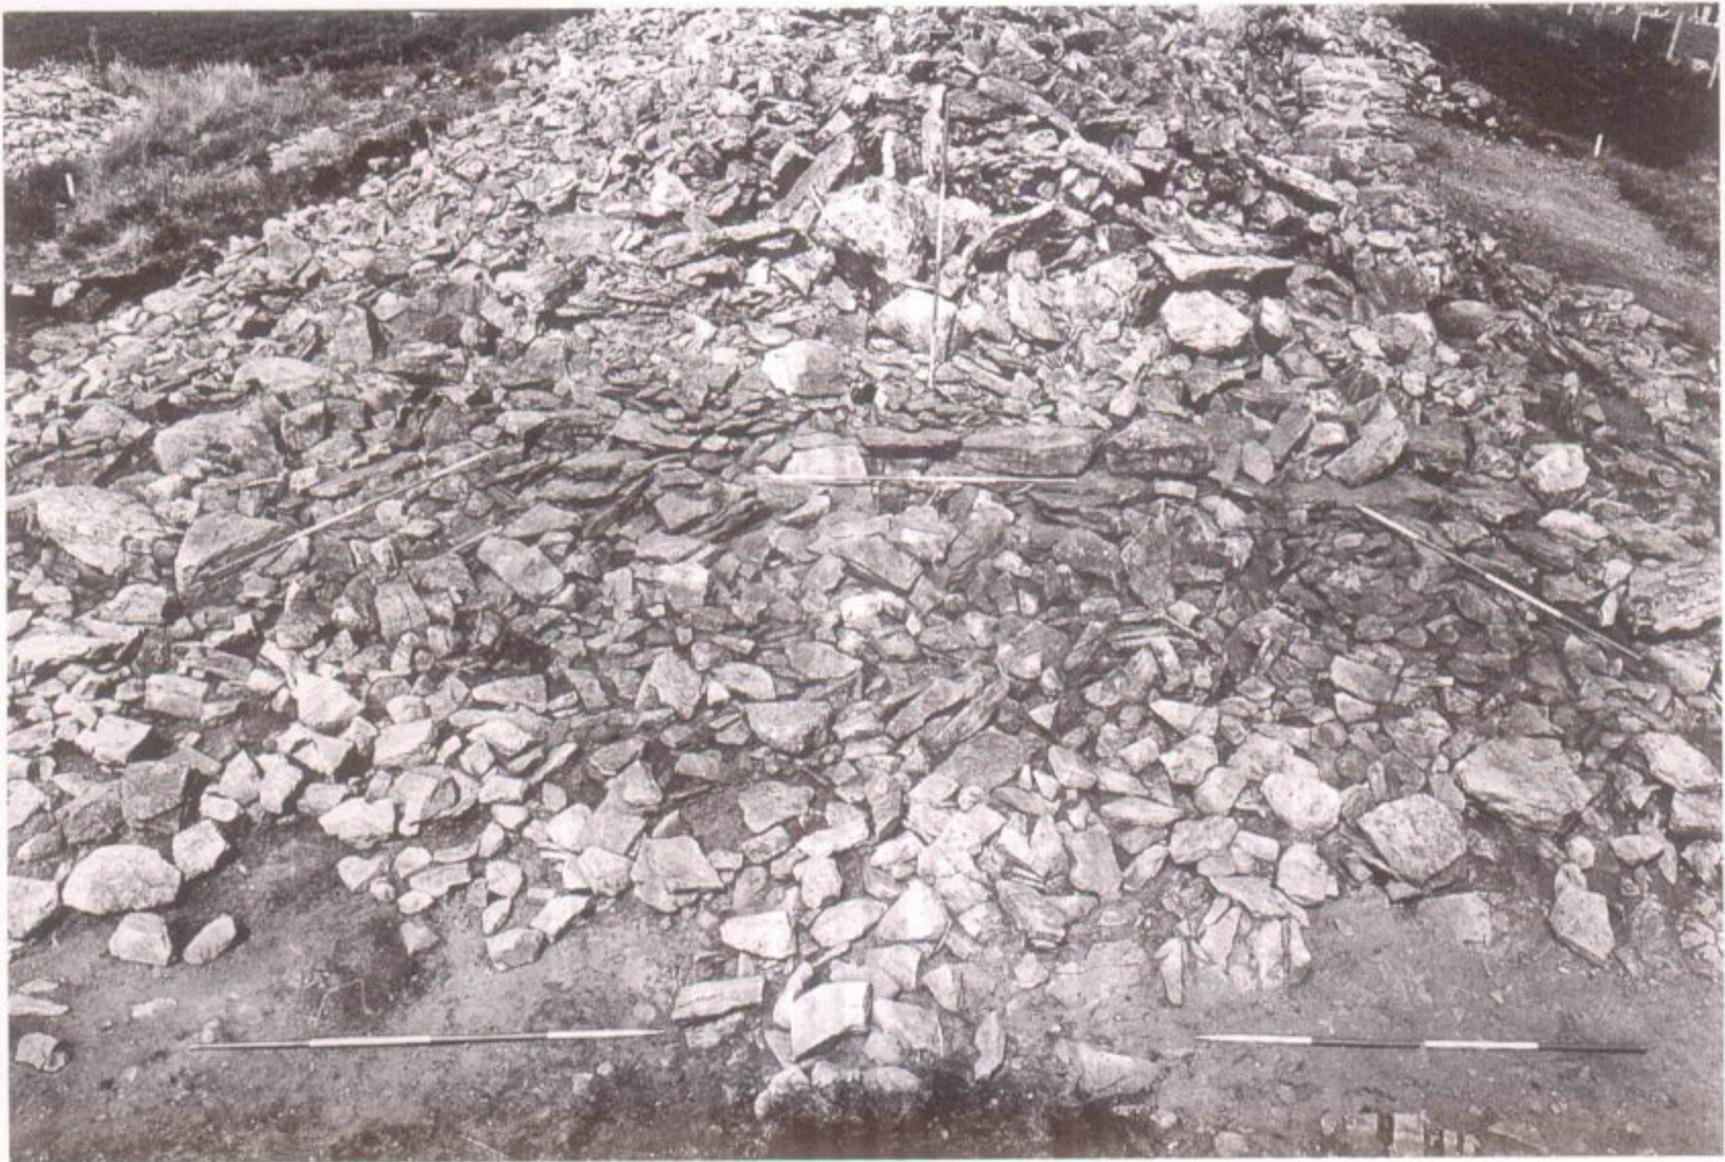
ILLUS 19 South-west forecourt with blocking *in situ*; from south-west

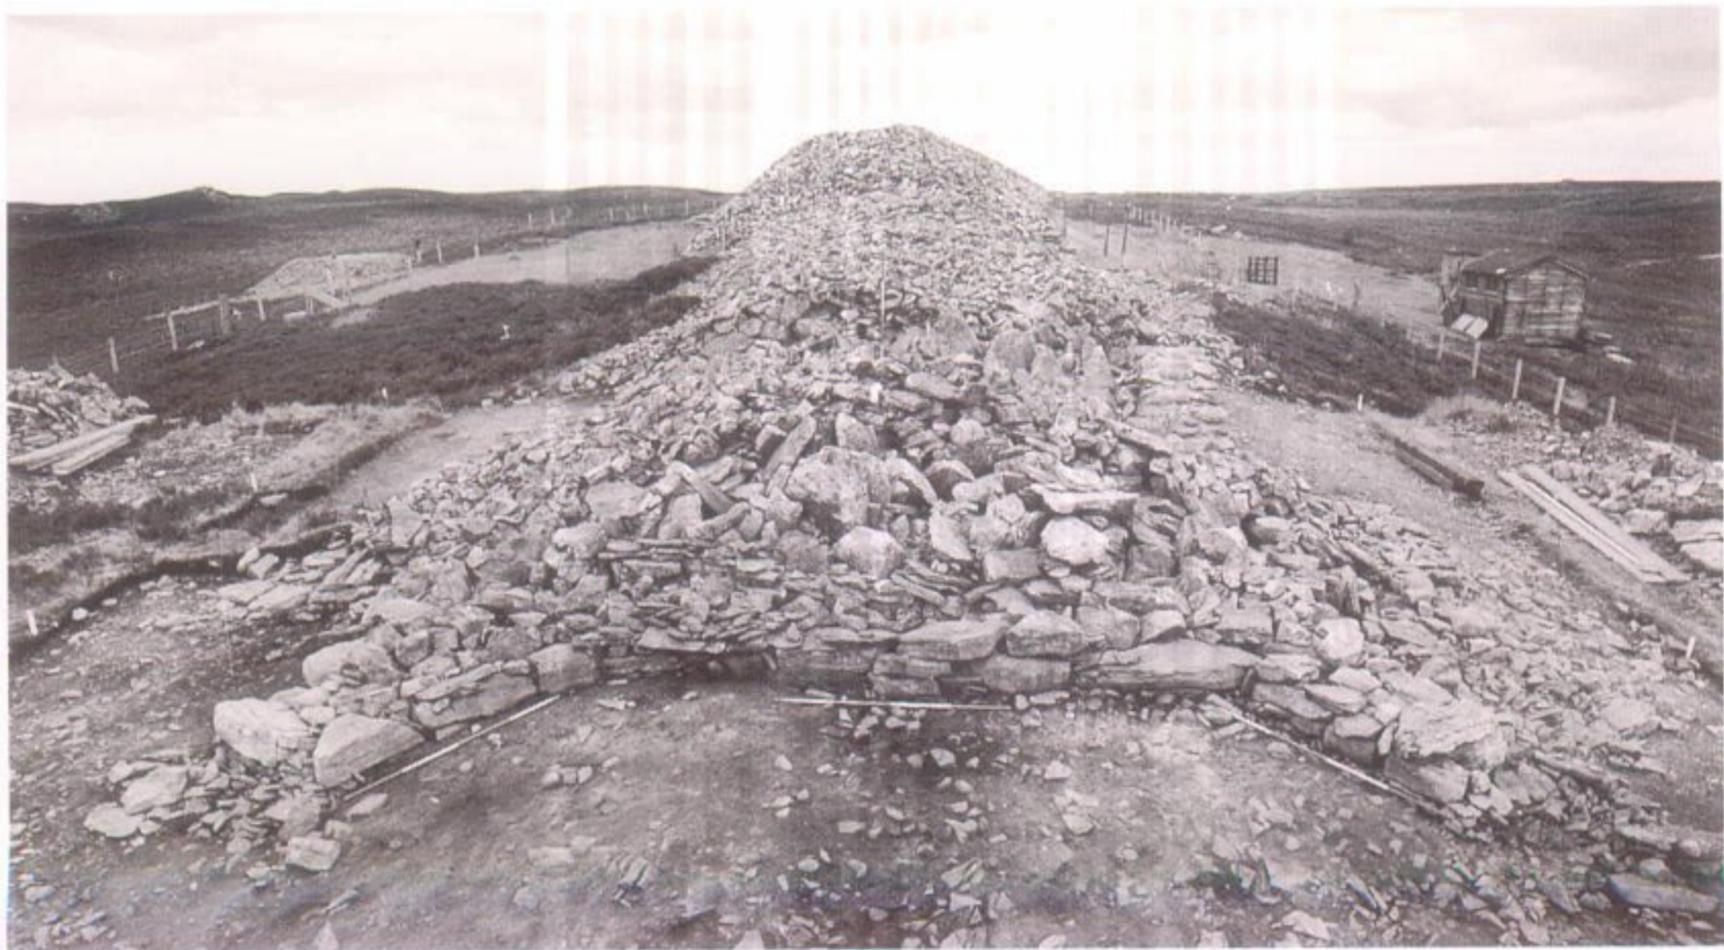
ILLUS 20 South-west forecourt with blocking removed, platform, façade and cairn; from south-west

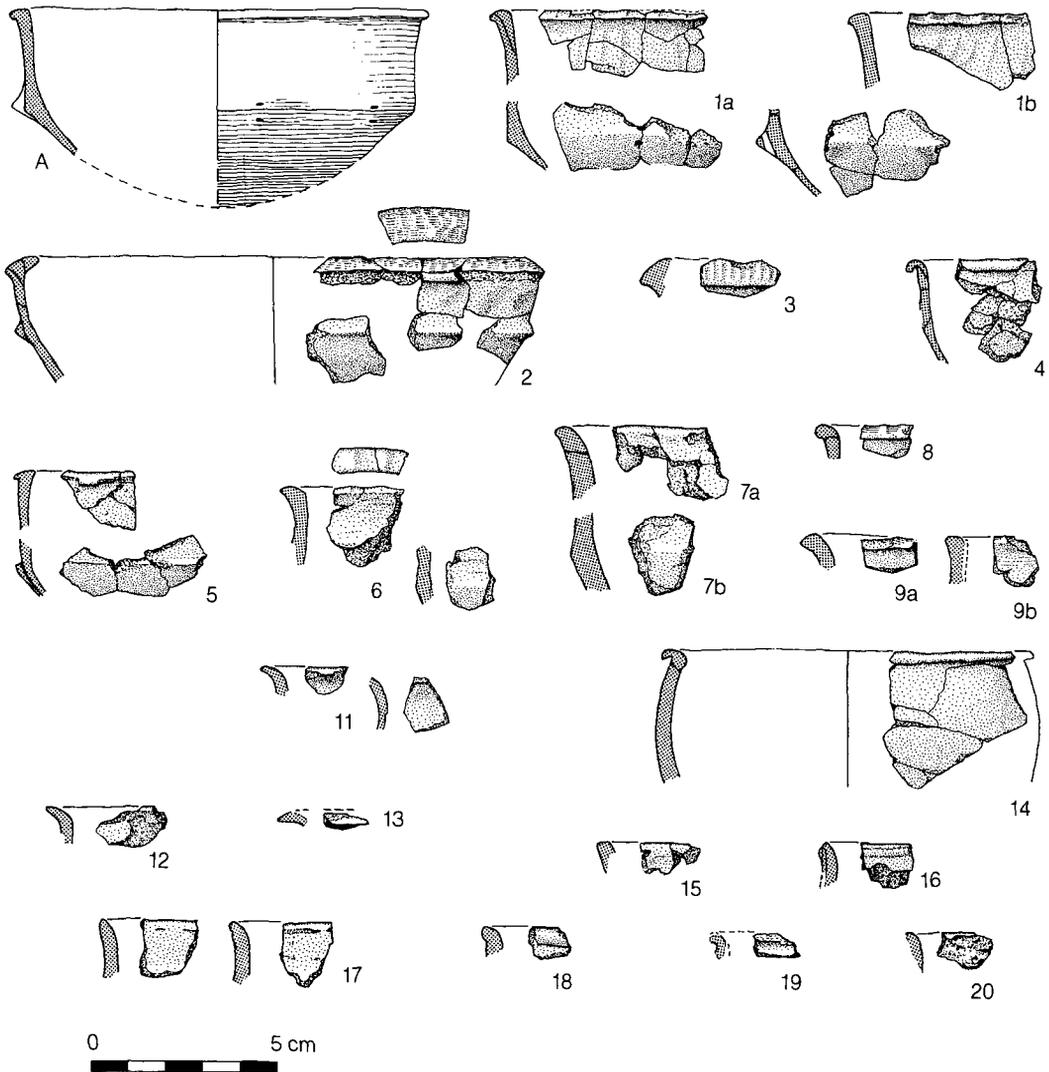
ILLUS 21 Pottery (A is a conjectural reconstruction of P1)
