The excavation and restoration of the Camster Long chambered cairn, Caithness, Highland, 1967–80

Lionel Masters*

ABSTRACT

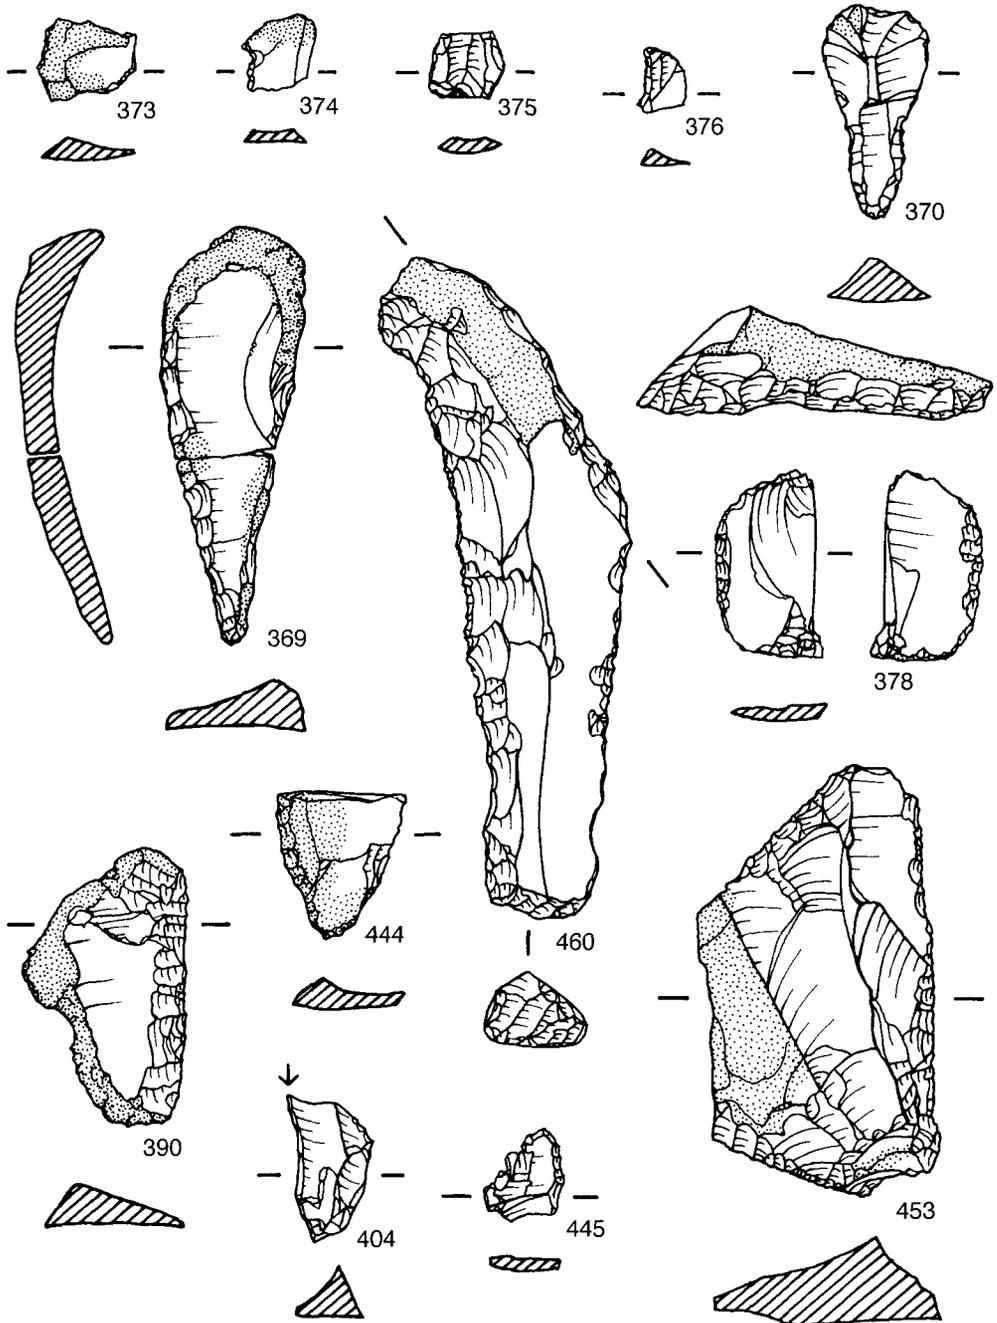
ILLUS 25 Flaked stone objects

Burin (no 404) (illus 25) One piece of secondary knapping remains, an inner flake that has been burinated by the removal of a long spall down the left side.

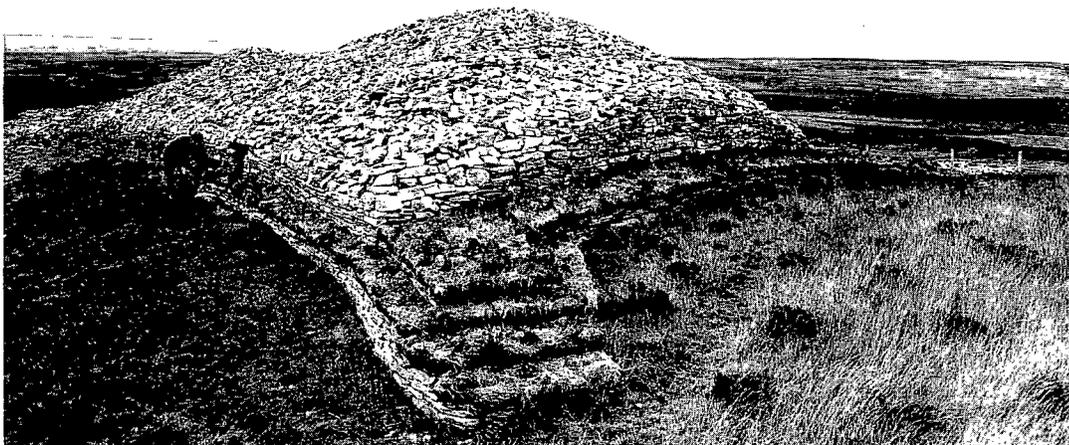
ILLUS 27 North-east forecourt and entrance to chamber A after rebuilding; from north-east

There can be no doubt that the visitor today will see in Camster Long a monument which is strikingly impressive. The change from a tumbled mass of stones with vegetation growing up the edges to, it is hoped, a pristine monument complete with forecourts, revetments and chambers, coupled with a visually distinctive hummocky cairn profile, now forms a dramatic feature rising
