The excavation of Iron Age buildings at Ironshill, Inverkeilor, Angus

Dave Pollock*

ABSTRACT

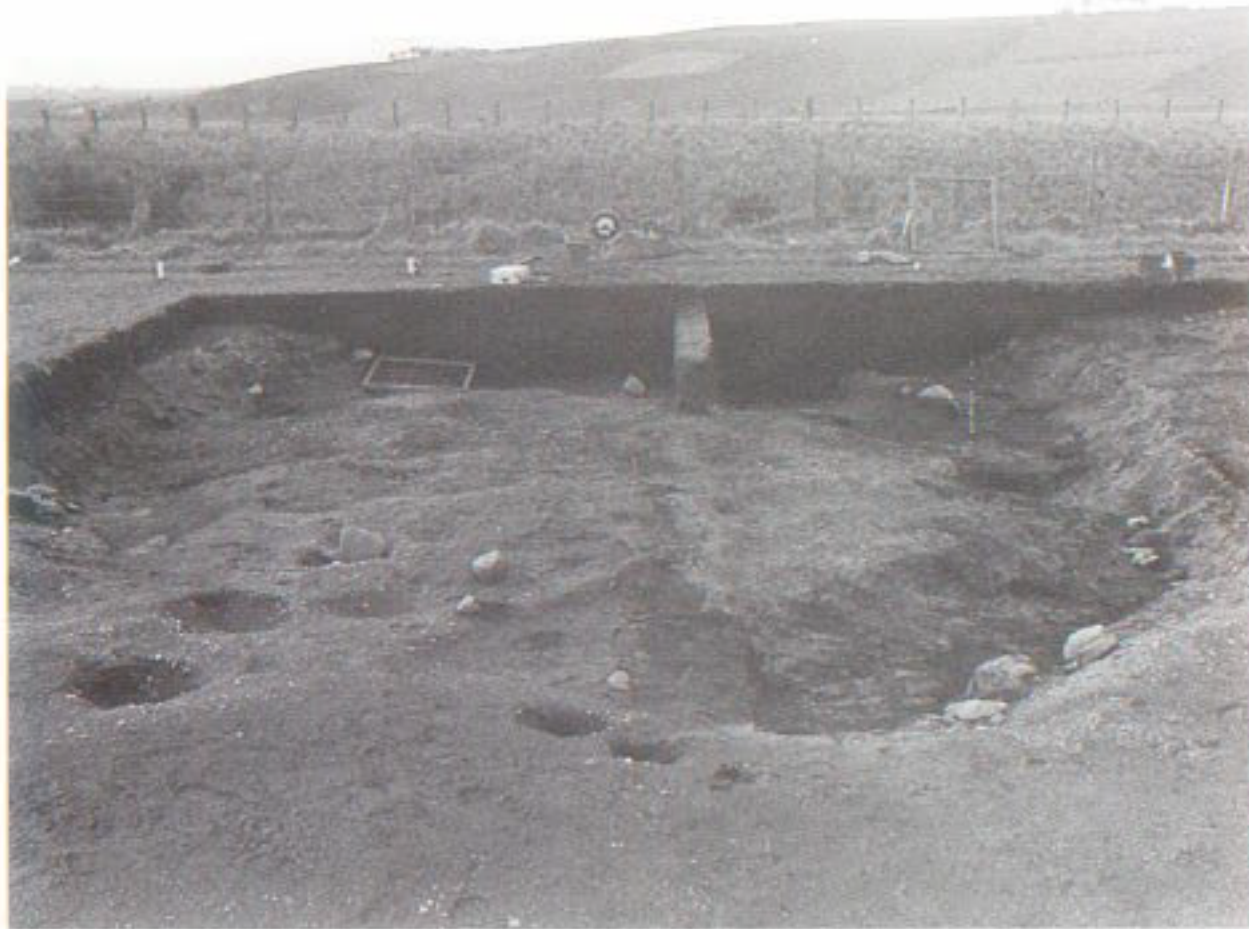
ILLUS 11 View from east of House 2: the ring-ditch house (Trench 3)

From an entrance causeway on the east side, the penannular ditch deepens gently in a clockwise direction, reaching a maximum depth of 1.2 m below the base of modern ploughsoil at the rear of the house, opposite the entrance; it rises more steeply from this point to ascend again towards the causeway on its north side (illus 11). A fragmentary pebble surface survived in the deeper parts of the ring ditch; the surface

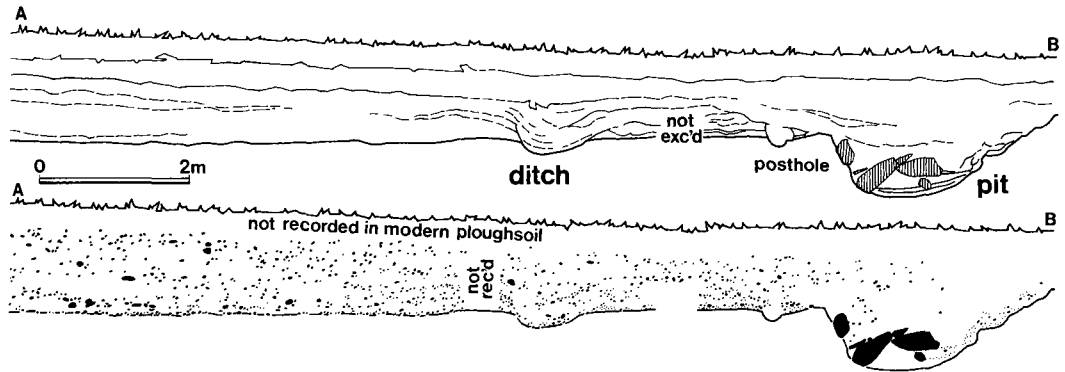
ILLUS 21 Sectional view of the soil layers (above) and the distribution of stones (below) in Trench 8

Before the parallel pair of ditches was cut a large pit was dug near the north edge of the natural hollow occupied by House 1 (illus 21). Some of its upcast formed a low bank in the hollow, and this was sealed with a layer of clay. The function of the pit is unknown, but it survived the cutting of the parallel ditches and, presumably therefore, was still in use after House 1 was abandoned. Both ditches respected the pit and their detour around its perimeter may define the edges of a roofed area over it. A single post-hole (or part of a timber slot) may indicate the site of a roof support, and large boulders rolled into the abandoned hole may be the rubble from a surrounding wall. Below the rubble in the pit, laminae of ash from material which was evidently not burnt *in situ* may be refuse from domestic hearths roundabout, or waste from an associated feature outwith the excavated area. Charred seeds (oats with barley and possibly rye: R McCullagh, pers comm) were recovered from the ash and a large socketed stone was recovered from the backfilled rubble (illus 17).
