Excavations at Bothwell Castle, North Lanarkshire

John Lewis*

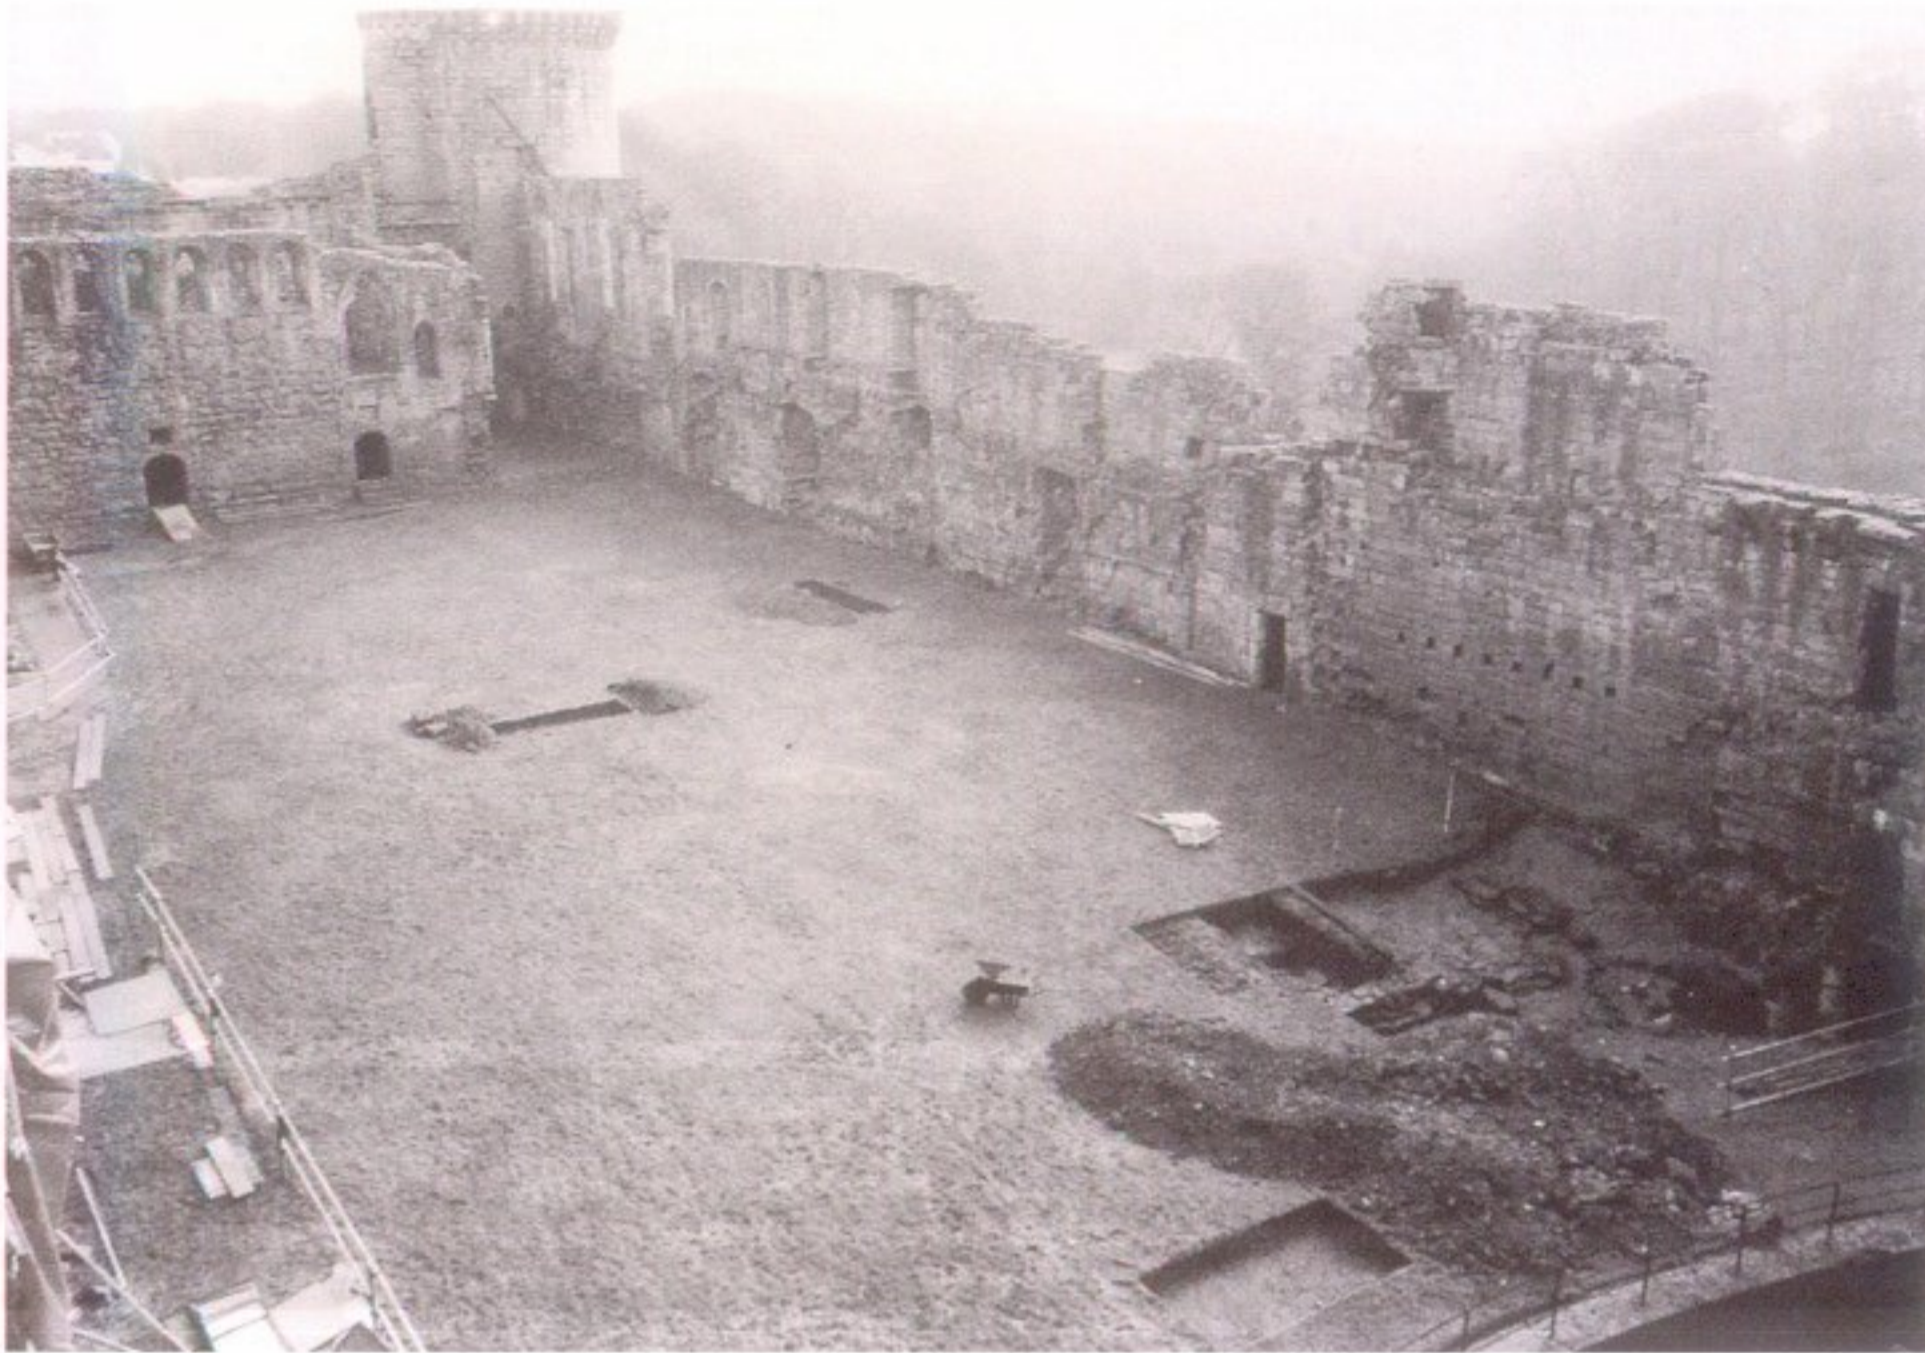
ILLUS 4 The castle courtyard in 1987, viewed from the north-west; Trench A is in the right foreground

Trenches B, C & D (illus 4)

These small trenches were excavated to a depth of about 0.3 m, only turf, topsoil and recently disturbed rubble and clays being removed. A brick-built drain, uncovered in Trench B, was presumably part of an earlier attempt to rid the courtyard of excess water; otherwise, nothing of archaeological interest was

discovered in any of these trenches. Trench B measured 4 m east/west by 1 m wide and was located approximately 3.5 m from the south curtain wall, midway along its length. Trench C was opened near the centre of the enclosure and measured 3 m north/south by 1 m wide. Trench D measured approximately 5 m east/west by 2 m north/south and was located 2 m east of the moat that protected the donjon tower. None of these trenches was drawn during the excavation, their positions being indicated only by photographs.

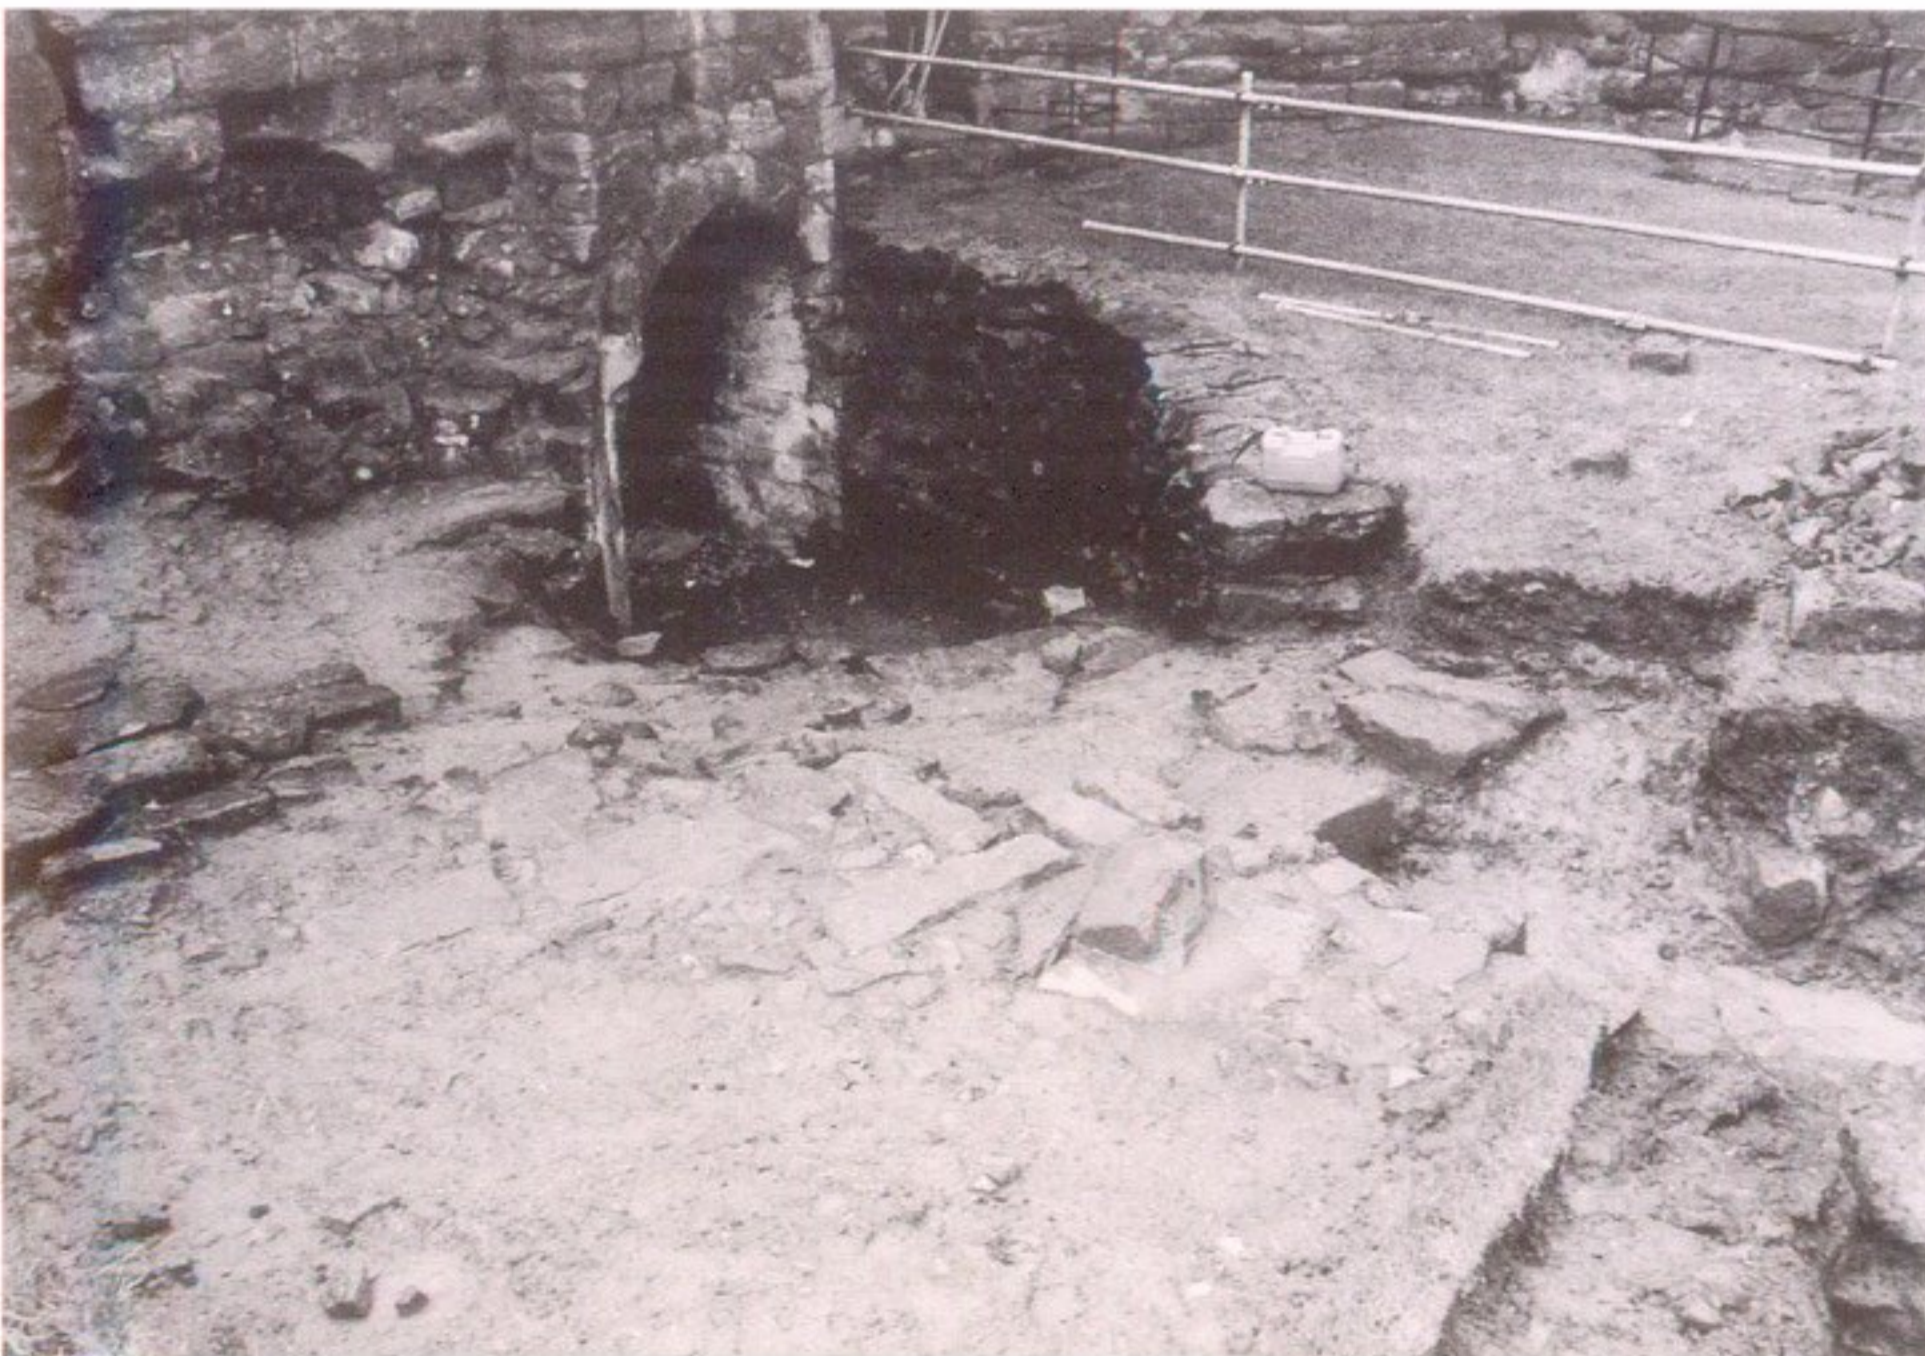
ILLUS 5 Trench A, viewed from the north-east

Trench A (illus 4-6)

Measuring a maximum 9 m north/south, this trench extended 6 m eastwards from the postern in the south curtain wall. The trench was defined on its west side by a retaining wall, 2.25 m high, to the left of which was a flight of steps leading down from the courtyard to the postern. This wall comprised a sandstone rubble core built against a vertical earth bank and lined on its east side with ashlar although much of the facing stonework had been removed. As in all the trenches, turf and topsoil overlay deposits of disturbed clay and rubble, the latter resulting from the partial demolition of the surrounding buildings and recent levelling operations within the courtyard.
