## Excavations at Sauchie Tower, Clackmannanshire

### ABSTRACT

*Excavations were carried out in 1984 and 1985 within the ground-floor chambers, the kitchen at entresol level and the first-floor hall of this 15th-century tower, prior to its restoration as a domestic residence. In addition, trenching outside the tower revealed traces of at least one lean-to building and the outflow of a latrine chute against its north wall; and, further north, remnants of a barmkin wall. The excavation was funded by Historic Scotland (former SDD/HBM).*

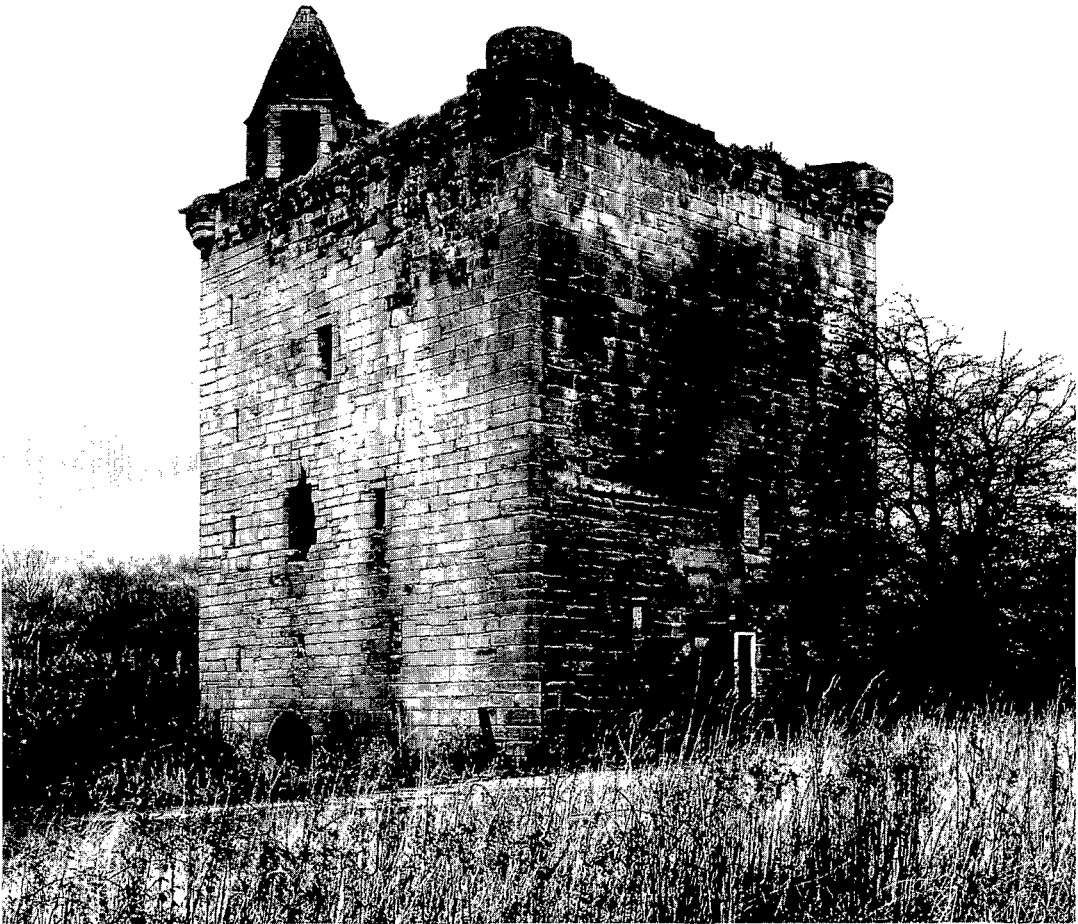
ILLUS 2 Sauchie Tower, from the south-west; the entrance to the tower is through the west wall, on the left.  
 (*Historic Scotland © Crown Copyright*)

Perhaps the most striking aspect of the architecture of Sauchie Tower is the sharp contrast between its external and internal appearances. Its rather plain, solid exterior, albeit of high quality, coursed ashlar, is relieved only by an attractive entrance arch and some decoration at the wall heads (illus 2). Within its walls, however, lie several features of architectural interest including mural chambers at several levels, ornate fireplaces and elaborate window recesses complete with bench seating.

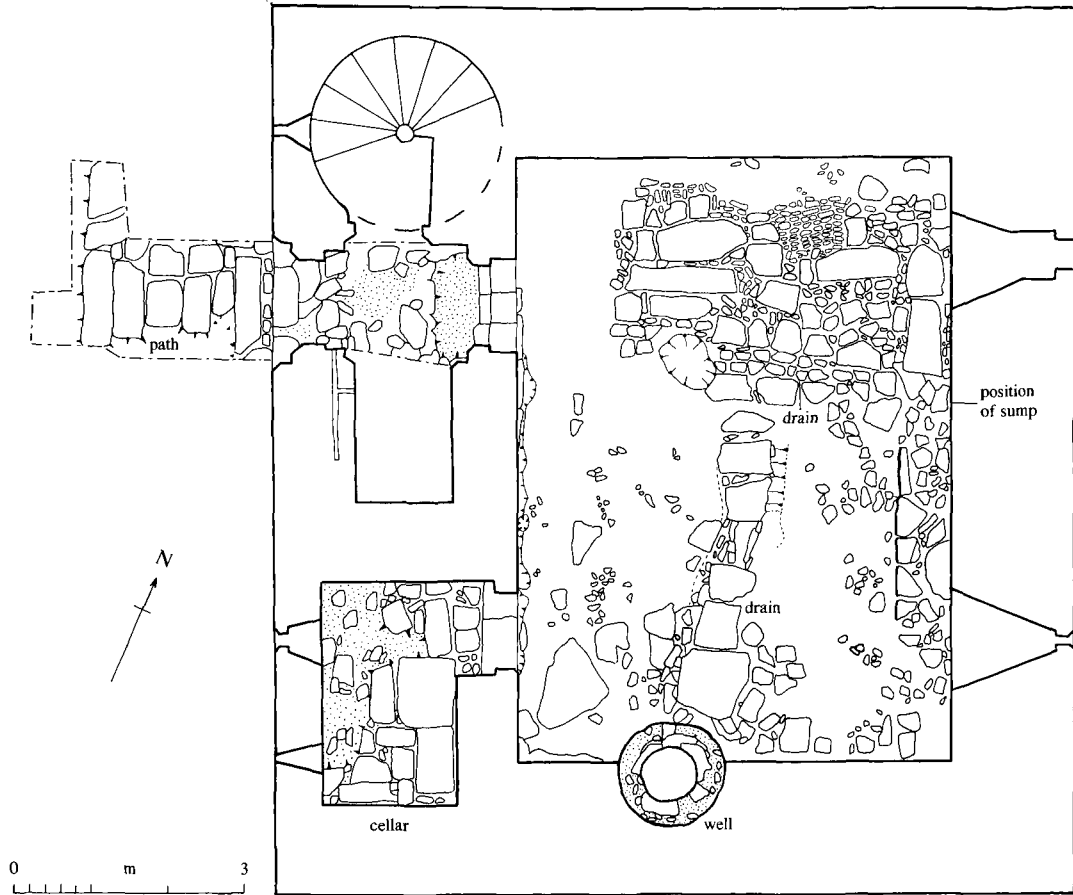
ILLUS 3 Plan of the excavated features at ground-floor level within the tower and adjacent to the doorway in the west wall

A small trench, measuring approximately 2.5 m east/west by 1.5 m wide, was opened immediately outside the entrance to the tower. The remnants of what appeared to be a path were uncovered up to 1 m below the modern ground surface. The path was made up of large, tightly jointed, rectangular sandstone flags, 0.2 m thick, and seemed to run along the side of the tower, extending 2.5 m from its west wall. It stretched beyond the north edge of the trench, but the flags appeared to have been robbed out on its south side. Near this point was a layer of bricks, perhaps evidence of a later repair to the path; unfortunately, it was not possible to investigate this feature further. Evidently, the flagstones had continued into the entrance passage of the tower, although few survived into the 1980s: most of the floor had been removed, exposing its mortared rubble base.

The tower was built on the clay subsoil, its walls bedded into shallow trenches that extended only 80 mm beyond their internal faces. At ground-floor level the principal chamber measured 8.0 m north/south by 5.65 m east/west within walls 1.6 m wide (except the 3 m-wide west wall which contained a guard room and a small mural cellar). The only evidence of constructional activities consisted of a beam slot and three post-holes — presumably traces of scaffolding — cutting the subsoil along the south wall, towards its east end.

Built into the south wall of the chamber was a circular well, its shaft measuring 0.7 m in diameter and lined with ashlar. The well was contained within a semicircular recess, 1.0 m high, beneath a low arch and roofed behind the arch with lintels. Approximately 1 m of deposits, containing recent artefacts and pottery dating from c 1700 onwards, were removed from the well. At that level the water-table was reached: during the excavation heavy rain caused its level to rise, flooding the ground floor of the tower.

The overflow from the well would once have been removed by a drain. This measured 0.2 m square, with a base of undisturbed clay subsoil, but lined and capped with sandstone flags, up to 1 m across. It was

completely infilled with silts, the upper layer of which contained 18th- and 19th-century pottery. This drain extended 4.3 m from the well where it issued into an open drain, 1 m wide, which ran from just inside the doorway in the west wall and which emptied into a sump near the east wall. The sump contained rubble and gravel, presumably to aid drainage, and was sealed with sandstone slabs which had slumped downwards. These slabs formed part of a floor surface which extended over an area measuring approximately 4.5 m by 2.0 m at the north end of the room: it was made up of large flags, rounded cobbles and some bricks. The flags continued sporadically along the east and south sides of the chamber as far as the well, forming a slightly raised platform, 0.7 m wide, adjacent to the east wall.

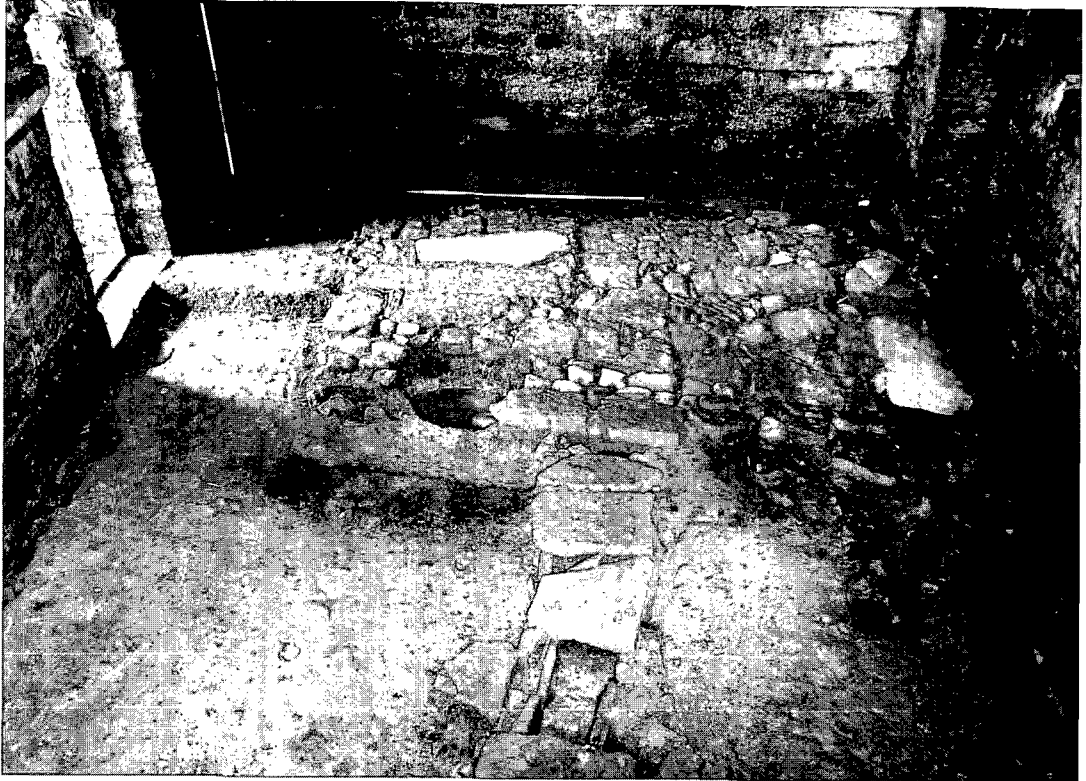
ILLUS 4 The interior of the tower at ground-floor level, viewed from the south; the capped drain, in the centre foreground, leads from the well towards the paved and cobbled floor at the north end of the principal chamber

Lenses of clay and silt lying on the capped drain and the stone floor may have been deposited whilst the well was in use; whereas the more uniform layer of silty loam that covered those materials, as well as most of the rest of the floor, probably post-dates the abandonment of the tower as a principal residence. Several post-holes which cut into this material and through the underlying features may date from a time when the ground floor was used as a store or animal house, perhaps in association with a nearby farm. Recently deposited rubble, loam, coal waste and animal dung sealed those features.

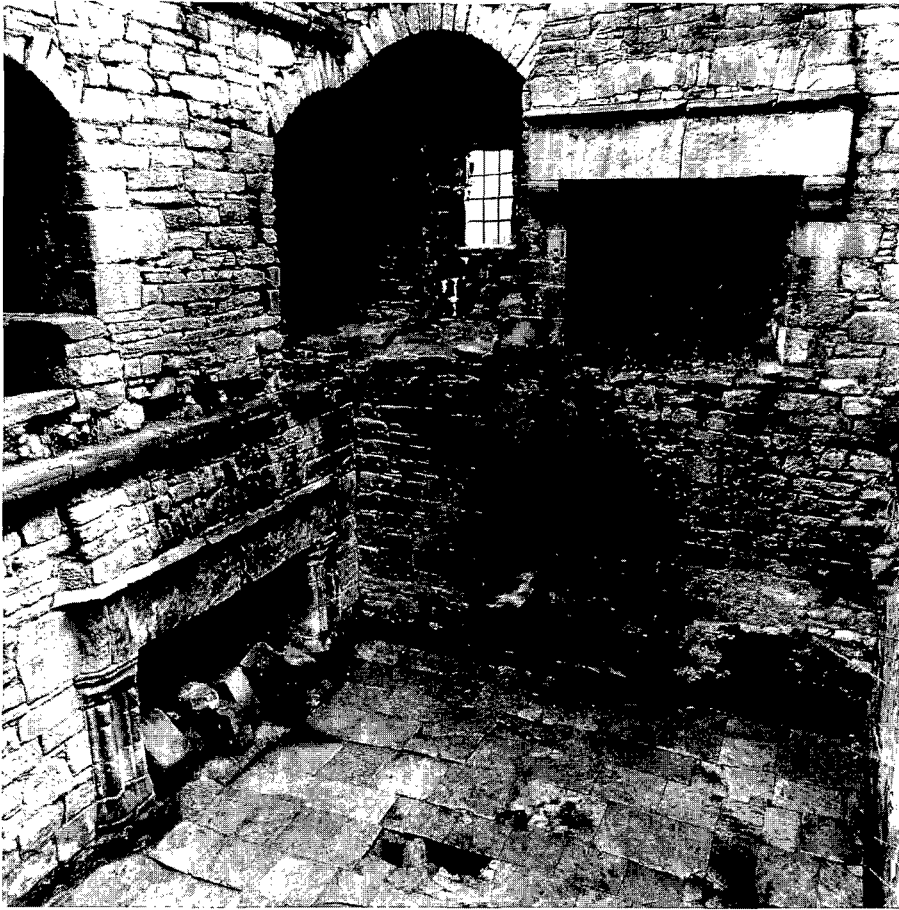
ILLUS 5 The first and second storeys of the tower, viewed from the south-west; the hall fireplace is on the left

Rubble, derived from the partly collapsed gables of the tower, was removed to reveal an almost intact flagged floor. The garderobe chamber in the north wall, the window recess and a private chamber set into the thickness of the west wall were also cleaned out.

The hall measured 8.1 m north/south by 5.7 m wide. It was floored with neatly cut sandstone flags, aligned east/west but of varying sizes. These were laid on a thick bed of red sand which overlay mortared rubble used to level up the room over the top of the vault below. On the east and west sides of the room, where the rubble infill was at its deepest, the floor had subsided slightly in places. No floor surface survived within the deep window embrasure in the west wall; in places the extrados of the underlying vault was exposed.

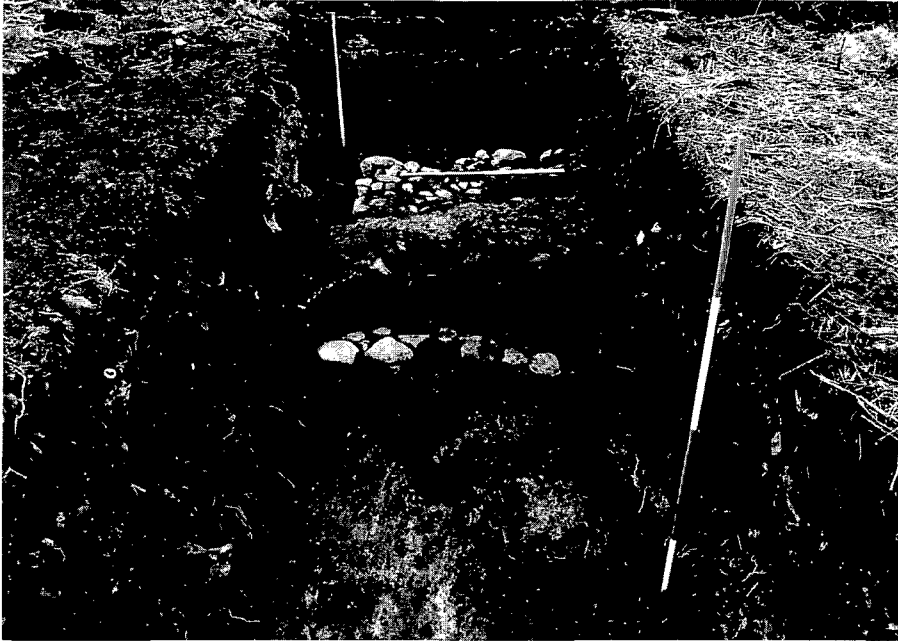
ILLUS 6 The cobbled surfaces outside the latrine outlet on the north side of the tower; viewed from the north

The earliest features to be uncovered within this trench were what appeared to be three post-holes, each 0.2 m in diameter and 0.1 m deep, forming a short line along the east side of the trench. They were exposed 1.6 m below ground surface; although it was not clear from what level they had been cut. To the west of the post-holes, and also cut into the subsoil, was a box drain, 0.3 m high internally and constructed of crude sandstone flags which were bonded and sealed with yellow clay. The drain continued beyond the northern limit of the trench. About 3 m from the north end of the trench the drain bifurcated, its western branch running towards the latrine outlet and its other arm seemingly aiming for the north-east corner of the tower.

It was not clear whether the drain had been intended to remove waste from the latrine outlet, but at some undetermined stage it went out of use when a cobbled surface was laid over it. These cobbles consisted mostly of rounded pebbles, up to 0.3 m across, bedded in a layer of fine, pale yellow sand with sandstone chips, 0.3 m deep. It was not possible to trace the full extent of the cobbling: it appeared to have been truncated by the recent intrusion; and excavation was incomplete adjacent to the tower. At some stage the metallised surface was raised when loam and sand were used to bed another set of similar cobbles. This surface was also truncated on its north side although it was well defined on its east. The layer of soil separating the two sets of cobbles extended into the latrine outlet, effectively blocking it. Sealing the upper cobbled surface and extending beyond its eastern limit was a thin, compact, spread of mortar. If both sets

of cobbles and the mortar spread were floor surfaces, it seems likely that they were associated with different structures, or a structure which was rebuilt.

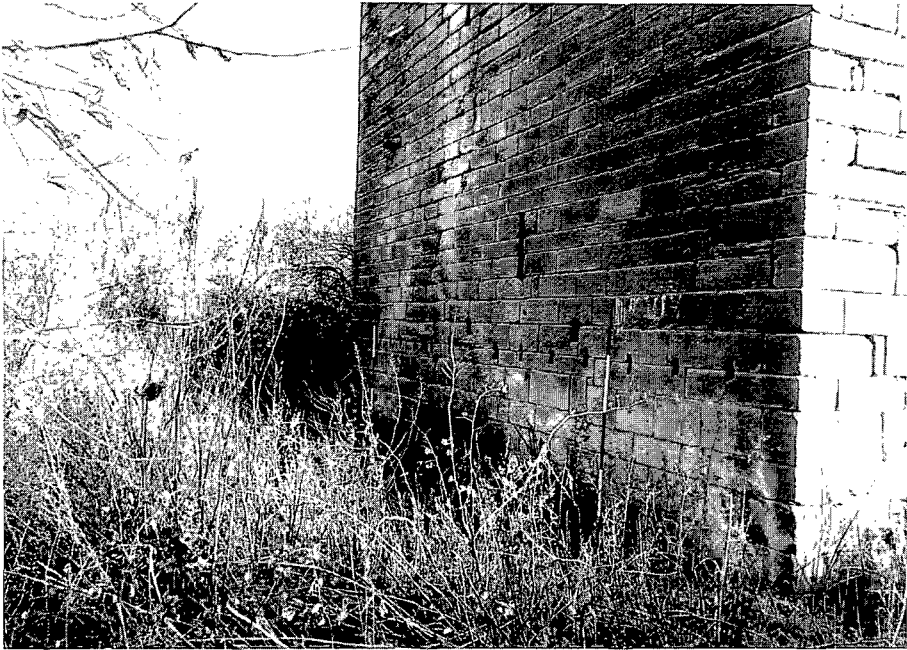
ILLUS 7 The north face of the tower showing timber sockets associated with at least one building formerly set against it

Measuring 5.5 m north/south by 2.0 m wide, this trench was opened mid-way along the outer face of the north wall in an attempt to locate the outlet of the latrine chute leading from the tower's first- and second-floor levels. It was also hoped that this investigation would help clarify the nature of two outbuildings apparently built against this side of the tower. On the evidence of a row of small sockets cut into the wall along most of its length, one of these structures was a lean-to building; the other structure appeared to have been a much smaller, gabled building whose outline could still be discerned in 1984. It is not clear how these two structures were related chronologically.

sets of cobbles appear to have been laid down after the abandonment of the latrine chute and, by inference, the first floor hall of the tower and the storey above it. It is not immediately obvious why a lean-to structure of some substance (at least on the evidence of its roof timber sockets) should be built against the tower (illus 7), while its main chambers lay empty. It is possible that after 1631 the ground floor of the tower became an animal house or a store, perhaps associated with a nearby farm, whereas the building's upper storeys, being less than ideal for such roles, were abandoned.
