#### 4. ROAD SYSTEM

##### 4.1 Link road to the fort (Area C)

#### 4.2 Bypass road and its ditches (Areas B, C, G, K, L)

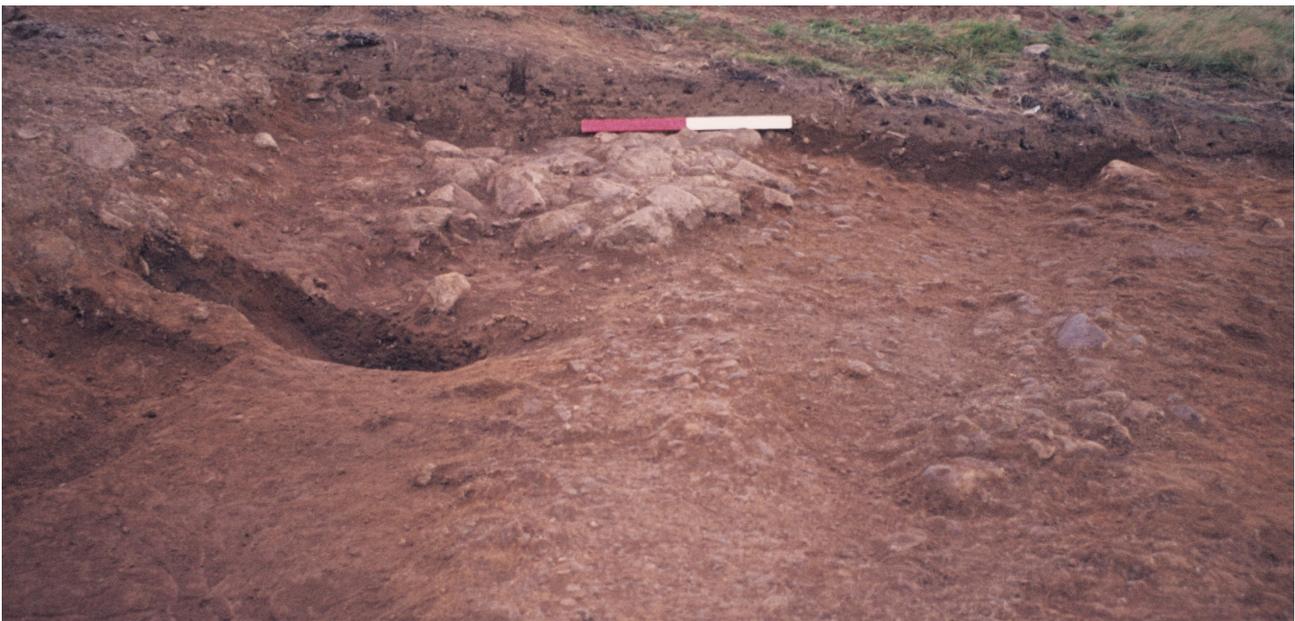
**Illus 4.1** Road surface (CCS) and overlying cobbling (CCP) from south. An excavated Macdonald trench confirms the line of the enclosure ditch (CAB) running beneath the cobbling

At some point the ditch on the east side of the enclosure was deliberately backfilled (see 2.1 and 2.4, above), its northern limit within the excavated area sealed by an area of heavy cobbling (CCP) some 2m by 2.5m in extent (Illus 2.1, 2.4 and 4.1). This presumably is all that survives of the rubble core of a new, slightly more westerly road alignment whose upper metalling has been lost to the plough.

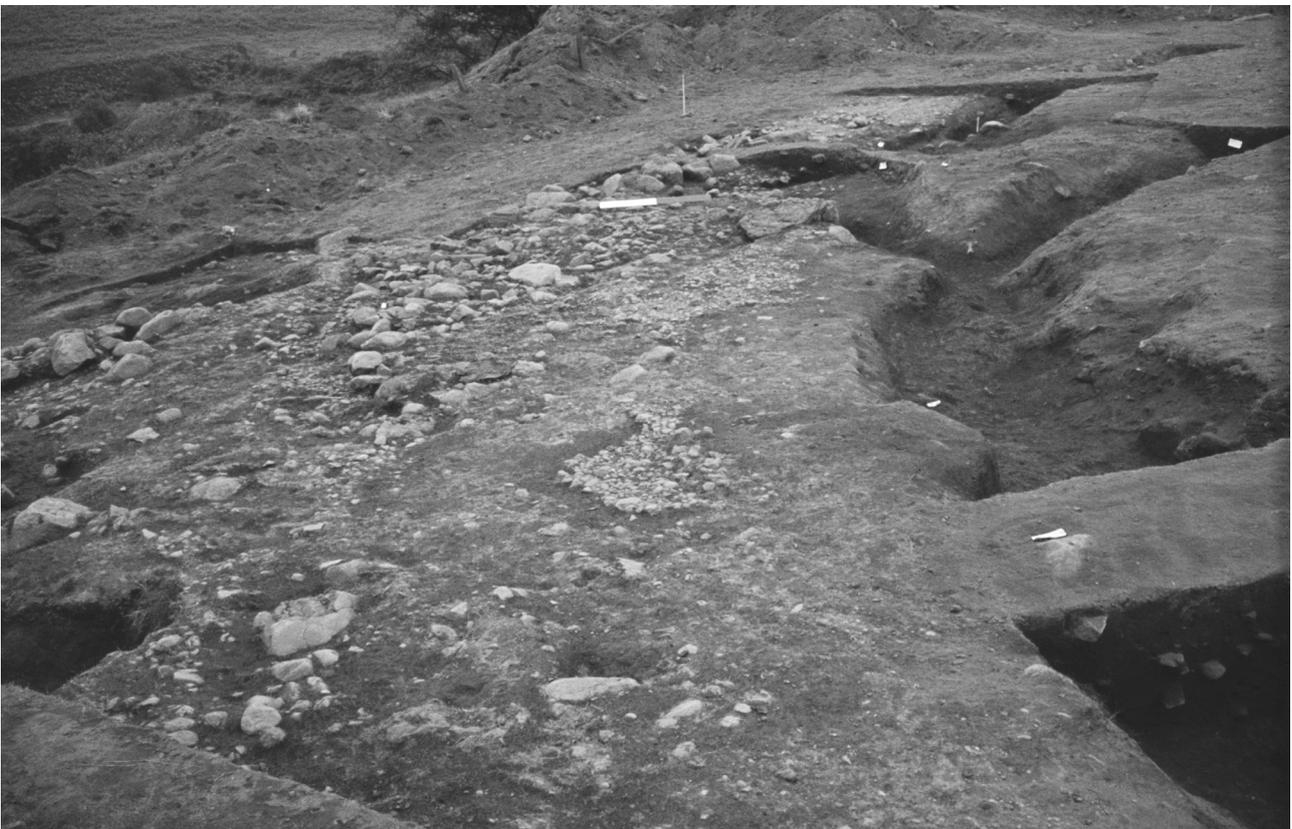
**Illus 4.2** Intersection of south-east corner of enclosure ditch and road ditch from north. Patches of surviving metalling of the link road are apparent in the foreground with the surface of the bypass road in the background

Slight traces were identified, however, some 17m further down the slope where they had been protected by soil creep and the proximity of a dry-stone dyke (Illus 4.2). Again, the remains appeared to skirt the eastern edge of the enclosure ditch and consisted of intermittent patches of compacted light metallising with occasional larger stones that merged into the bypass road (CCR) (see 4.2, below) a further 5m to the south. The remains were partly concealed beneath the stone dyke and too fragmentary to calculate the road width with any accuracy, but the gap between the south-eastern corner of the enclosure ditch and the start of a drainage ditch (CCT) on the north side of the bypass road to the east would have readily facilitated

Much of the surface of the bypass road at the T-junction with the link road to the fort was quite badly preserved. The later phase had been largely ploughed away, with only scattered large stones and small areas of disturbed metalling (Illus 2.1 and 4.2). However, preservation seemed to improve as the investigation moved westward, with larger areas of compacted metalling of the primary phase road surviving beneath patches of damaged metalling immediately west of the junction, though this primary phase also showed signs of possible filling of a pothole (Illus 4.4). In a small section of road uncovered some 17m further west, a well-preserved surface of compacted small stones was recorded with a neat kerb of larger stones and even signs of wheel ruts (Illus 2.1 and 4.5). This was not sectioned, but presumably represents the secondary phase of construction, as in another cut through the overlying silts slightly closer to the T-junction

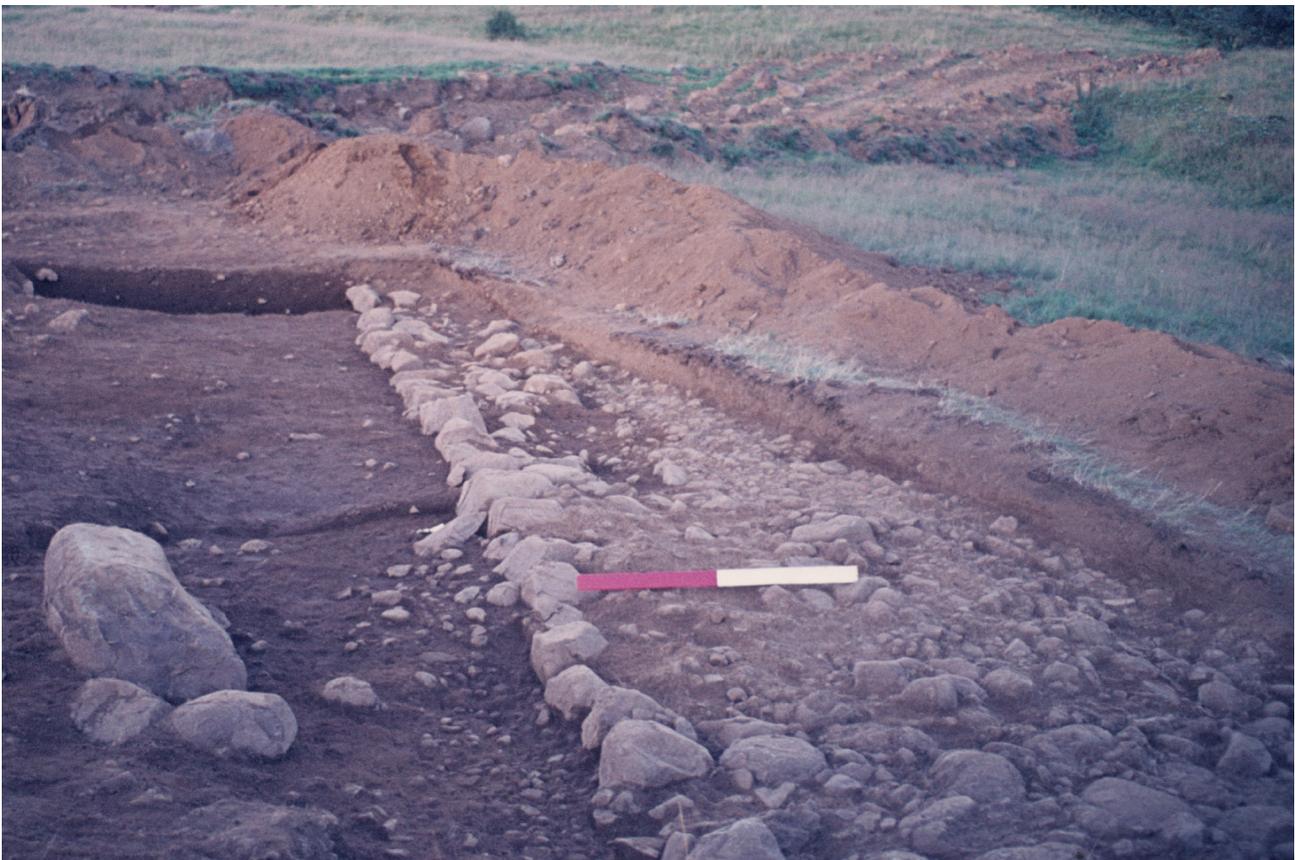
**Illus 4.3** East section of road (CCR) from west showing earlier surface (CAE) projecting beneath later stone kerb in the foreground and section through drainage ditch (CAA/CCZ) in the background

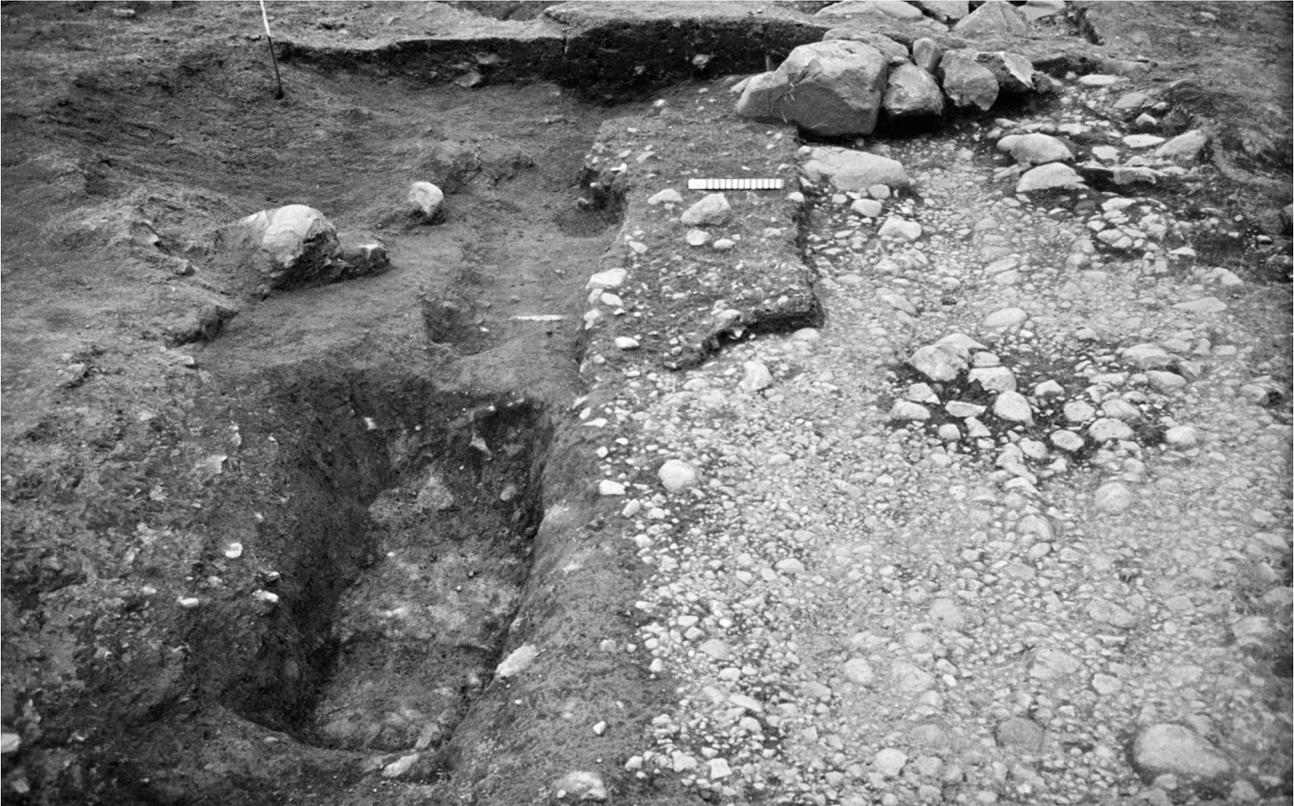
**Illus 4.4** Well-preserved section of metalling of primary road surface and associated drainage ditch (CCK) immediately to the west of intersection with link road to the fort, from south-west. Some large displaced kerbstones and a patch of later damaged metalling are apparent (top centre), with a probable pothole repair to the primary surface (centre right)

The bypass road was first encountered down the slope running along the southern limits of the trench opened in the first season and was very well preserved in places, where it had been covered with hillwash (Illus 2.1, 4.4 and 4.5). A length of 27m was exposed (CCR) immediately outside, but running at a slight angle to, the south side of the enclosure and continuing beyond it to the east. The road came closest to the pre-fort enclosure ditch at the south-east corner, where it formed a T-junction with the link road to the fort (4.1, above). Its western continuation immediately south of the enclosure was tested by extending two sections through the enclosure ditch to the south and clearing the hillwash from an area at the south-west limit of the excavated trench.

A drainage ditch was recorded to the north of the road along the whole of its excavated length both east and west of the T-junction (Illus 2.1, 4.4 and 4.5). It was sectioned in several places on the west side (BBS, CCW, CCK, CCV) with varying widths and depths recorded, but was generally 1m–1.4m wide and only 0.25m–0.45m deep, filled with yellow-brown sandy silt. As already noted above, it ran into the south-east corner of the enclosure ditch on the west side of the T-junction (Illus 4.2). To the east of that junction the ditch showed similar dimensions and characteristics. The curving butt end (CCT) by the road junction and two further sections (CAC and CAA/CCZ) were excavated. Here the ground sloped away quite markedly to the

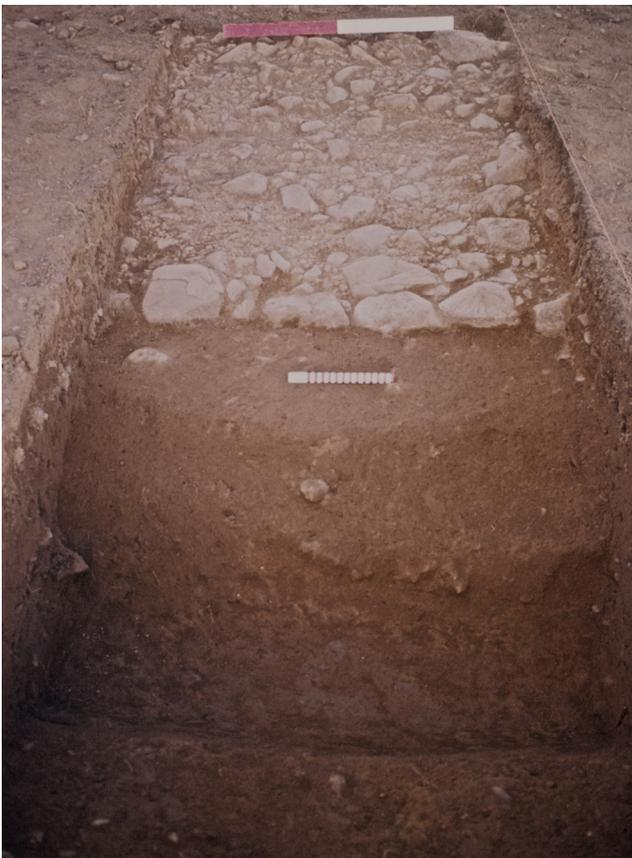
**Illus 4.5** Well-preserved surface of bypass road to south of the pre-fort enclosure in Area B/C showing wheel ruts and associated drainage ditch (CCW) to the north

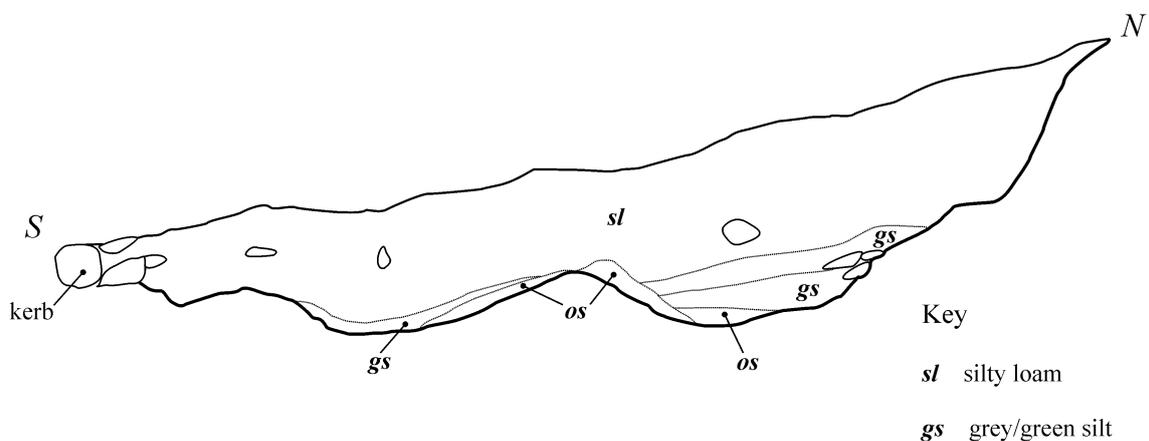
Illus 4.6 Section through drainage ditch (CAC/CCZ) north of the bypass road in Area C

south and east, and drainage had probably been a problem as there was evidence both of the provision of a shallow double ditch (CAC/CCZ) (Illus 4.6) and a considerable build-up of silt, up to 0.2m deep, against the side of the road (CCY).

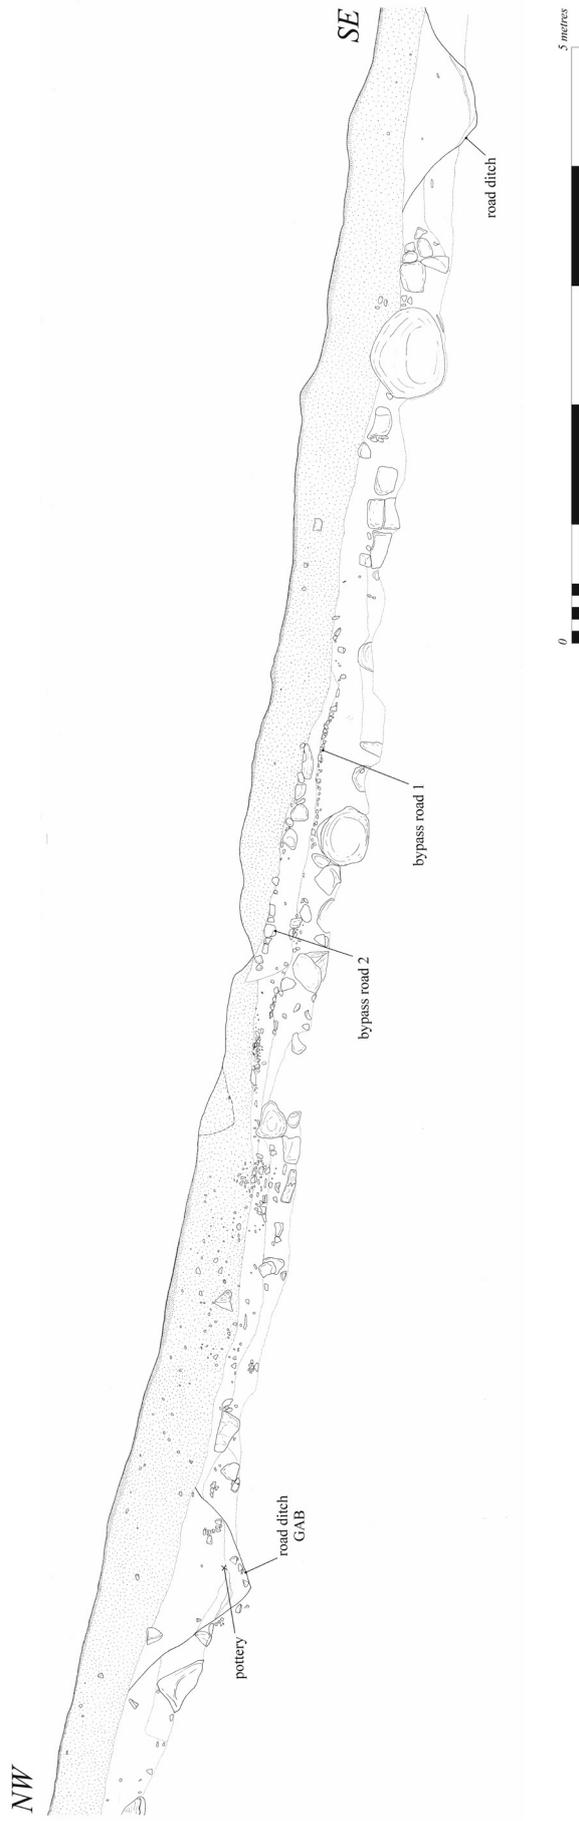
Illus 4.7 Section through two-phase bypass road and associated drainage ditches on north-east side of quarry test excavation trench

The following season the line of the bypass road was sought further to the east. Its alignment was picked up first of all in section on the north-east side of the large quarry test trench where two phases were again apparent, though by this point their relative spatial relationship had changed, with the primary phase starting some 0.75m further south (Illus 1.2 and 4.7). Allowing for the obliquity of the section and the state of preservation of the remains, the primary phase was *c* 2.5m wide and the secondary phase *c* 2.85m. This was the first occasion when drainage ditches were revealed on both sides of the road. Both were V-shaped and more substantial than those examined further to the west, *c* 1.2m wide and up to 0.66m deep. Successive layers of silting filled the bottom 0.25m of the north ditch (GAB), sealed by a more homogeneous layer of sandy silt. Quantities of coarse ware were recovered from the very bottom of this upper fill during cleaning.

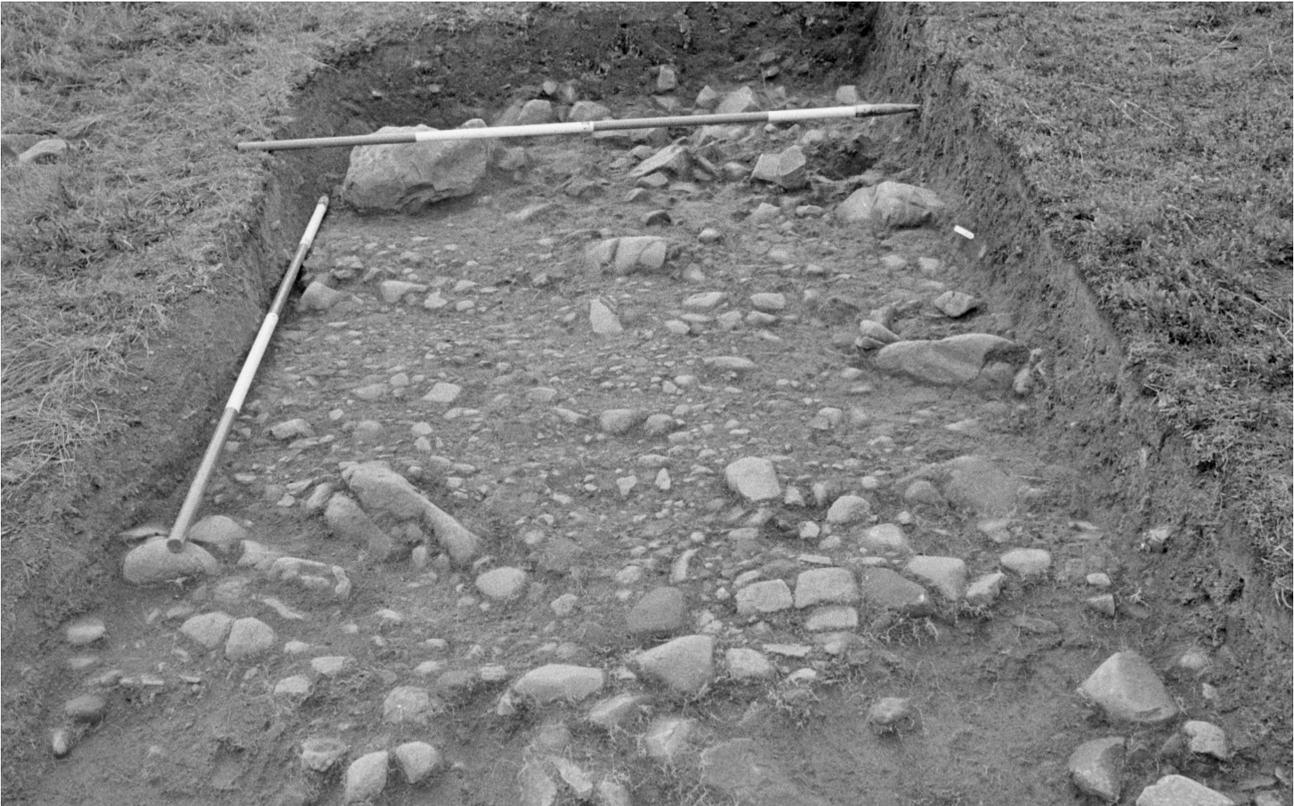
**Illus 4.8** Well-preserved section of road surface (GBF) from the west

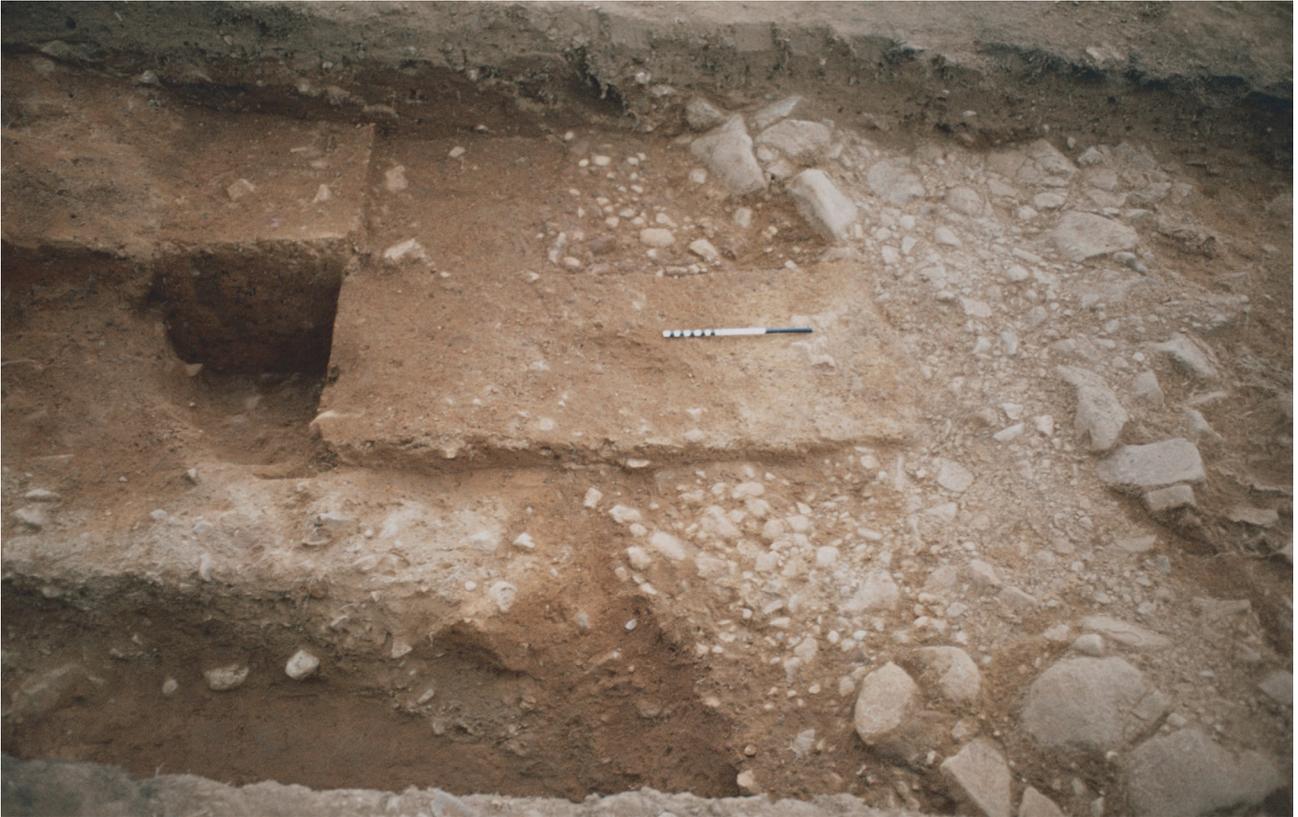
**Illus 4.9** Well-preserved section of road surface (GBO) with segmented road ditch (GBP and GBL) to the left

pebbles interspersed with a few larger stones (GBO) (Illus 4.9). The immediately adjacent roadside ditch, which varied between 0.75–1.6m wide and 0.2–0.38m deep, was not continuous but apparently segmented, coming to a butt end in both trenches (GBI and GBP/GBL). The short, very narrow gap created by one pair of the butt ends coincided with the beginning of a shallow gully or fence line (GAI/DAD) 1.8m to the north (see 5.1, below). Despite extensive excavation to the north and east, no further evidence was found for the continuation of the line of the road.

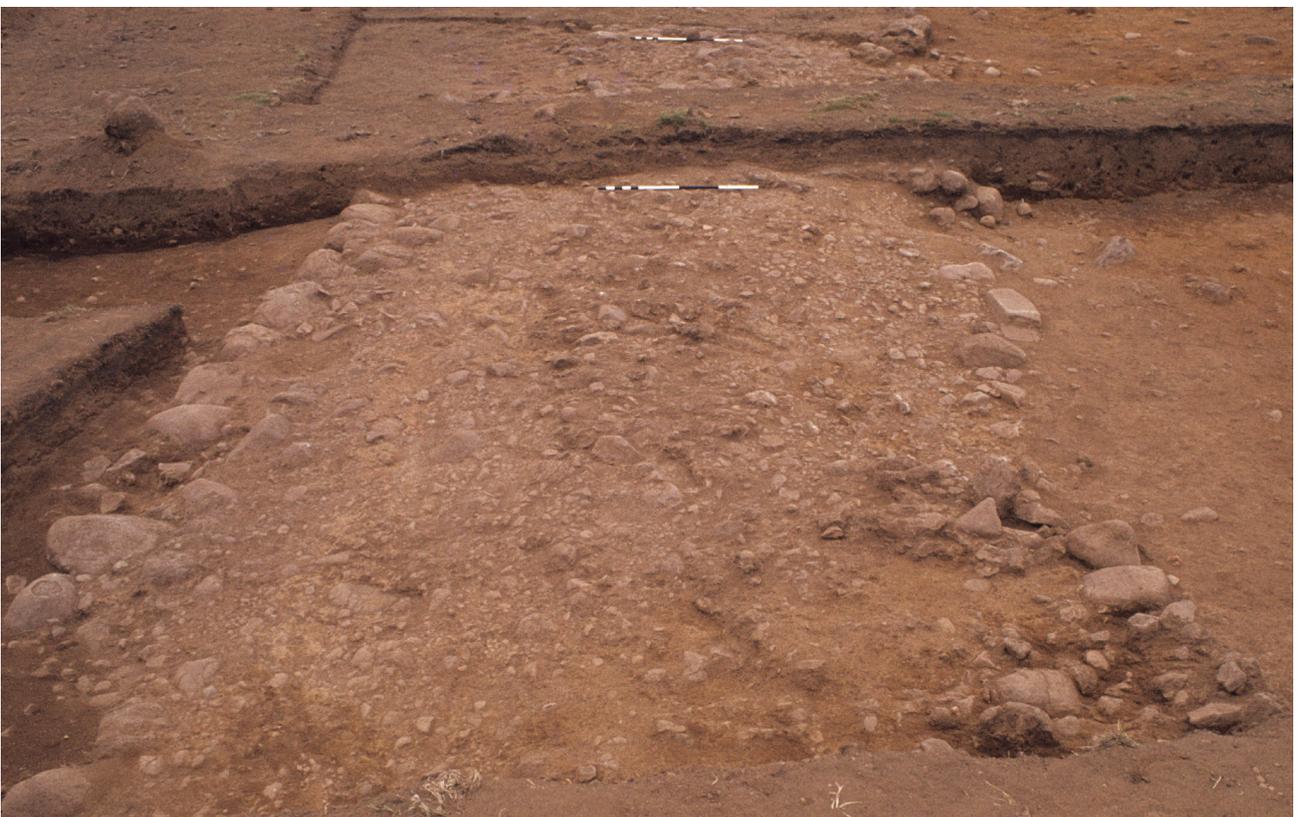
**Illus 4.10** Well-preserved section of bypass road (LBZ) in Area L from the east

The best-preserved section of the bypass road (LBZ/LCC) was uncovered to the south-west of the fort (Illus 4.10 and 6.1), south of the postulated focus of the *vicus*, where it had been protected by a substantial build-up of hillwash (LBX). It was 4.2m wide and consisted of a slightly cambered surface of compacted small and medium-sized stones, set between a kerb of large, irregular stones (representing Phase 2/3 noted below). It had been preserved for a distance of some 28m before petering out where the plough had taken its toll as the ground rose to the west, its alignment confirmed by the

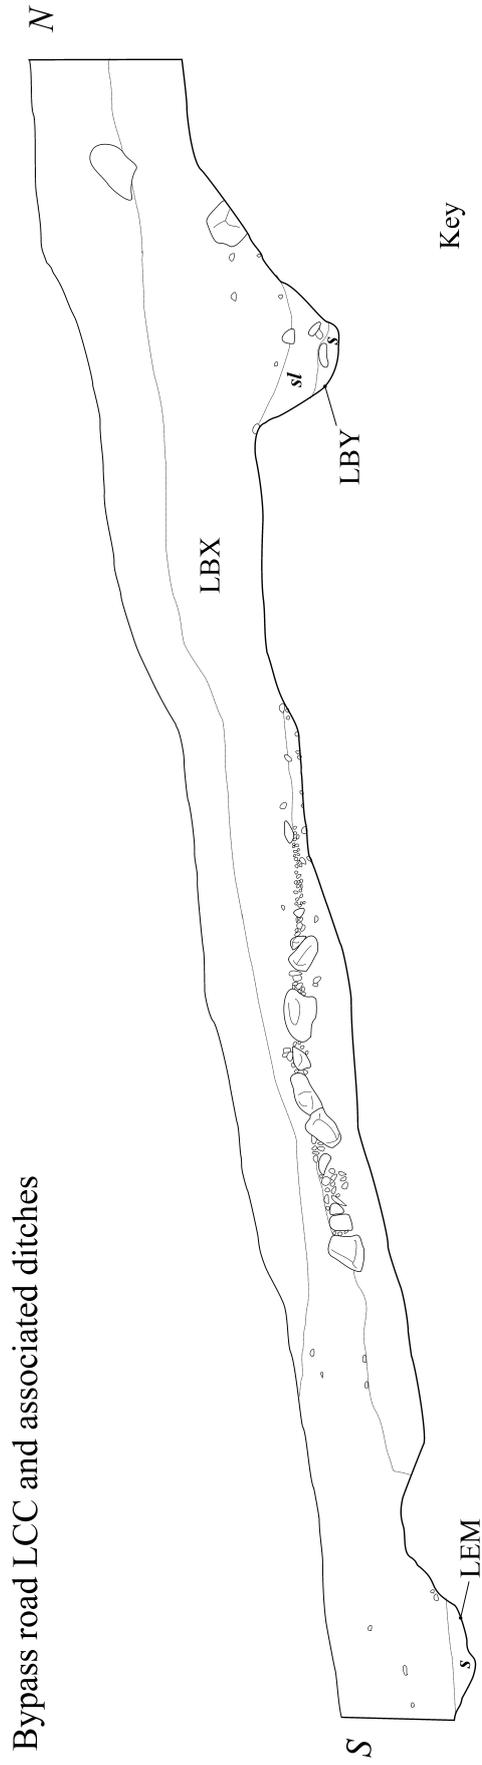
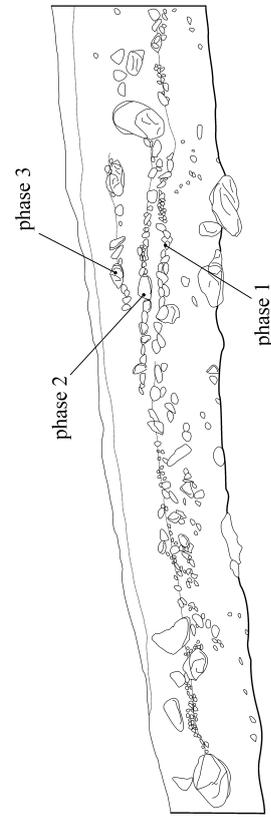
Bypass road LBZ

Illus 4.11 Sections through the bypass road: top: LCC and associated ditches, LBY and LEM; bottom: LBZ, showing three phases

continuation of the associated northern drainage ditch (RCC/RCH – below). Sectioned in two places (Illus 4.11) the road revealed traces of two phases of resurfacing which survived primarily in a narrow strip on the north side. The earliest road, which lacked a kerb, projected 0.5m further north than the later alignment, as had been observed also on the east side of the pre-fort enclosure (CCR above). It consisted of a well-made surface of small, rammed, water-worn pebbles. Traces of wear in the form of a wheel rut were noted sealed beneath the secondary surface of similar character which butted against a kerb of large, irregular stones. This surface was in turn overlain by a further, less coherent layer of slightly larger stones.

Associated with the road on its north side was a ditch (LBY/LCG) 1–1.3m wide and generally U-shaped, 0.5–0.73m deep (Illus 4.11). It was contiguous with a drainage ditch (LBR/LBT) running down the slope from the north (see 6.2, below) the two joining almost at right angles (LBW) (Illus 4.12 and 6.1). After a gap of *c* 6m the road ditch continued westwards and again linked into a ditch draining downslope (LDE), though this time

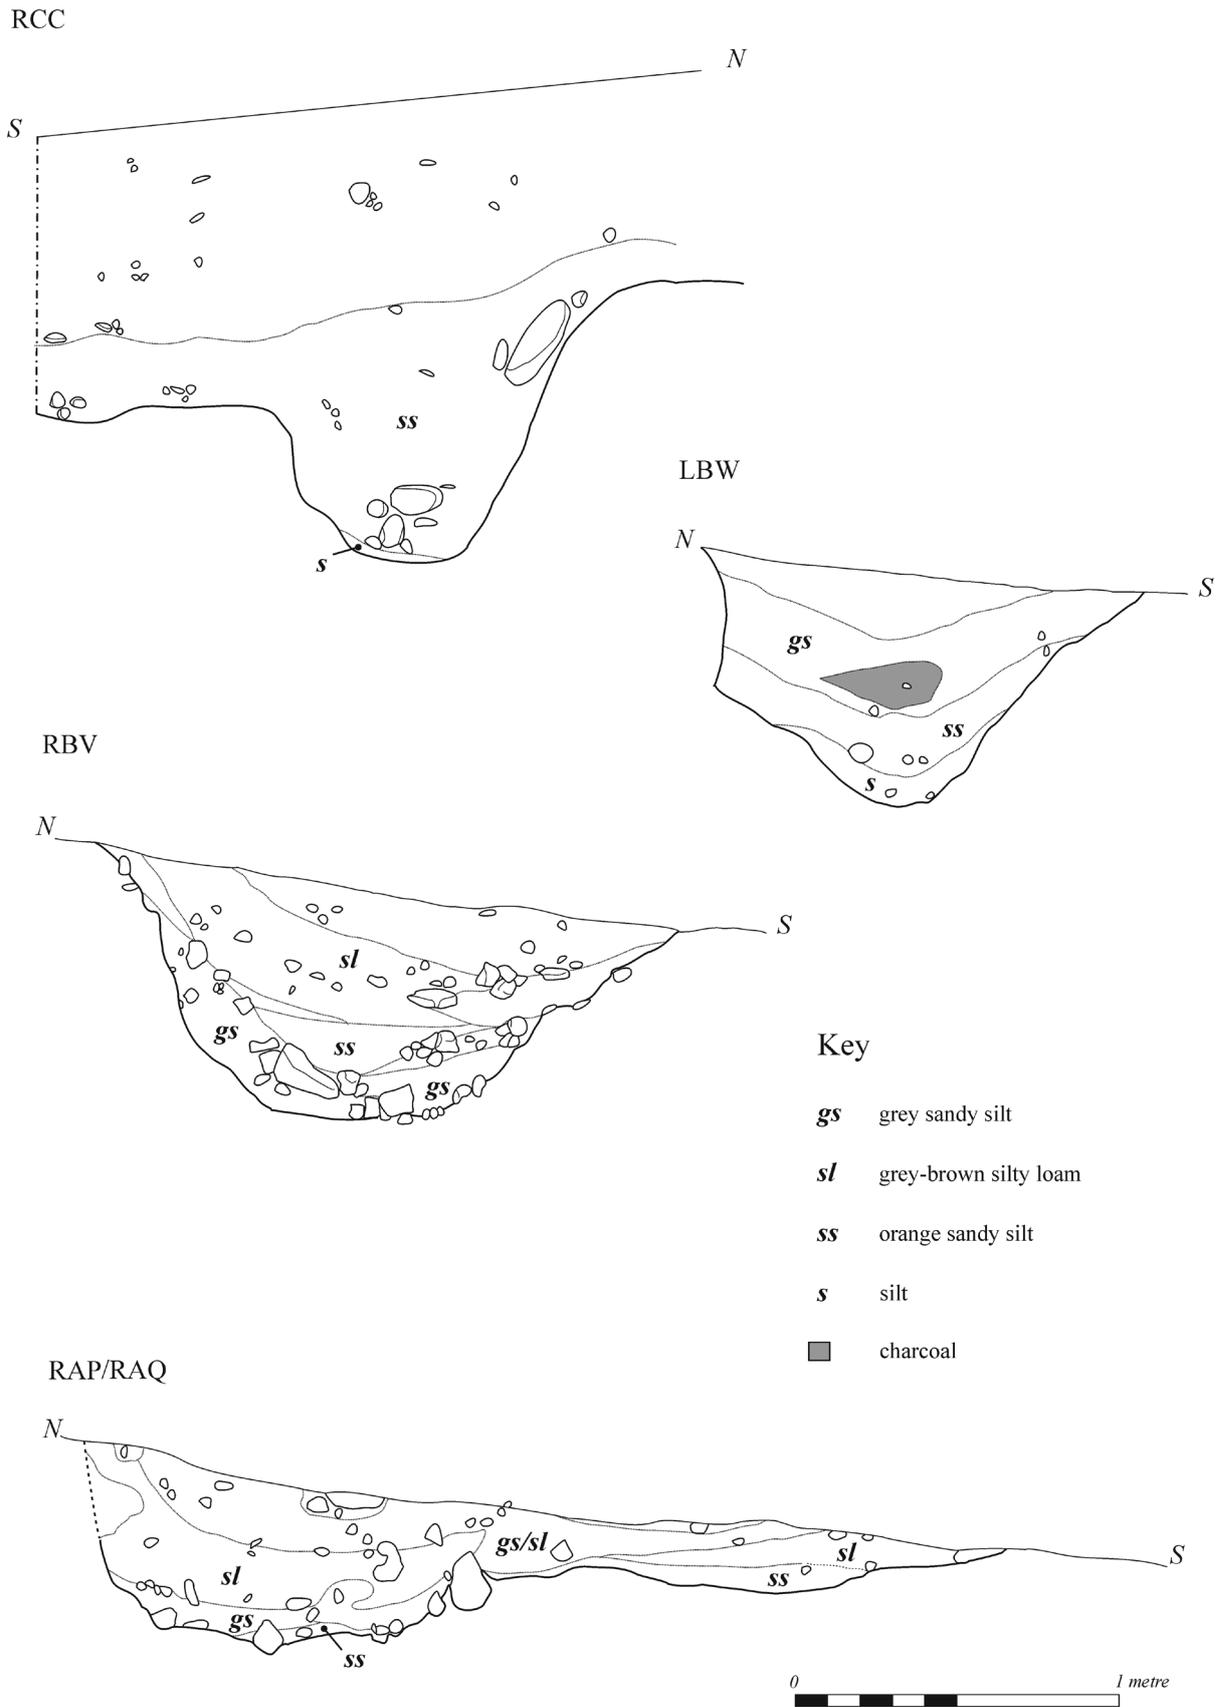
Illus 4.12 Sections of ditches on north side of the Phase 2 bypass road in Areas L and R

This western continuation of the northern road ditch (LEA/LCX/RAO/RBV) came to a butt end after 11.5m (Illus 6.1 and 6.6). It was generally large, 1.6–2m wide and 0.65–0.75m deep, U-shaped with quite steep sides, and filled with layers of silty sand and loam with scattered stones (Illus 4.12). Beyond that it seemed to be made up of a series of conjoined delvings (RAP/RAR), including one that was offset to the south (RAQ), though this may be much earlier in date (see 7, below). This irregular stretch of road ditch ranged in width from 1.1m

to 1.9m and in depth from 0.5m to 1m, and again came to a butt end after 11.5m. Beyond that the line continued for a further 23m (RCH/RCC), but was sectioned in only three places (Illus 6.1). The ditch here was 1.4–2.3m wide and 0.7–0.85m deep, with a steep-sided U-shaped profile (Illus 4.12) filled with sandy silt. The corresponding ditch on the south side of the road was detected only in section at the east end of the excavated area (LEM) (Illus 4.11 and 6.1), where it was *c.* 1.2m wide and 0.35m deep, largely filled with and overlain by hillwash (LBX).

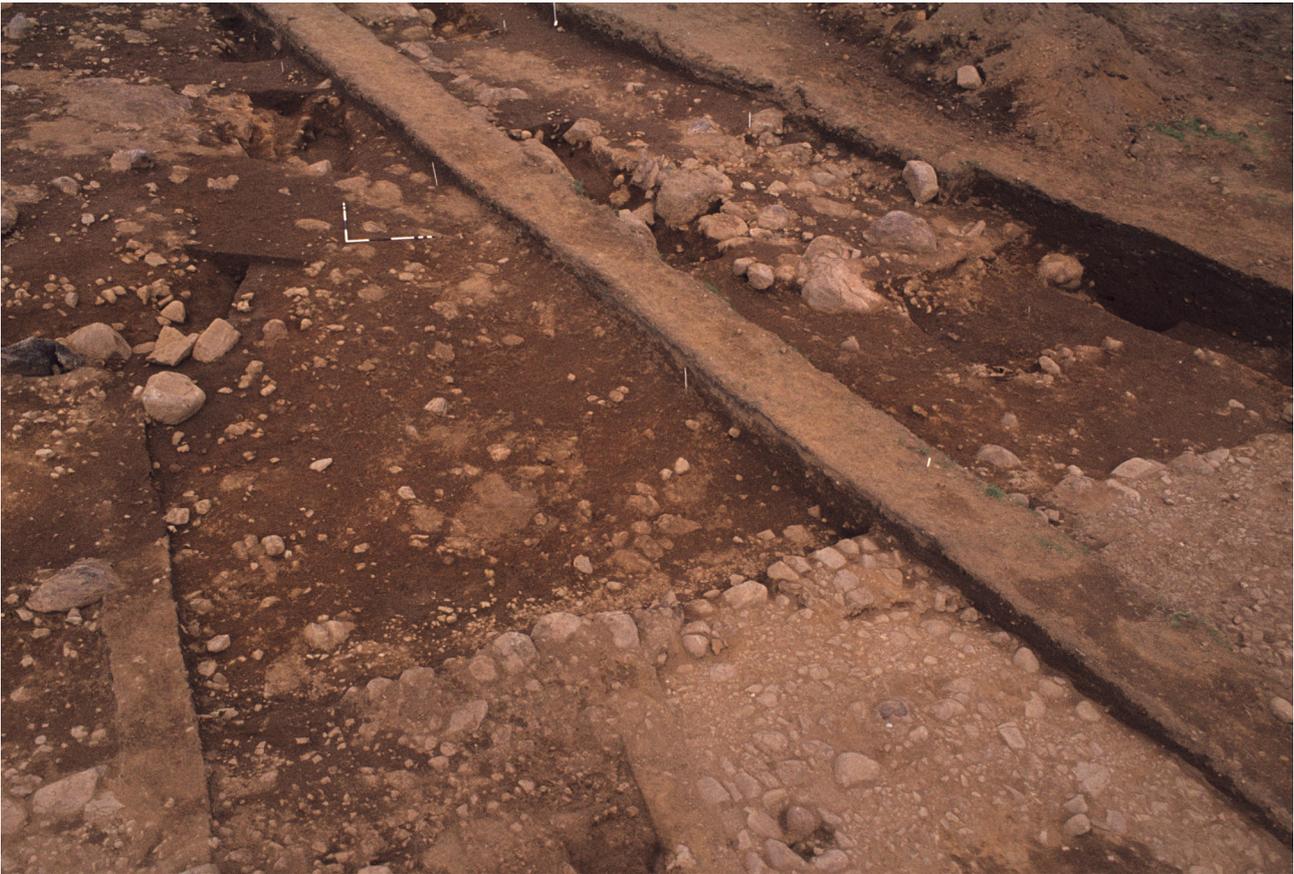
**Illus 4.13** Intersection of road ditches (LEA and LBW/LCG) with curvilinear trackway drainage ditches (LDE/LCT and LBT/LBR) north of road (LBZ) from south

the intersection followed a more gentle curving alignment. The gap between the two ditches (LBR/LBT and LBS/LCT/LDE) is suggestive of a road junction leading north directly into the main area of the *vicus*, but no metalling was observed and there was no break in the kerb of the bypass road (see below) so it may have been just a ditch-defined path or trackway (Illus 4.13). The northern end of the proposed trackway aligns well with the curvature of the *via principalis* as it exits the west side of the fort (Illus 1.2).

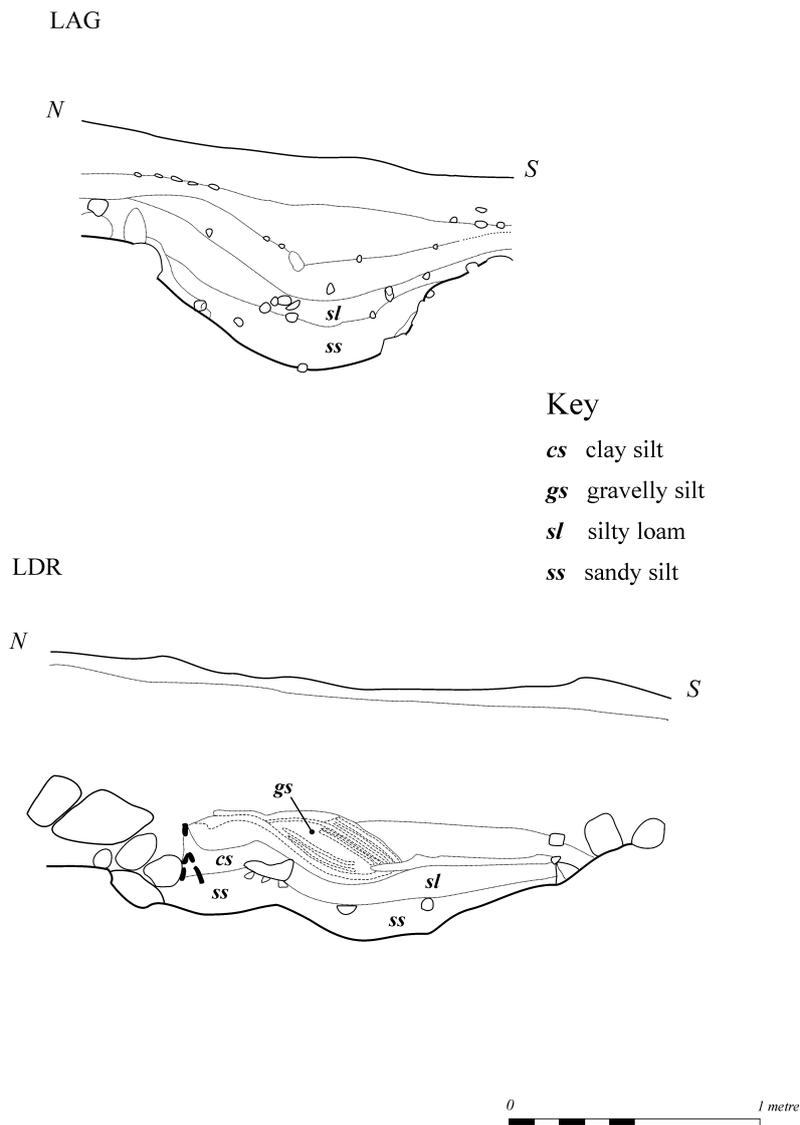
**Illus 4.14** Sections of ditches associated with the Phase 1 bypass road in Area L

(LDR) 1.05–1.4m wide and 0.4–0.45m deep. Both ditches were filled with silty sand/loam, the southern ditch revealing a series of more gravelly lenses in section, which presumably reflect wash from the original road surface (Illus 4.14). There were also indications in one section of LDR of an earlier, smaller ditch, only *c* 0.6m wide and 0.25m deep, closer to the road on the south side. No stratigraphic relationship between the two parallel roads could be established, but all the other trenches draining down the slope (see 6.2, below) relate to the more northerly line, while the southerly example was less well preserved and showed no signs of more than a single phase, other than in its southern ditch, so may represent an earlier alignment that was abandoned.
