6. CIVIL SETTLEMENT (*VICUS*)

6.1 Structural remains

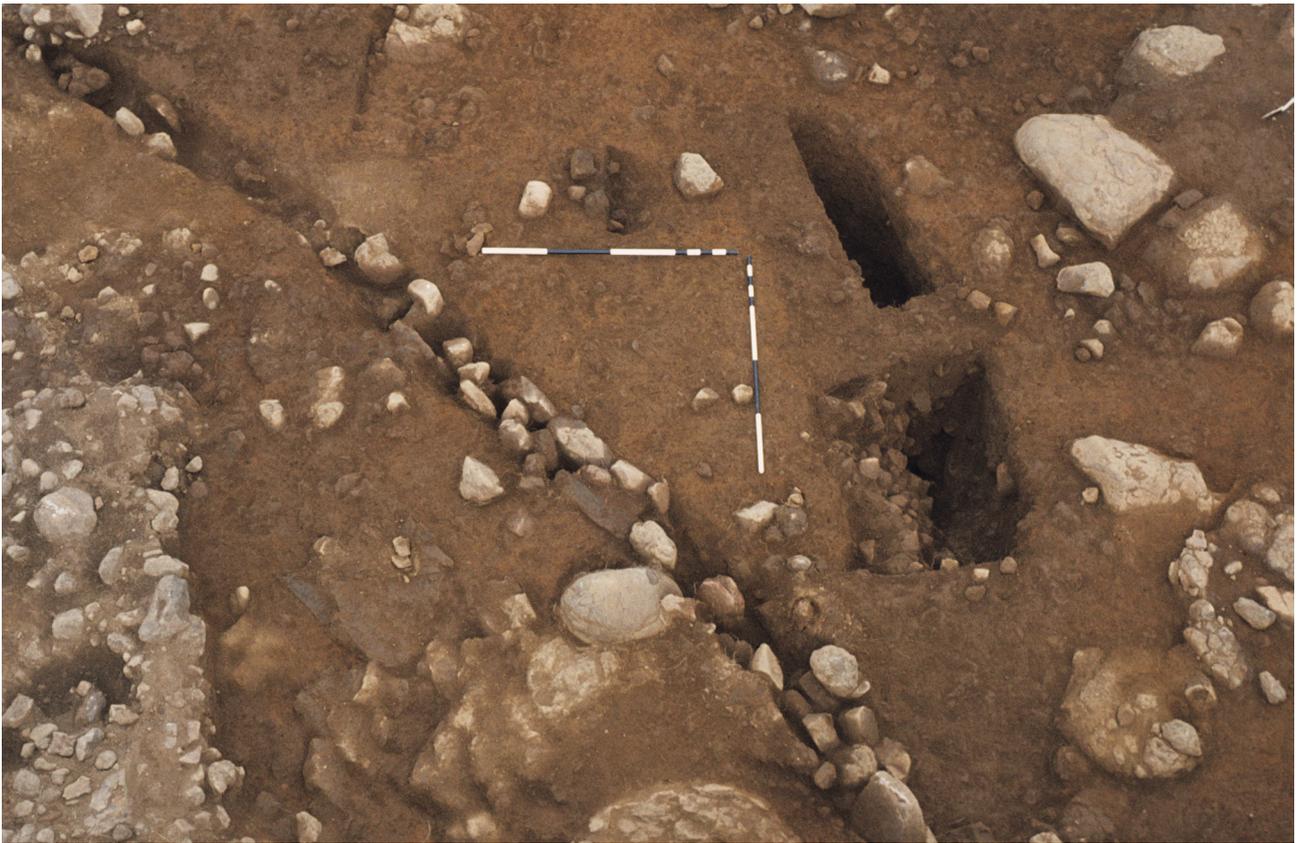
Illus 6.3 Western end of rectangular structure from the north-west, showing intersection of its south wall slot (RAF) with the palisade trench (RAB); post hole (RBC) and probable west wall slot (RAZ). The post-medieval field dyke, here partly removed, runs up the left-hand side

At the northern limit of Area R, overlapping the Iron Age palisaded enclosure (7.1, below), were remains of a rectangular, subdivided and apparently open-ended structure aligned east/west (Illus 6.2). Its maximum recovered dimensions were 12.5m by 4.6m, assuming all the different structural elements described below are related. The east/west alignment of a 10.15m-long slot (RAF) may have been continued by a single post hole (RBC) some 0.6m from its western end. The fill of RBC contained

a number of medium-sized stones, perhaps the remains of packing (Illus 6.3 and 6.4; Table 6.1). Slot RAF was slightly irregular, quite wide (0.5–0.8m) and shallow (0.1–0.2m), with fairly straight sides and a flat bottom, containing a high proportion of small stones in its fill (Illus 6.4 and 6.5). Abutting it at right angles, 3.8m from its eastern end, was another slot (RAG) with very similar characteristics, though slightly less wide (0.4–0.65m). It ran for 3.85m before disappearing into the northern edge of the excavated area. Three contemporary post holes (RAL, RAK, RAI), similarly packed with small stones, were appended to it, two on the west side and one on the east (Illus 6.4 and 6.5; Table 6.1). The north/south distance between the post holes varied between 0.35m and 0.8m centre to centre. A narrow slot (RCE) with a very stony fill, 0.15m wide and only 60mm deep, emerged from the baulk and ran parallel to RAG for 0.9m and seems likely to relate to the structure. It was situated 3.5m west of RAG, the distance between them split equally by a small post hole (RCF) (Table 6.1) (Illus 6.2 and 6.5). A further 4m to the west a discrete 3m-long, slightly curving trench (RAZ) may have formed part of the western wall of the structure. It was 0.6m wide, though tapering towards its northern end, and 0.55m deep with vertical sides (Illus 6.3 and 6.4). Both the latter characteristic and its fairly homogeneous sandy-silty-loam fill, differentiated only by slight variations in colour and the varying proportion of small stones, suggested it had been deliberately backfilled.

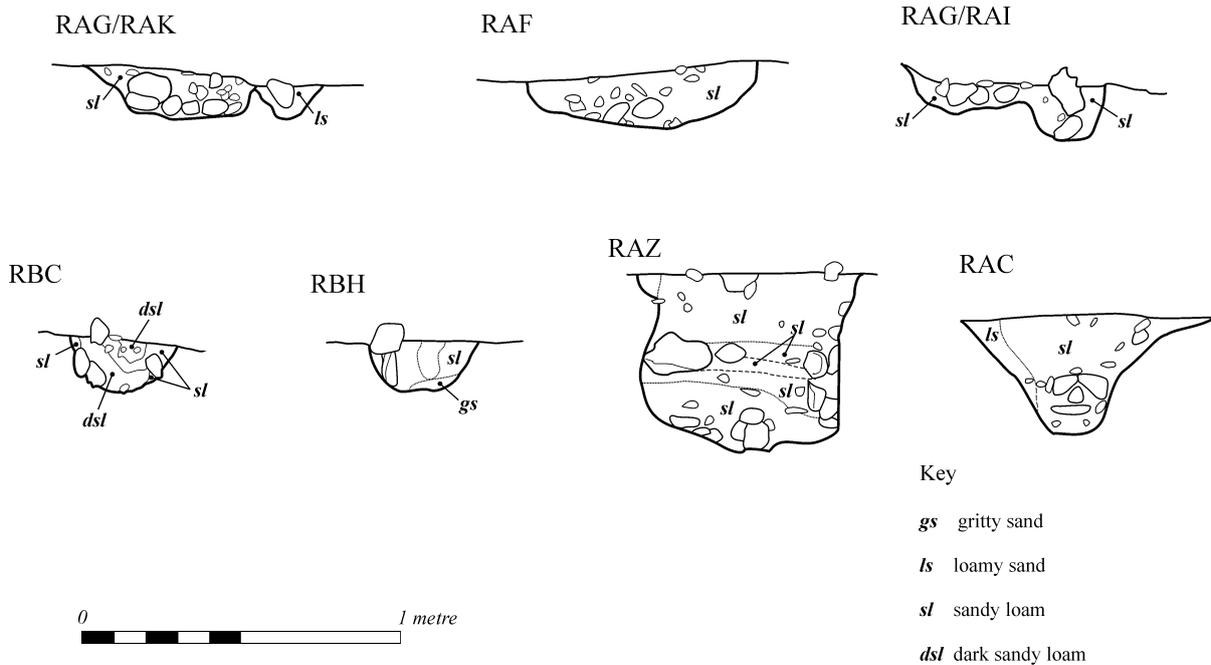
Illus 6.4 Sections through Roman structural features, Area R

approximately 140mm by 60mm in cross-section (Illus 6.2 and 6.4; Table 6.1). If the latter two post holes were associated, they would have maintained the same north/south alignment as the building.

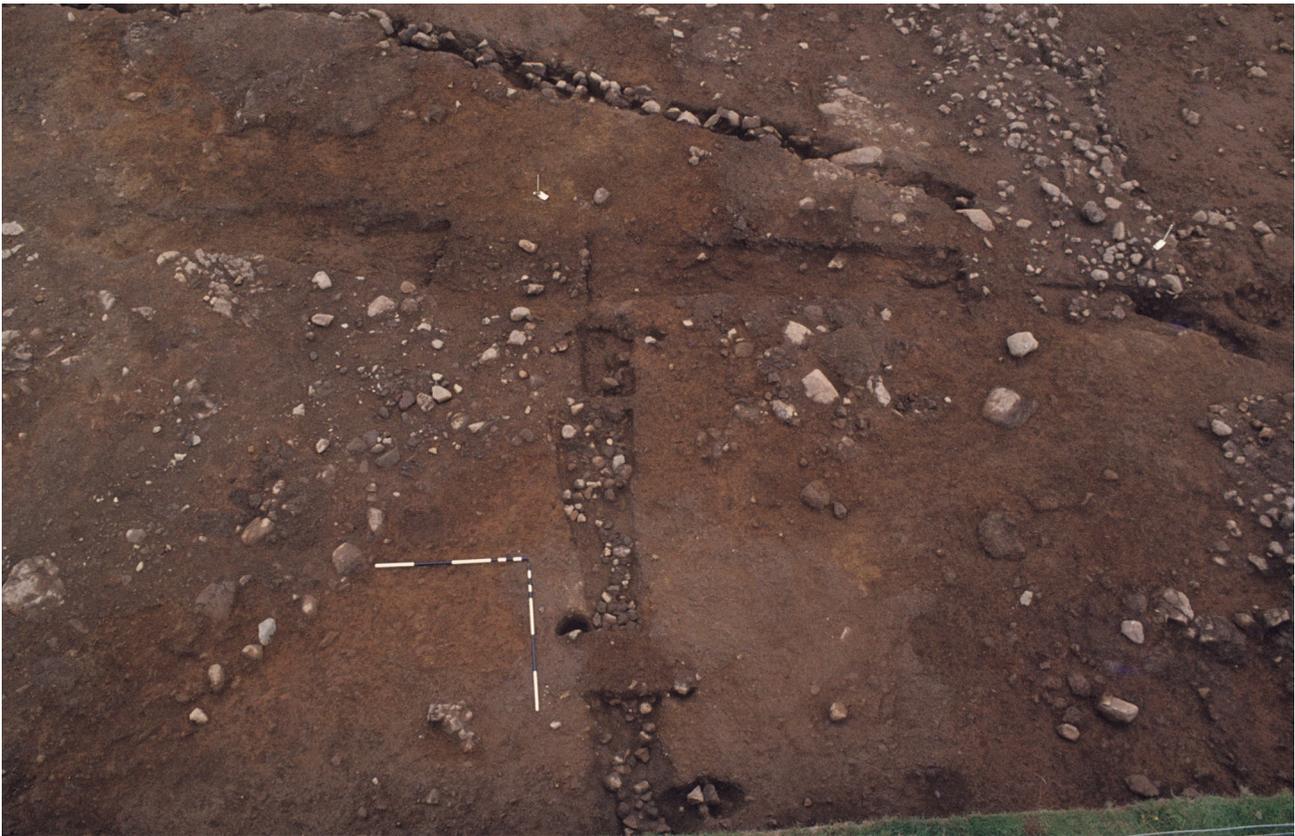
Illus 6.5 Central part (RAF/RAG) of rectangular structure and associated post holes (RAI/RAK/RAL) from the north. Part of the palisade runs obliquely across the top of the photograph and the base of a post-medieval field dyke (partly removed) is visible to the right. Post hole RCF and Slot RCE are visible as unexcavated features (bottom right), while traces of a metallised surface (RAT) are apparent (centre left)

An imprecisely defined surface of light metalling with some heavier cobbles (RAT) to the east of RAG extended beyond the eastern end of RAF and may have been an associated floor or area of hard-standing (Illus 6.2 and 6.5). In places the surface overlay the slots RAG and RAF. The latter slot intersected with the palisade trench (RAB) at the point where both underlay the denuded remains of the post-medieval field wall (Illus 6.2 and 6.3), making it difficult, given the shallowness of RAF, to establish their relationship. However, some 7m to the east a Roman period gully/fence line (LET/RAC) clearly cut the palisade trench (7.1, below and Illus 7.3) and several finds from the three construction slots (RAF, RAG and RAZ), including nails, sherds of coarse ware and a fragment of a pottery lamp, attest to the Roman date of the structure.

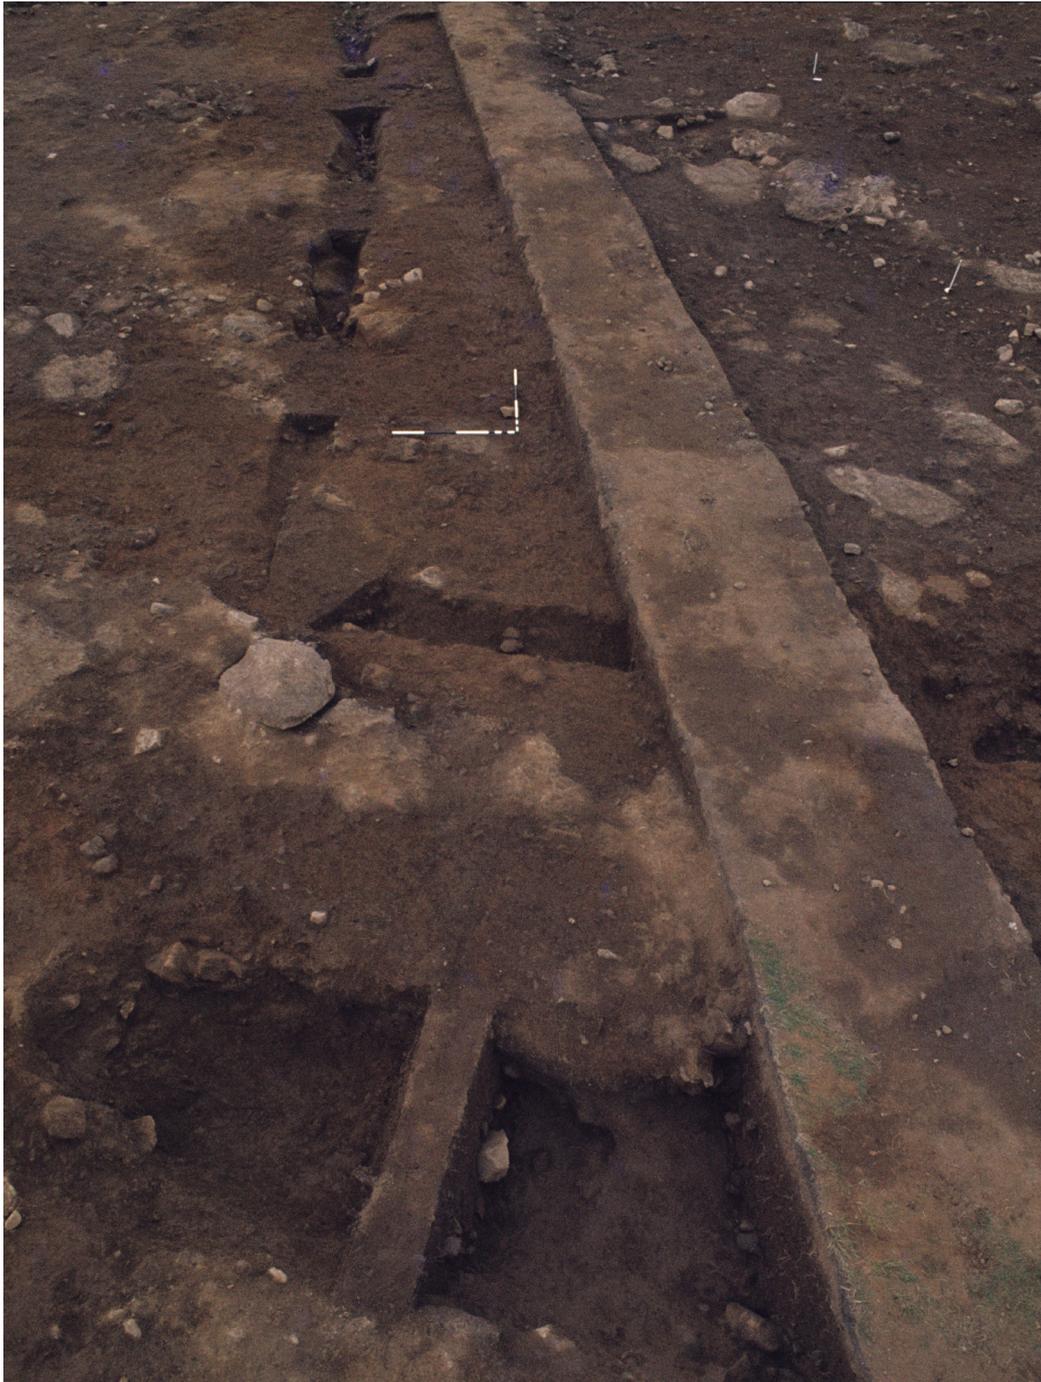
Illus 6.6 Line of Gully/fence RAC with its right-angled turn into RBA after excavation from the south. Excavated sections of road ditch (RAO and RBV) are visible in the foreground

from a straight line only where it cut into and briefly followed the line of the palisade trench (7.1, below and Illus 6.1 and 6.6), and then turned a right angle (RBA), shortly after which it changed character, widening and deepening (see 6.2, below). While it could be a drainage feature, the stone packing serving a function similar to post-medieval field drains, its right-angled turn is more likely to indicate that it was a fence line.

Moving east, the fence line LET/RAC/RBA morphed into an irregular, segmental ditch (LDS) to the east of a narrow excavation baulk (Illus 6.1 and 6.6). This ditch varied in width from 0.8m to 1.4m; in depth from 0.32m to 0.48m; and in profile from sharply V-shaped to flat-bottomed U-shaped (Illus 6.9). It continued east for a further 8.5m before intersecting the line of a ditch (LDX/LBS/LCT/LDE) that defined the lower part of the west side of a probable trackway (see 4.2, above). The latter ditch was secondary as it was cut by LDE (Illus 6.9), and had itself been recut. This was evident in plan (Illus 6.10), though the fact was not recognised until excavation of the relevant segment was almost complete. In its final form the ditch (LDX/LBS/LCT/LDE) ran approximately north/south for some 20m from a butt end immediately adjacent to Ditch LAC/LBM/LCQ (Illus 6.1) until it joined the northern road ditch (LEA/LCX) (Illus 4.13). It was 1–1.5m wide and 0.4–0.5m deep with a generally very silty fill (Illus 6.9), and produced a range of finds, including possible fragments of human bone. A quite extensive layer of ash and burning was noted in the lower fill in section LCT (Illus 6.10).

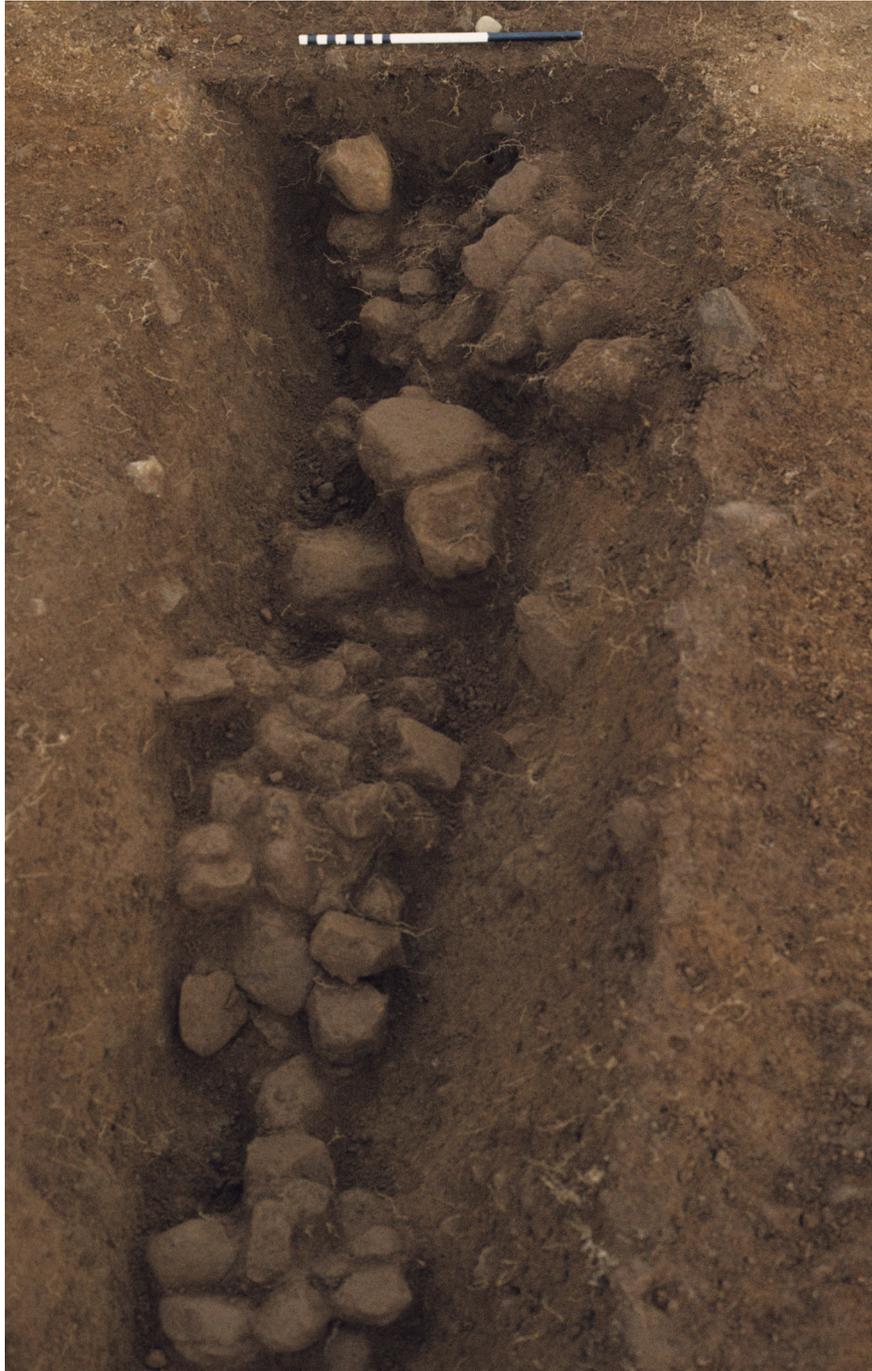
Illus 6.7 Excavated section of Gully RAC showing the extent of its stone packing

was recorded (Illus 6.1 and Table 6.1). It lay immediately adjacent to Gully LET/RAC, whose characteristics are reminiscent of several of the gullies interpreted as fence lines in Areas D, G and H (see 5.1, above). The gully was consistently 0.3–0.5m wide, V-shaped in section, its lower fill often packed with small stones (Illus 6.4 and 6.7). It ran north/south from the northern limit of excavation towards the bypass road, diverging

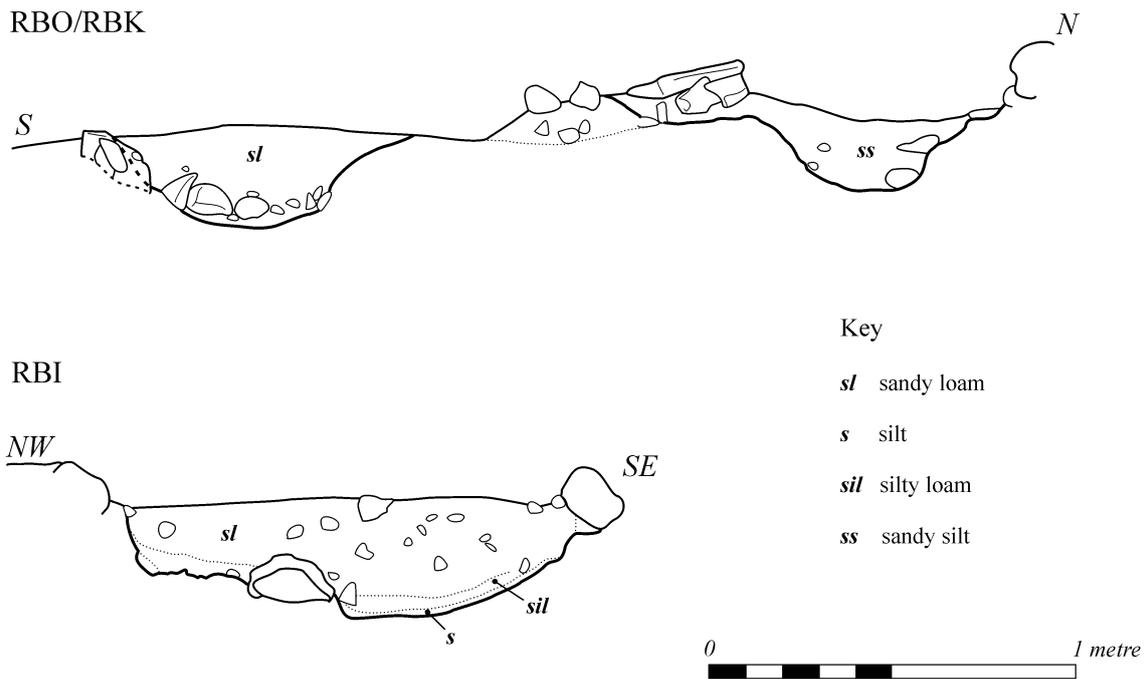
Illus 6.8 Sections through drainage features (RBI and RBK) and pit/stone hole (RBO), Area

Starting from the south-west corner of the rectangular structure described above (6.1), a shallow gully (RBK/RBW) (0.25–0.4m deep) ran west for *c* 13m before turning south (RBX) to join the drainage ditch on the north side of the bypass road (RCC/RCH). Except at its northern end (RBI), which was rather broader, it was 0.55–1m wide with a fairly uniform steep-sided, U-shaped profile, filled with silty loam (Illus 6.8). It may have been a further

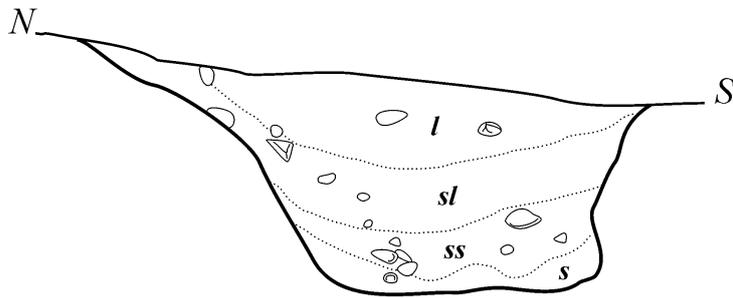
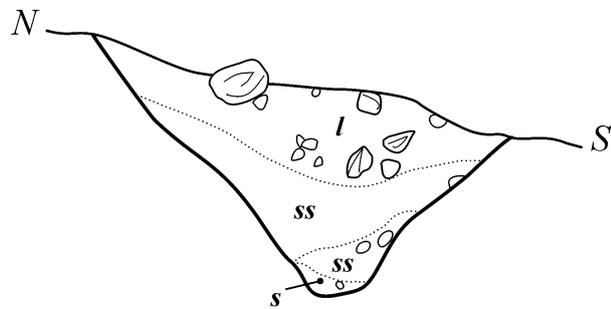
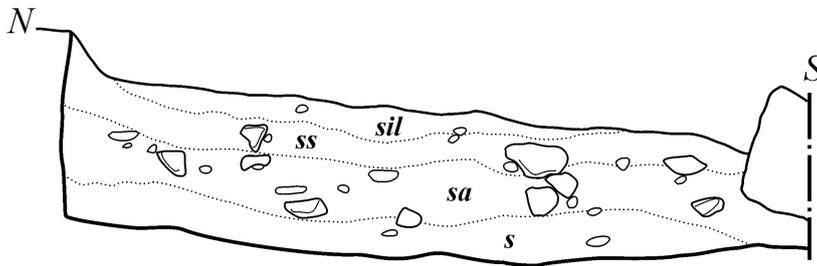
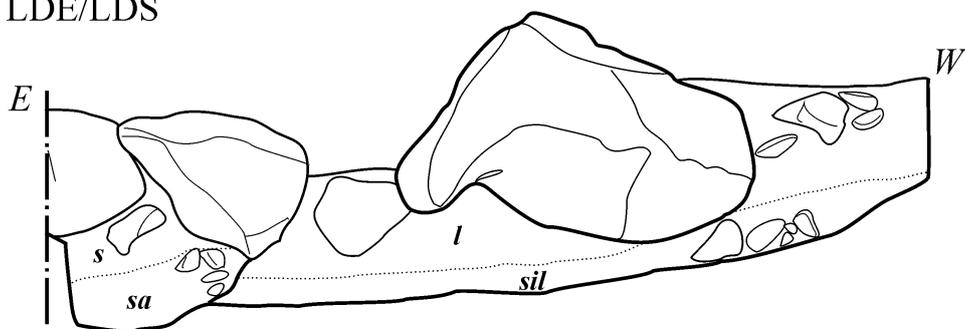
Illus 6.9 Sections through drainage ditch LDS/LDE to the west of the trackway, Area L

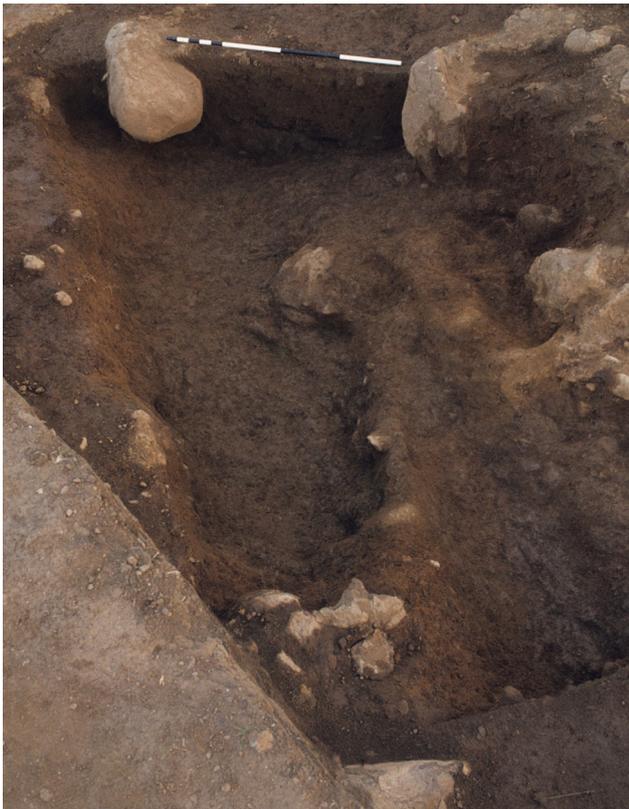
Illus 6.10 Segment of drainage ditch (LCT) on the west side of the trackway from the north, showing the original line to right and burning within secondary fill in section

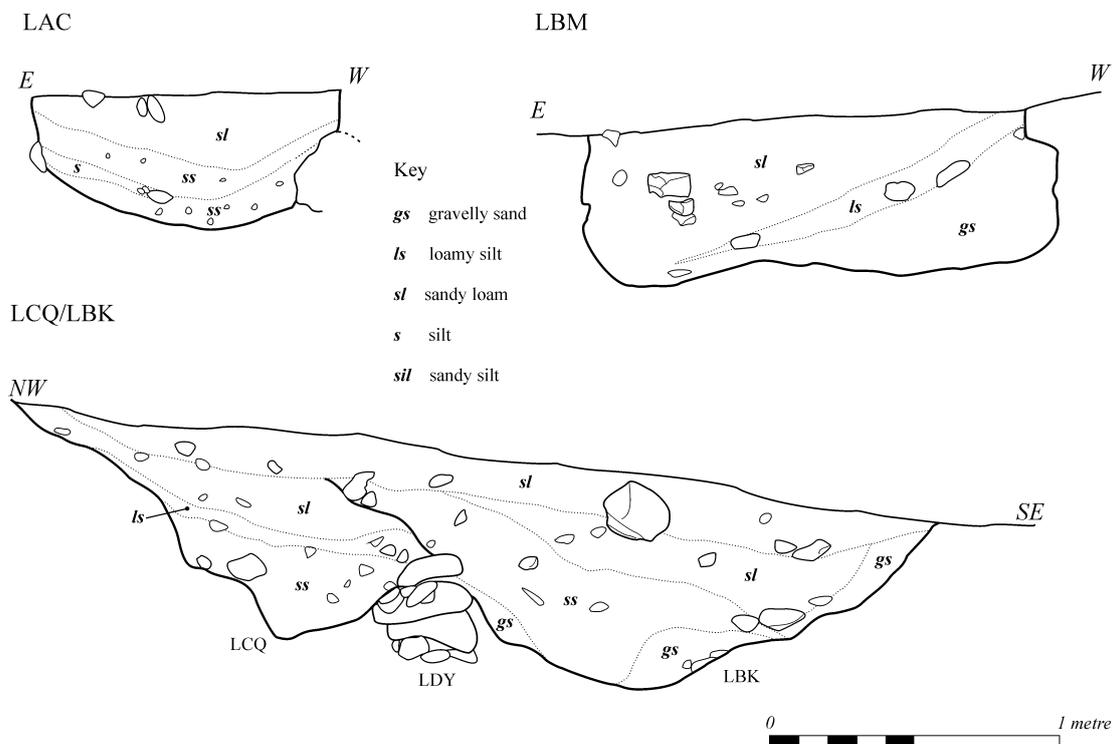
Illus 6.11 Sections through drainage ditch (LAC/LBM/LCQ/LBK), west side of trackway, Area L

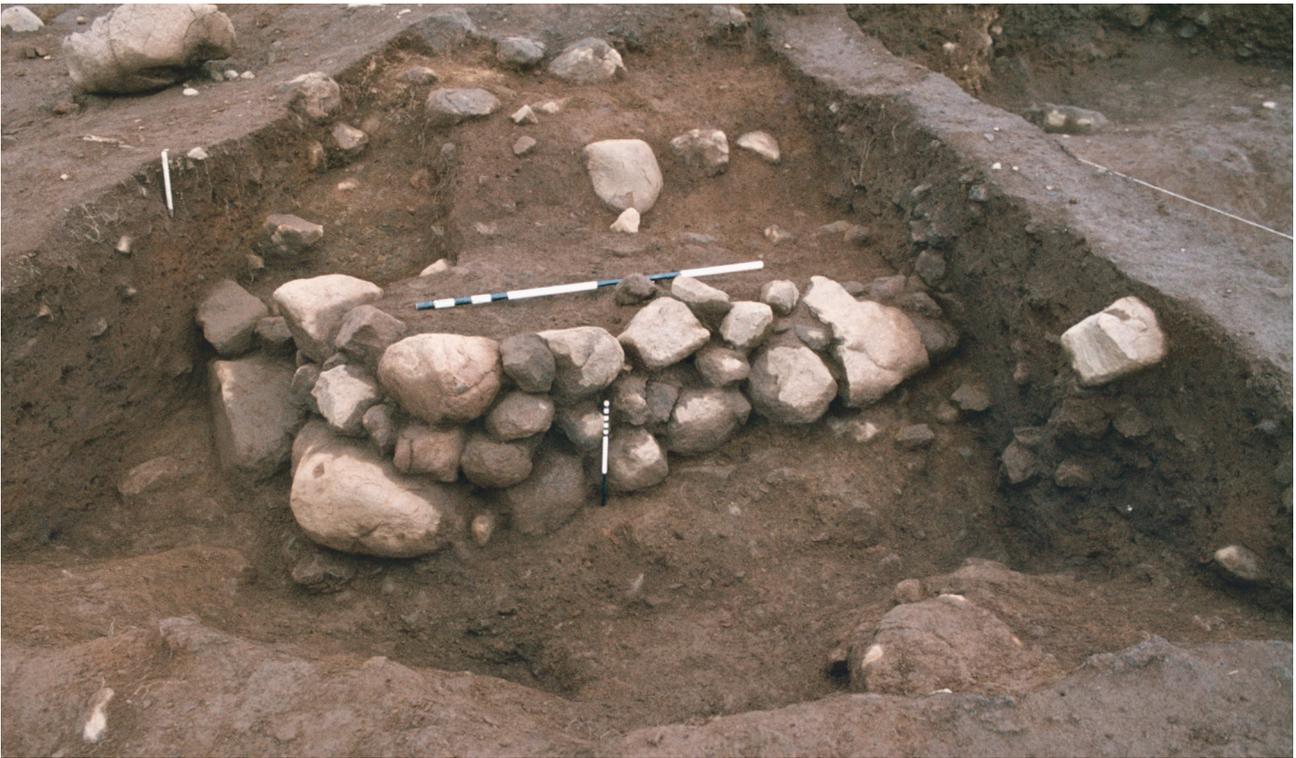
Illus 6.12 Excavated section through secondary drainage Ditch LBK from the south, with stone revetment (LDY) on the south side of primary Ditch LCQ

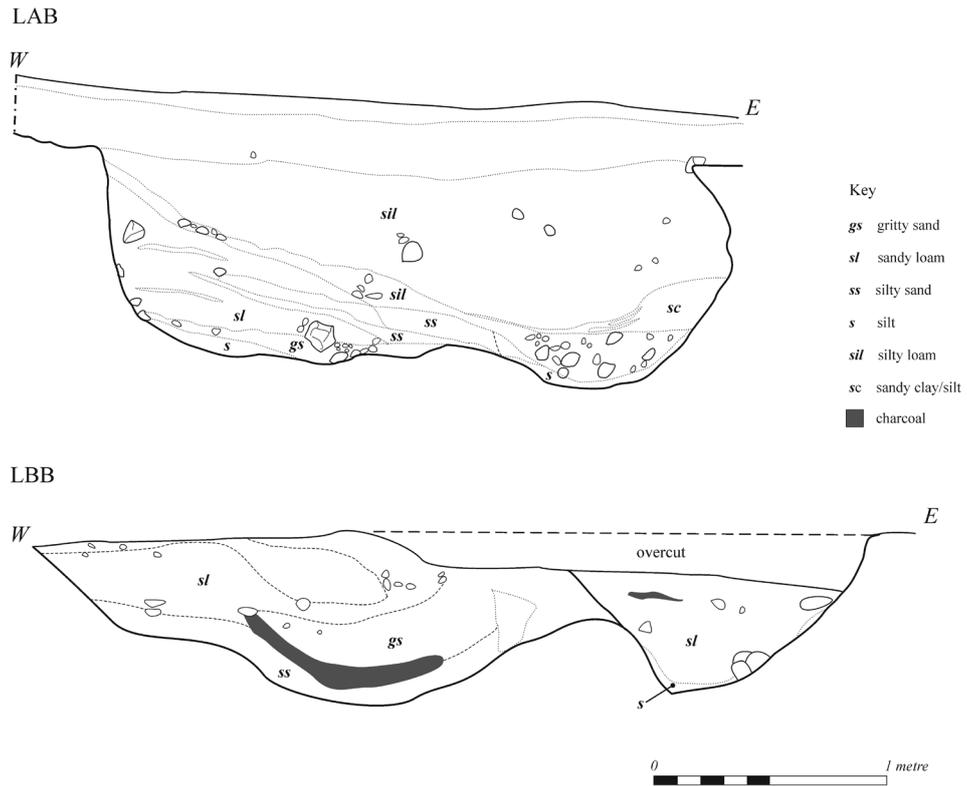
Illus 6.13 Sections through drainage ditch (LAB/LBB) east side of trackway, Area L

(Illus 6.1 and 6.13). The primary ditch widened slightly to 2m before reducing back to 1.6m, and maintained a depth of 0.65m; the recut ditch narrowed to 1.3m and reduced in depth to 0.58m as it reached a butt end. The primary ditch maintained its width but reduced in depth to 0.7m. The upper fills of both ditches were consistently loamy in character above silty lower fills containing occasional charcoal lenses and areas of sand and gravel from slumping of the sides. Like Ditch LAC/LBM/LCQ on the other side of the trackway, these fills contained a large number and variety of finds, with greater quantities coming from the fill of the recut ditch, including a denarius of Trajan and a number of hobnail groups still maintaining the shape of shoes (Illus 9.11).

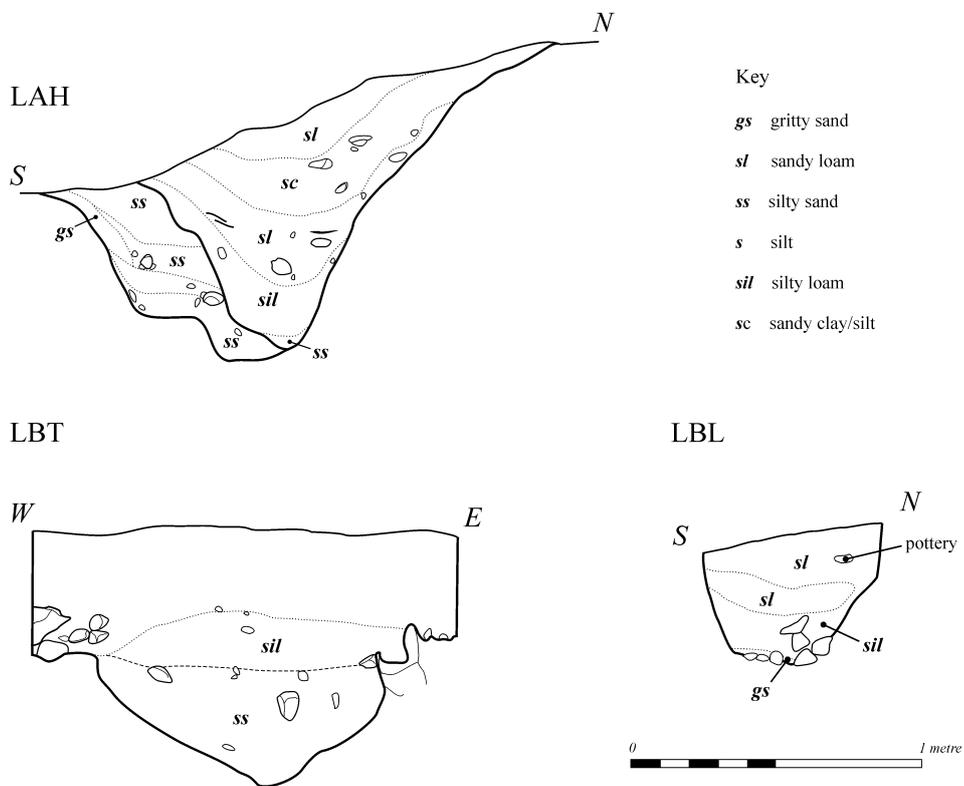
Illus 6.14 Sections through drainage ditch (LBL/LAH/LBT), east side of trackway, Area L

After this break, the line of the ditch (LBL/LAH) continued west for 6m before turning south to run down the slope to join the ditch (LBW/LCG) on the north side of the bypass road (Illus 6.1 and 6.16). Near its northern butt end, Ditch LBL was 0.62m wide and 0.45m deep with a steep-sided, U-shaped profile (Illus 6.14). It appeared to widen to 1.6m as it approached the southern bend (LAH), where it cut through Gully LDL (see below), but a section revealed that it had been recut (Illus 6.14). The surface dimensions of the first phase could not be determined, but it was 0.65m deep and replaced by a ditch 1.4m wide and 0.8m deep with a steep-sided, V-shaped profile. Further down the slope after the bend the ditch dimensions decreased, particularly as it approached the road ditch where it was cut through outcropping rocks and reduced to *c* 1m wide and 0.6m deep (LBT) (Illus 4.13 and 6.14). Upper fills were consistently more loamy in character, though with occasional lenses of charcoal or ash, sometimes containing burnt daub, with increasing proportions of silt in lower fills intermixed with sand as a result of slumping of the ditch sides. Once again, the ditch was rich in finds, particularly in the segments further up the slope, including fragments of a rare

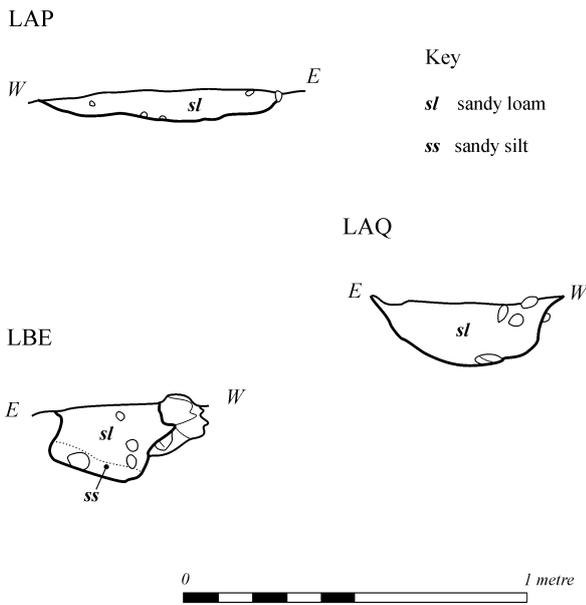
Illus 6.15 Sections through gullies (LAP/LAQ/LBE), Area L

In the south-east corner of Area L, north of the bypass road, a number of disconnected, shallow gullies of uncertain function were recorded (Illus 6.1 and 6.15). A 4.5m length of straight-sided, flat-bottomed gully (LBE), 0.3m wide and 0.12–0.22m deep, could have been structural, but had no other associated features and a layer of sandy silt at the bottom of its fill, so probably served as a drain. To its west, a very shallow, sandy loam-filled gully 0.7m wide (LAP) was traced for 5.7m. It may be contemporary with an earlier fence line (LCR/LDL/LAL – see below), which runs parallel to it, but lacks the characteristics of a structural feature. It in turn abuts a discontinuous gully (LAQ), which runs for 2m on a slightly different alignment before being lost under hillwash. LAQ was narrower (0.55m) but slightly deeper (0.18m) with fairly straight sides, so may have been structural. No finds were recovered from either LAP or LAQ.

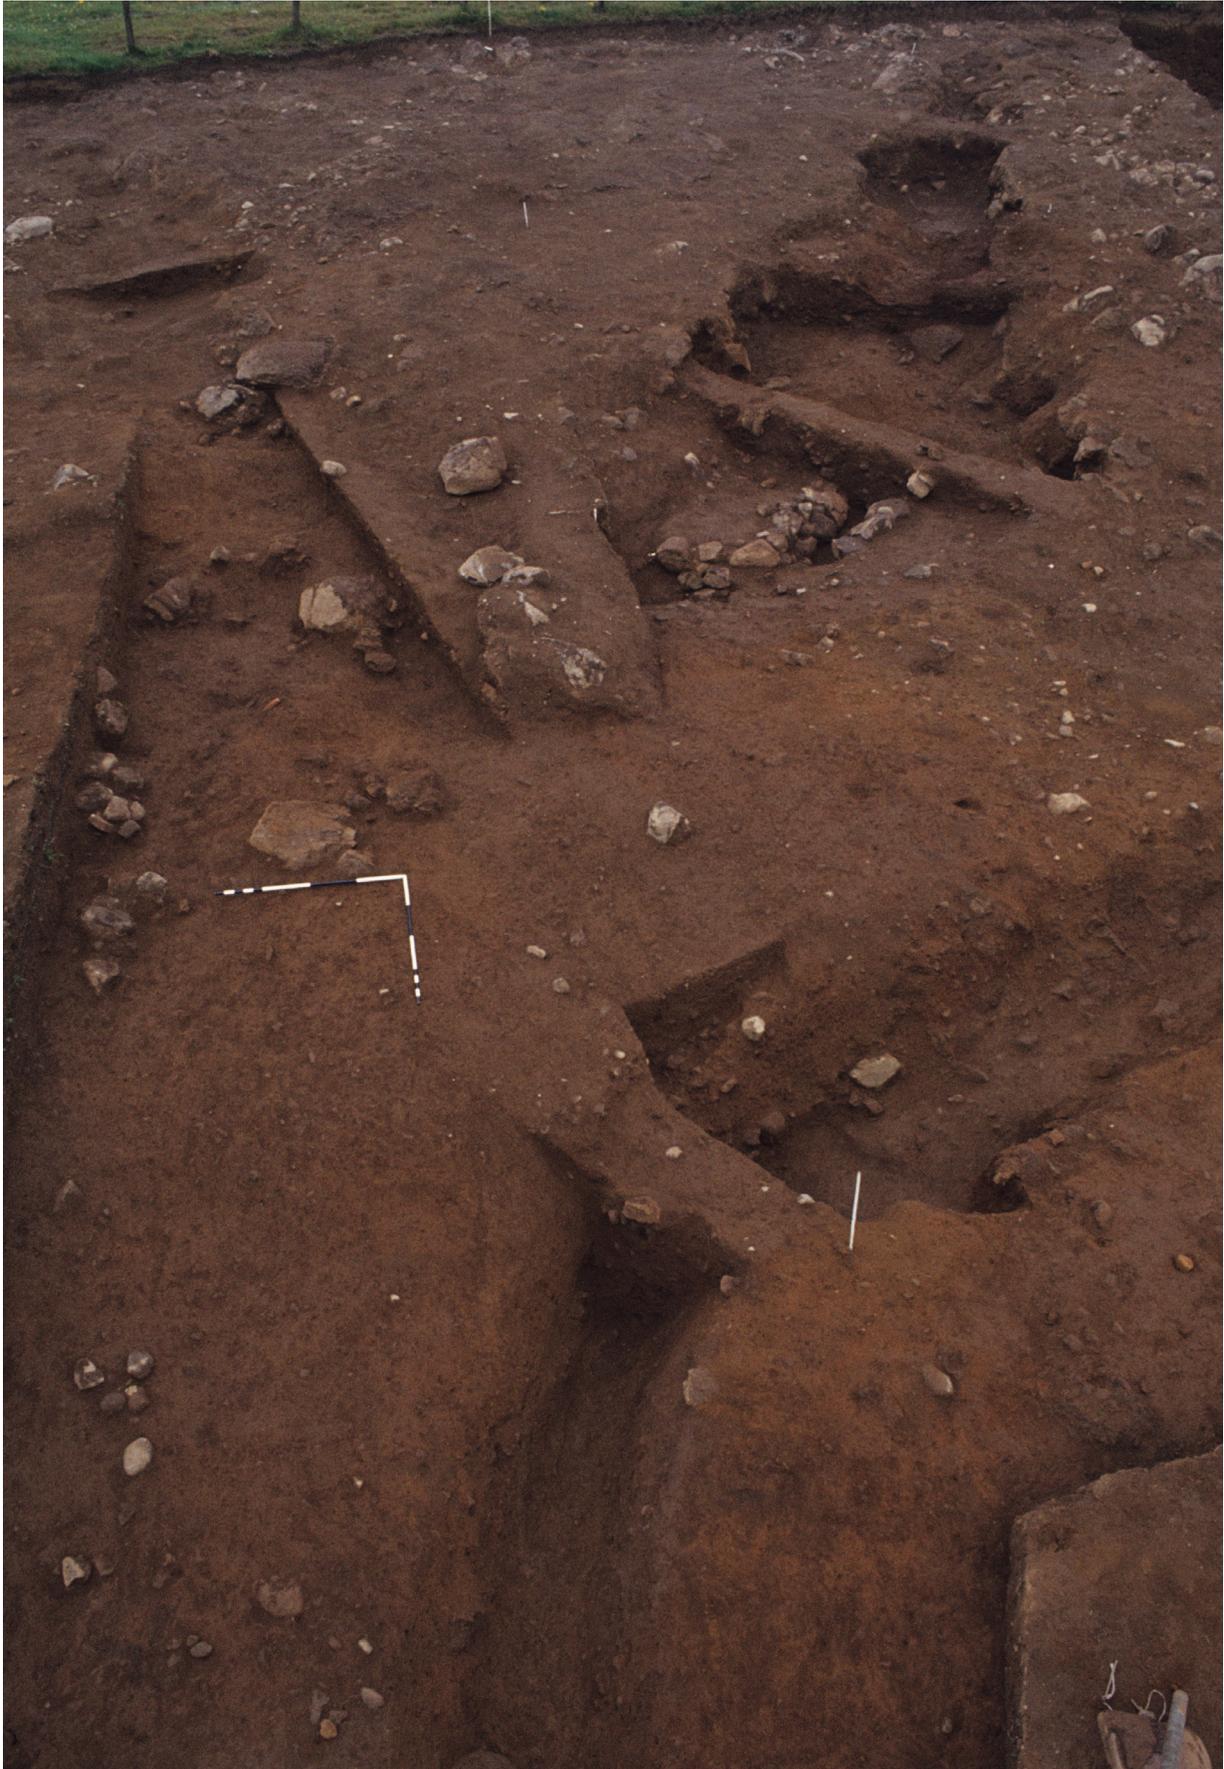
Illus 6.16 Line of the northern half of Gully LCR/LDL partially excavated, cut by trackway ditches LCQ/LDX and LAH, from the south

of Roman ditches described above (Illus 6.1 and 6.16). Despite the presence of a sherd of cordoned urn in its fill (16.2, below), quantities of Roman material, including a samian sherd from the same vessel as sherds recovered from the ditches on both sides of the trackway that cut across it, confirm its Roman date. It commenced 1.7m from the northern limit of excavation and continued for 25.5m before disappearing into the southern limit. The most northerly section spread to a width of 1.9m, but south of the intersection with LCQ it was more consistent in width (0.5–0.7m) and 0.25–0.4m deep, filled mainly with sandy loam. It is unclear whether this was a drainage feature or a fence line.
