4. RESULTS FROM INTRUSIVE WORKS

4.1 Architectural survey

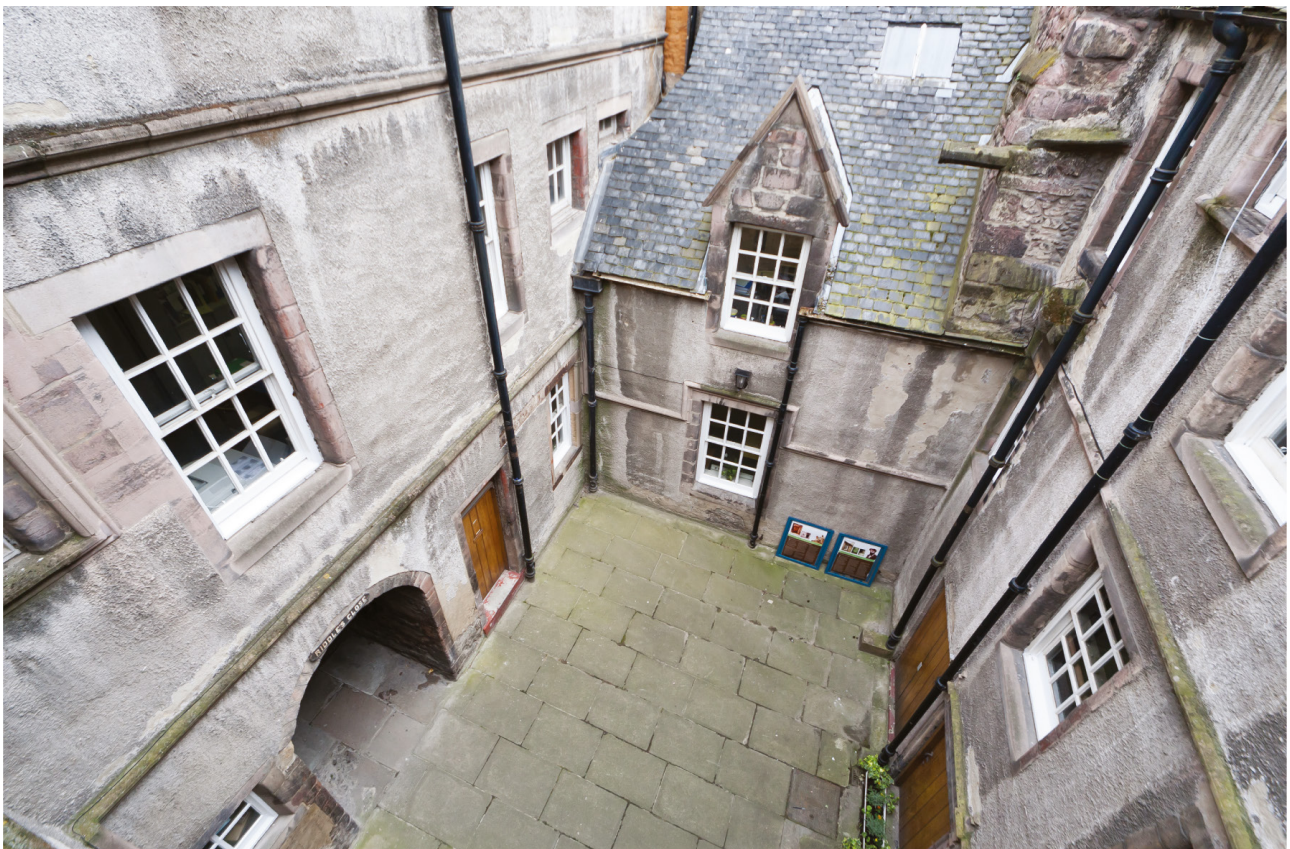
Illus 13 View of the courtyard prior to alteration works. (© Scottish Historic Buildings Trust)

The external building elevations were comprehensively photographed in 2013 and phased interpretations produced, which included the four sides of the internal courtyard (Illus 13) and the external north- and west-facing elevations. Additional recording was carried out during the refurbishment

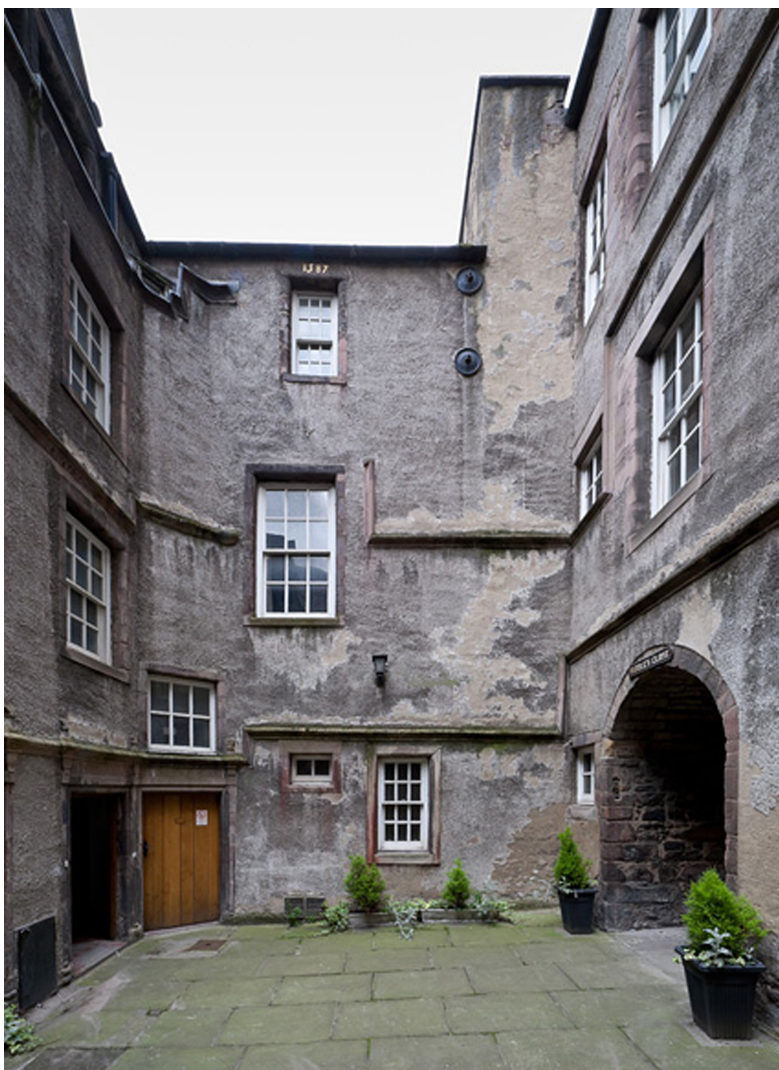
One of the most significant features on the east-facing elevation (Illus 17 & 18) was a chimney in the north-west corner of the courtyard that was comprised of large dressed blocks of sandstone laid in a series of quoins with rubble at its centre. The chimney was not keyed into the North Block, and on the south-facing elevation of the North Block (Illus 14) several windowsills and lintels were visible and clearly running behind this chimney, showing that in terms of phase development the North Block

Illus 18 Courtyard, east-facing elevation. (© CFA Archaeology Ltd)

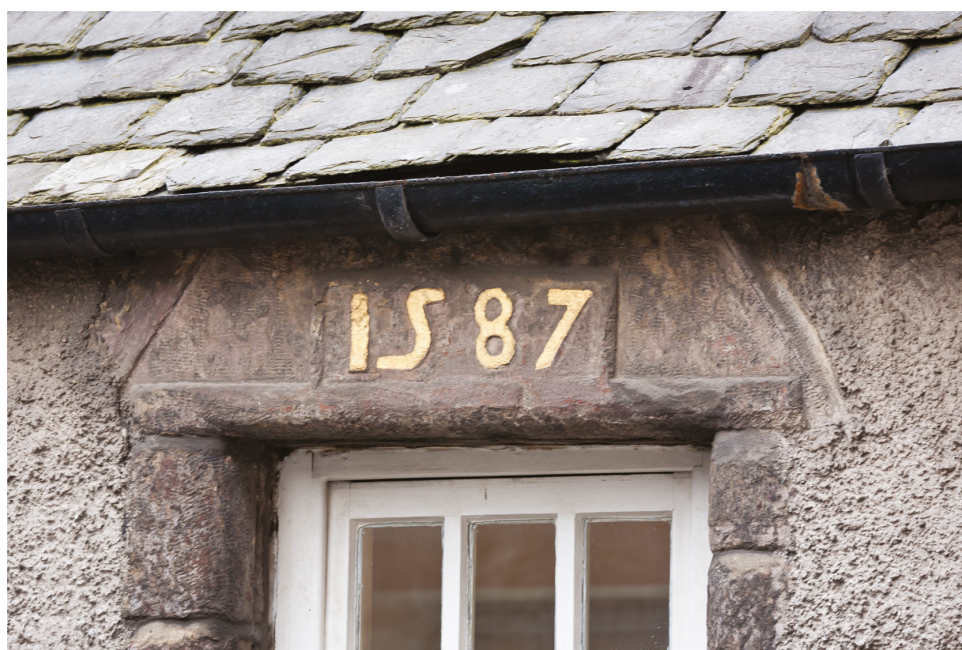
had to have been built before the West Block. This is not at odds with the fact that the Great Tenement built by McMorran was the first building at the site, with the West Block built soon after and certainly by 1587, according to the date stone (Illus 19) and dendrochronology results (see section 5).

Illus 19 The 1587 date stone. (© Scottish Historic Buildings Trust)

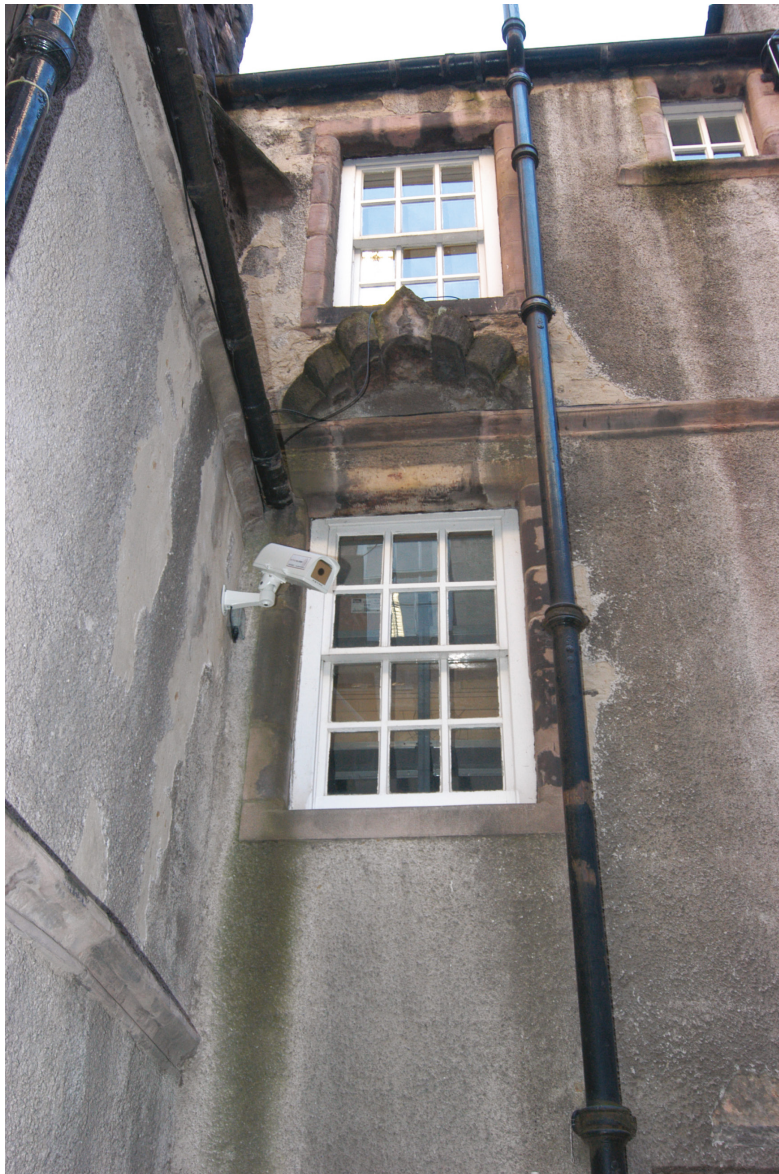
An enigmatic item recorded at first-floor level on the north-facing elevation (Illus 21) was a scallop feature comprising seven individual segments projecting from the main wall line. Past interpretations include a support for a goods-loading beam or mantel/hood over a bell. The quality of the masonry makes this unlikely and alternative interpretations could be a painted heraldic device over an earlier doorway or a formal ‘Great Entrance’ since removed.

Illus 21 Scallop feature on the north-facing courtyard elevation. (© CFA Archaeology Ltd)

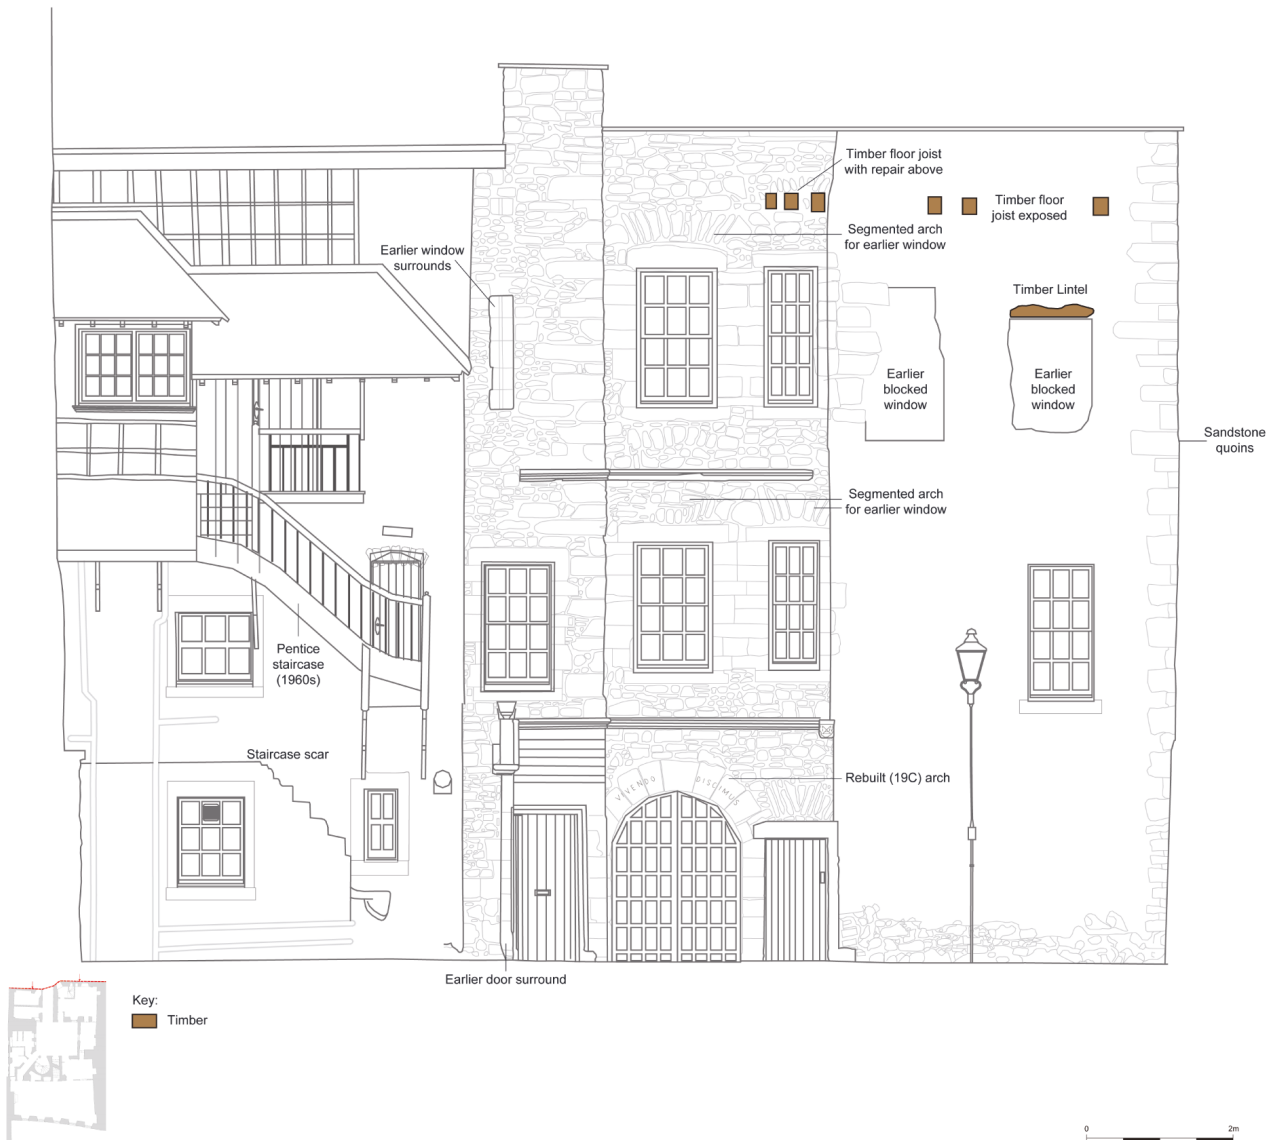
The north-facing elevation (Illus 22 & 23) incorporates the main arched entrance leading from Riddle’s Close into the interior courtyard (Riddle’s Court). The segmented arched entrance had been inscribed in Geddes’s time with the Latin inscription *Vivendo discimus* – ‘By living we learn’ (Illus 24). The arched opening was flanked by two plank-built doors, the left-hand of which has an ornate door surround with corbel work above it. An ornate moulded return stub marked the position of another door, which became a common entrance for the aforementioned demolished tenement building that occupied this position, and the scar of a stone staircase can also be seen on the wall.

The largest feature on this elevation (Illus 22) is the advanced extramural pentice staircase that is a 1960s replacement of the architect Capper’s 19th-century staircase. In the absence of an internal staircase between the first and second floor of the block this pentice staircase was required.

Illus 22 External north-facing elevation. (© CFA Archaeology Ltd)

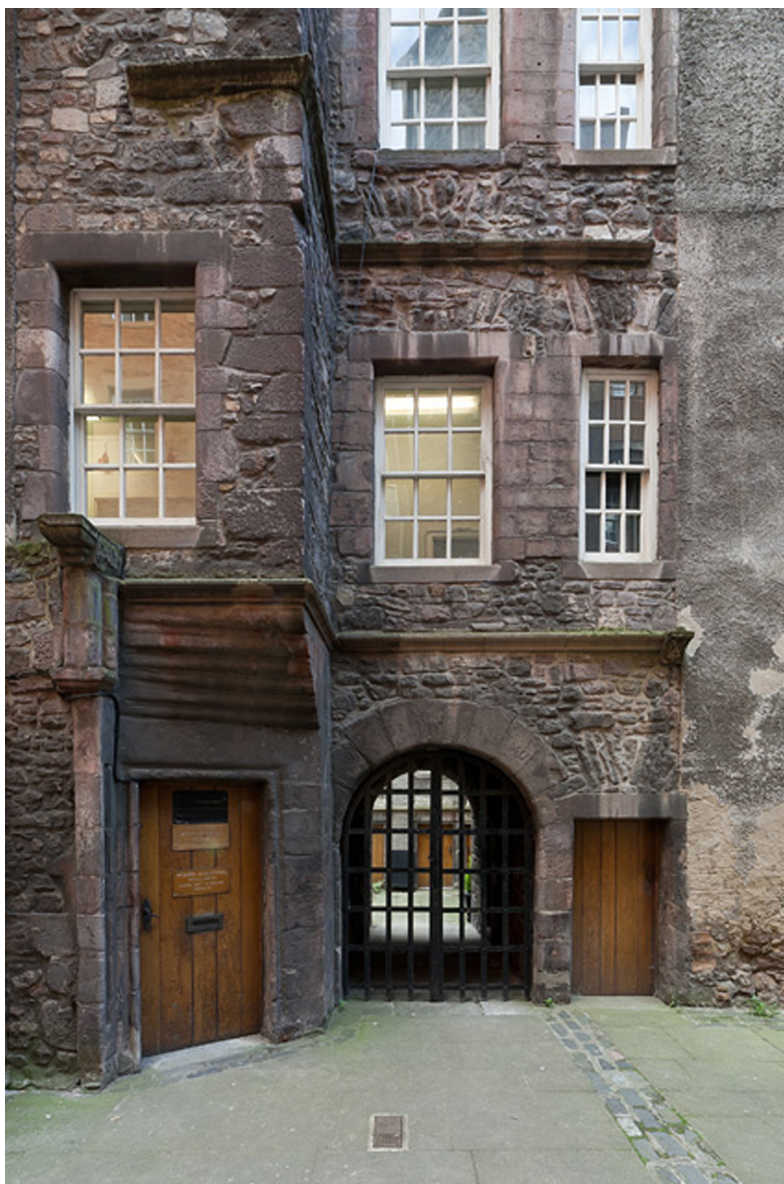
Illus 23 External north-facing elevation. (© Scottish Historic Buildings Trust)

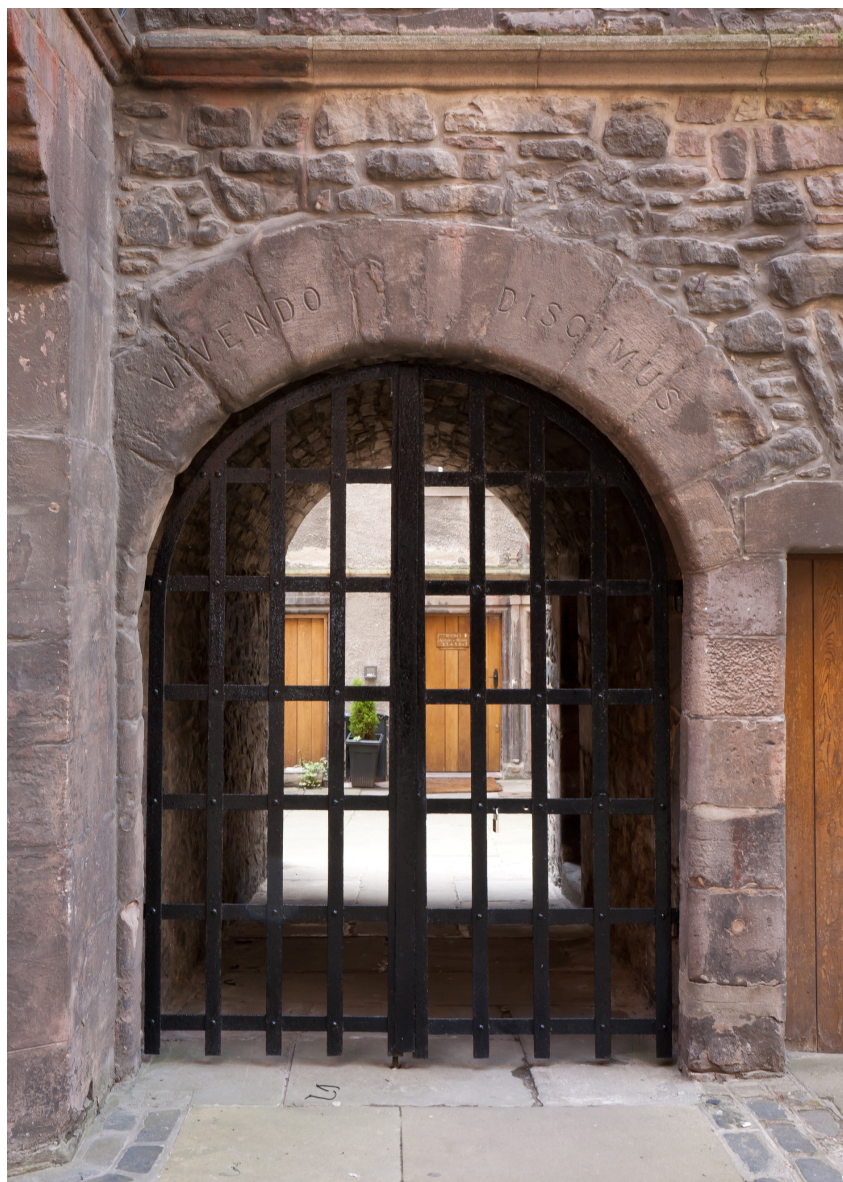
Illus 24 The inscription above the courtyard entrance. (© Scottish Historic Buildings Trust)

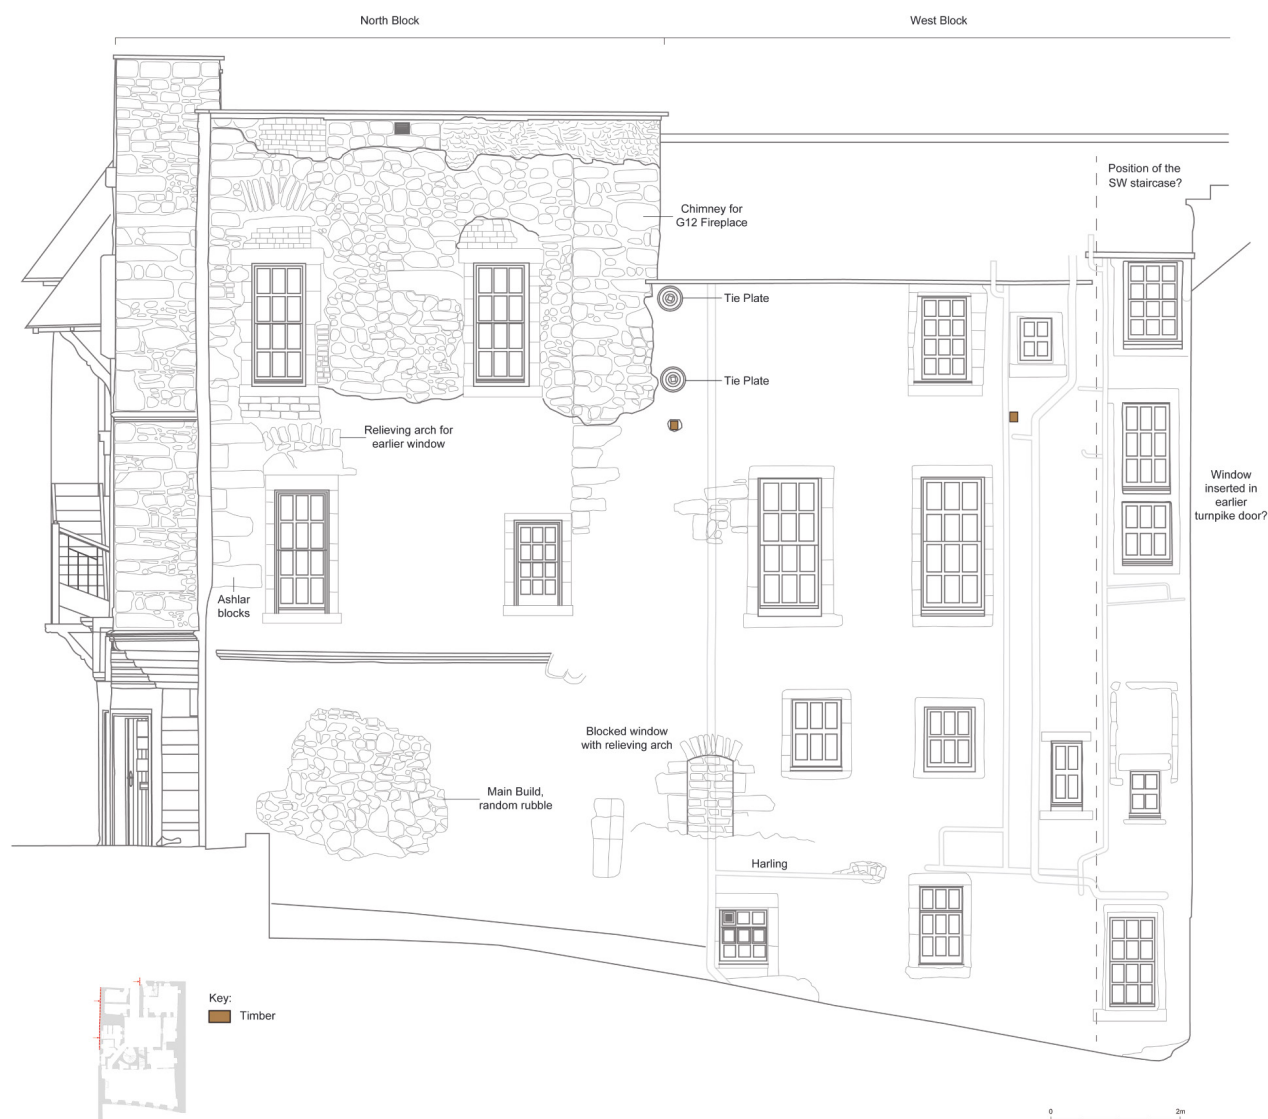
The west-facing elevation contained 18 individual windows of varying size and level (Illus 25). Only three windows on the first floor and two windows on the second floor shared the same lintel height. The line of windows including at the right-hand side (facing) of the elevation may have been associated with an external turnpike staircase; the surrounds around the second and third windows from the top are conjoined, suggesting that this was originally the position of a door.

Illus 25 External west-facing elevation. (© CFA Archaeology Ltd)

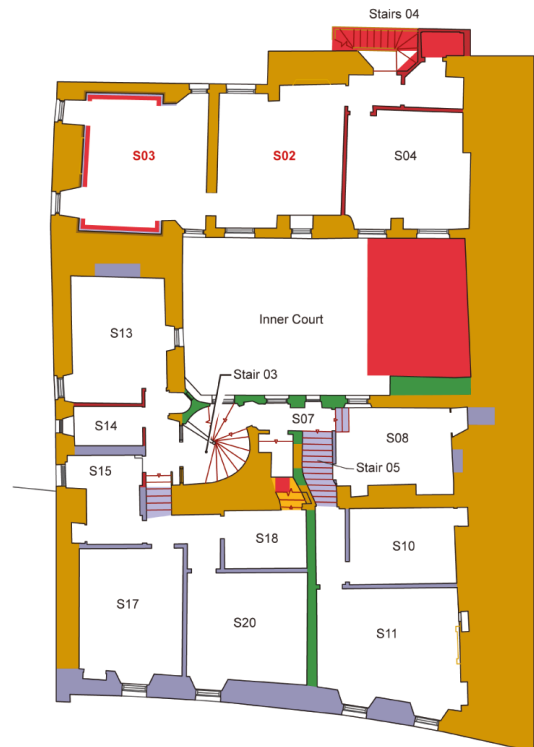
Illus 26 Phase development floor plans of Riddle's Court. (©CFA Archaeology Ltd)

room numbers and relative phase development of the building are shown in Illus 26. The phase development model shown on this plan proposes five main phases, ranging from the pre-16th century (Phase 1 medieval period) through to the 20th century (Phase 5 modern period). The phasing does not account for the possibility of sub-phases, which are likely to exist.

The archaeological work carried out in the basement was confined to Room B02, the former cafe, and B10, a small office (Illus 26).

In Room G12 (Illus 26), blocking work was removed from the large kitchen fireplace and it was found to contain within its interior side walls an intact bread oven and salt press. This fireplace was in use probably up until the 19th century when it was reduced in size by the insertion of a smaller fireplace and a coal cupboard (Illus 31 & 32). The date of construction of the fireplace was *c* 1587 according to the dendrochronology results obtained from the first-floor oak beams directly above it (see 5 'Dendrochronology' below). Parallels for this monumental feature lie in other high-status houses,

The removal of the ceiling in Room F03 (Illus 26) within the North Block revealed the remains of a painted beam and board ceiling dating from the late 16th century (see 6.2.2 'Room F03 ceiling (first floor)' below); the first to be uncovered since the famous painted commemorative beam and board ceiling in Room F02 (King's Chamber) was found in the 1960s (see 6.2.1 'Room F02 ceiling (King's Chamber, first floor)' below).

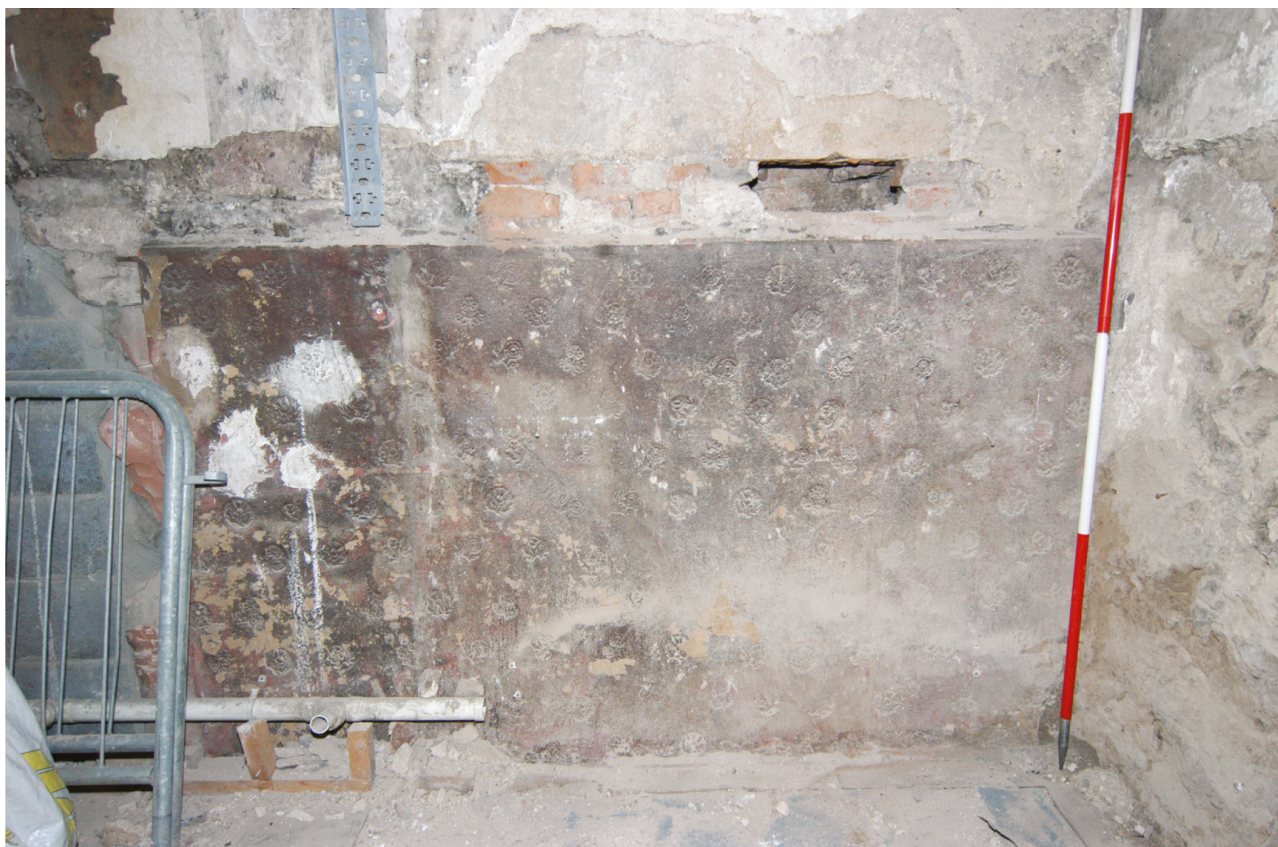
A cement panel, with a randomly placed series of butter-press type impressions including roses, thistles and shamrocks, on the east-facing internal wall of the room is of historical interest in that it may represent a sample of a tradesman’s work specialising in this type of material (Illus 27). Many decorative updates were commissioned by residents during their time in the house, and a craftsman may have left an example of their work for the owner/tenant’s consideration. A similar impressed panel is known to exist in a flat at Ramsey Gardens close to Edinburgh Castle (SHBT pers comm.)

Illus 27 Impressed cement panel in Room B02. (© CFA Archaeology Ltd)

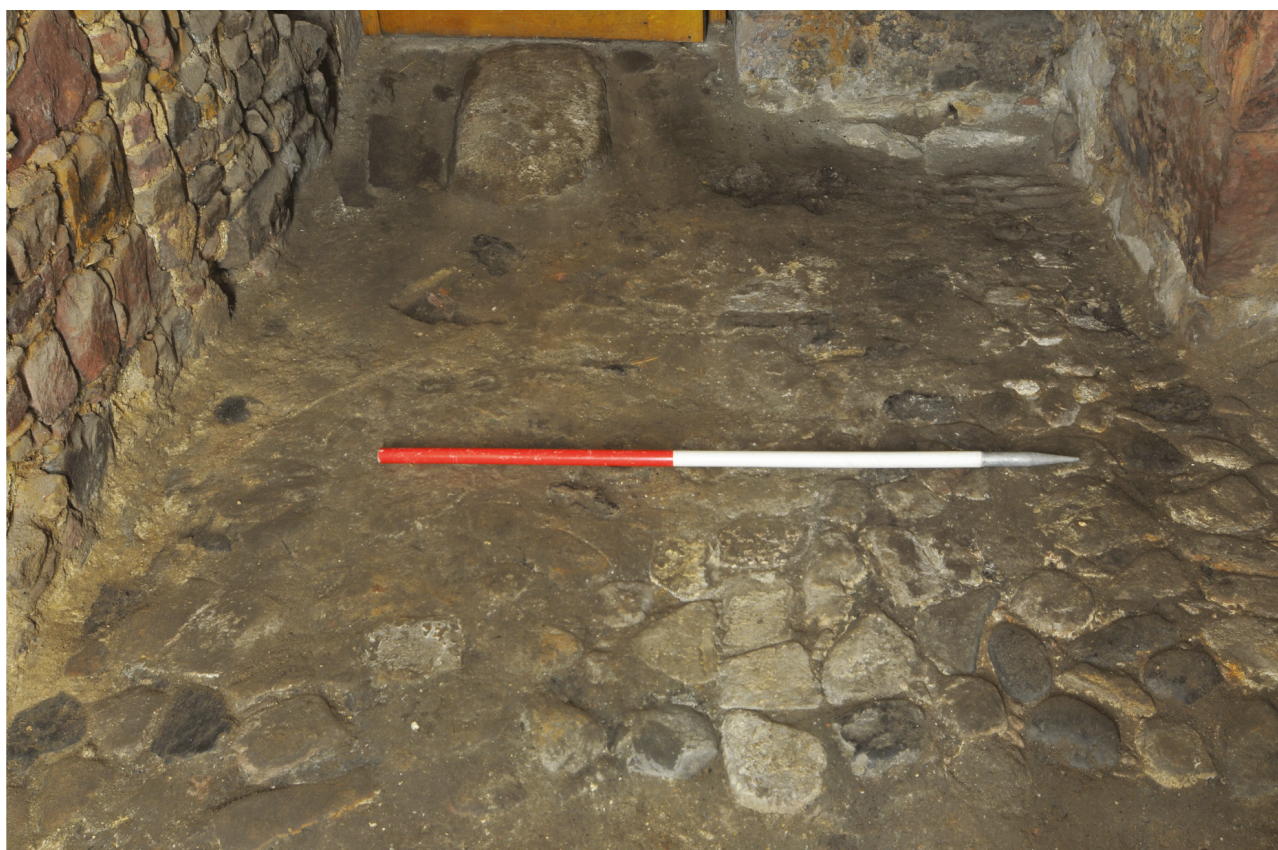
Watching briefs carried out in Rooms G01, G02 and G06 showed that these had beaten earth and cobble floors (Illus 28). Room G02 produced the largest number of finds, including metalwork, pottery fragments, shell and animal bone. The animal bone and shell included fish bone and oyster shell which may have been food waste, and pottery was found dating to the late medieval and

Illus 28 Cobble floor recorded in Room G02. (© CFA Archaeology Ltd)

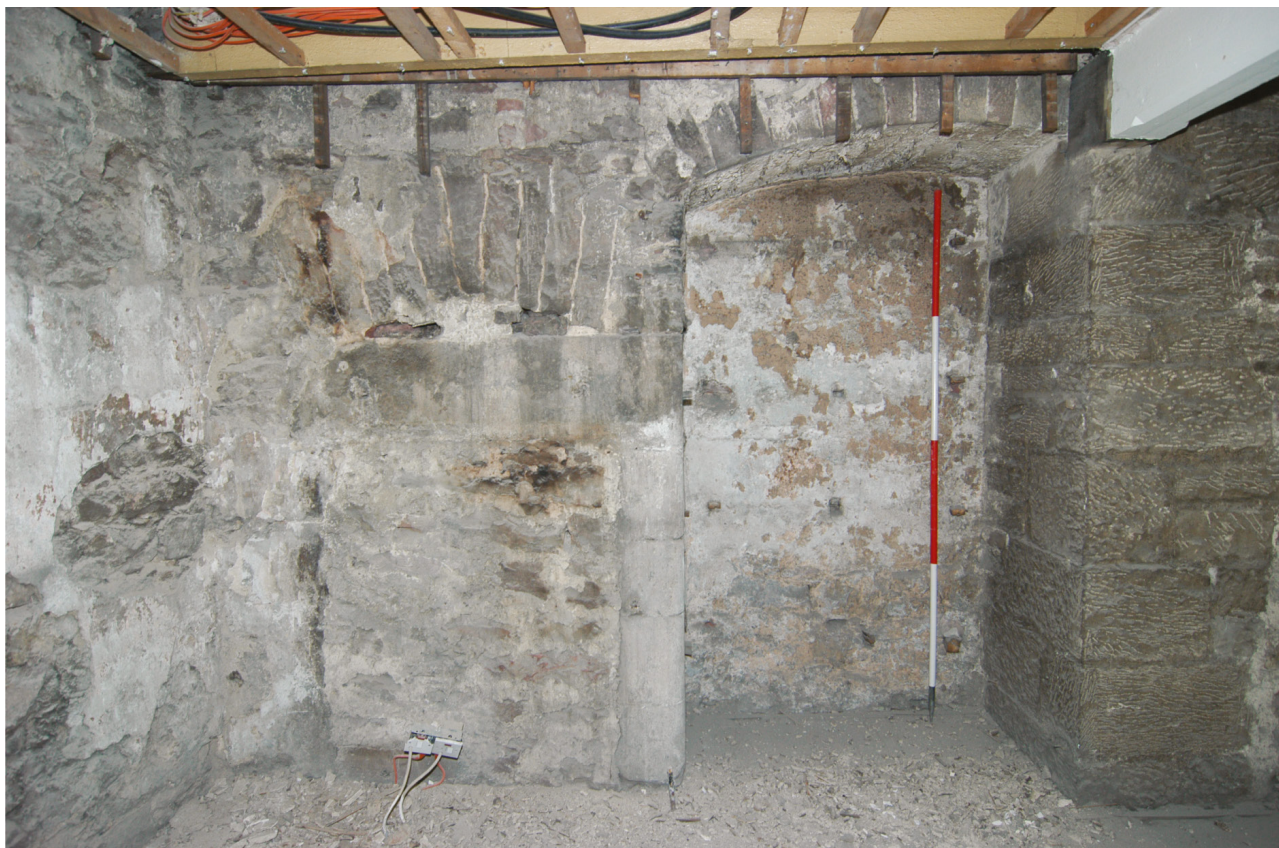
Immediately to the south of Room G06, in Room G07, a fireplace and press were recorded within the area excavated to accommodate the lift shaft. The fireplace was blocked and surmounted by a large stone lintel (Illus 29). The significance of the fireplace is that it was very large in relation to the room in which it sat: a similar but smaller fireplace was recorded in Room G08, and again this was a large fireplace for a relatively small room, but this room likely formed part of the principal family chambers in the early 17th century. The most significant find from Room G08 was a crushed hallmarked silver mount from a walking cane which

Illus 29 Blocked fireplace and press in Room G07. (© CFA Archaeology Ltd)

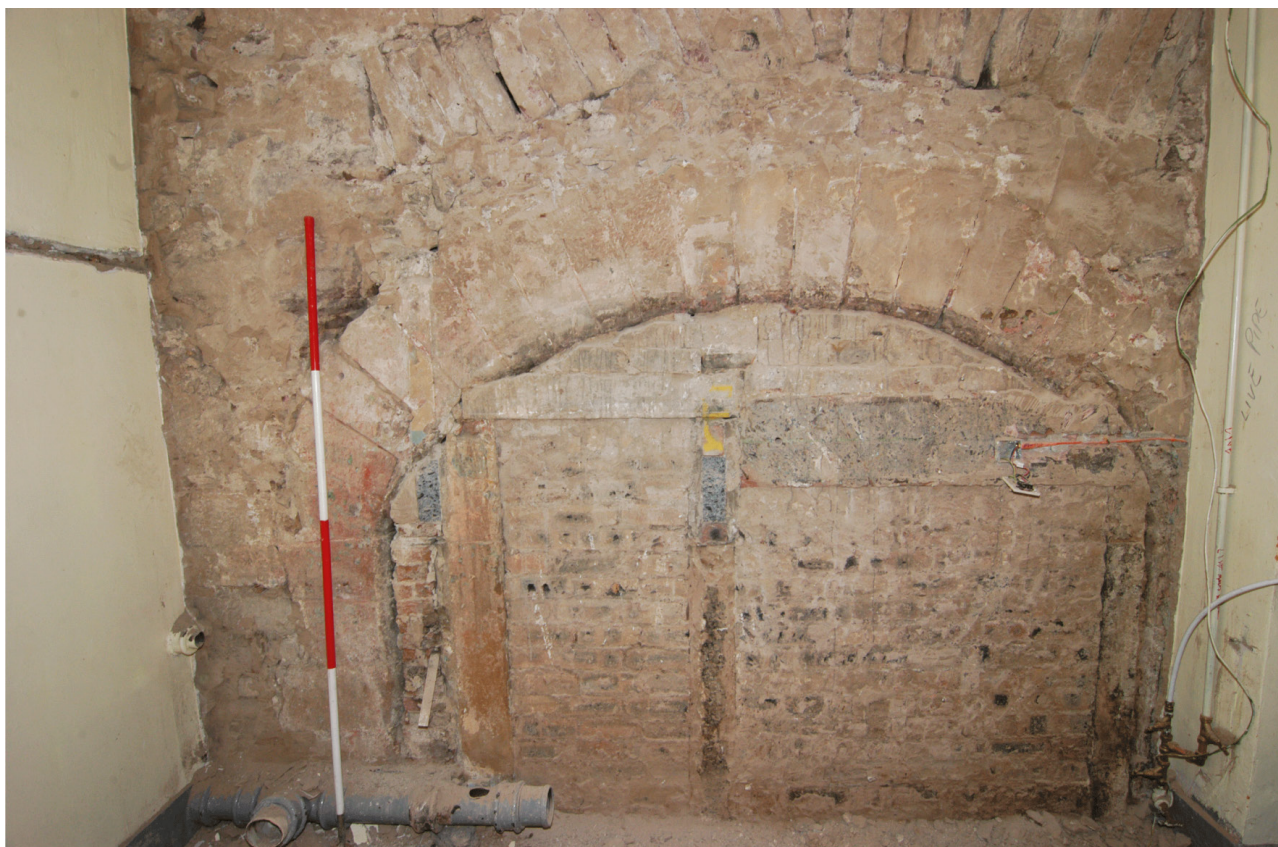
Illus 31 The G12 fireplace showing the segmented arch of the 16th-century fireplace with a later blocked fireplace and coal cupboard. (© CFA Archaeology Ltd)

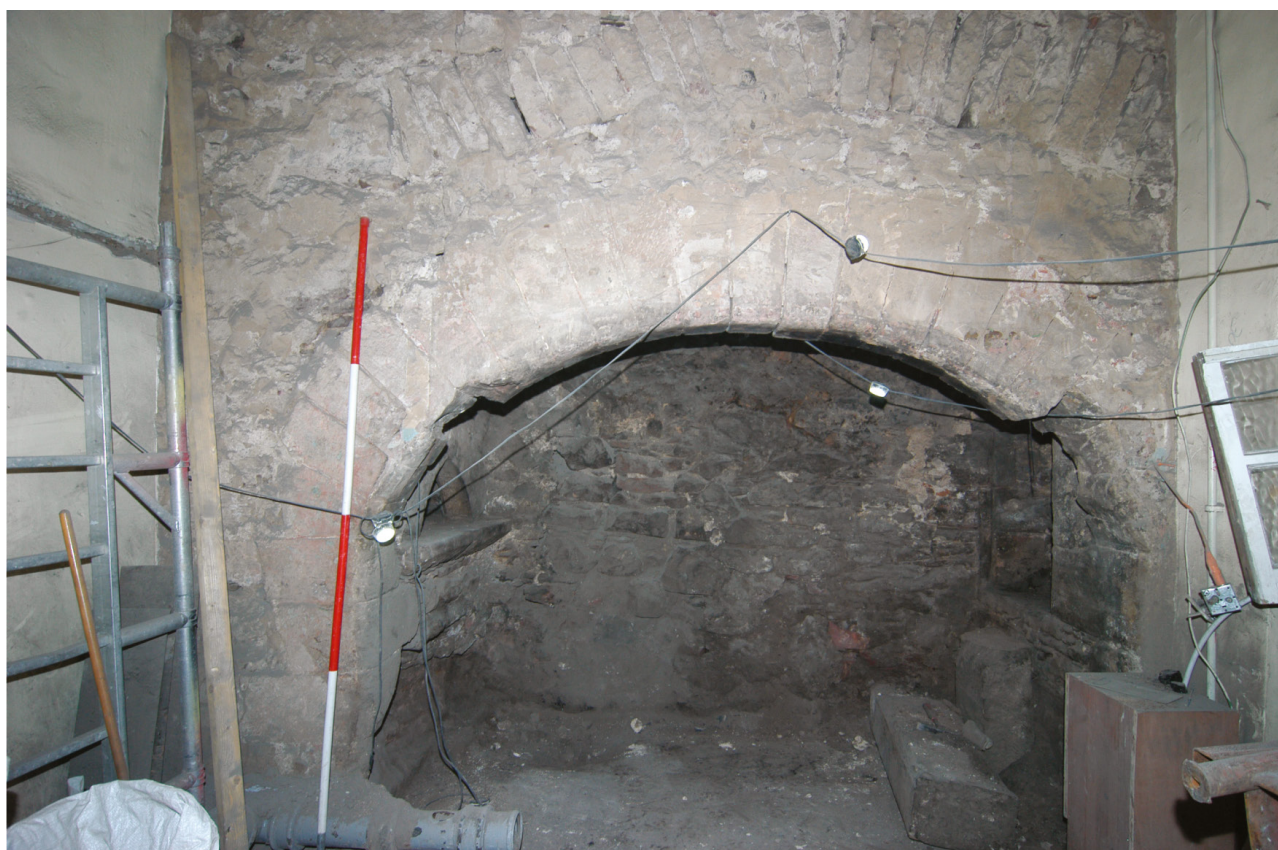
Illus 32 The G12 fireplace after the removal of the later insertions. (© CFA Archaeology Ltd)

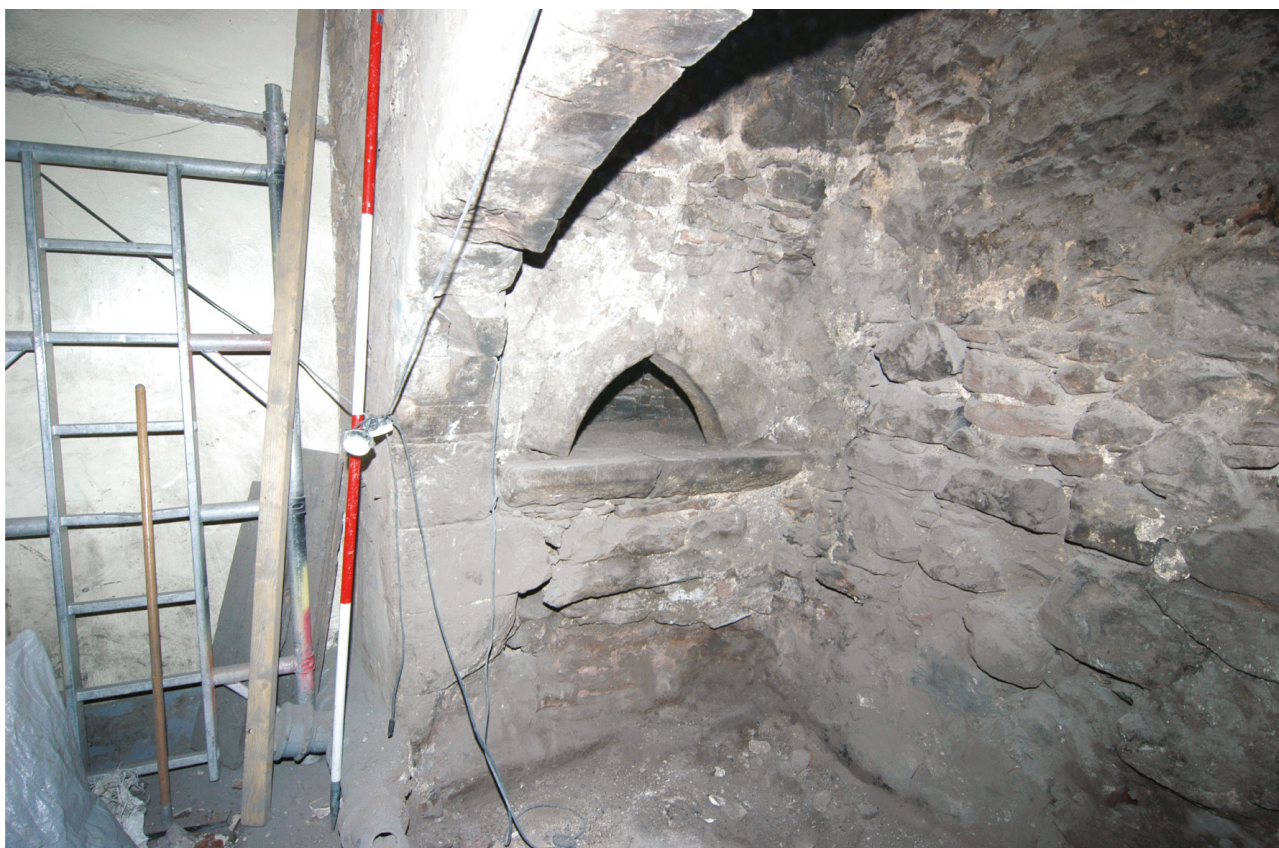
The bread oven was framed by four individual sandstone blocks, two of which were curved to form a beehive-shaped opening (Illus 33). The interior of the oven was lined with small rectangular refractory clay bricks that formed a small dome. The oven had no flue and it was stoked and vented through its opening. On the opposite wall to the bread oven was the salt press, where pots of sea salt could be kept dry (Illus 34). The press had a lintel stone surmounted by a small relieving arch, confirming that this was an original feature integral to the 16th-century fireplace

and not a later insertion. A small slot had been cut into one of the reveals, possibly to hold a thin stone shelf.

Illus 33 The flue-less bread oven within the interior of the G12 fireplace. (© CFA Archaeology Ltd)

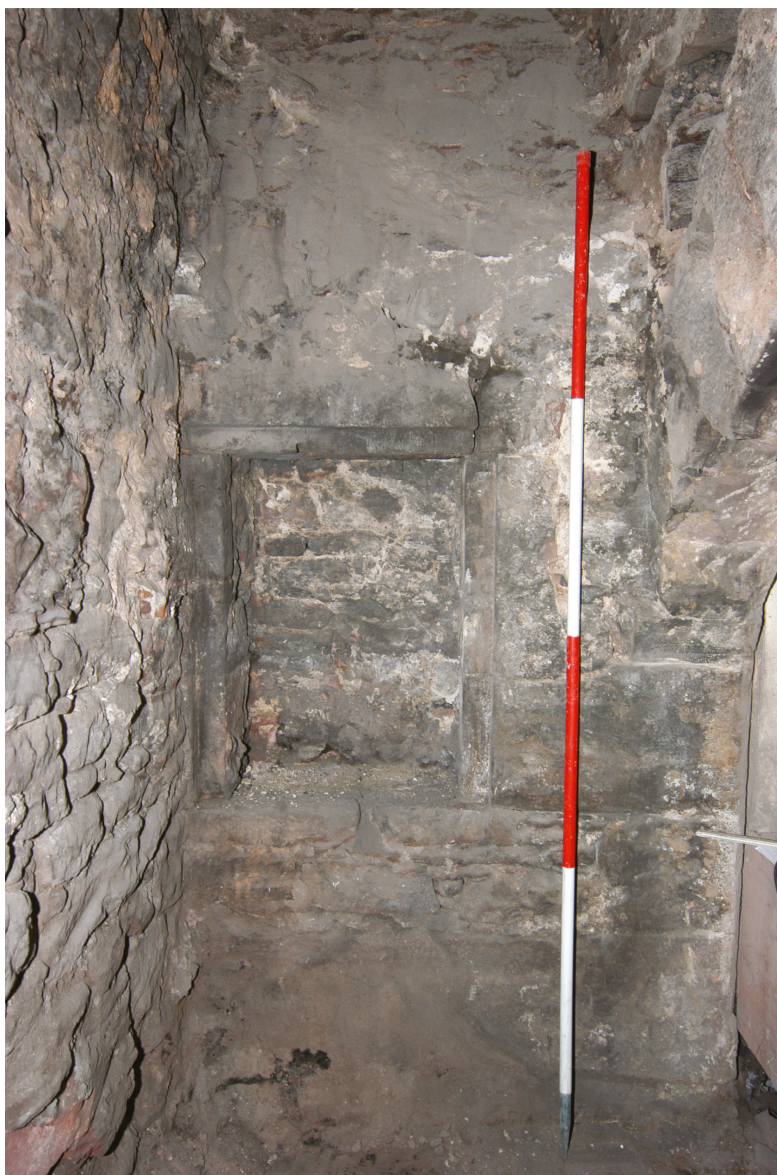
Illus 34 The salt press within the interior of the G12 fireplace. (© CFA Archaeology Ltd)

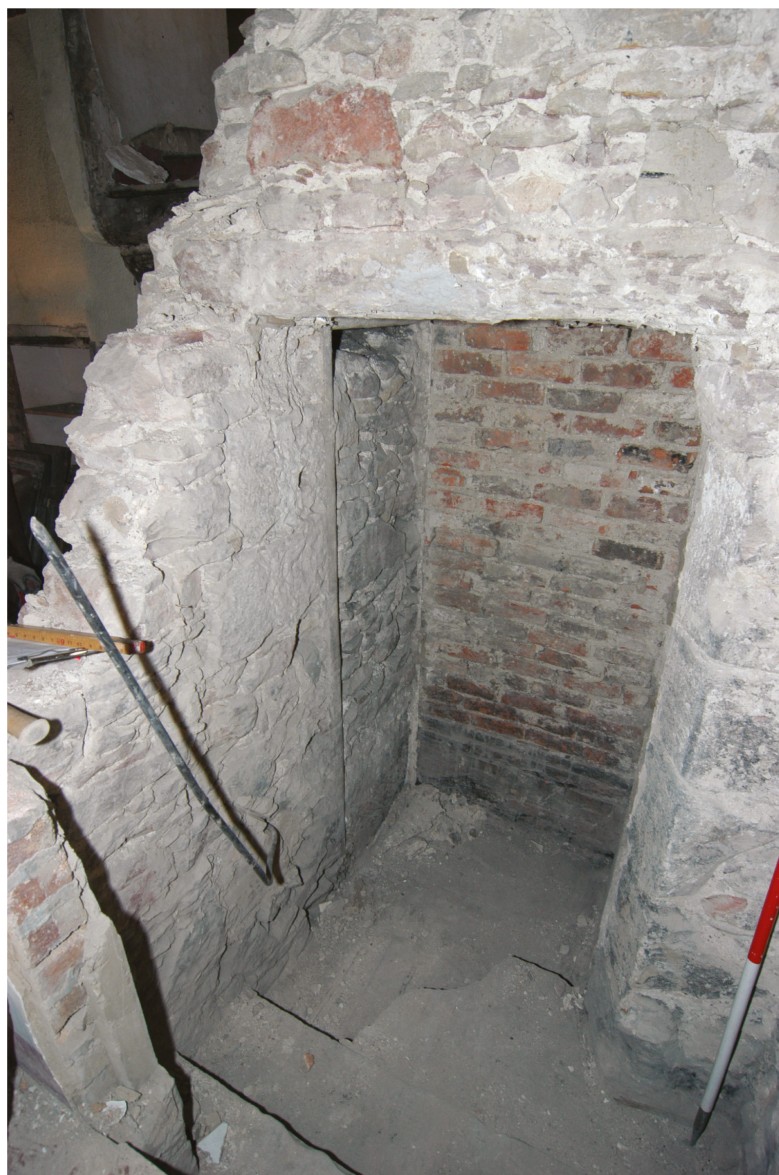
Illus 35 Blocked doorway in Room S07 with chamfered door surround. (© CFA Archaeology Ltd)

staircase between the Cupboard S07 and Room S08. The removal of the staircase revealed a 16th-century blocked doorway within the east wall of the cupboard (Illus 35). This doorway must have opened into a larger room (part of Room S08) with a lean-to roof with a steeper pitch supported on stone corbels. The *c* 1580s wall must have run the full length of the north side of the South Block but it was replaced by a thinner wall supporting the existing (19th-century) windows overlooking the courtyard. This wall was later modified when the north-facing windows were installed along with the only surviving turnpike staircase in the 17th century. Room S08 would have been a chamber of significant size in the 17th century.
