SCOTTISH ARCHAEOLOGICAL INTERNET REPORTS

Cowhides and motorcars: the history of Beaverbank Tannery

Morag Cross, Magnar Dalland and Debora Moretti

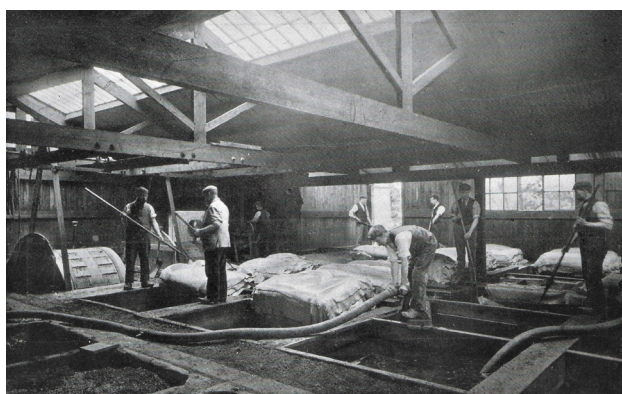
Illus 19 An example of a 19th-century tannery (© Keighley News)
