### 3. ARCHAEOLOGICAL RESULTS

#### 3.1 Standing building recording

### 3.2 Watching brief

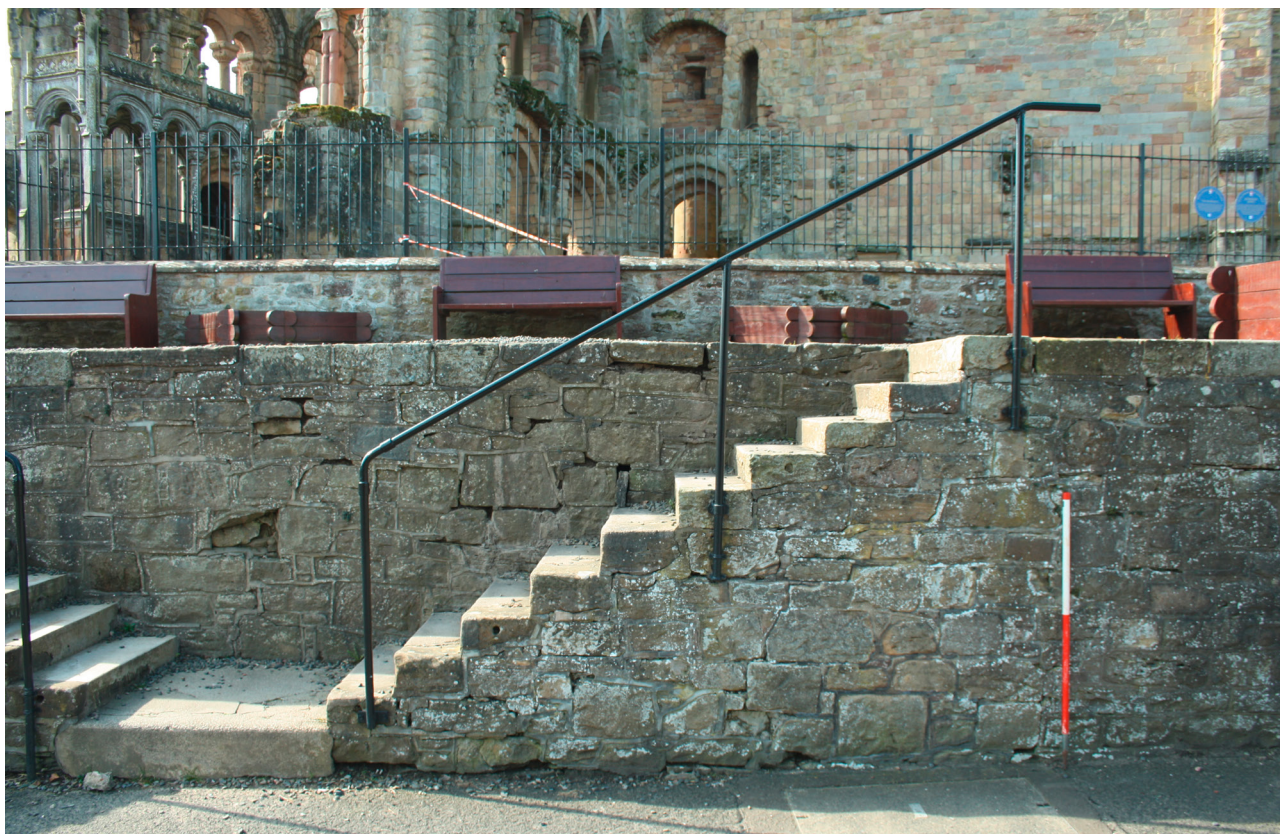
**Illus 5** Photograph showing failure and damage to ‘rampart’ wall at former double access steps (Image by Heritage and Archaeological Research Practice)

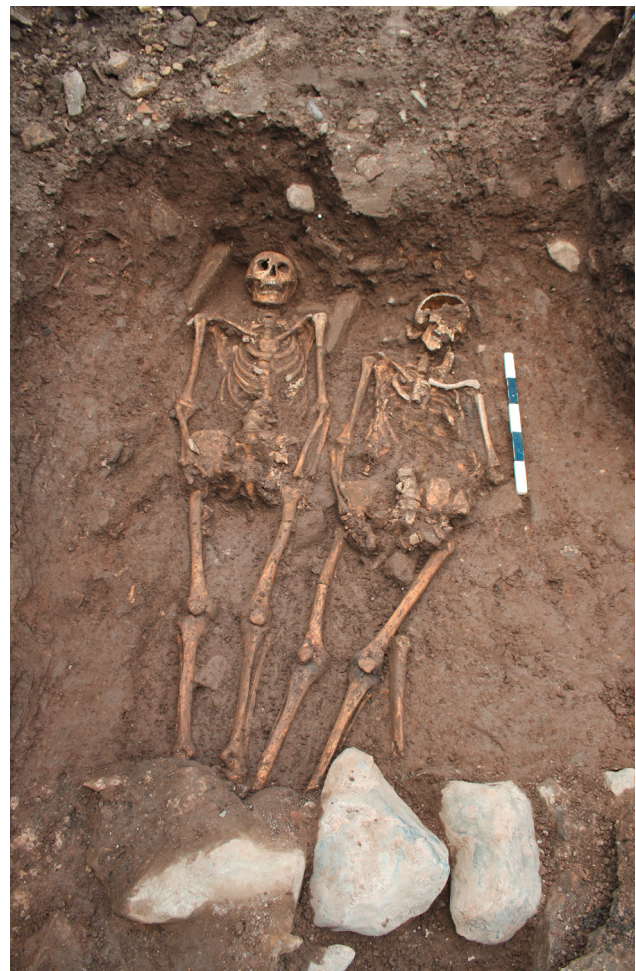
Both skeletons were positioned on their backs, lying east-west with heads to the west and hands positioned beneath the hips. The two bodies were lying adjacent to each other with C028 (Individual ‘A’) located to the north, and C029 (Individual ‘B’) located to the south. No distinct grave goods were found buried with either individual, however three small fragments of a horseshoe key (SF10) were found clasped in the left hand of Individual ‘B’. The position and close proximity of the remains suggest that both individuals were interred at the same time, and it was only possible to identify evidence of one grave cut, C038, that surrounded both individuals. The grave cut was only clearly distinguishable in deposit C032, an unexcavated, orange-brown sandy silt revealed below C025. The base of grave cut C038 had very shallow sloping sides and a concave base, with the limits of the grave cut extending just beyond the extent of the

**Illus 9** Photograph showing Individuals ‘A’ and ‘B’ (Image by Heritage and Archaeological Research Practice)

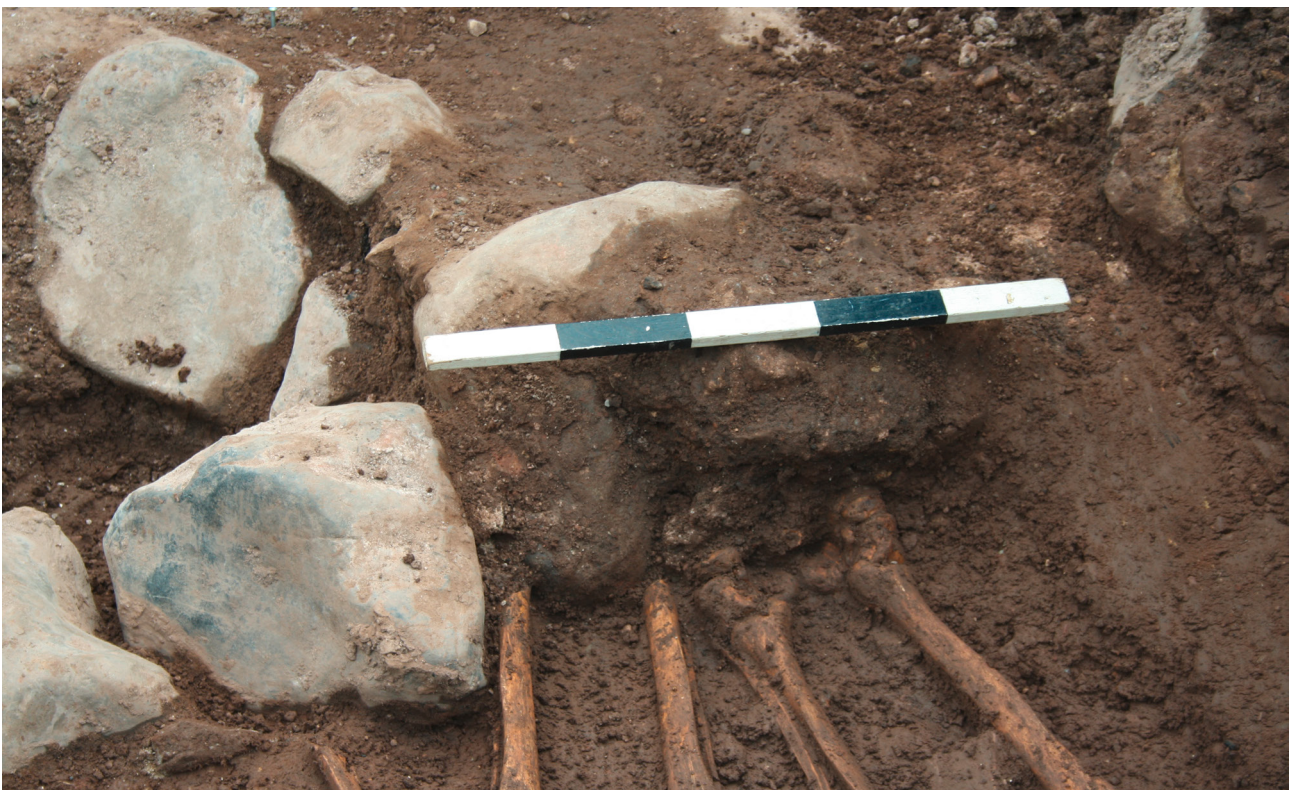
The eastern end of grave C038, along with the lower legs and feet of both individuals 'A' and 'B', had been subsequently damaged and cut through during the construction of the 'rampart' wall and steps (Illus 10). The visible, linear foundation cut

**Illus 10** Damage to lower limbs from 'rampart' construction (Image by Heritage and Archaeological Research Practice)

for the 'rampart' wall, C047, was found to have cut through the distal ends of the tibiae of Individual 'A', with the lower portion removed along with their feet. The feet of Individual 'B' had also been disturbed and partially crushed/covered over by 'rampart' wall foundation stones, C039, and matrix, C040. The wall foundation cut and foundation stones were traced for 3.6m in this area of the repair works, with the foundation cut extending to up to 0.65m wide, and bounded on the east by modern tarmac/pavement. The depth of the foundation cut was not revealed as the rounded boulders forming the foundation stones of the 'rampart' walls were left in situ to provide a solid base for the new 'rampart' wall to be built on.

The eastern end of grave C038, and as a result, the lower limbs and feet of both Individual 'A' and Individual 'B' were found to have been disturbed and cut through by the foundation cut for the construction of the 'rampart' wall, with both tibiae of Individual 'A' being cut through completely, and the feet of the individual removed. Whilst the tibiae of Individual 'B' were not cut through, the feet were disturbed by the construction of the wall foundations, and not fully intact.
